2018 Routine/Fracture Critical Member Inspection Report

Anna Hunt Marsh Bridge
NH Route 119 over the Connecticut River
NHDOT Bridge No. 041/040
Hinsdale, New Hampshire

July 2018

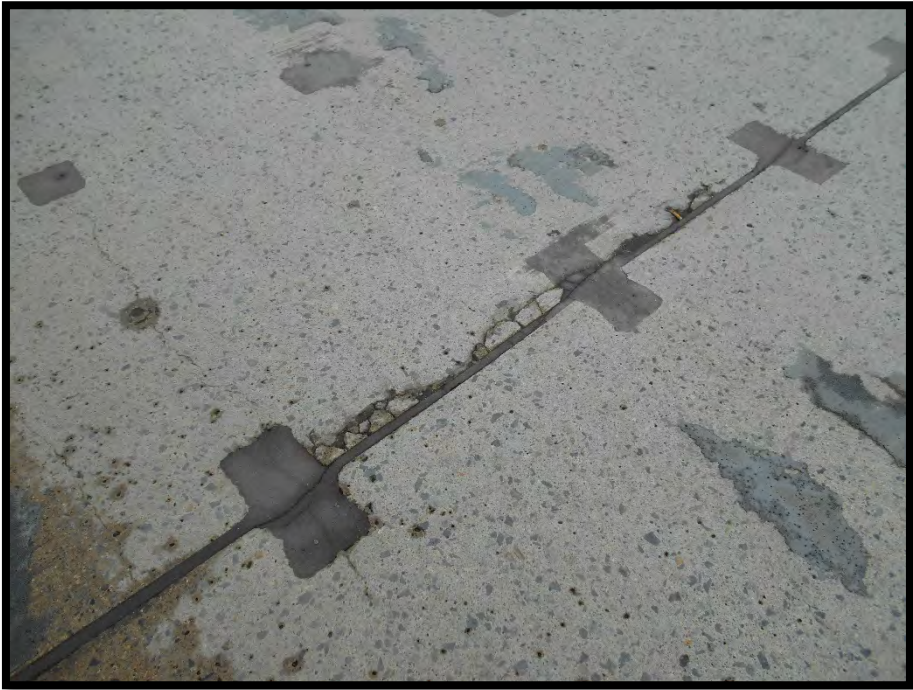
<p>PHOTO NO. 1</p>	
<p><u>Location:</u> Bridge deck</p>

<p><u>Description:</u> Top of deck longitudinal cracking.</p>

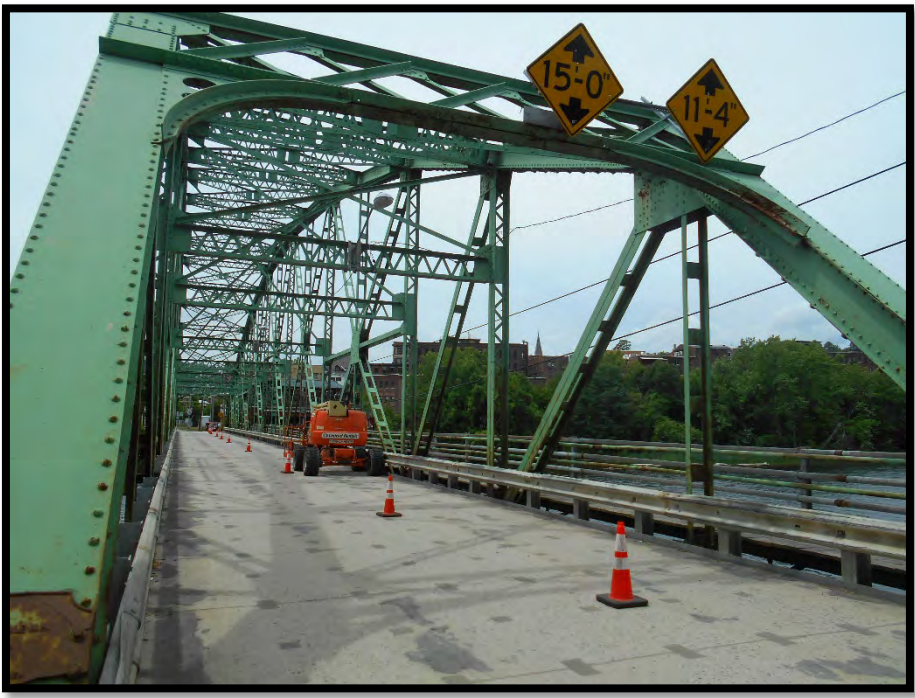
<p>PHOTO NO. 3</p>

<p>Location: W-beam bridge rail</p>	
<p>Description: Typical condition.</p>

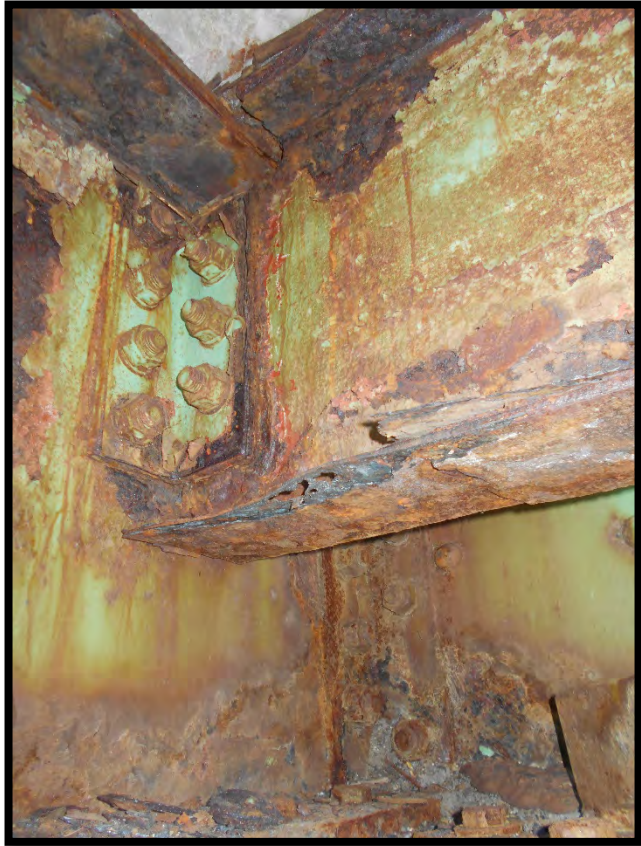
<p>PHOTO NO. 4</p>

<p>Location: Interior stringer S151</p>	
<p>Description: Bottom flange section loss.</p>

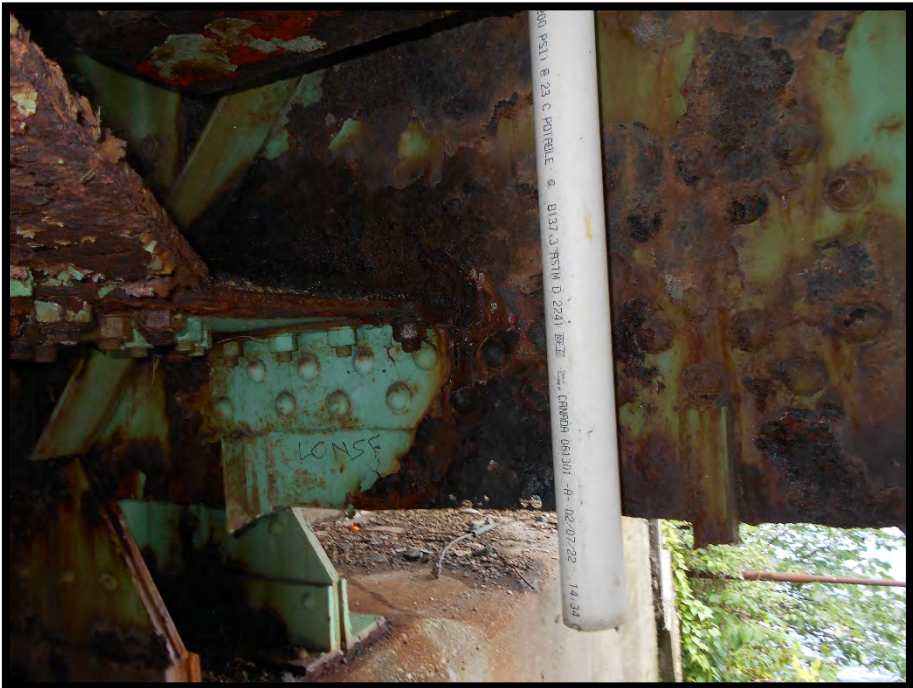
<p>PHOTO NO. 5</p>

<p>Location: North truss, L0 south gusset plate</p>	
<p>Description: Up to 100% section loss with knife edge.</p>	
<p>PHOTO NO. 6</p>

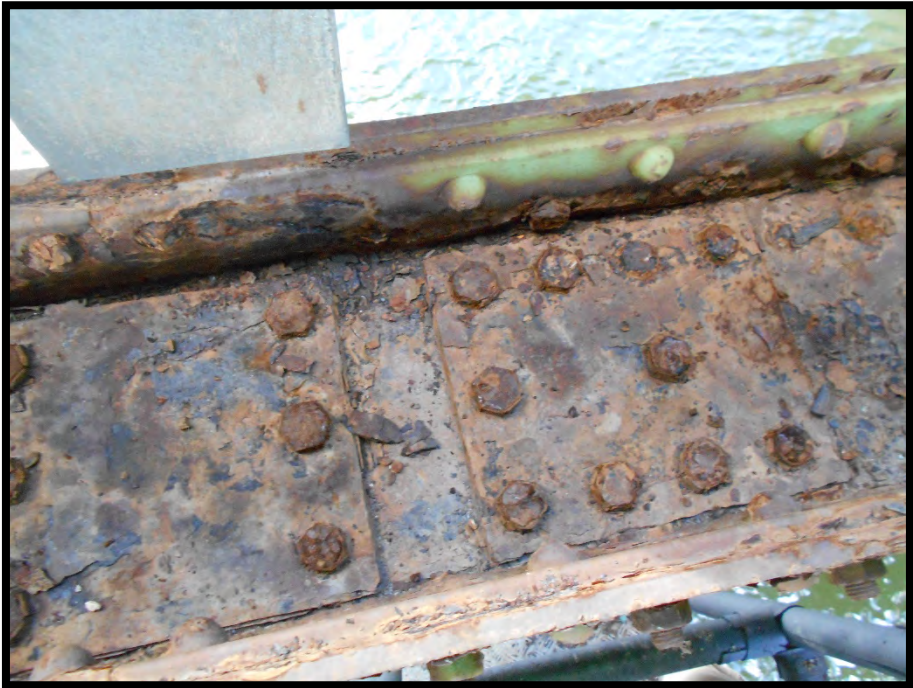
<p>Location: North truss member L1-L2</p>	
<p>Description: Horizontal splice with heavy laminar corrosion and section loss.</p>

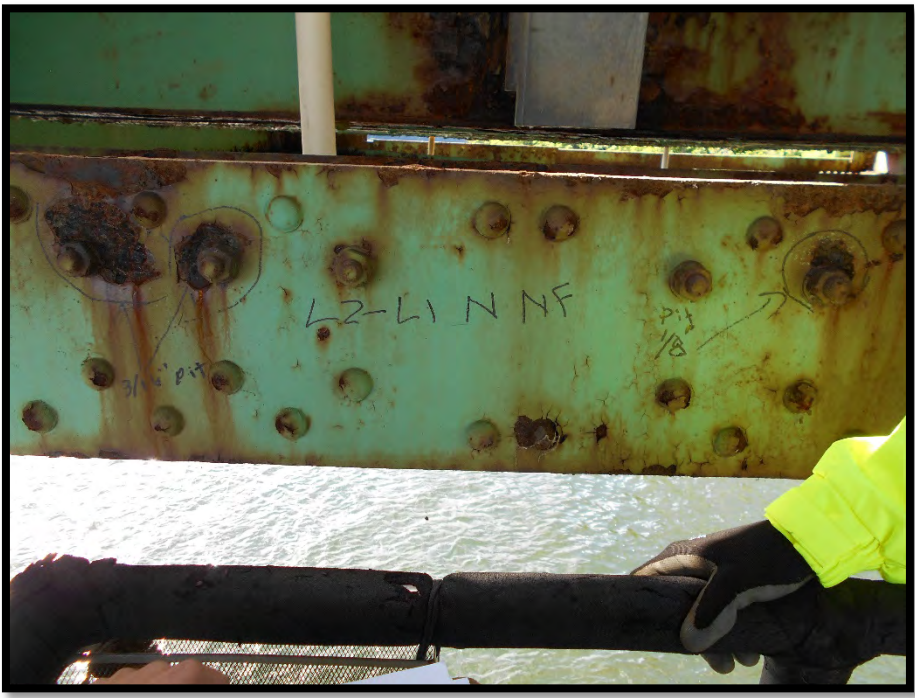
<p>PHOTO NO. 7</p>

<p>Location: North truss member L1-L2 north element, north face</p>	
<p>Description: Pitting around bolts.</p>

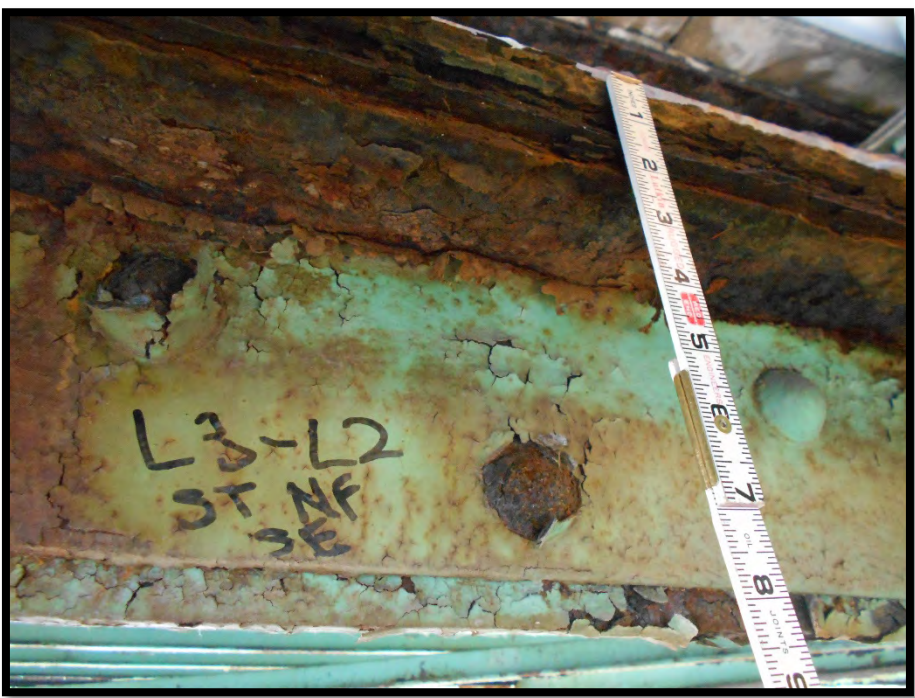
<p>PHOTO NO. 8</p>

<p>Location: South truss member L2-L3, north element, south face</p>	
<p>Description: Typical lower chord pack rust.</p>

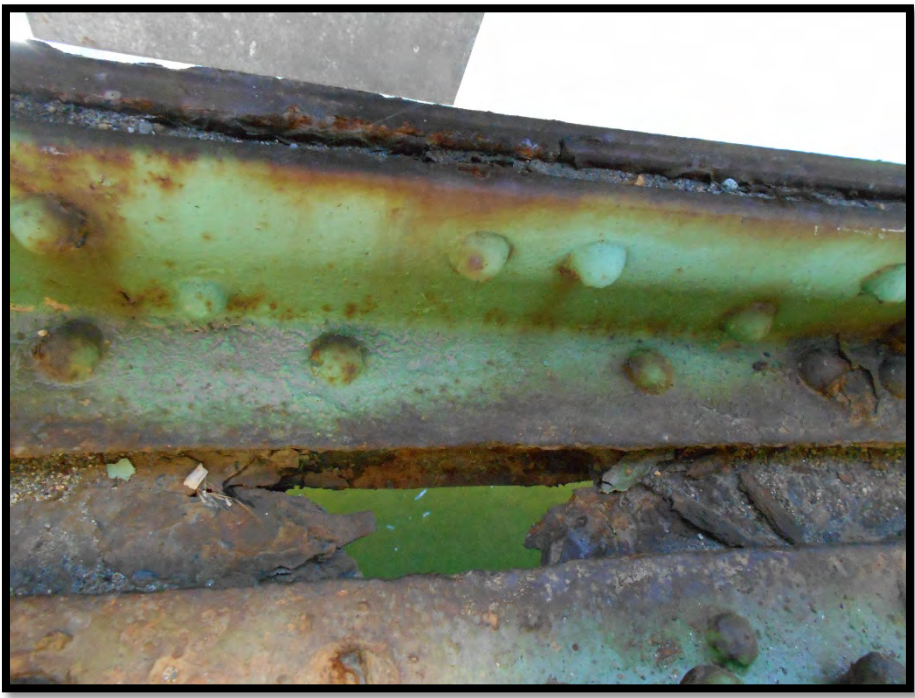
<p>PHOTO NO. 9</p>

<p>Location: North truss</p>	
<p>Description: 100% section loss in tie plate.</p>

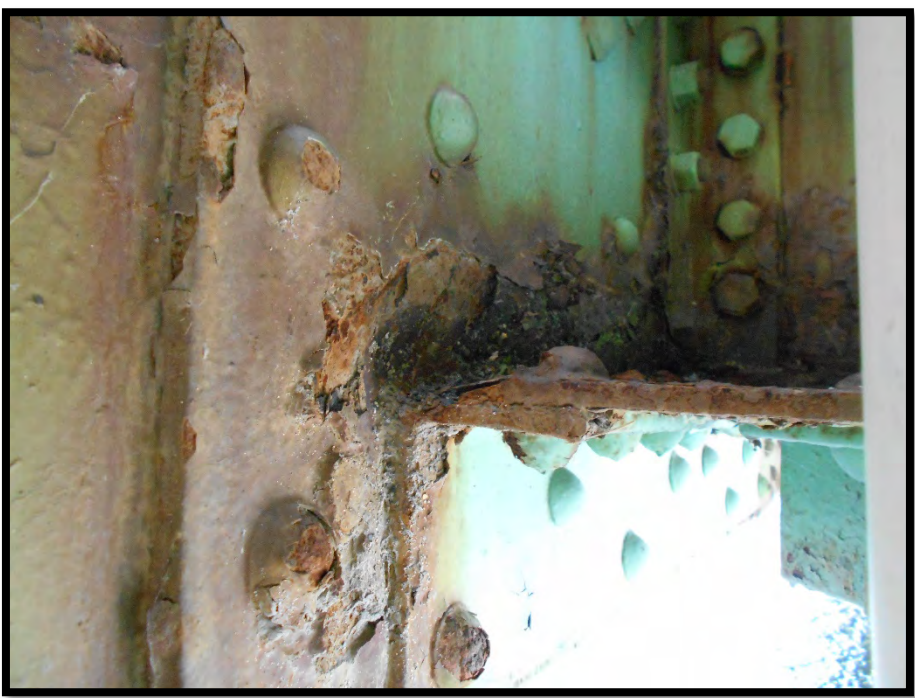
<p>PHOTO NO. 10</p>

<p>Location: North truss, L3 south gusset plate, south face</p>	
<p>Description: Section loss around lower lateral bracing gusset plate.</p>

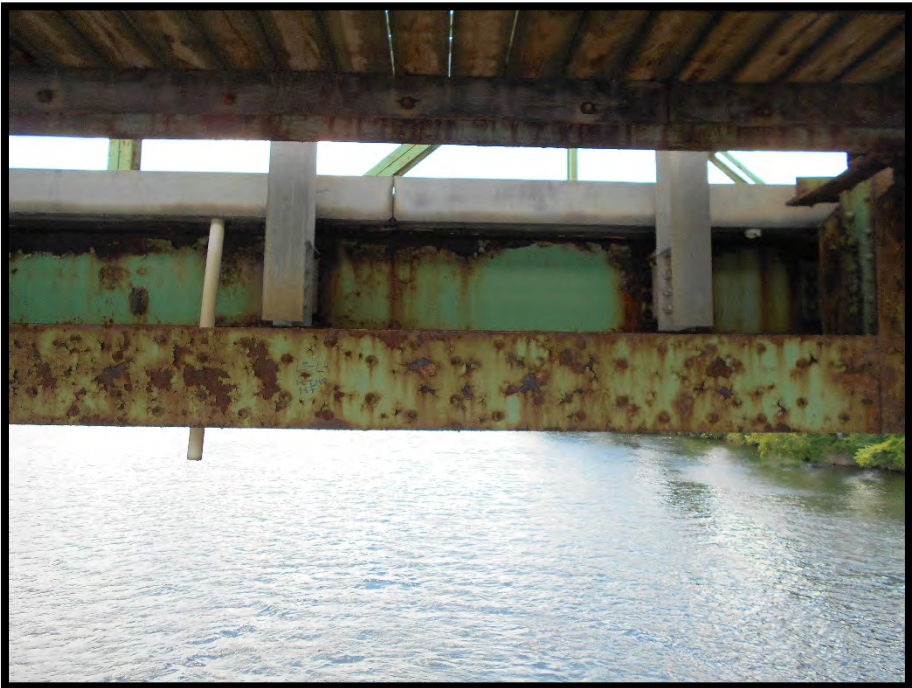
<p>PHOTO NO. 11</p>

<p>Location: North truss member L4-L5, north element, north face</p>	
<p>Description: Typical lower chord condition.</p>	
<p>PHOTO NO. 12</p>

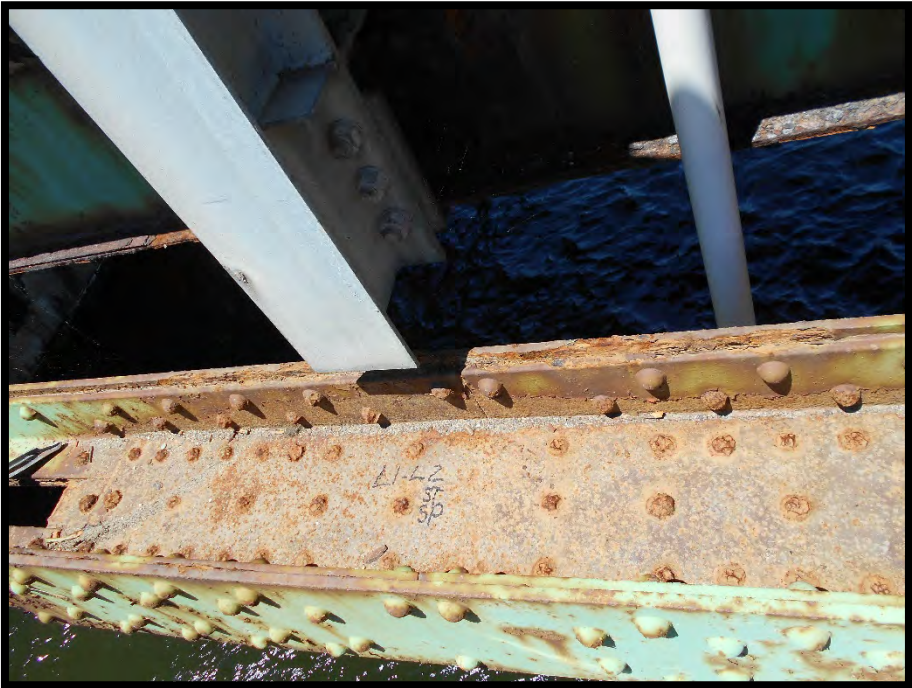
<p>Location: South truss member L1-L2</p>	
<p>Description: Splice plate rivet head section loss.</p>

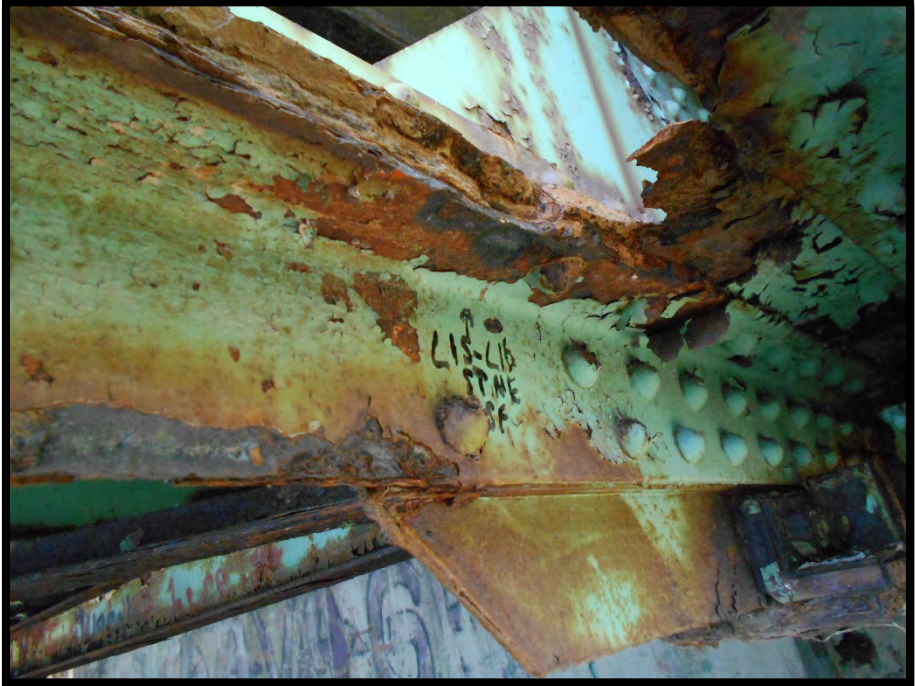
<p>PHOTO NO. 13</p>

- South truss member L14-L15 angle horizontal legs exhibit approximately ½" of leg width loss. This condition was also observed throughout.
- South truss member L15-L16 north element bottom angle horizontal leg has a remaining thickness of approximately 0.58".

<p>Location:</p> <p>South truss member L15-L16 north element, south face</p>	
<p>Description:</p> <p>Heaving pack rust with loss of angle leg width.</p>

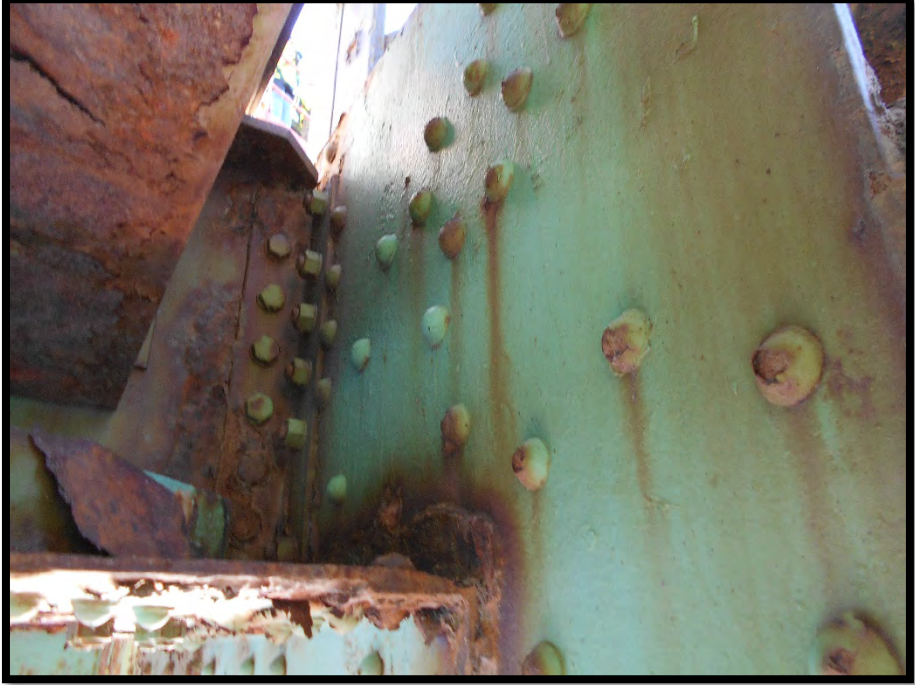
<p>PHOTO NO. 14</p>

<p>Location:</p> <p>Floorbeam FB5</p>	
<p>Description:</p> <p>Web laminar corrosion and section loss.</p>

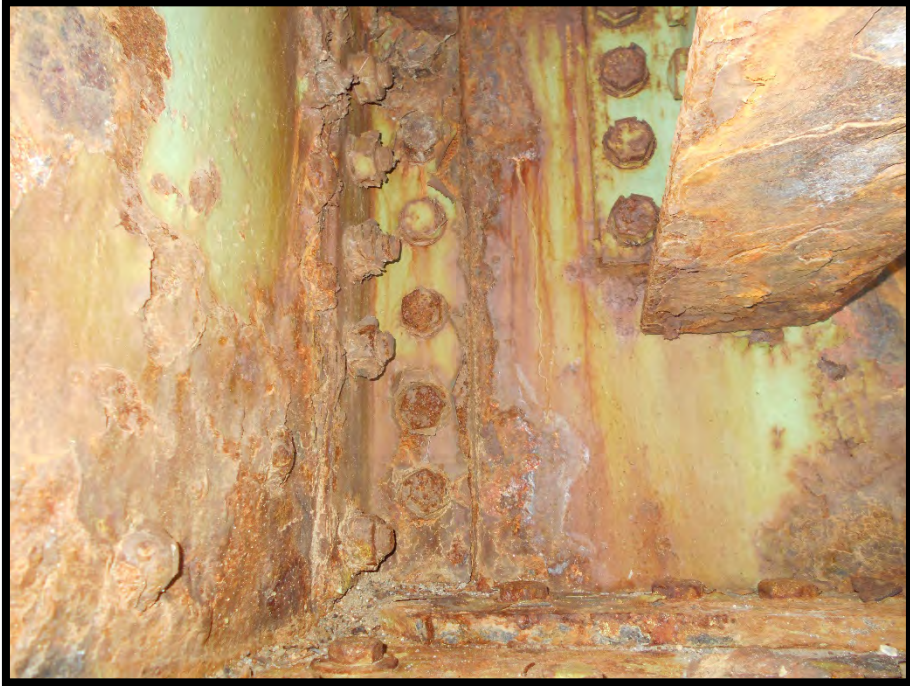
<p>PHOTO NO. 15</p>

<p>Location: North truss, L14, FB 14 connection to South gusset plate Looking West</p>	
<p>Description: Heavy rusting with laminar corrosion.</p>	
<p>PHOTO NO. 16</p>

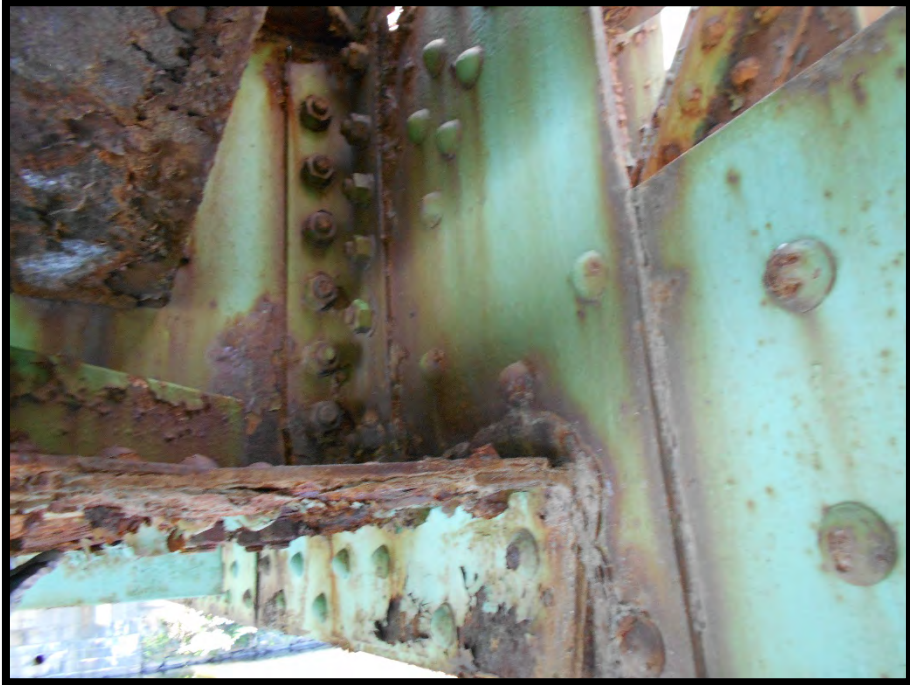
<p>Location: North truss, L7 south gusset plate, south face</p>	
<p>Description: Typical gusset plate condition, pitting and pack rust.</p>

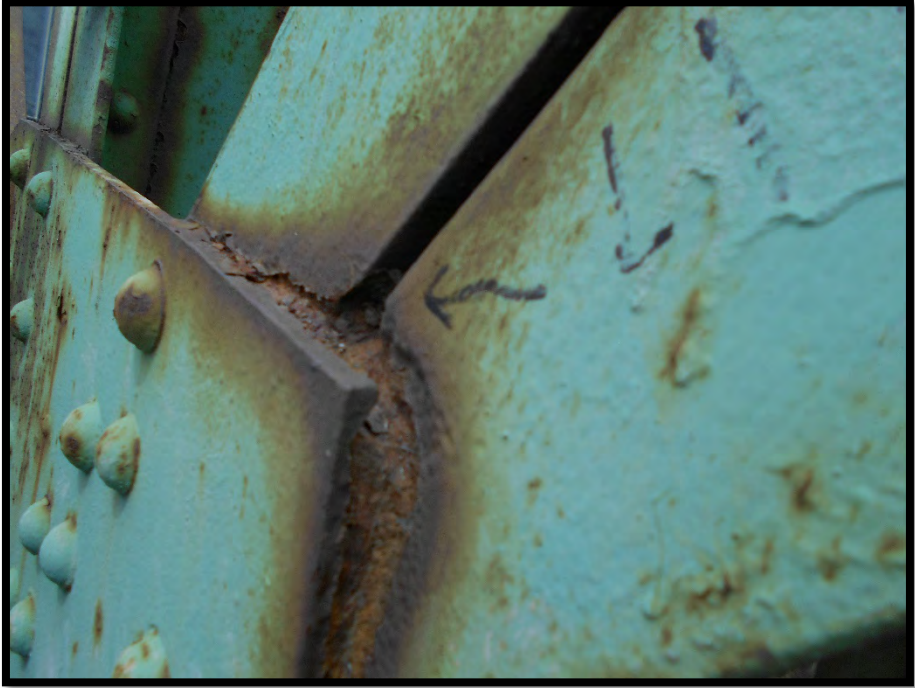
<p>PHOTO NO. 17</p>

<p>Location: South truss, south gusset plate connection to member L14-U15</p>	
<p>Description: Pack rust and pit.</p>

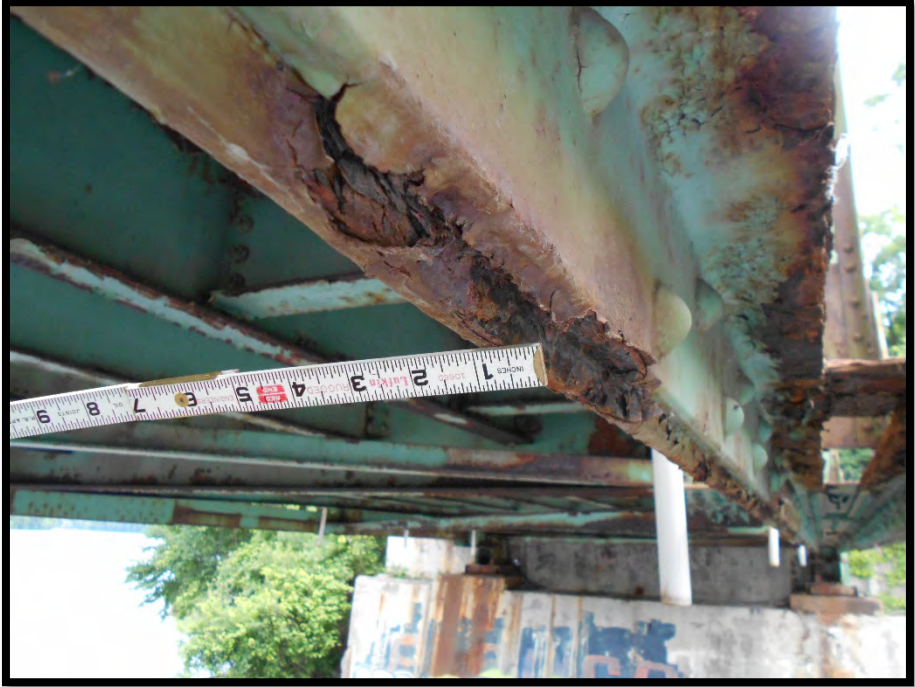
- South truss member L9-L10 exhibits heavy rusting with laminar corrosion and 1/16" to 1/8" of section loss at the splice.
- South truss member L13-L14 exhibits significant pack rust on the bottom of the bottom chord between the vertical leg of the angle and interior plate with approximately 25% section loss in the interior plate.

<p>PHOTO NO. 18</p>	
<p>Location: South truss member L13-L14</p>	
<p>Description: North element pack rust and section loss.</p>

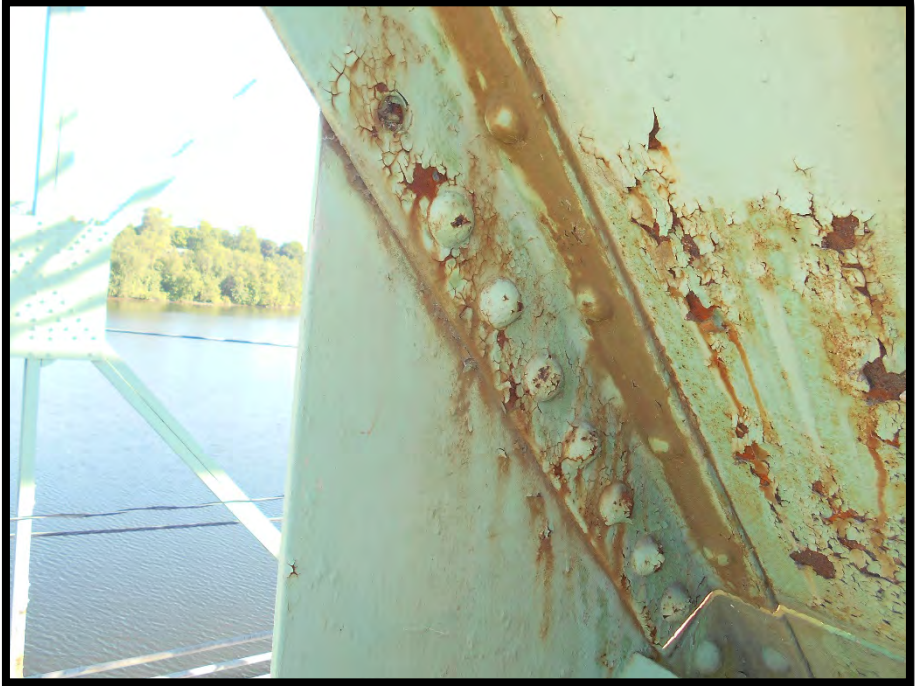
<p>PHOTO NO. 19</p>

- South truss member U5-M6 has one empty rivet hole at the M6 gusset plate. The M6 gusset plate does not have the corresponding rivet hole.
- South truss member L13-M14 south element horizontal legs exhibit 1/16" section loss due to pack rust.

<p>Location:</p> <p>South truss member U5-M6, north element, bottom angle</p>	
<p>Description:</p> <p>Empty rivet hole near corner of M6 gusset plate.</p>	
<p>PHOTO NO. 20</p>

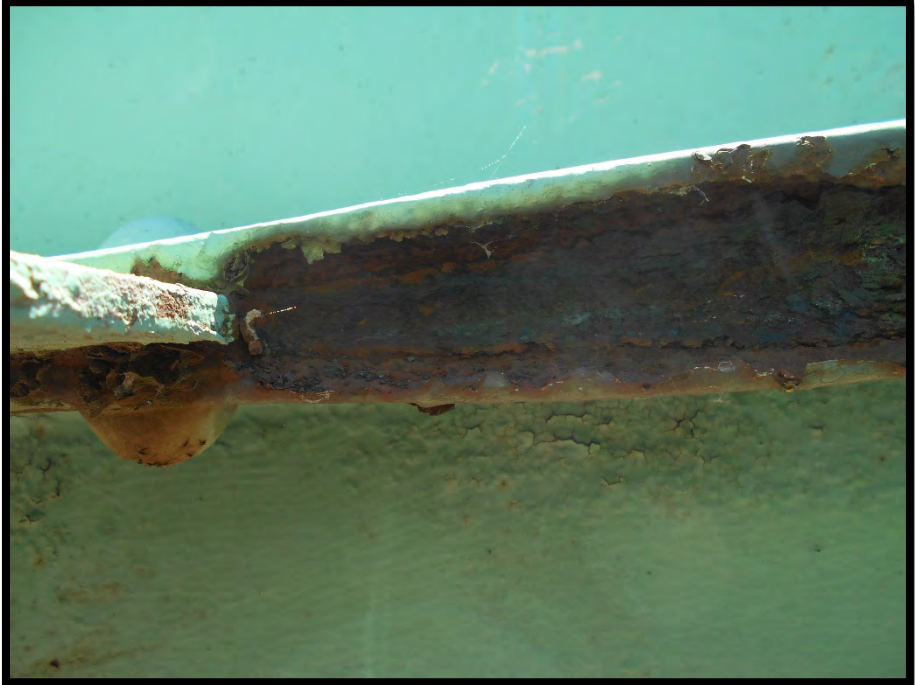
- North truss member U1-L2 exhibits up to 10% rivet head loss at tie plates located in spray zone.
- South truss member U3-M4 exhibits approximately ½" of leg width loss immediately below tie plate near U3 gusset plate and varying degrees of section loss at other locations with pack rust.

<p>Location:</p> <p>South truss member U3-M4, south angles</p>	
<p>Description:</p> <p>Pack rust between angle legs above the tie plate.</p>

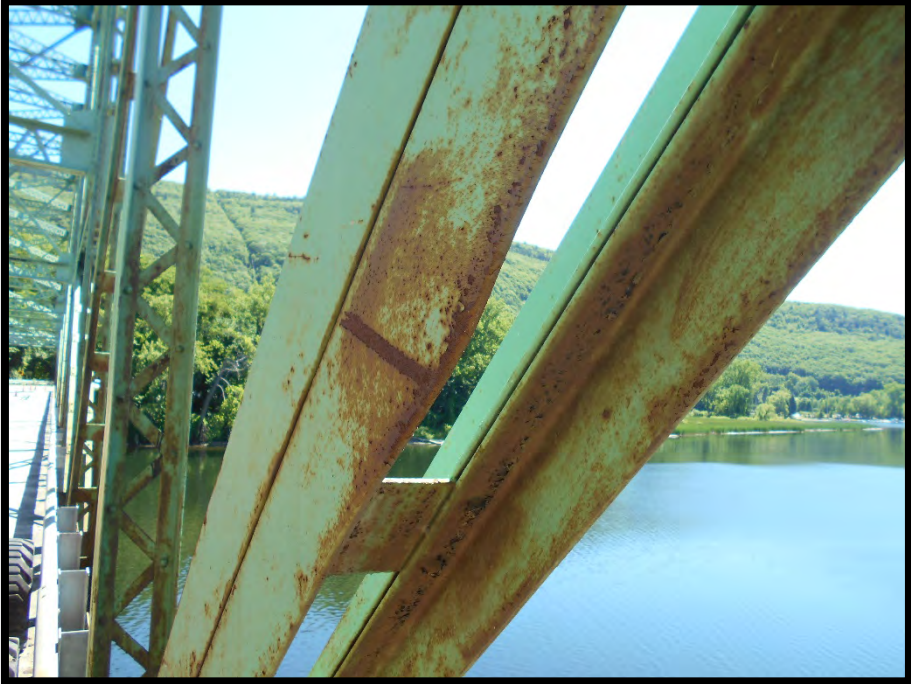
<p>PHOTO NO. 21</p>

- Gouges, scrapes, abrasions and damage from impact were also observed, including the following specific locations:
 - South truss member U1-L2 north element bottom angle flange is bent up to ¾" out-of-plane, for a length of 16", located 7'-0" above top of deck. No cracks were observed.

<p>Location:</p> <p>South truss member U1-L2, north element, bottom angle</p>	
<p>Description:</p> <p>16" long deformation, angle bent up to 3/4" out of plane, 7' above top of deck.</p>

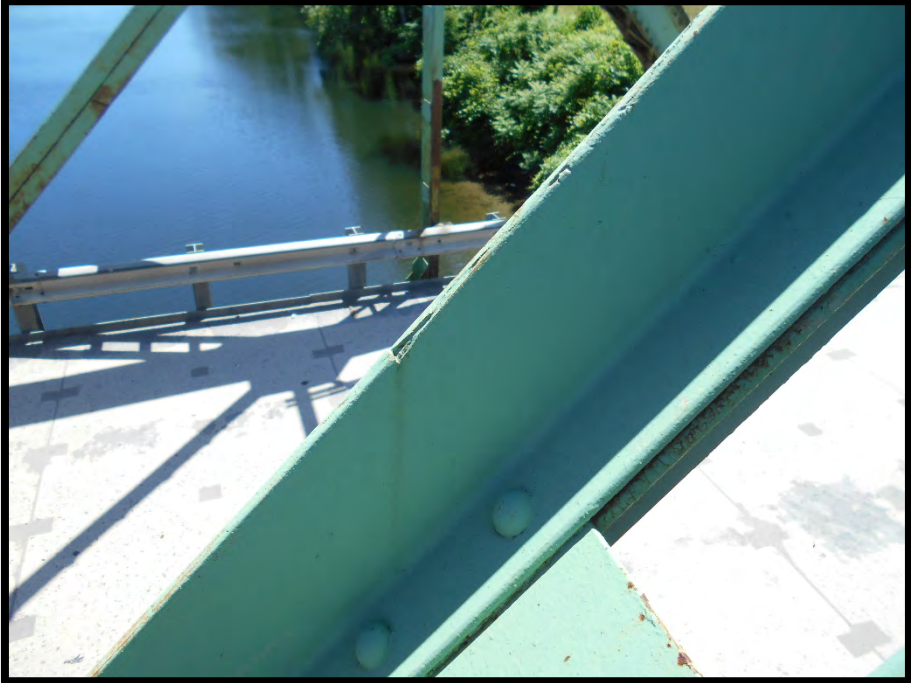
<p>PHOTO NO. 22</p>

<p>Location:</p> <p>North truss member U1-L2, south element, top angle</p>	
<p>Description:</p> <p>Series of gouges in top flange. 11" along the south, top angle leg, up to 3/16" deep.</p>

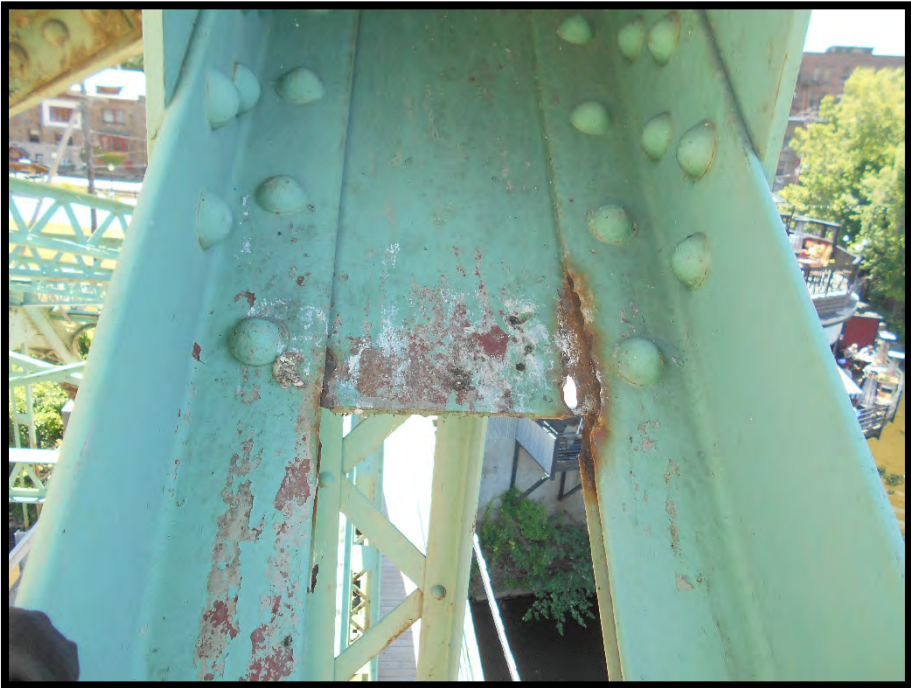
<p>PHOTO NO. 23</p>

<p>Location: North truss member U3-M4, north angles</p>	
<p>Description: Up to 100% section loss of toes at the tie plate, 7" long up to 1/2" deep.</p>

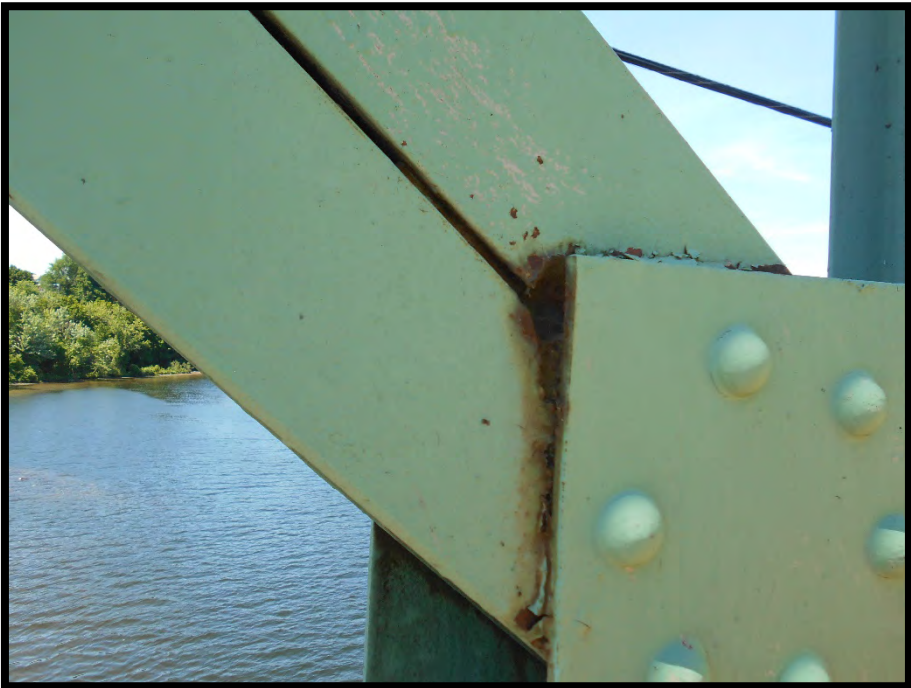
<p>PHOTO NO. 24</p>

<p>Location: North truss member U3-M4, south angle</p>	
<p>Description: 1¼" diameter by ½" deep pit at heel of top angle.</p>

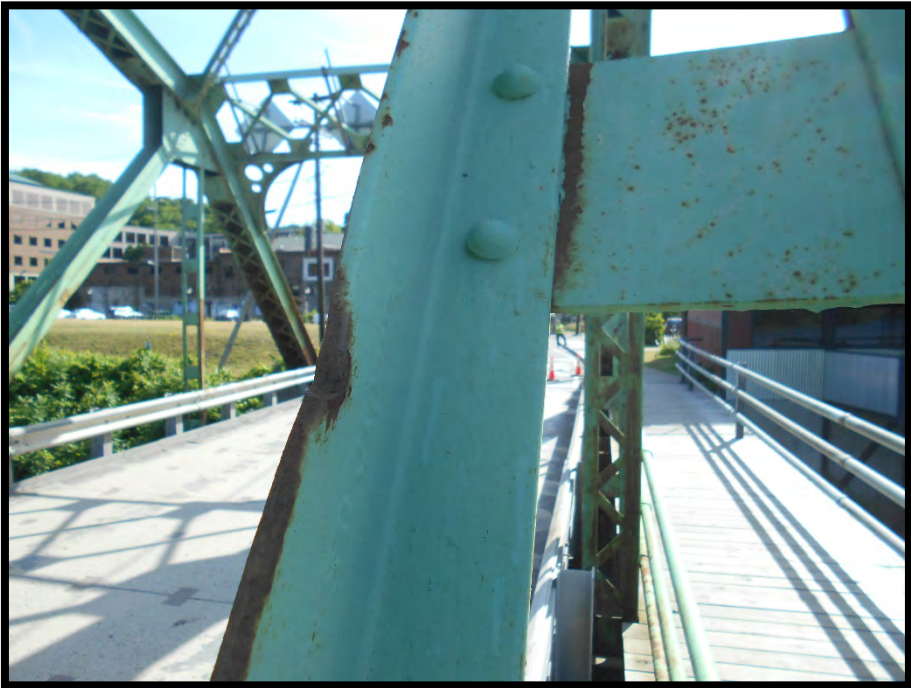
<p>PHOTO NO. 25</p>

<p>Location: North truss member U2-L3, south angle</p>	
<p>Description: 1/4" gouge in top angle leg.</p>

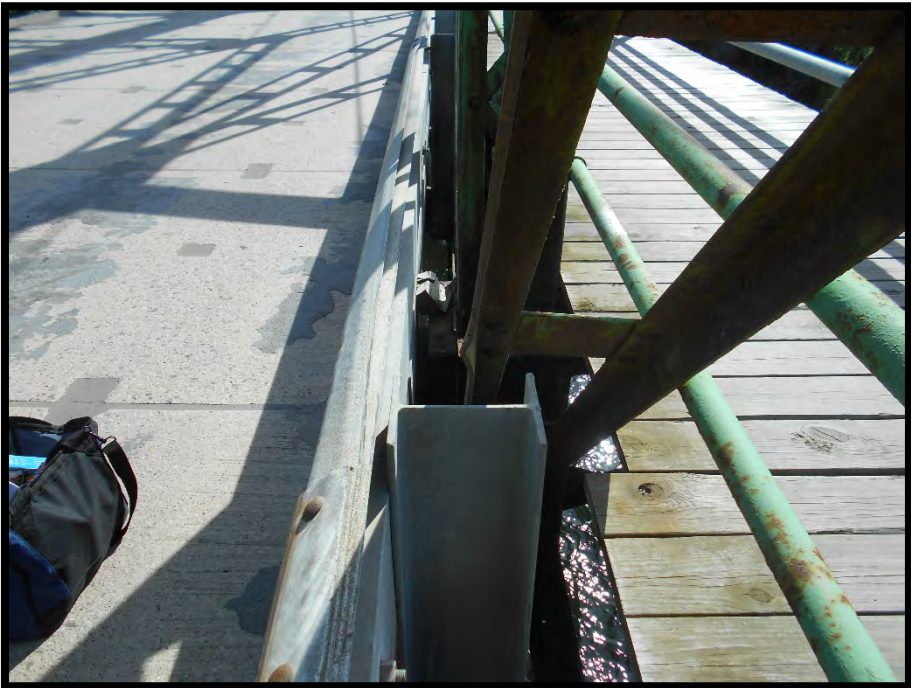
<p>PHOTO NO. 26</p>

<p>Location: North truss member L5-M6, south element</p>	
<p>Description: Angle leg bent 1/2" out of plane, 30" above top of deck.</p>

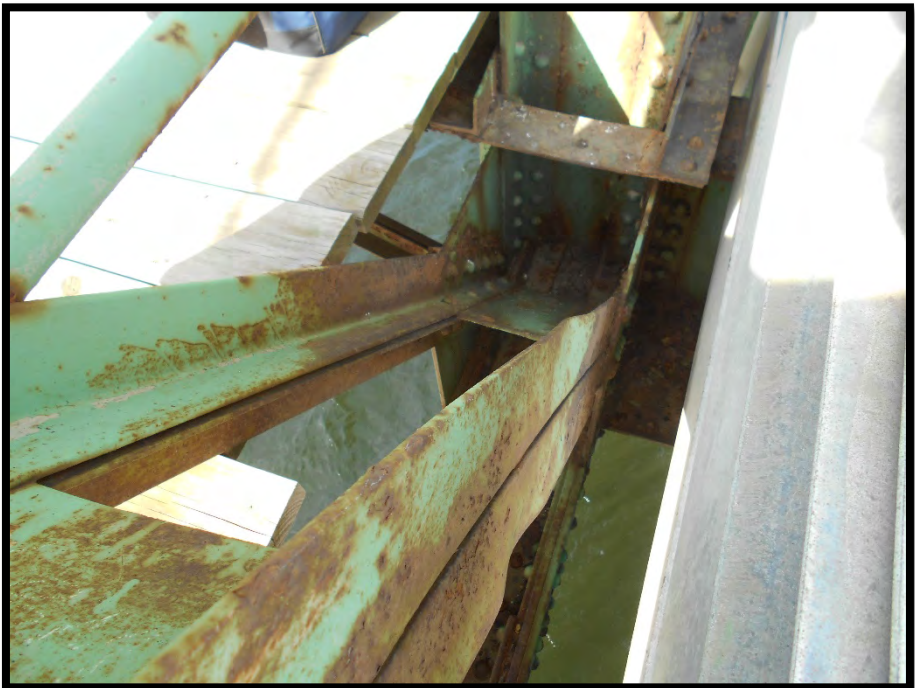
<p>PHOTO NO. 27</p>

<p>Location:</p> <p>North truss member L5-M6, south element</p>	
<p>Description:</p> <p>1/4" gouge in top angle 3' length out of alignment, flange bent up to 5/8", 1' from top of deck.</p>

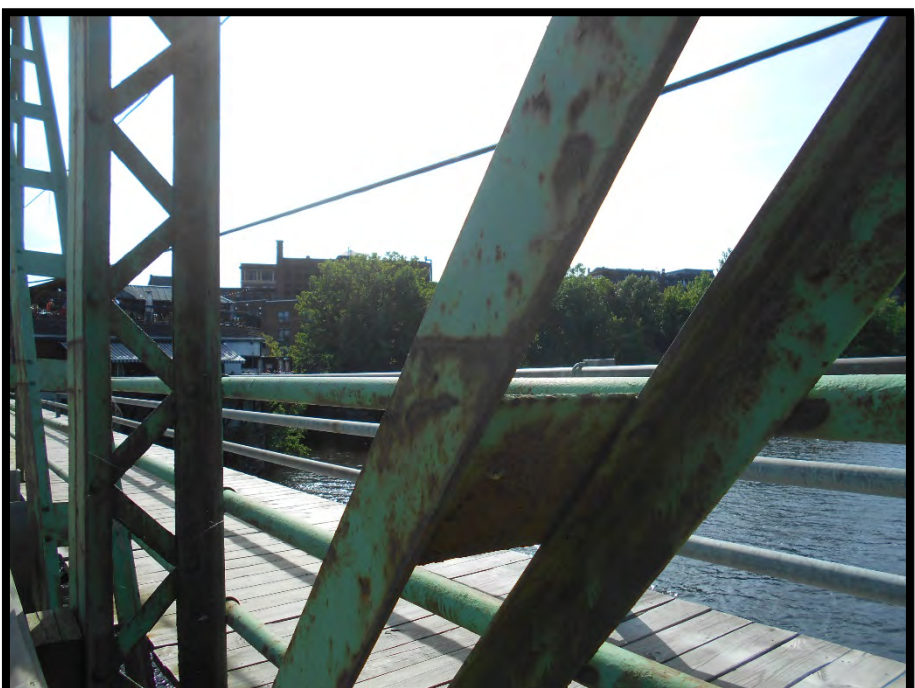
<p>PHOTO NO. 28</p>

<p>Location:</p> <p>North truss member L7-L8</p>	
<p>Description:</p> <p>Gouge in south angle leg, 4' above top of deck, 3/8" diameter.</p>

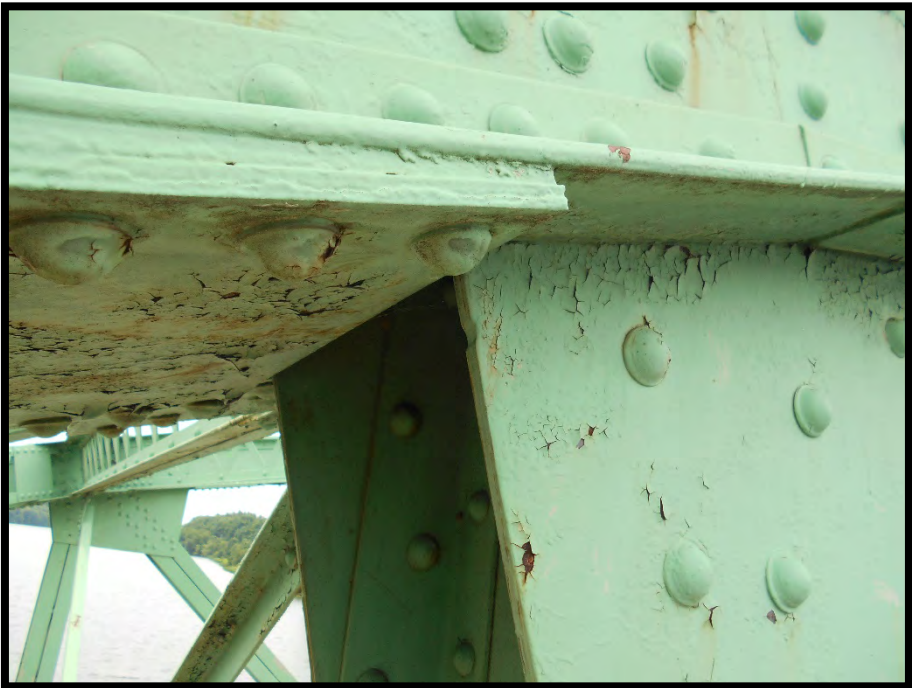
<p>PHOTO NO. 29</p>

<p>Location: North truss</p>	
<p>Description: Gouge in U13 north gusset plate between U13-U14 and M13-U13 members. 3/4" long x 1/8" deep x 7/16" wide (full depth of plate).</p>

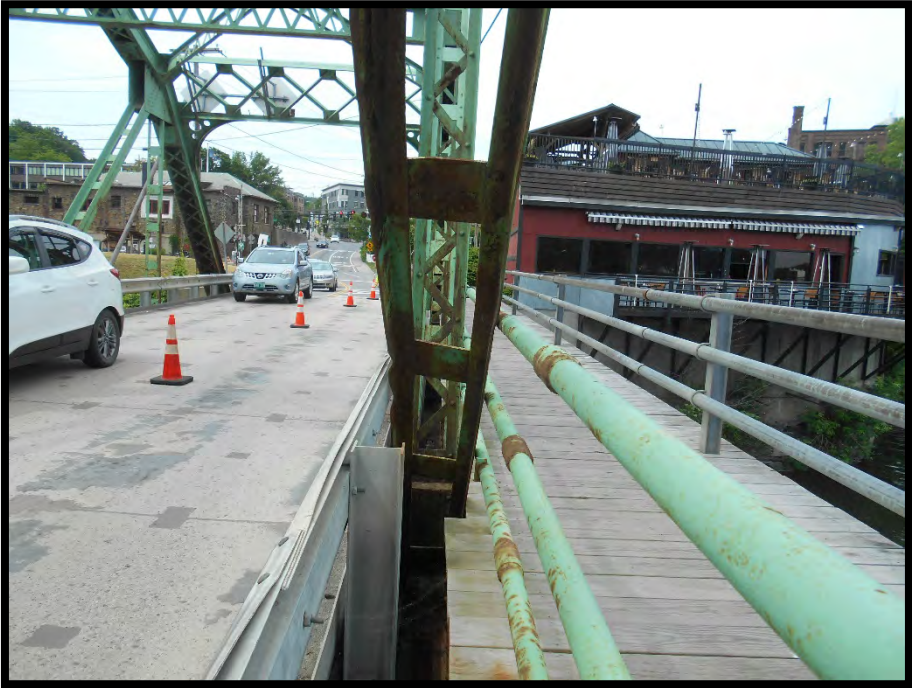
<p>PHOTO NO. 30</p>

- North truss L3-M4 has significant impact damage over one quarter of its length.
 - North truss member M4-U5 south element is rotated towards the center of the bridge. Tie plates in this area are bent.

<p>Location: North truss member L3-M4</p>	
<p>Description: Considerable impact damage along length, angle legs bent and member twisted out of plane.</p>

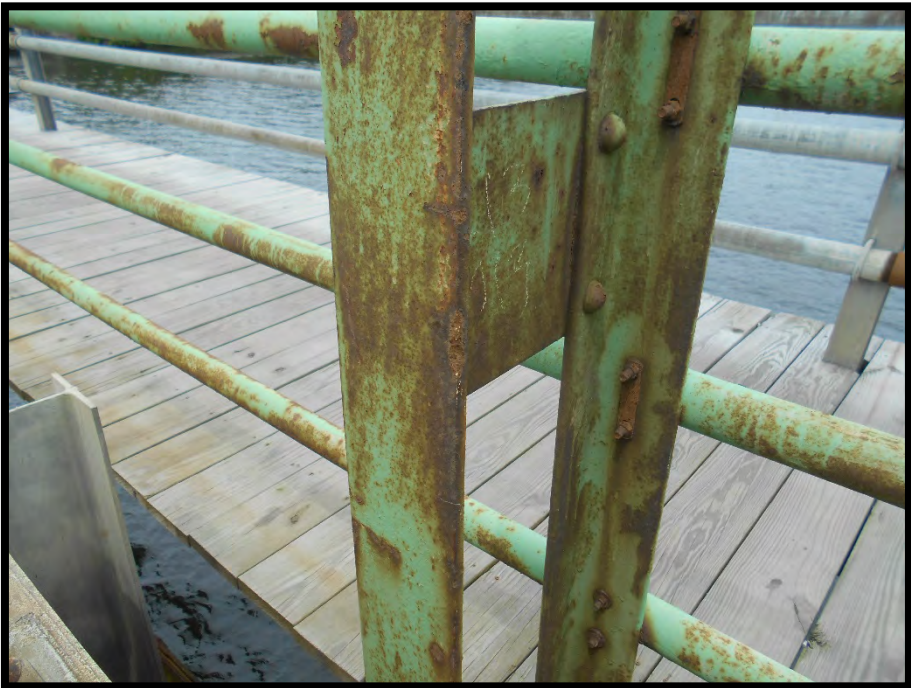
<p>PHOTO NO. 31</p>

<p>Location:</p> <p>North truss member L12-M12</p>	
<p>Description:</p> <p>1/16" deep gouge in angle leg, 1" long, 4' above top of deck.</p>

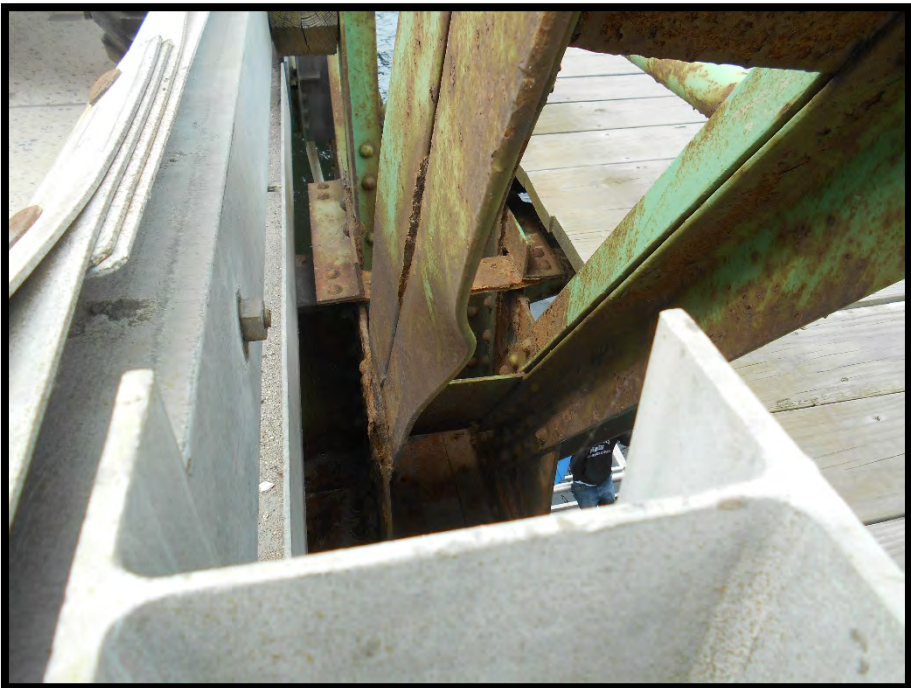
<p>PHOTO NO. 32</p>	
<p>Location:</p> <p>North truss member L13-U14</p>	<p>Description:</p> <p>Bottom angle leg bent out of plane, 30" long, 1.5" max deformation, 2' above top of deck.</p>

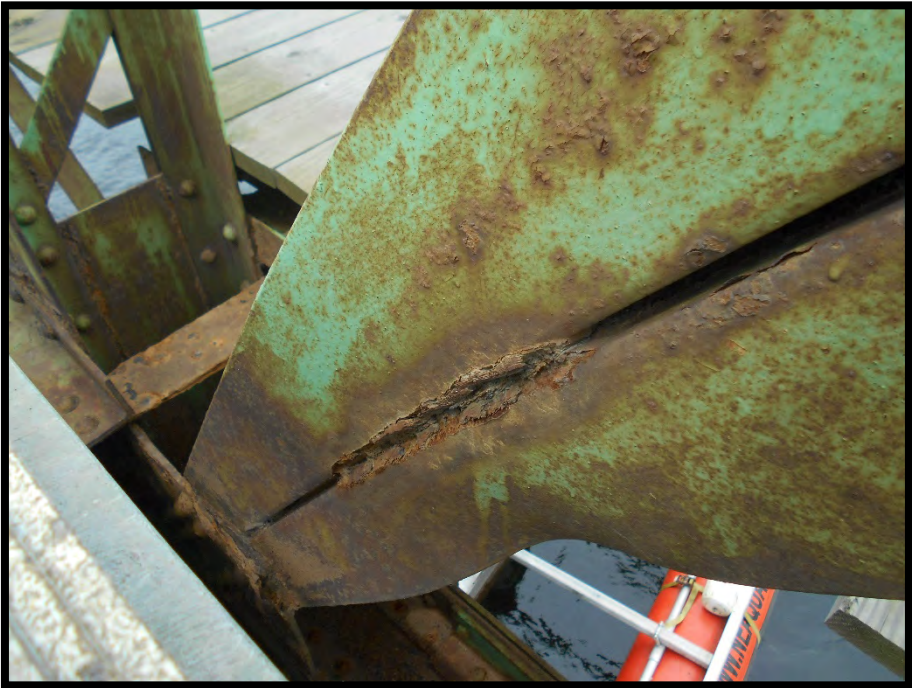
<p>PHOTO NO. 33</p>

<p>Location: North truss member L13-U14</p>	
<p>Description: Bottom angle leg bent and pack rust between angle members.</p>

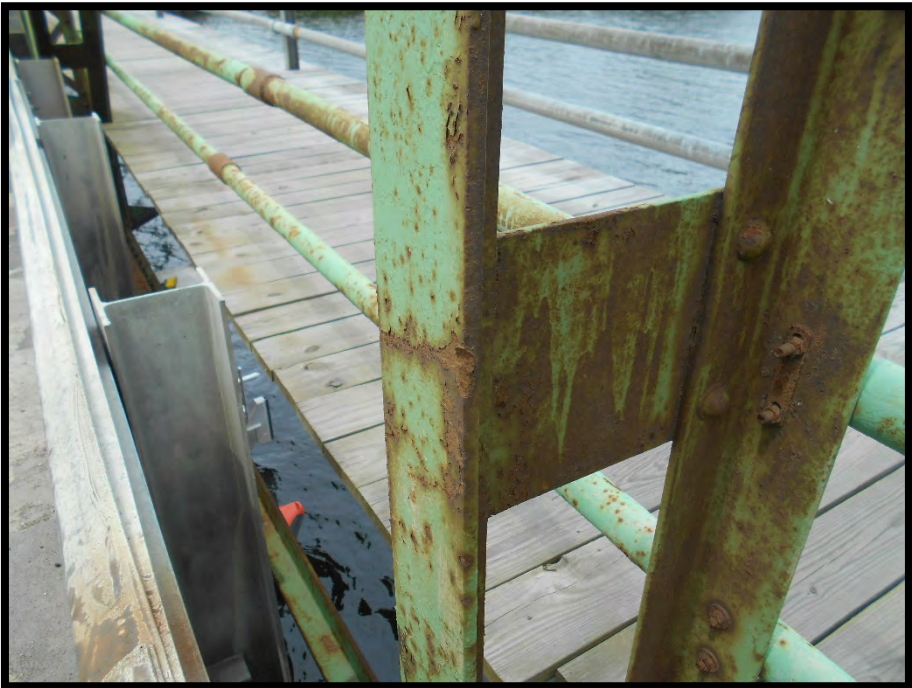
<p>PHOTO NO. 34</p>

<p>Location: North truss member L15-U15</p>	
<p>Description: 1/8" deep gouge in angle leg, 1/2" long, 3.5' above top of deck.</p>

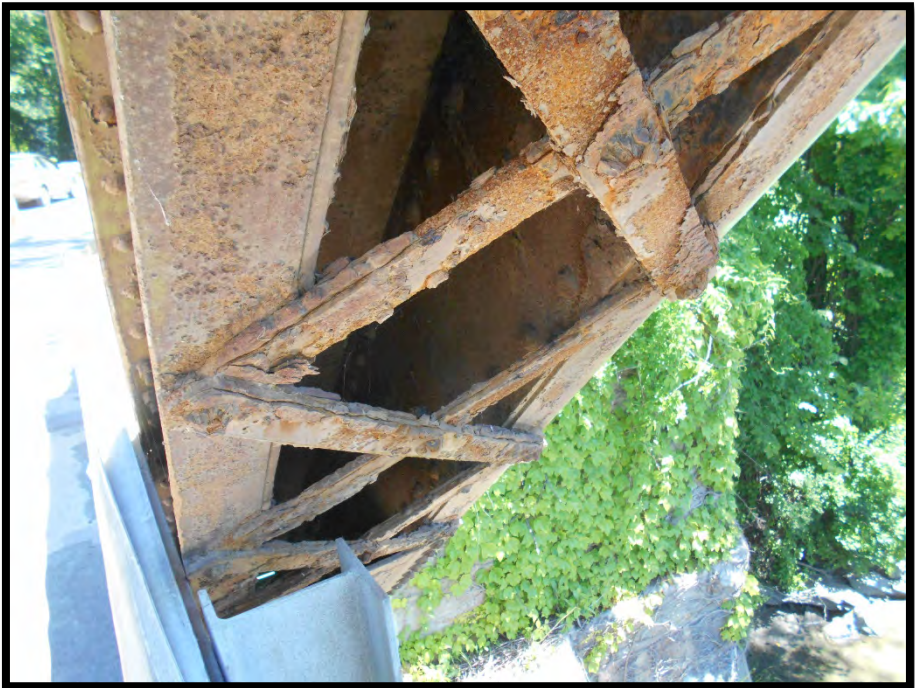
<p>PHOTO NO. 36</p>

<p>Location: End diagonal</p>	
<p>Description: Typical condition.</p>
