2018 Routine/Fracture Critical Member Inspection Report

Anna Hunt Marsh Bridge
NH Route 119 over the Connecticut River
NHDOT Bridge No. 041/040
Hinsdale, New Hampshire

July 2018

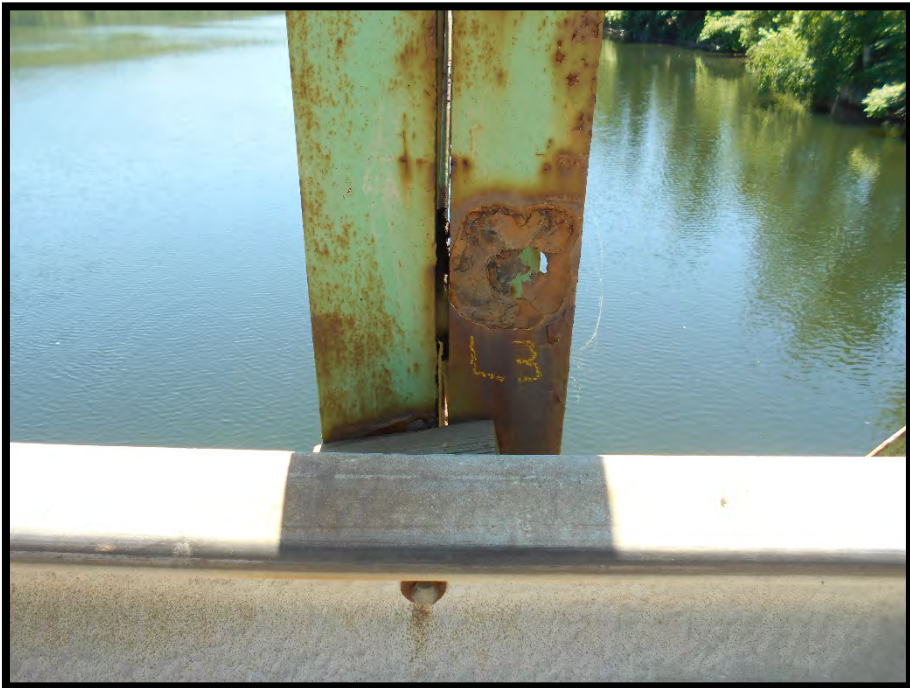
<p>PHOTO NO. 37</p>

- Member also exhibits a 5" by 5" area with up to 100% section loss.
- North truss member U3-L3 exhibits pack rust with prying up to ½" thick between member angle legs and L3 gusset plates.

<p>Location: South truss member U3-L3</p>	
<p>Description: Section loss.</p>

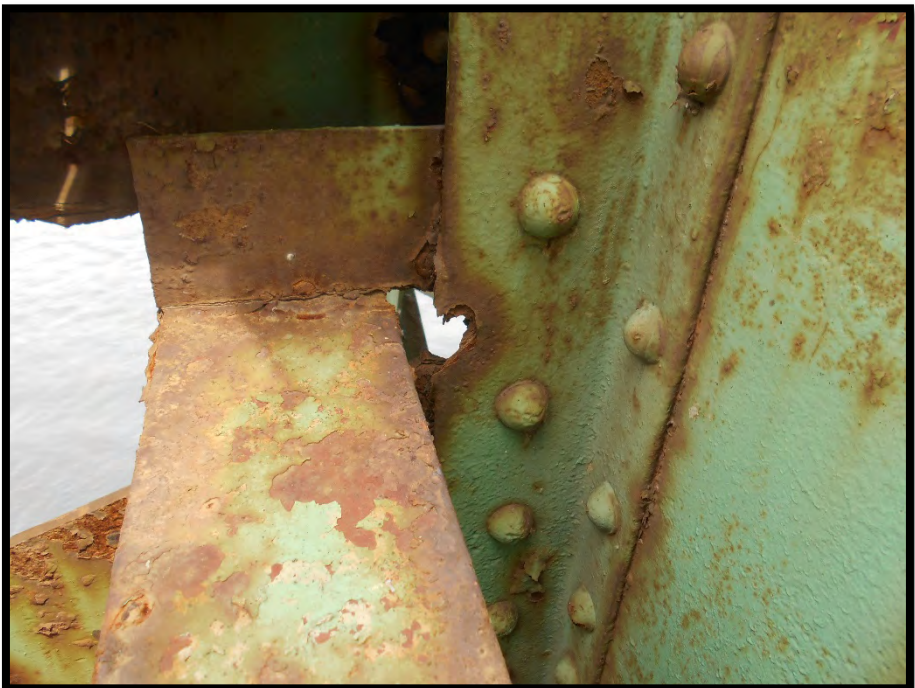
<p>PHOTO NO. 39</p>

<p><u>Location:</u> North truss member U13-L13</p>	
<p><u>Description:</u> Section loss.</p>

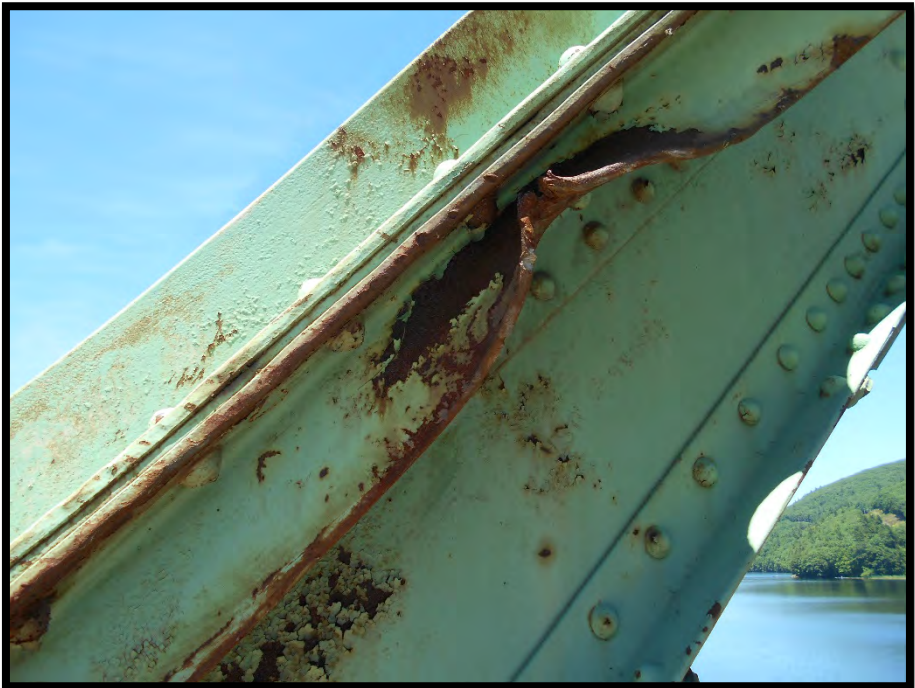
<p>PHOTO NO. 40</p>

<p><u>Location:</u> West Portal</p>	
<p><u>Description:</u> Impact damage.</p>

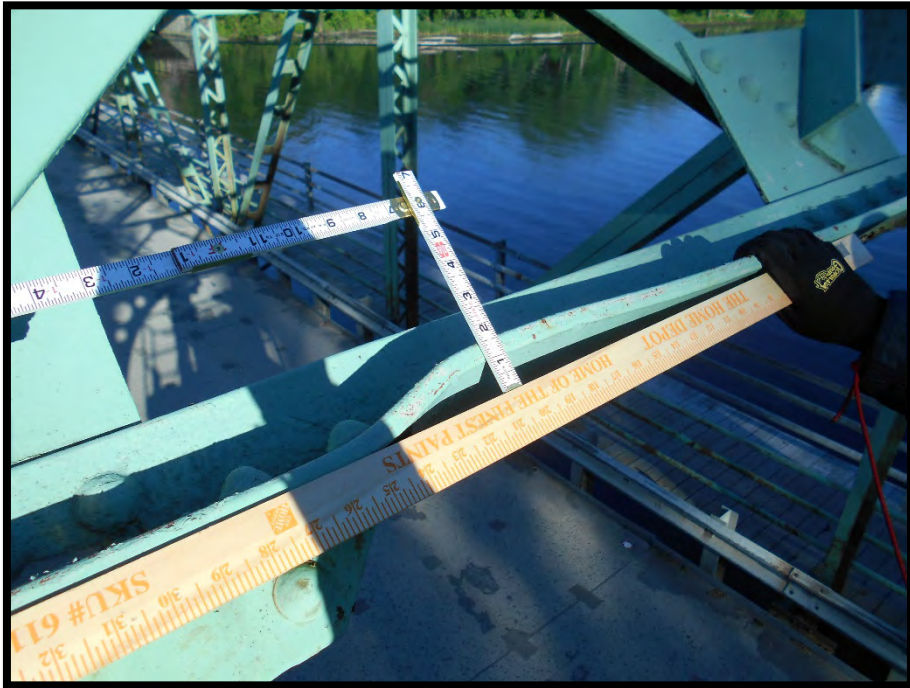
Location:
East Portal

Description:
Impact damage.

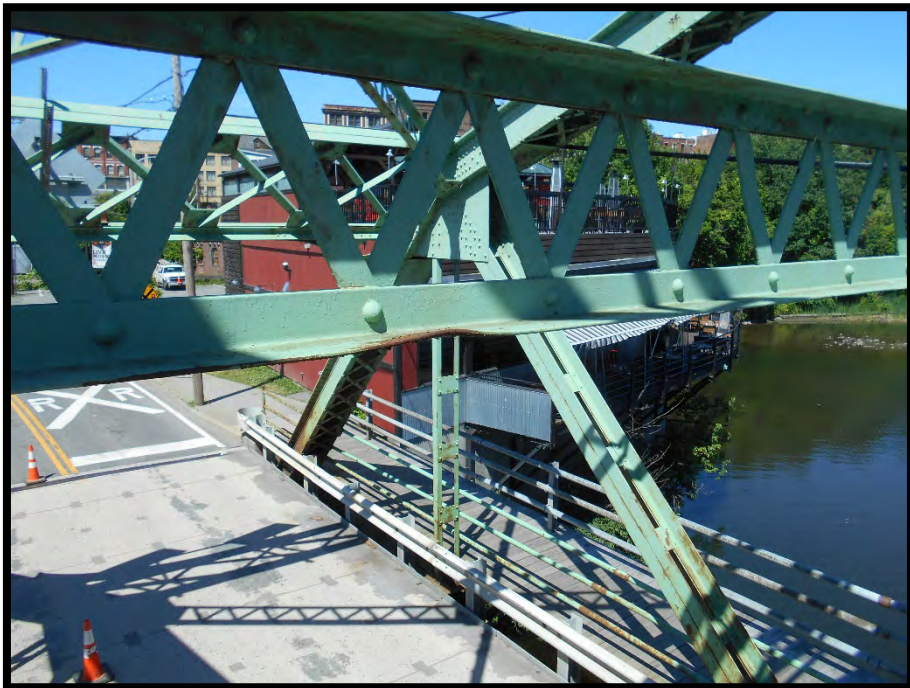
PHOTO NO. 42

Description:
Impact damage.

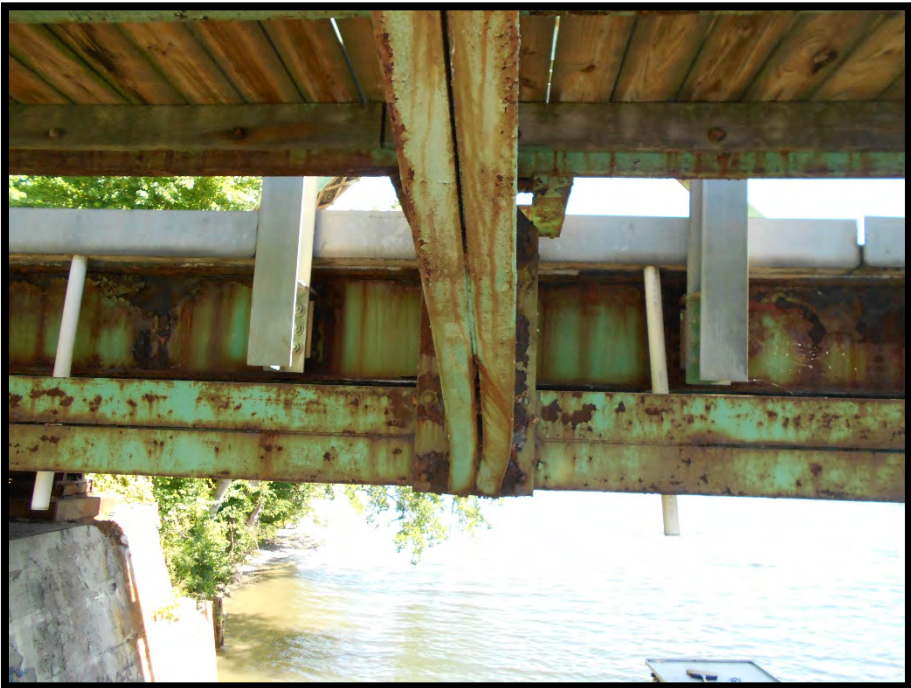
<p>PHOTO NO. 45</p>

<p>Location: Sidewalk support @ L15</p>	
<p>Description: Bent out-of-plane.</p>

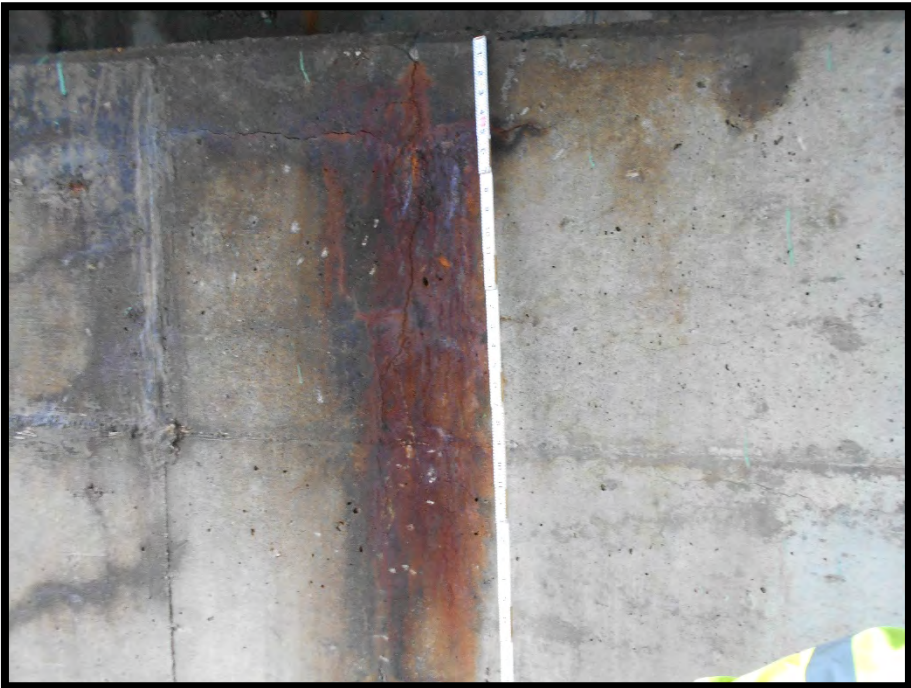
<p>PHOTO NO. 46</p>

<p>Location: West abutment</p>	
<p>Description: Delaminated area.</p>

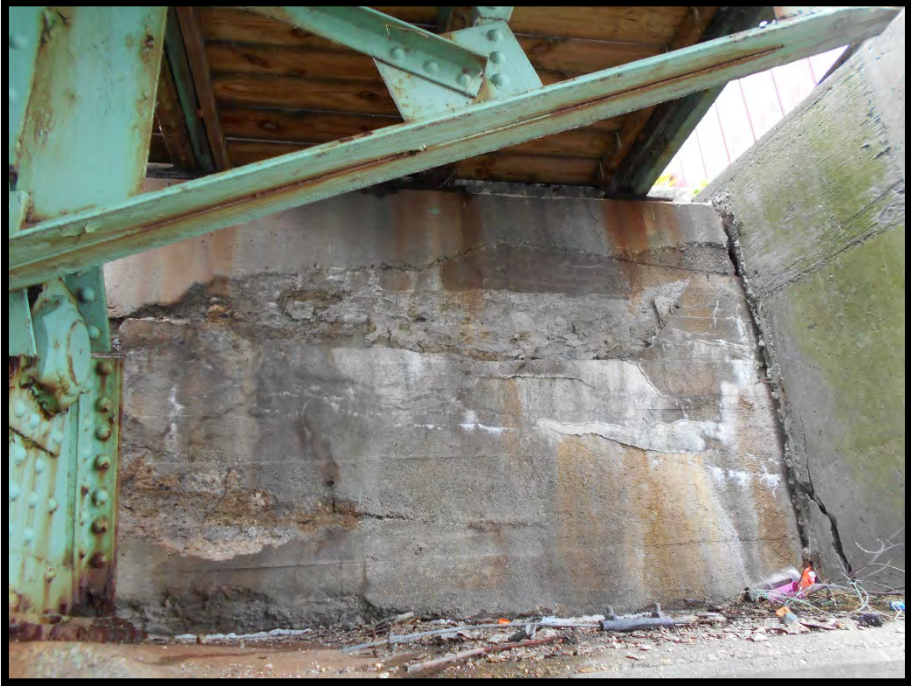
<p>PHOTO NO. 47</p>

<p>Location: West abutment backwall</p>	
<p>Description: Backwall spalling, cracking and efflorescence.</p>

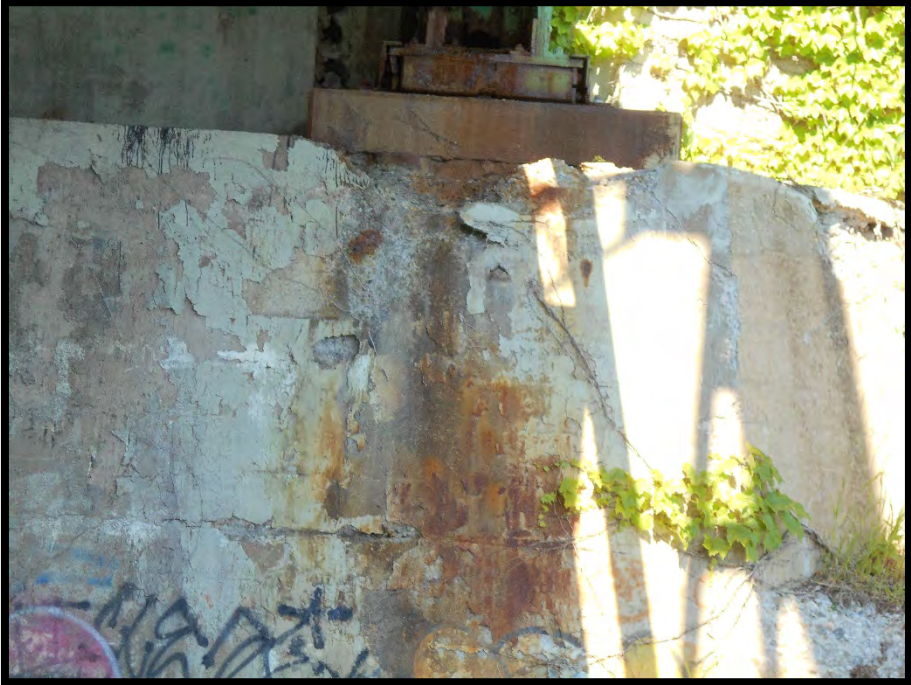
<p>PHOTO NO. 48</p>	
<p>Location: East abutment</p>	<p>Description: Concrete spalling and deterioration.</p>

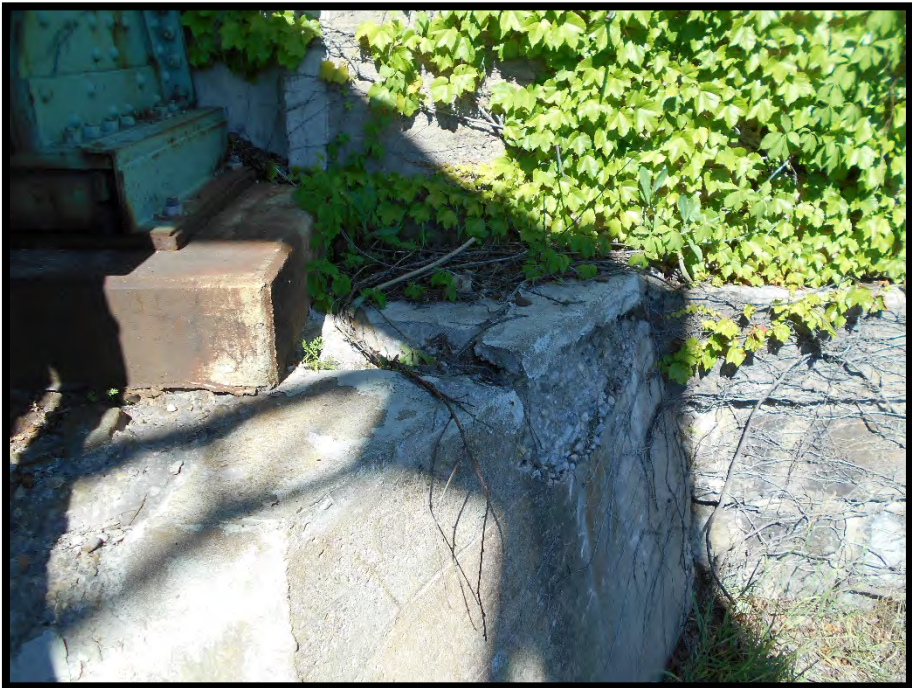
<p>PHOTO NO. 49</p>

<p>Location: East abutment</p>	
<p>Description: Concrete spalling and deterioration.</p>

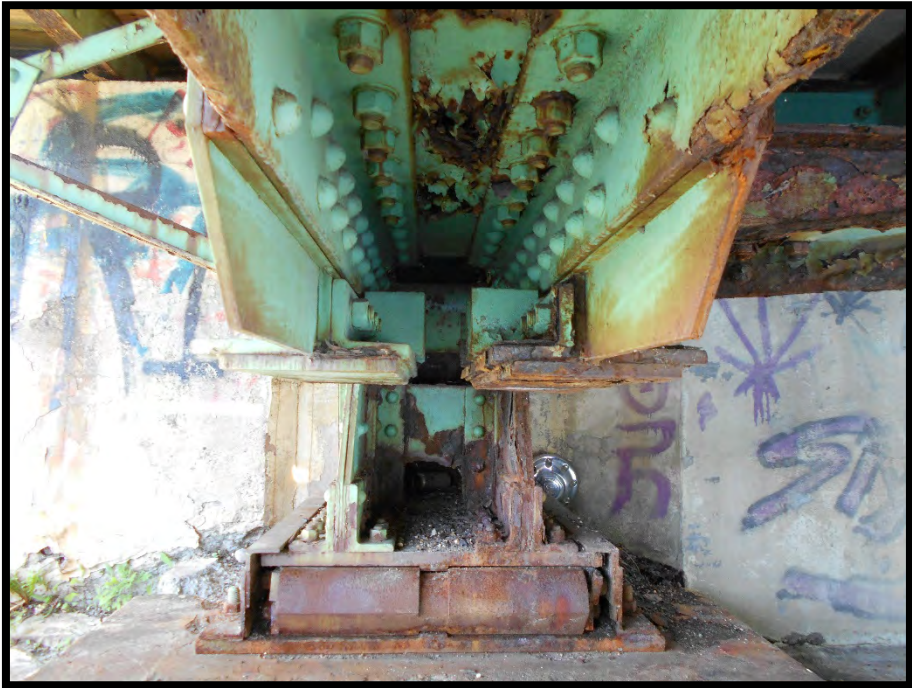
<p>PHOTO NO. 50</p>	
<p>Location: North truss expansion bearing</p>	
<p>Description: Rotated exterior rollers and guides not plumb.</p>

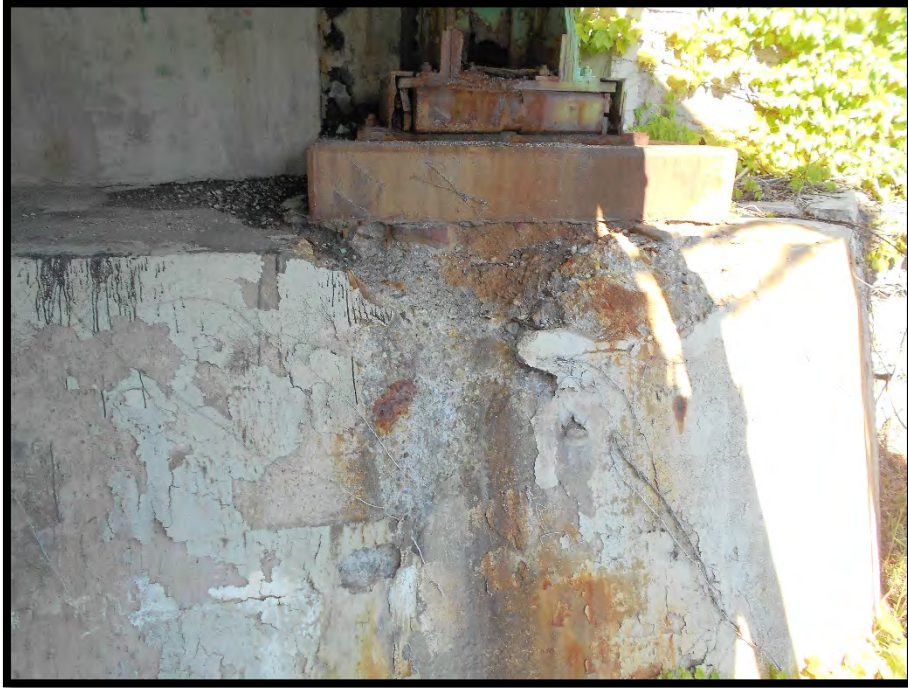
Location:
South truss expansion bearing

Description:
Rotated exterior rollers and guides not plumb.
