NH119 over CONNECTICUT RIVER

Owner: NHDOT Inspection Team: B Bridge Maintenance Crew: 7

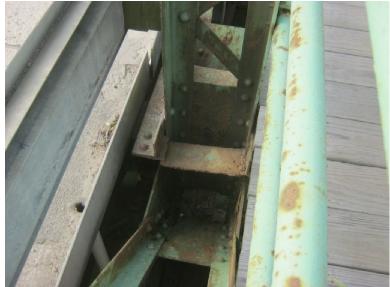
B571 04

TOP OF SIDEWALK BRACKET BROKEN

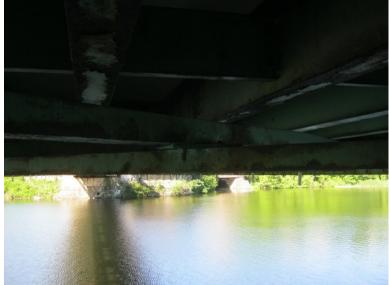
B561 27

RUST AT FLOOR BEAM EXTERIOR

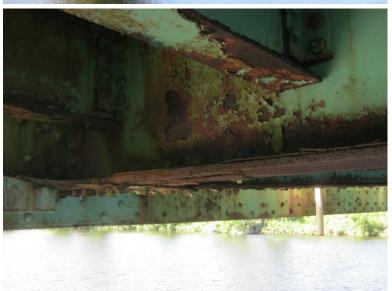
B561 28

RUST AT FLOOR BEAM EXTERIOR

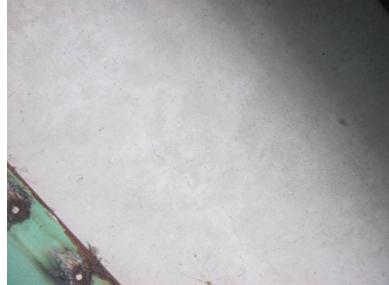
B561 30

FINE CRACKS IN SOFFIT

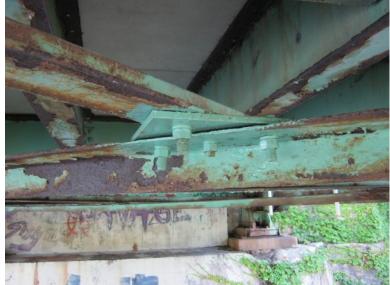
B506 01

CROSS BRACE REPAIR, SECOND BAY FROM EAST.

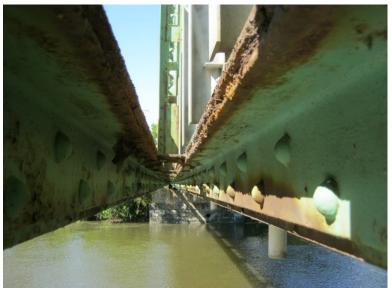
B506 05

PACK RUST BETWEEN LOWER CHORD ANGLES.

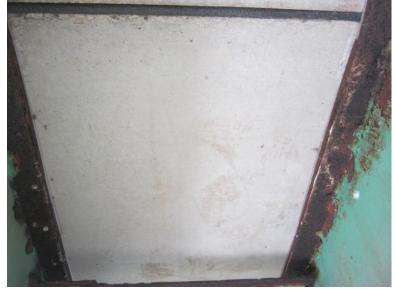
B506 07

FINE CRACKS IN SOFFIT.

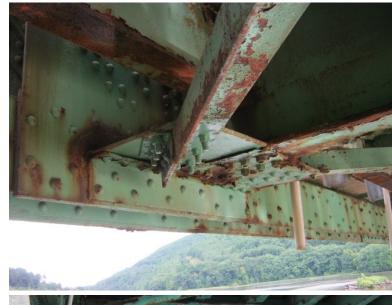
B506 08

CONNECTOR PLATE REPAIR, FLOORBEAM # 3 AT NORTH.

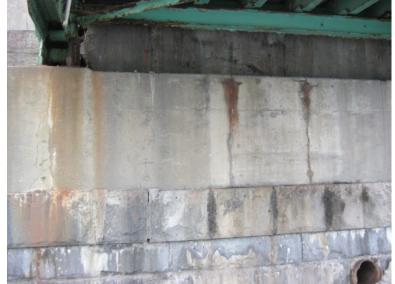
VERTICAL CRACKS, RUST STAINS, WEST ABUTMENT.

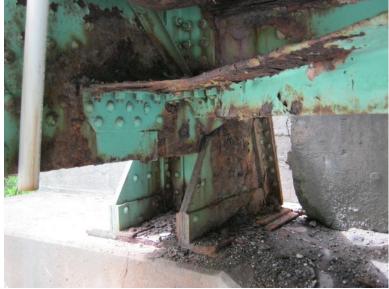
B506 10

RUST AND SCALE AT SOUTHWEST BEARING.

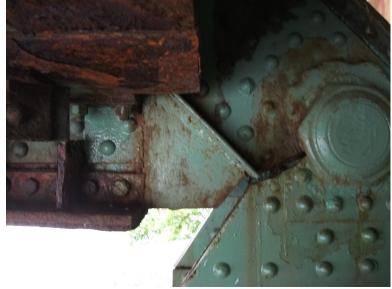
X009 13

PLATED REPAIR AT NORTHEAST BEARING

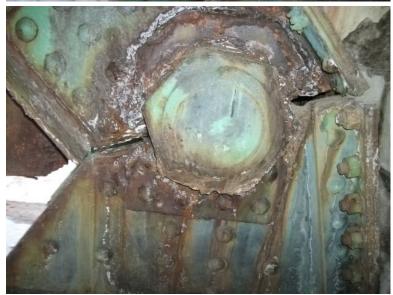
NORTHEAST ROLLER BEARING PLATE RUSTED WITH SECTION LOSS.

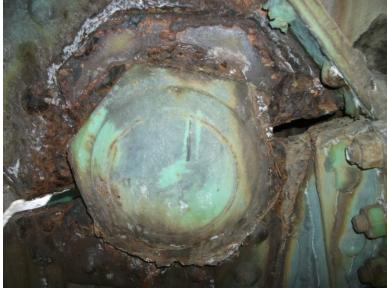
B456 04

NORTHEAST ROLLER BEARING PLATE RUSTED WITH SECTION LOSS.

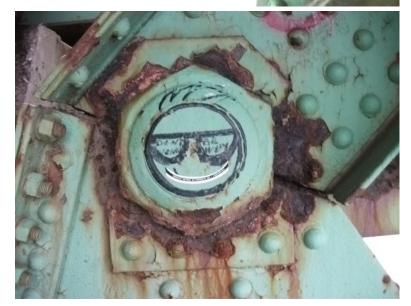
EXTERIOR SIDE OF NORTHEAST ROLLER BEARING PLATE RUSTED WITH SECTION LOSS.

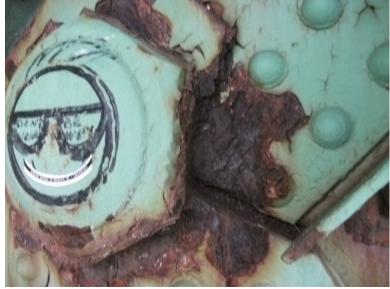
B456 07

EXTERIOR SIDE OF NORTHEAST ROLLER BEARING PLATE RUSTED WITH SECTION LOSS.

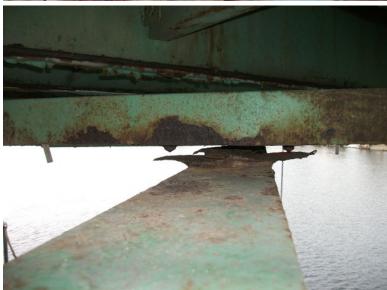
B456 08

LOWER LATERAL BRACING CONNECTION BROKEN AT EAST.

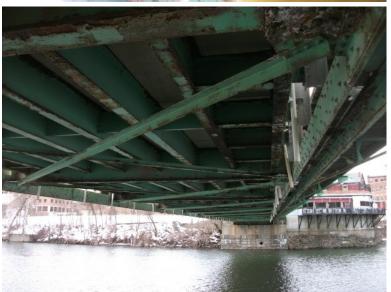
B456 11

MINOR RUST ON STRINGERS AND FLOOR BEAMS.

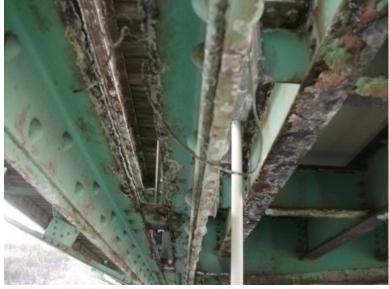
B456 13

PACK RUST IN MIDDLE OF LOWER CHORD AT NORTH.

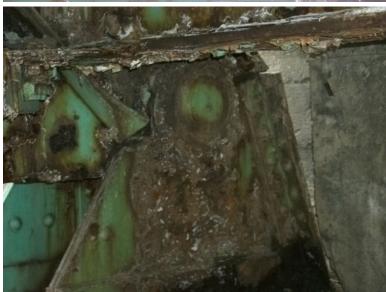
B456 17

SOUTHWEST ROLLER BEARING PLATE RUSTED WITH SECTION LOSS.

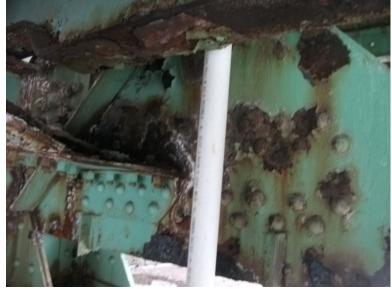
B456 19

MODERATE RUST AT GUSSET PLATE NEAR NORTHWEST ROLLER BEARING.

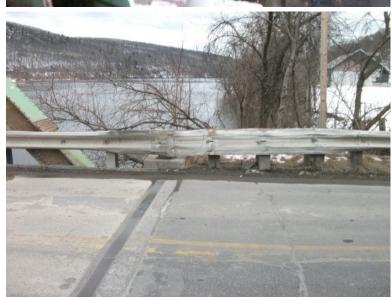
HEAVY TRAFFIC DAMAGE TO SOUTHWEST RAIL.

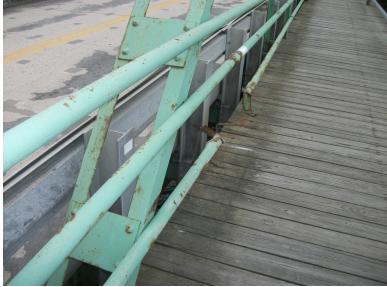
B434 37

BOTTOM SIDEWALK RAIL BROKEN AT MIDSPAN.

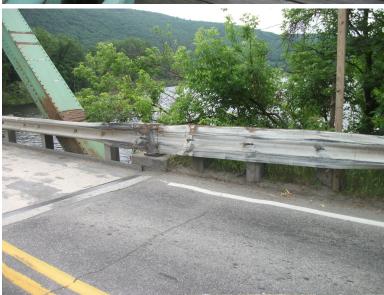
B434 38

SOUTHWEST RAIL HEAVILY DAMAGED. TYPICAL OF NE AND SE.)

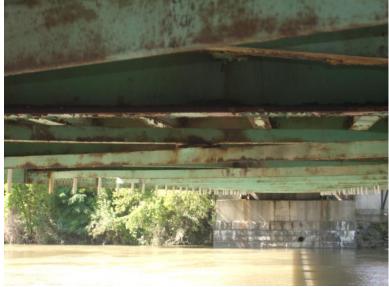
B409 26

SECOND SWAY BRACE FROM EAST BROKEN

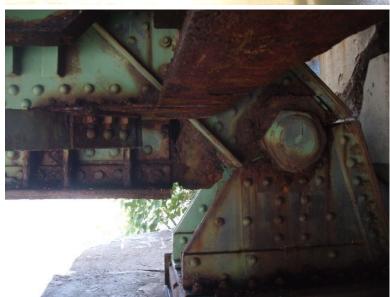
B409 27

NORTHEAST BEARING RUSTED

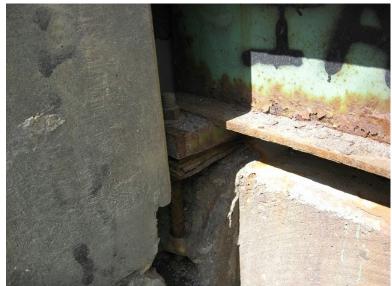
B332 36

BRIDGE SEAT SPALLED AT STRINGER ONE SOUTHWEST, ANCHOR BOLT EXPOSED.

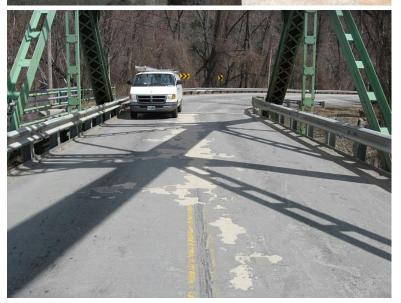
B332 37

PROTECTIVE WEARING SURFACE COATING PEELING AWAY.

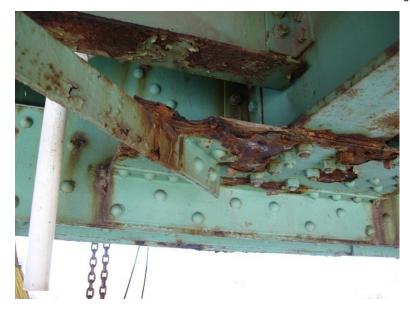
B332 34

LATERAL BRACING CONNECTION PLATE HOLED, WEST SIDE OF THIRD FLOORBEAM FROM EAST.

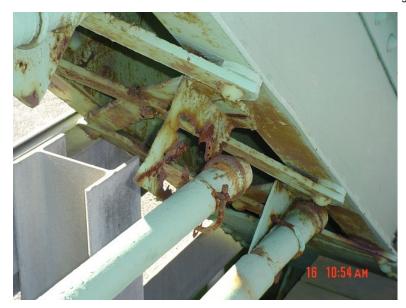
B293 05

PIPE RAIL LOOSE AT NORTHWEST SIDEWALK

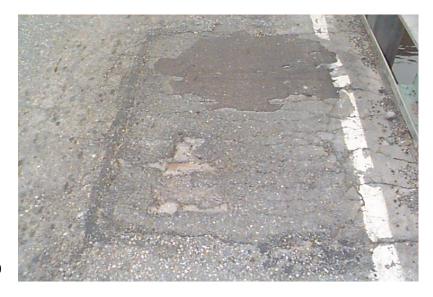
B146 20

ASPHALT CRACKED AND LOOSE OVER SECTION OF DETERIORATED BRIDGE PLANK.

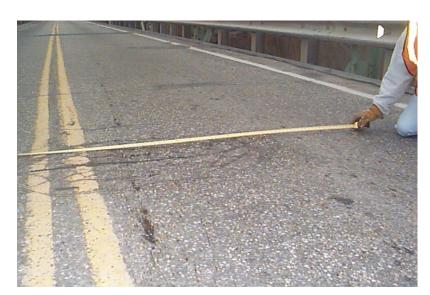
B146 22

ASPHALT SETTLED AND HUMPED UP 3 INCHES, 20 FEET FROM WEST END.

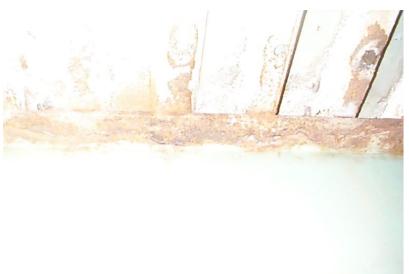
B146 24

BOLTS MISSING AT BRIDGE PLANK CONNECTION TO UPPER FLANGE AT EAST END.

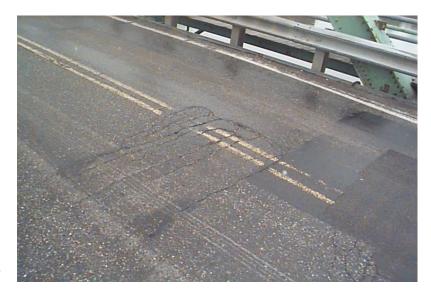
B146 25

AREA TOPSIDE OF PREVIOUS PICTURE B146-24.

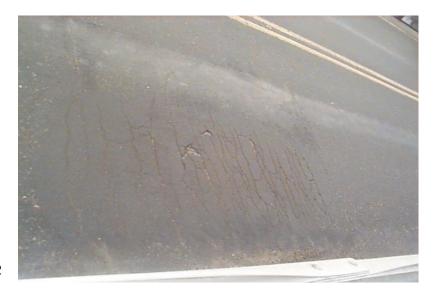
B141 12

CRACKED, DEPRESSED, LOOSE AREA IN DECKING (TYP OF SEVERAL AREAS THROUGHOUT BRIDGE)

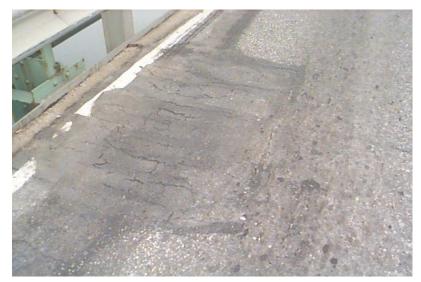
B138 41

CRACKED, DEPRESSED AREA IN ASPHALT TOPSIDE (TYP OF MANY AREAS)

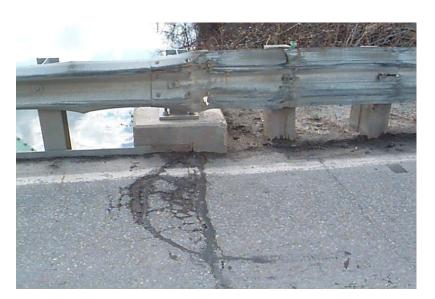
DECK CRACKED AND DEPRESSED AT SOUTHWEST END.

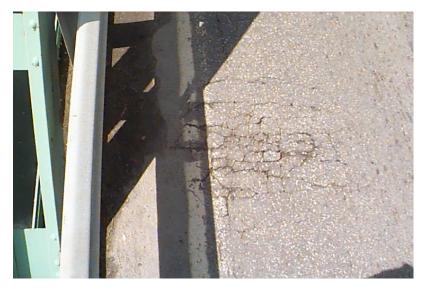
B032 10

DECK CRACKED AND DEPRESSED AT FLOORBEAM # 3, AT SOUTH.

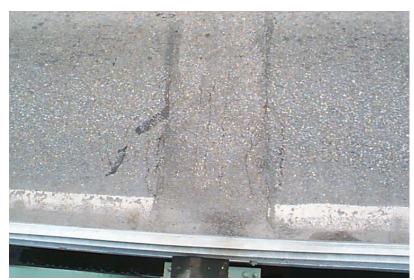
B032 11

DECK CRACKED AT PATCH OVER FLOORBEAM # 6,AT NORTH.

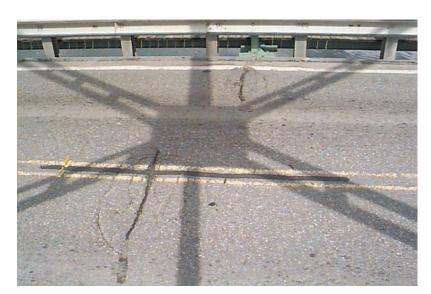
DECK CRACKED, DEPRESSED IN BAY # 6.

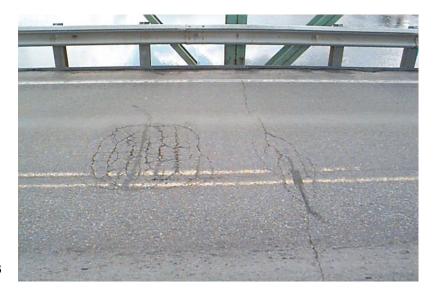
B032 13

DECK CRACKED, DEPRESSED AT FLOORBEAM # 8.

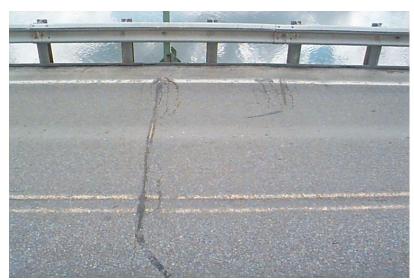
B032 14

DECK CRACKED, DEPRESSED AT BAY # 8.

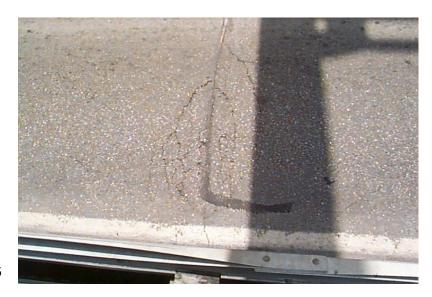
DECK CRACKED, DEPRESSED AT FLOORBEAM # 10,NORTH.

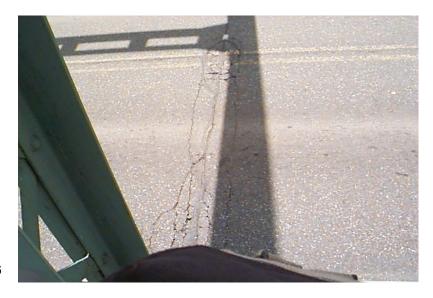
B032 16

DECK CRACKED, DEPRESSED AT FLOORBEAM # 12.

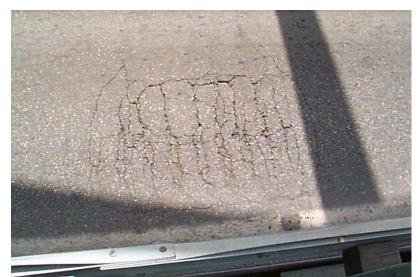
B032 17

DECK CRACKED, DEPRESSED AT FLOORBEAM # 14,NORTH.

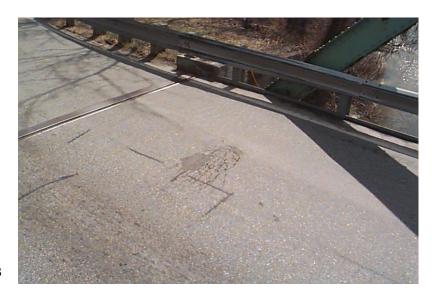
DECK CRACKED, DEPRESSED, AND PATCHED AT EAST END.

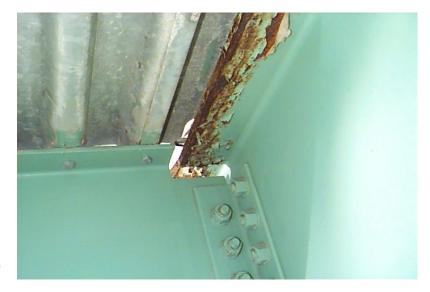
B032 19

BRIDGE PLANK HOLED THROUGH OVER FLOORBEAM #2, BAY 2.

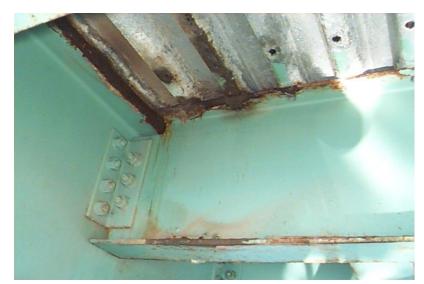
B032 20

BRIDGE PLANK LEAKING AT FLOORBEAM #5, BAY 5.

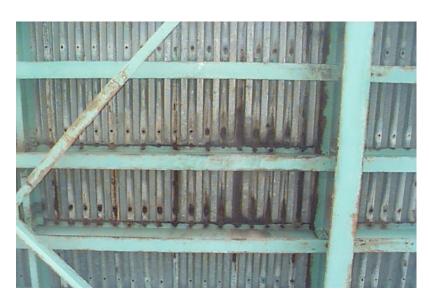
RUST AND LEAKING BAY #6.

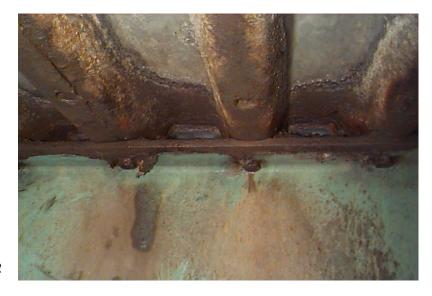
B032 22

TOP FLANGE OF STRINGER #5, WITH SECTION LOSS, IN BAY # 6.

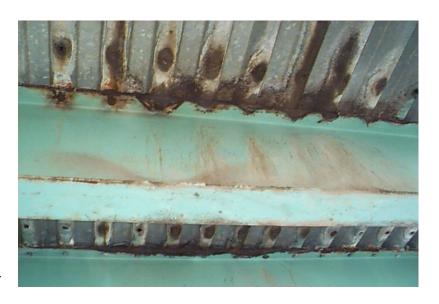
BRIDGE PLANK LEAKING IN BAY #8.

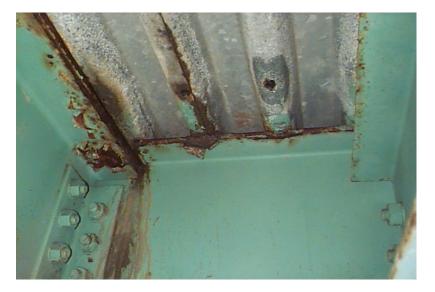
B032 25

BRIDGE PLANK LEAKING IN BAY #9.

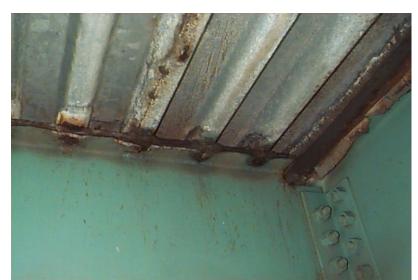
B032 26

BRIDGE PLANK LEAKING IN BAY #10, FLOORBEAM # 9.

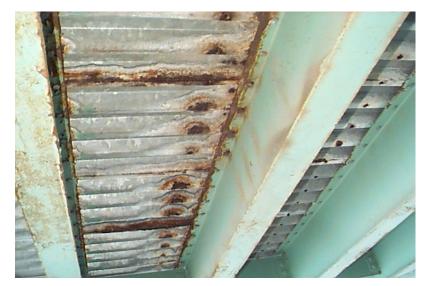
BRIDGE PLANK LEAKING IN BAY #11.

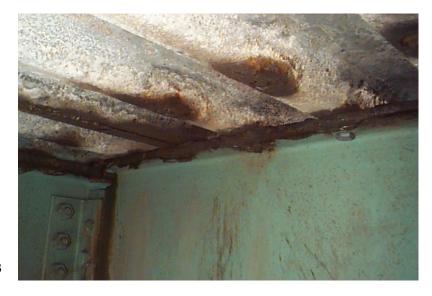
B032 28

BRIDGE PLANK LOOSE IN BAY #11.

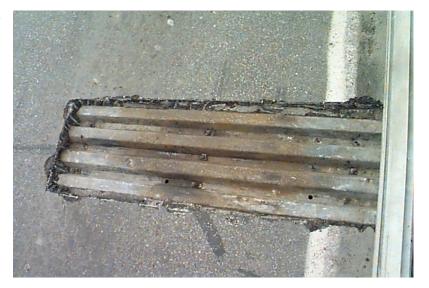
B018 04

DETERIORATED AREA OVER FB#6 @N. W/ FLEX CRACKS & HOLES THROUGH BRIDGE PLANK.

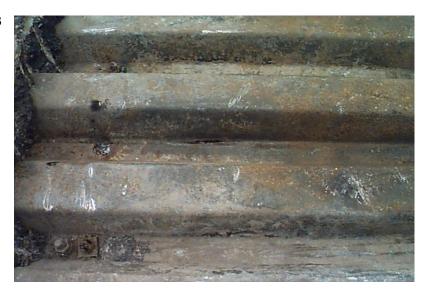
FLEX CRACKED AREA OF BRIDGE PLANK @ N . OVER FB#6.

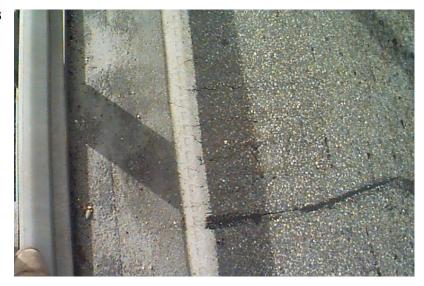
B018 07

ASPHALT CRACKED & DEPRESSED OVER FB#5 @ SOUTH & BRIDGE PLANK MOVING WITH LOADINGS.

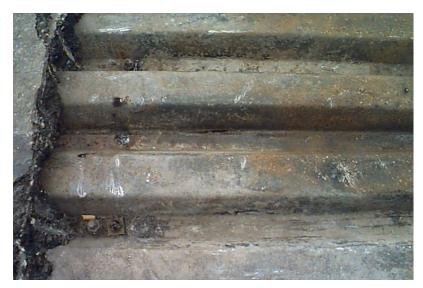
B018 08

FLEX CRACKED AREA OF BRIDGE PLANK @ N . OVER FB#6.

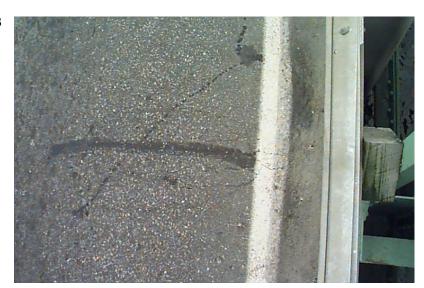
ASPHALT CRACKED OVER FB#7 @ NORTH.

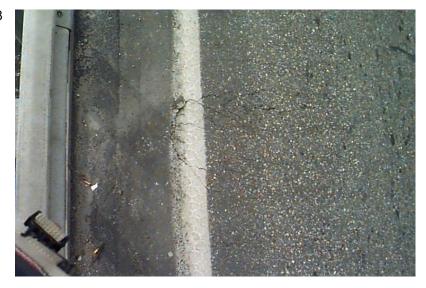
B018 10

ASPHALT CRACKED OVER FB#7 @ SOUTH.

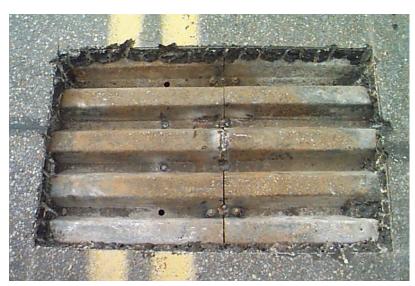
B018 11

DETERIORATED AREA OVER FB#10 @ CENTERLINE.

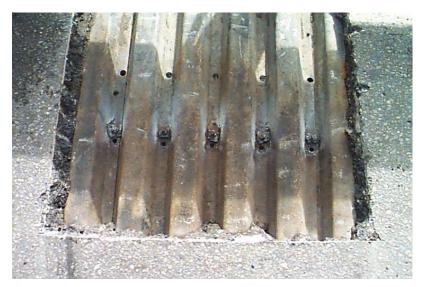
LOOSE BOLTS CUT OUT @ SOUTH OVER FB#4.

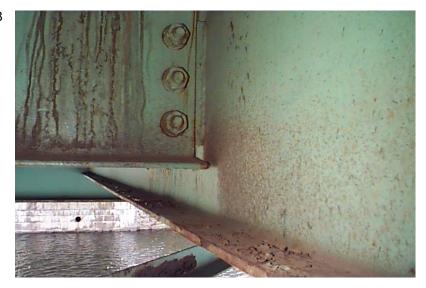
B018 13

APPEARS TO BE CRACKED WELD @ DIAPHRAGM, BAY#6, BETWEEN STRINGER #4 & #5 @ MIDSPAN. WAS NOT CRACKED WHEN PAINT WAS REMOVED.

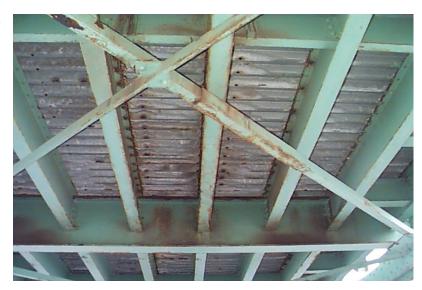
B018 14

DECK LEAKAGE, BAY#6.

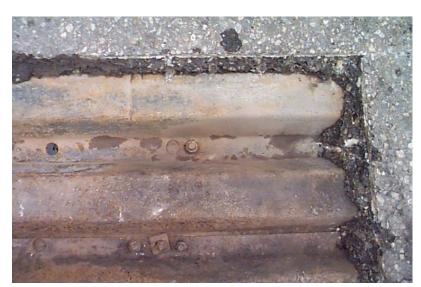
RUNNING CRACK IN BRIDGE PLANK @ FB#7 @ SOUTH.

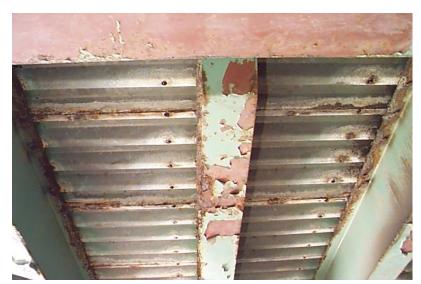
B018 23

NH END HAS BRIDGE PLANK LEAKAGE.

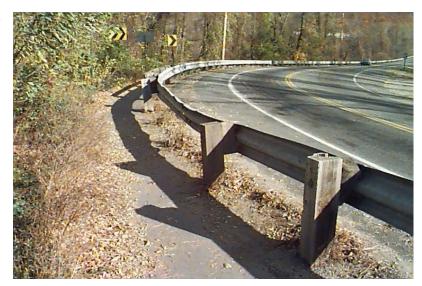
B018 26

NORTH EAST APPROACH RAIL DAMAGE.

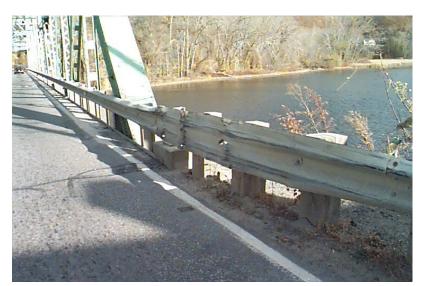
SOUTH WEST APPROACH RAIL DAMAGE @ VT. END.
