# 2018 Routine/Fracture Critical Member Inspection Report

Charles Dana Bridge  
NH Route 119 over the Connecticut River  
NHDOT Bridge No. 042/044  
Hinsdale, New Hampshire

July 2018

Prepared for:  
New Hampshire Department of Transportation

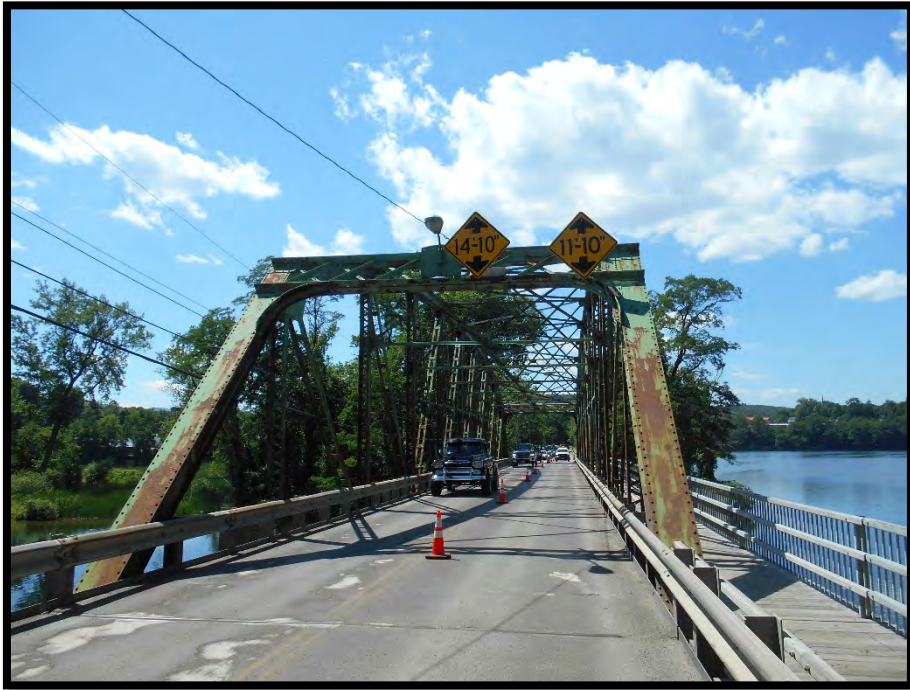
**Location:**  
Bridge deck

The epoxy overlay wearing surface is mainly intact but does have areas of potholing. Refer to Appendix A for representative condition photographs.

**Description:**  
Wearing surface potholes.

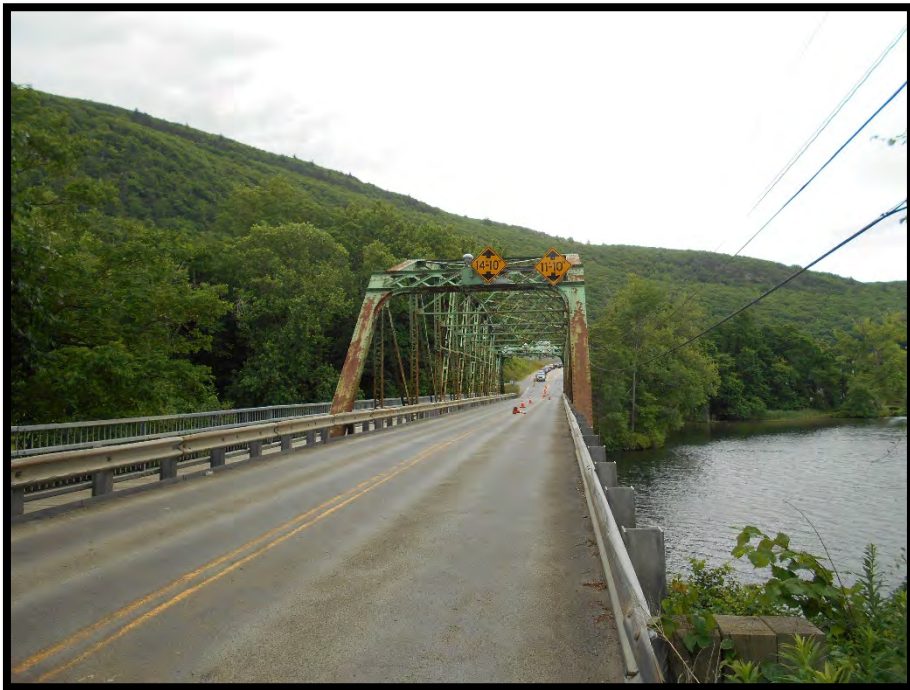
**PHOTO NO. 2**

The bridge rail is considered to be in good condition. The W-beam bridge rail exhibits galvanized coating damage with light rusting, minor scrapes and minor impact damage throughout. Damage is more significant at the rail approach ends. Refer to Appendix A for representative condition photographs.

**Location:**  
W-beam bridge rail

**Description:**  
Typical condition.

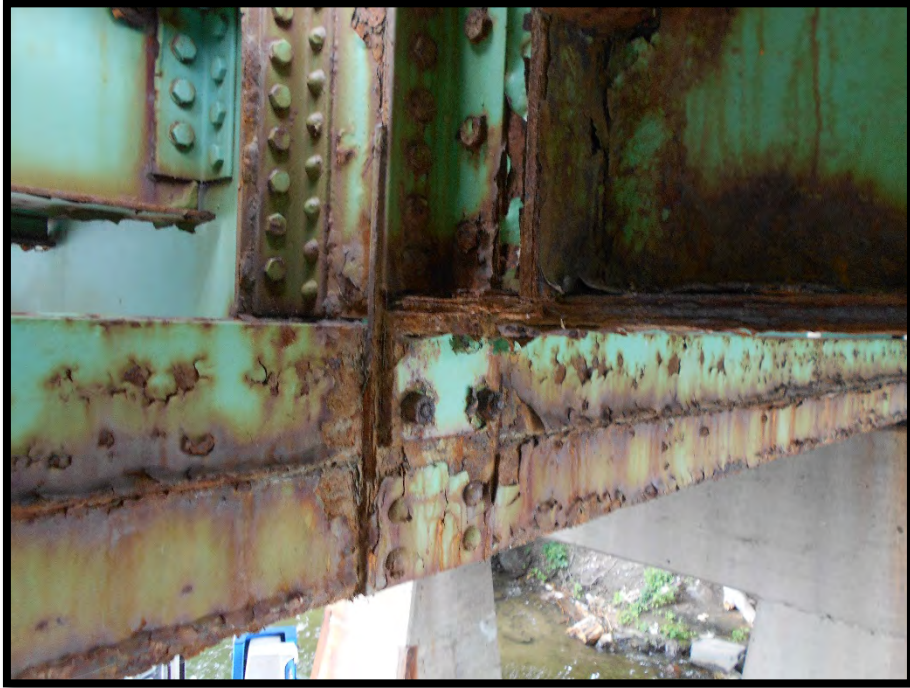
**Location:**  
North truss L1 north gusset plate, north face

- Missing rivets/bolts were observed at the following locations:
  - North truss gusset plate L1 north plate has one missing rivet/bolt.

**Description:**  
Typical gusset plate pack rust and laminar corrosion.

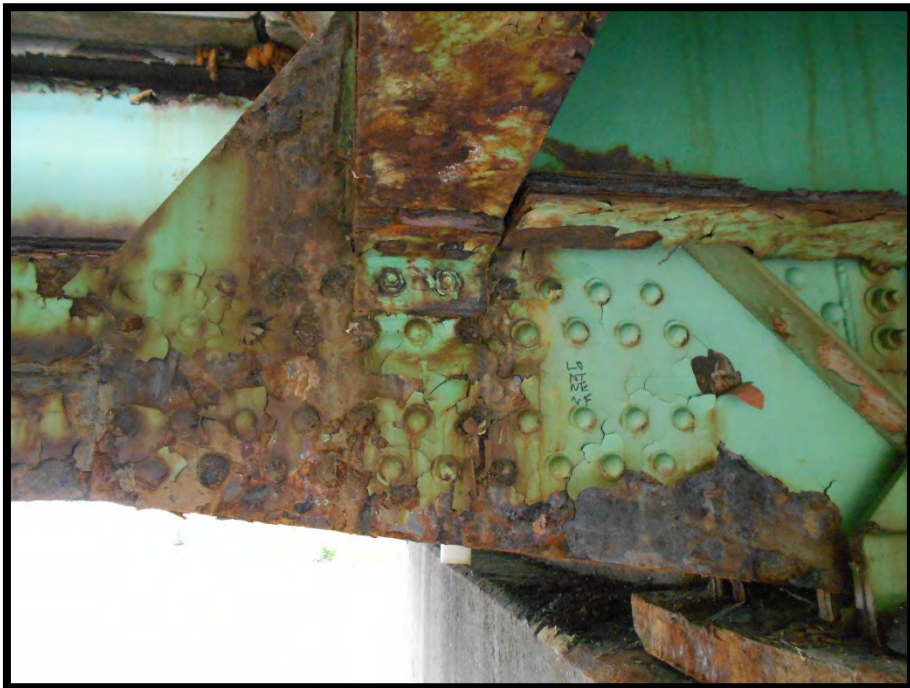
**PHOTO NO. 4**

**Location:**  
North truss L0 north gusset plate north face

**Description:**  
Section loss.

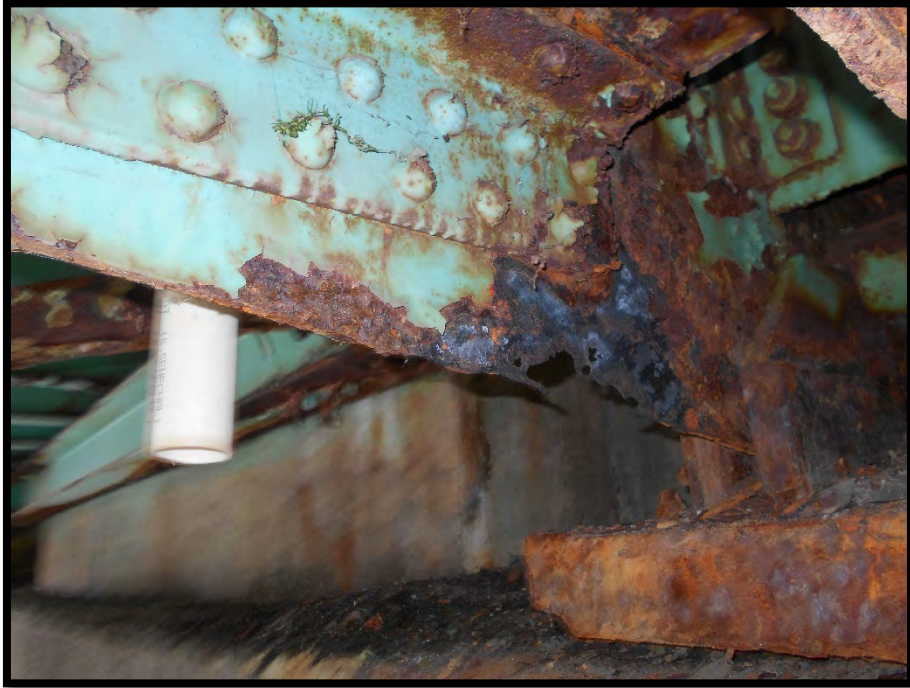
**Location:**  
North truss L0,  
south gusset plate  
north face

**Description:**  
Section loss and  
knife edge.

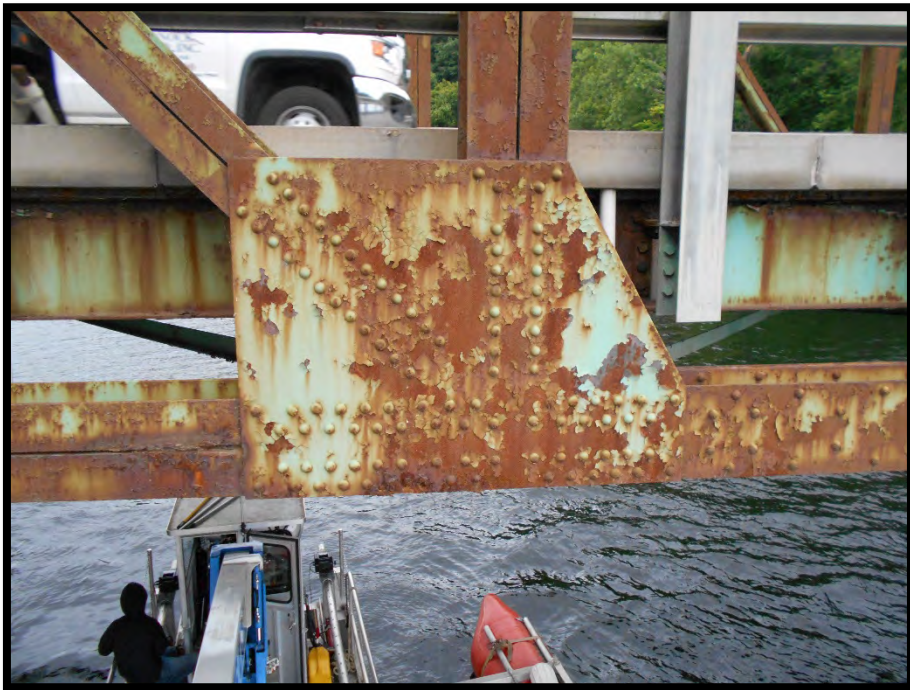
**PHOTO NO. 6**

**Location:**  
South truss L2 south  
gusset plate, south  
face

**Description:**  
Typical gusset plate  
condition.

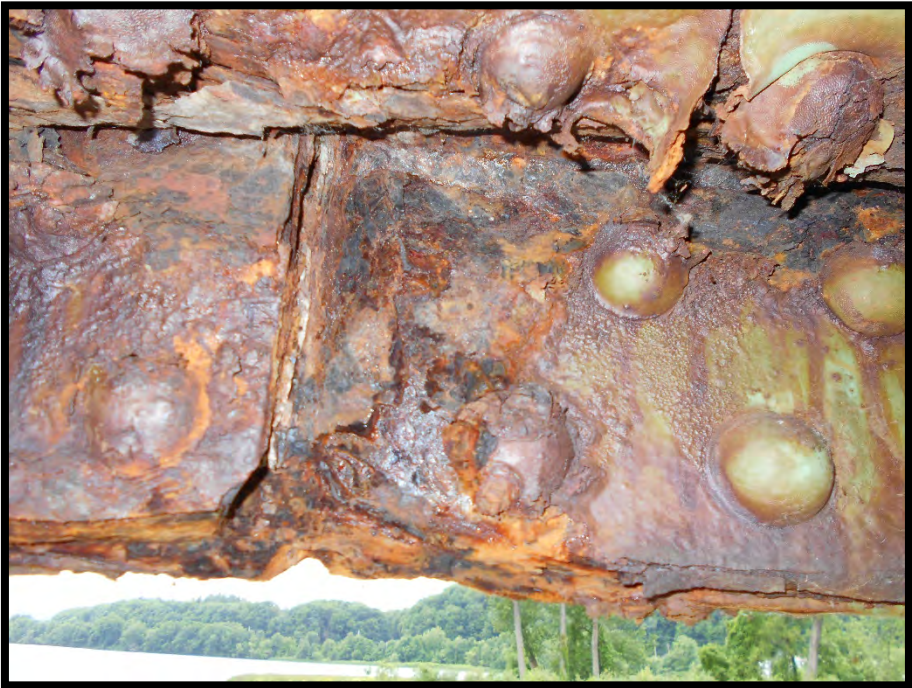
<p><b>PHOTO NO. 7</b></p>

<p><b>Location:</b></p> <p>South truss lower chords at L2, south element, north face</p>	
<p><b>Description:</b></p> <p>Lower chord member knife edge and section loss.</p>

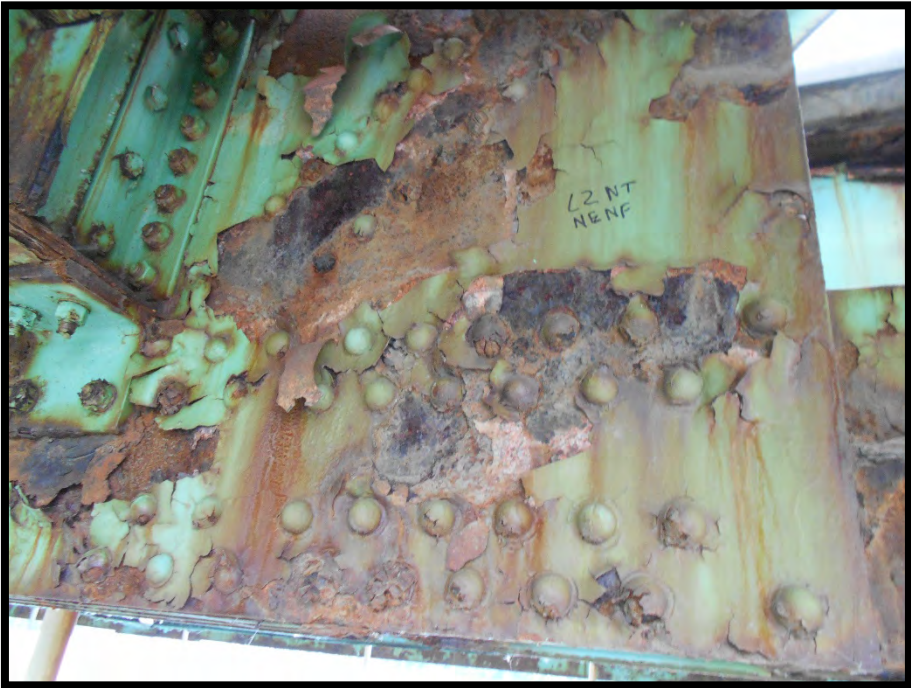
<p><b>PHOTO NO. 9</b></p>

<p><b>Location:</b></p> <p>North truss L2 north gusset plate, north face</p>	
<p><b>Description:</b></p> <p>Typical gusset laminar corrosion and rivet head section loss.</p>

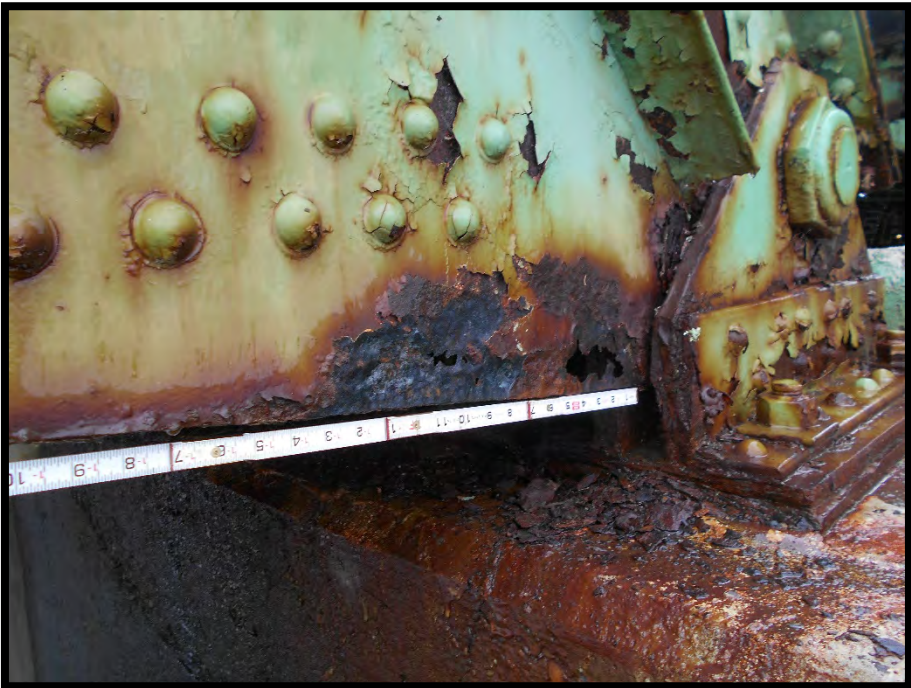
<p><b>PHOTO NO. 10</b></p>

<p><b>Location:</b></p> <p>South truss L10 south gusset plate, south face</p>	
<p><b>Description:</b></p> <p>Section loss along bottom of plate.</p>

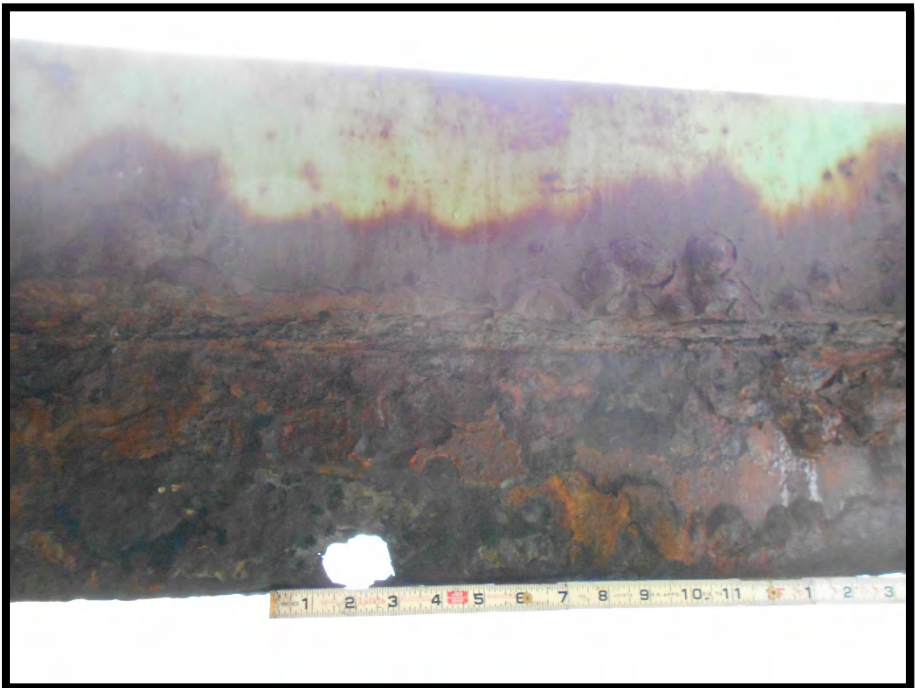
<p><b>PHOTO NO. 11</b></p>

<p><b>Location:</b> South truss member L9-L10, north element, north face</p>	
<p><b>Description:</b> Bottom angle vertical leg section loss.</p>

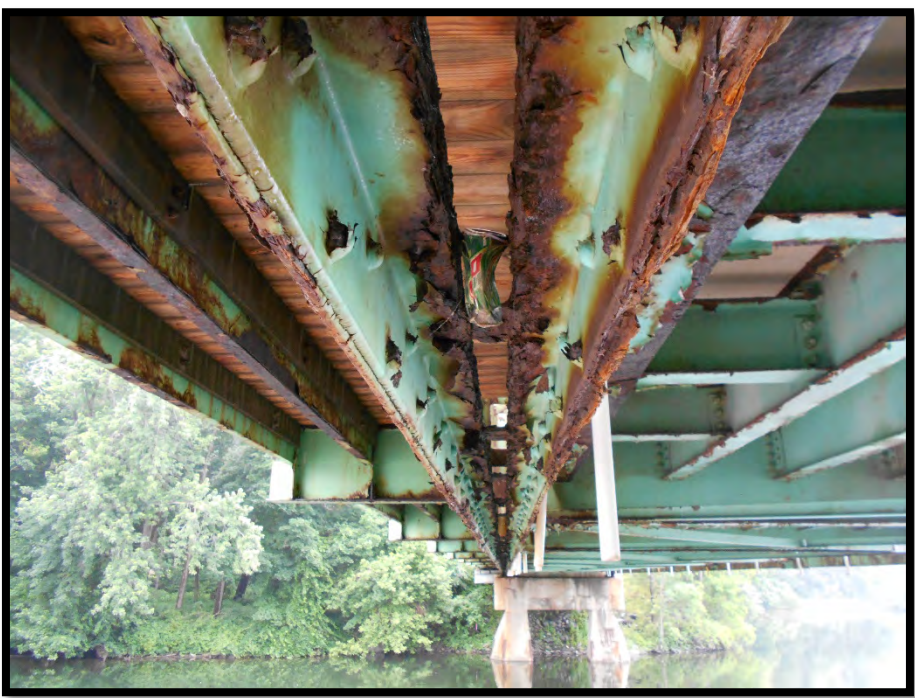
<p><b>PHOTO NO. 12</b></p>

- North truss member L1-L2 north element lower angle vertical leg has 0.31" remaining thickness in an area 3" high by 12" long.
- North truss member L3-L4 south element lower angle vertical leg exhibits laminar corrosion with approximately 1/8" section loss.

<p><b>Location:</b> North truss member L3-L4</p>	
<p><b>Description:</b> Typical lower chord condition.</p>

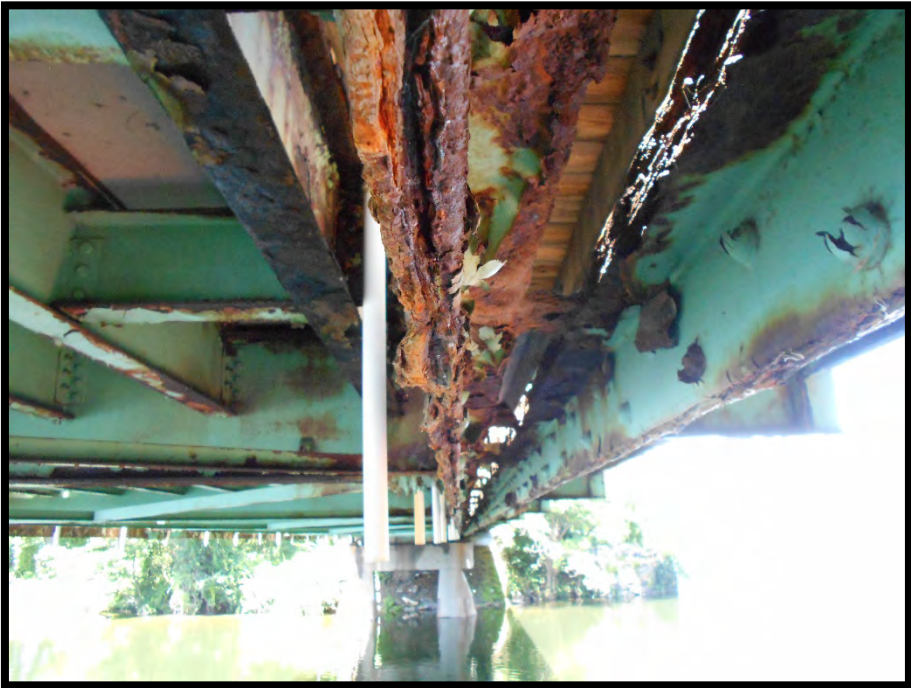
<p><b>PHOTO NO. 13</b></p>

<p><b>Location:</b> North truss member L7-L8</p>	
<p><b>Description:</b> Typical lower chord pack rust and member section loss.</p>

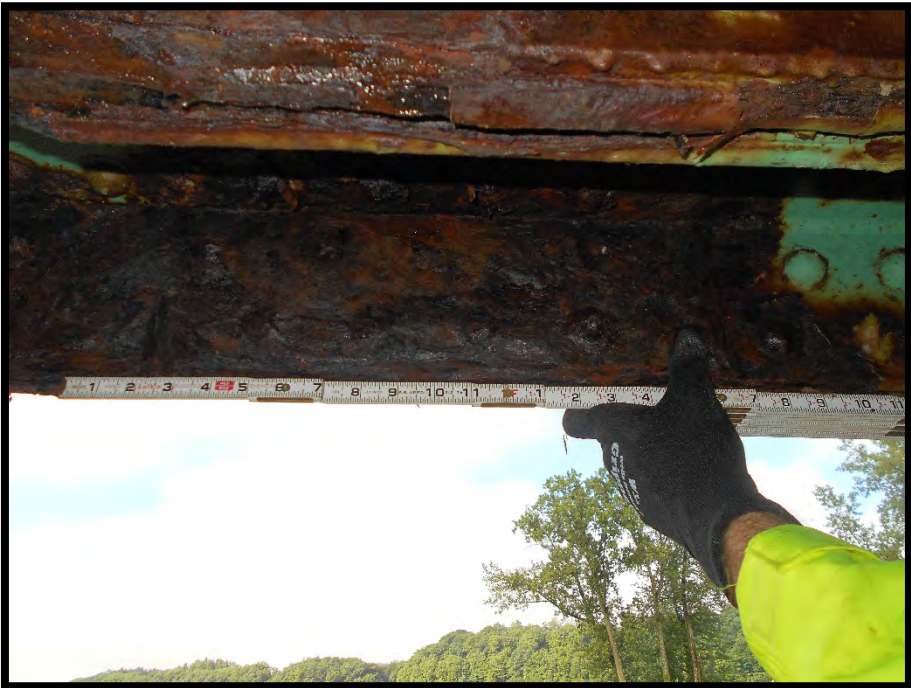
<p><b>PHOTO NO. 14</b></p>

<p><b>Location:</b> South truss lower chord splice at L4, south gusset plate, north face</p>	
<p><b>Description:</b> Splice plate section loss.</p>

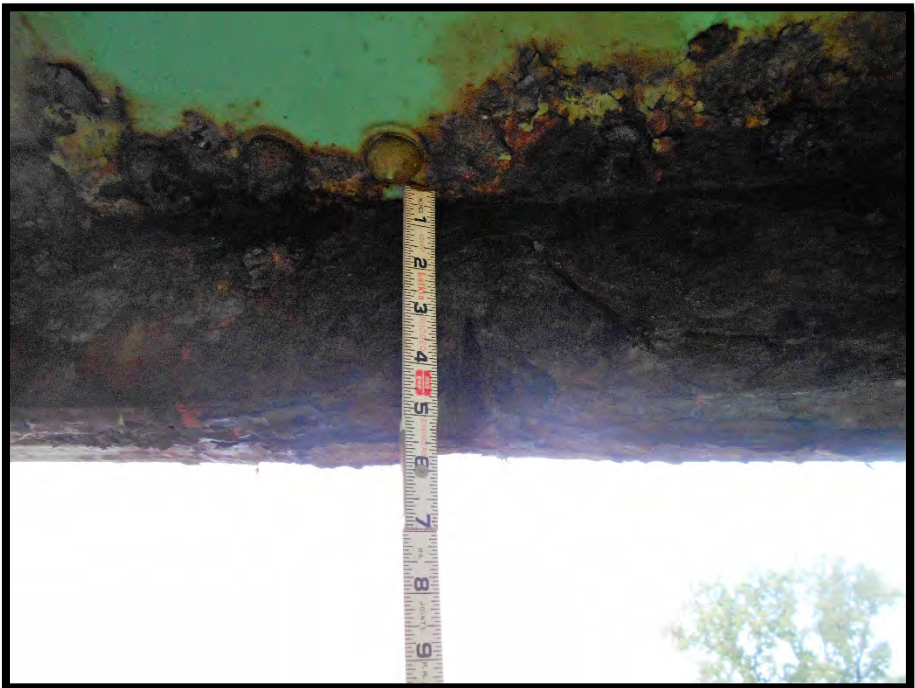
<p><b>PHOTO NO. 15</b></p>

<p><b>Location:</b></p> <p>South truss lower chord splice at L4, south gusset plate, north face</p>	
<p><b>Description:</b></p> <p>Splice plate section loss.</p>

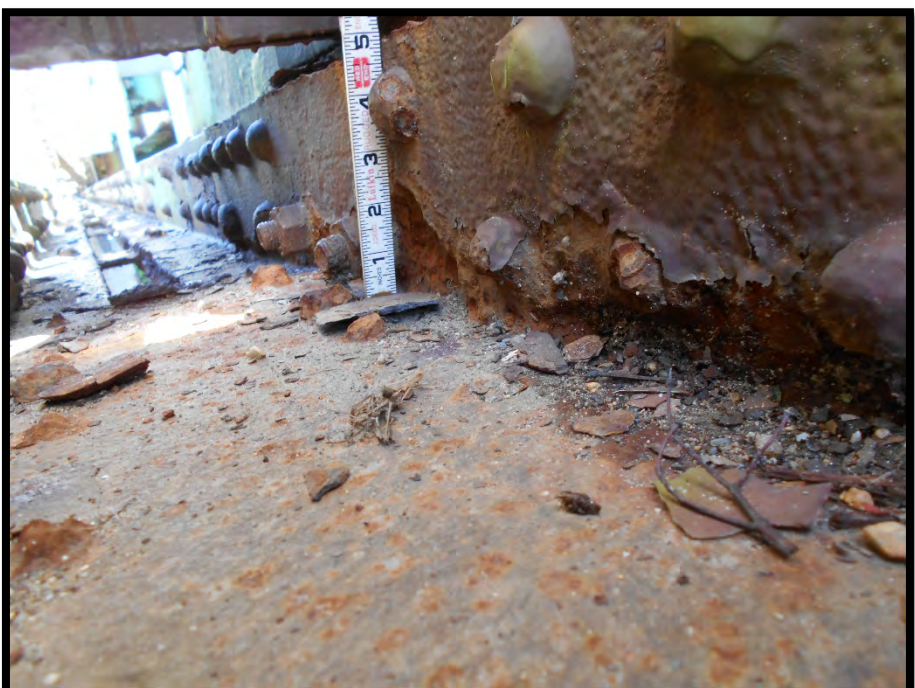
<p><b>PHOTO NO. 16</b></p>

- South truss gusset plate L6 north plate has one unfilled rivet hole in the lower chord connection. Lower chord does not have the corresponding hole.
- South truss gusset plate L8 north plate has one missing rivet in the lower chord connection.

<p><b>Location:</b></p> <p>South truss lower chord splice at L6 north gusset plate, south face</p>	
<p><b>Description:</b></p> <p>Section loss.</p>

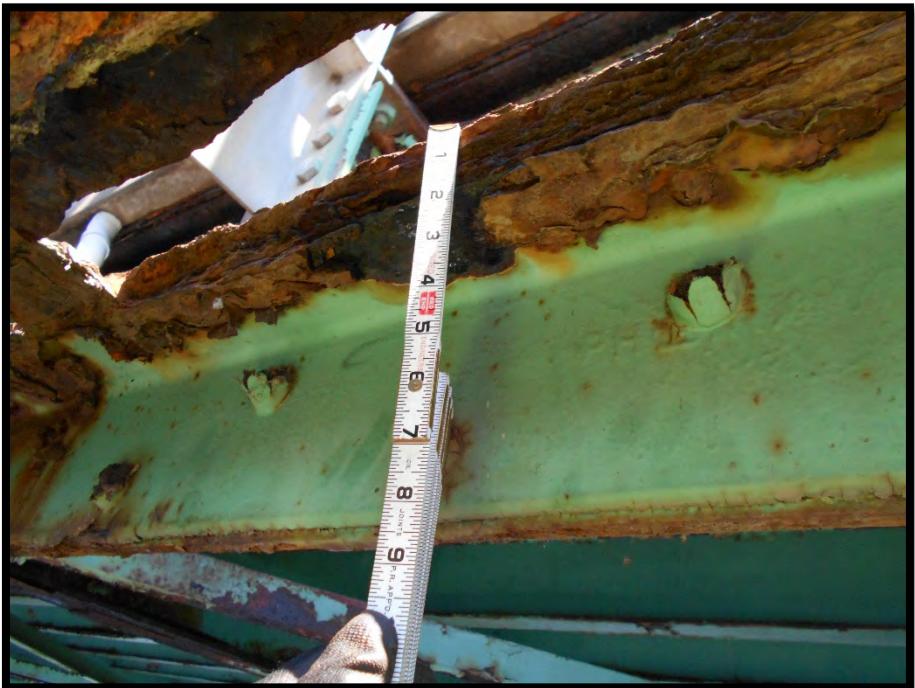
<p><b>PHOTO NO. 17</b></p>

- South truss member L6-L7 north element angle horizontal leg remaining thickness ranging from 0.19" to 0.30".
  - Other lower chord members not measured and previously noted are considered to have a remaining horizontal leg thickness of approximately ¼" based on the level of pack rust, laminar corrosion, deterioration and section loss observed.

<p><b>Location:</b> South truss member L6-L7 north element, south face</p>	
<p><b>Description:</b> Typical pack rust and lower chord section loss.</p>

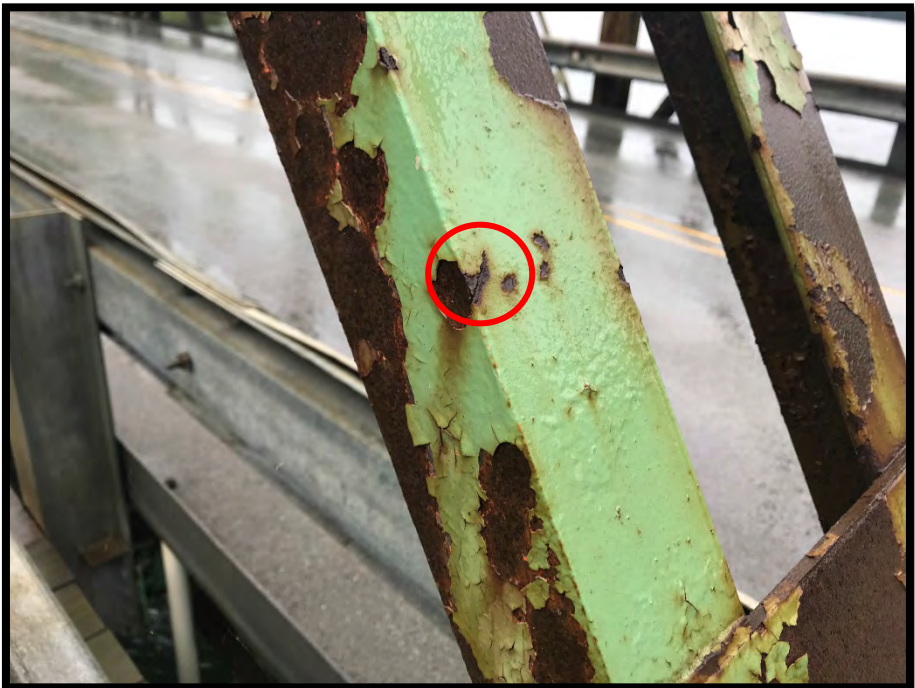
<p><b>PHOTO NO. 19</b></p>

<p><b>Location:</b> North truss member L4-M45 north element</p>	
<p><b>Description:</b> Little gouge in heel.</p>

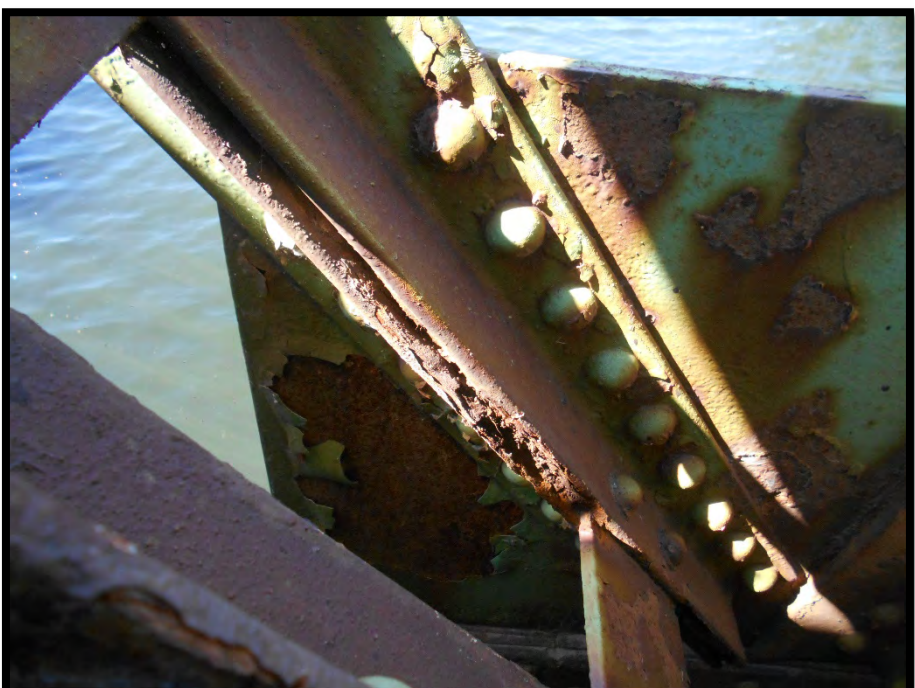
<p><b>PHOTO NO. 20</b></p>

<p><b>Location:</b> South truss member L7-U8: south element</p>	
<p><b>Description:</b> Pack rust between angles above tie plate at L7 gusset plate, 9" long, up to 3/4" at toe.</p>

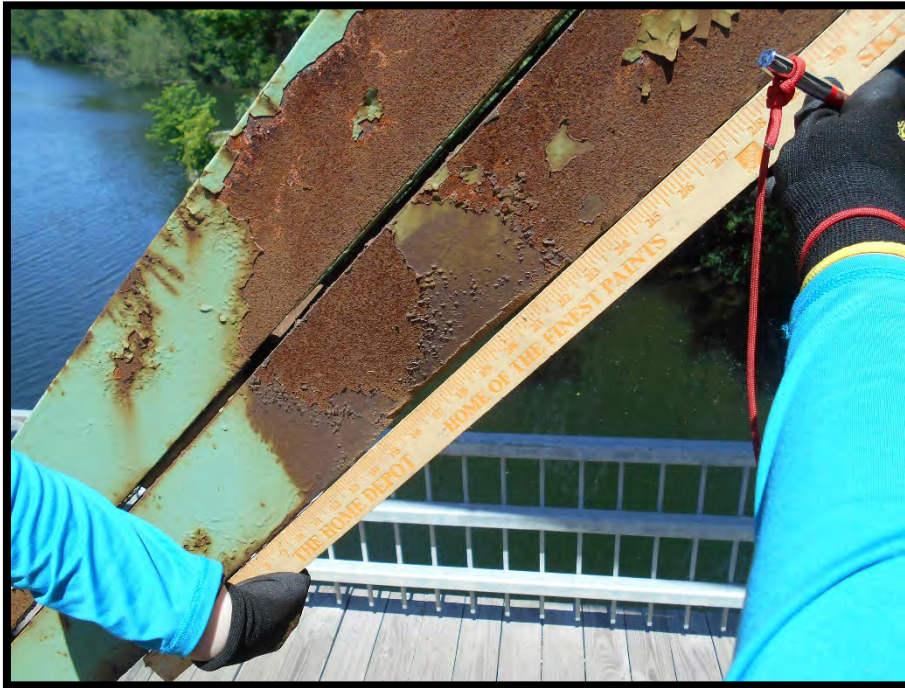
PHOTO NO. 21

**Location:**North truss member  
L8-U9**Description:**South element  
bottom flange bent  
 $\frac{1}{2}$ " to north, 1' long,  
7.5' above top of  
deck.

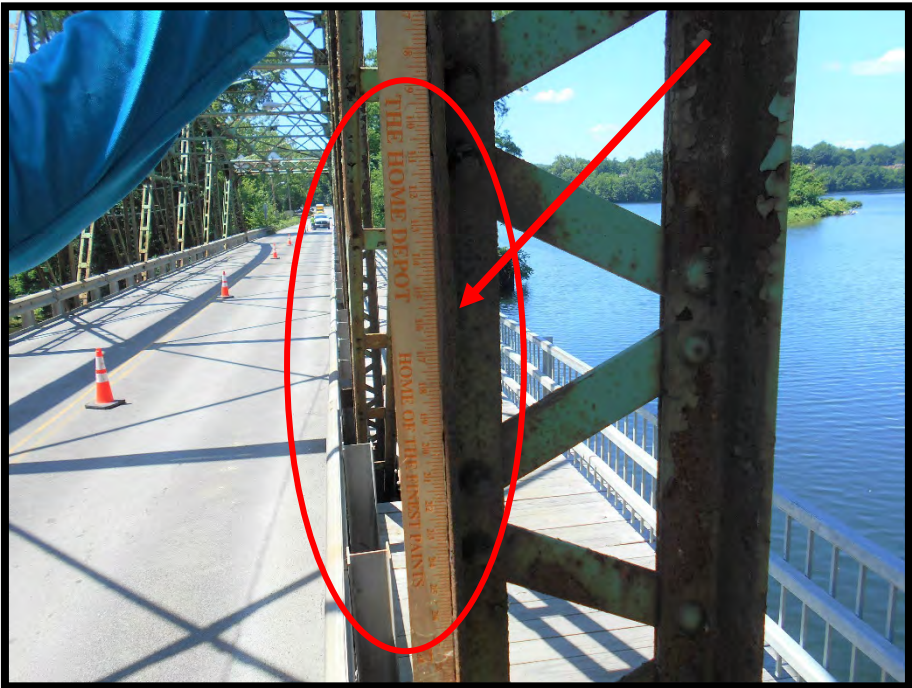
<p><b>PHOTO NO. 23</b></p>

<p><b>Location:</b></p> <p>North truss, L9-U9: south element</p>	
<p><b>Description:</b></p> <p>East flange bent 3/8" to north, 6" long, 7.5' above top of deck.</p>

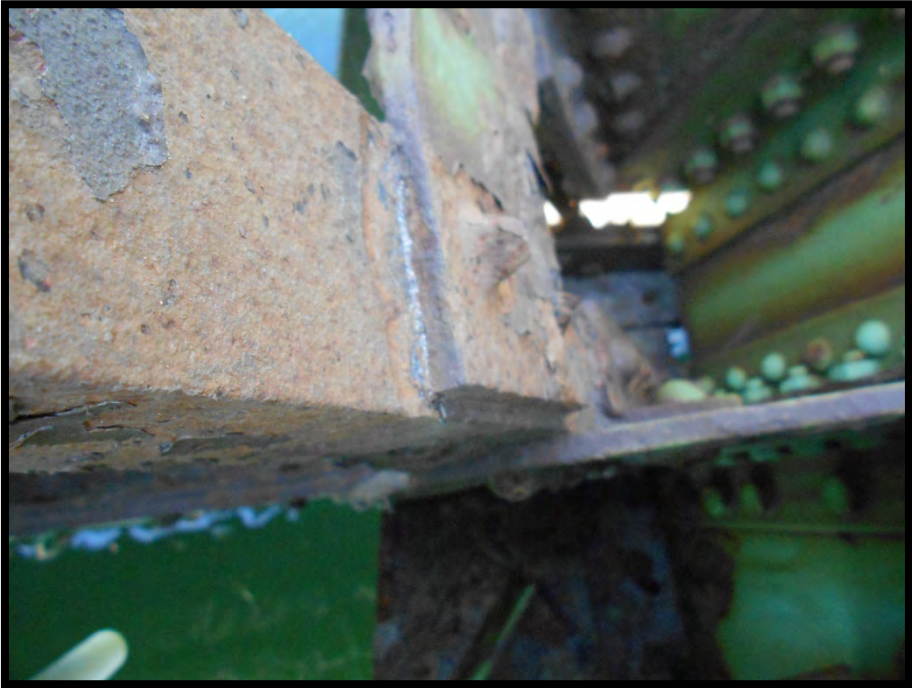
<p><b>PHOTO NO. 24</b></p>

- Pack rust between member angles varies from 1/2" to 3/4" thick.
- Some diagonal members exhibit rust blooms with up to 1/16" deep pitting.
- North truss diagonal member M34-L4 and M45-L5 south elements have up to 1/8" section loss on angle top legs.

<p><b>Location:</b></p> <p>North truss member M45-L5 south element</p>	
<p><b>Description:</b></p> <p>Section loss up to 1/8" on top of heel above first tie plate from L5 gusset plate.</p>

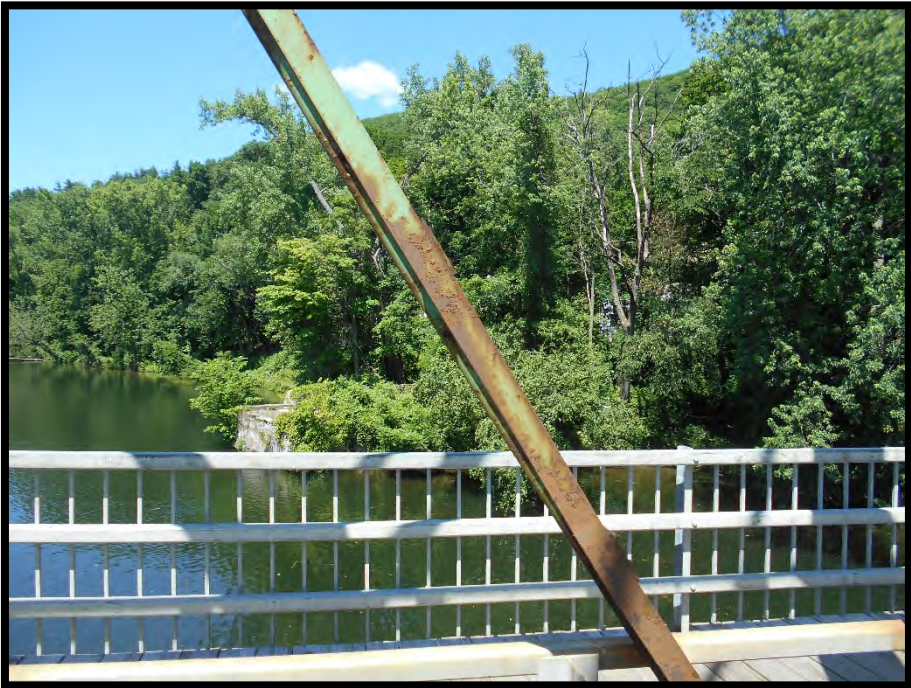
<p><b>PHOTO NO. 25</b></p>

<p><b>Location:</b></p> <p>North truss member M56-L6</p>	
<p><b>Description:</b></p> <p>Member bent and twisted toward centerline of bridge.</p>

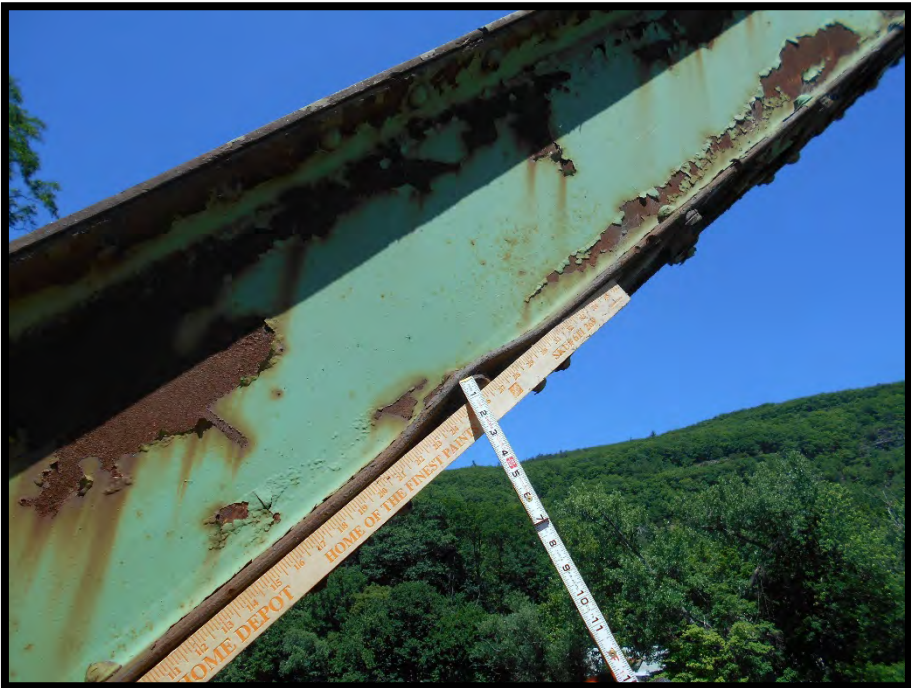
<p><b>PHOTO NO. 26</b></p>

<p><b>Location:</b></p> <p>North truss member U9-L10</p>	
<p><b>Description:</b></p> <p>Member impact damage.</p>

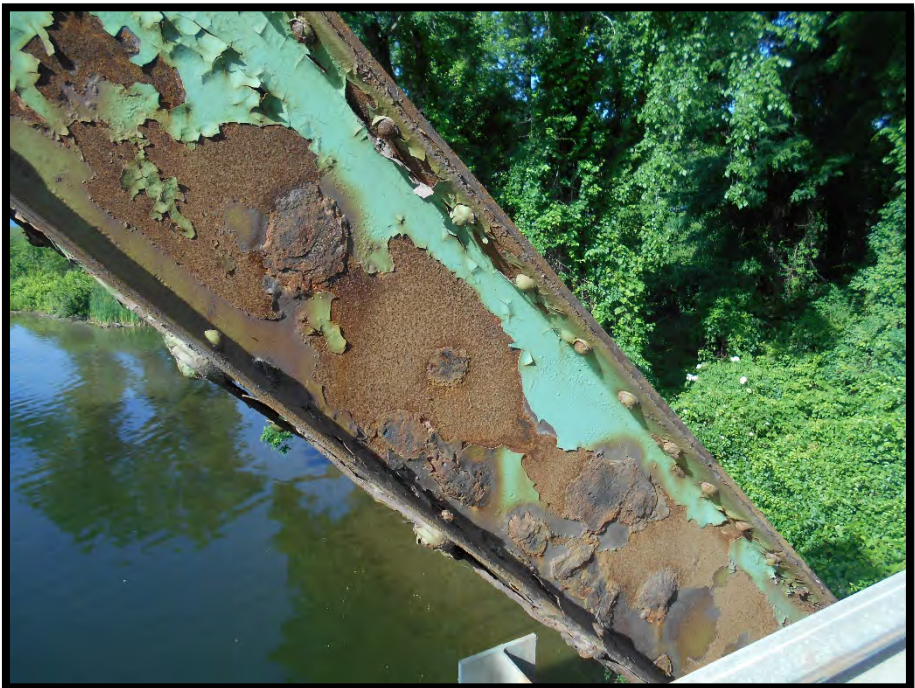
<p><b>PHOTO NO. 27</b></p>

The end diagonals are considered to be in satisfactory condition. The member exterior surfaces exhibit paint system failure with light to moderate surface rusting. The end diagonals also exhibit areas of minor impact damage. The end diagonal interior surfaces and lacing bars generally exhibit paint system failure with varying degrees of light to heavy surface rusting, laminar corrosion and section loss. Lacing bars have up to 100% section loss. Rivet heads exhibit up to 50% section loss.

<p><b>Location:</b> End diagonal</p>	
<p><b>Description:</b> Typical condition.</p>

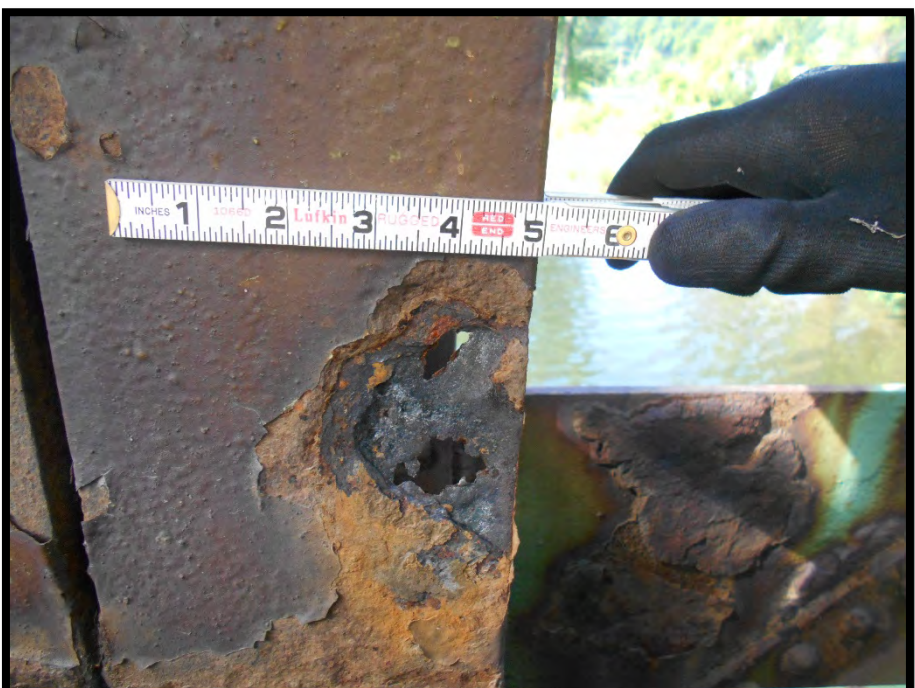
<p><b>PHOTO NO. 28</b></p>

<p><b>Location:</b> South truss member U2-L2</p>	
<p><b>Description:</b> Section loss.</p>

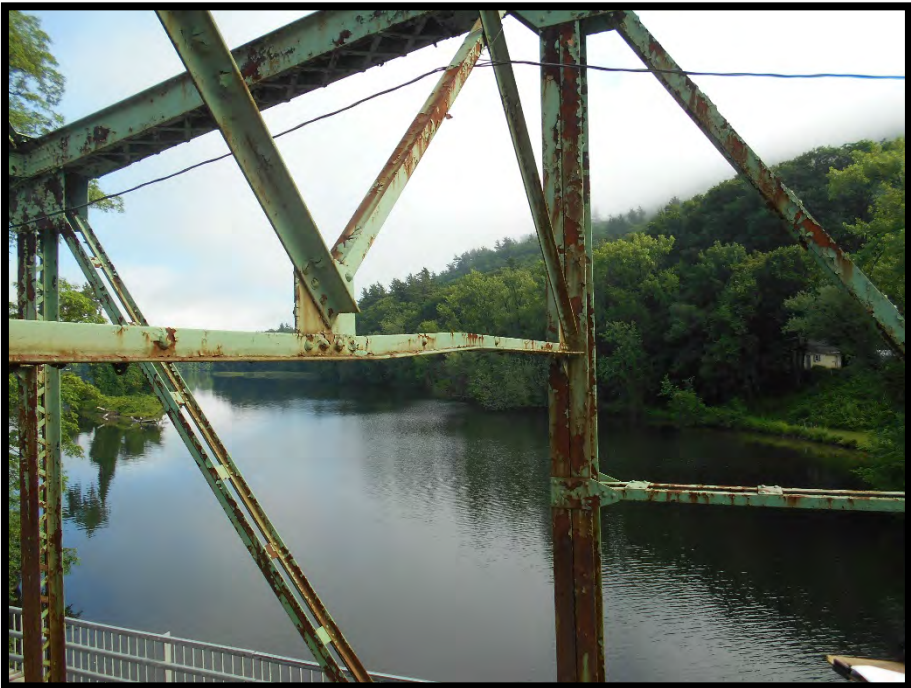
<p><b>PHOTO NO. 29</b></p>

<p><b>Location:</b> Panel Point 3</p>	
<p><b>Description:</b> Impact damage.</p>

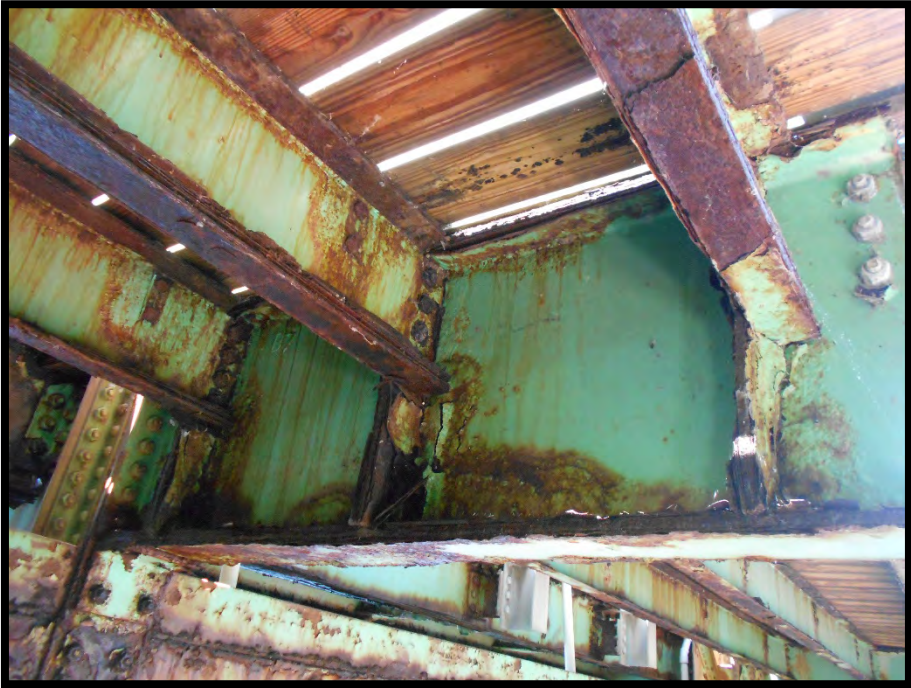
<p><b>PHOTO NO. 30</b></p>

The cantilevered sidewalk support members generally exhibit paint system failure with varying degrees of light to heavy rusting with laminar corrosion and section loss. Rolled shape stringers exhibit advanced deterioration with up to 50% flange section loss. Refer to Appendix A for representative condition photographs.

<p><b>Location:</b> Cantilevered sidewalk support system</p>	
<p><b>Description:</b> Typical condition.</p>

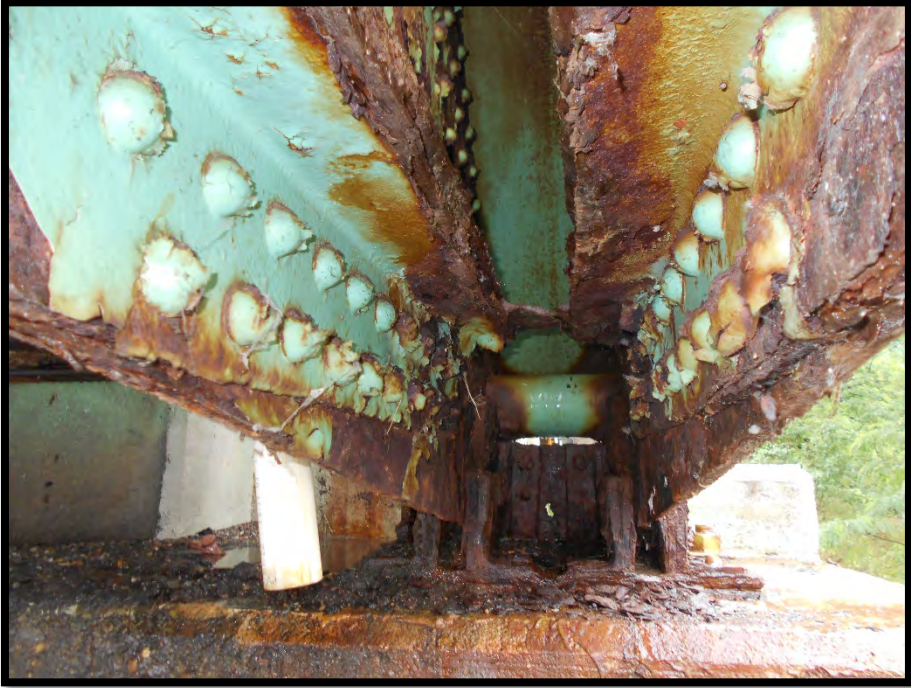
<p><b>PHOTO NO. 31</b></p>

The bearings are considered to be in satisfactory to poor condition. The expansion and fixed shoes exhibit paint system failure with moderate to heavy rusting. There is heavy rusting with laminar corrosion of the pins and bearing saddles. Refer to Appendix A for representative condition photographs.

<p><b>Location:</b> East pier south truss bearing</p>	
<p><b>Description:</b> Heavy rusting.</p>

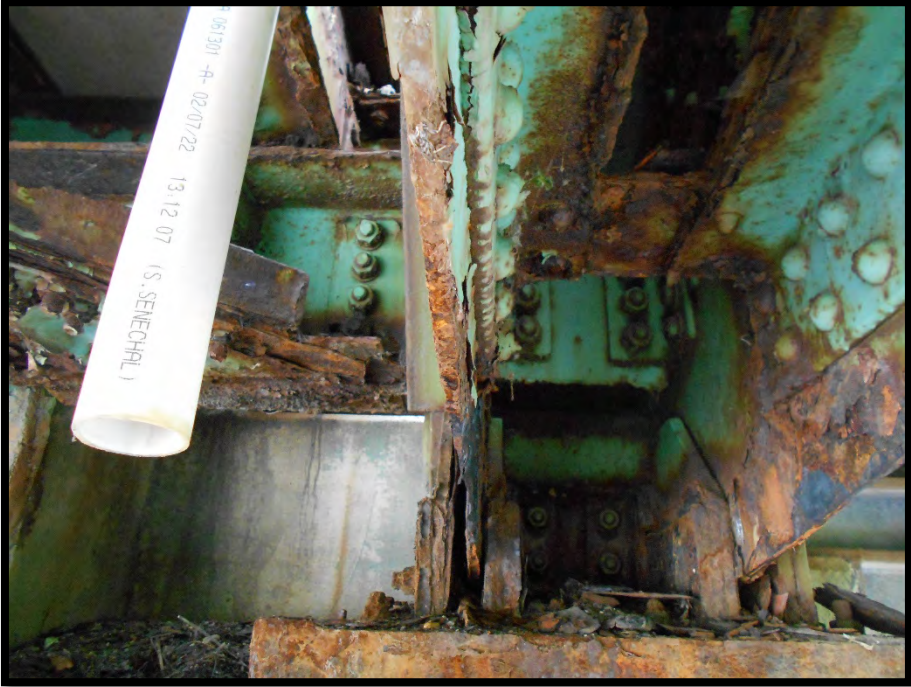
<p><b>Location:</b> West pier north truss bearing</p> <p><b>Description:</b> Heavy rusting.</p>

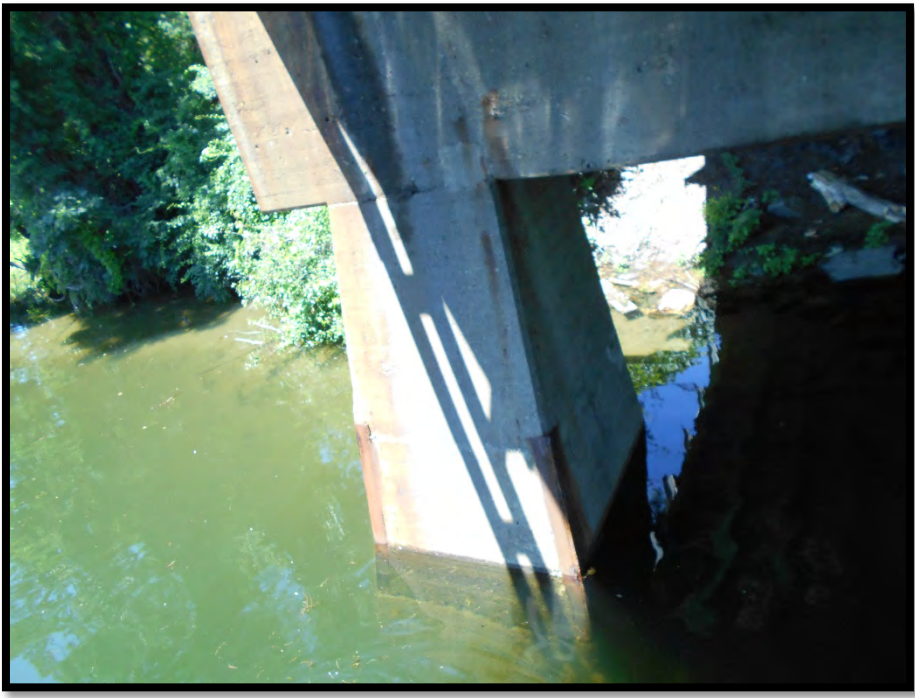
<p><b>PHOTO NO. 33</b></p>

<p><b>Location:</b> West pier south column</p>	
<p><b>Description:</b> Abrasion with exposed aggregate below water surface.</p>

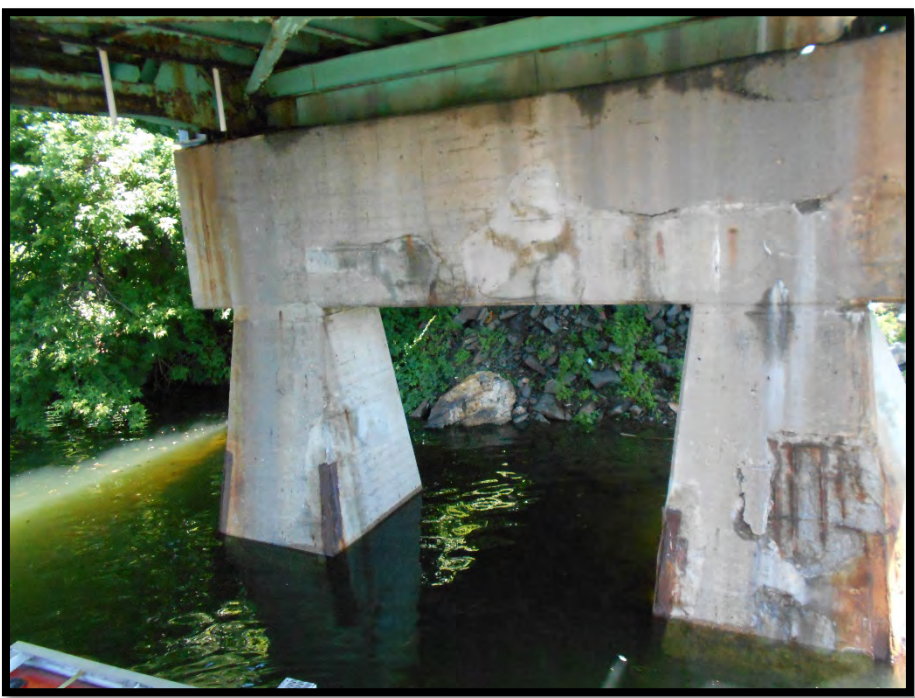
<p><b>PHOTO NO. 34</b></p>

<p><b>Location:</b> East pier west face</p>	
<p><b>Description:</b> Map cracking and spalling.</p>

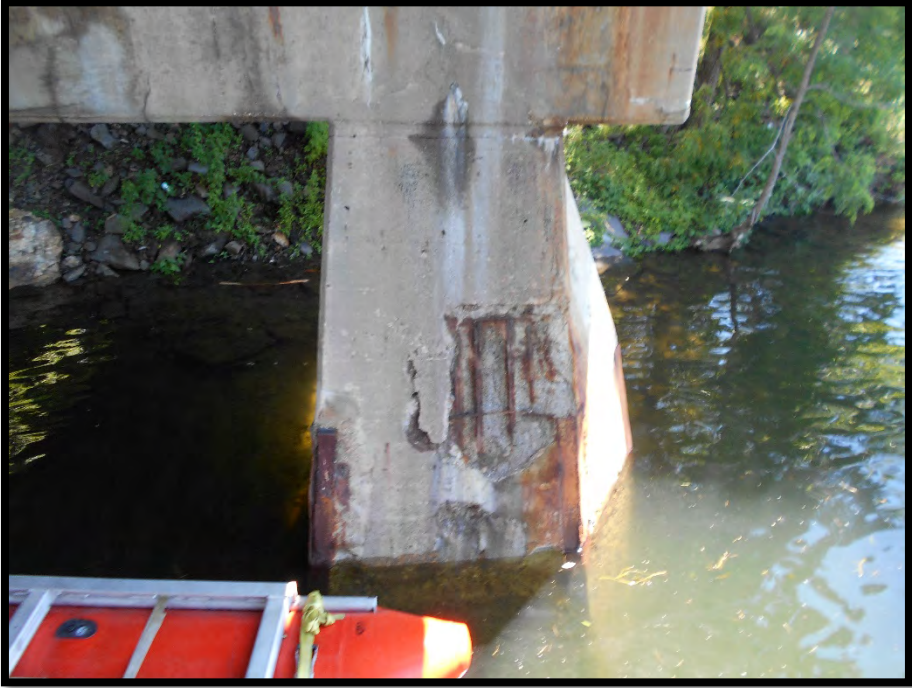
<p><b>PHOTO NO. 35</b></p>

- The piers exhibit random areas of map cracking and spalling.
- The piers exhibit abrasion with exposed aggregate below the water surface.
- East pier cap west face repair concrete is delaminated.
- The east pier south column west face has a large spall with exposed and corroded reinforcement.

<p><b><u>Location:</u></b>  East pier south column west face</p>	
<p><b><u>Description:</u></b>  Concrete spall with exposed reinforcement.</p>	
<p><b>PHOTO NO.</b></p>	
<p><b><u>Location:</u></b></p>	
<p><b><u>Description:</u></b></p>
