HINSDALE 042/044
NH119 over CONNECTICUT RIVER

Owner: NHDOT
Inspection Team: B
Bridge Maintenance Crew: 7

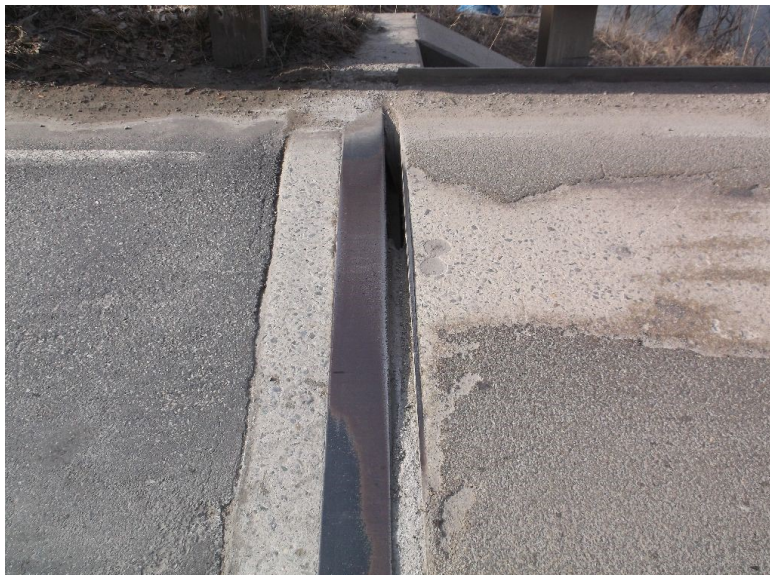
B609 46

SEAL FAILING AT SOUTH
END OF JOINT # 4.

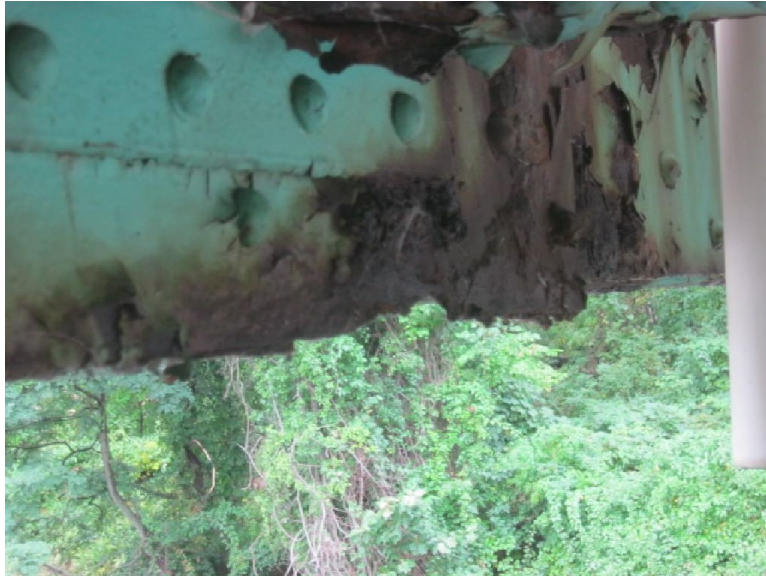
B568 52

BOTTOM EDGE OF GUSSET
PLATE AT FLOORBEAM # 2,
SOUTH, RUSTED AND
HOLED.

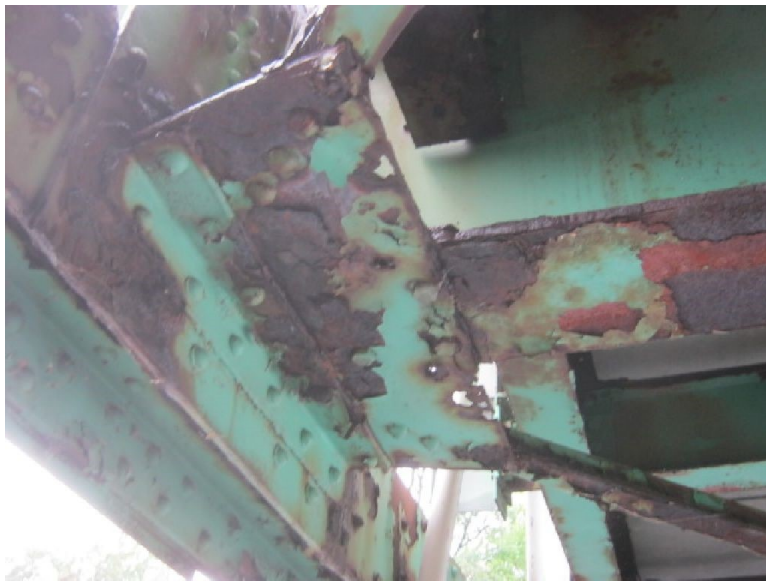
B568 53

LATERAL BRACING
CONNECTION PLATE
HOLED AT SOUTH END OF
FLOORBEAM # 5.

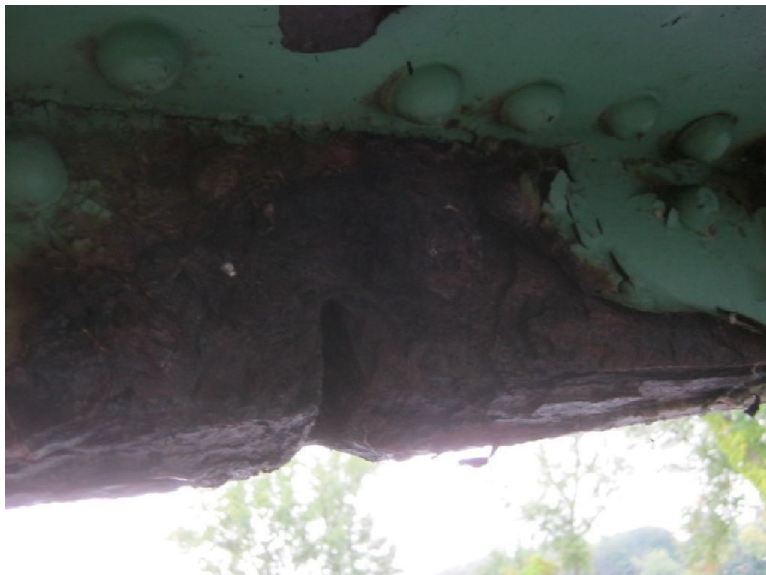
B568 54

COVER PLATE HOLED AT
LOWER CORD SPLICE,
SOUTH END OF
FLOORBEAM # 6.

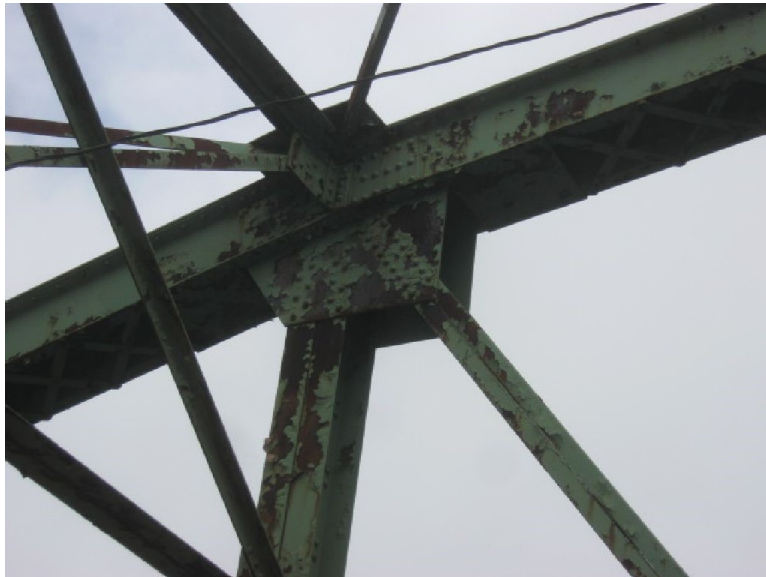
B568 56

PAINT PEELING, LIGHT
SURFACE RUST AT UPPER
CORD.

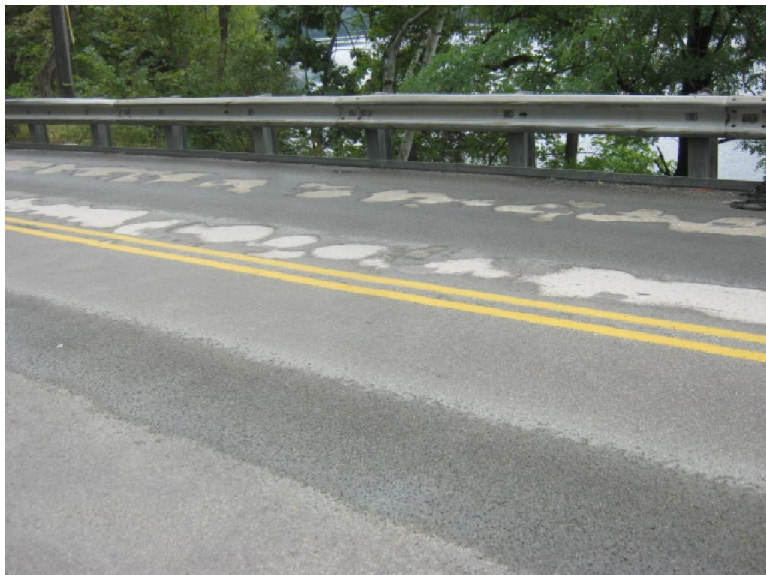
B568 57

WEARING SURFACE
POTHOLED AT EAST END
OF EASTBOUND LANE.

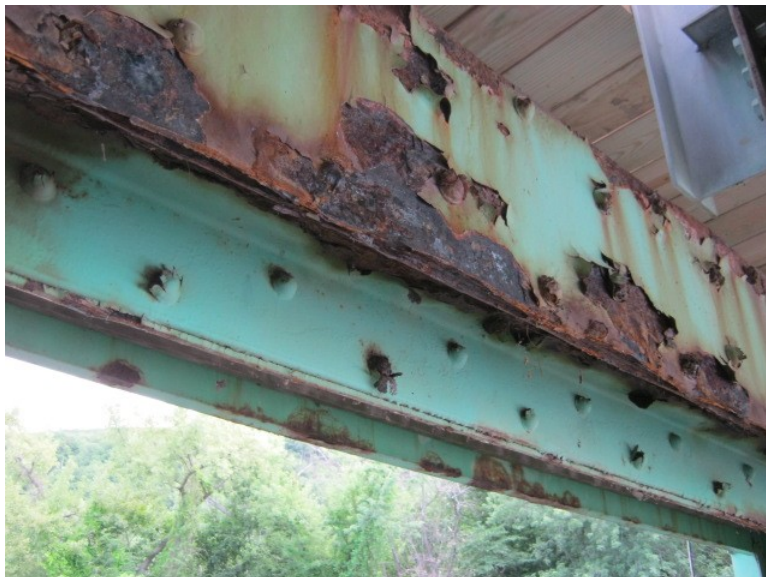
B506 22

PACK RUST AT LOWER
CHORD AT NORTH.

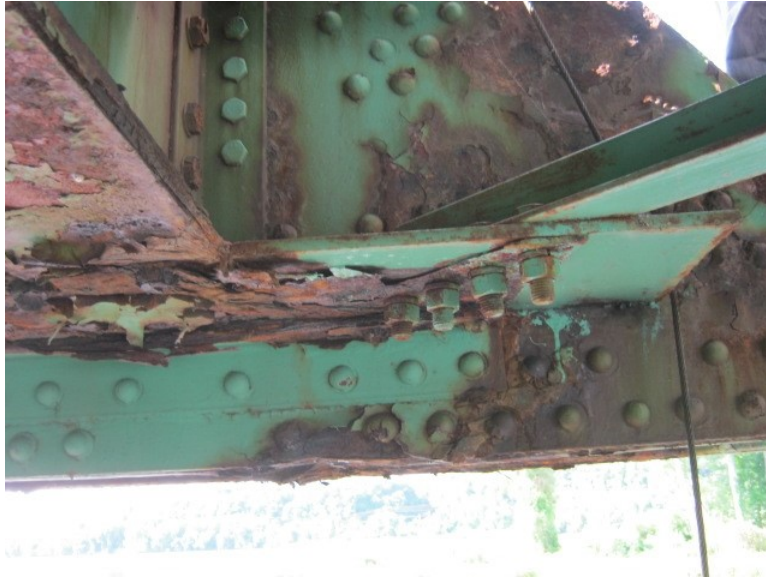
B506 24

CONNECTION PLATE
REPAIRED.

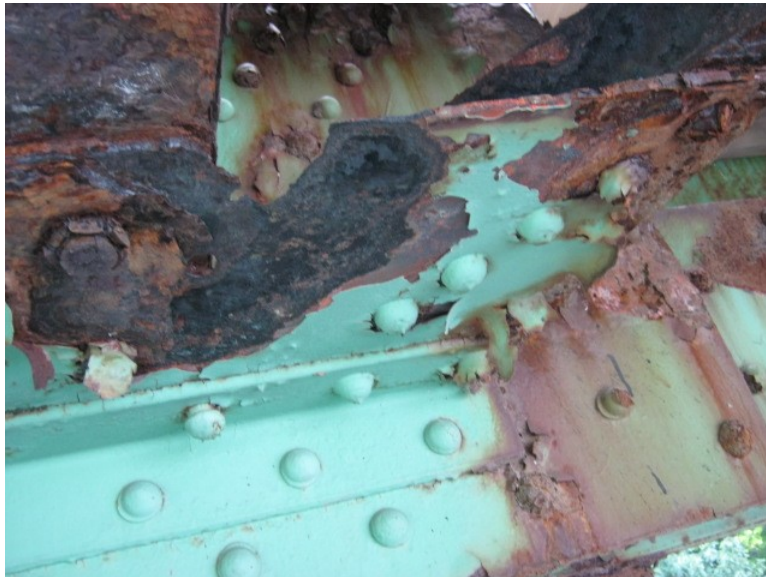
B506 25

CONNECTION PLATE
HOLED.

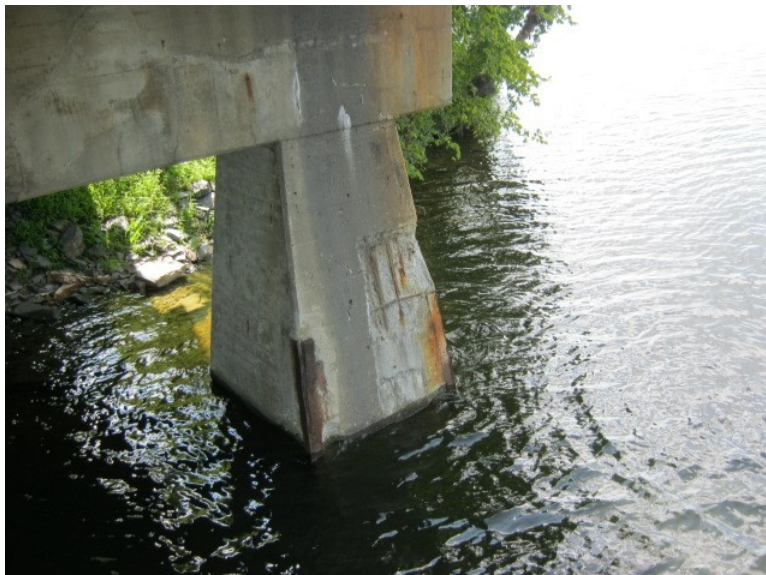
B506 26

SPALL AT PIER 2.

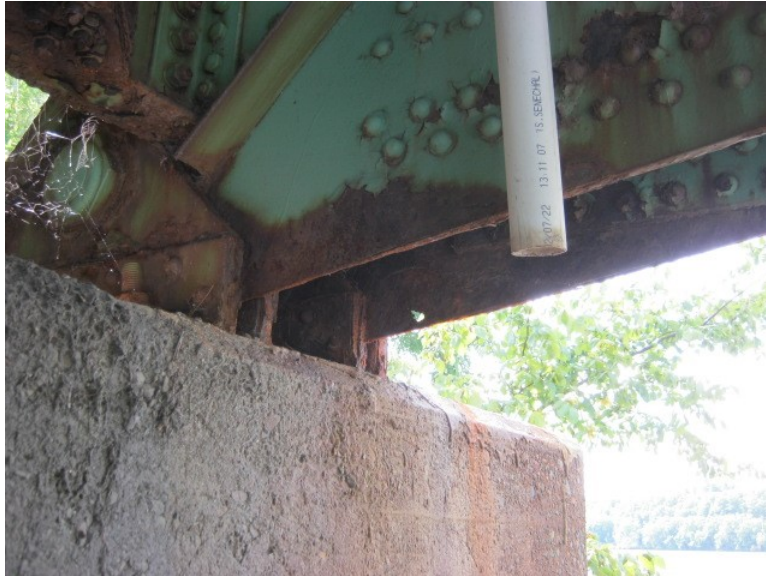
B506 27

HOLE IN GUSSET PLATE AT
BEARING 1 PIER 2.

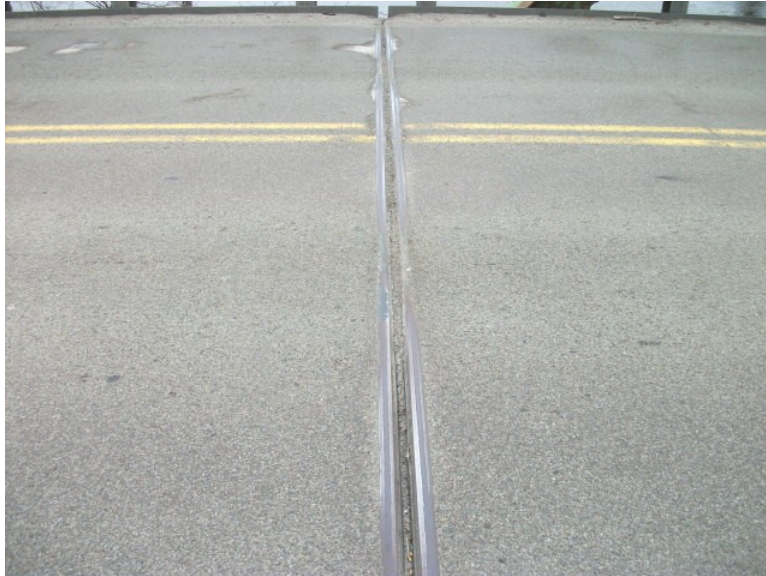
B460 42

MINOR ADHESION FAILURE
AT JOINT #3.

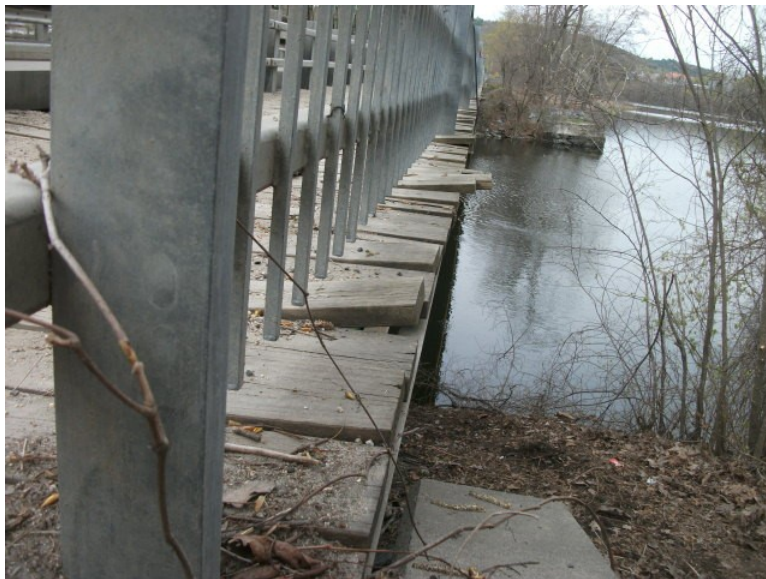
B460 43

SIDEWALK PLANKS
CURLING, A FEW LOOSE.

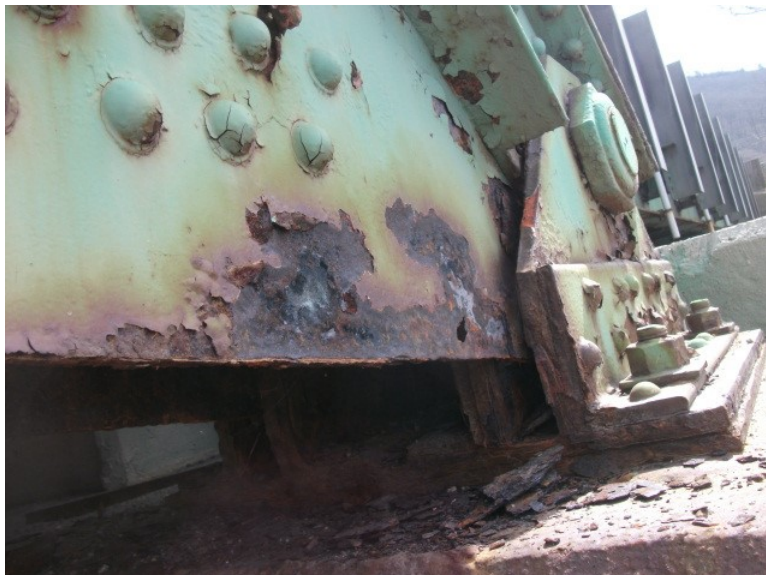
B460 44

GUSSET PLATE HOLED AT
BEARING #1 AT PIER #2.

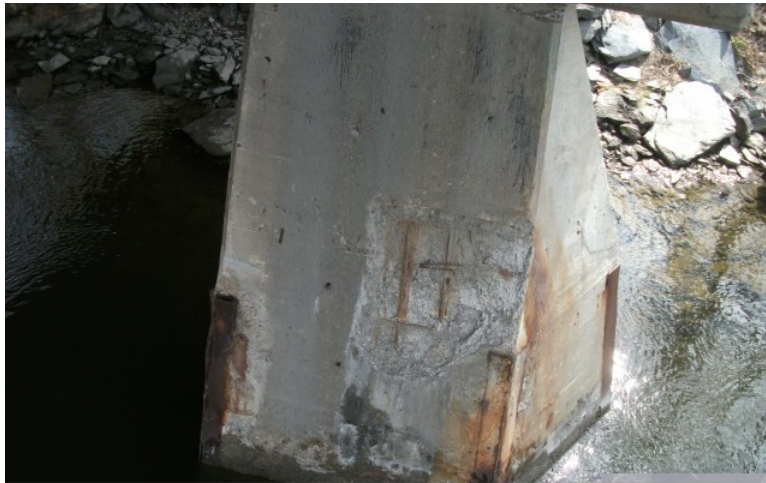
B460 46

LARGE SPALL AT COLUMN
#1, PIER #2.

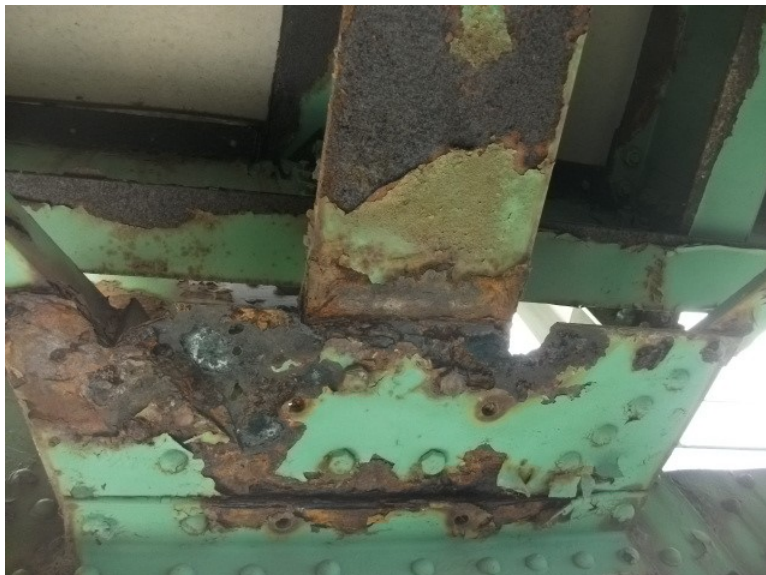
B460 47

LOWER LATERAL BRACING
CONNECTION PLATE
HOLED BOTH SIDES OF
FLOORBEAM #9.

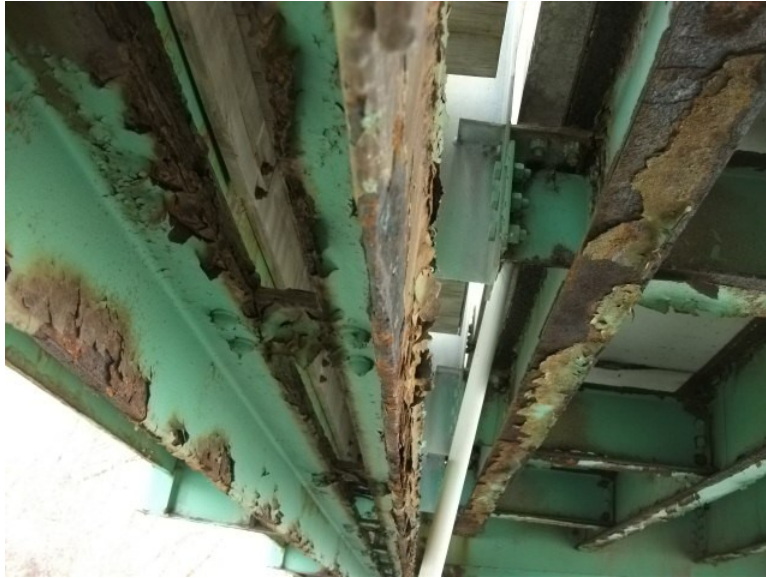
B460 48

SECTION LOSS AT BOTTOM
CHORD, BAY #10.

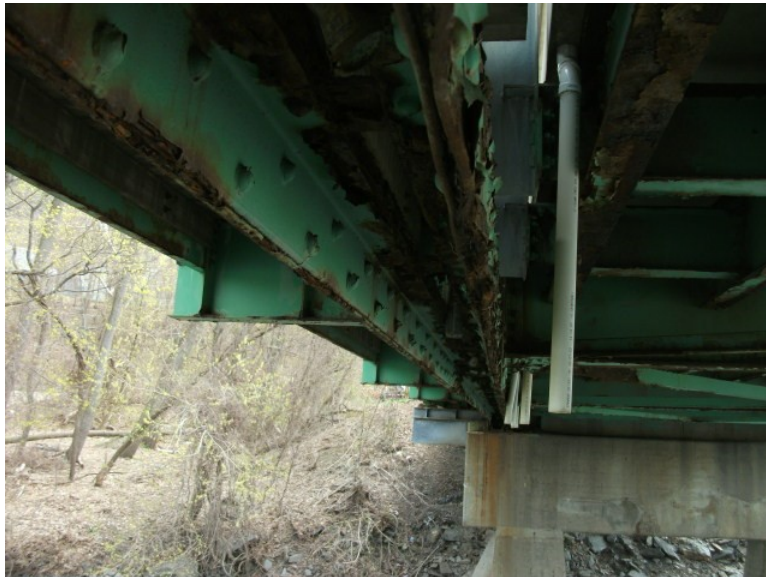
B460 49

PACK RUST AT BOTTOM
CHORD.

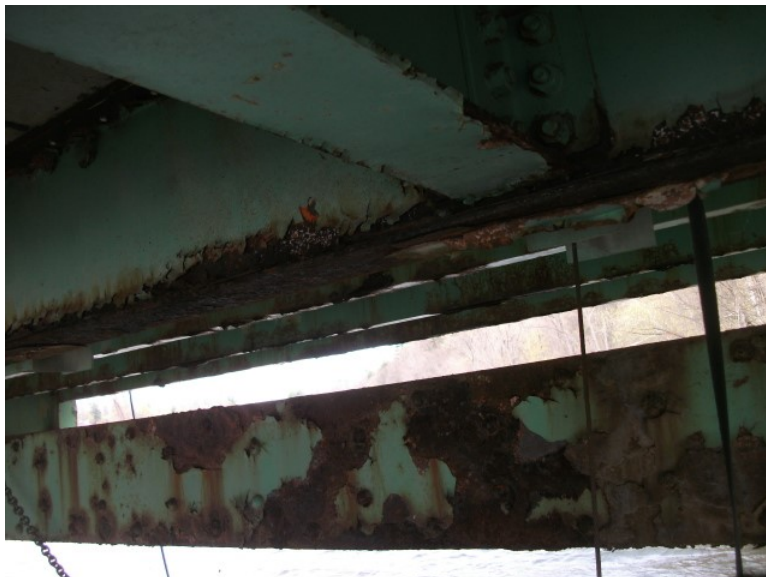
B460 50

SECTION LOSS AT NORTH
EXTERIOR STRINGER, 3/8"
REMAINING.

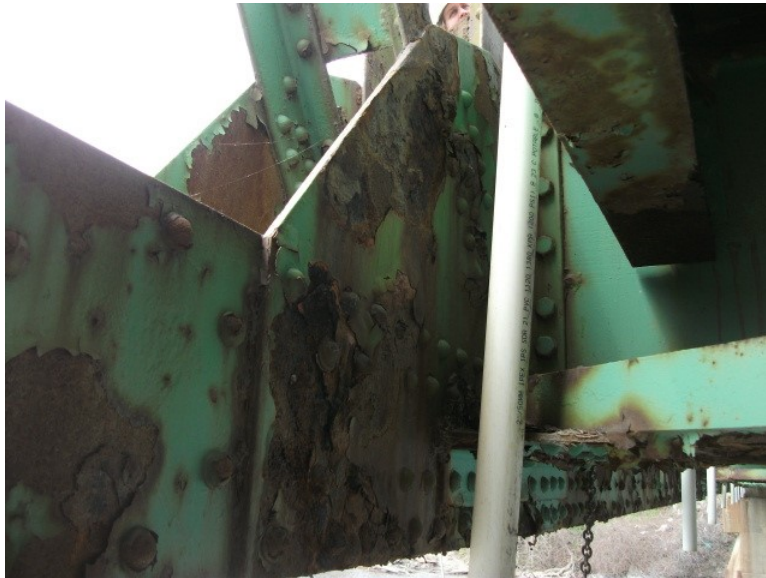
B460 51

RUST, SCALE, MINOR
SECTION LOSS, TYPICAL OF
MOST GUSSET PLATES.

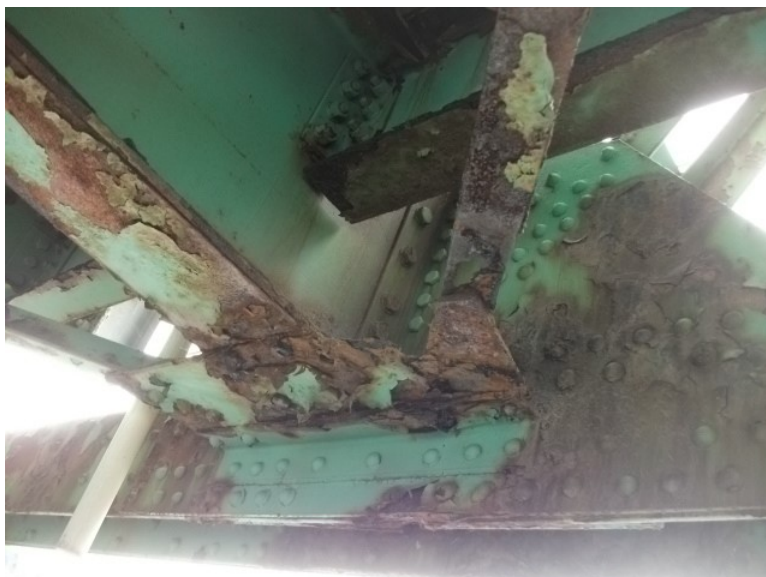
B460 53

CONNECTION PLATE AND
LOWER LATERAL BRACING
HOLED AT FLOORBEAM #5,
AT SOUTHWEST.

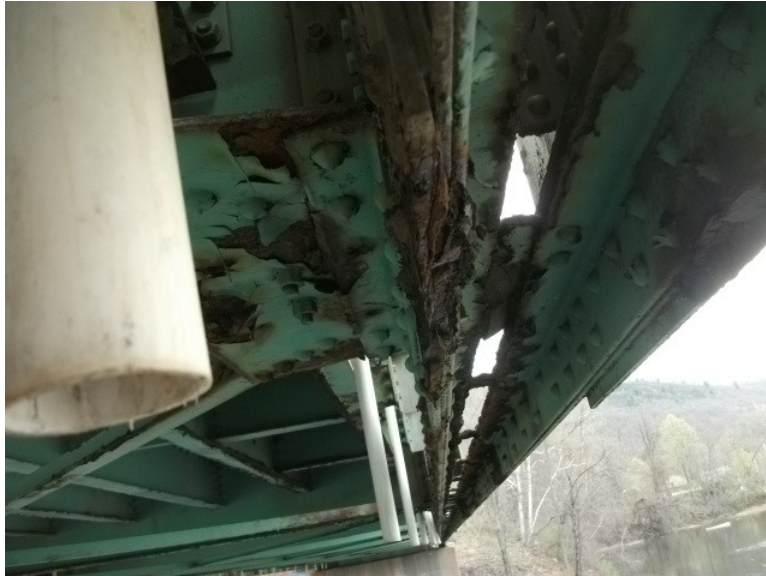
B460 54

SECTION LOSS AT BOTTOM
OF GUSSET PLATE AT
FLOORBEAM #4, AT SOUTH.

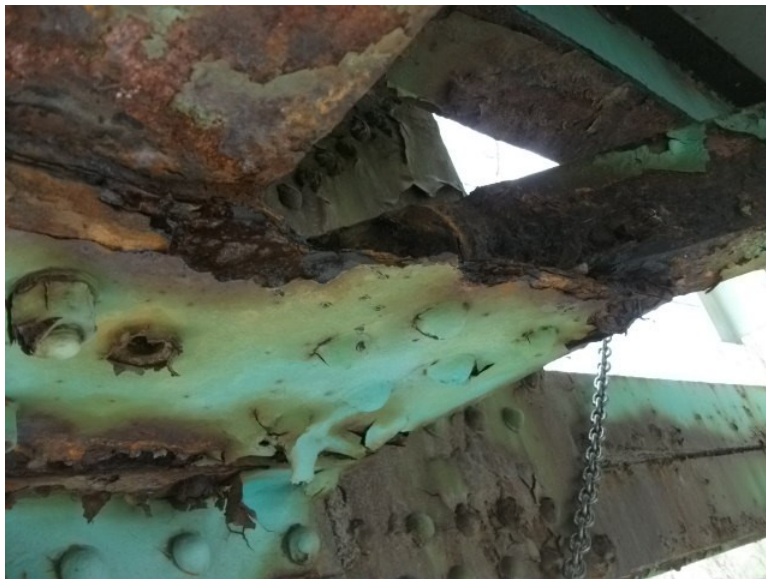
B460 55

CONNECTION PLATE KNIFE-
EDGED AT FLOORBEAM #3.

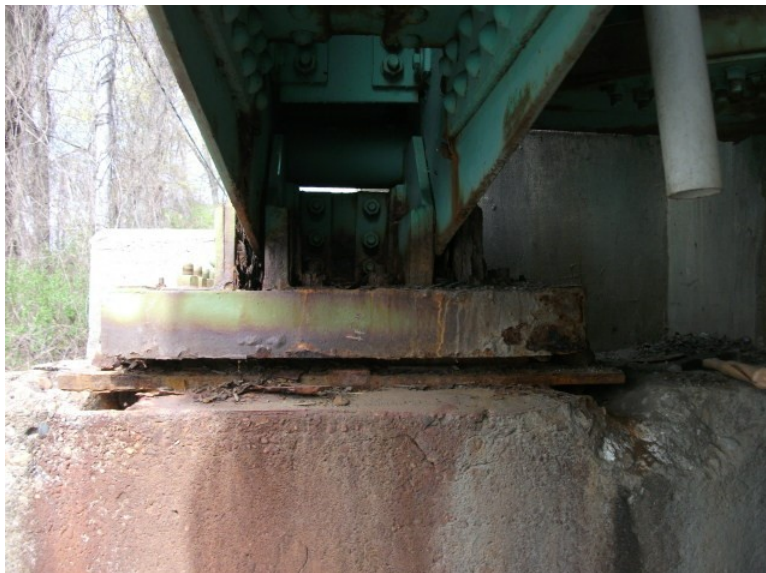
B460 56

PIER # 1 SPALLED AT
SOUTHWEST, UNDER
BEARING #1.

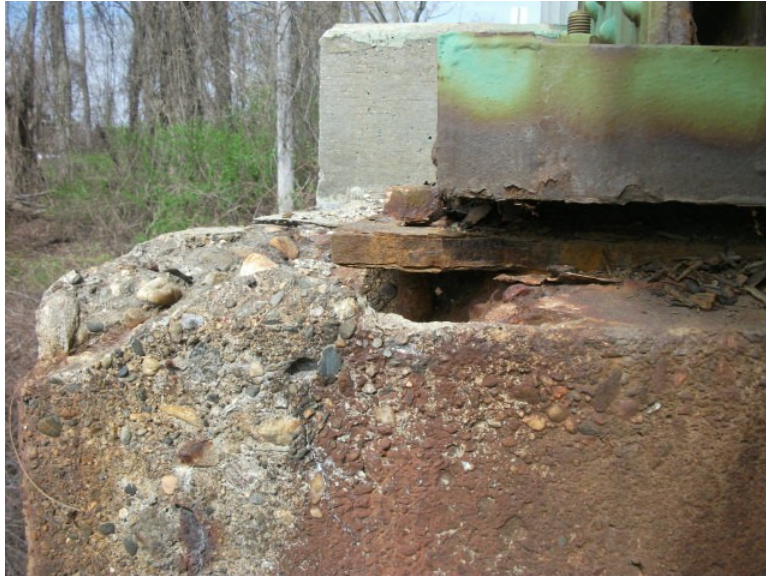
B460 57

BEARING BOLT EXPOSED,
PIER #1, BEARING #1, AT
EXTERIOR.

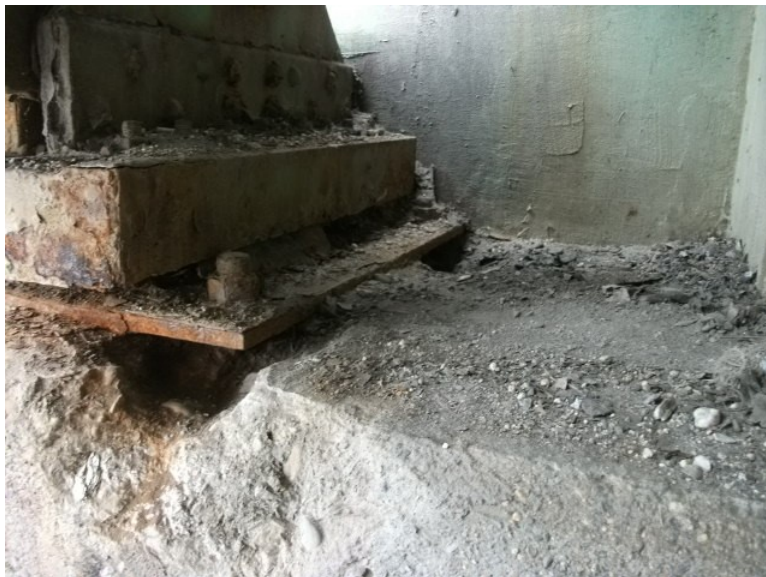
B460 58

BEARING BOLT EXPOSED,
PIER #1, BEARING #1, AT
INTERIOR.

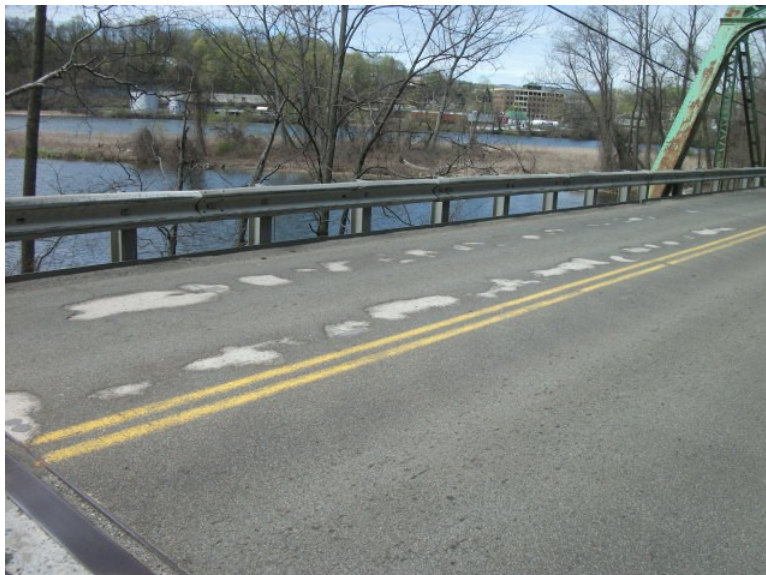
B460 59

WEARING SURFACE
POTHOLED AT SOUTHEAST.

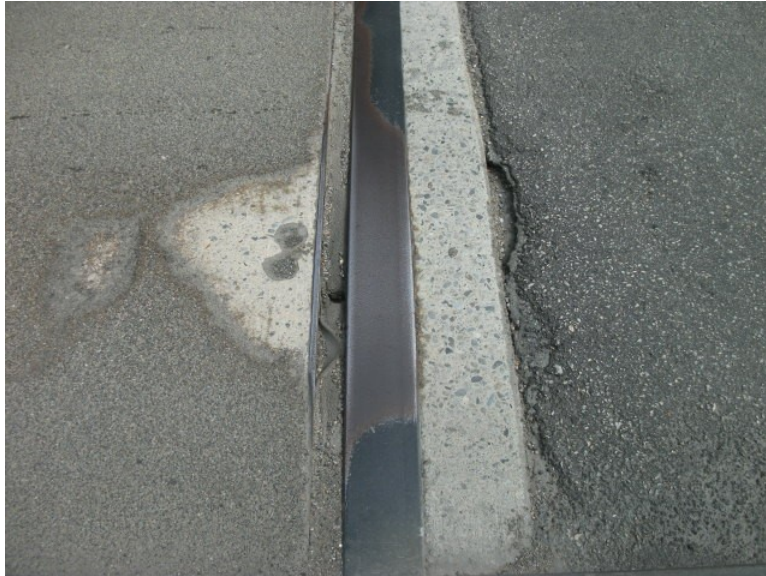
B460 60

SEAL HOLED AT SOUTH OF
JOINT # 4.

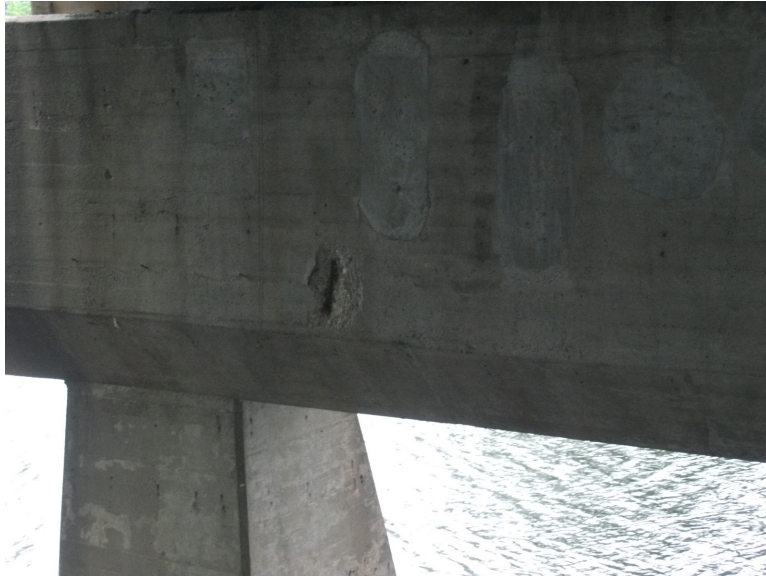
B434 40

SPALL AT EAST OF PIER #2.

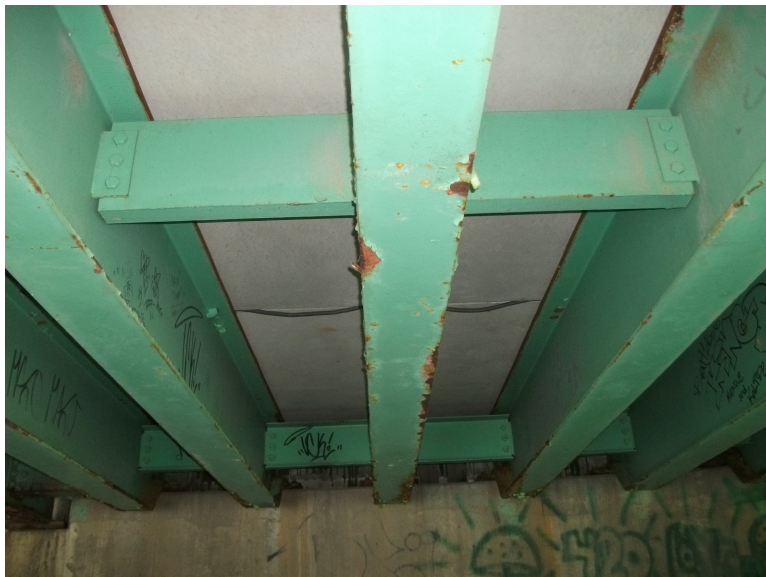
B434 41

GASKET PROTRUDING
SPAN #3, TYPICAL OF A
FEW.

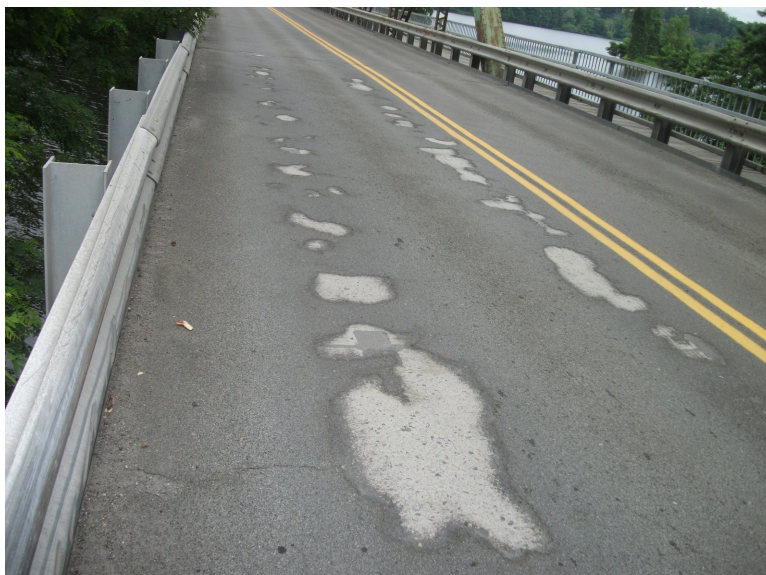
B434 42

HEAVY WEAR OF ASPHALT
AT EAST.

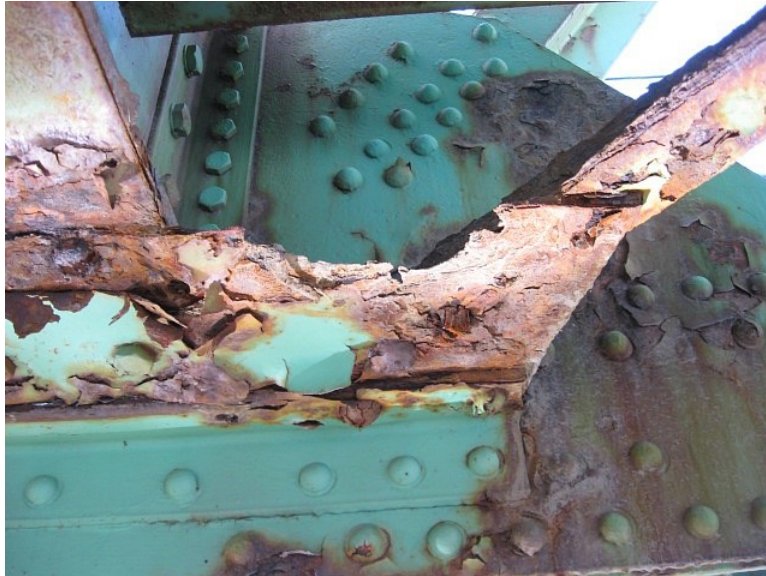
B332 42

LATERAL BRACING
CONNECTION PLATE
HOLED IN SPAN 2 (
TYPICAL OF SEVERAL)

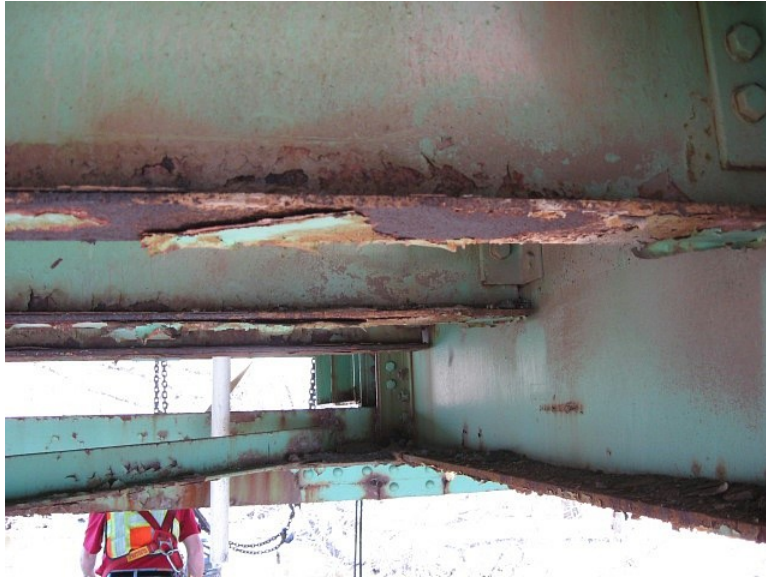
B332 38

TYPICAL RUST AND SCALE
ON STRINGERS.

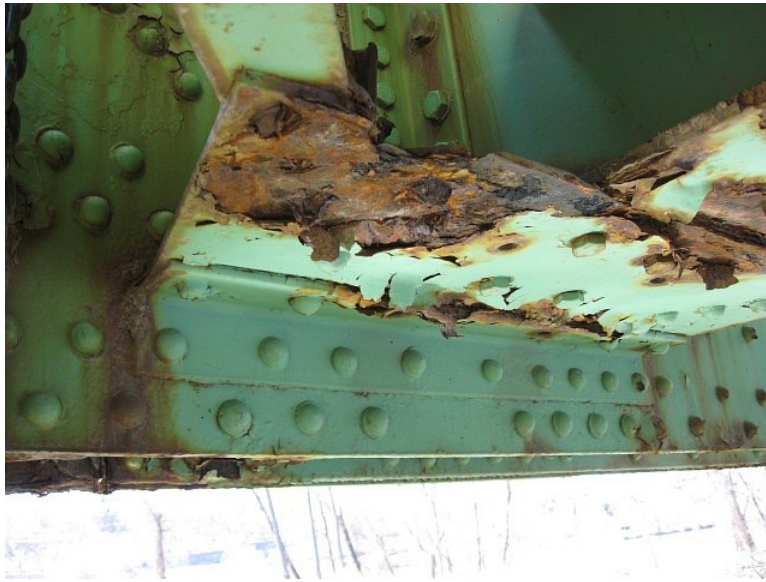
B332 39

LATERAL BRACING
CONNECTION PLATE
HOLED IN SPAN 2 (
TYPICAL OF SEVERAL)

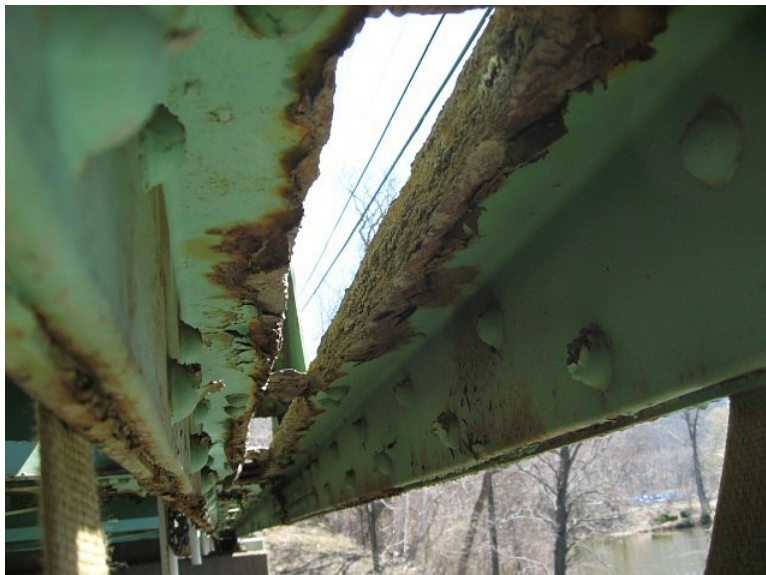
B332 40

HEAVY PACK RUST WITH
LIGHT SECTION LOSS ON
LOWER CHORD ON
DOWNSTREAM SIDE. (
TYPICAL OF BOTH.

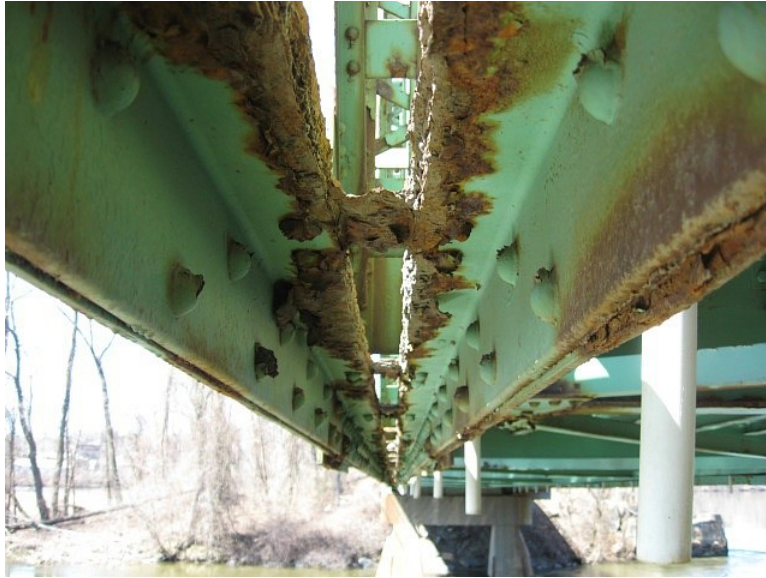
B332 41

BATTEN PLATES RUSTING
AWAY ON LOWER CHORD
DOWNSTREAM. (TYPICAL
OF UPSTREAM.)

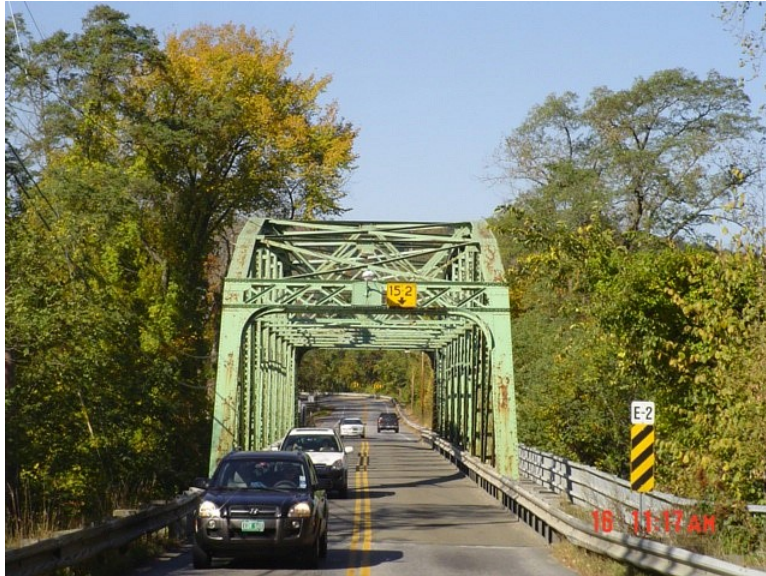
B293 06

EAST APPROACH (HEIGHT
SIGN MISSING AT NE

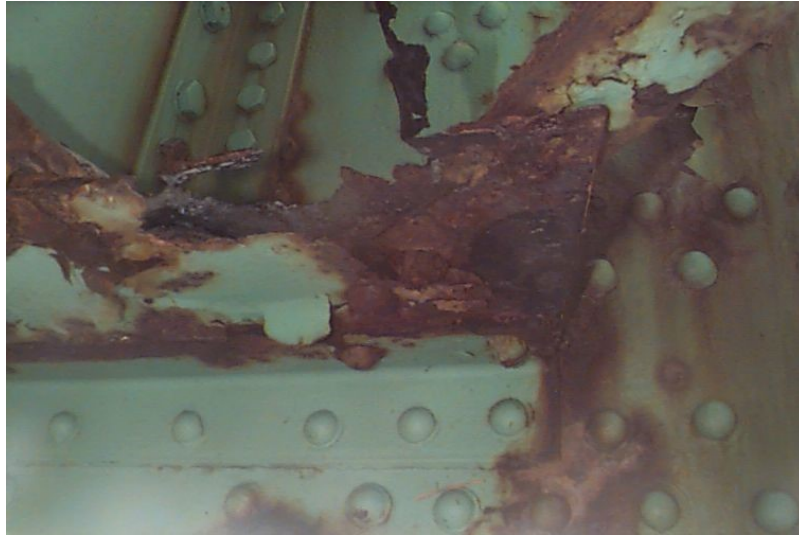
B228 05

CONNECTION PLATE AT
SOUTH BOTTOM CHORD
HOLED (TYPICAL OF FEW)

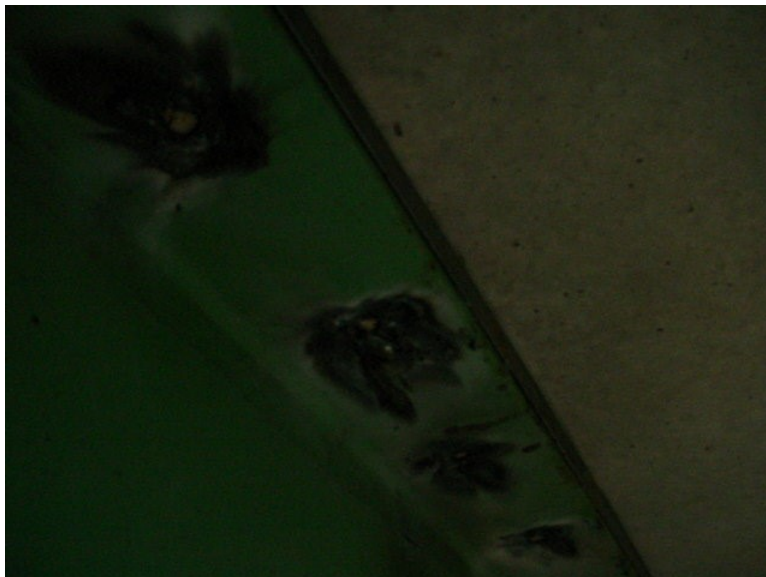
B193 17

TYPICAL VIEW OF DRILL
HOLES IN TOP FLANGES,
SEVERAL WITH FLAME
CUTS.

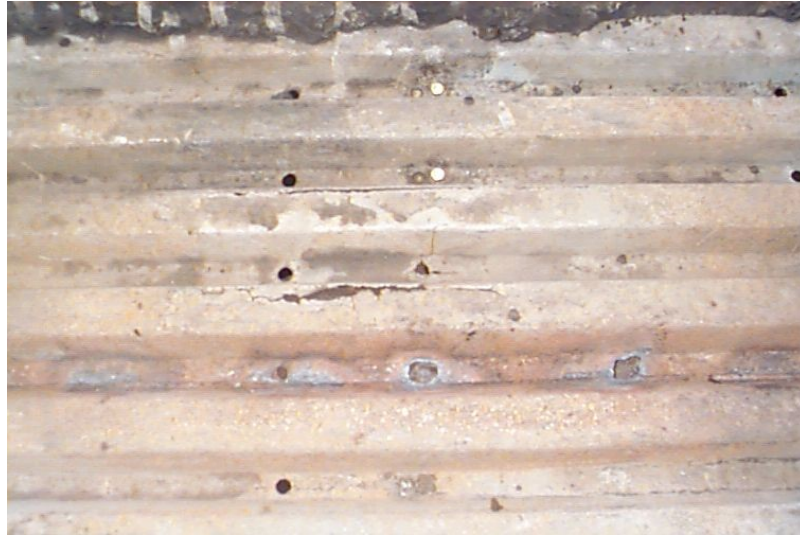
B141 07

GALVANIZED BRIDGE
DECKING VERY THIN W/
HOLES NEAR BOLTED
ATTACHMENTS

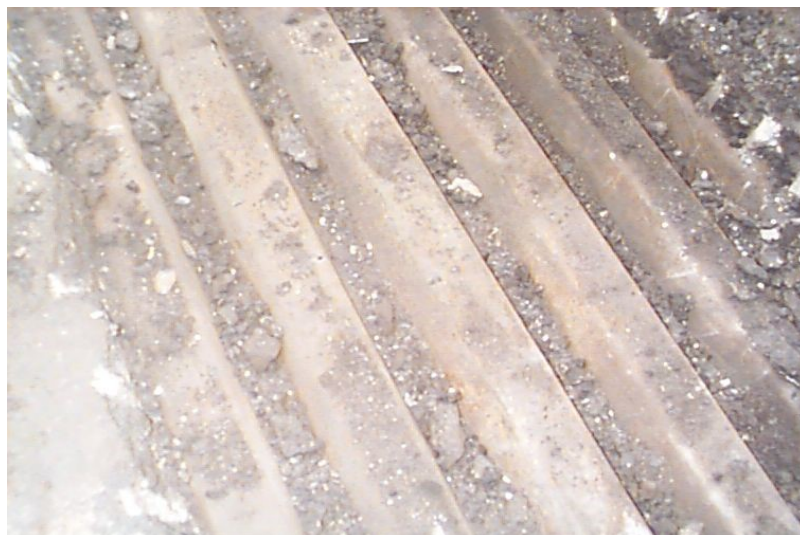
B141 09

BRIDGE PLANK THIN AND
HOLED IN WHEEL PATH
BETWEEN STRINGERS AND
BOLTED ATTACHMENTS.

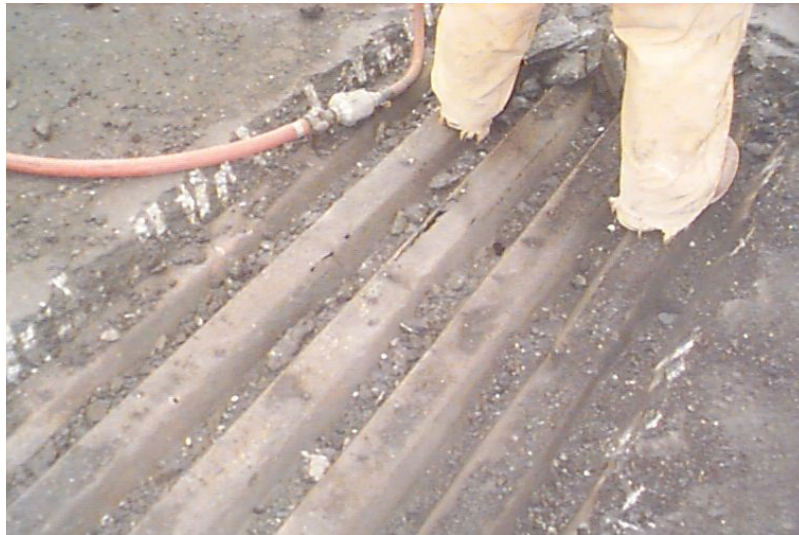
B141 11

HOLES IN BRIDGE PLANK
AT WEST REPAIR NEAR
BOLTED ATTACHMENTS.

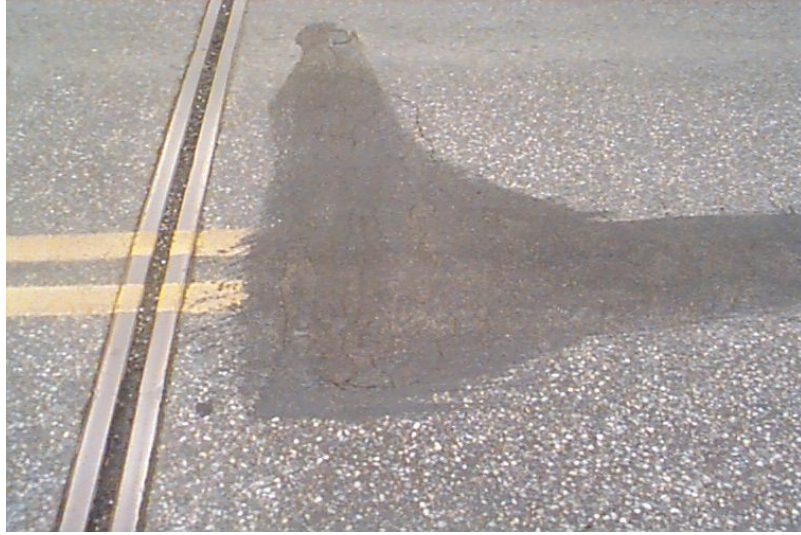
B138 39

REPAIRED AREA CRACKED
AND MOVING UNDER LOAD
AT EAST.

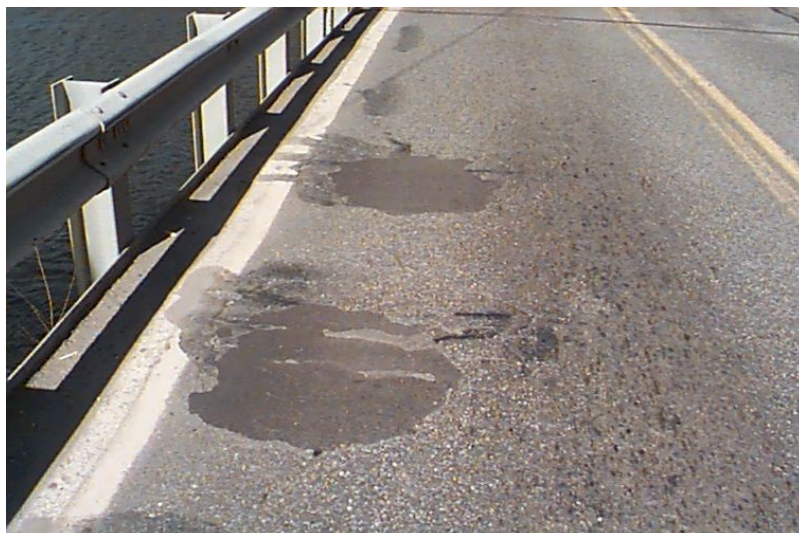
B032 03

DEPRESSED AND PATCHED
AREA IN WEARING
SURFACE AT SOUTHEAST
WITH BRIDGE PLANK
LOOSE UNDERNEATH.

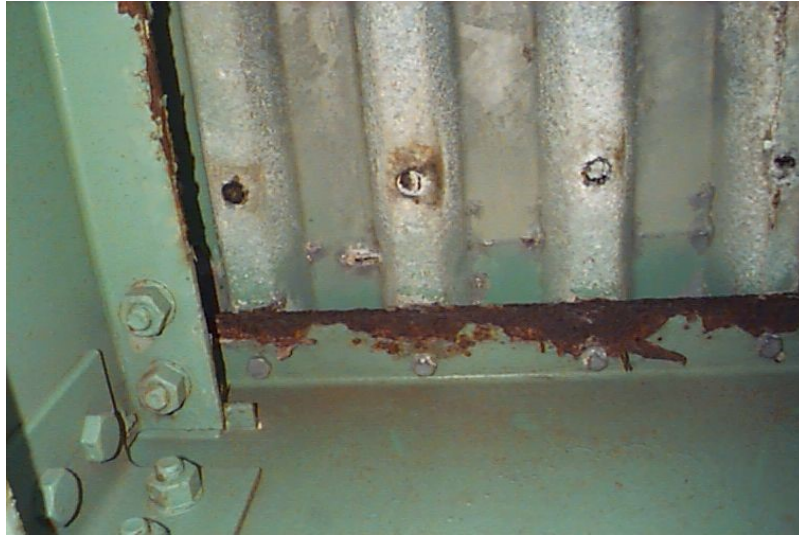
B032 04

SCARIFIED HOLE THROUGH
BRIDGE PLANK IN SPAN #2,
BAY #2 FROM EAST.

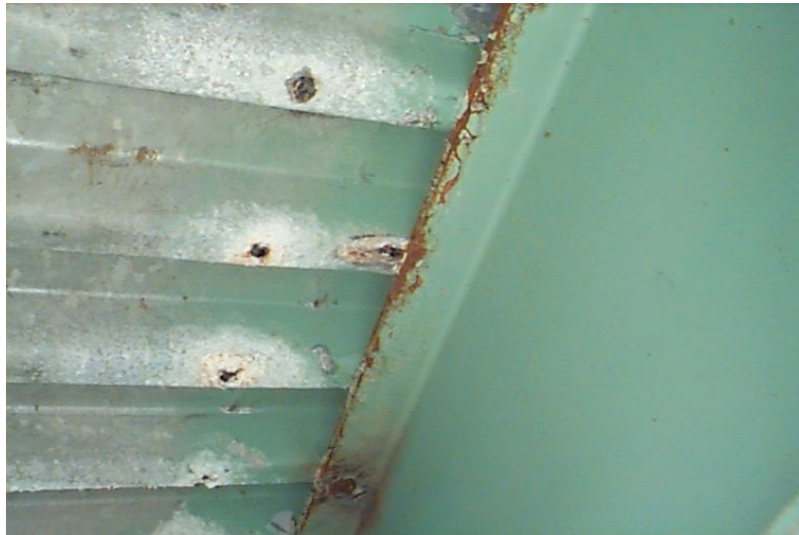
B032 05

SCARIFIED HOLE THROUGH
BRIDGE PLANK IN SPAN #2,
BAY #2 FROM EAST.

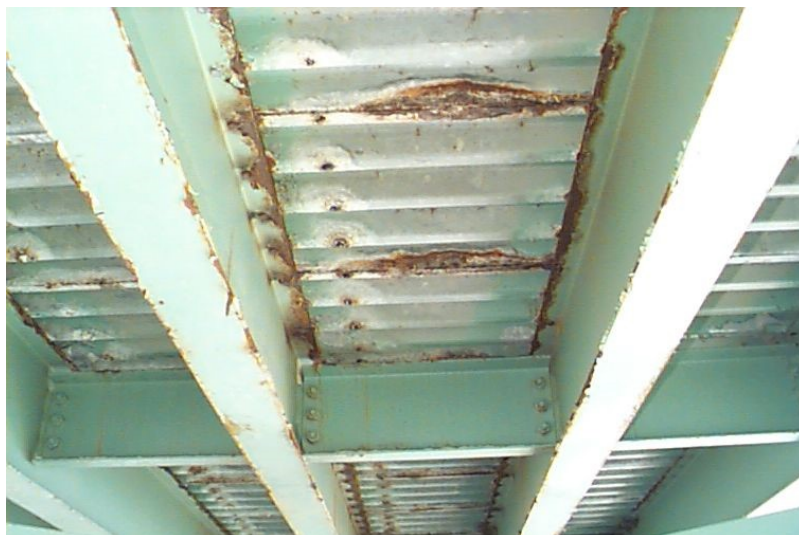
B032 06

BRIDGE PLANK LEAKING IN
SPAN #2, BAY #2 FROM
EAST.
