HINSDALE 041/040
NH119 over CONNECTICUT RIVER

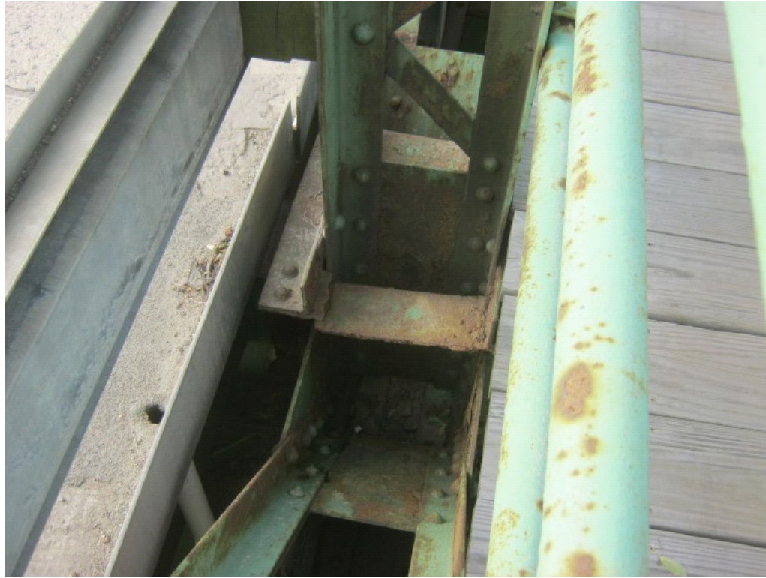
B571 04

TOP OF SIDEWALK
BRACKET BROKEN

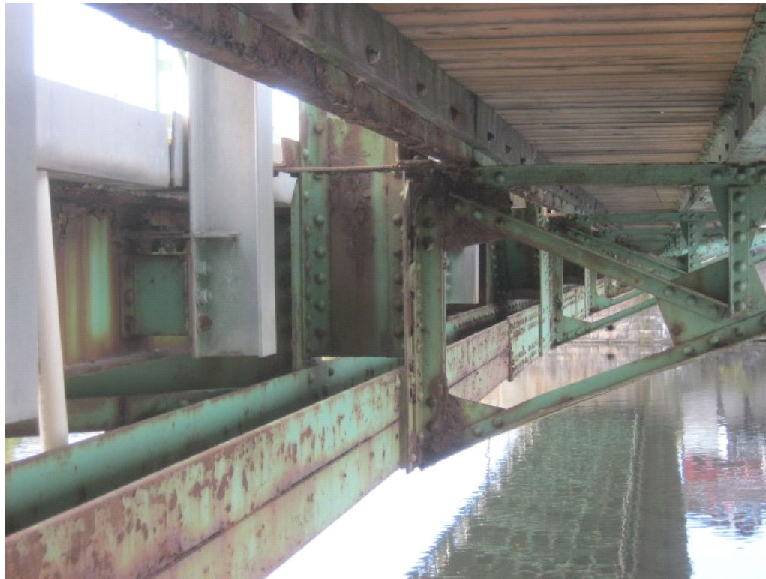
B571 05

SIDE VIEW OF SIDEWALK
BRACKET

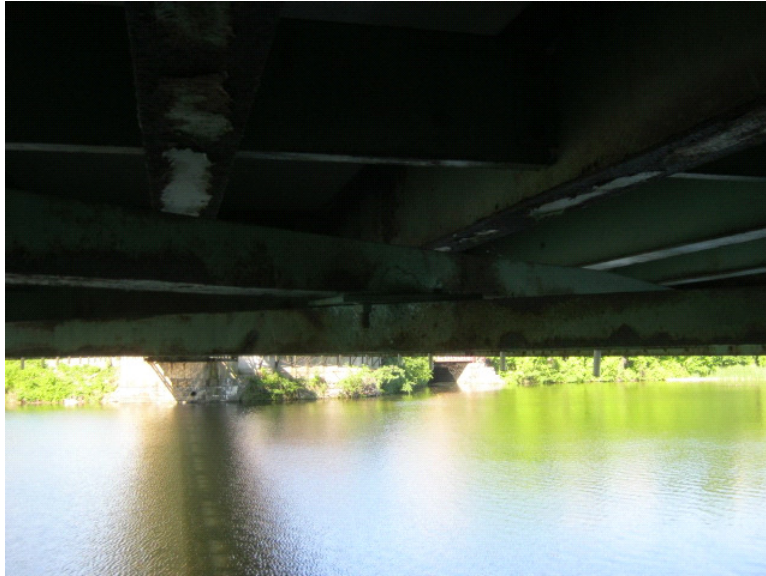
B561 27

RUST AT FLOOR BEAM
EXTERIOR

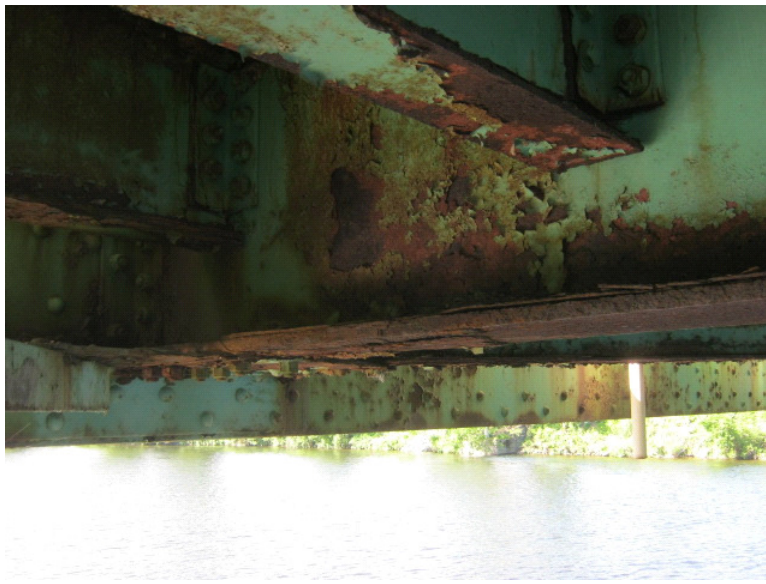
B561 28

RUST AT FLOOR BEAM
EXTERIOR

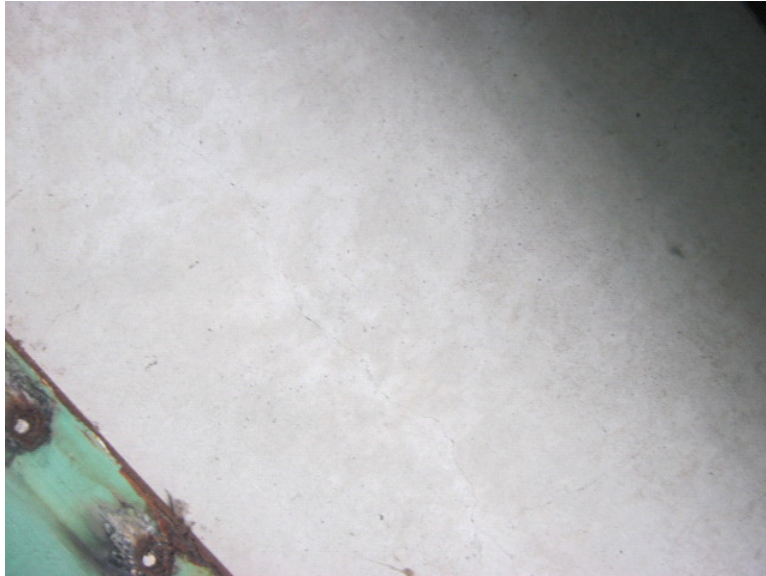
B561 30

FINE CRACKS IN SOFFIT

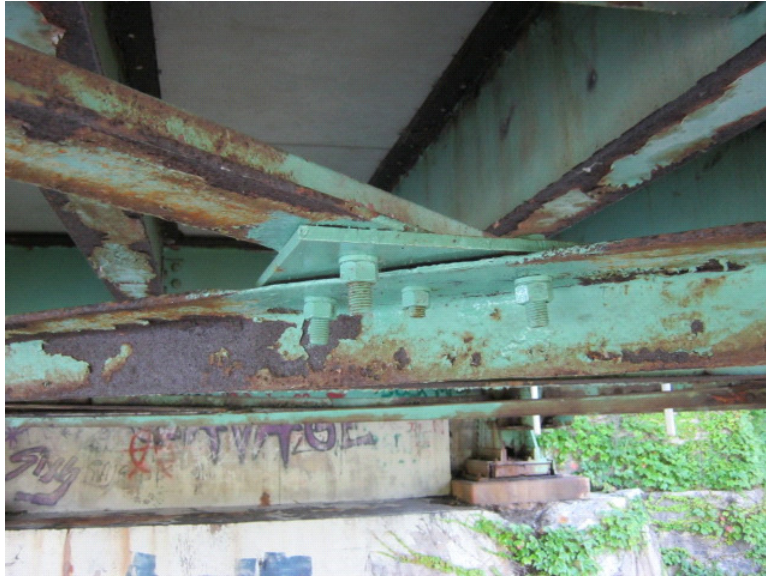
B506 01

CROSS BRACE REPAIR,
SECOND BAY FROM EAST.

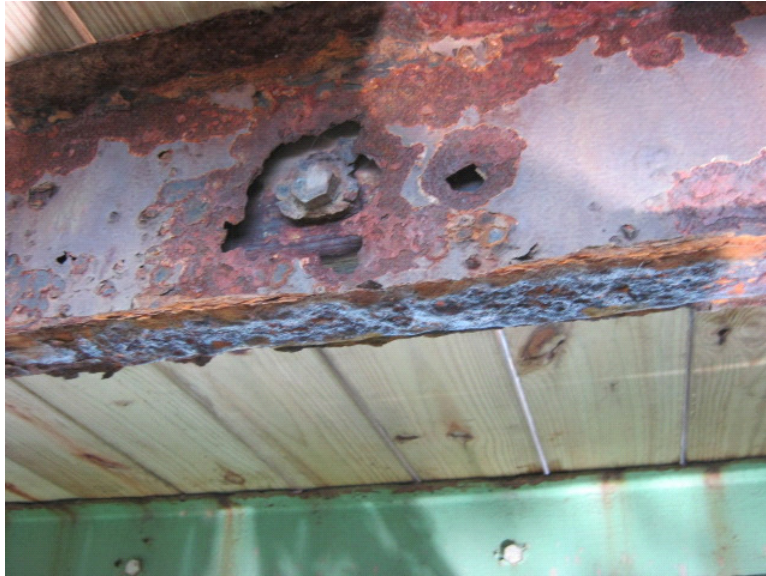
B506 04

WEB HOLED UNDER
SIDEWALK STRINGER # 1,
MIDSPAN.

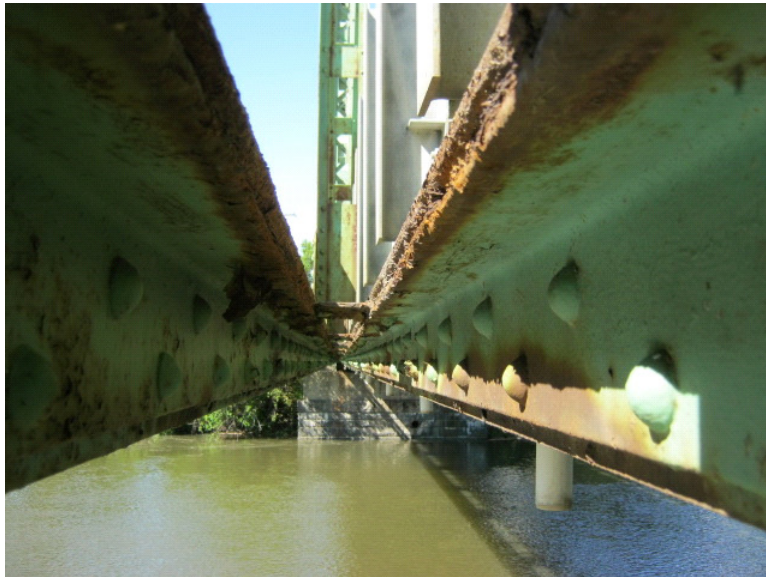
B506 05

PACK RUST BETWEEN
LOWER CHORD ANGLES.

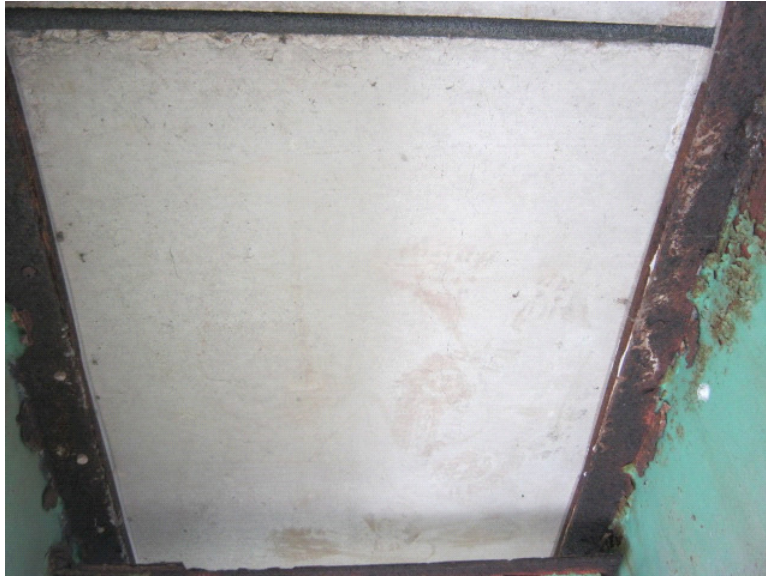
B506 07

FINE CRACKS IN SOFFIT.

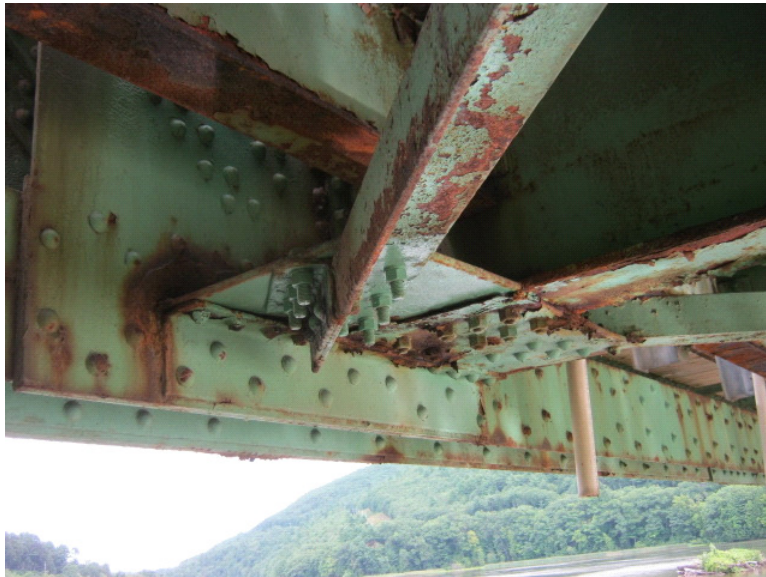
B506 08

CONNECTOR PLATE
REPAIR, FLOORBEAM # 3 AT
NORTH.

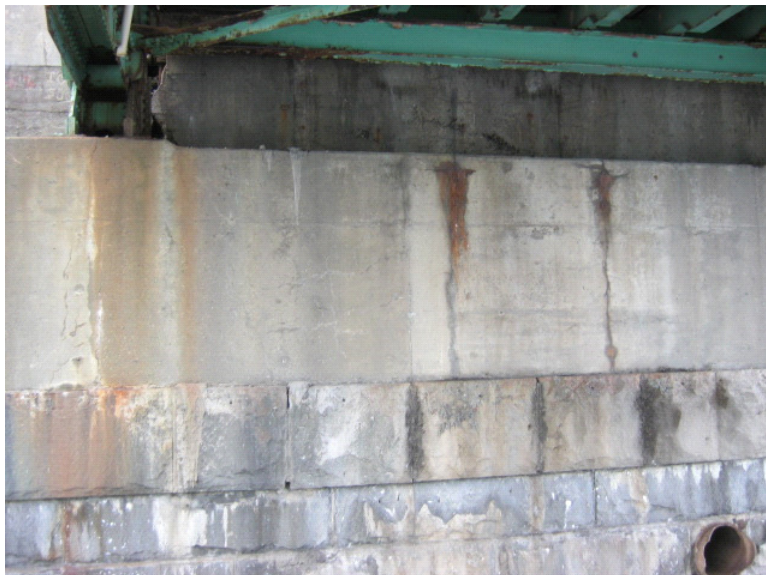
B506 09

VERTICAL CRACKS, RUST
STAINS, WEST ABUTMENT.

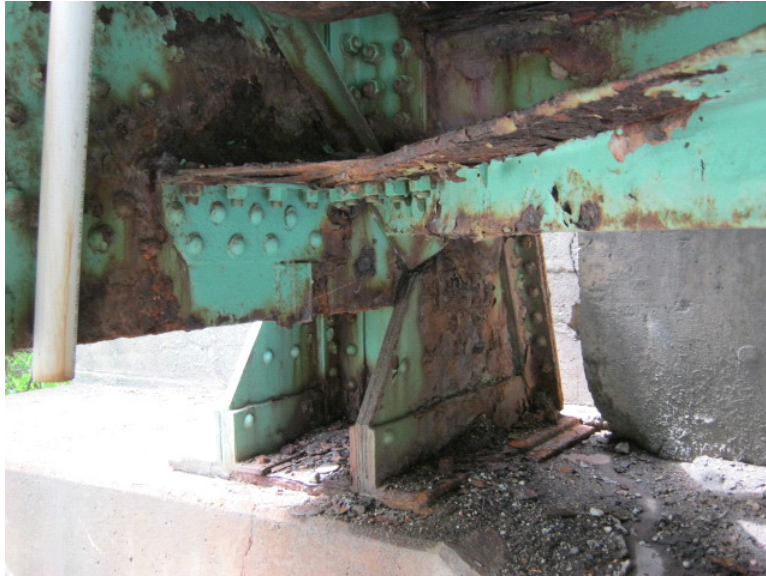
B506 10

RUST AND SCALE AT
SOUTHWEST BEARING.

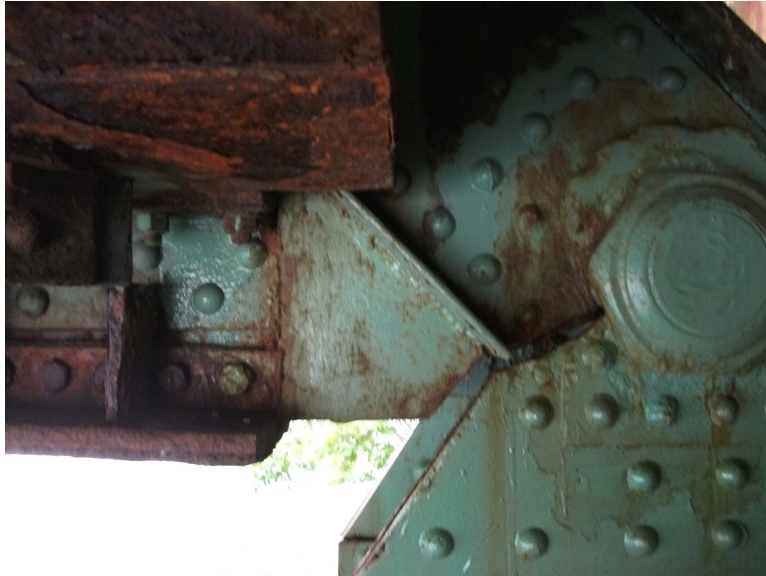
X009 13

PLATED REPAIR AT
NORTHEAST BEARING

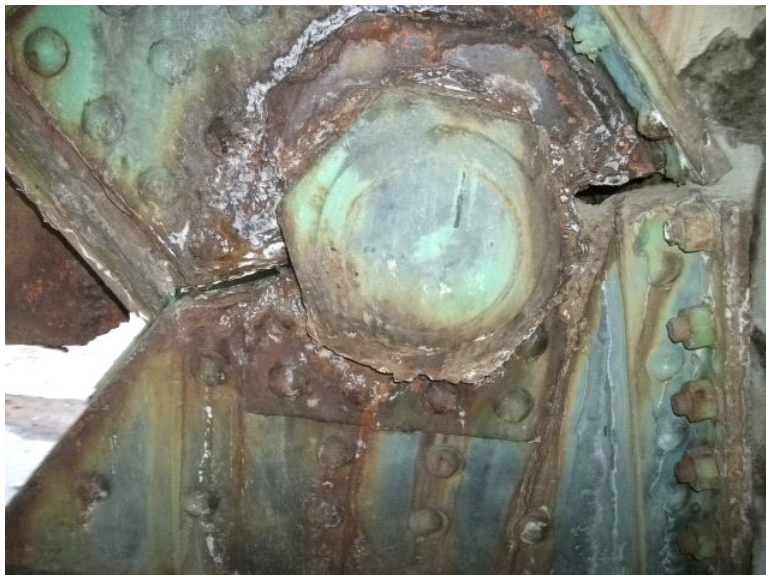
B456 03

NORTHEAST ROLLER
BEARING PLATE RUSTED
WITH SECTION LOSS.

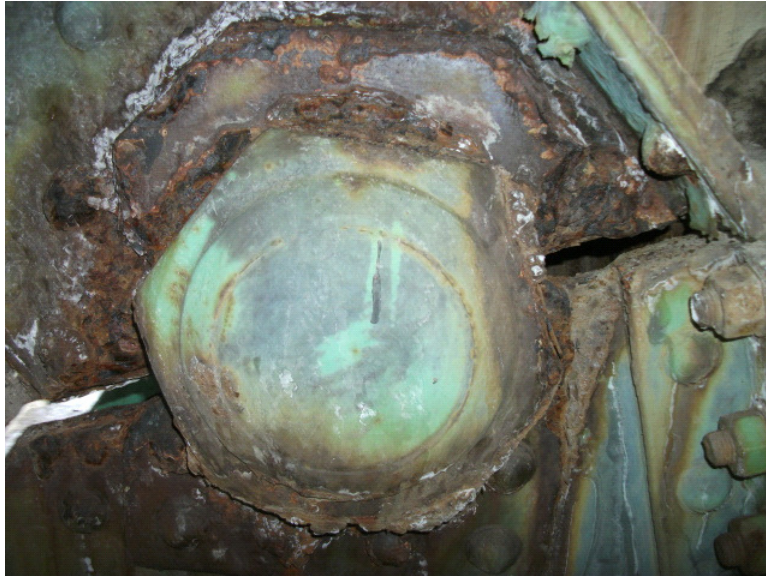
B456 04

NORTHEAST ROLLER
BEARING PLATE RUSTED
WITH SECTION LOSS.

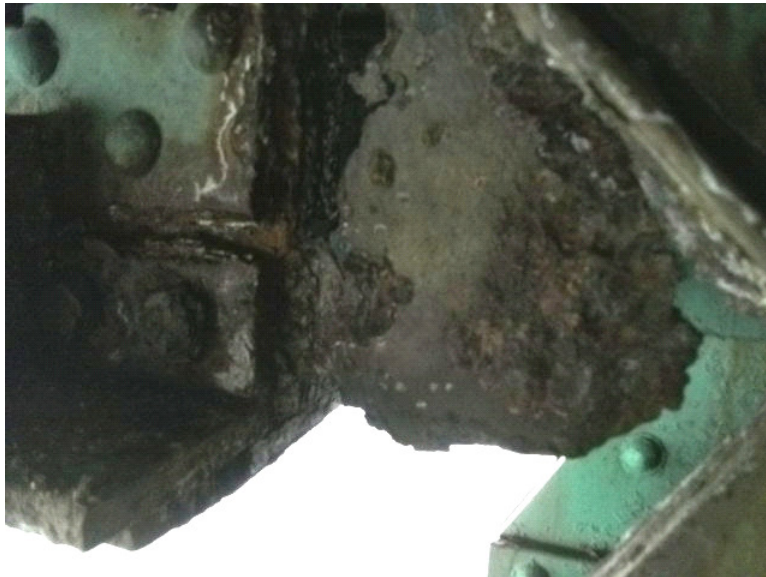
B456 05

PLATE HOLED AT
NORTHEAST ROLLER
BEARING.

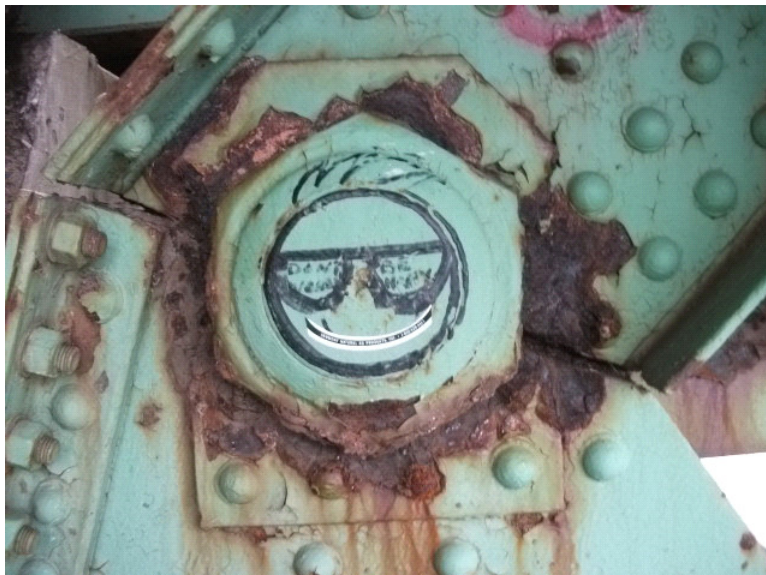
B456 06

EXTERIOR SIDE OF
NORTHEAST ROLLER
BEARING PLATE RUSTED
WITH SECTION LOSS.

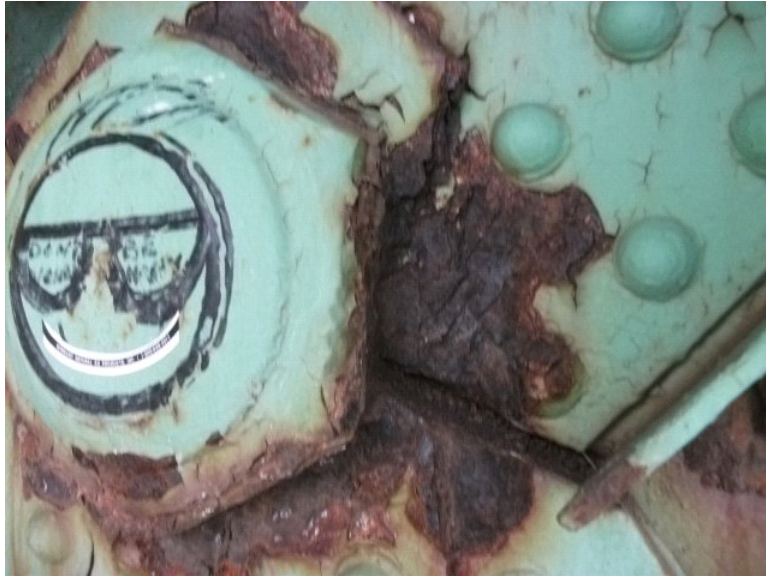
B456 07

EXTERIOR SIDE OF
NORTHEAST ROLLER
BEARING PLATE RUSTED
WITH SECTION LOSS.

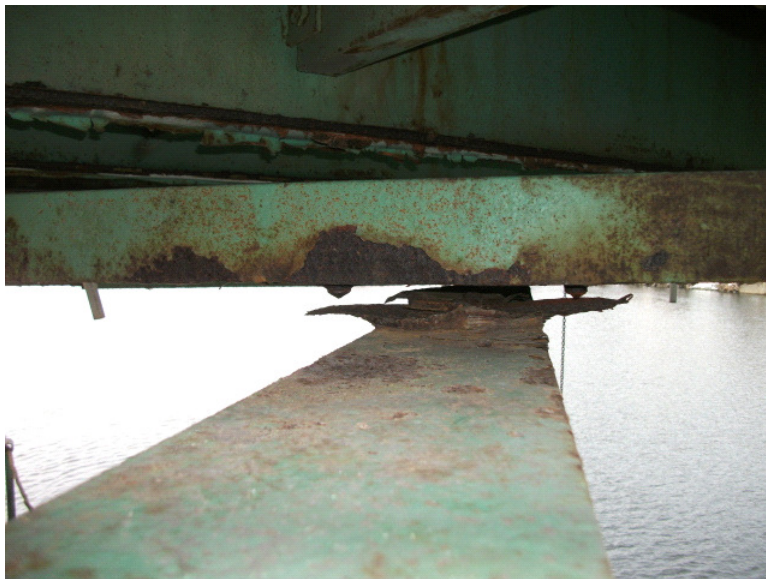
B456 08

LOWER LATERAL BRACING
CONNECTION BROKEN AT
EAST.

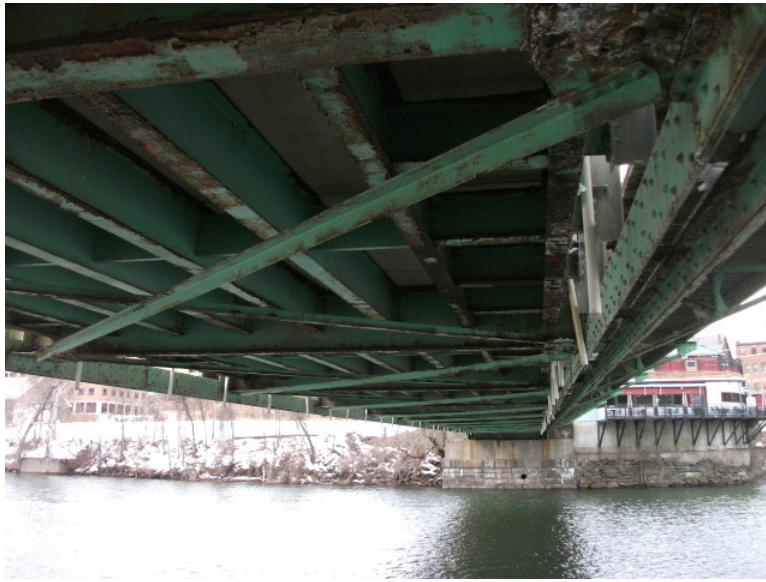
B456 11

MINOR RUST ON
STRINGERS AND FLOOR
BEAMS.

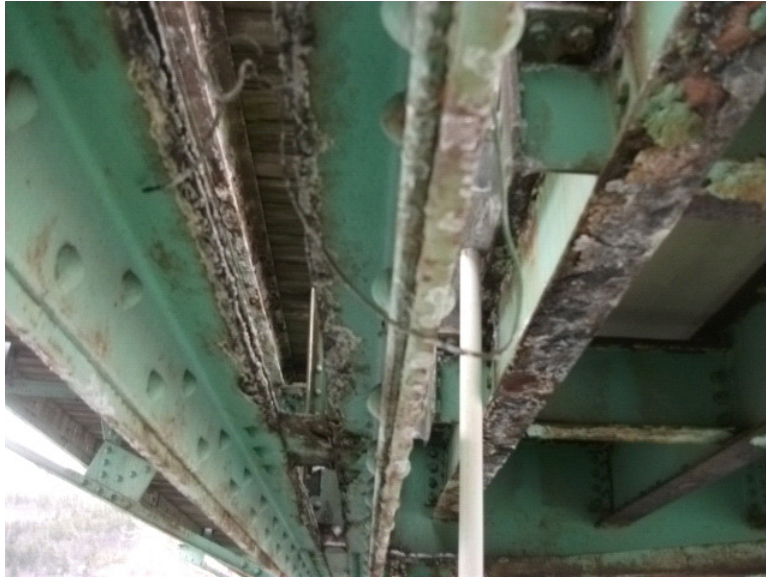
B456 13

PACK RUST IN MIDDLE OF
LOWER CHORD AT NORTH.

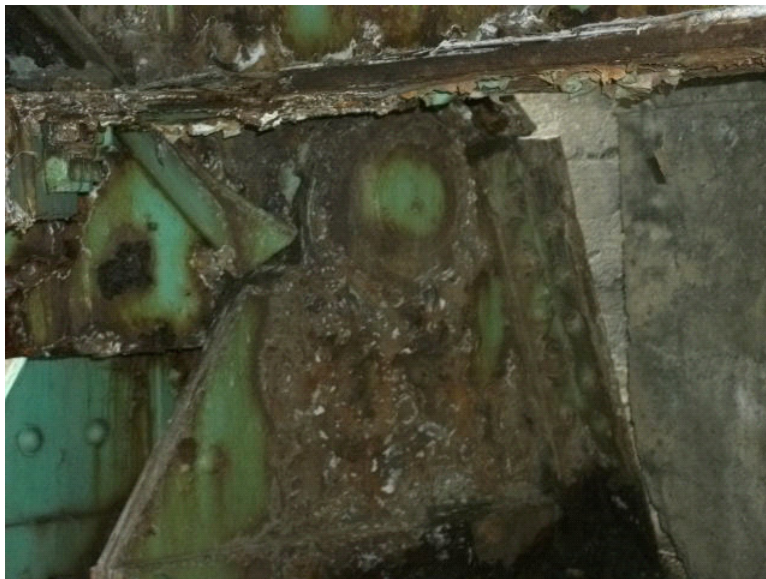
B456 17

SOUTHWEST ROLLER
BEARING PLATE RUSTED
WITH SECTION LOSS.

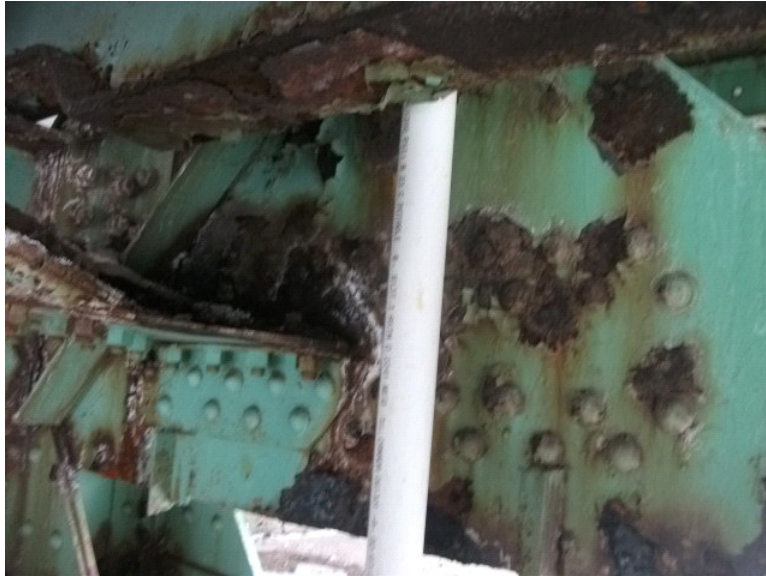
B456 19

MODERATE RUST AT
GUSSET PLATE NEAR
NORTHWEST ROLLER
BEARING.

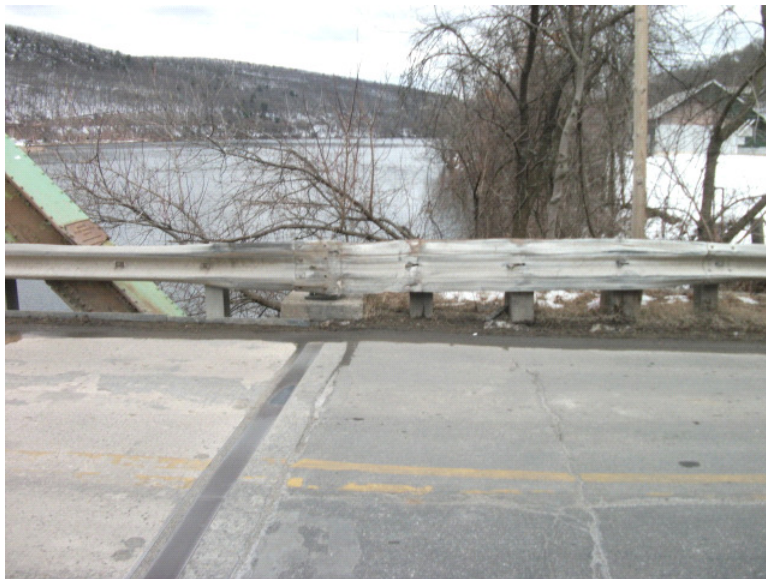
B456 20

HEAVY TRAFFIC DAMAGE
TO SOUTHWEST RAIL.

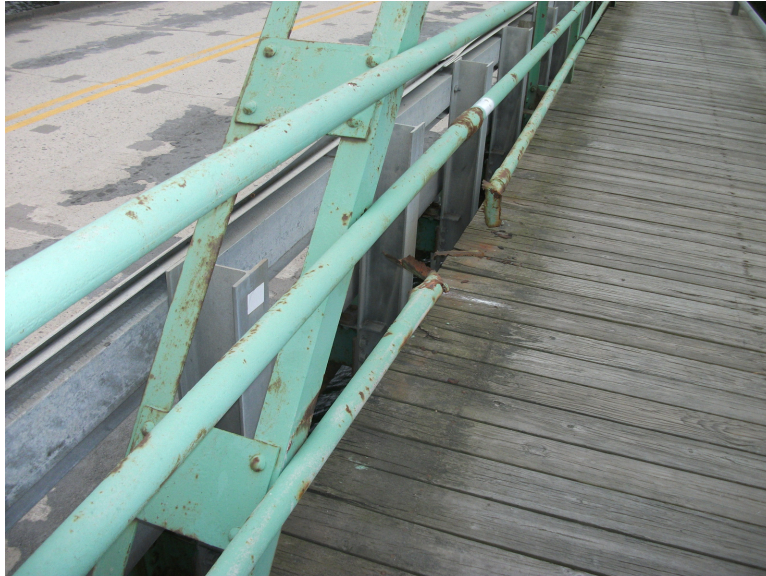
B434 37

BOTTOM SIDEWALK RAIL
BROKEN AT MIDSPAN.

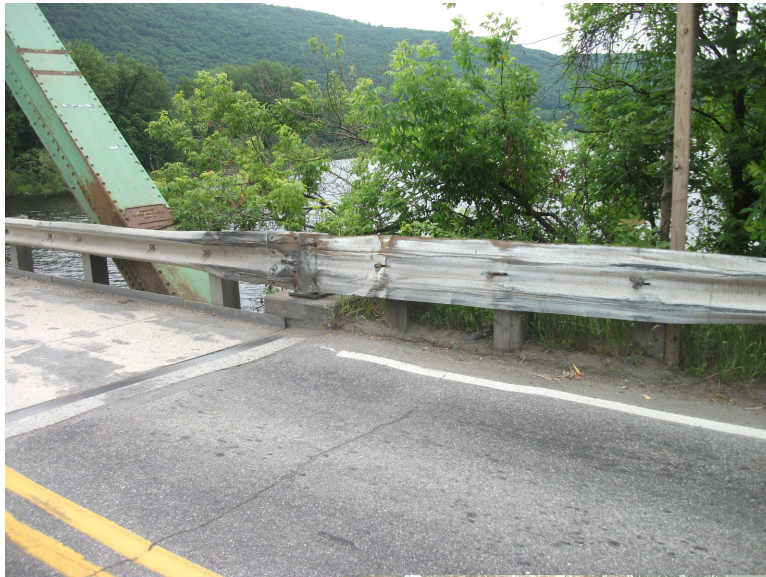
B434 38

SOUTHWEST RAIL HEAVILY
DAMAGED. TYPICAL OF NE
AND SE.)

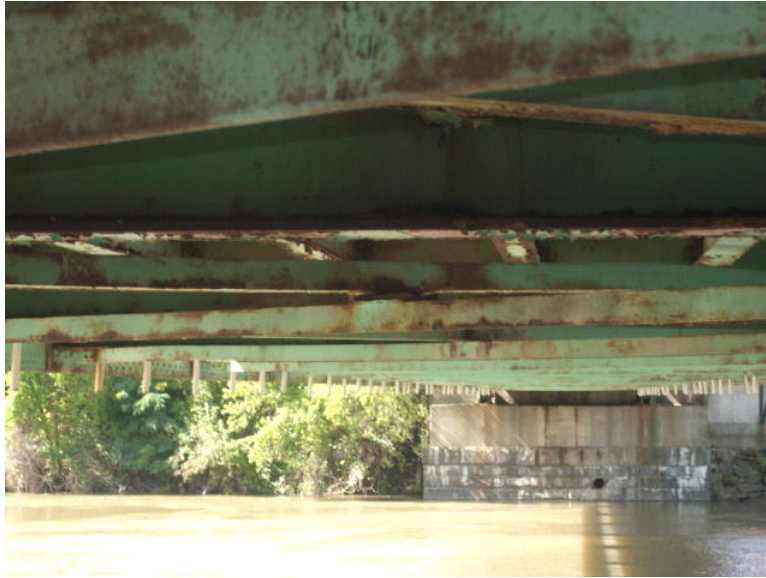
B409 26

SECOND SWAY BRACE
FROM EAST BROKEN

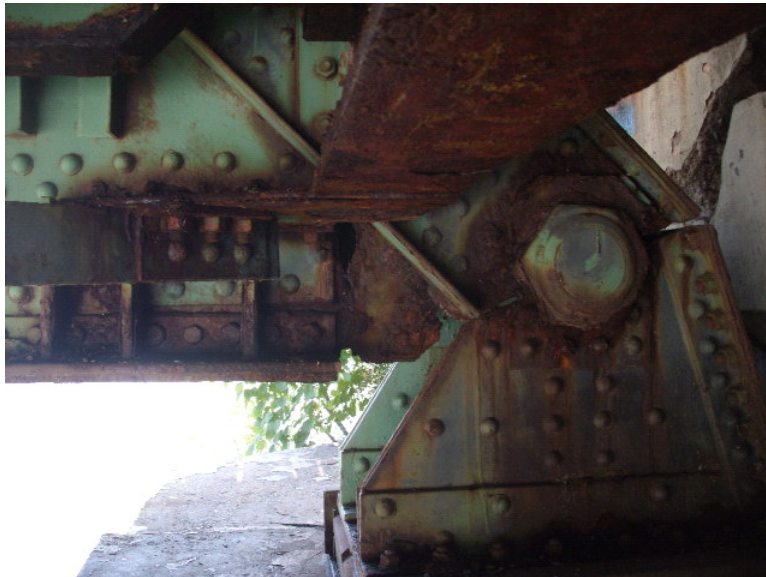
B409 27

NORTHEAST BEARING
RUSTED

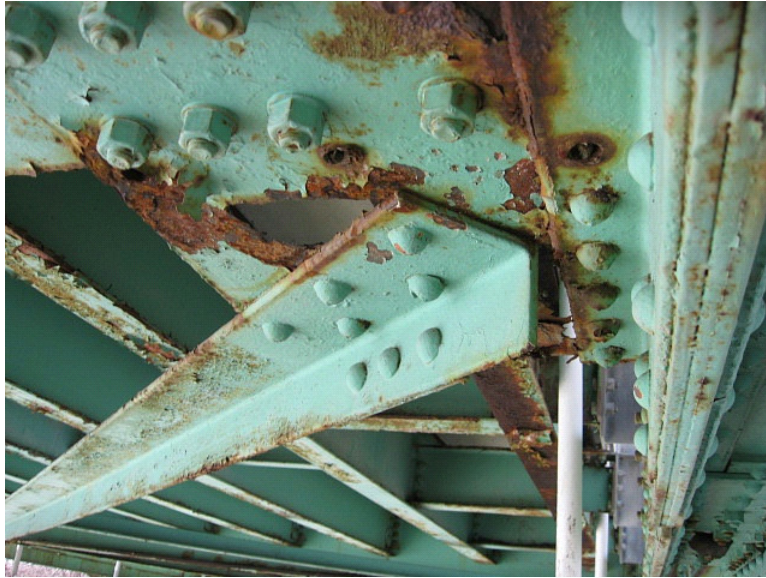
B332 35

LATERAL BRACING
CONNECTION PLATE
HOLED, WEST SIDE OF
FLOORBEAM TWO

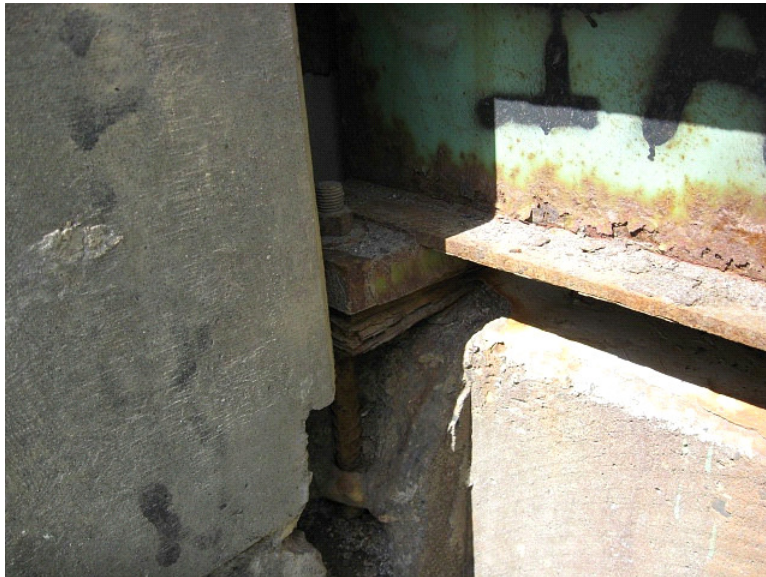
B332 36

BRIDGE SEAT SPALLED AT
STRINGER ONE
SOUTHWEST, ANCHOR
BOLT EXPOSED.

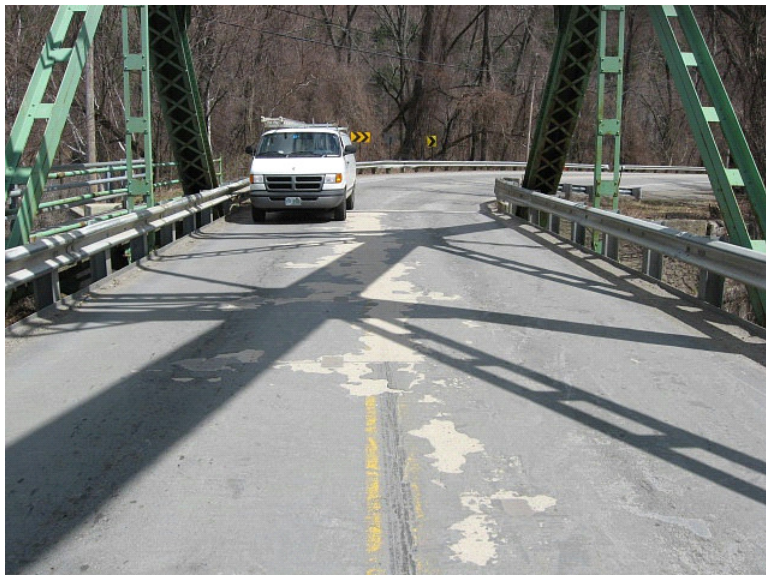
B332 37

PROTECTIVE WEARING
SURFACE COATING
PEELING AWAY.

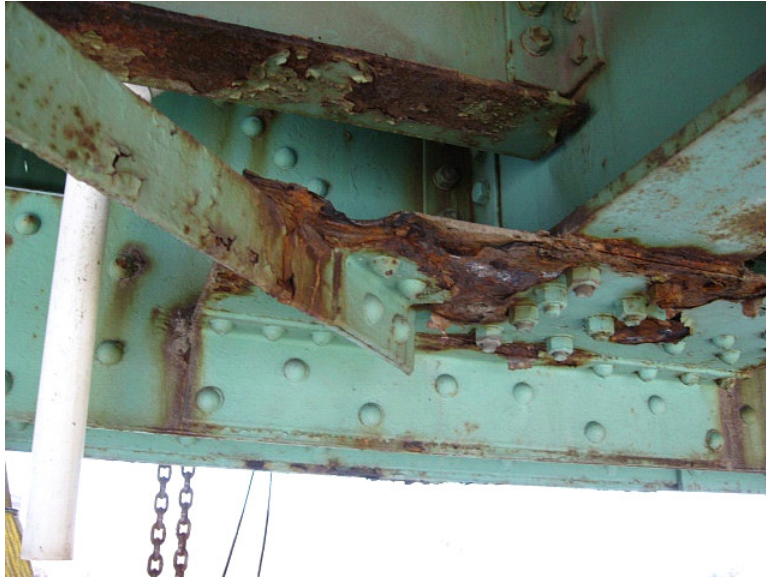
B332 34

LATERAL BRACING
CONNECTION PLATE
HOLED, WEST SIDE OF
THIRD FLOORBEAM FROM
EAST.

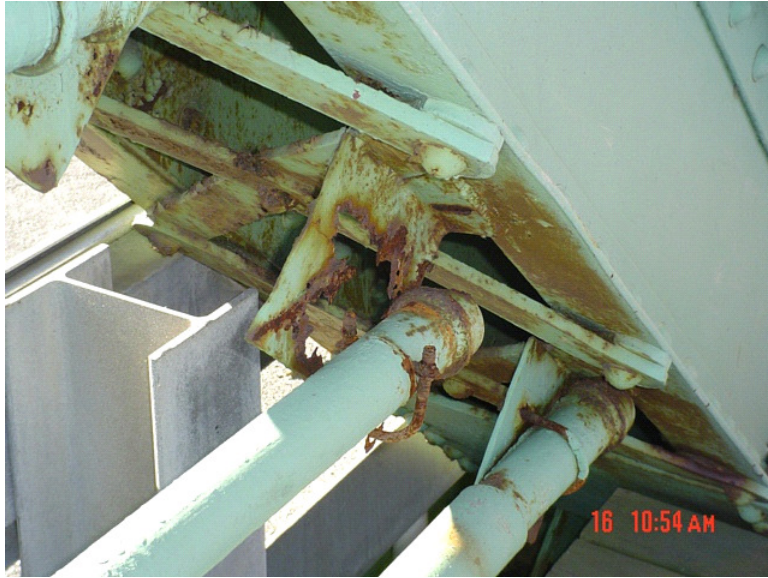
B293 05

PIPE RAIL LOOSE AT
NORTHWEST SIDEWALK

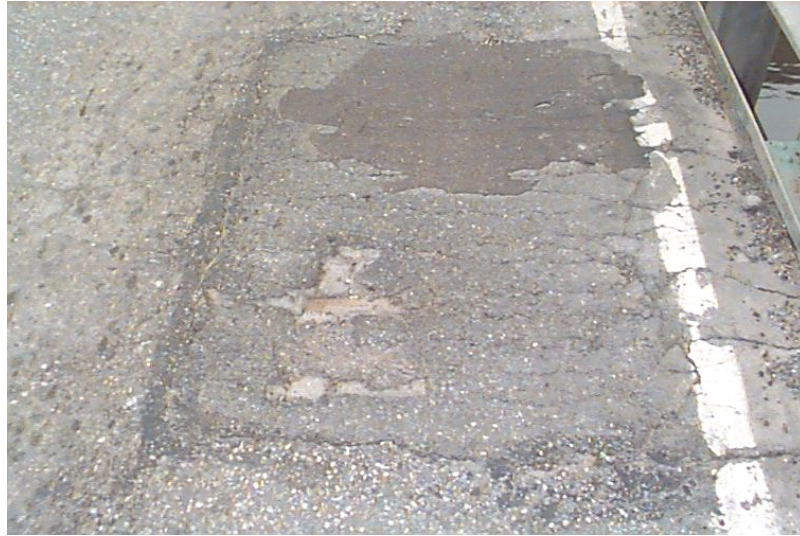
B146 20

ASPHALT CRACKED AND
LOOSE OVER SECTION OF
DETERIORATED BRIDGE
PLANK.

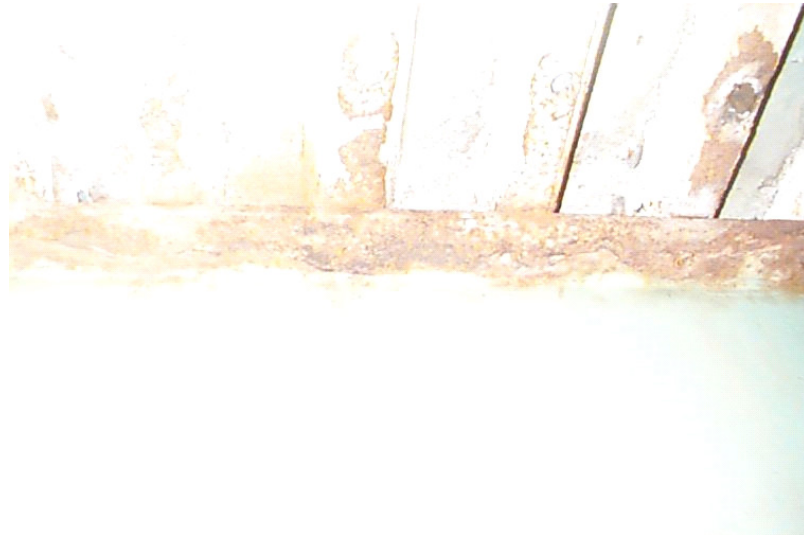
B146 24

BOLTS MISSING AT BRIDGE
PLANK CONNECTION TO
UPPER FLANGE AT EAST
END.

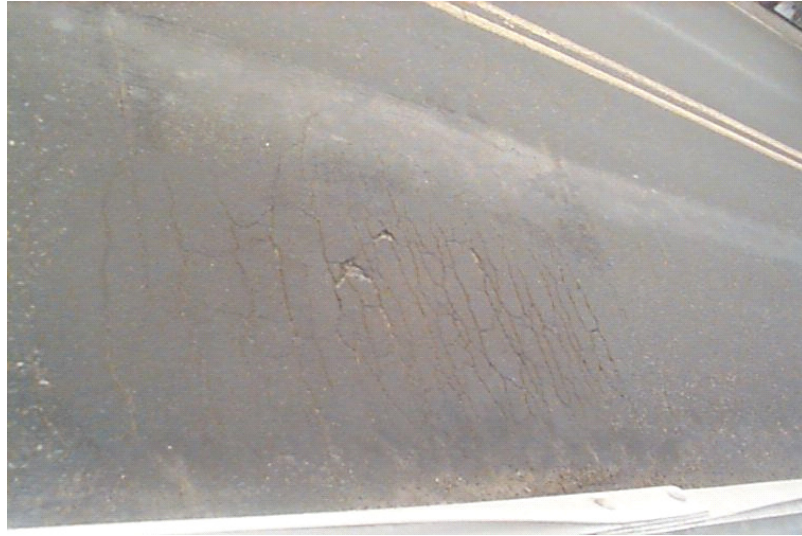
B141 12

CRACKED, DEPRESSED,
LOOSE AREA IN DECKING
(TYP OF SEVERAL AREAS
THROUGHOUT BRIDGE)

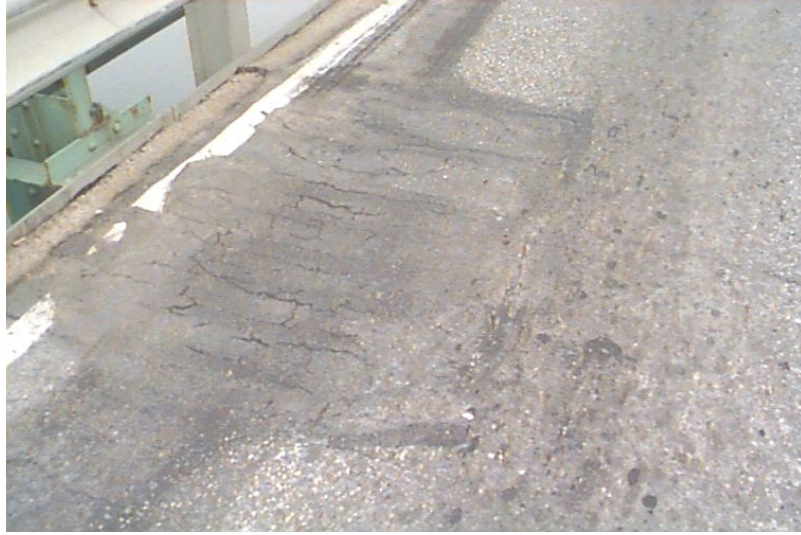
B138 41

CRACKED, DEPRESSED
AREA IN ASPHALT TOPSIDE
(TYP OF MANY AREAS)

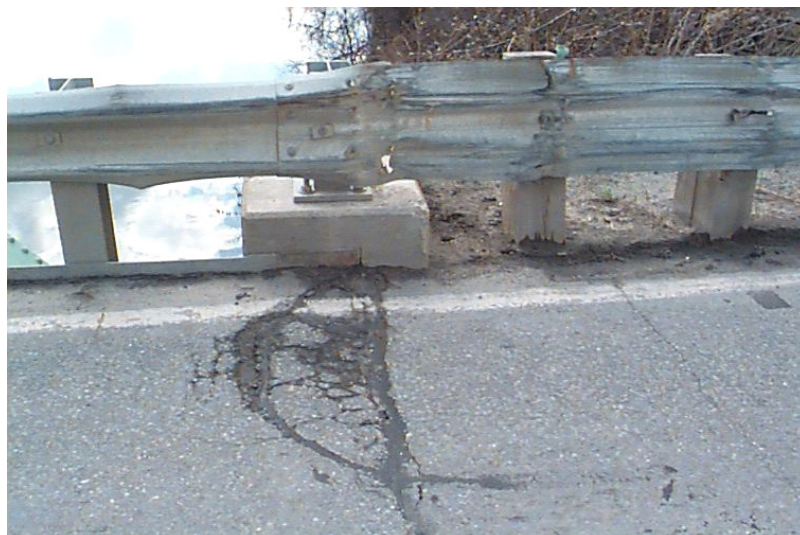
B032 09

DECK CRACKED AND
DEPRESSED AT
SOUTHWEST END.

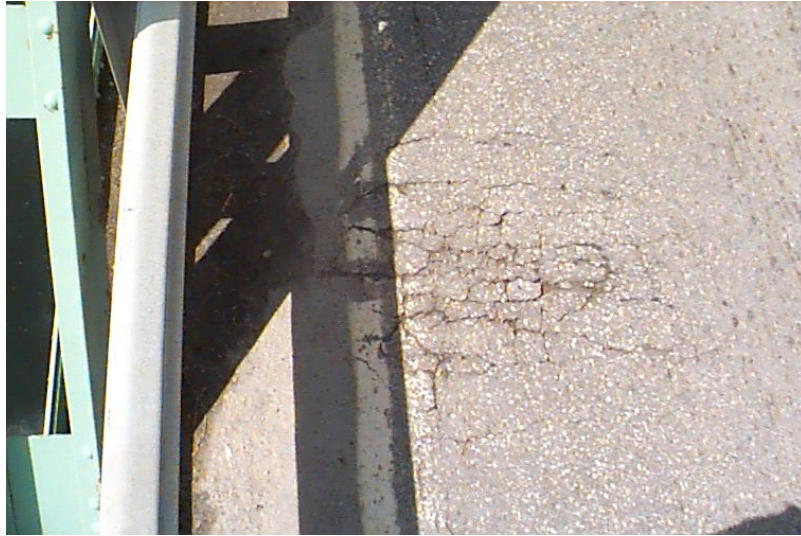
B032 10

DECK CRACKED AND
DEPRESSED AT
FLOORBEAM # 3, AT SOUTH.

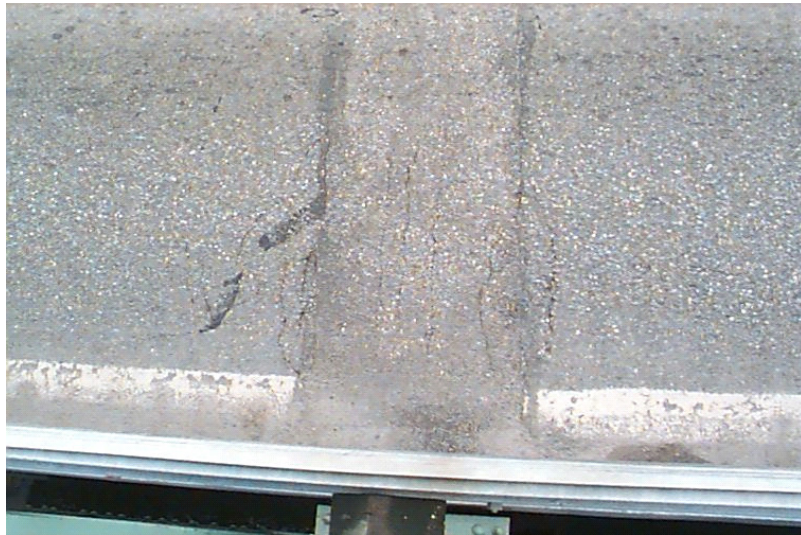
B032 11

DECK CRACKED AT PATCH
OVER FLOORBEAM # 6, AT
NORTH.

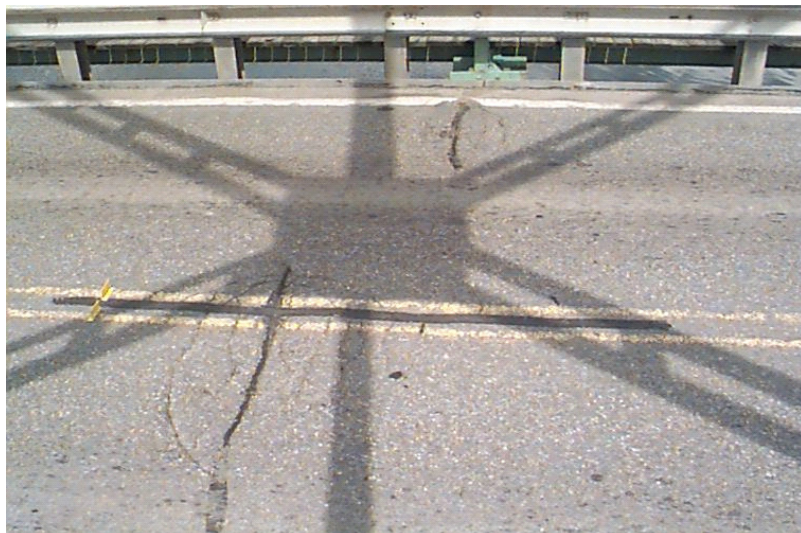
B032 12

DECK CRACKED,
DEPRESSED IN BAY # 6.

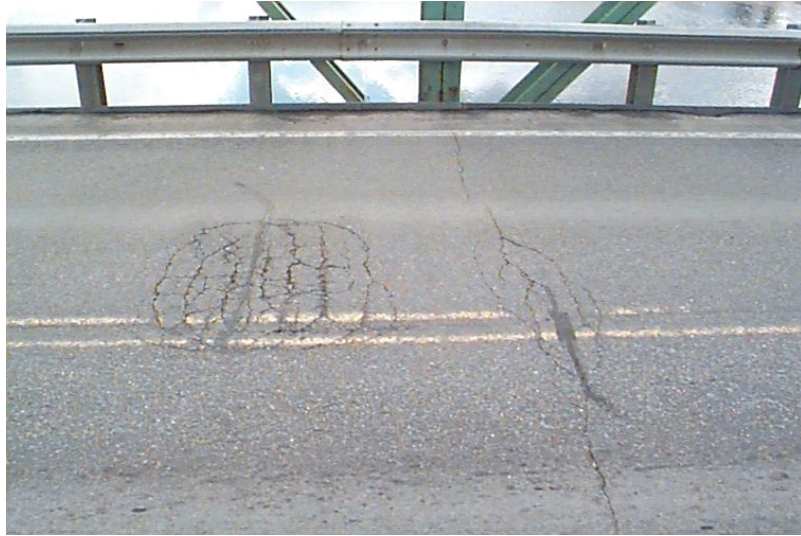
B032 13

DECK CRACKED,
DEPRESSED AT
FLOORBEAM # 8.

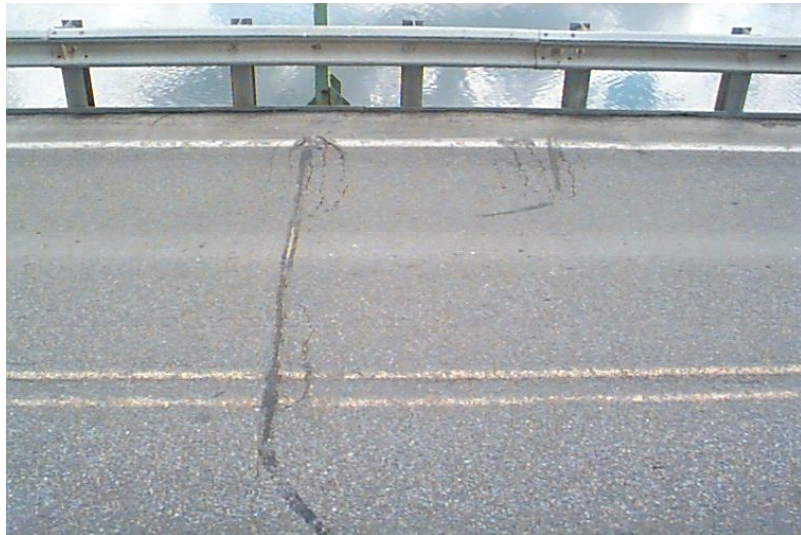
B032 14

DECK CRACKED,
DEPRESSED AT BAY # 8.

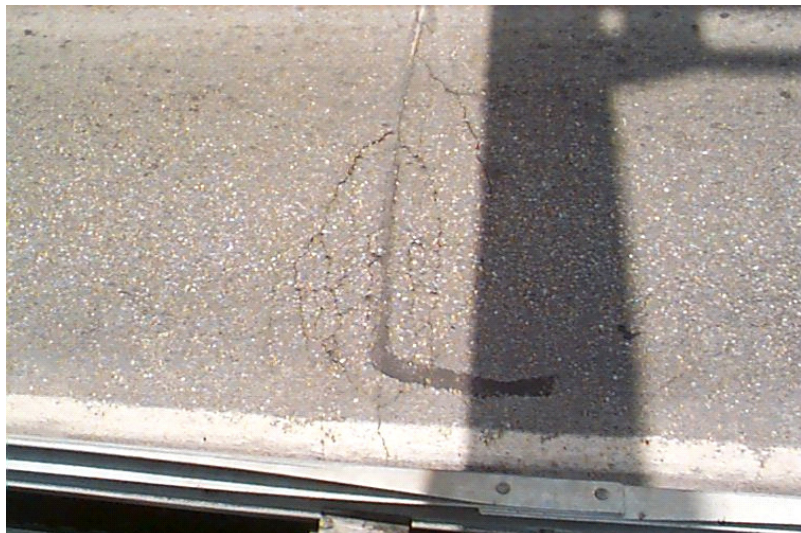
B032 15

DECK CRACKED,
DEPRESSED AT
FLOORBEAM # 10,NORTH.

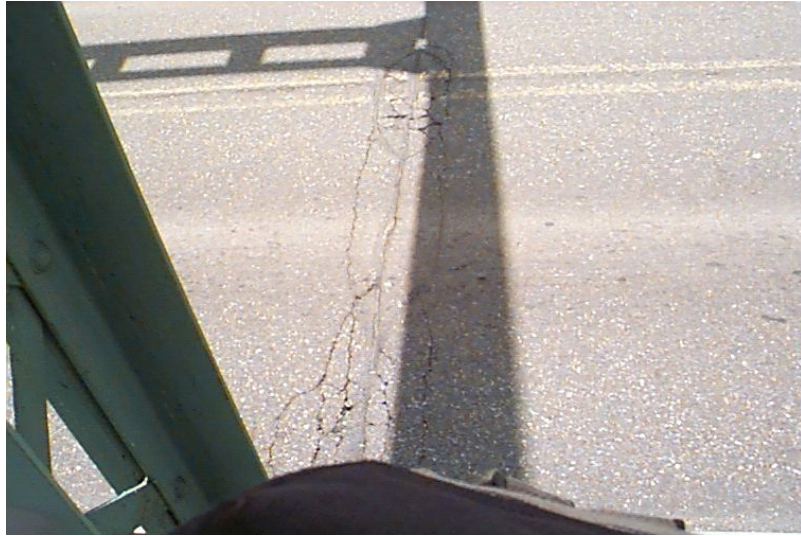
B032 16

DECK CRACKED,
DEPRESSED AT
FLOORBEAM # 12.

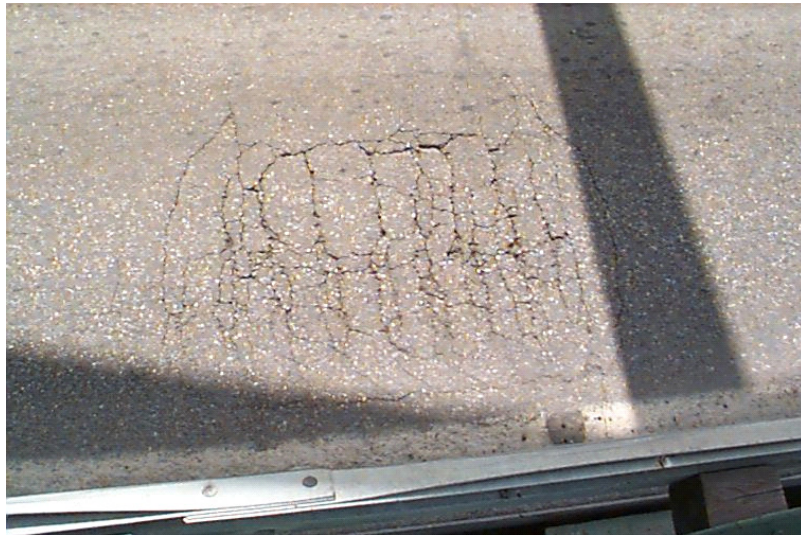
B032 17

DECK CRACKED,
DEPRESSED AT
FLOORBEAM # 14,NORTH.

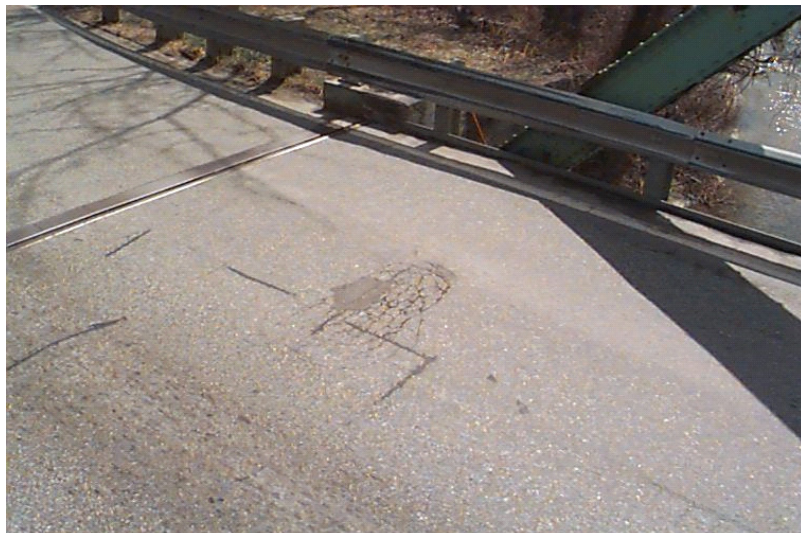
B032 18

DECK CRACKED,
DEPRESSED, AND
PATCHED AT EAST END.

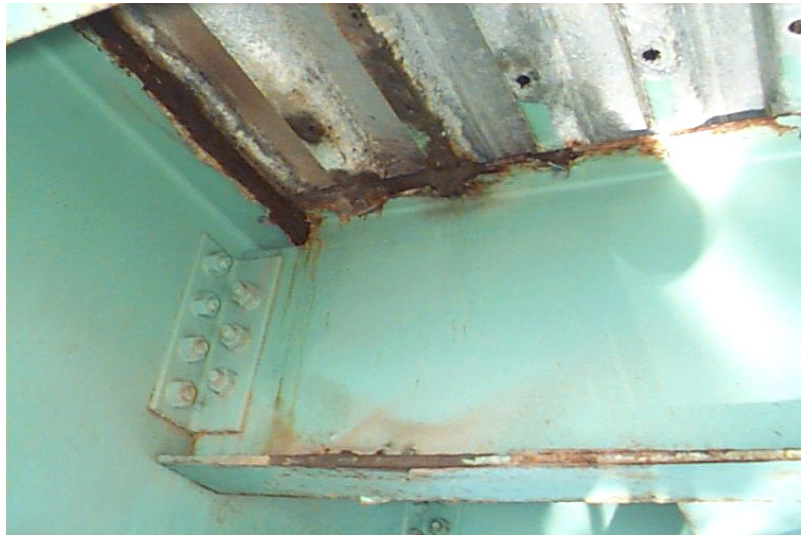
B032 20

BRIDGE PLANK LEAKING AT
FLOORBEAM #5, BAY 5.

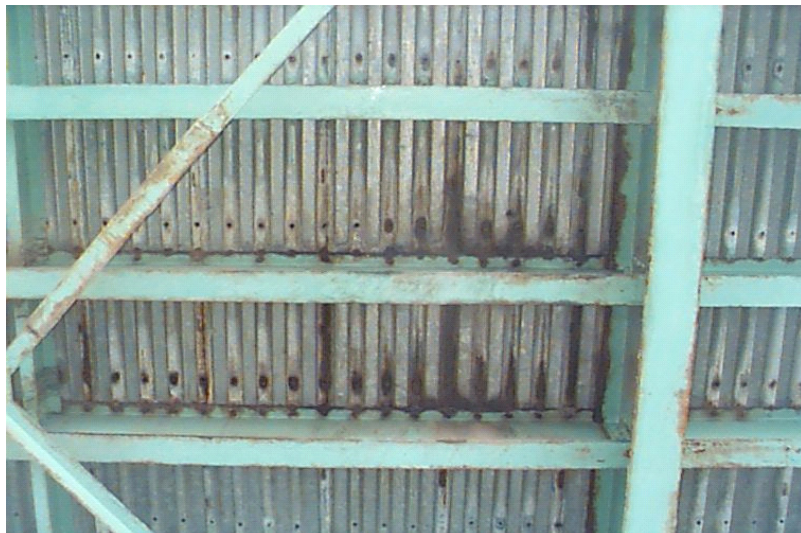
B032 21

RUST AND LEAKING BAY #6.

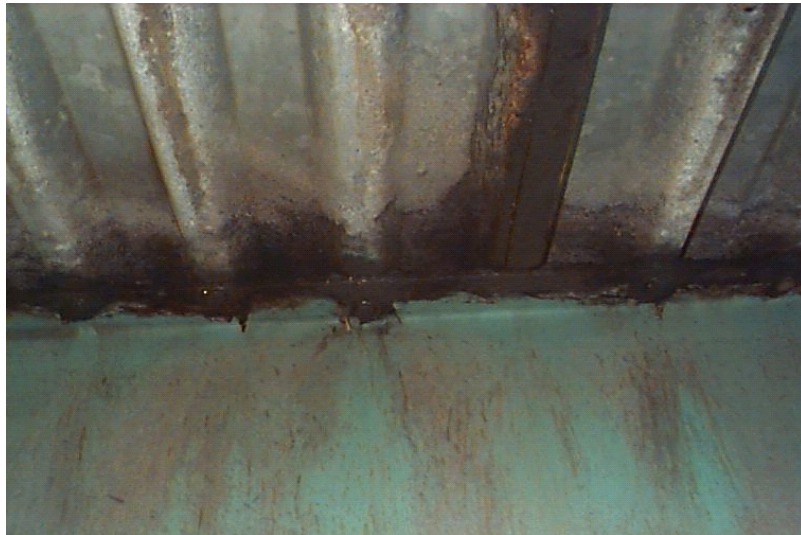
B032 23

TOP FLANGE OF STRINGER
#4, WITH SECTION LOSS, IN
BAY # 6.

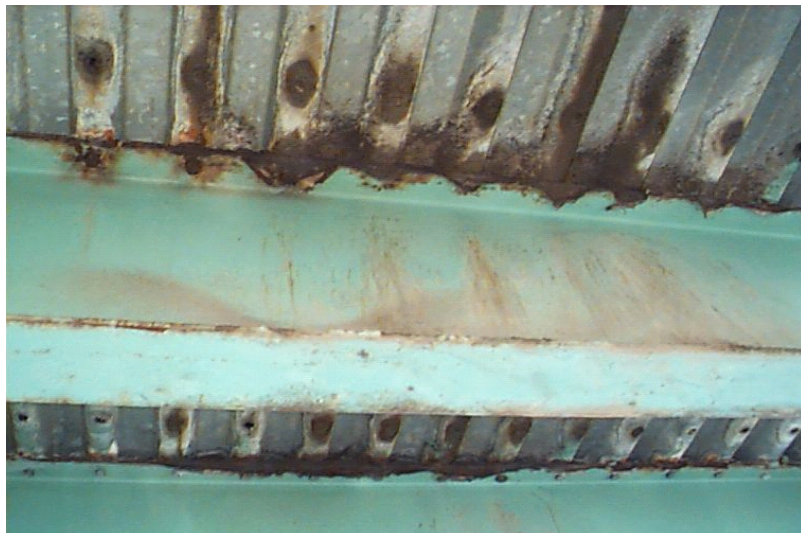
B032 24

BRIDGE PLANK LEAKING IN
BAY #8.
