HINSDALE 041/040
NH119 over CONNECTICUT RIVER

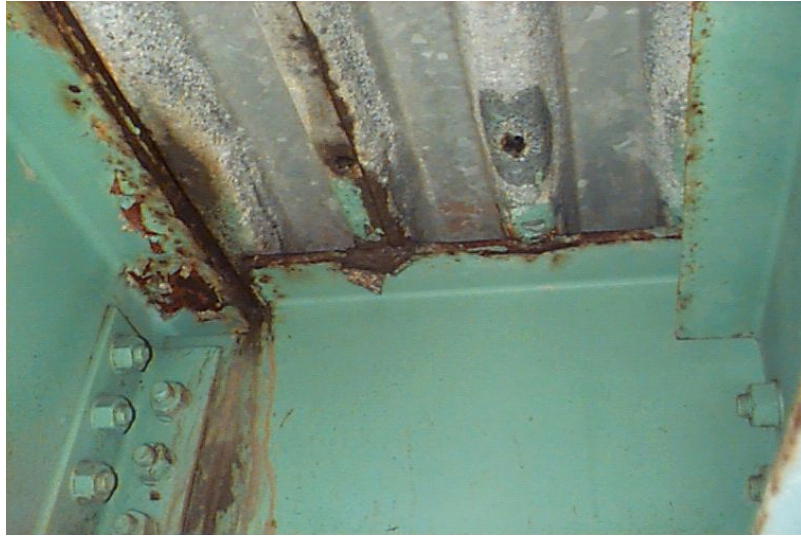
B032 25

BRIDGE PLANK LEAKING IN
BAY #9.

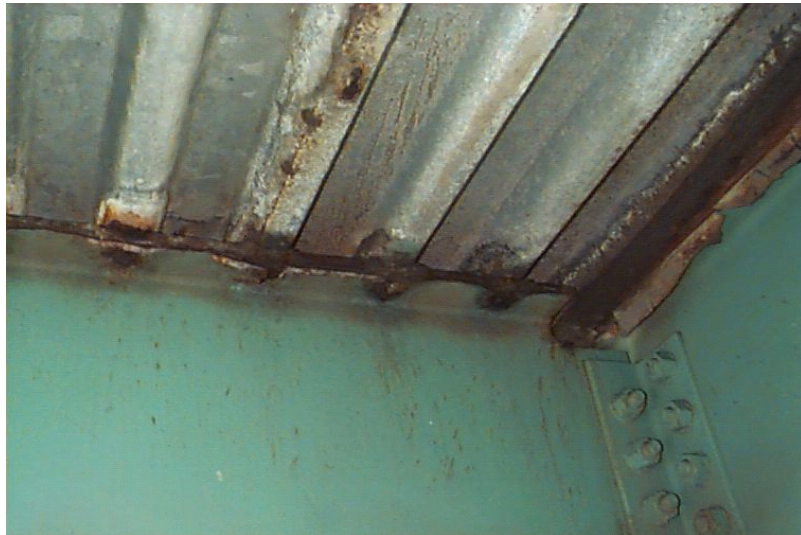
B032 26

BRIDGE PLANK LEAKING IN
BAY #10, FLOORBEAM # 9.

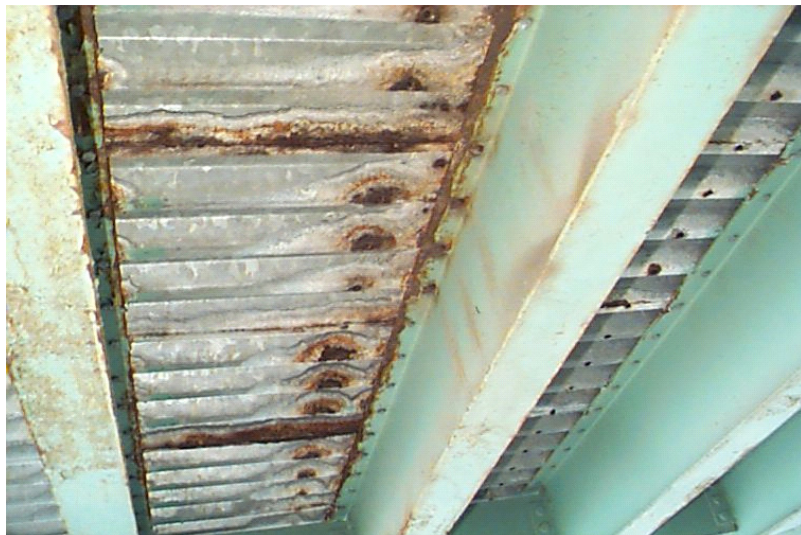
B032 27

BRIDGE PLANK LEAKING IN
BAY #11.

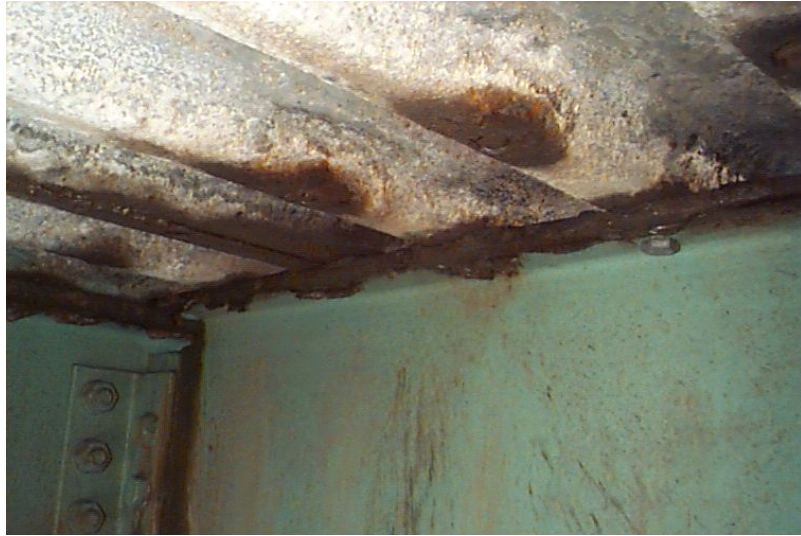
B032 28

BRIDGE PLANK LOOSE IN
BAY #11.

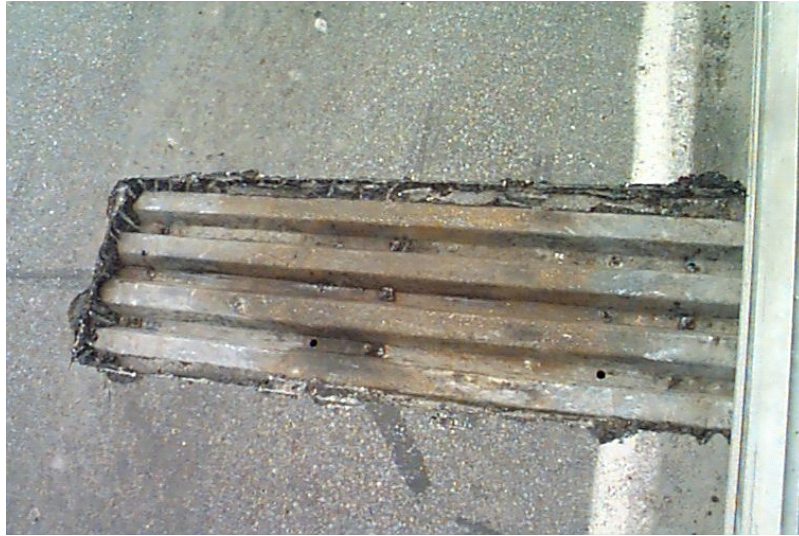
B018 04

DETERIORATED AREA
OVER FB#6 @N. W/ FLEX
CRACKS & HOLES
THROUGH BRIDGE PLANK.

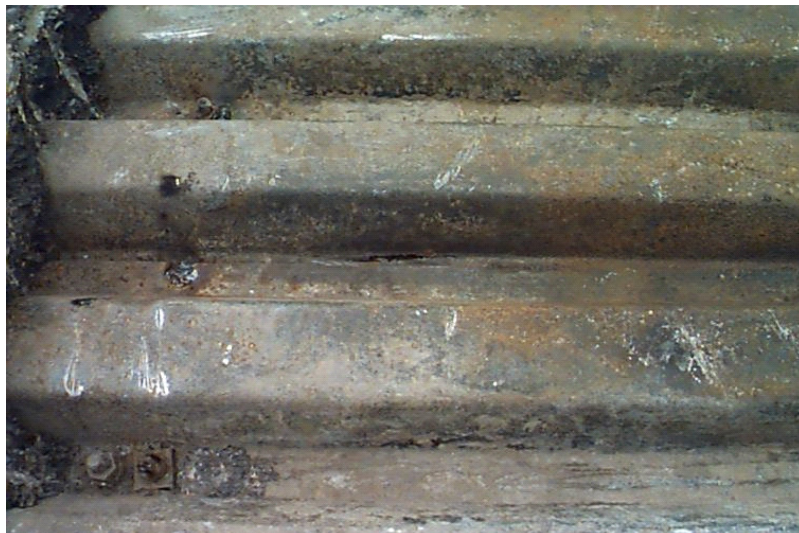
B018 06

FLEX CRACKED AREA OF
BRIDGE PLANK @ N . OVER
FB#6.

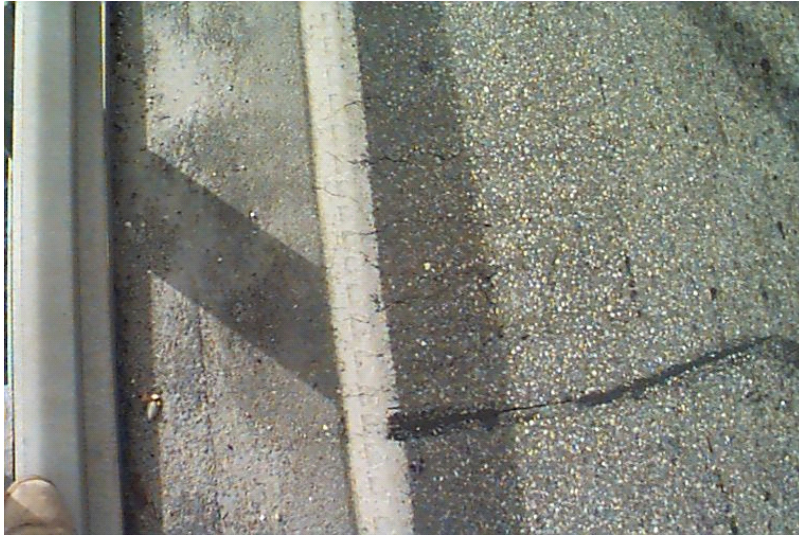
B018 07

ASPHALT CRACKED &
DEPRESSED OVER FB#5 @
SOUTH & BRIDGE PLANK
MOVING WITH LOADINGS.

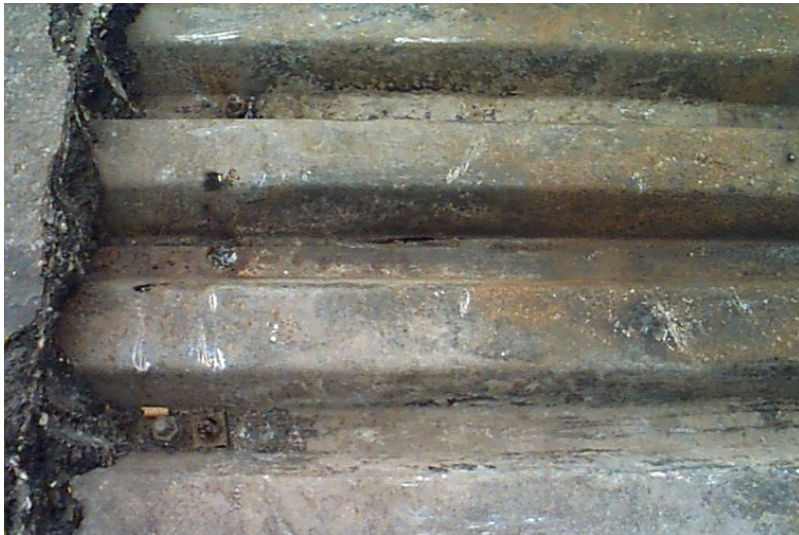
B018 08

FLEX CRACKED AREA OF
BRIDGE PLANK @ N . OVER
FB#6.

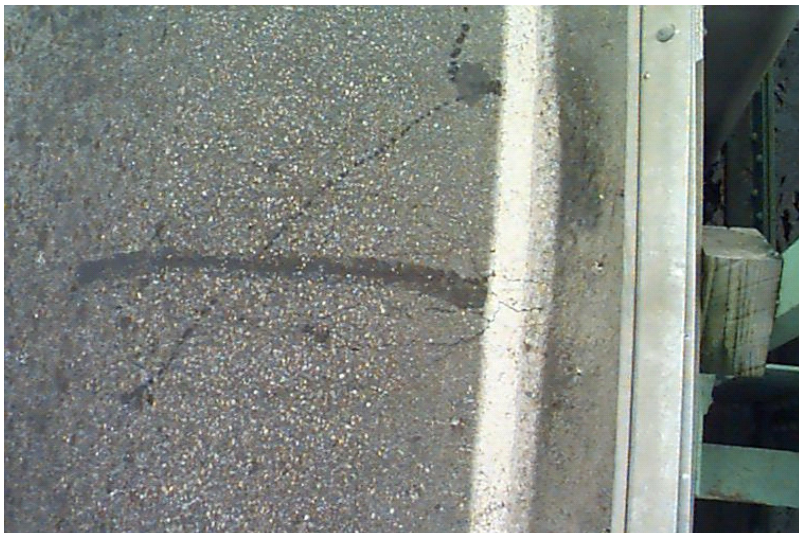
B018 09

ASPHALT CRACKED OVER
FB#7 @ NORTH.

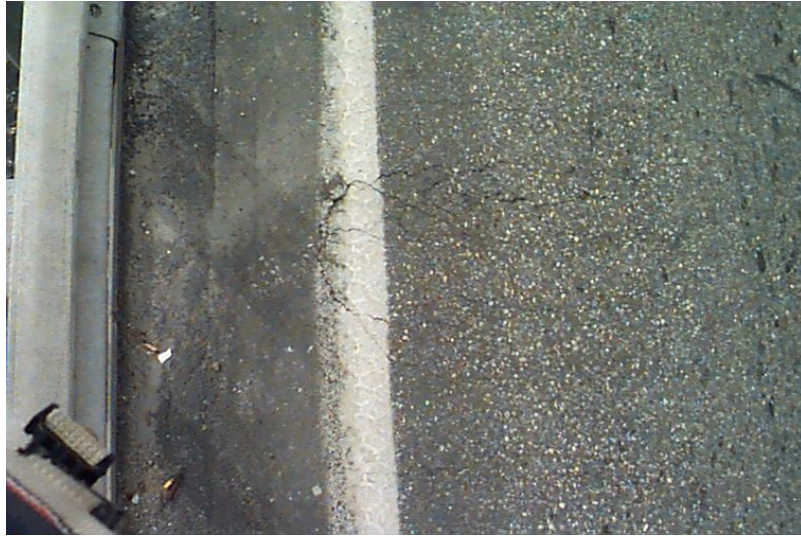
B018 10

ASPHALT CRACKED OVER
FB#7 @ SOUTH.

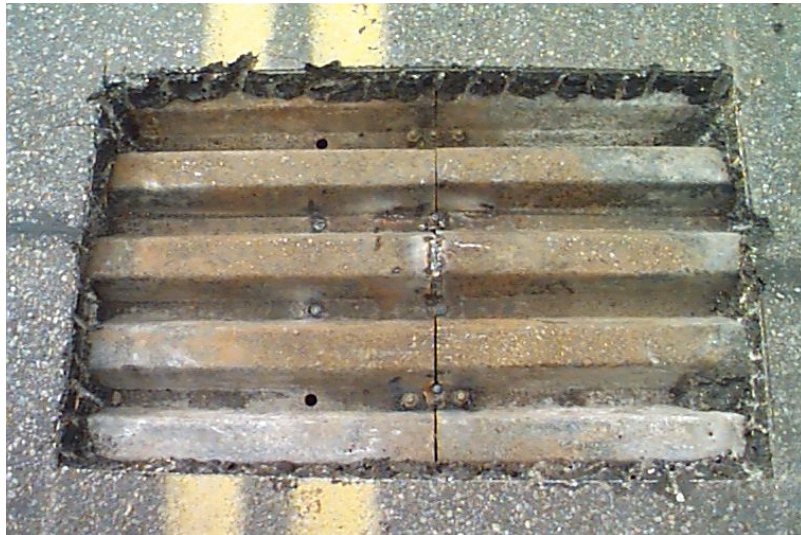
B018 11

DETERIORATED AREA
OVER FB#10 @
CENTERLINE.

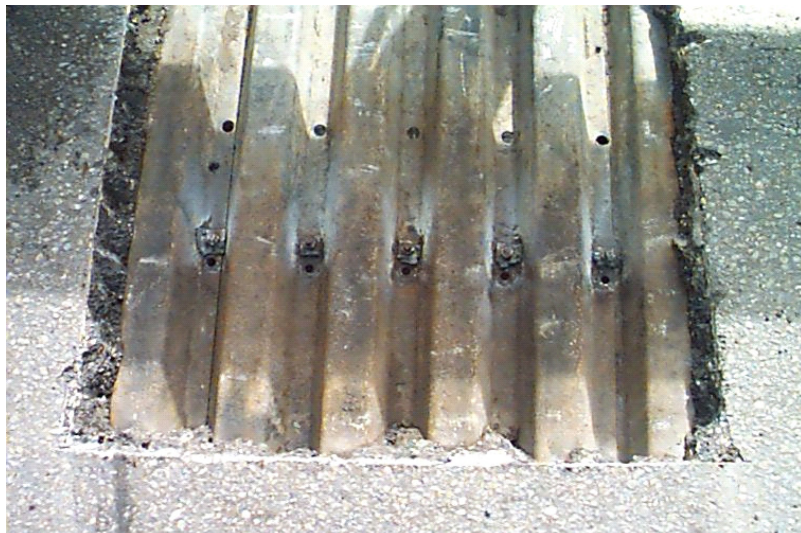
B018 12

LOOSE BOLTS CUT OUT @
SOUTH OVER FB#4.

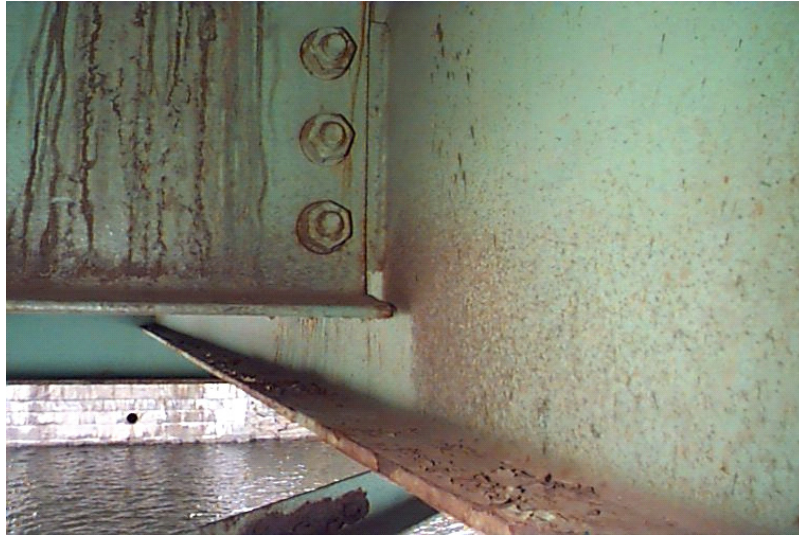
B018 13

APPEARS TO BE CRACKED
WELD @ DIAPHRAGM,
BAY#6, BETWEEN
STRINGER #4 & #5 @
MIDSPAN. WAS NOT
CRACKED WHEN PAINT
WAS REMOVED.

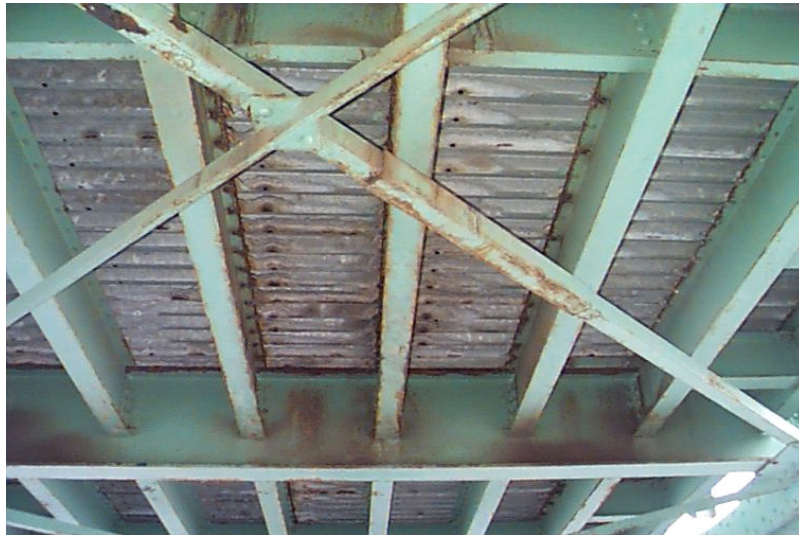
B018 14

DECK LEAKAGE, BAY#6.

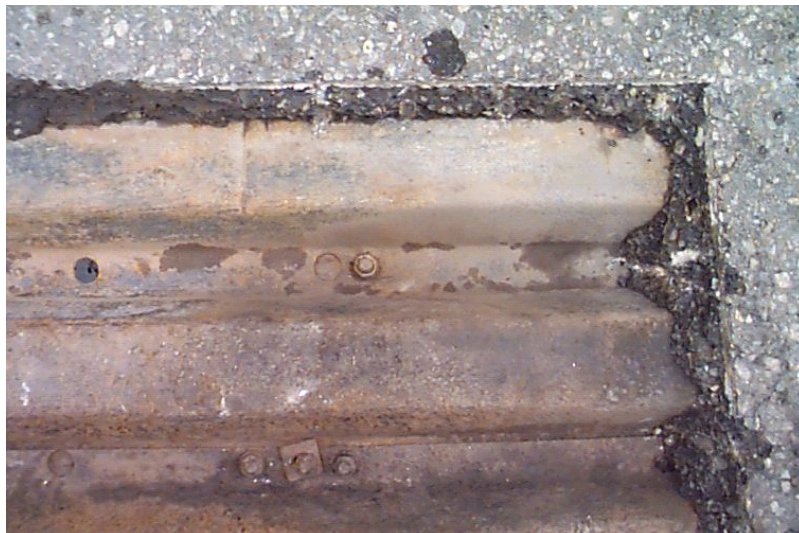
B018 15

RUNNING CRACK IN BRIDGE
PLANK @ FB#7 @ SOUTH.

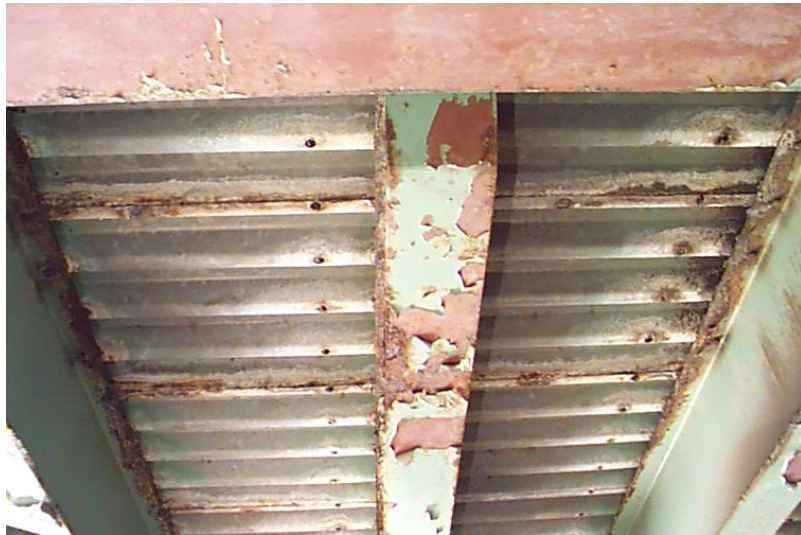
B018 23

NH END HAS BRIDGE PLANK
LEAKAGE.

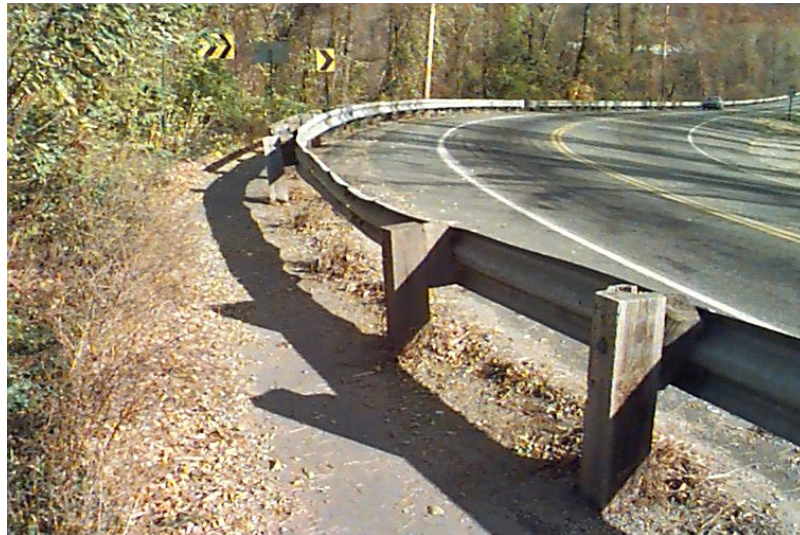
B018 26

NORTH EAST APPROACH
RAIL DAMAGE.

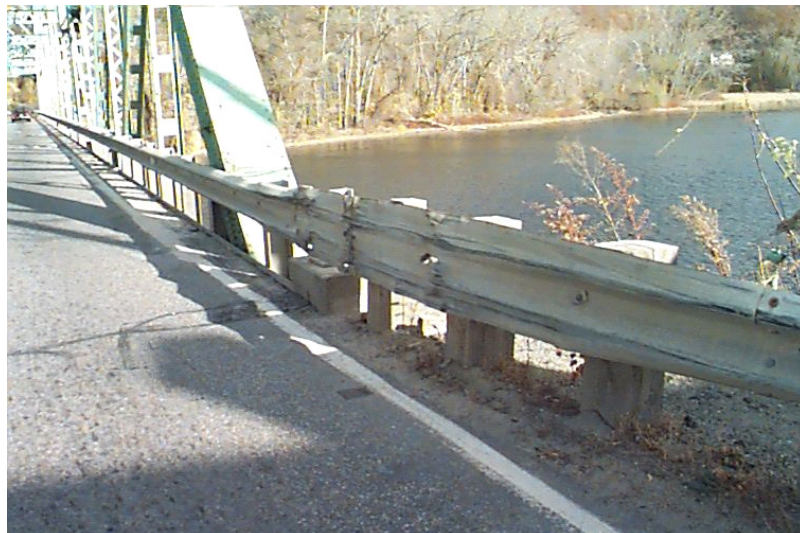
B018 27

SOUTH WEST APPROACH
RAIL DAMAGE @ VT. END.

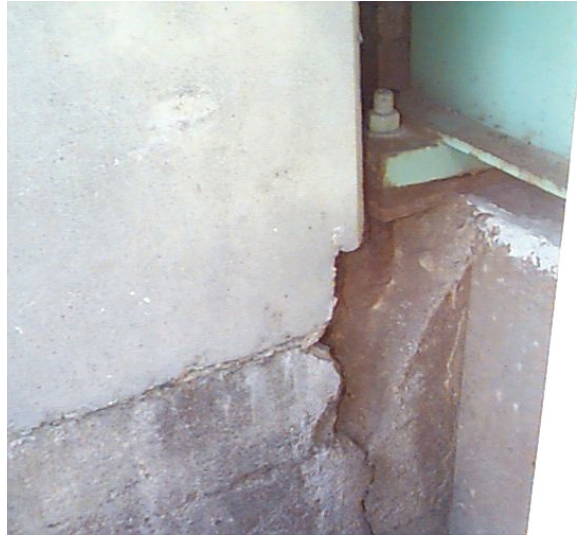
B018 28

SOUTH WEST BEARING
@ STRINGER#1,HAS
SPALLED AREA BENEATH
IT.
