HINSDALE 042/044

NH119 over CONNECTICUT RIVER

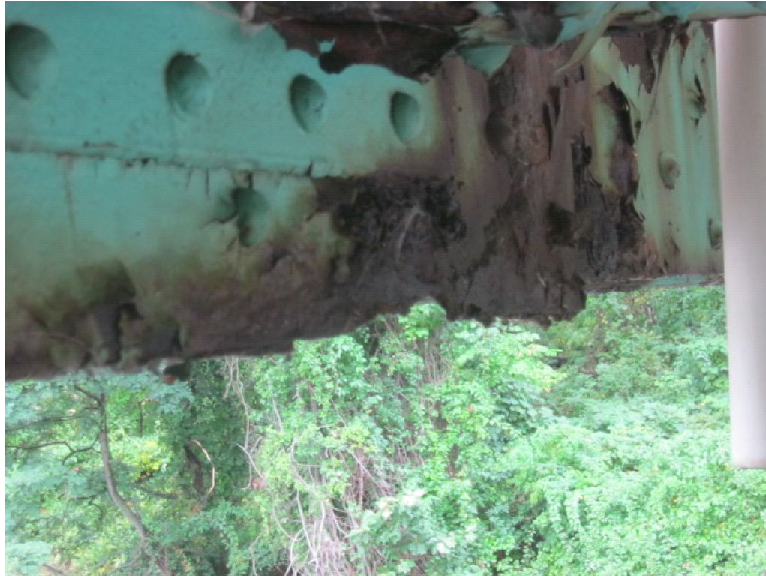
B568 52

BOTTOM EDGE OF GUSSET
PLATE AT FLOORBEAM # 2,
SOUTH, RUSTED AND
HOLED.

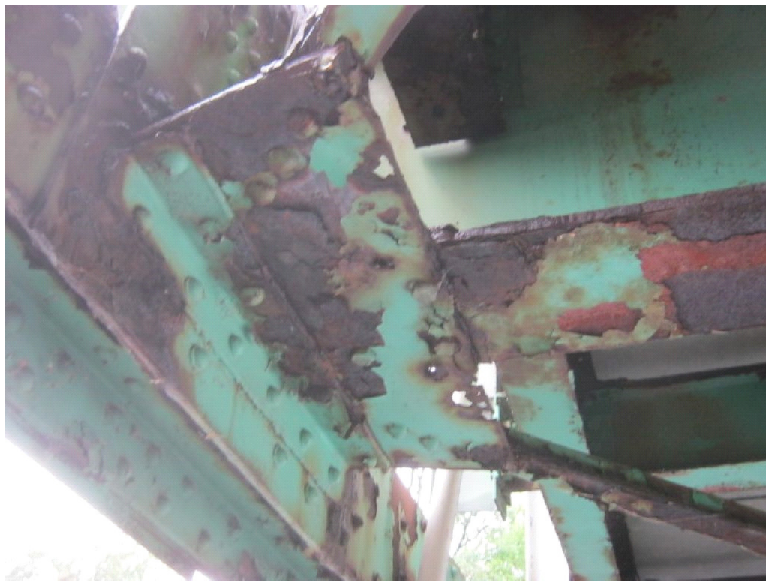
B568 53

LATERAL BRACING
CONNECTION PLATE
HOLED AT SOUTH END OF
FLOORBEAM # 5.

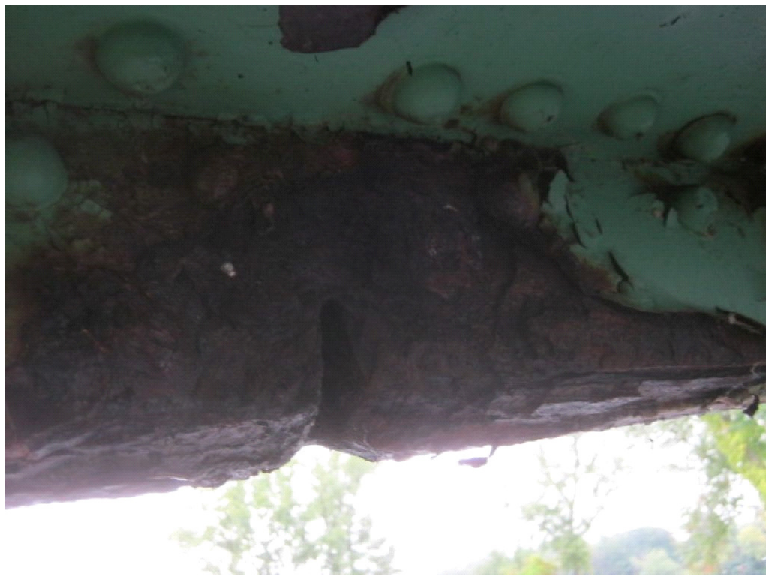
B568 54

COVER PLATE HOLED AT
LOWER CORD SPLICE,
SOUTH END OF
FLOORBEAM # 6.

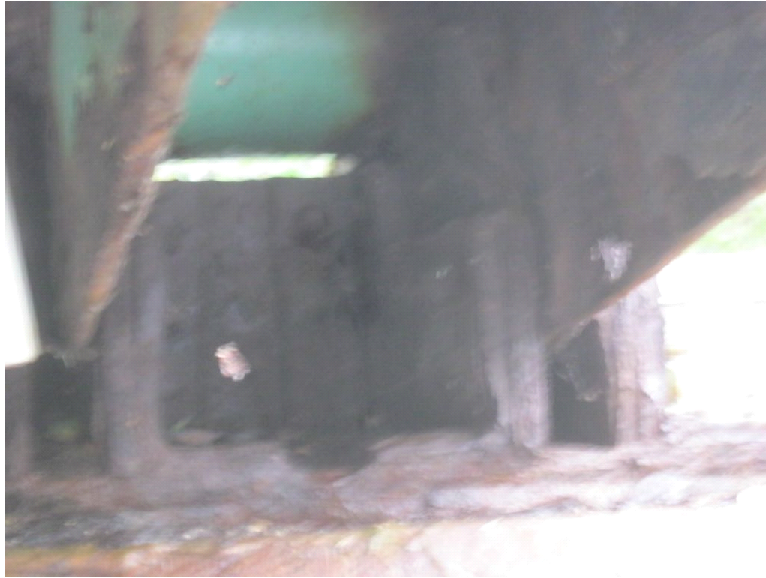
B568 55

GUSSET PLATE AND BEARING SPACER PLATE HOLED, BEARING # 1, PIER # 2.

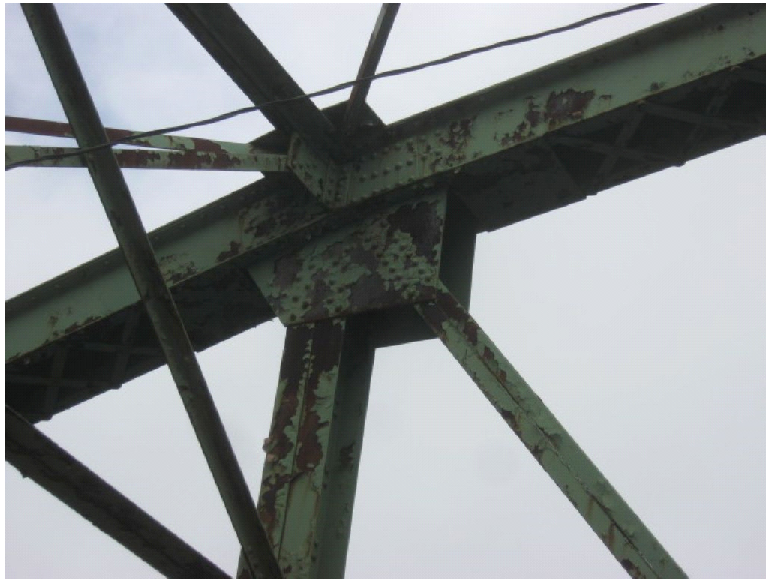
B568 56

PAINT PEELING, LIGHT SURFACE RUST AT UPPER CORD.

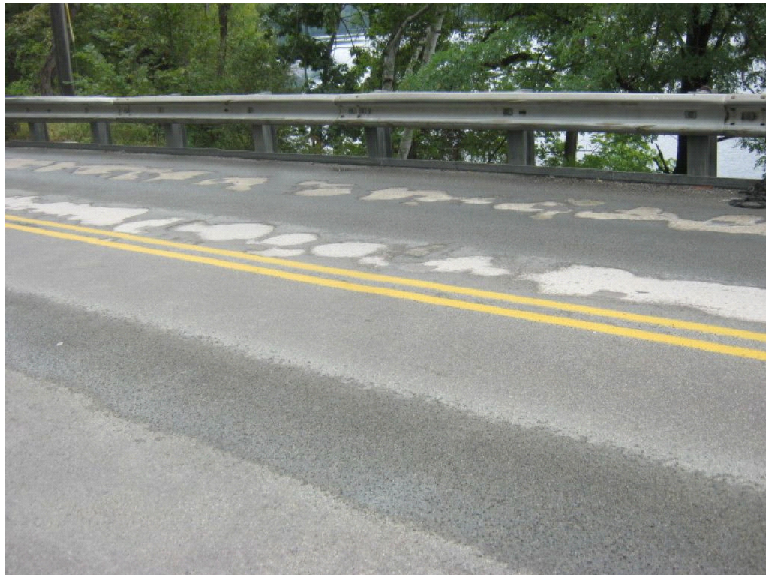
B568 57

WEARING SURFACE POTHOLED AT EAST END OF EASTBOUND LANE.

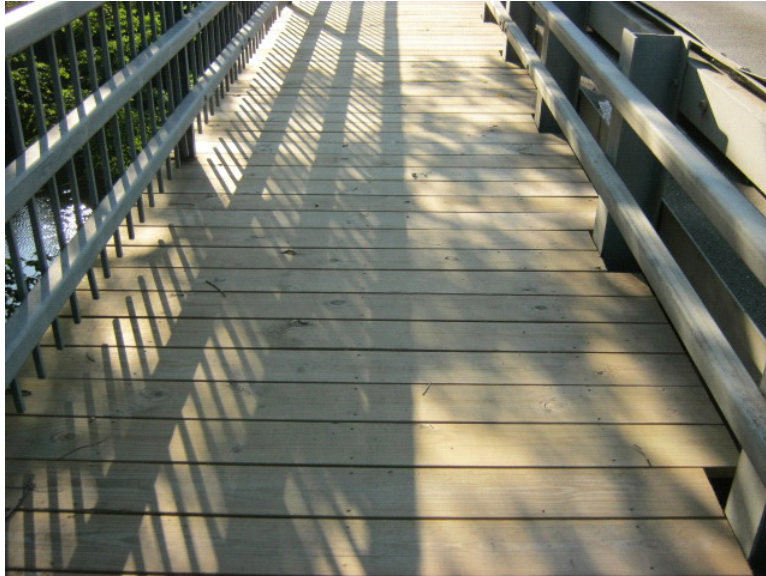
B506 21

NEW PLANKS ON SIDEWALK.

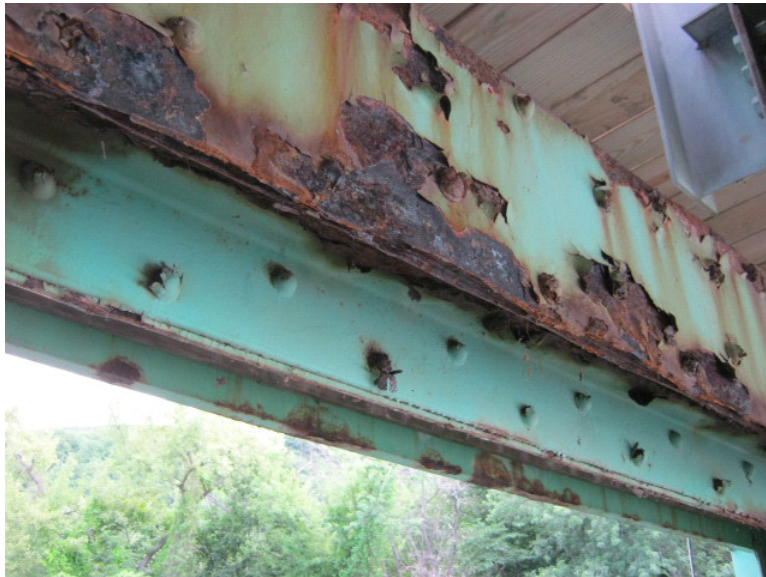
B506 22

PACK RUST AT LOWER
CHORD AT NORTH.

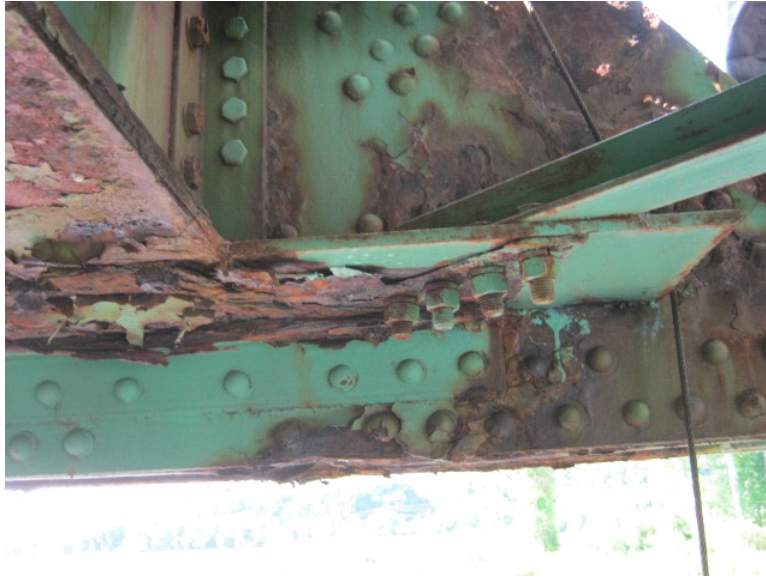
B506 24

CONNECTION PLATE
REPAIRED.

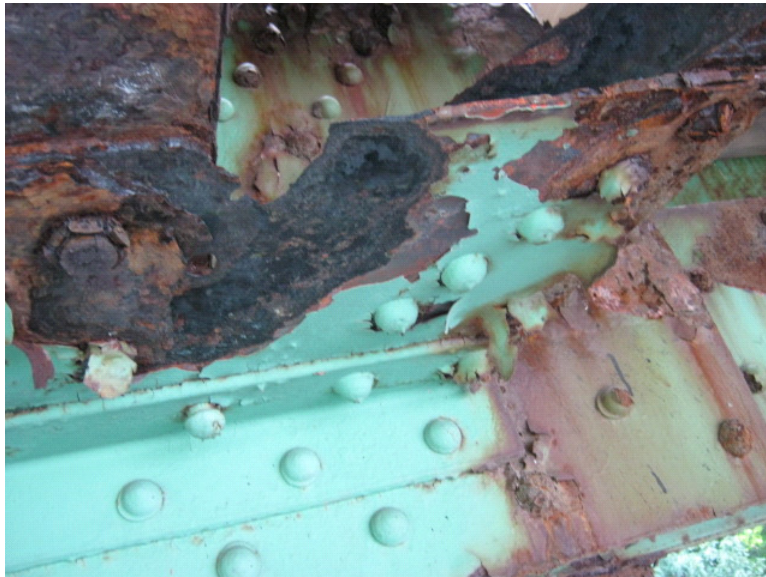
B506 25

CONNECTION PLATE
HOLED.

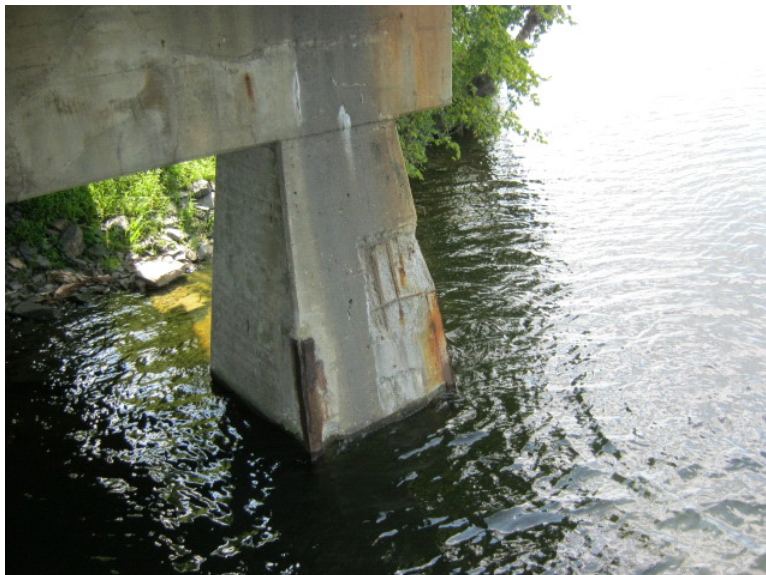
B506 26

SPALL AT PIER 2.

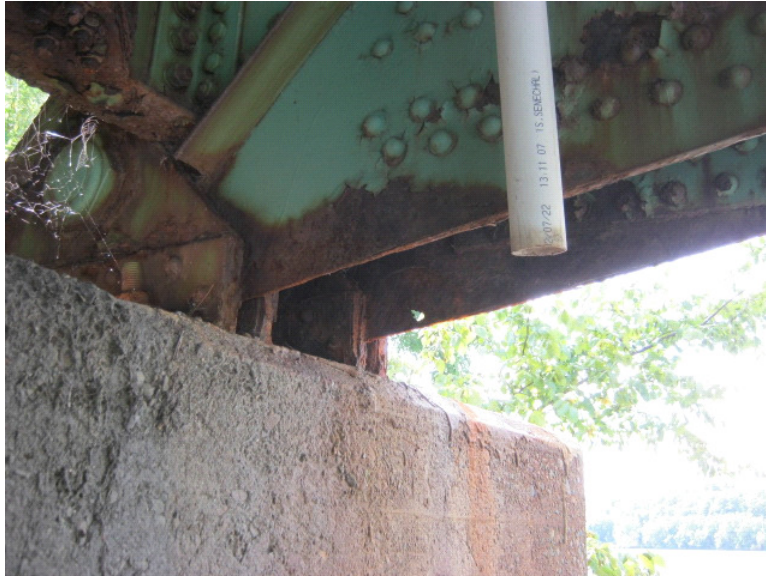
B506 27

HOLE IN GUSSET PLATE AT
BEARING 1 PIER 2.

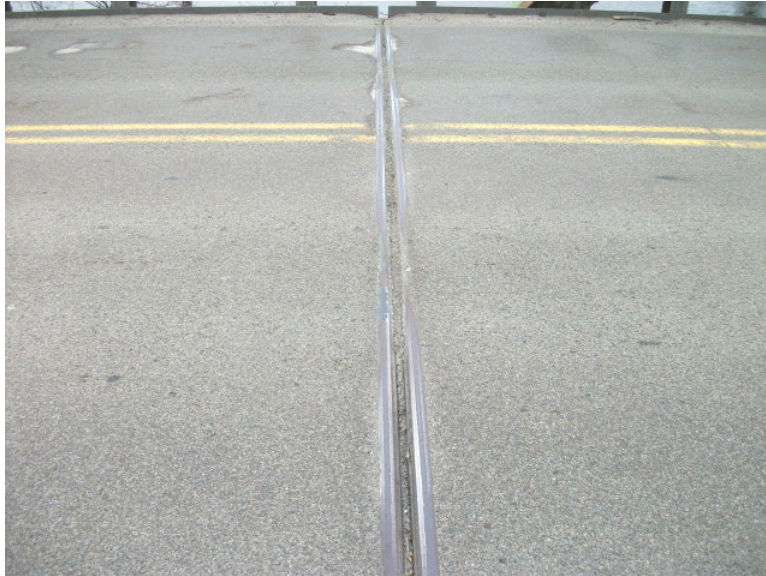
B460 42

MINOR ADHESION FAILURE
AT JOINT #3.

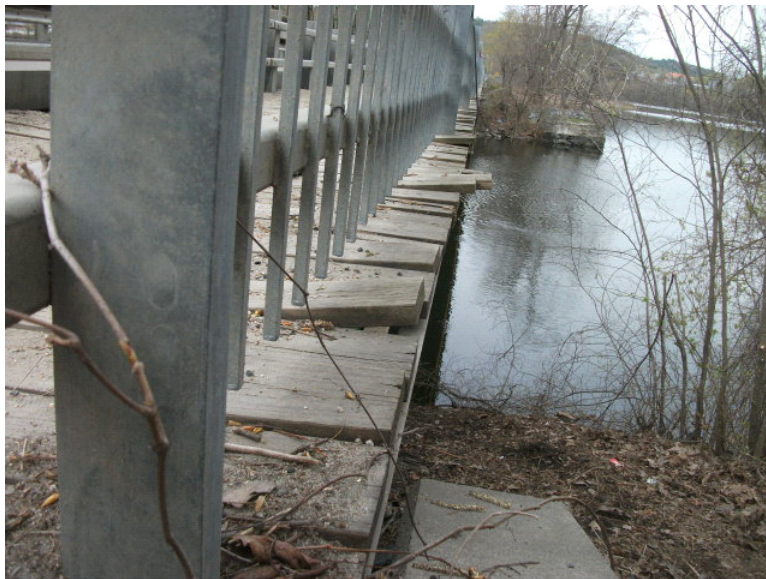
B460 43

SIDEWALK PLANKS
CURLING, A FEW LOOSE.

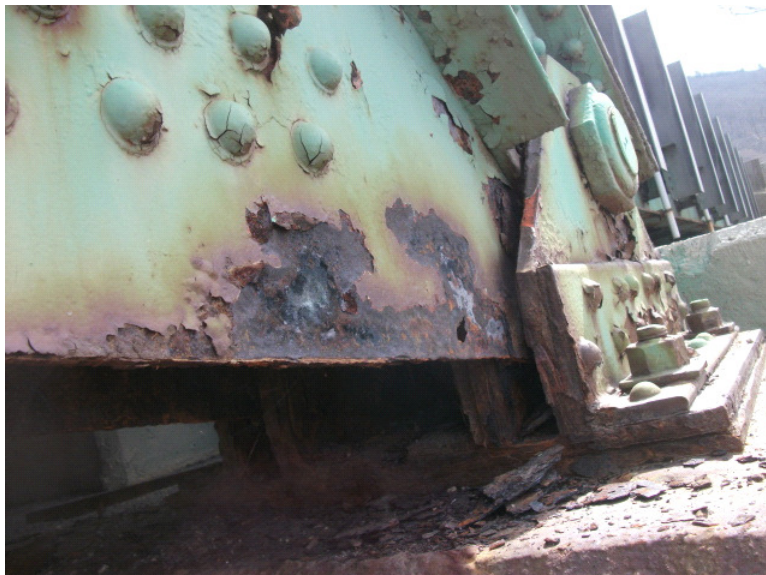
B460 44

GUSSET PLATE HOLED AT
BEARING #1 AT PIER #2.

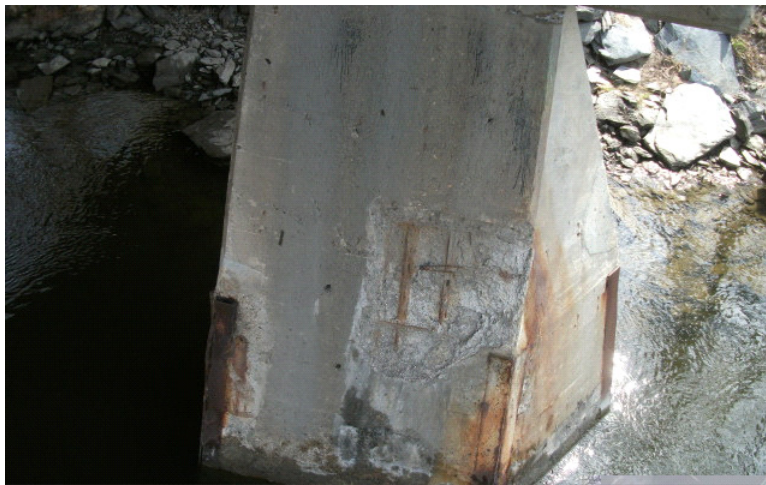
B460 46

LARGE SPALL AT COLUMN
#1, PIER #2.

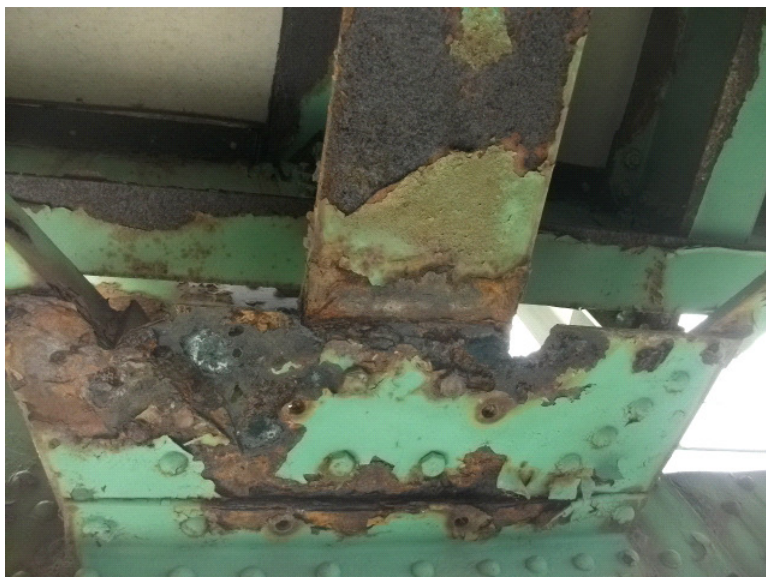
B460 47

LOWER LATERAL BRACING
CONNECTION PLATE
HOLED BOTH SIDES OF
FLOORBEAM #9.

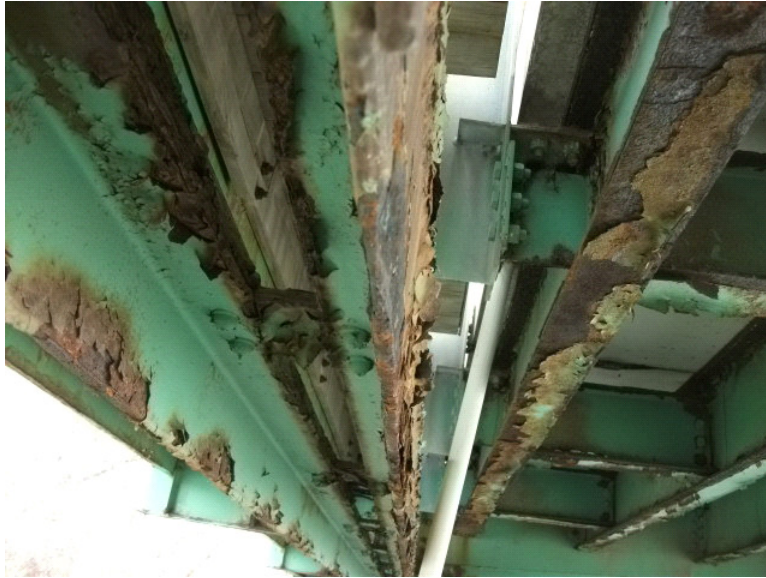
B460 48

SECTION LOSS AT BOTTOM
CHORD, BAY #10.

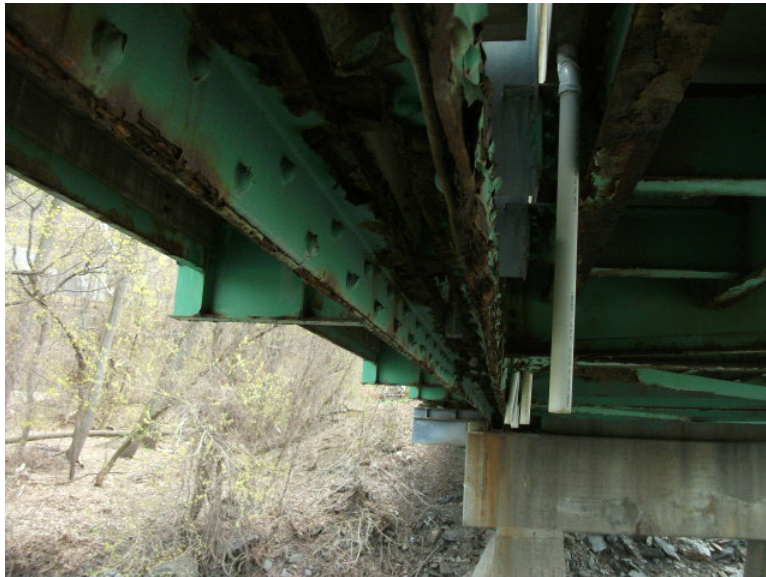
B460 49

PACK RUST AT BOTTOM
CHORD.

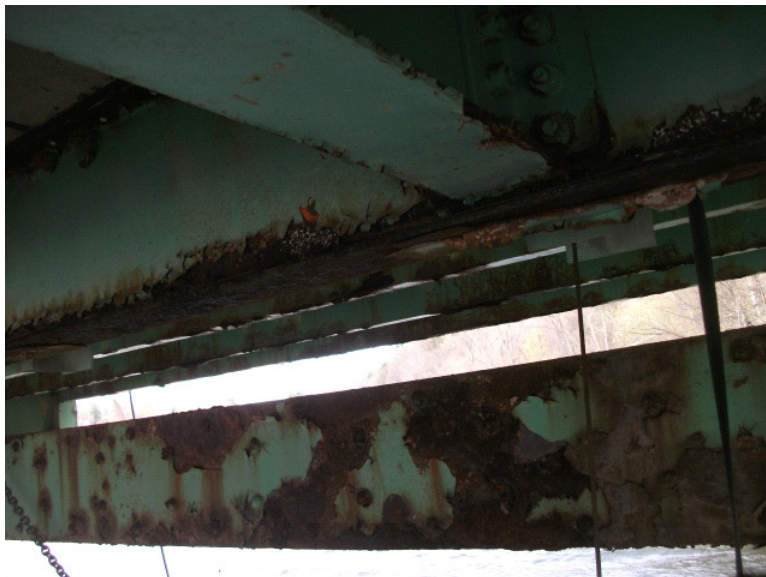
B460 50

SECTION LOSS AT NORTH
EXTERIOR STRINGER, 3/8"
REMAINING.

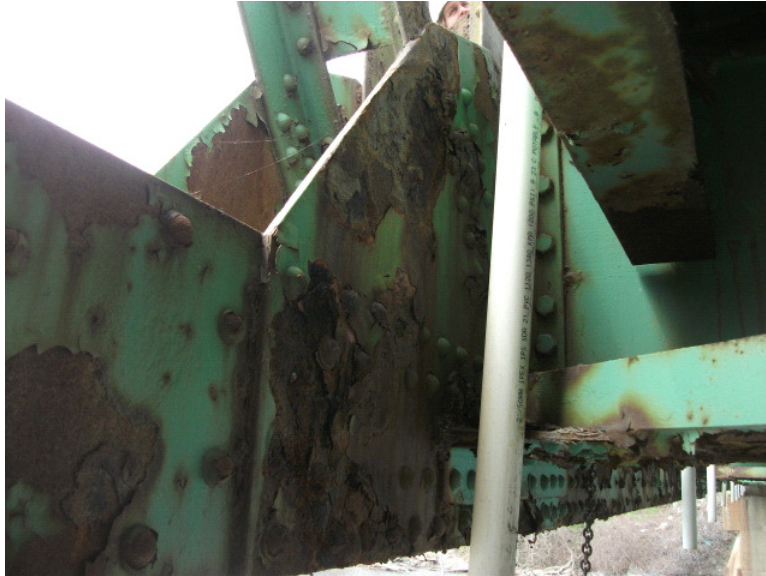
B460 51

RUST, SCALE, MINOR
SECTION LOSS, TYPICAL OF
MOST GUSSET PLATES.

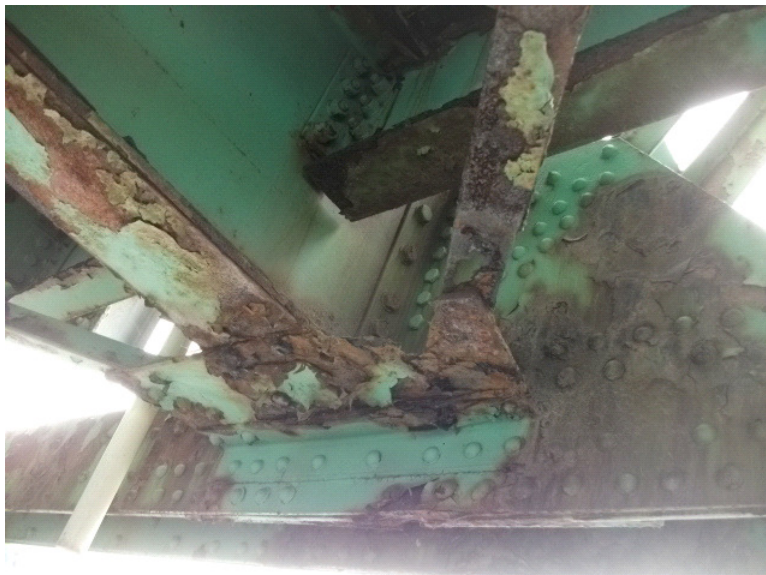
B460 53

CONNECTION PLATE AND
LOWER LATERAL BRACING
HOLED AT FLOORBEAM #5,
AT SOUTHWEST.

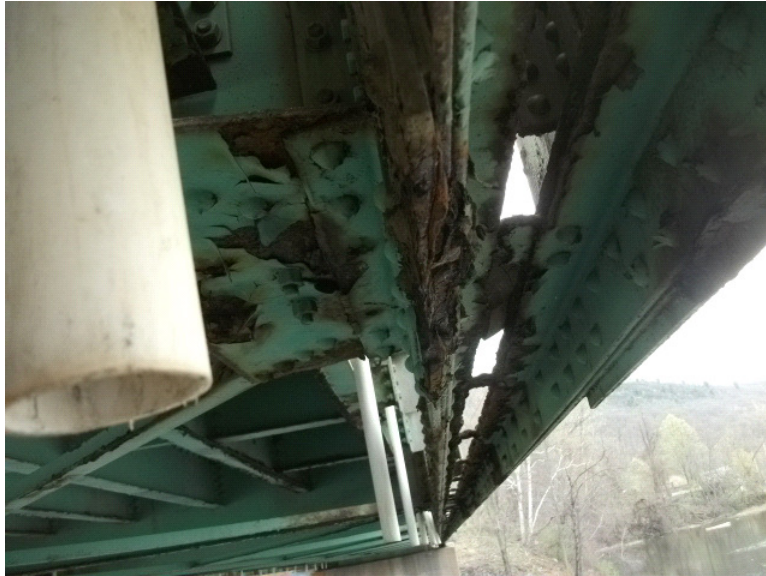
B460 54

SECTION LOSS AT BOTTOM
OF GUSSET PLATE AT
FLOORBEAM #4, AT SOUTH.

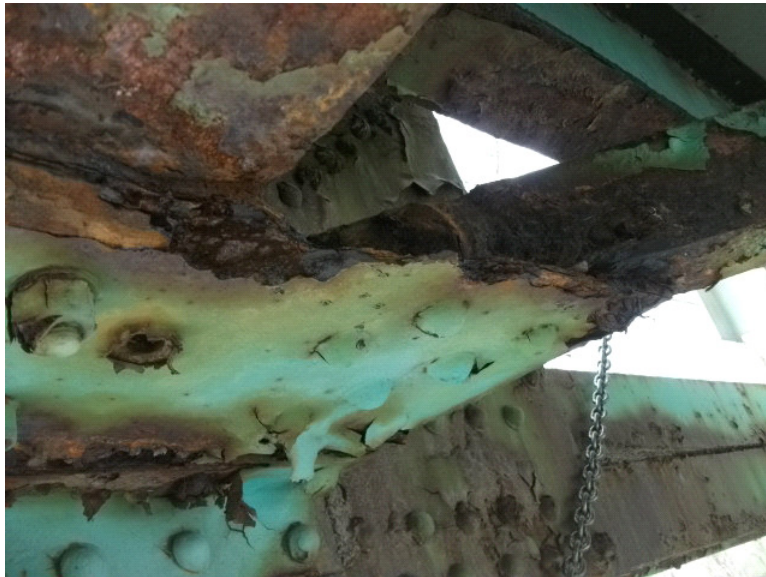
B460 55

CONNECTION PLATE KNIFE-
EDGED AT FLOORBEAM #3.

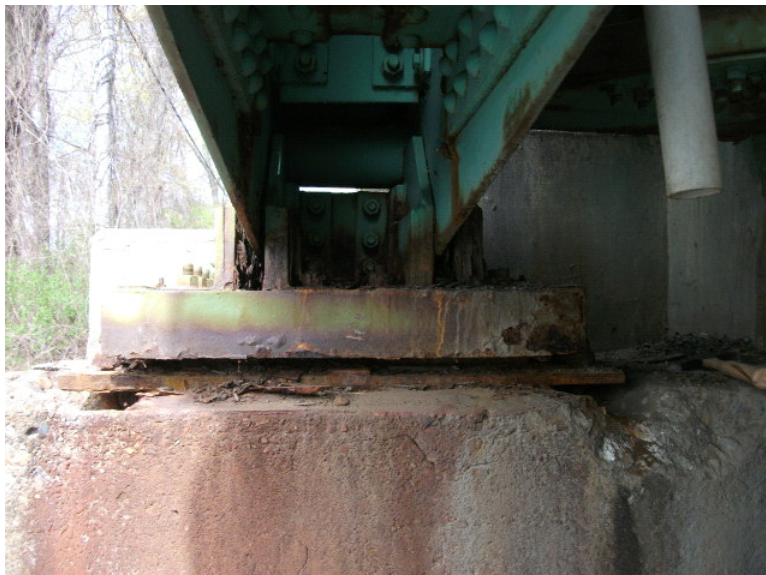
B460 56

PIER # 1 SPALLED AT
SOUTHWEST, UNDER
BEARING #1.

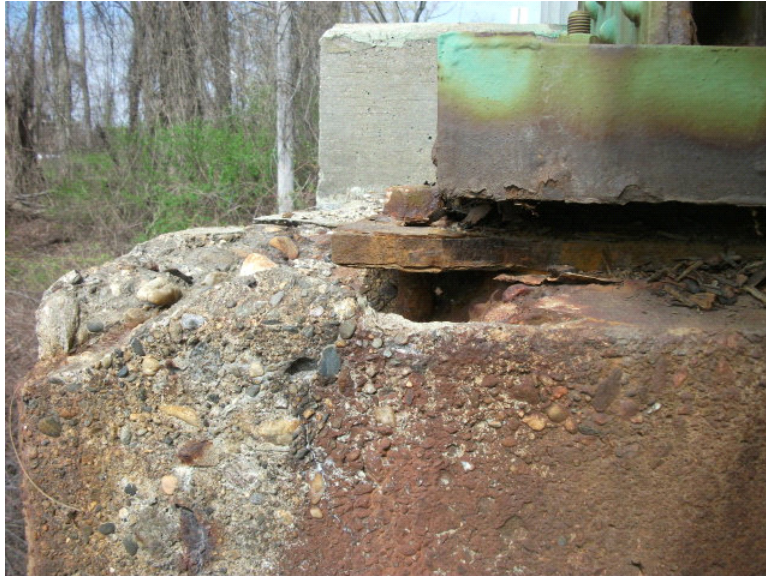
B460 57

BEARING BOLT EXPOSED,
PIER #1, BEARING #1, AT
EXTERIOR.

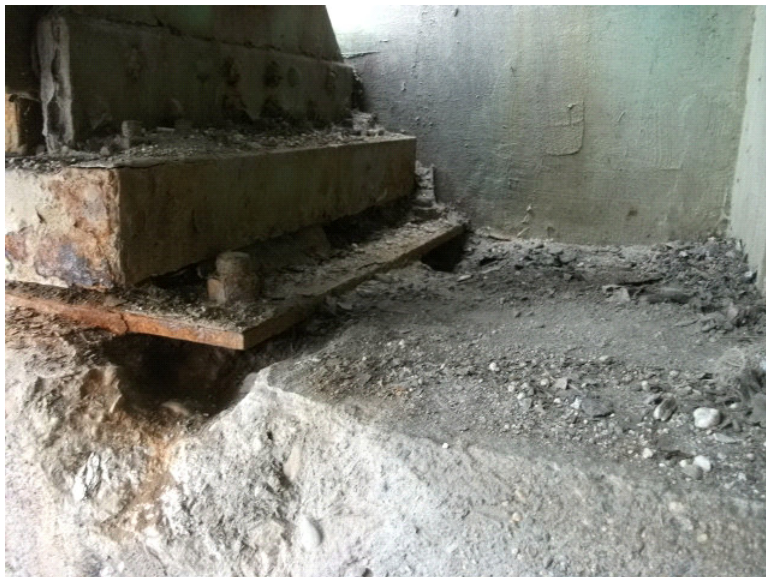
B460 58

BEARING BOLT EXPOSED,
PIER #1, BEARING #1, AT
INTERIOR.

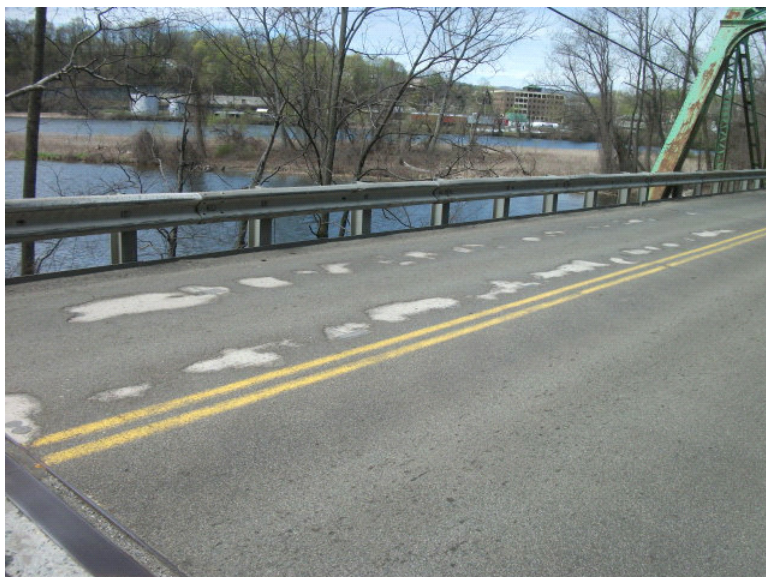
B460 59

WEARING SURFACE
POTHOLED AT SOUTHEAST.

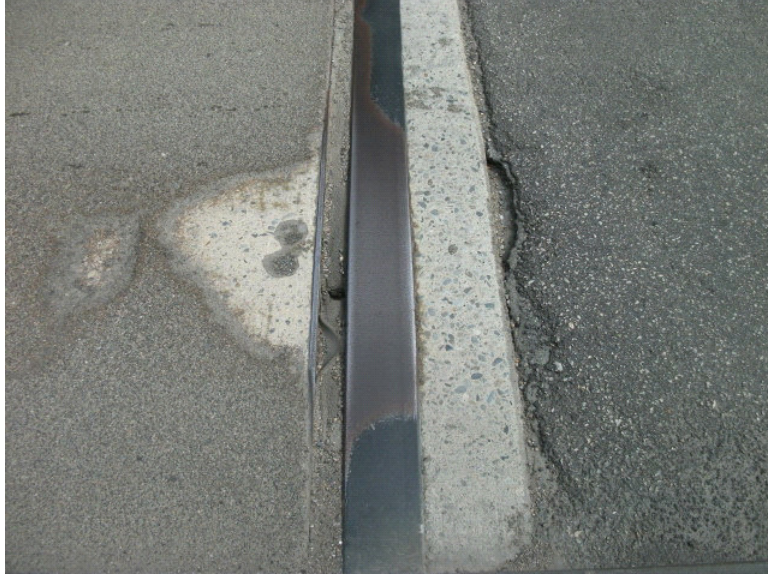
B460 60

SEAL HOLED AT SOUTH OF
JOINT # 4.

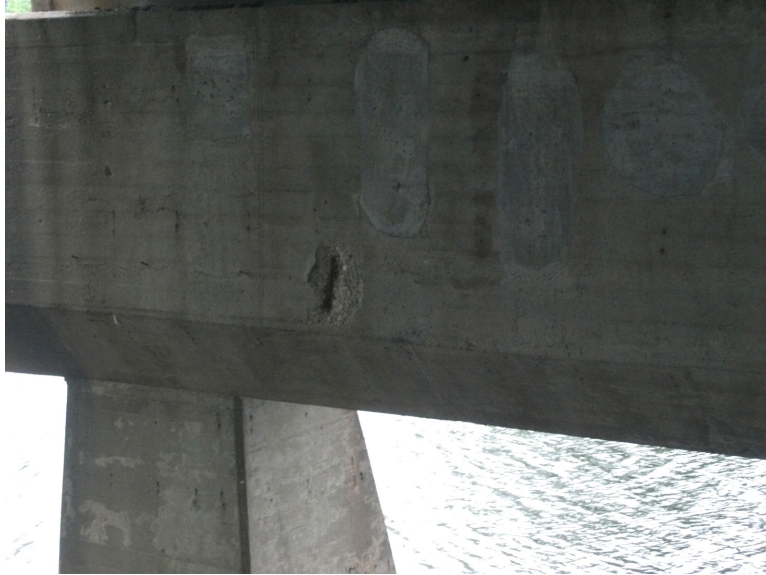
B434 40

SPALL AT EAST OF PIER #2.

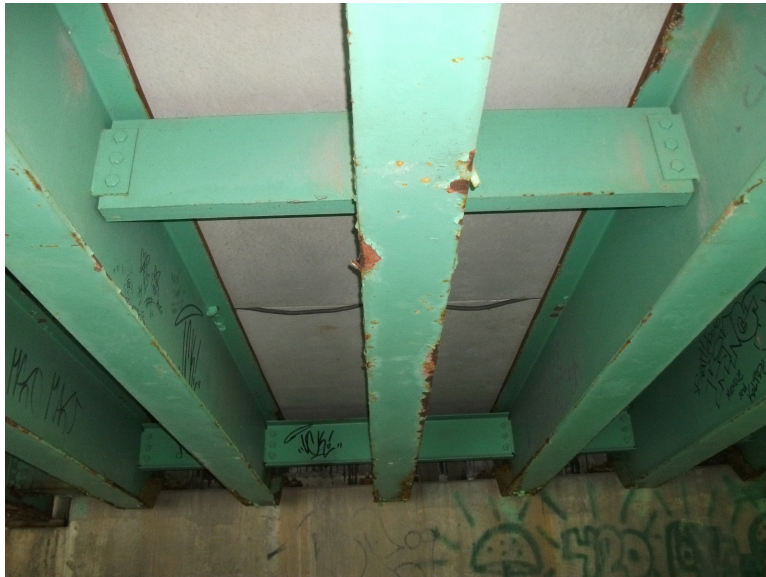
B434 41

GASKET PROTRUDING
SPAN #3, TYPICAL OF A
FEW.

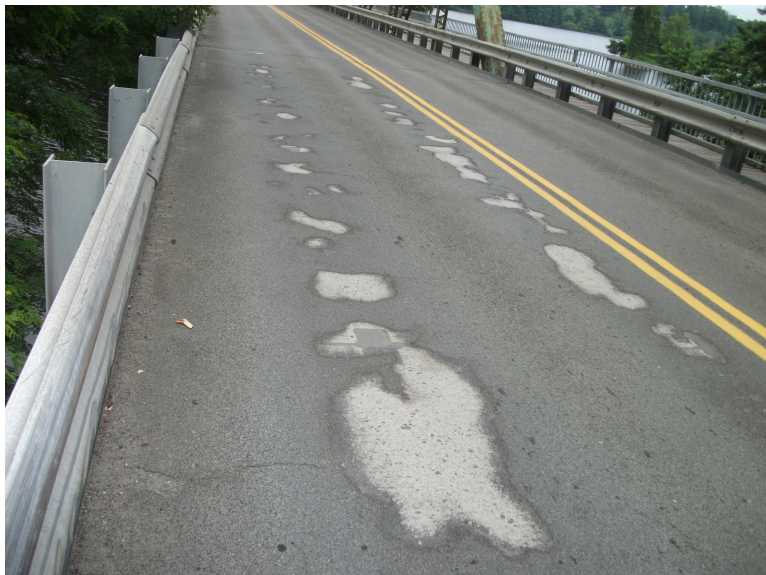
B434 42

HEAVY WEAR OF ASPHALT
AT EAST.

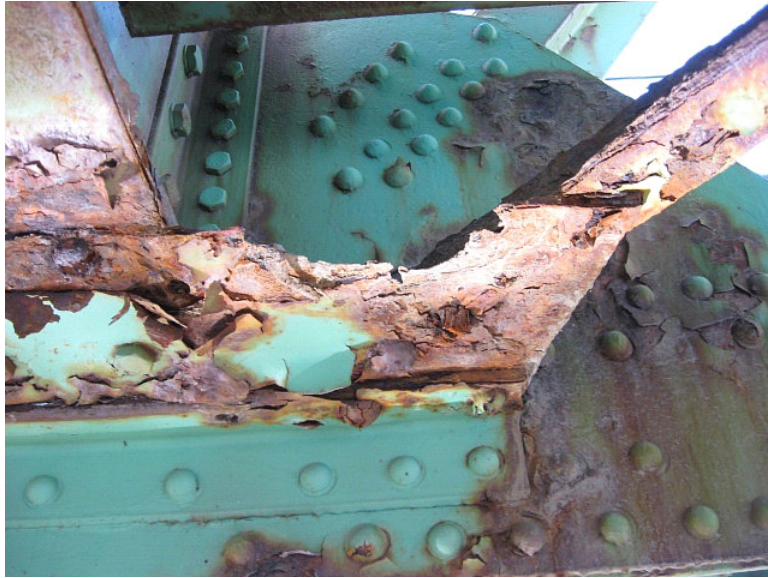
B332 42

LATERAL BRACING
CONNECTION PLATE
HOLED IN SPAN 2 (TYPICAL
OF SEVERAL)

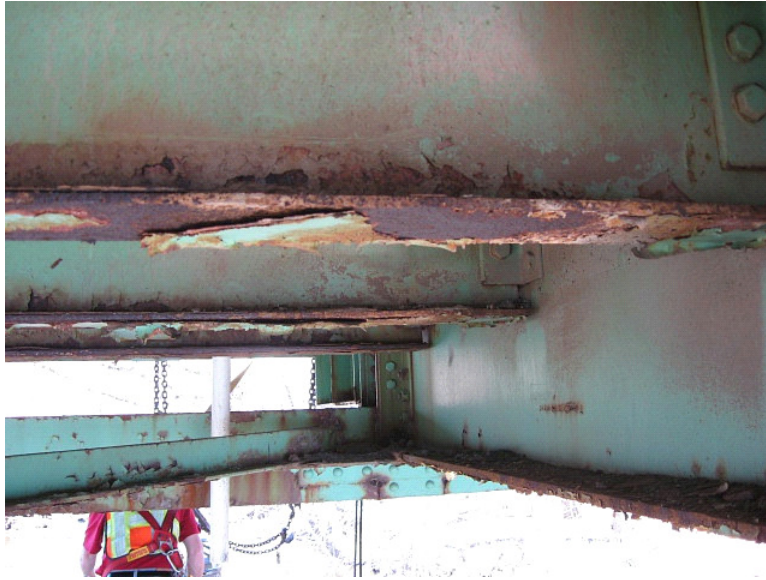
B332 38

TYPICAL RUST AND SCALE
ON STRINGERS.

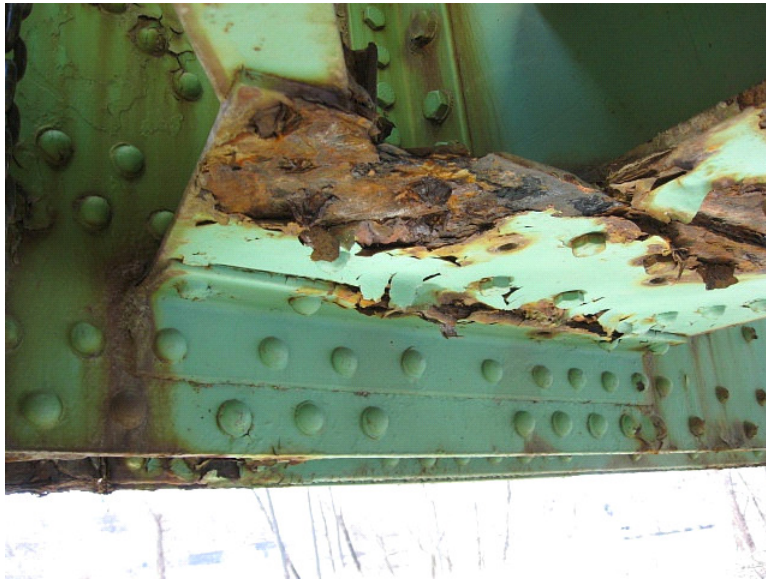
B332 39

LATERAL BRACING
CONNECTION PLATE
HOLED IN SPAN 2 (TYPICAL
OF SEVERAL)

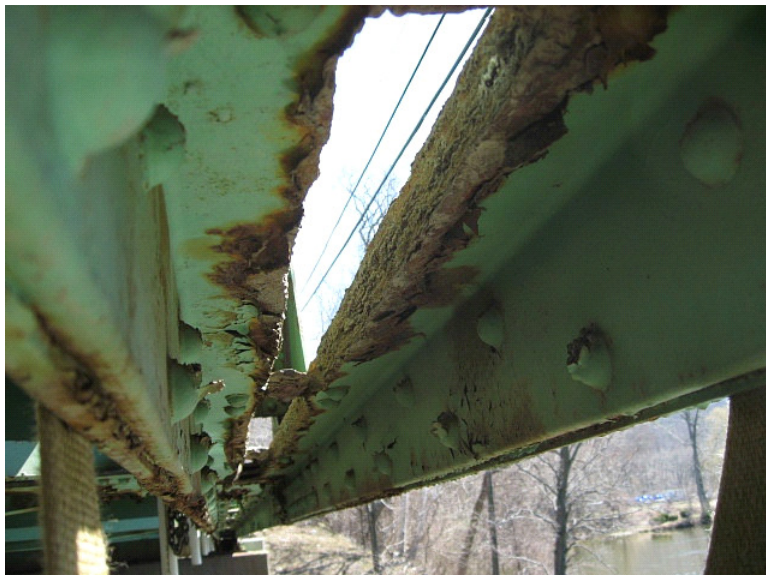
B332 40

HEAVY PACK RUST WITH
LIGHT SECTION LOSS ON
LOWER CHORD ON
DOWNSTREAM SIDE. (TYPICAL
OF BOTH.

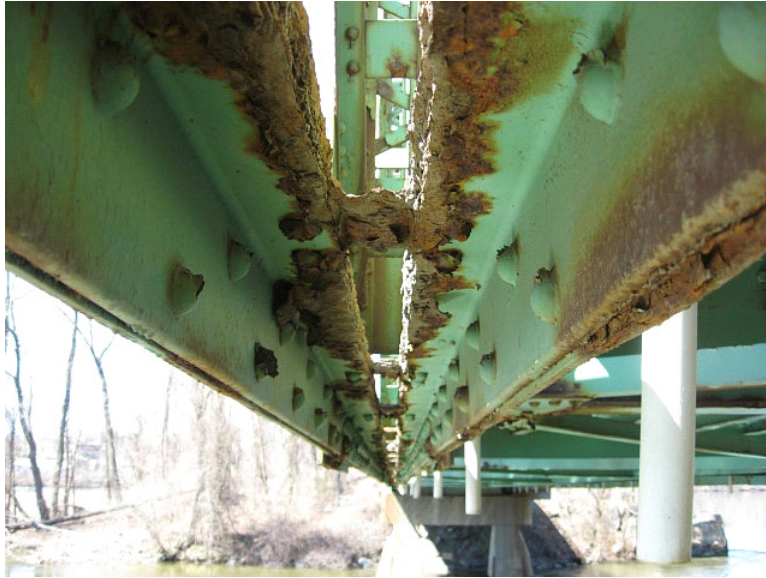
B332 41

BATTEN PLATES RUSTING
AWAY ON LOWER CHORD
DOWNSTREAM. (TYPICAL
OF UPSTREAM.)

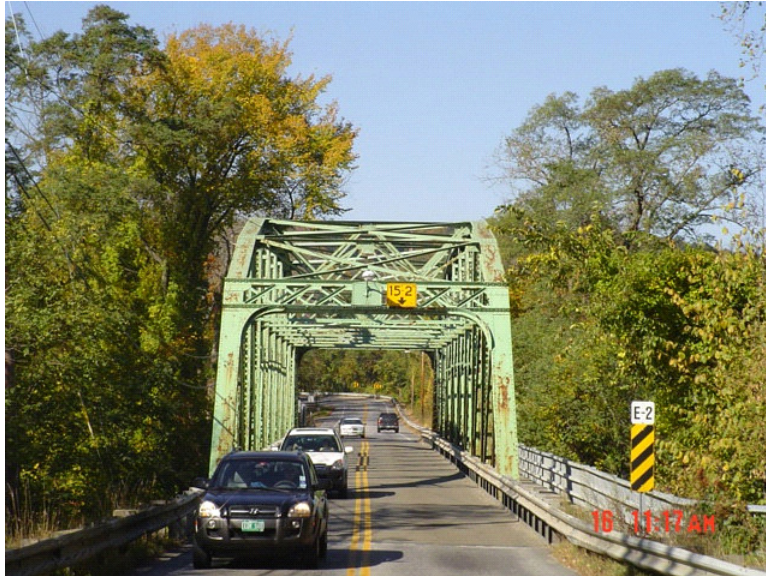
B293 06

EAST APPROACH (HEIGHT
SIGN MISSING AT NE

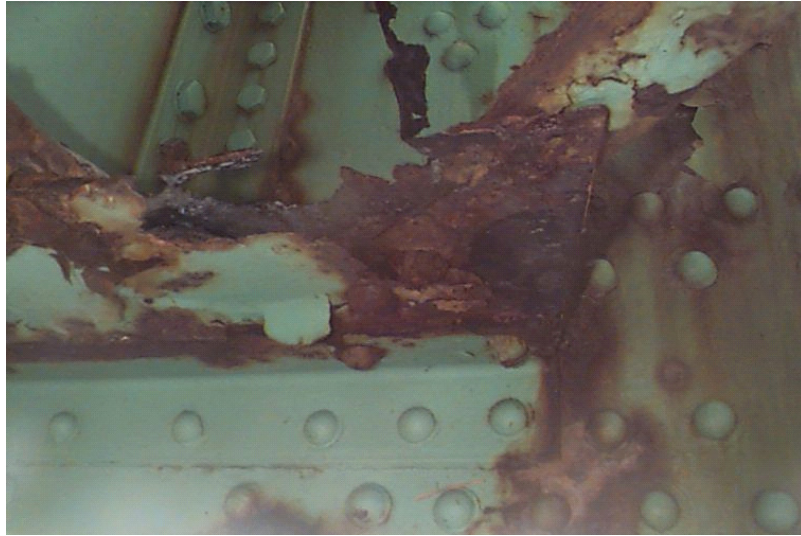
B228 05

CONNECTION PLATE AT
SOUTH BOTTOM CHORD
HOLED (TYPICAL OF FEW)

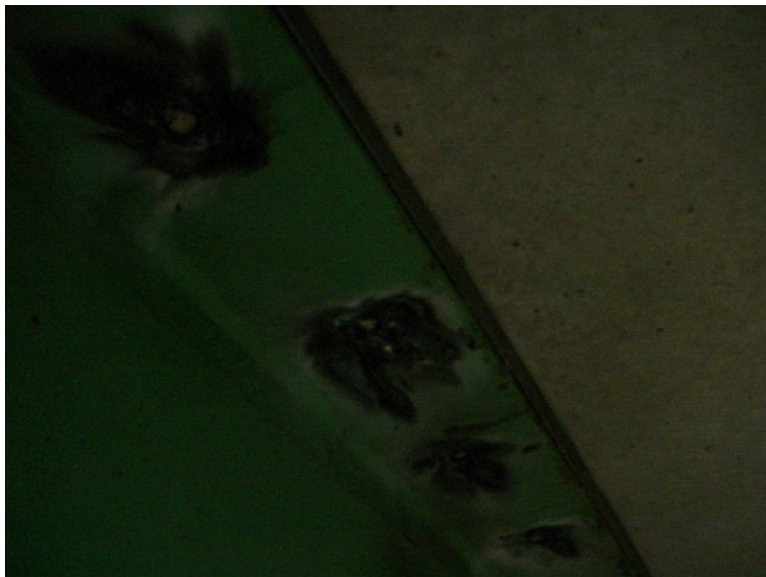
B193 17

TYPICAL VIEW OF DRILL
HOLES IN TOP FLANGES,
SEVERAL WITH FLAME
CUTS.

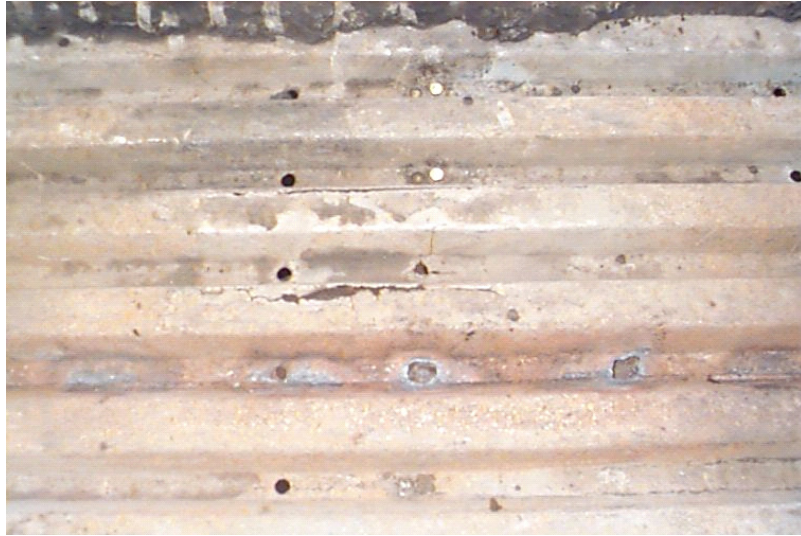
B141 07

GALVANIZED BRIDGE
DECKING VERY THIN W/
HOLES NEAR BOLTED
ATTACHMENTS

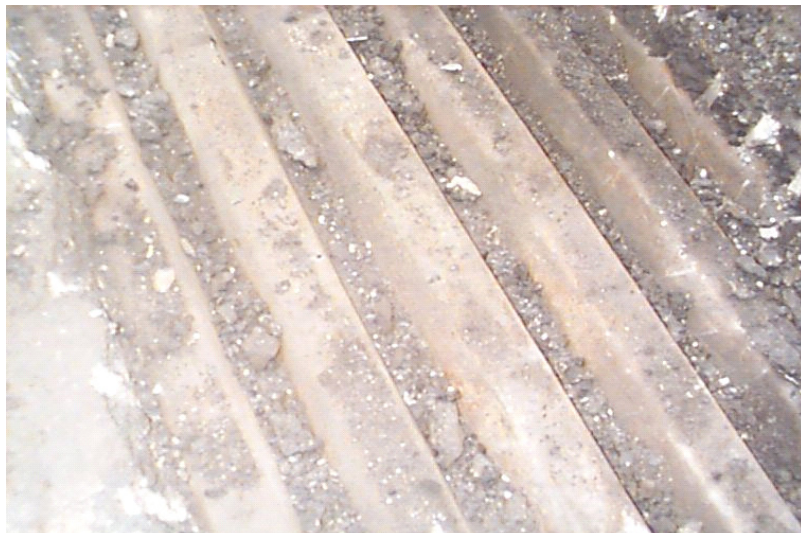
B141 09

BRIDGE PLANK THIN AND
HOLED IN WHEEL PATH
BETWEEN STRINGERS AND
BOLTED ATTACHMENTS.

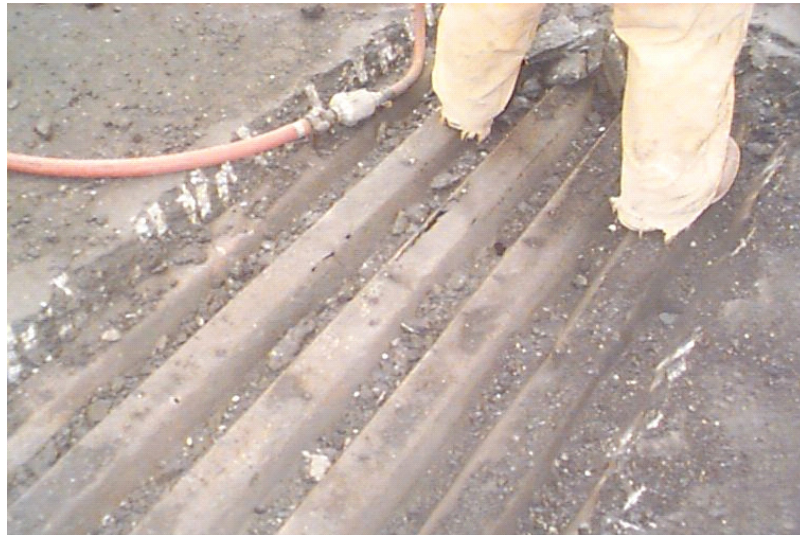
B141 11

HOLES IN BRIDGE PLANK AT WEST REPAIR NEAR BOLTED ATTACHMENTS.

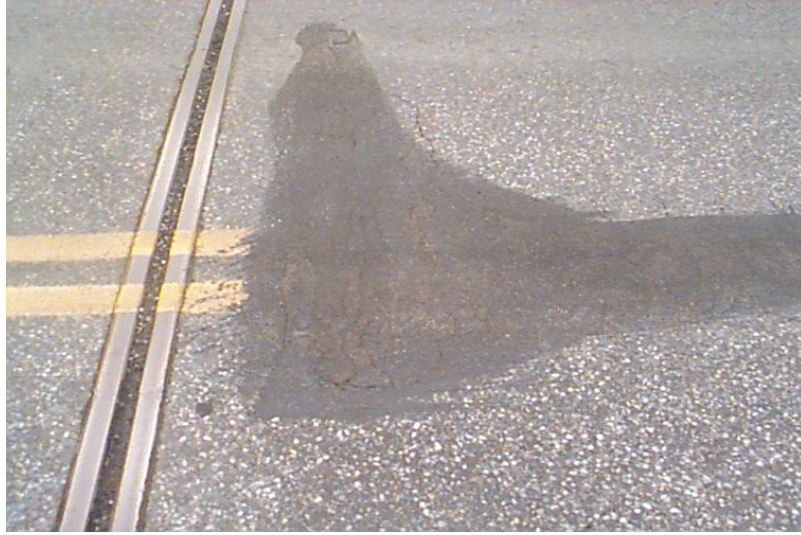
B138 39

REPAIRED AREA CRACKED
AND MOVING UNDER LOAD
AT EAST.

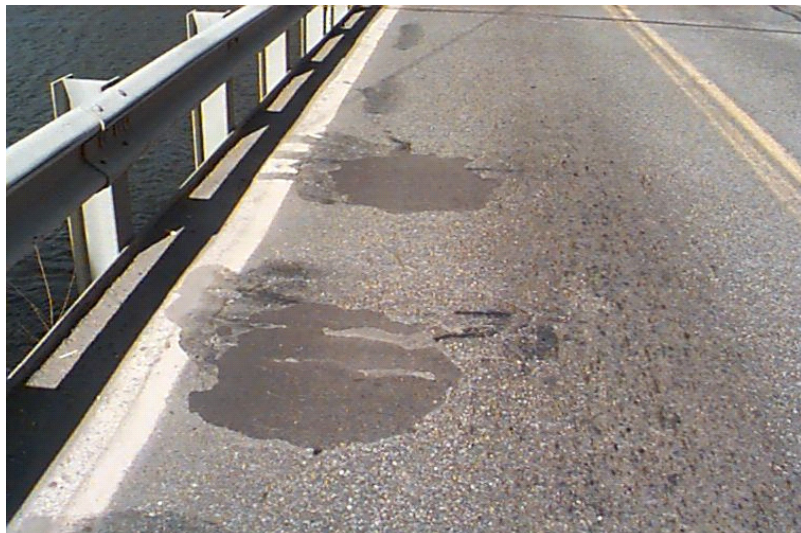
B032 03

DEPRESSED AND PATCHED
AREA IN WEARING
SURFACE AT SOUTHEAST
WITH BRIDGE PLANK
LOOSE UNDERNEATH.

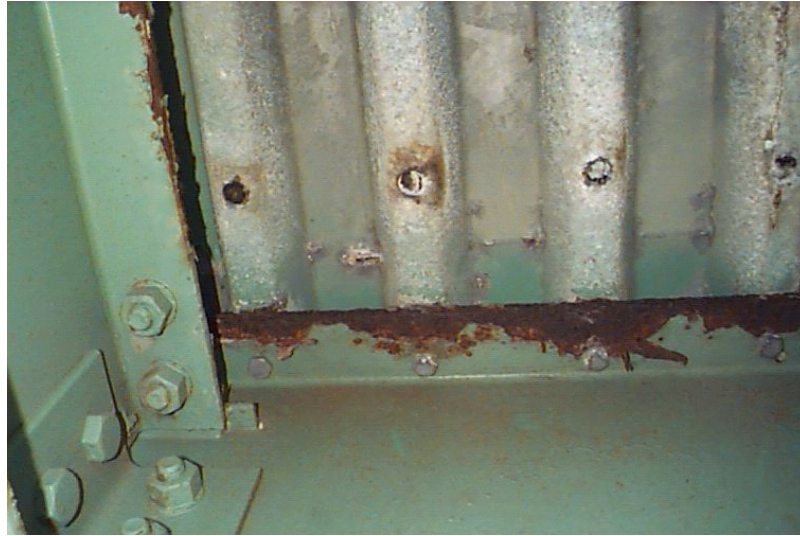
B032 04

SCARIFIED HOLE THROUGH
BRIDGE PLANK IN SPAN #2,
BAY #2 FROM EAST.

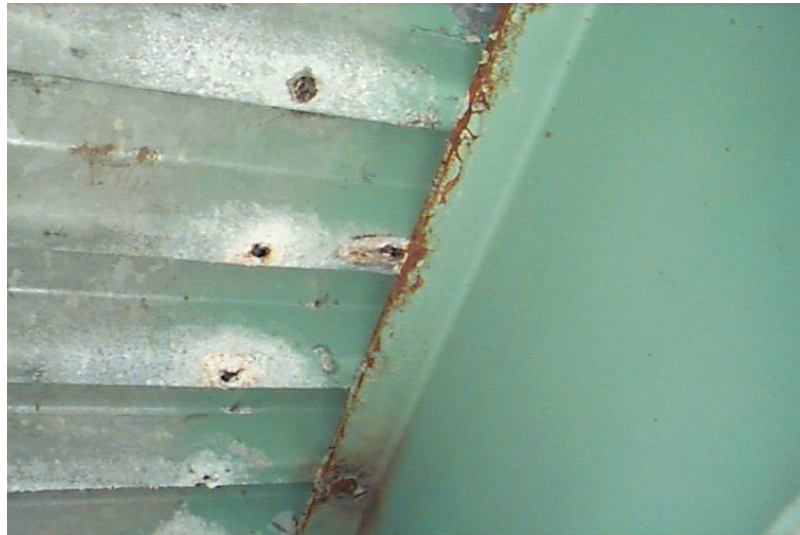
B032 05

SCARIFIED HOLE THROUGH
BRIDGE PLANK IN SPAN #2,
BAY #2 FROM EAST.

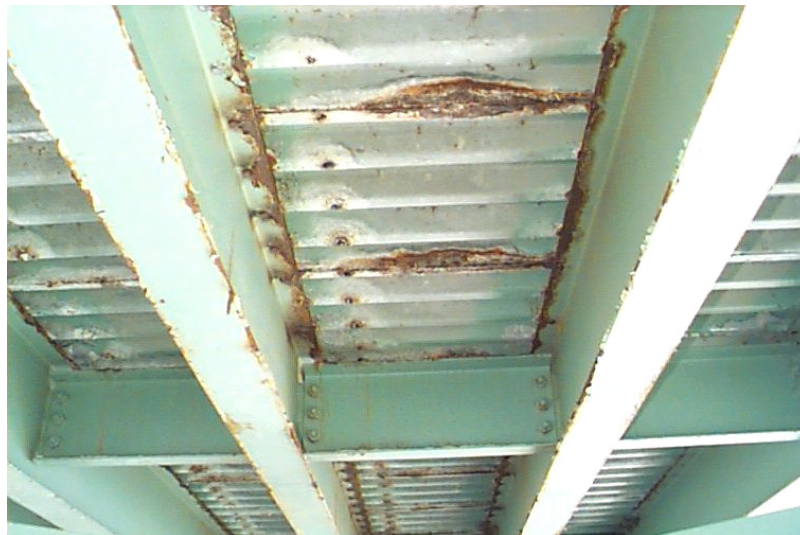
B032 06

BRIDGE PLANK LEAKING IN
SPAN #2, BAY #2 FROM
EAST.
