A588 WEATHERING STEEL GUARDRAIL

ROUTINE MAINTENANCE TURNS UP PROBLEMS

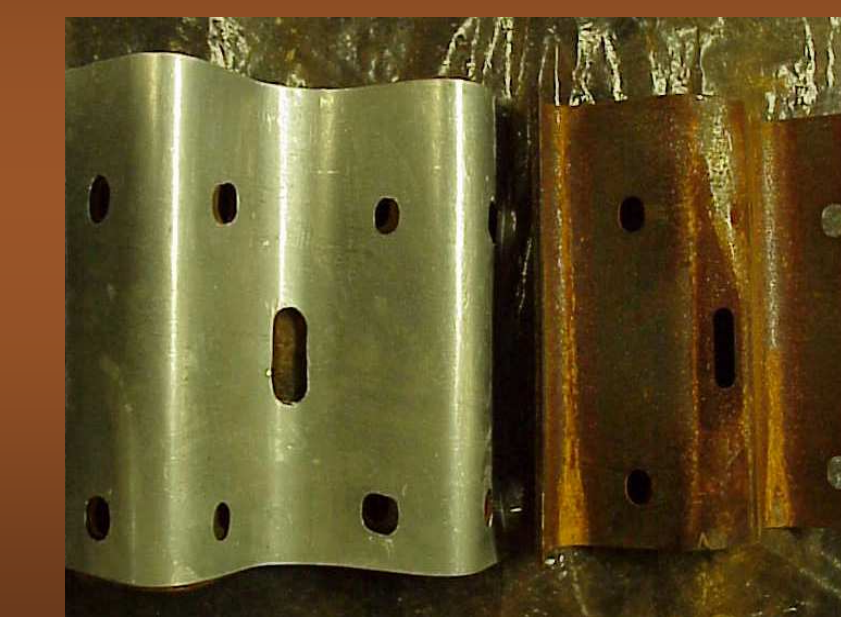
Zinc Insert — Pre Salt Fog
Zinc insert on left

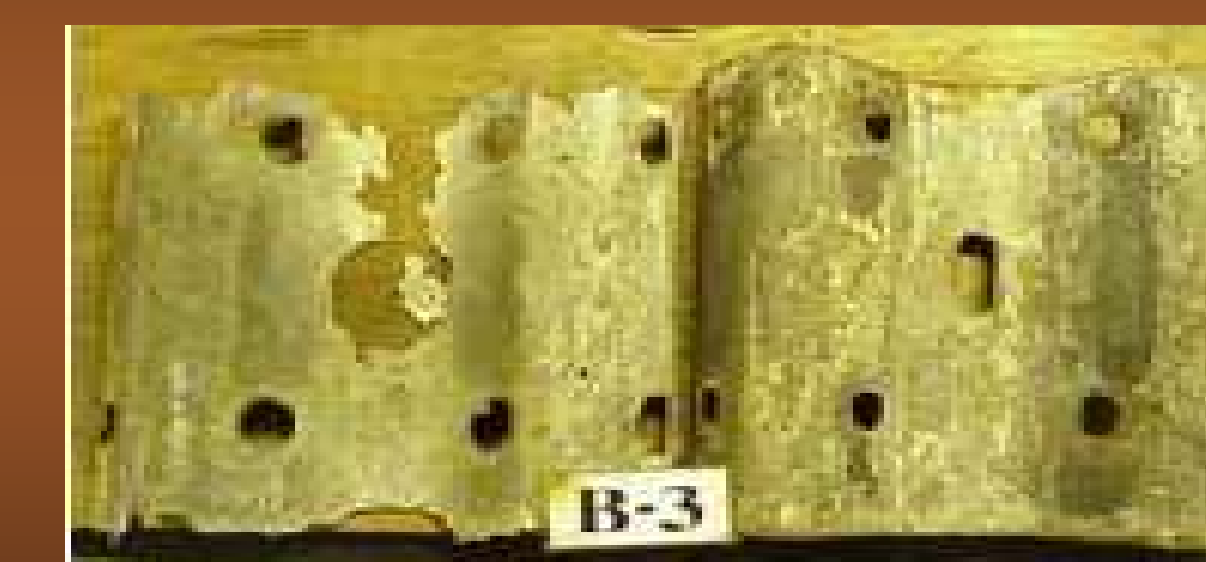
Zinc Insert — Post Salt Fog
Sacrificed zinc insert on left—little damage to rail
(Insides shown)

Zinc inserts showed the least corrosion after salt fog exposure. Preliminary estimates indicate that inserts increase guardrail construction costs by approximately 20%.

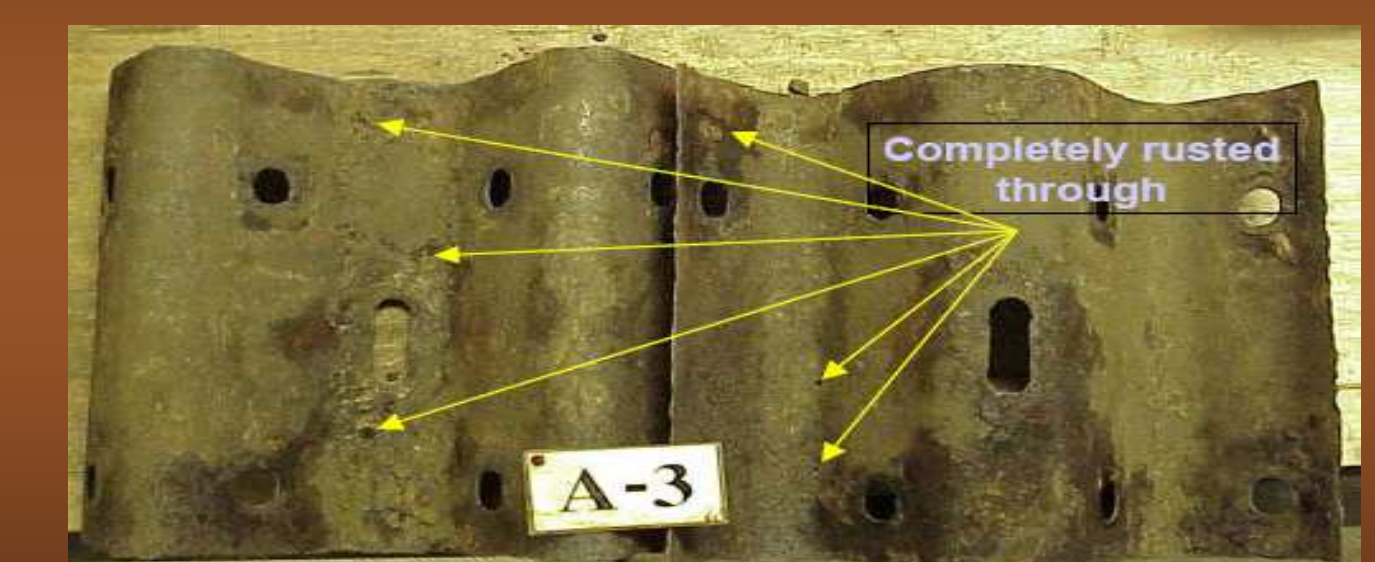
Control Sample — Post Salt Fog
Heavily rusted with thin, sharp edges
