ALTERNATE PAINT SYSTEMS FOR OVERCOATING

**SPR-PL-PR-1(31)
PROJECT 12323 D
(Formerly Project 94-10, X2727)**

Research Project Conducted by
Gary L. Tinklenberg
CORROSION CONTROL CONSULTANTS & LABS, INC.
KENTWOOD, MICHIGAN

October, 2000

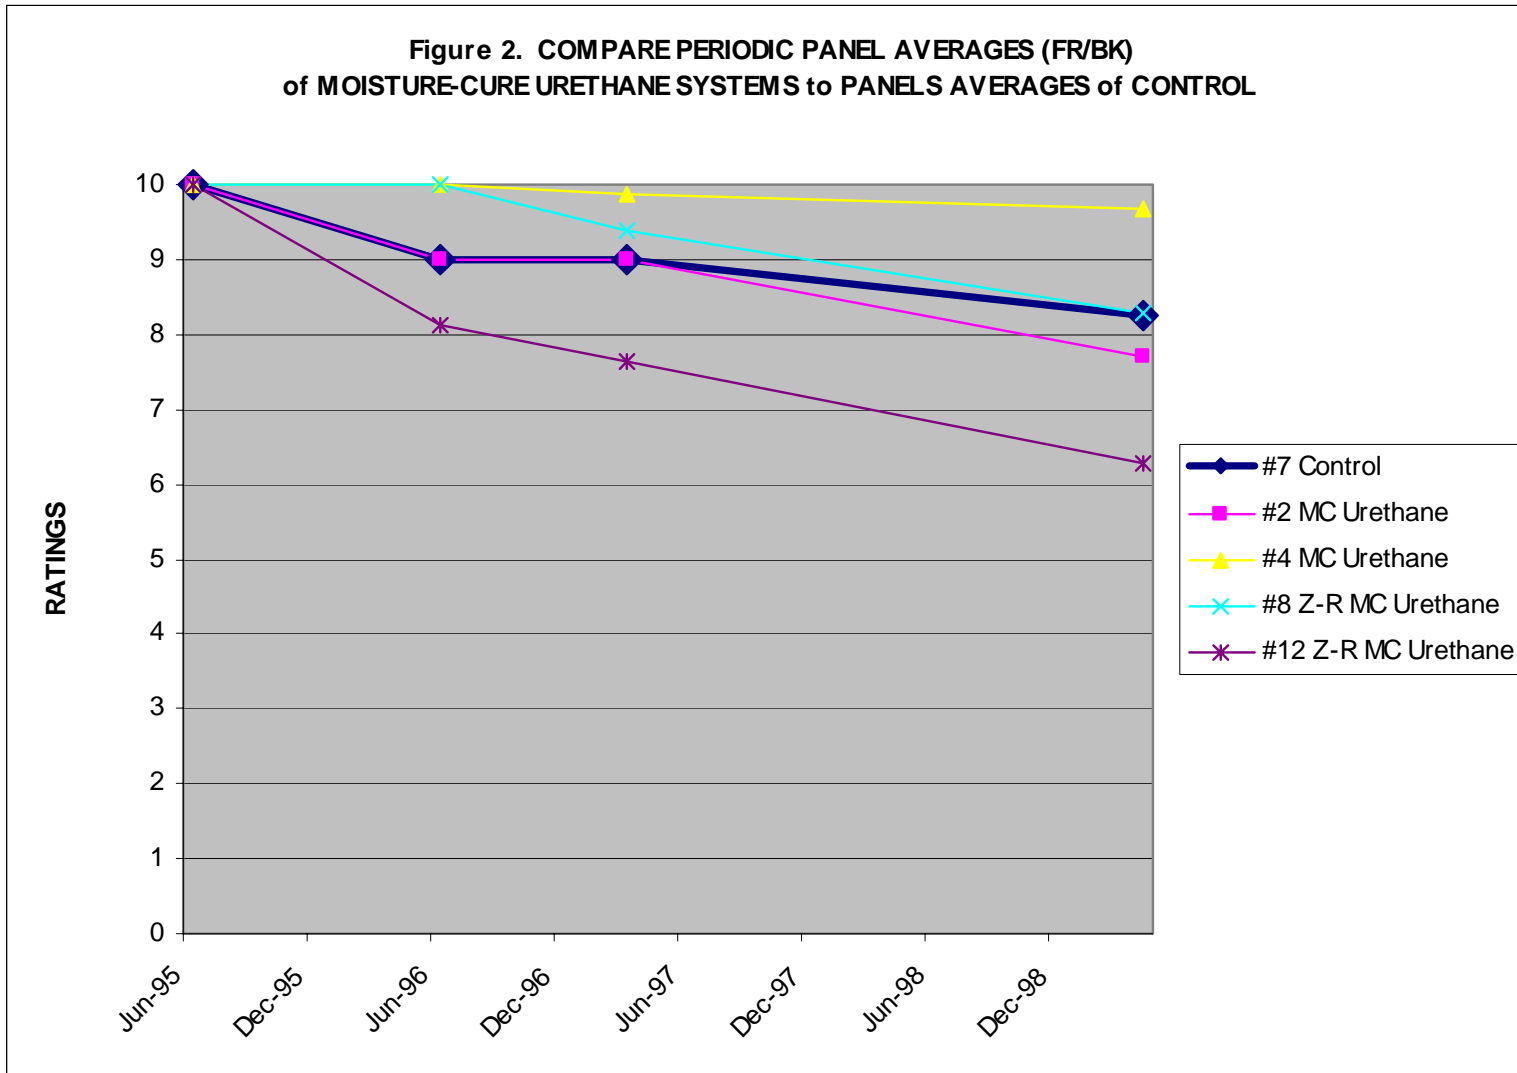
Figure 2. COMPARE PERIODIC PANEL AVERAGES (FR/BK)
of MOISTURE-CURE URETHANE SYSTEMS to PANELS AVERAGES of CONTROL

In general the three-coat urethane systems did very well. The two-coat systems rated somewhat lower, mostly as a result of their poorer performance in the previously rusted areas. A thicker film build over rust did enhance performance. Figure 2 is a comparison of the various urethane systems to the control. It should be noted that in this comparison graph and all others, the worst test panel from each set of eight (four locations, front and back) was deleted and the remaining seven panels averaged. In almost every case, the worst panel rating was the result of a delamination of the original primer. We believe that a system should not be down-graded based on one unusual data point caused by a loosely adherent existing coating. If however, there were numerous panels that had a delamination problem, it is more likely that the paint system had an effect on the adhesion of the original system. If there was no panel that delaminated, all eight values were used in the average rating.

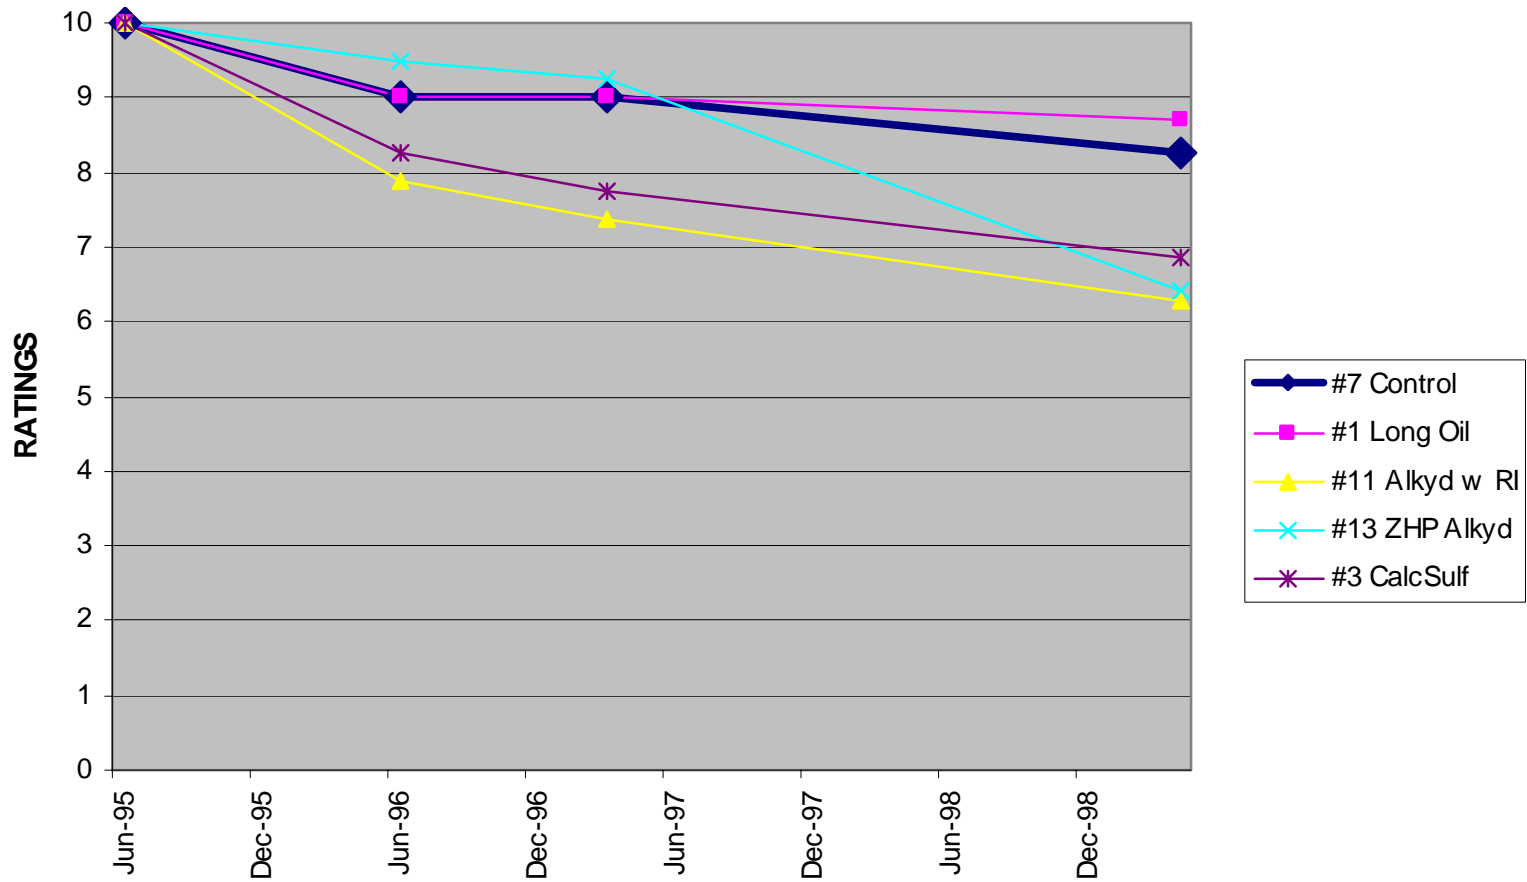
**Figure 3. COMPARE PERIODIC PANEL AVERAGES (FR/BK)
of ALKYDS & CALCIUM SULFONATE to PANEL AVERAGES of CONTROL**

In the four years of the evaluation period, one of the three alkyds - a very slow-drying long oil variety - performed equal to the Control; the other two were not as good as the Control. This is clearly demonstrated in Figure 3. The only concern was System 13 - The New Hampshire Zinc-Hydroxy Phosphite System. This system appears to be deteriorating at a significant rate between the third and fourth rating. The slope of this line is not encouraging.

yard with no traffic below the beams, it can only be assumed that on a "real world" bridge, the dirt accumulation problem would be further exacerbated. For these reasons it is clear that the calcium sulfonate system as tested cannot be recommended for use. If the system had utilized a topcoat that does not have such an affinity for dirt collection, it is probable that the results would be much different. (See Figure 3-included in chart with alkyds.)

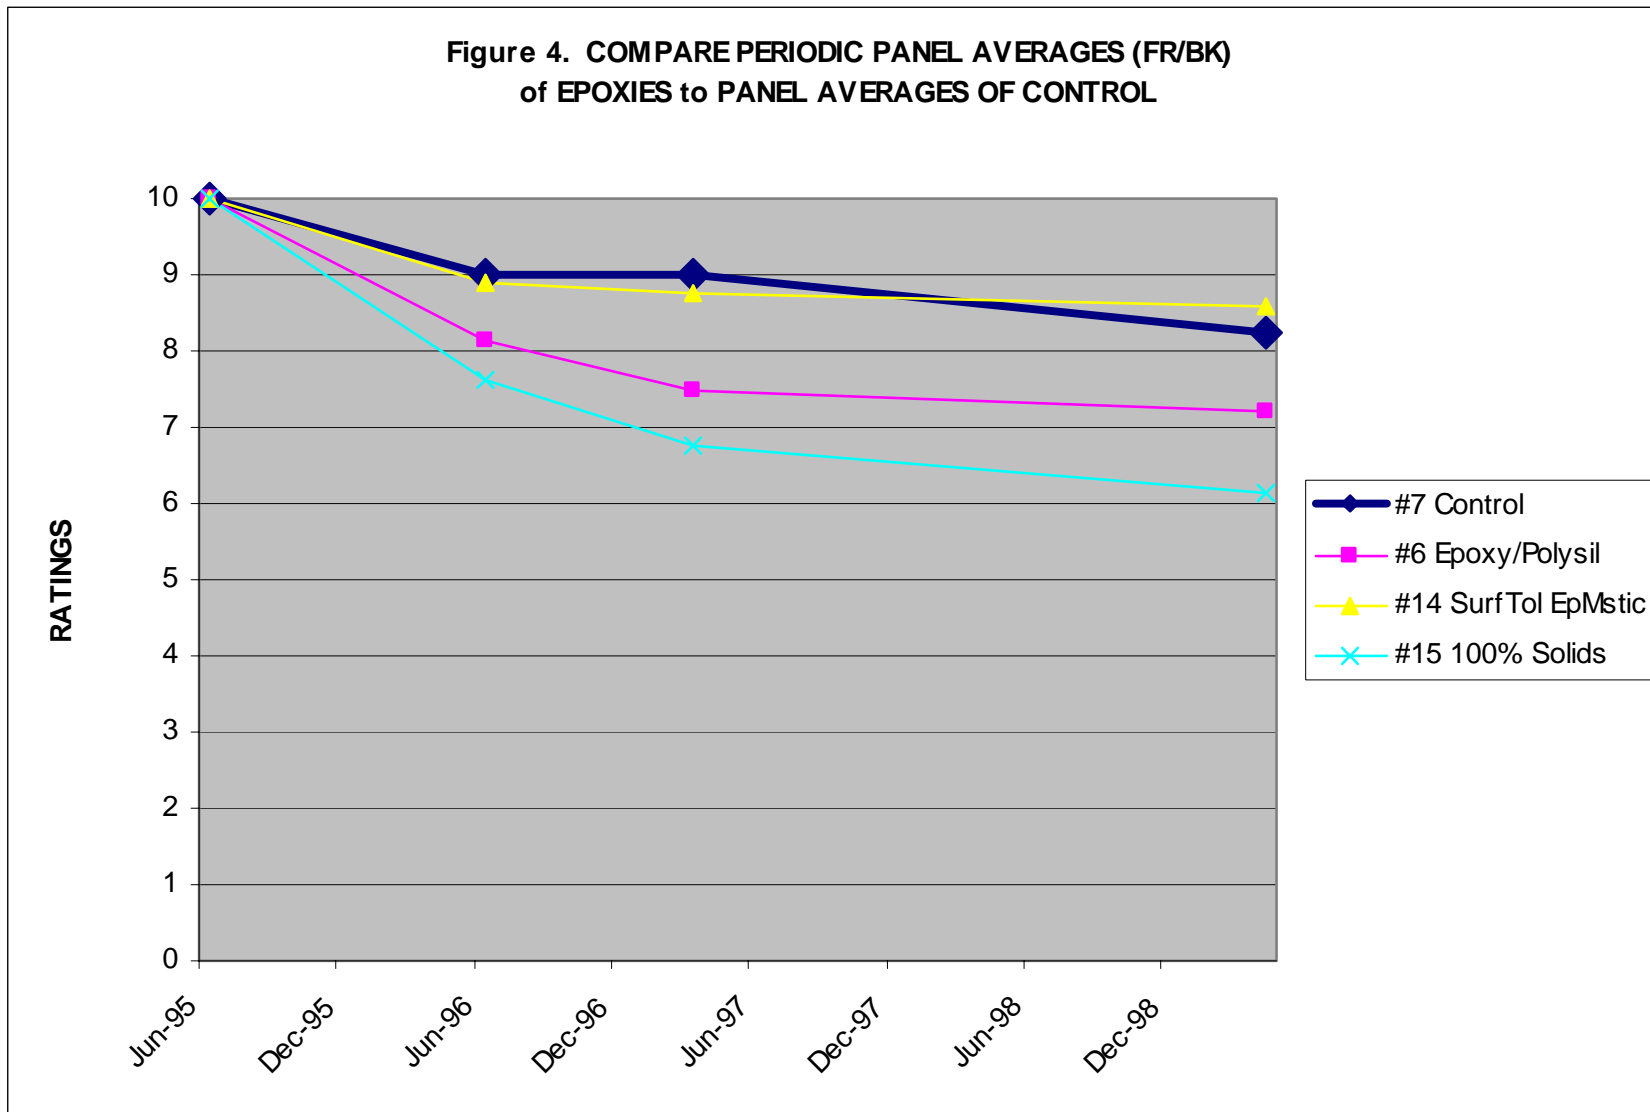
The epoxies, where they did not delaminate, generally looked very good, but it was clear, based on the scribed areas, that epoxies placed the most stress on the existing paint. System 14 utilized a "flexible" resin in the primer and was noticeably better (and equal to the Control) than the other epoxy systems tested. The performance of the 100% epoxy system was disappointing in that these systems are touted for their performance over existing coatings; yet in four years it was one of the worst of the solvent-borne systems. (Figure 4.)

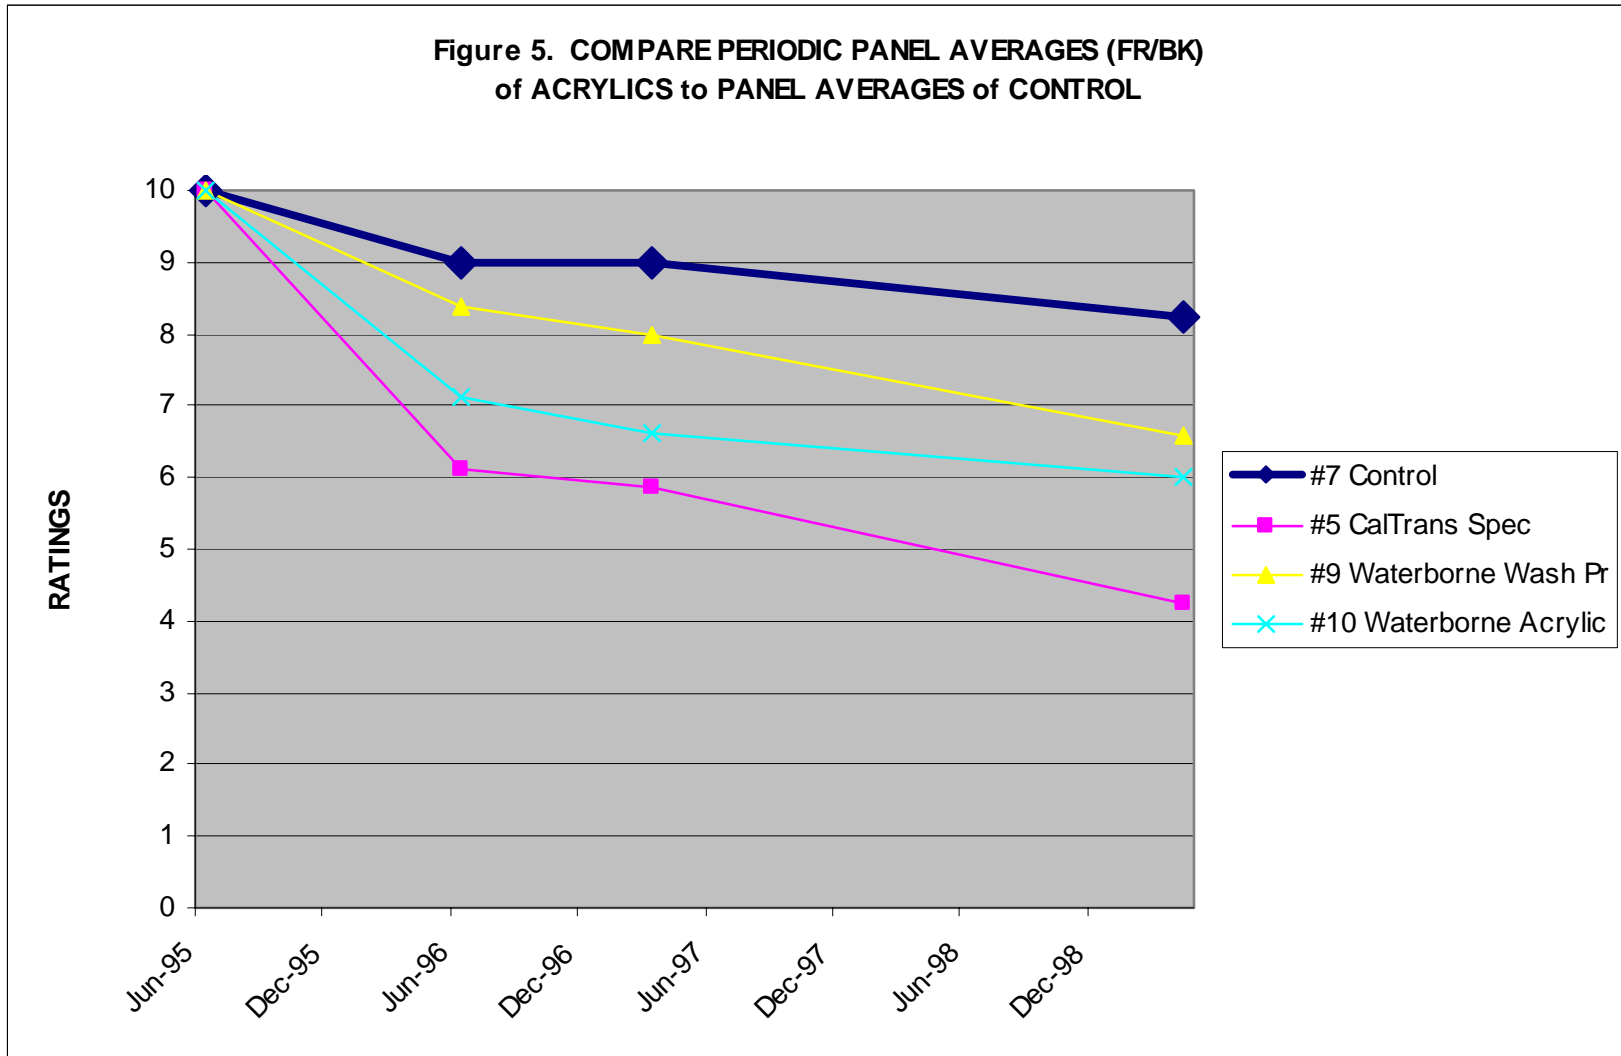
The acrylics were the biggest disappointment in the study. See Figure 5. If they could have been utilized only over sound, existing coating, they would have performed quite well. However, once the previously rusted areas were considered, the group as a whole performed the worst of all coatings. Simply put, there was not enough resistance to flash rusting and/or contamination below the coating for acrylics to perform well in the test. Since it is our belief that on any re-coating project, there are bound to be some areas of rust, and these areas must be protected, we cannot recommend acrylics at this time. If a system were found which utilizes a solvent-borne spot primer for rusted areas, it is probable that the performance of acrylic systems would be greatly enhanced. This would allow the obvious advantages of acrylics - water clean-up, one component materials, easy application - to be fully utilized.
