Barron Mountain
Rock Reinforcement Evaluation – Phase I
I-93, Woodstock, New Hampshire

| 4. Title and Subtitle PHASE I: CONDITION ASSESSMENT AND EVALUATION OF ROCK REINFORCEMENT ALONG I-93, BARRON MOUNTAIN ROCK CUT, WOODSTOCK, NEW HAMPSHIRE | | 5. Report Date February 18, 2004 | |
| 7. Author(s) Kenneth L. Fishman, Ph.D., P.E. | | 8. Performing Organization Report No. | |

Project No. 03-024

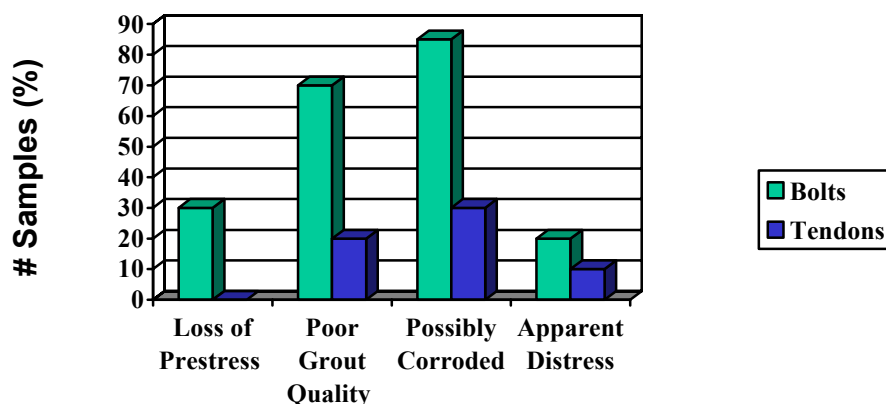
Summary of Condition Assessment at Barron Mountain

rock bolts and tendons are summarized in the bar chart shown below. In general, results indicate that tendon reinforcements are in better condition relative to rock bolt reinforcements. Results from NDT indicate that 30% of the rock bolts may have suffered a loss of prestress, 85% have “possibly” experienced corrosion, and 18% have apparent distress in terms of possible loss of cross section from corrosion, or a bend or kink along the bar from deformation of the rockmass. Rock bolts and tendons that have apparently suffered corrosion, or are possibly distressed, are primarily located in a distinctly identifiable area of the site near Station 1775+25.

MMCE recommends that the results of NDT be verified by further, more invasive, testing on selected reinforcements; and that the NHDOT continue to monitor reinforcement condition at regular ten year intervals. Verification of results from NDT should be performed as a second phase to this project.

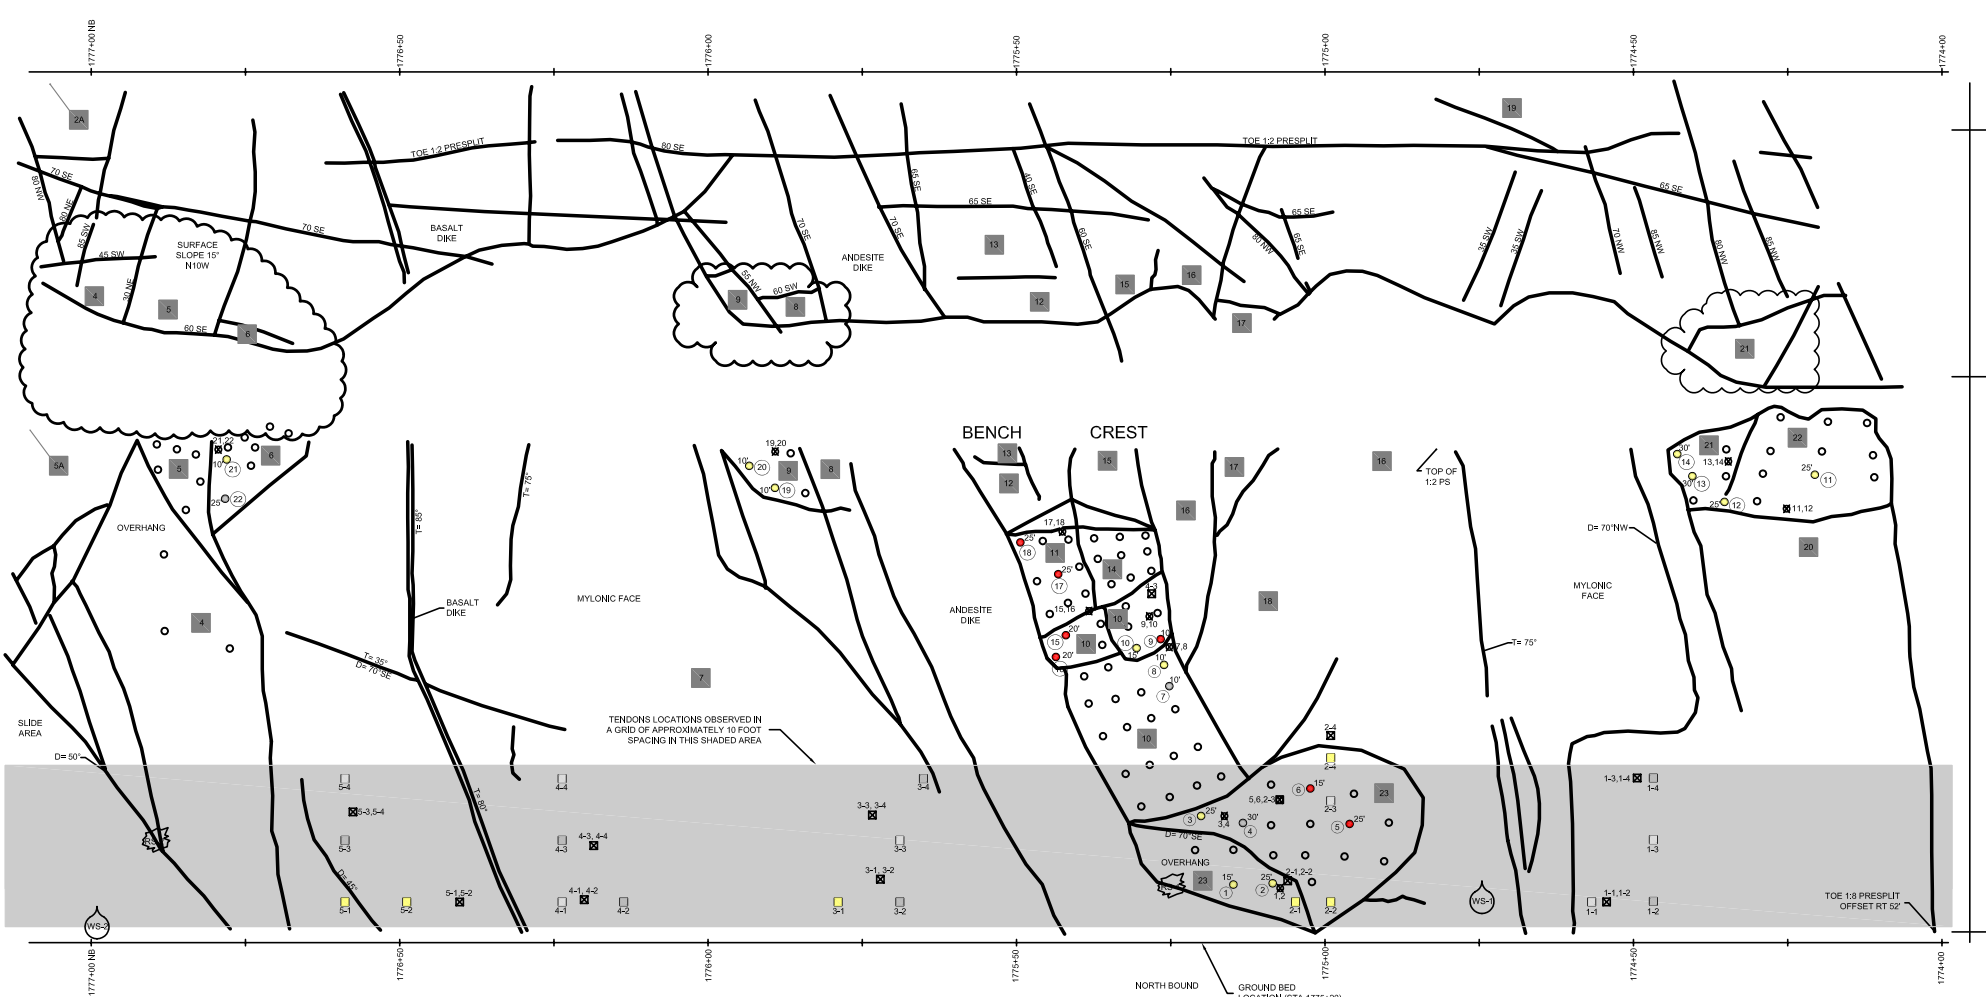
Figure 5 is a detailed elevation view of the site depicting structural features of the rockmass, and rock bolt and tendon locations. Figure 5 is based on the “Geologic Structure Map Woodstock P-7889-F” and field notes provided by NHDOT. Stationing established along the northbound lane of I-93 increases in a northerly direction. Figure 5 includes details between Station 1774+00 and 1777+00.

Dark lines in Figure 5 depict geologic features of the rock mass including rock joints, overhangs, and intrusions (dikes), as well as the slide area at the north end of the site and the rock bench constructed at approximate El. 820 ft. Based on field notes provided by NHDOT, the rock mass is divided into blocks, numbered from 4 to 23, and identified with large, filled, squares in Figure 5. These block numbers are useful to reference bolt locations and descriptions provided in the field notes. In general, blocks are mapped

Most of the rock bolts and tendons adjacent to the northbound lane are located between Stations 1774+00 and 1777+00. Rock bolt and tendon locations shown on Figure 5 are approximate. Rock bolts, identified as small circles in Figure 5, include all bolt locations observed by MMCE below the bench (El. 820 ft). Most of the rock bolts are located in the vicinity of Sta. 1775+25, near the southern contact with the andesite dike. Rock bolts included in the sampling population for condition assessment are identified as filled circles. These circles are color coded based on the results of NDT. Symbols filled with "x" are used to identify half-cell placement for electrochemical tests.

Tendons are located in an approximately 10 ft. by 10 ft. grid pattern, along three rows, within the shaded area between Stations 1774+00 and 1777+00. Tendons included in the sample population for condition assessment are identified with small squares, which are also color coded.

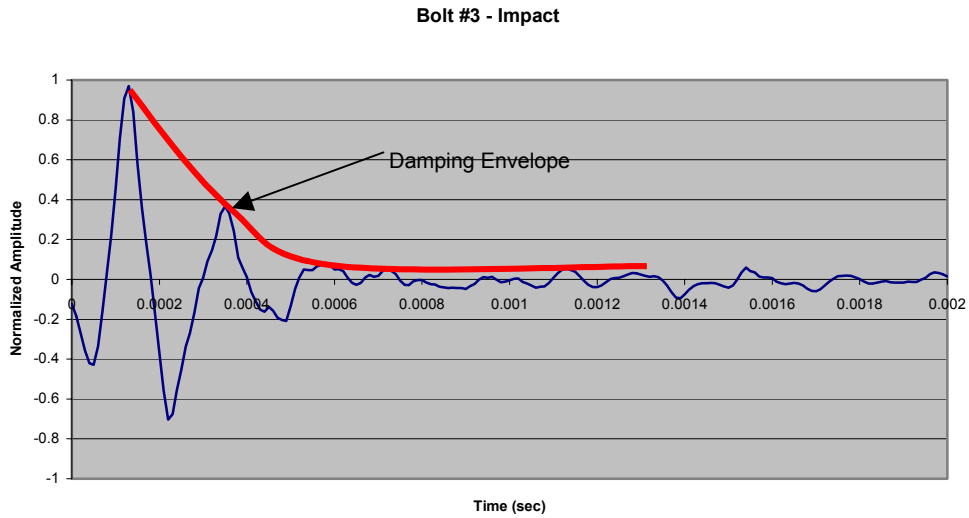
a) High rate of decay indicative of relatively high bolt load.

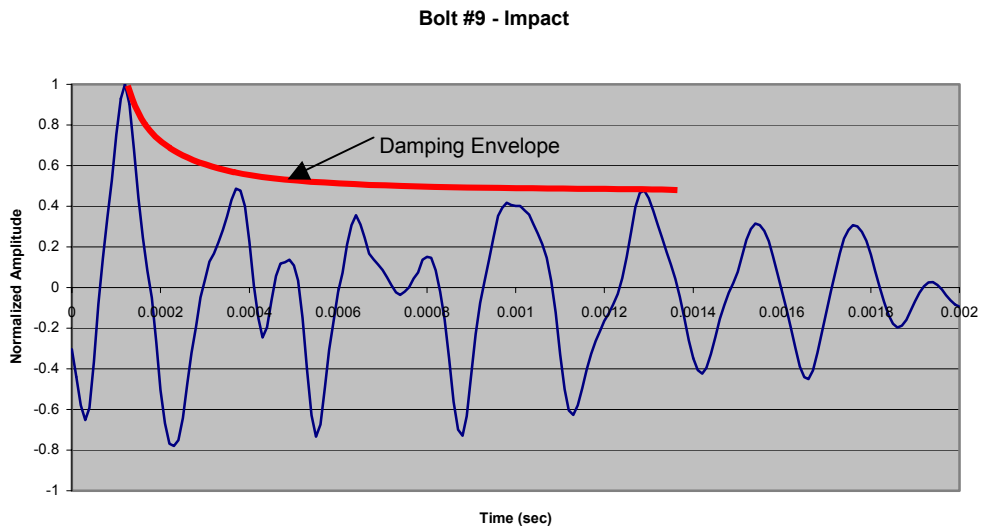
b) Low rate of decay indicative of prestress loss.

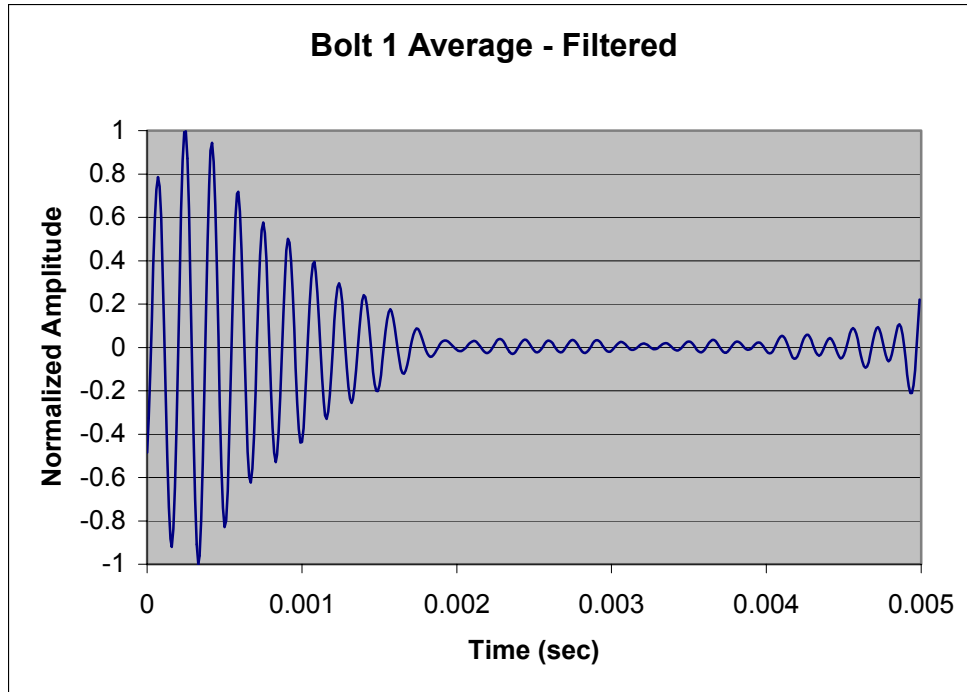
a Strong signal attenuation indicative of relatively “good” quality grout.

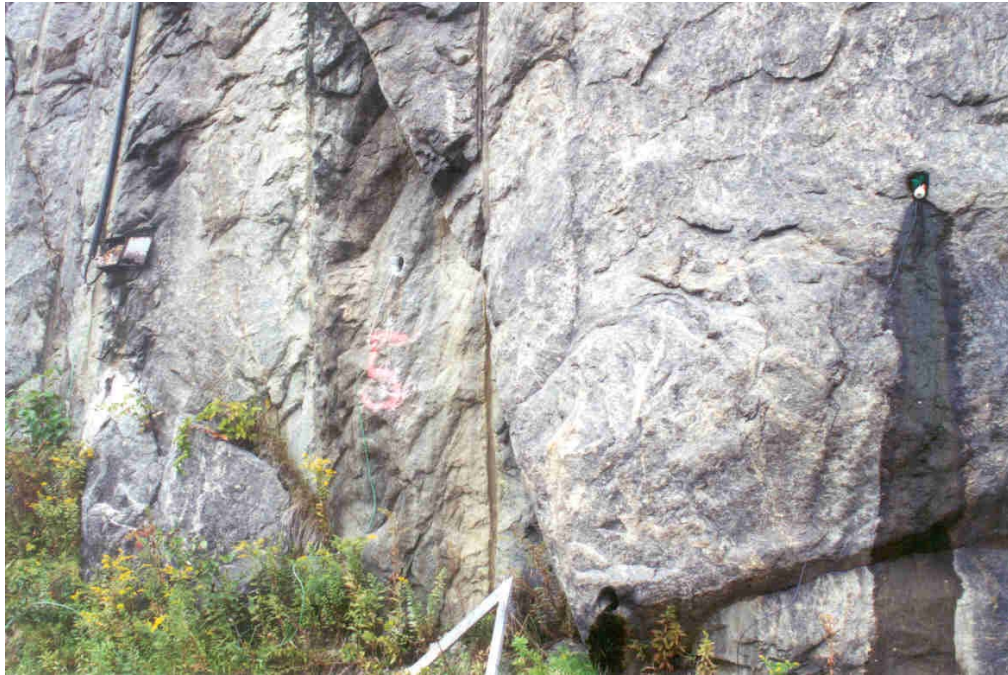
Photograph 5 – Half-cell location for Tendons 5-1 and 5-2. Half-cell is placed in the hole directly above the water stain (right).

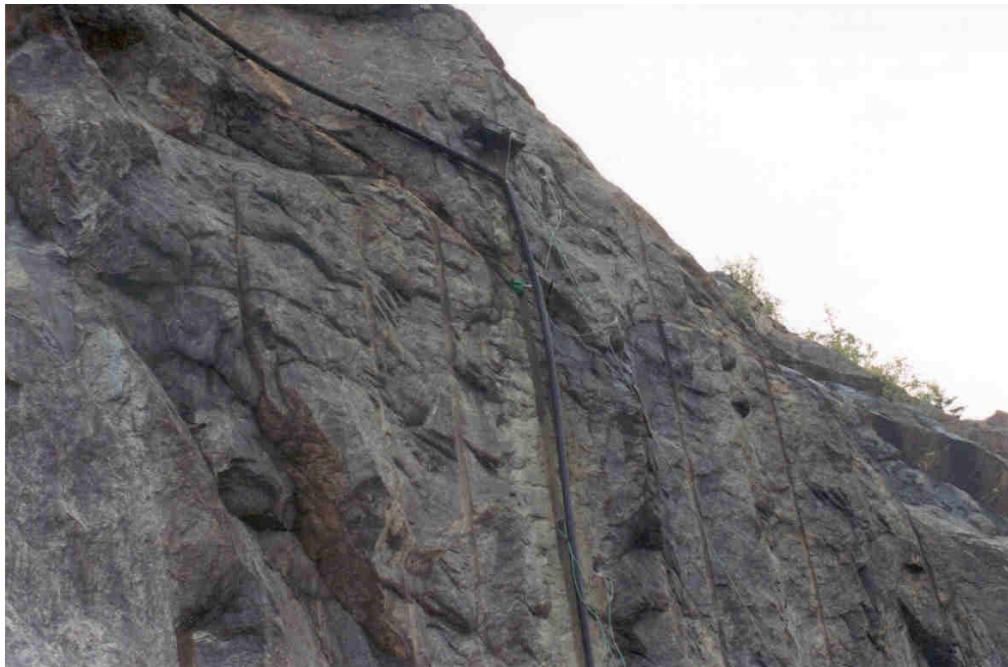
Photograph 6 – Half cell location for Tendons 5-3 and 5-4. Half-cell is placed beneath the black cable conduit approximately three-quarters of the way up the vertical section located in the center of the photograph.
