Barron Mountain
Rock Reinforcement Evaluation – Phase II
I-93, Woodstock, New Hampshire
Validation of NDT Results for Condition Assessment of
Rock Reinforcements

1. Report No. FHWA-NH-RD-14282C		2. Gov. Acc. No.	3. Recipient's Catalog No.
4. Title and Subtitle PHASE II: CONDITION ASSESSMENT AND EVALUATION OF ROCK REINFORCEMENT ALONG I-93 BARRON MOUNTAIN ROCK CUT, WOODSTOCK, NH Validation of NDT Results for Condition Assessment of Rock Reinforcements		5. Report Date SEPTEMBER, 2005

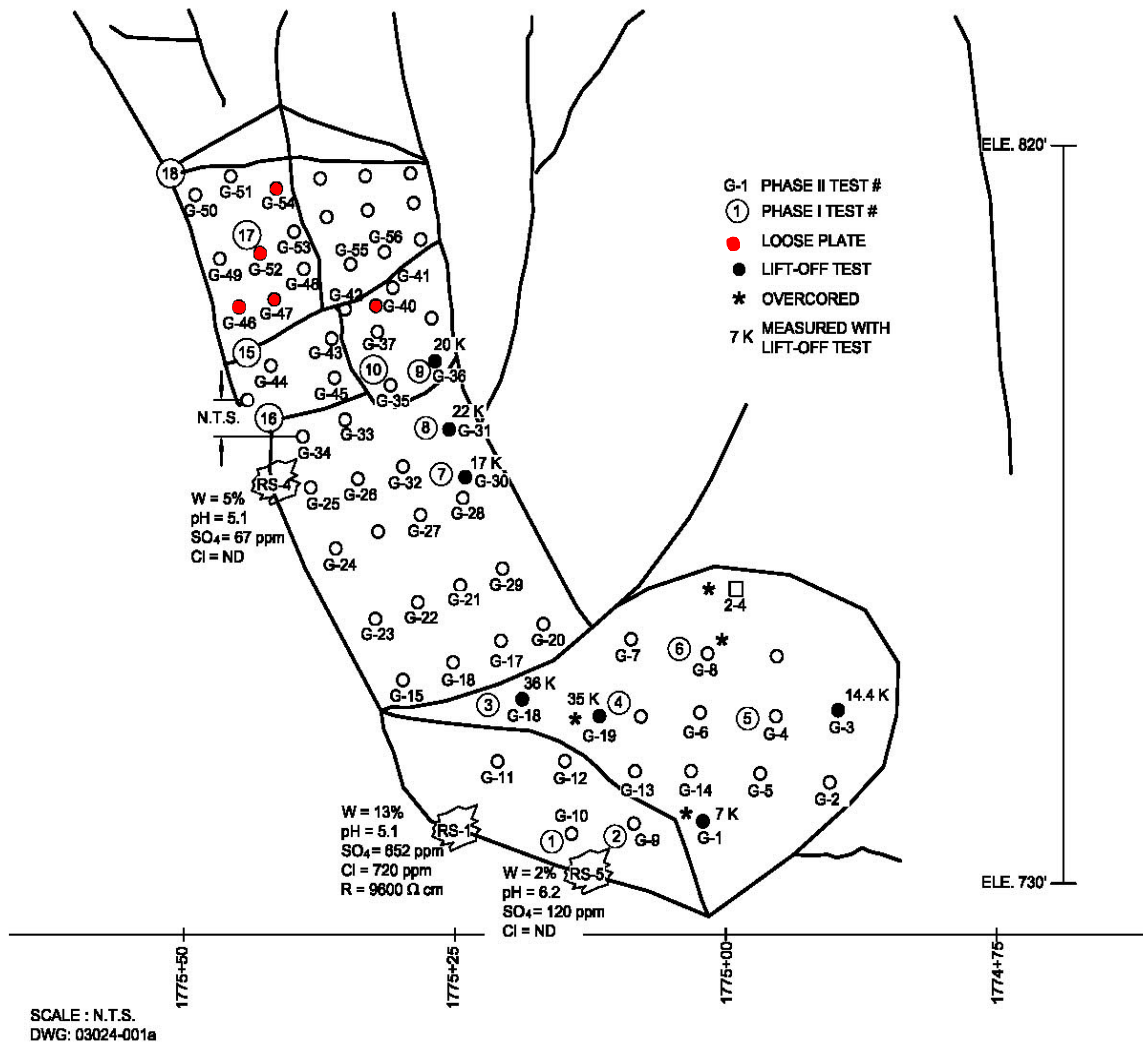
Figure 4. Rock Face Elevation View With Stationing, Reinforcement Locations, and Test Numbers for Phase I and II.

MMCE also observed loose or slack bearing plates at the anchorage for bolts G-40, G46, G-47, G-52 (MMCE #17), and G-54 (see Figure 4). Because a slack bearing plate indicates that the anchorage cannot sustain prestress, these observations contribute to five additional direct observations. Thus, Phase II includes twelve direct observations of prestress; seven lift off tests and five slack plates.

JANOD installed replacement bolts corresponding to locations where invasive testing and decommissioning of existing reinforcements by overcoring was anticipated. JANOD installed eight replacement reinforcements corresponding to rock bolts G-1, G-8 (MMCE #6), G-19 (MMCE #4), G-30 (MMCE #7), G-52 (MMCE #17), MMCE #11, and Tendons –MMCE #'s 1-4, and 2-4 (see Figures 1 and 4).

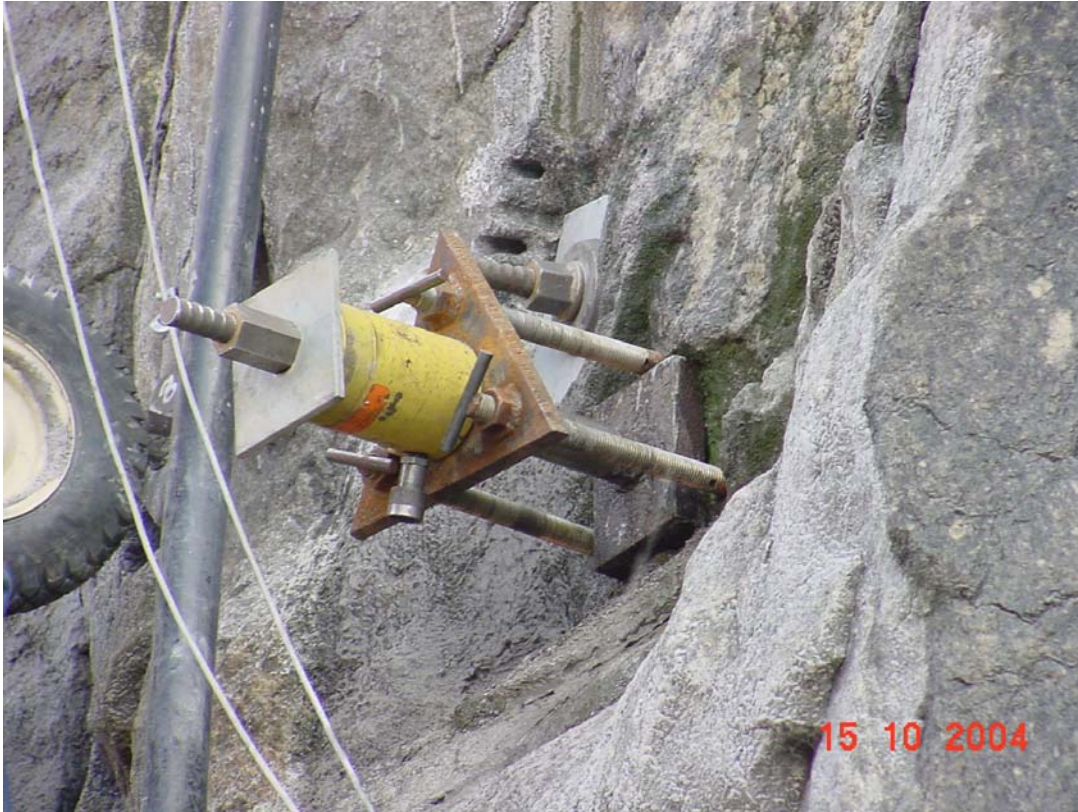
Figure 5. Lift-off Test for Prestressed Rock Bolts

MMCE observed the lift-off tests to document that they were performed using equipment and procedures recommended by PTI (1996). Load is applied to the end of the rock bolt with a center hole hydraulic jack. Figure 5 shows the load assembly including a chair to seat the hydraulic jack and facilitate load transfer at the bolt head. The preload in the rock bolt is observed when the anchor nut lifts off the bearing plate at the anchorage assembly.

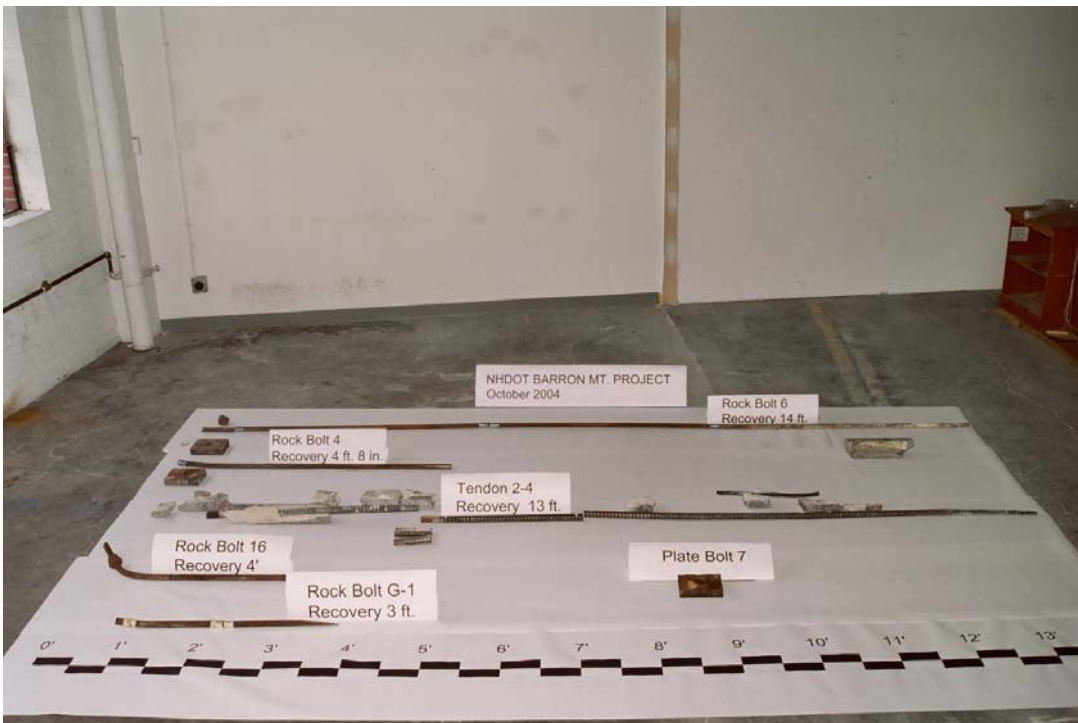
Figure 6. Recovered Rock Reinforcement

Figure 6 shows the lengths and overview of the reinforcement samples obtained from the site. Appendix VI describes detailed observations obtained for each sample including general observations, measurements of remaining diameter, observations of pitting corrosion and hardness measurements where grout samples were available.

Bolt #G-8 (MMCE # 6) was retrieved in its entirety for a sample length of approximately fourteen feet. The bolt appears to be in relatively good condition although some pitting corrosion is evident. Grout was observed at intermittent locations beginning four feet from the distal end of the bolt. The resin grout appeared to provide poor coverage to the bar, and for most of the area that had traces of grout, the thickness was not sufficient to cover the bar deformations. The best coverage was observed in an area about 4.25 inches in length, covering one side within the last foot of the bar. This poor coverage probably accounted for the bond breaking and the bolt spinning as the contractor removed the nut and bearing plate prior to overcoring. Bolt #G8 (MMCE #6) was installed at an upwards angle and slid out of the hole after over coring to a depth of approximately eight feet. Bolts #G30 (MMCE #7) and #G19 (MMCE #4) were also loosened as the nut was turned. Bolt # G30 (MMCE #7) could not be pulled from the hole with 70 kips, and the bolt was not over cored.

An approximately four feet long sample of MMCE #G19 (MMCE #4) was retrieved. The sample was terminated after a coupling was encountered. This sample exhibited more corrosion compared to # G8 (MMCE #6) and loss of cross section was observed at a location near the backside of the bearing plate. A three feet long section of Bolt # G-1 was also retrieved and similar loss of cross section was observed near the bearing plate.

Bolt – MMCE #16 was not overcored, but was recovered when JANOD fractured and removed the loose block of rock it supported with the Boulder Buster™. The Boulder Buster™ is a small charge that usually fractures the rock surrounding a rock bolt when detonated, causing the loosened rock to slide toward the base of the rock cut. In this case the rock bolt was severed and removed with the block. The fracture surface at the end of the approximately four feet long sample of bolt – MMCE #16 was sent to a metallurgy lab for analysis as described in the “Results” Section. Loss of section was also observed near the backside of the anchor plate.

Tendon – MMCE #2-4 was over cored to a depth of approximately twelve feet. The proximal end of the sample included an approximately two feet long annulus of grout adhered to the reinforcement and surrounding rock core. Cement grout was exposed on one side of the sample as the core barrel wandered slightly off track. The exposed grout measured about 5 by 20 inches in plan. Recorded observations include hardness, absorption and bulk specific gravity. The steel reinforcement appeared to be in excellent condition and the surface did not appear to have been subject to corrosion. A coupling was encountered at a depth of approximately five feet from the rock face.

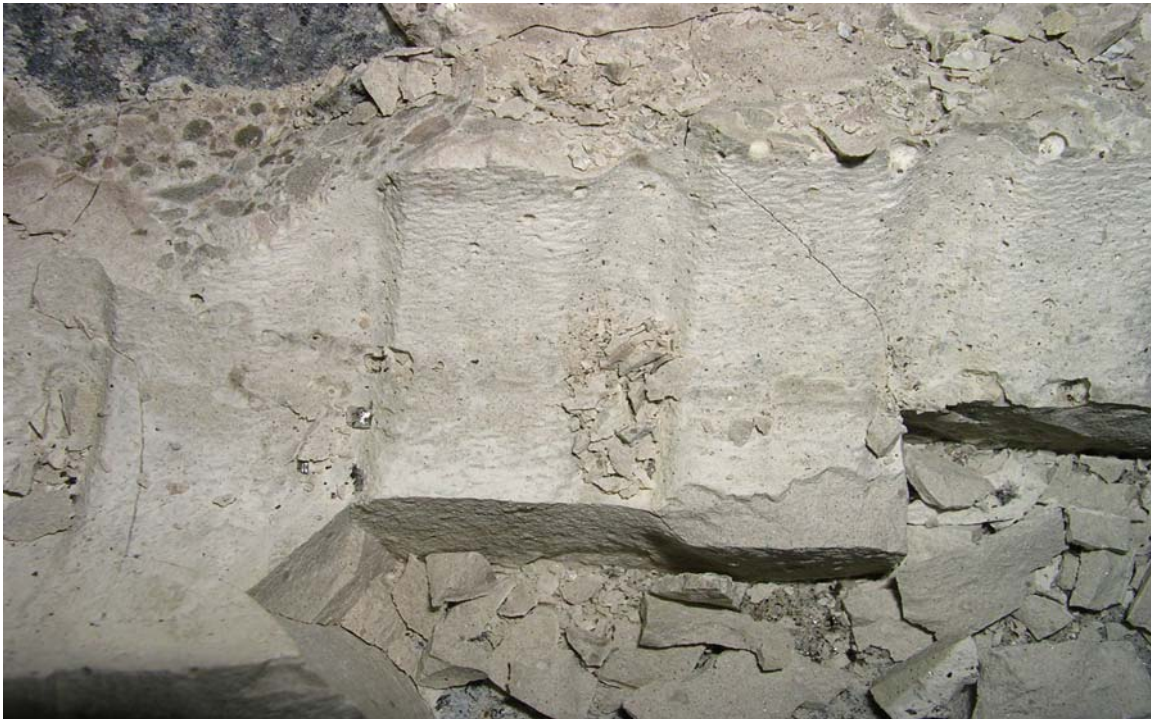
Figure 8. Pores Distributed Throughout Portland Cement Grout Sample.

that grout condition is questionable and that corrosion is likely. The high porosity observed for the exhumed grout sample may confirm the interpretation of grout quality from the results of NDT. In general, the exhumed tendon element (Tendon – MMCE #2-4), which was protected by Portland cement grout, was in very good condition compared to the resin grouted rock bolt (Rock bolt G8- MMCE #6) and this is also consistent with observations from NDT.

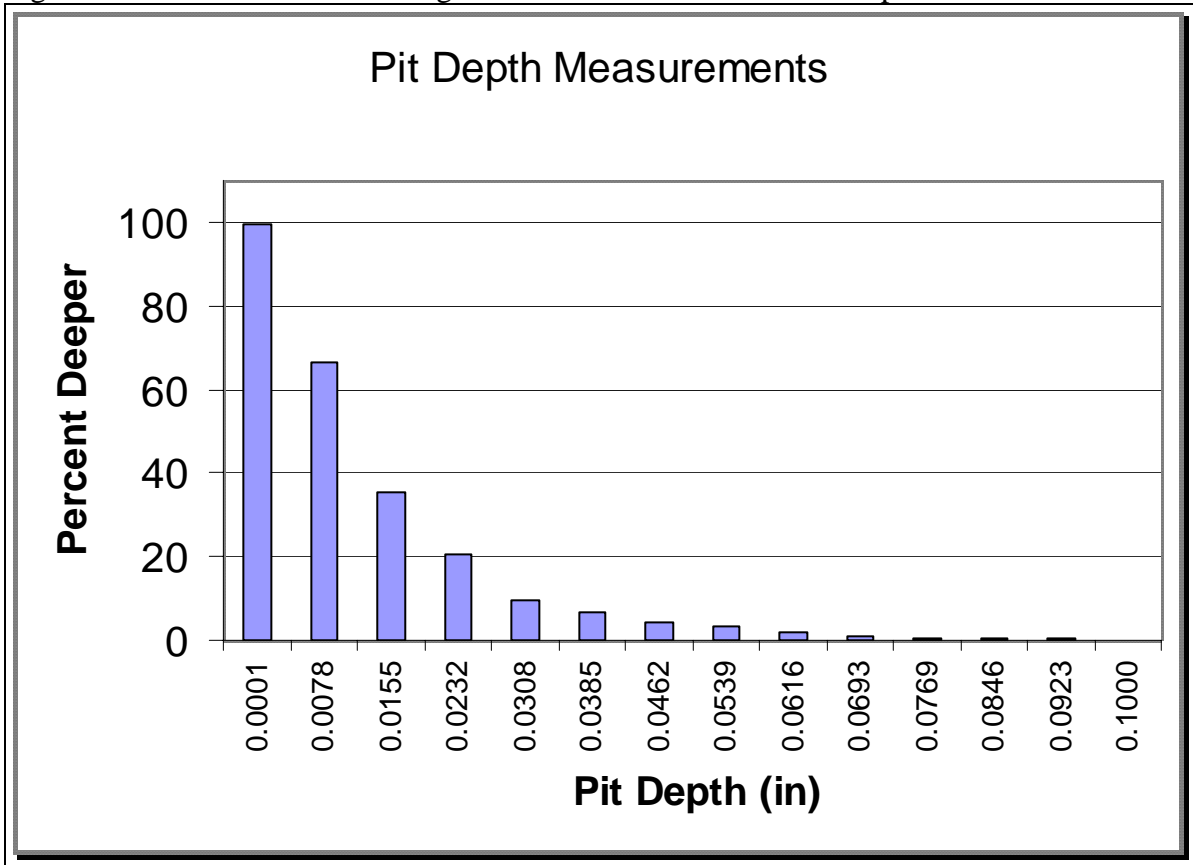
Figure 9. Cumulative Distribution of Pit Depth Measurements

Pits and craters were observed at a number of locations along the rock bolt samples, and craters appear to coalesce into areas of uniform corrosion extending for lengths of approximately four inches. One hundred and seventy-eight pit depth measurements were obtained from the surface of the rock bolt samples. Pit depths were measured with a pit depth gage having a sensitivity of 0.0001 inches. The average measured pit depth was approximately 0.015 inches with a standard deviation of 0.014. Figure 9 shows the cumulative distribution of pit depth measurements indicating that the maximum measured pit depth was 0.1 inches and 10 percent of the measured pit depths were greater than 0.031 inches. We observed that deeper pits are often associated with larger pit diameters, supporting the notion that pitted areas coalesce into areas of uniform corrosion.

Three of the rock bolt specimens exhibited a maximum loss of section corresponding to approximately 0.1 inches in diameter. This loss is consistent with existing mathematical models of service-life and with the observation from NDT that 70% of the rock bolts have experienced significant corrosion. Considering the initial diameter, level of prestress, and rate of metal-loss, we estimate that rock bolts will not become overstressed from loss of section due to corrosion for another fifteen to twenty years.

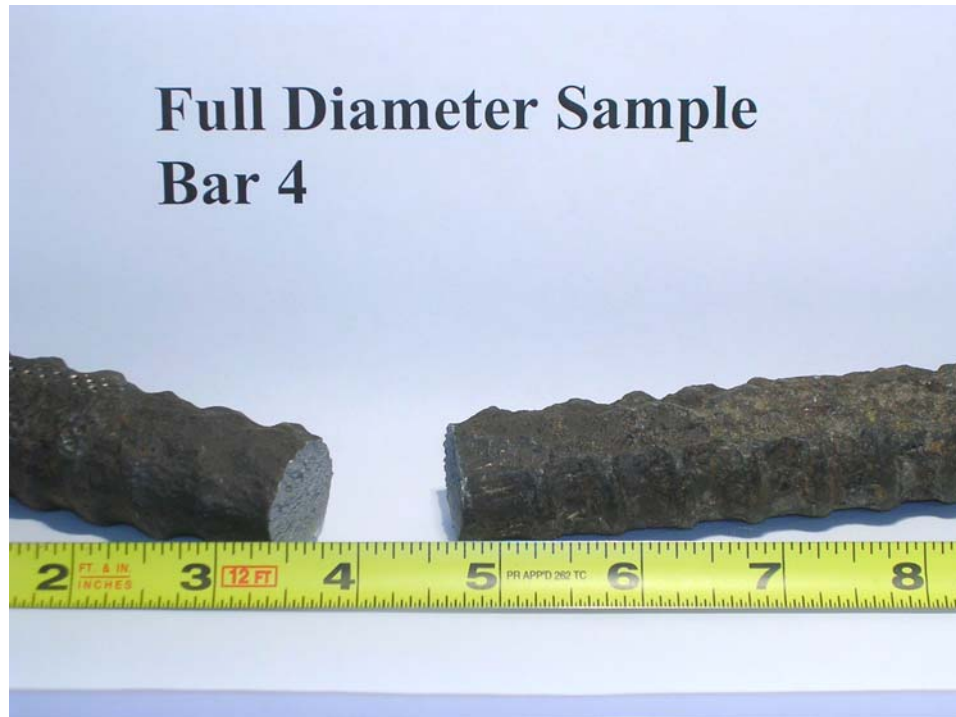
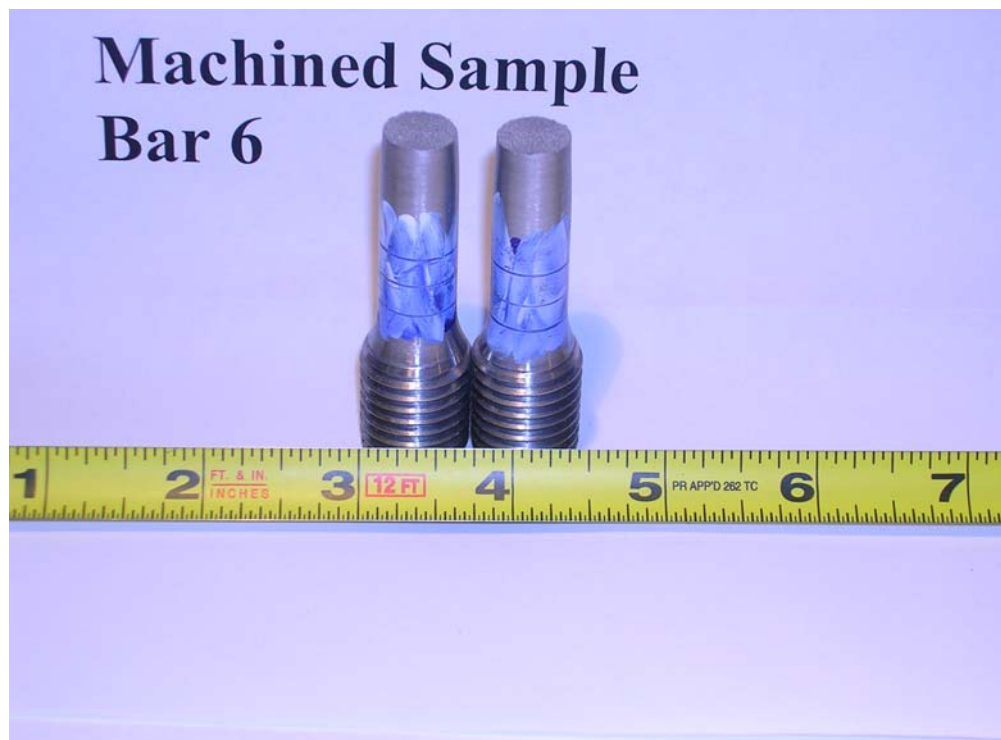
Figure 10. Tension Test Specimens

WMT&R tested one machined-section and one full section from each pair of specimens. The purpose of testing the full sections was to determine if the ultimate tensile stress (UTS) was affected by a change in geometry due to non-uniform loss of section, or localized corrosion such as pitting. The machined sections have a controlled geometry and are similar to the test specimens described in ASTM A 370, "Standard Test Methods and Definitions for Mechanical Testing of Steel Products." Machined sections had an initial diameter of 0.5 inches and a gage length of 2 inches. Full sections were approximately 18 inches long with a gage length of 2 inches. Typical specimens are pictured in Figures 10 (a) and (b). Results from tension testing are summarized in Table 2.

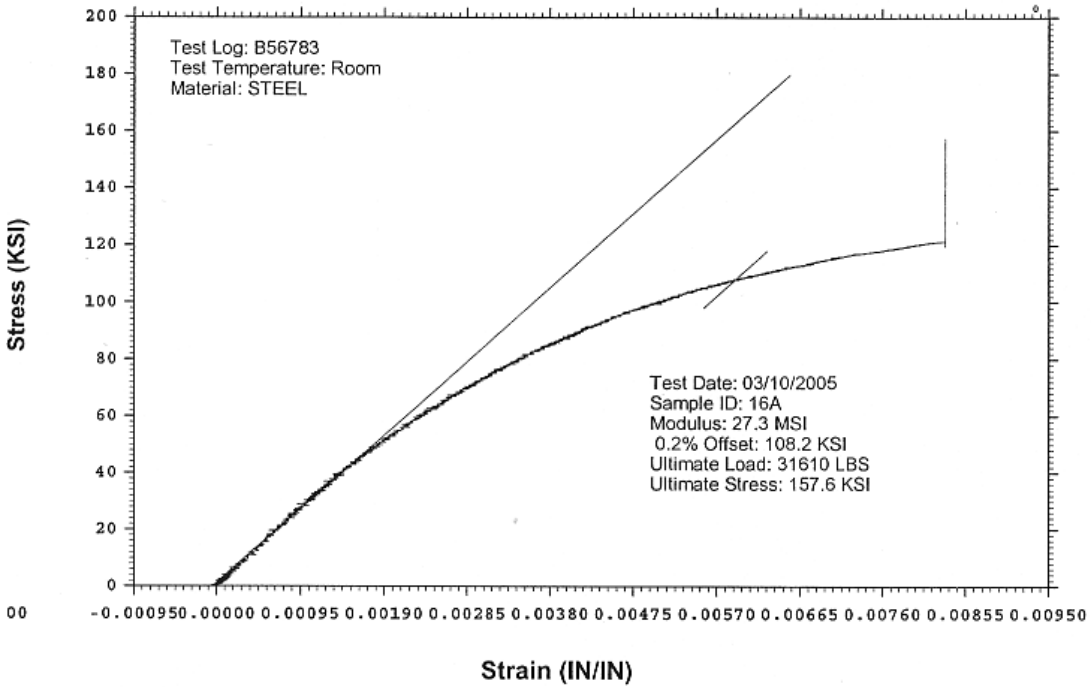
(b) Response of Specimen from Sample MMCE #16

The fracture initiation site is identified near the perimeter of the cross section. Inclusions, one high in chlorine, were found near the fracture initiation site; and, in another area of the fracture surface, intergranular separation cracks were found. Inclusions with higher concentrations of silicon, aluminum, with lesser amounts of sodium, potassium and calcium were also observed in areas away from the fracture initiation site.

A corrosive environment, e.g. one high in chlorine may have been the cause of the intergranular separation cracks. We postulate that fracture initiated at the inclusions, and propagated by fast fracture through the structure, which was already weakened by intergranular corrosion.
