Improve the Quality and Service Life of
Water-based Pavement Marking Paints on
Pavements with High-Iron Aggregates
Final Report

Prepared by Jacobs Engineering Group Inc. for the
New Hampshire Department of Transportation in cooperation with the
U.S. Department of Transportation, Federal Highway Administration

1. Report No. FHWA-NH-RD-15680J	2. Government Accession No.	3. Recipient's Catalog No.	
4. Title and Subtitle Improve the Quality and Service Life of Water-based Pavement Marking Paints on Pavements with High-Iron Aggregates		5. Report Date August 2015

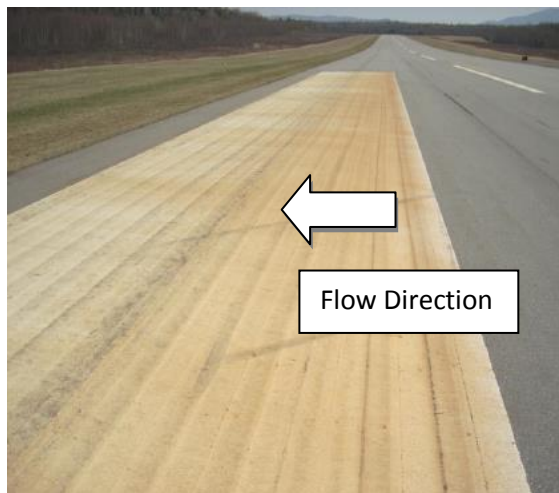
Before describing the work and methodology, an illustration of the paint staining problem is warranted. Staining of paint markings on airport pavement has been noted to occur by two means: over-pavement sheet flow during rain events that carry stains onto the paint markings (Figure 1), and rusting aggregates that create point stains within the pavement markings (Figure 2).

Figure 1 – Sheet flow stains

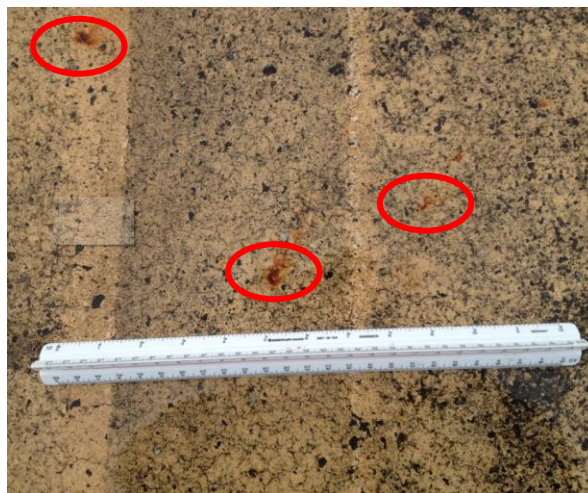
Figure 2–Point stains (red circles)

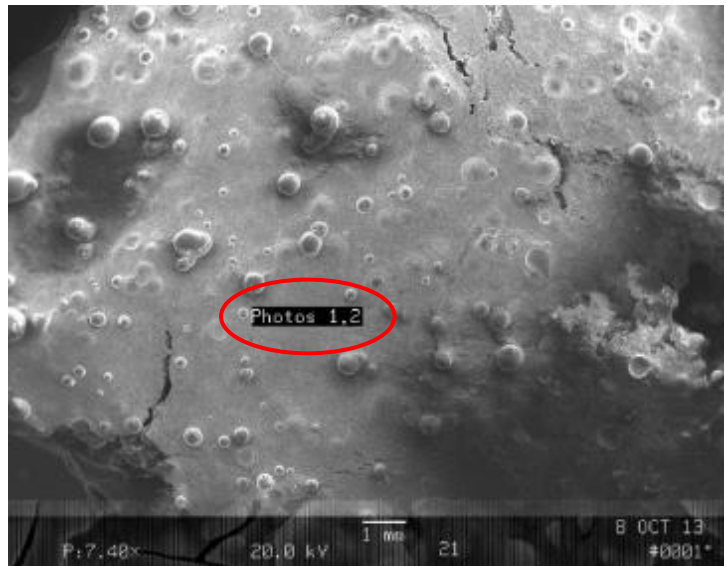
Figure 5 – Sample SEM Photograph of Paint Chip

The SEM and EDS results show that the source of staining is iron at all five airports. As an example, the EDS indicated a higher percentage of iron, greater than 50%, directly over the rust spot located with the SEM. Testing further away from the spot with the EDS, resulted in the percentage of iron decreasing.

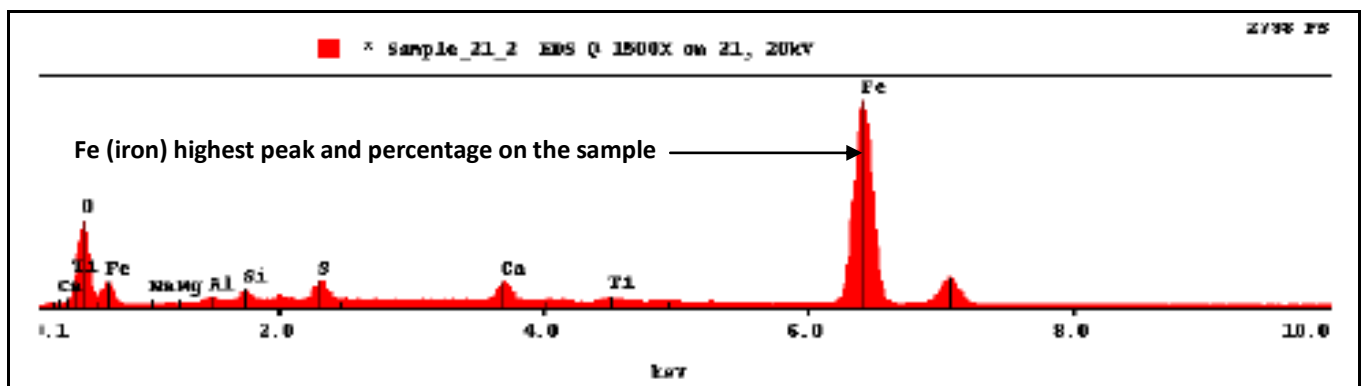
Figure 6 – Sample EDS Elemental Analysis. Fe (iron) highest peak and percentage on the sample.

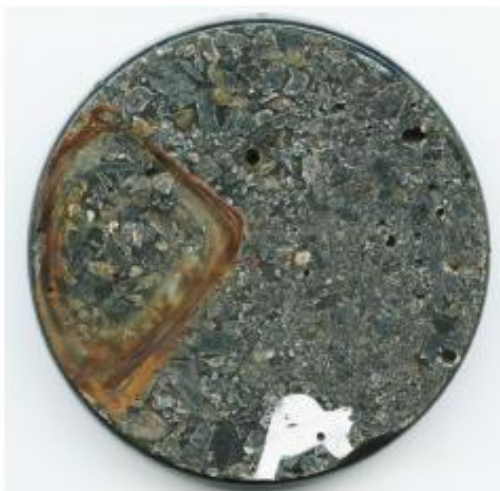
Figure 8- Laboratory Aging Test Rust Stain

The test resulted in rust staining. The rust originated in the aggregate then became mobile within the pavement matrix, similar to what happens in the field on the paint markings and the bituminous concrete surface.

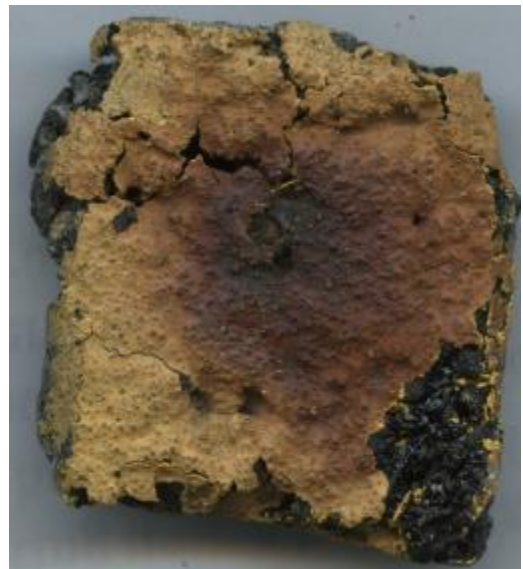
The EDS results show high iron (Fe) content in locations on paint chips that are stained. This confirms the staining is rust. The EDS data includes multiple sample points on individual paint chips. The higher Fe percentages were found on the darker stains and lower Fe percentages on the lighter stains. Paint chips were collected from 8 different projects. All 5 airports selected for the study were included. All the paint chips had some level of rust staining.

Figure 9 - Sample Rust Stained Paint Chip

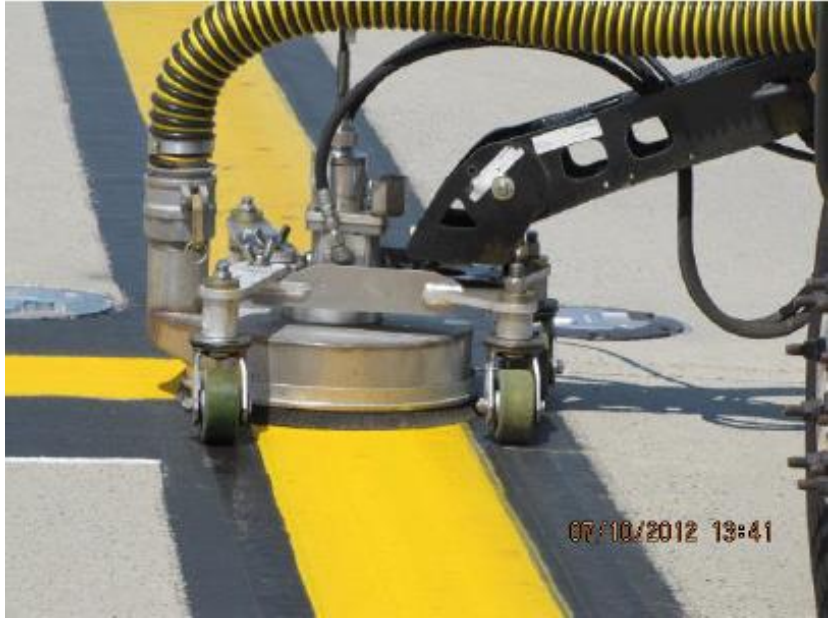
Figure 10 - Paint restoration (Speidel, 2008)

Pressure washing uses a pressurized water spray to remove the surface stained material. The water pressure selected for rust removal is important to preserve the existing paint and glass beads that are on the surface of the paint. Glass beads are used to reflect paint color to the pilots under low light conditions. The amount of water pressure used to remove rust build-up must be less than the pressure used to remove paint build-up. The higher pressures used to remove paint will

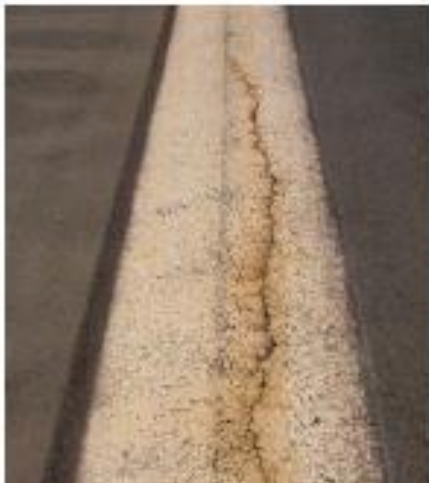
Figure 12 was taken two years after Figure 11, demonstrating the advantage of using the best practice modified formulation of TT-P-1952E to resist the rust staining²².

Figure 11 - Stained markings before modified paint (Speidel, 2008)

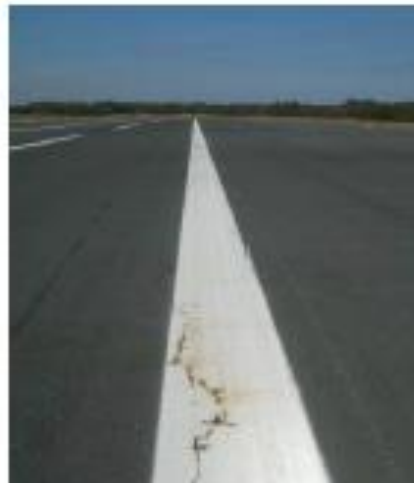
Figure 12 - Modified paint 2 years after (Speidel, 2008)

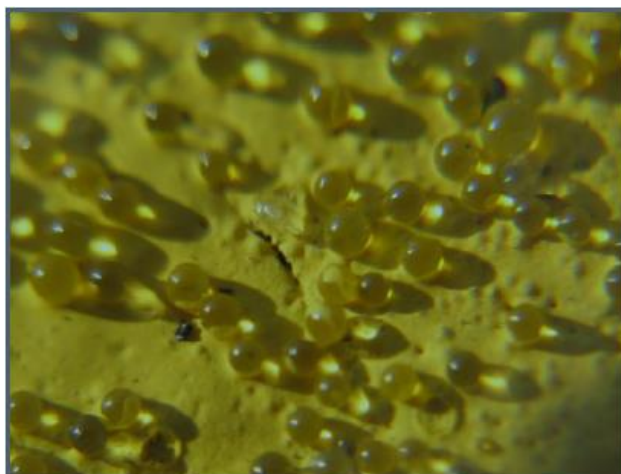
Type I, Type III and Type IV Gradation A beads have maximum diameters of 850, 1180 and 1700 microns, respectively.²⁸ The respective conversion to mils is 33, 46 and 66 mils²⁹. Therefore, based upon the 50 to 60% anchor depth, the wet film paint thickness for Type I beads should be 17-20 mils; the wet film thickness of Type III beads should be 23-28 mils; and the wet film thickness for Type IV beads should be 33-40 mils.

Figure 16 – Poorly placed beads (Speidel, 2014)

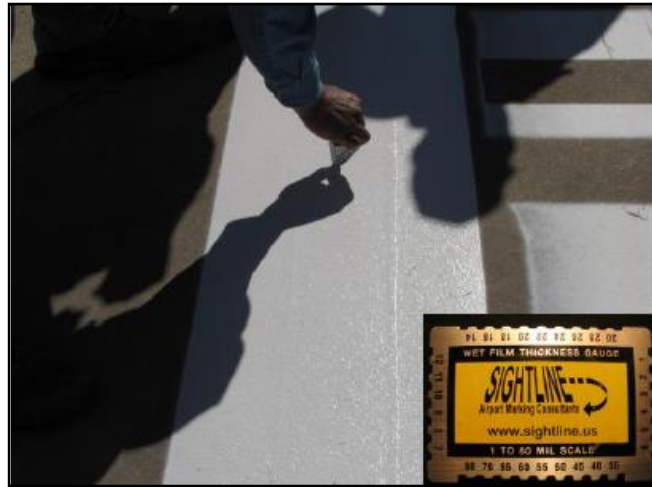
specified to be statistically placed in random locations within the areas to be painted in order to determine an average thickness of the paint as compared to the specified thickness. An example of a thickness measurement and tool is shown in Figure 17.

Figure 17 – Paint thickness measurements and Mil Thickness measuring tool -lower right (Speidel 2014)

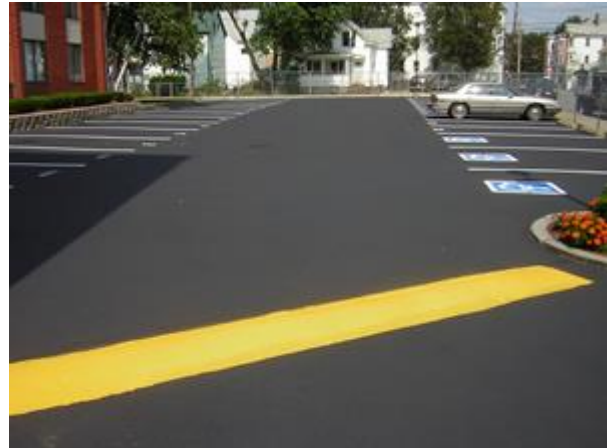
Sealing pavements is a common method to preserve the pavement life. Sealing the pavement would encapsulate and therefore repel the moisture from contacting the aggregates that contain iron. This would eliminate the development of the rust point stains. In the pavement cores taken from the NH airports, those that were sealed exhibited no surface rusting.

Figure 18 - Sealed and painted pavement

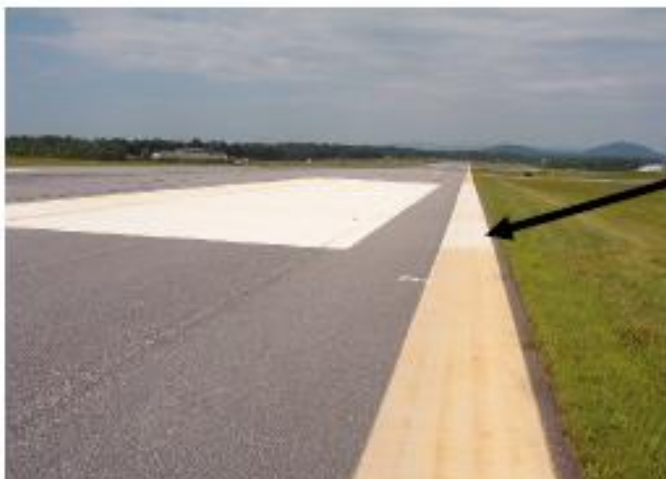
The grooves would concentrate the rainwater flow. This would increase the velocity of the water and, in theory, allow the rust deposits to stay suspended in the water until the water runs off onto the pavement shoulder. On non-grooved pavement, rainwater spreads out and travels slower. Slower water drops the rust particles onto the pavement and paint surface. The grooves could be cut for the larger markings (aiming points, touch down zone, threshold and edge stripes). Figure 20 shows reduced rust stains where the pavement is grooved (black arrow pointing to grooved pavement).

Figure 20 – Grooved Pavement Example (white with black arrow) and not grooved (stained) pavement (Speidel 2008)

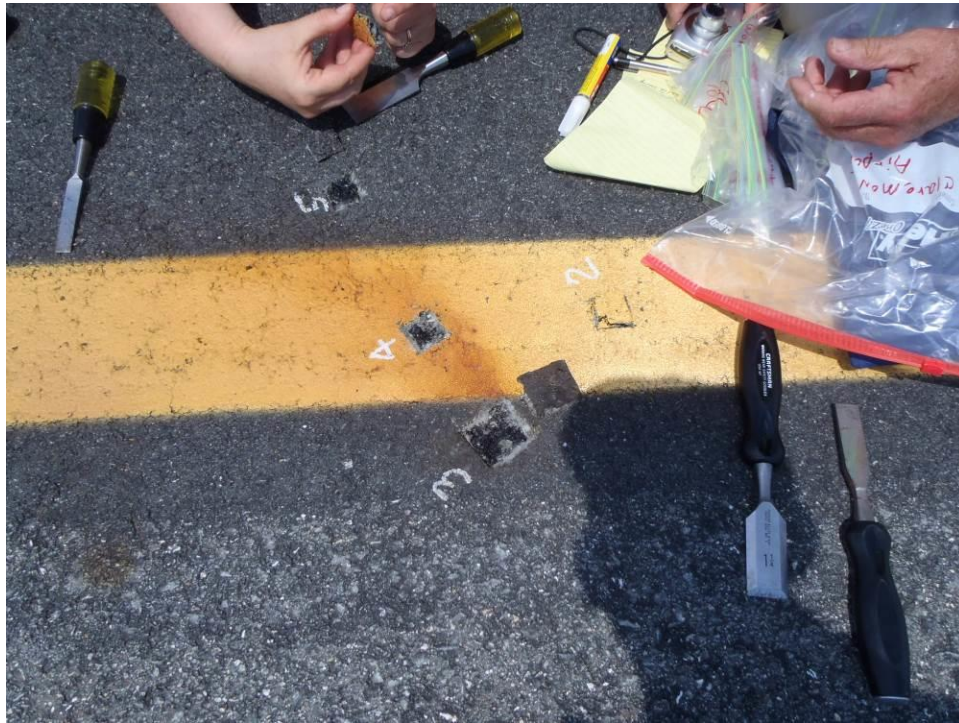
Photo 5 – Paint sample 2 located on no stained paint. Paint sample locations 3, 4 and 5. Sample 3 up gradient, 4 on the paint and 5 down gradient.

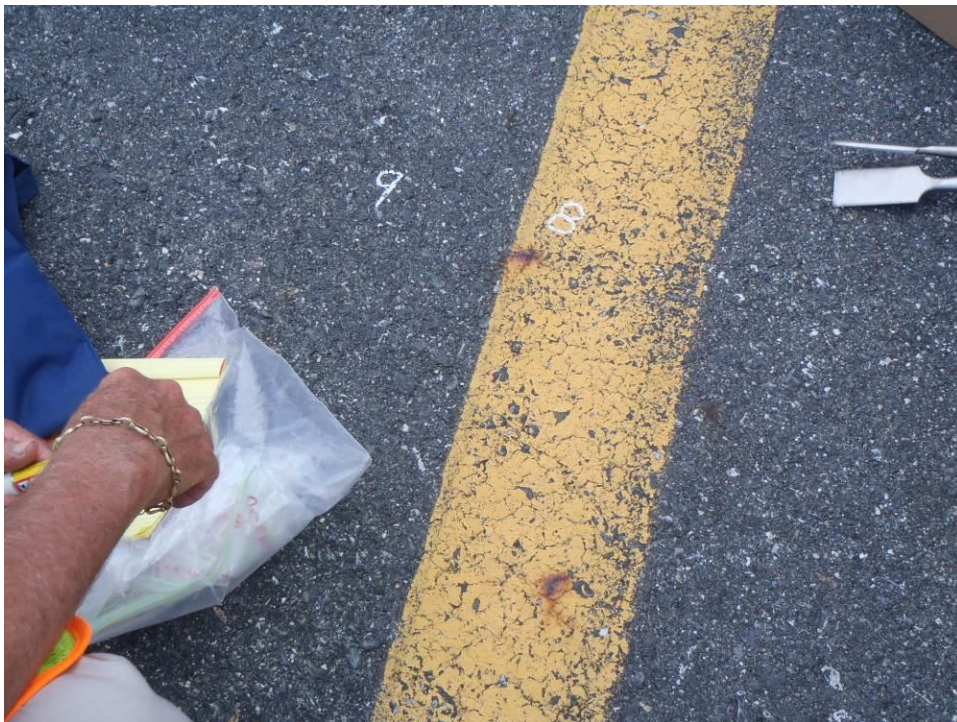
Photo 8 – Paint sample locations 8 and 9. Note sample 8 is on a stain and 9 is not.

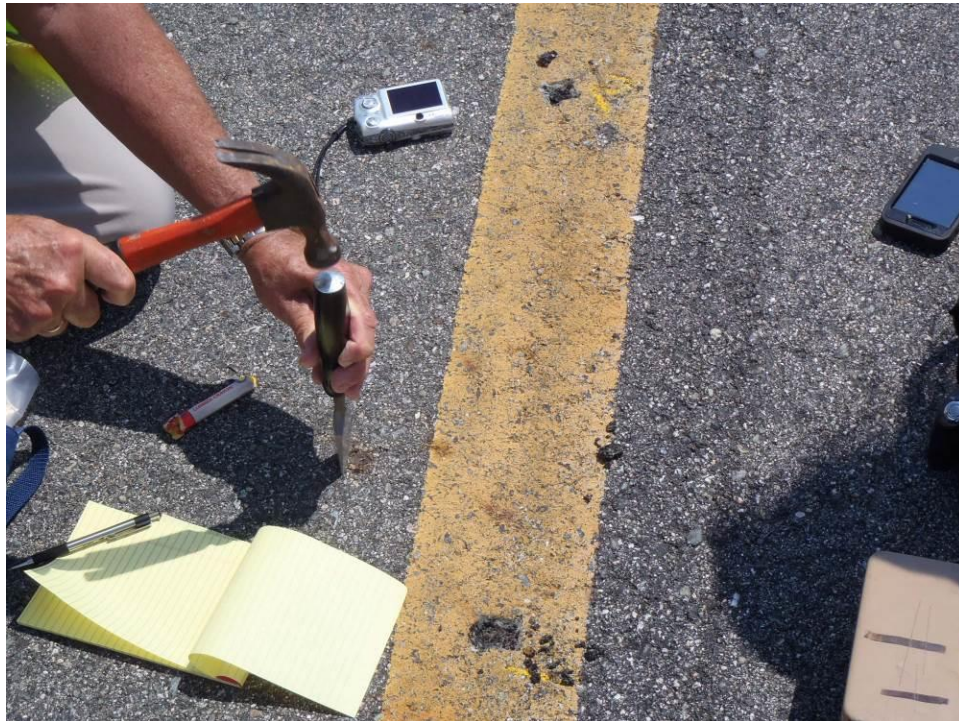
Photo 4 – Sampling of rust stain location 3.

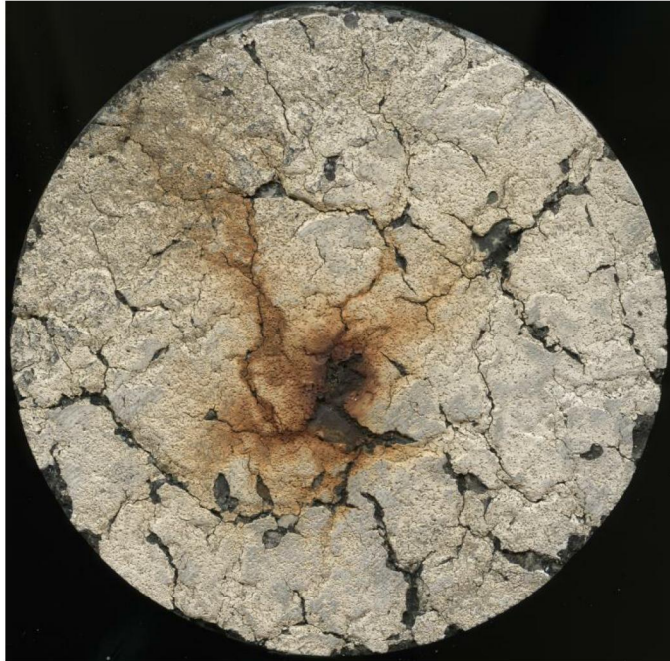
Figure 1 Concord core showing source of major iron staining

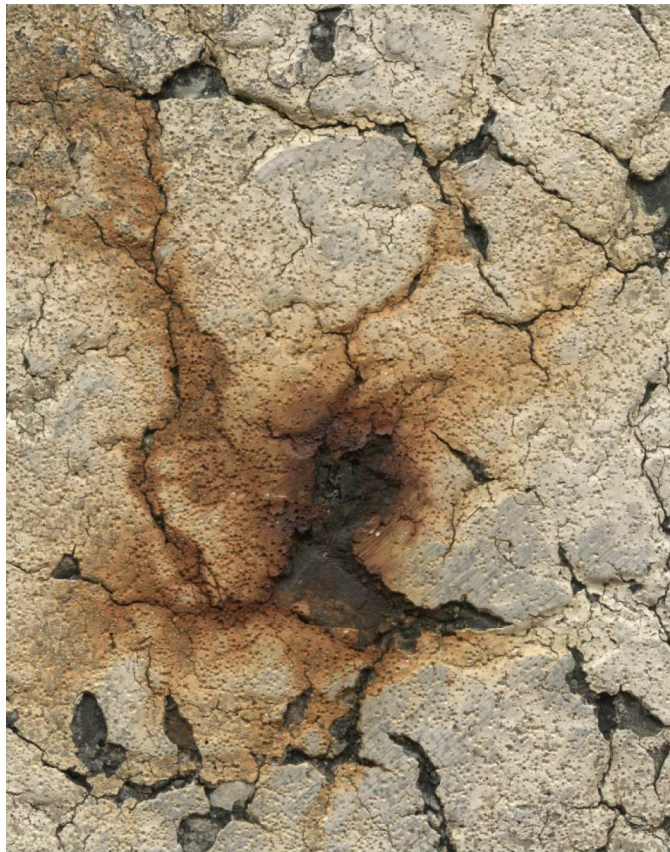
Figure 2 Close up of Figure 1 showing iron staining

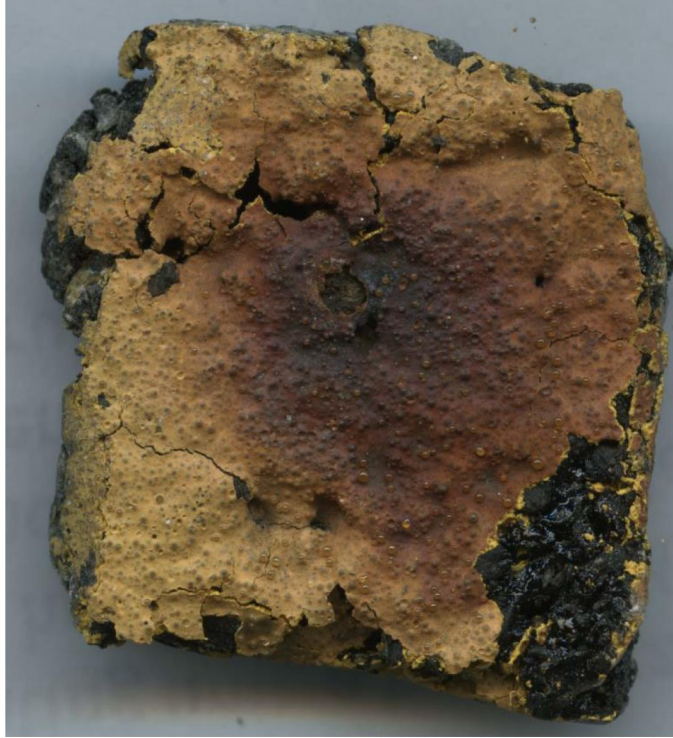
Figure 3 Claremont paint chip showing source of iron stain

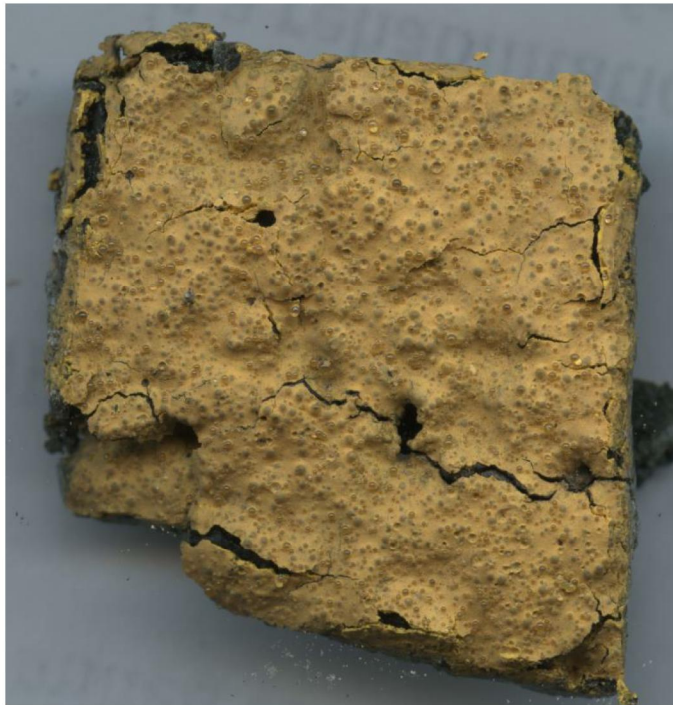
Figure 4 Claremont paint chip showing uniform iron stain coating

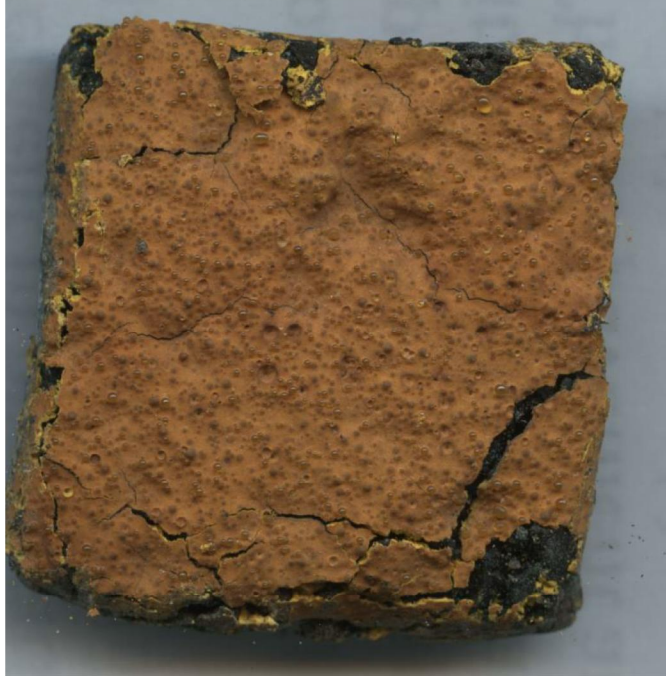
Figure 5 Claremont paint chip showing uniform iron staining (note original paint color at fractures)

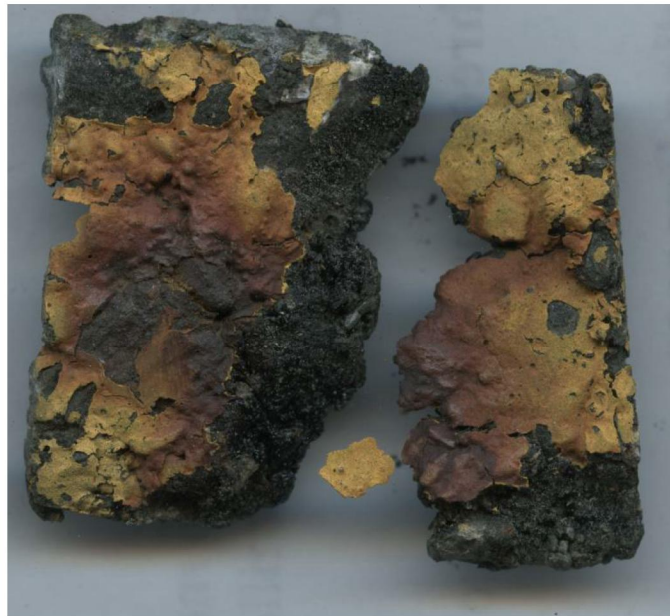
Figure 6 Claremont paint chip showing source of major iron staining

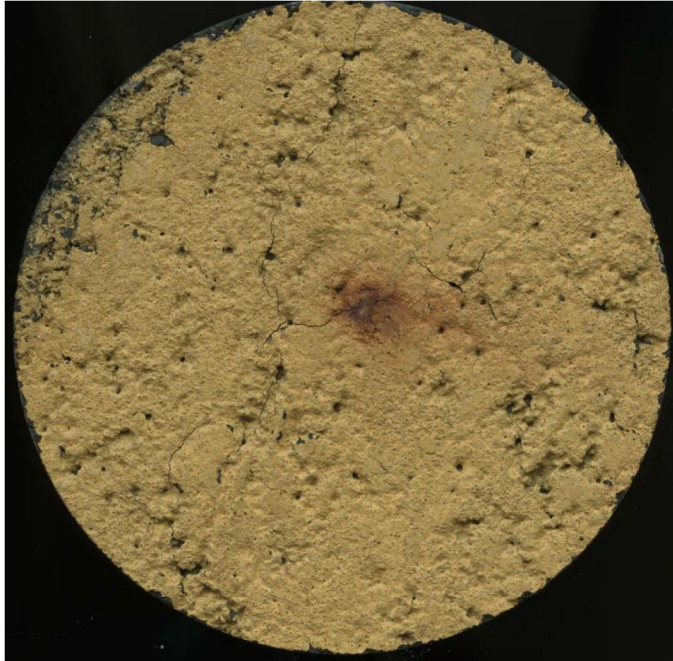
Figure 7 Claremont core showing iron staining

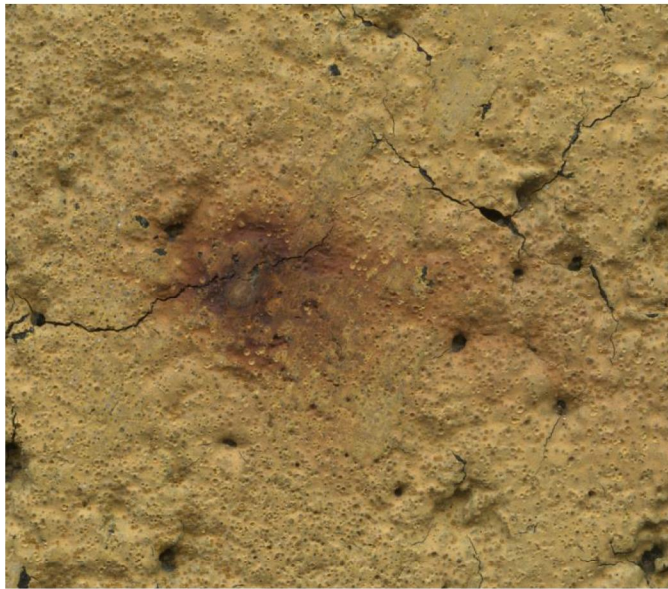
Figure 8 Close up of stain source on Figure 7

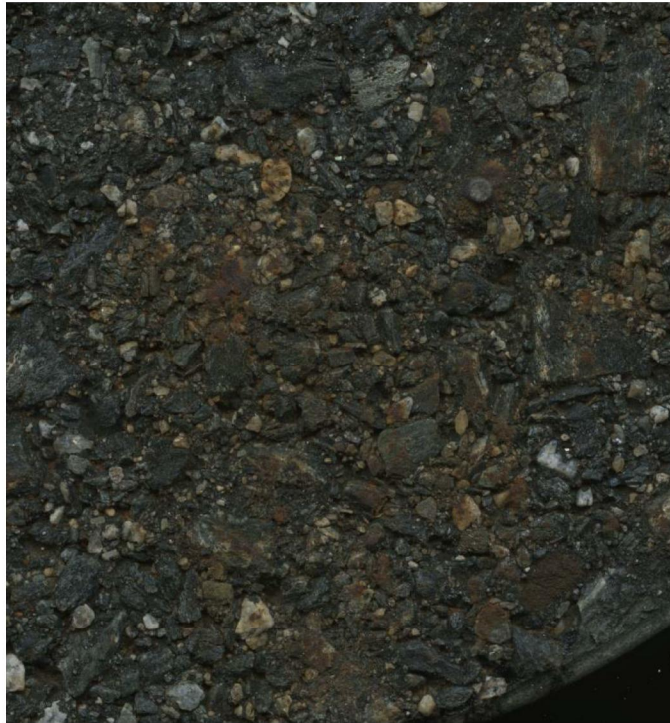
Figure 10 Close up of Figure 9 showing uniform iron staining of the exposed aggregate

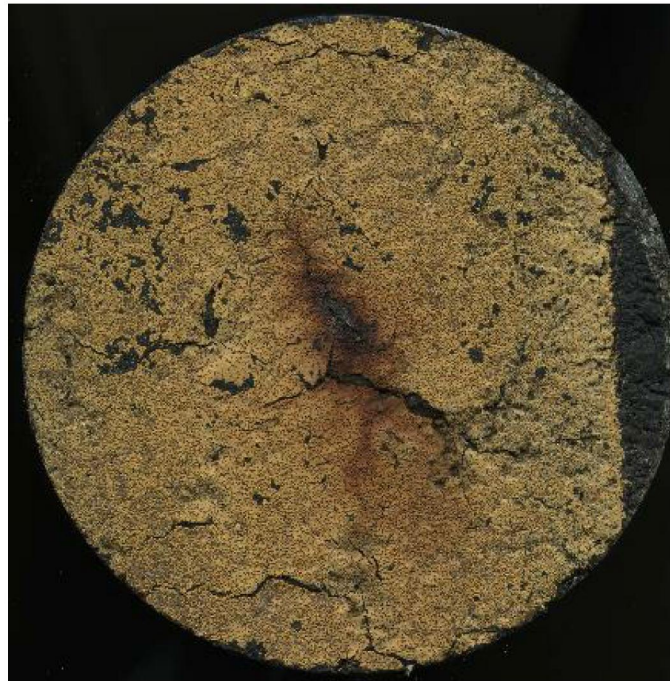
Figure 12 Keene core showing source of iron staining

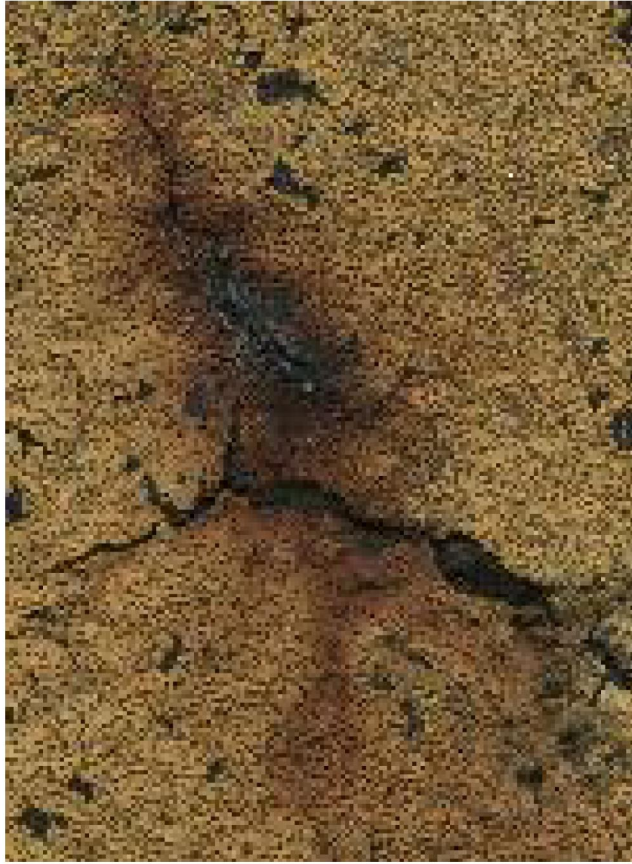
Figure 13 close up of stained area in Figure 12

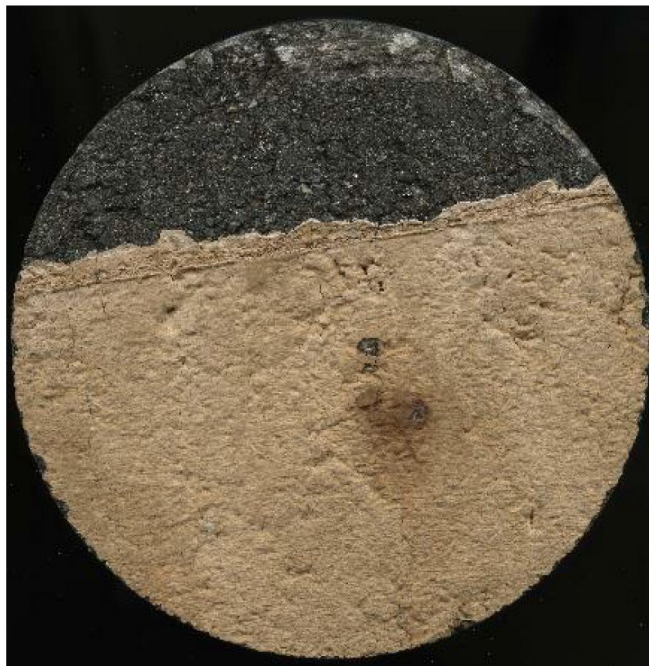
Figure 14 Keene core showing source of stain area

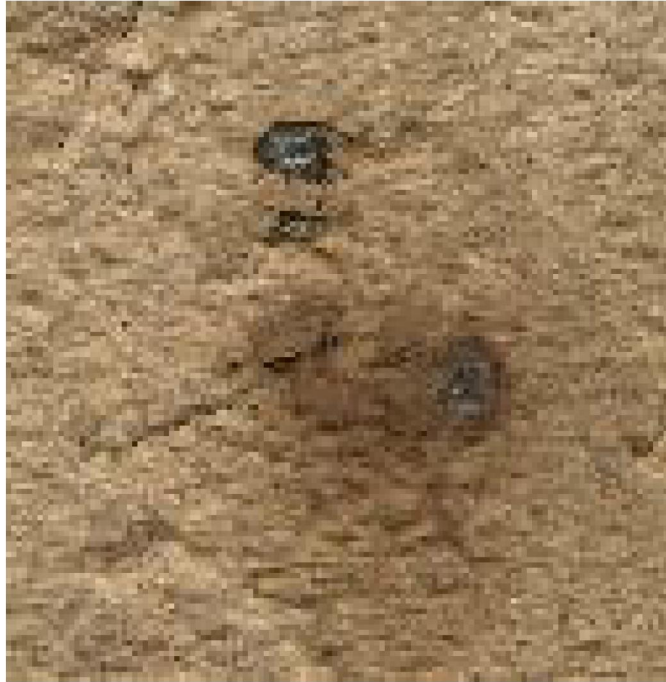
Figure 15 Close up of stained area from Figure 14

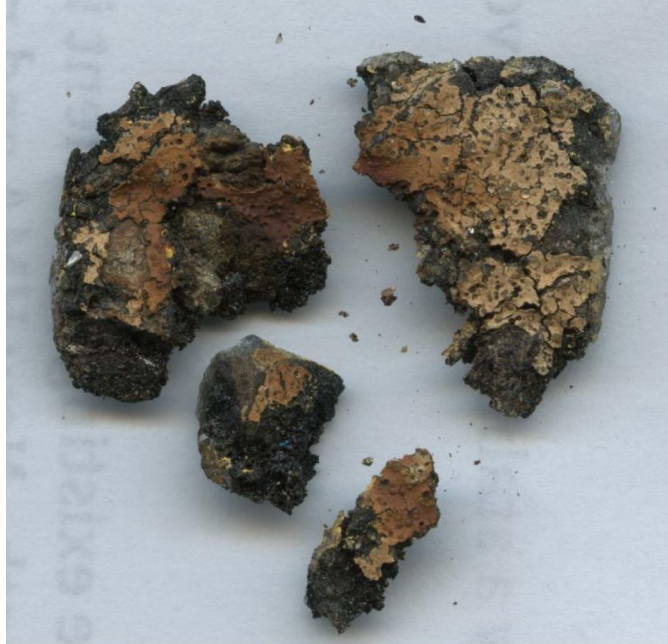
Figure 16 Laconia paint chips showing iron staining

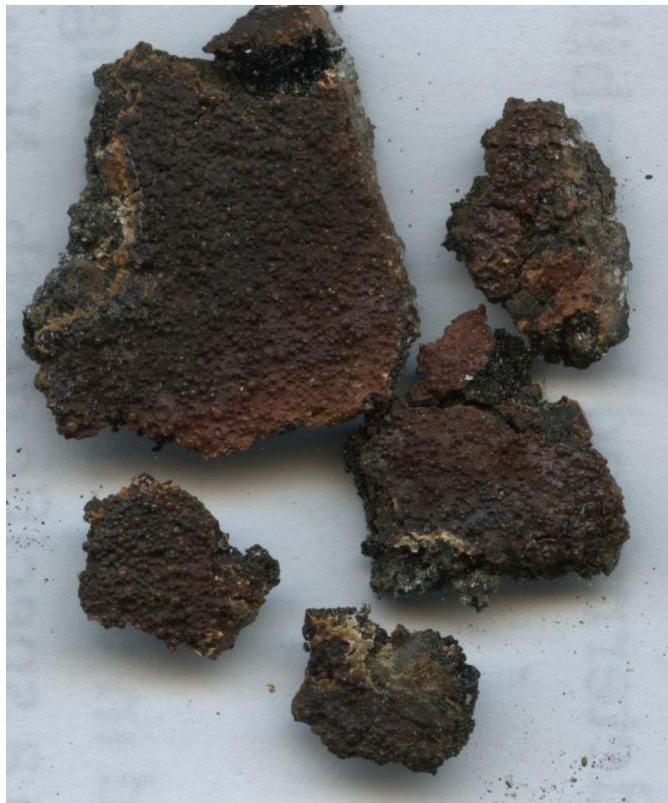
Figure 17 Laconia paint chips showing major iron staining

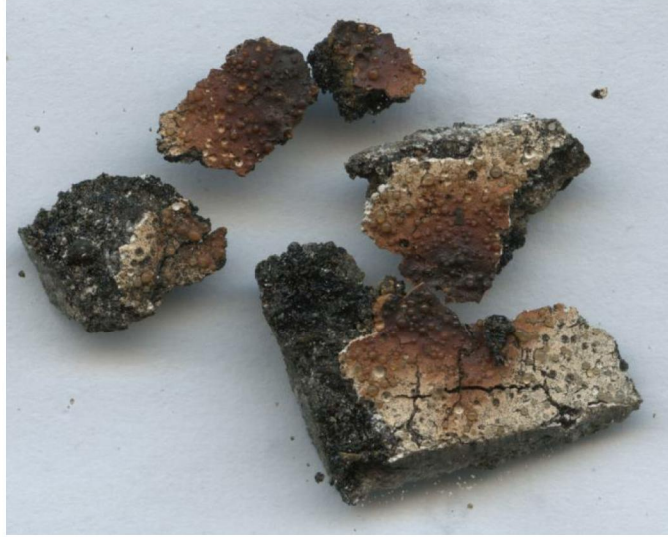
Figure 18 Laconia paint chips showing source of iron staining

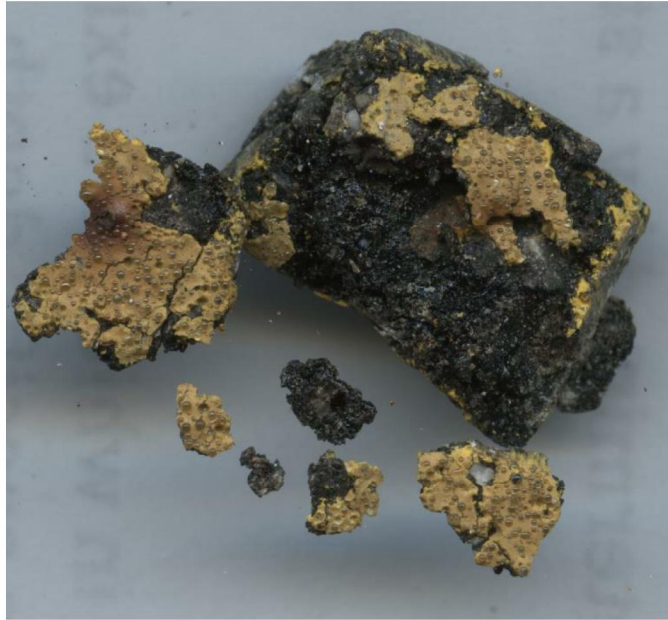
Figure 19 Laconia paint chip showing stained glass beads

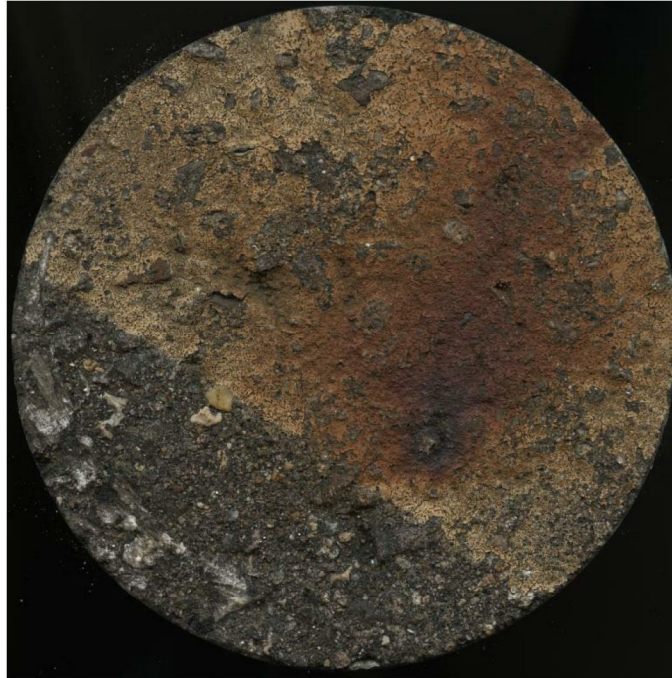
Figure 20 Laconia core showing source of iron staining

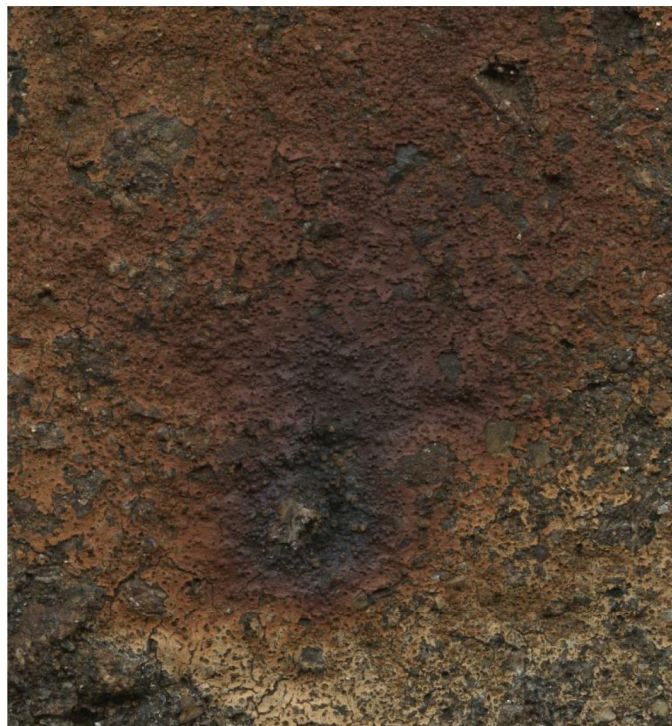
Figure 21 close up of Figure 20 showing major staining

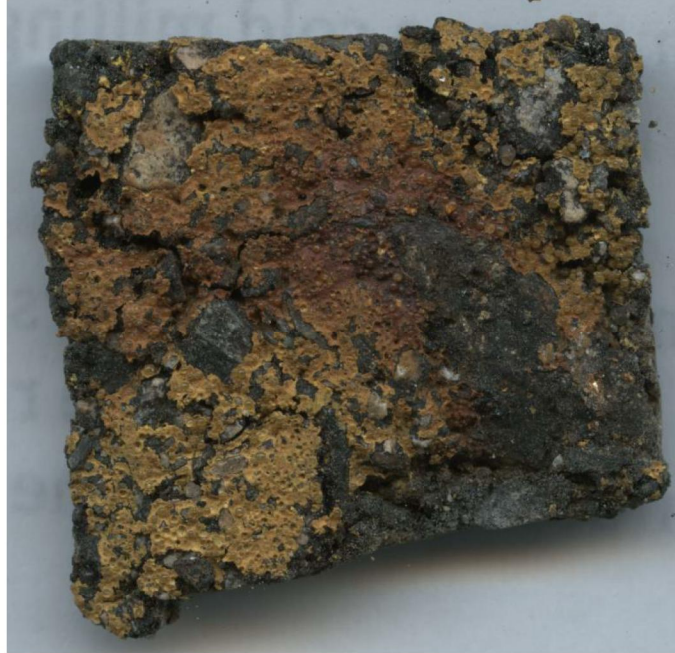
Figure 22 Whitefield paint chip showing source of iron staining

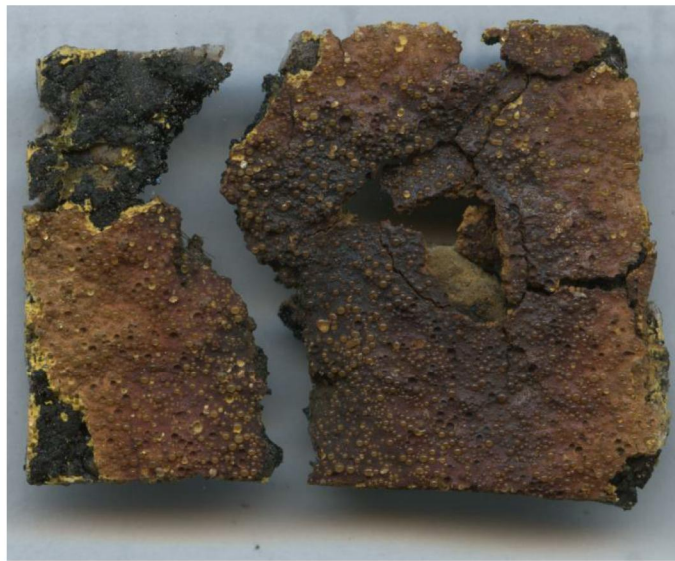
Figure 23 Whitefield paint chip showing large area where staining emerged

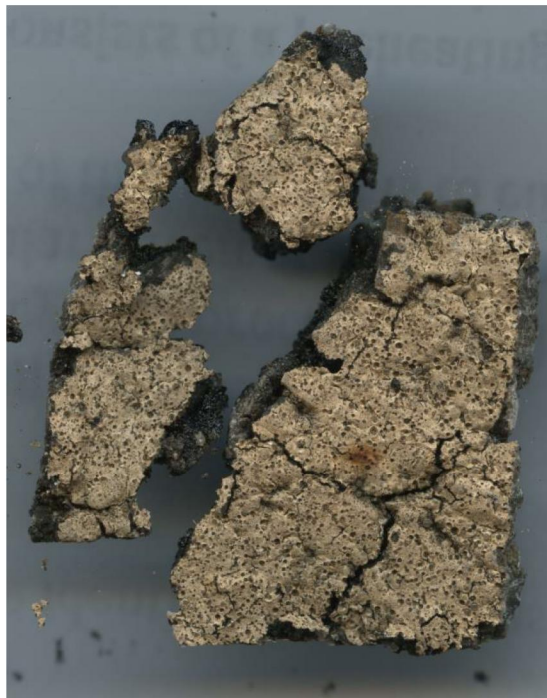
Figure 25 Whitefield paint chip showing small source of staining

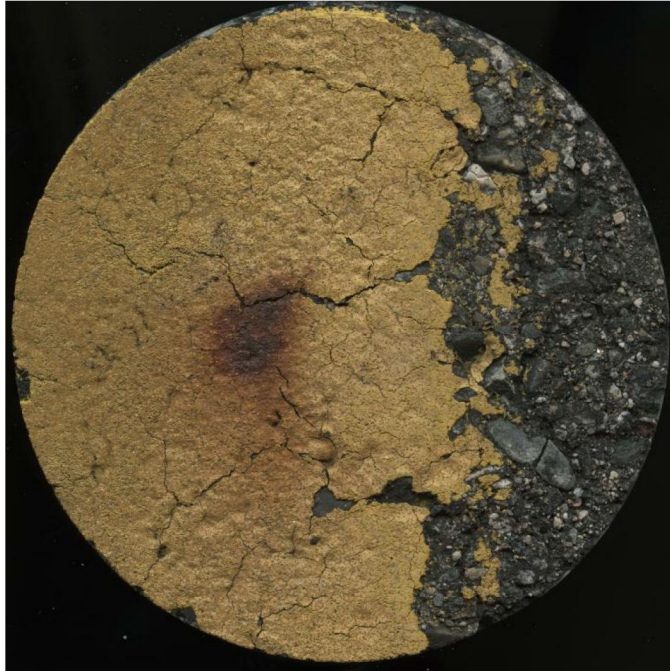
Figure 26 Whitefield core showing source of iron staining

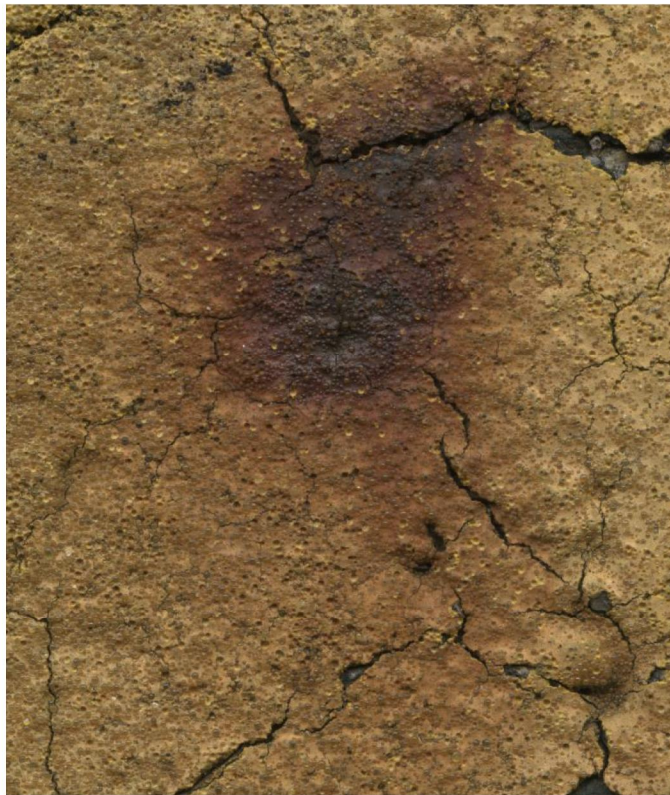
Figure 27 Whitefield close up of Figure 26 note intensity of light color of paint under glass beads lost during coring

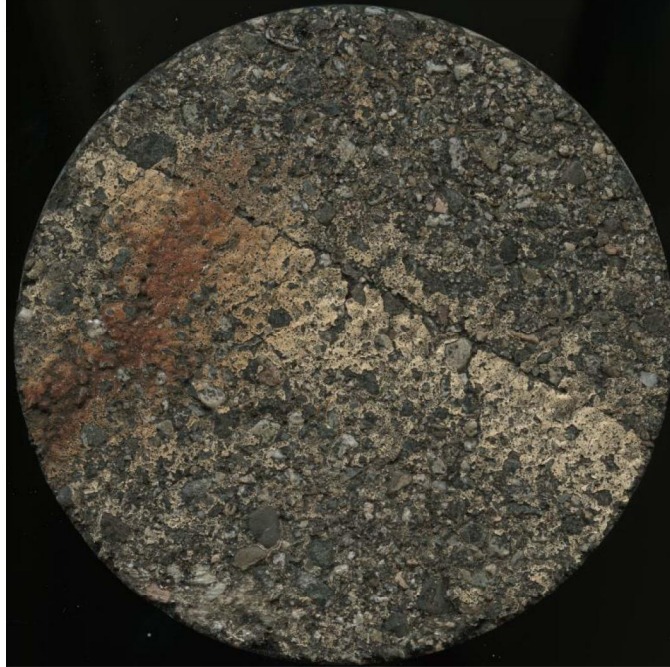
Figure 28 Whitefield core showing staining source

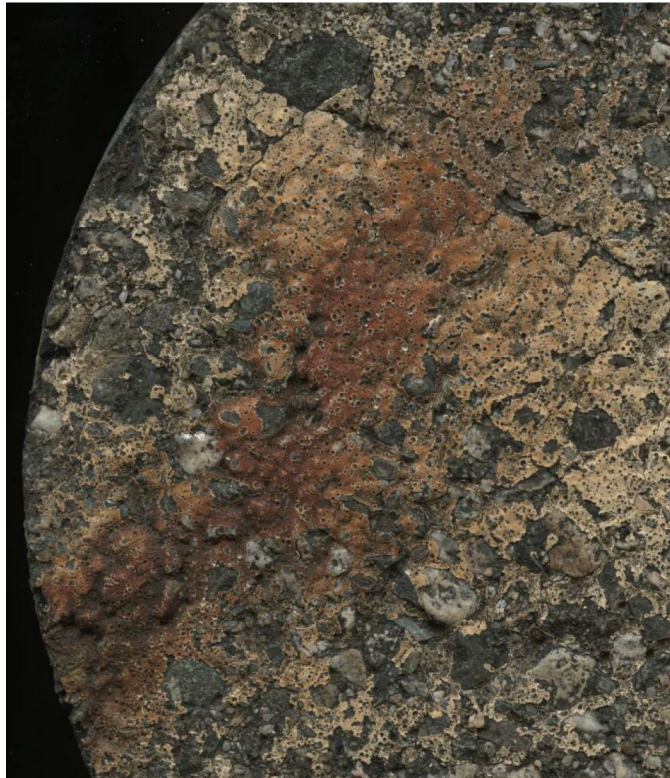
Figure 29 Close up of Figure 28 note degree of heavy staining

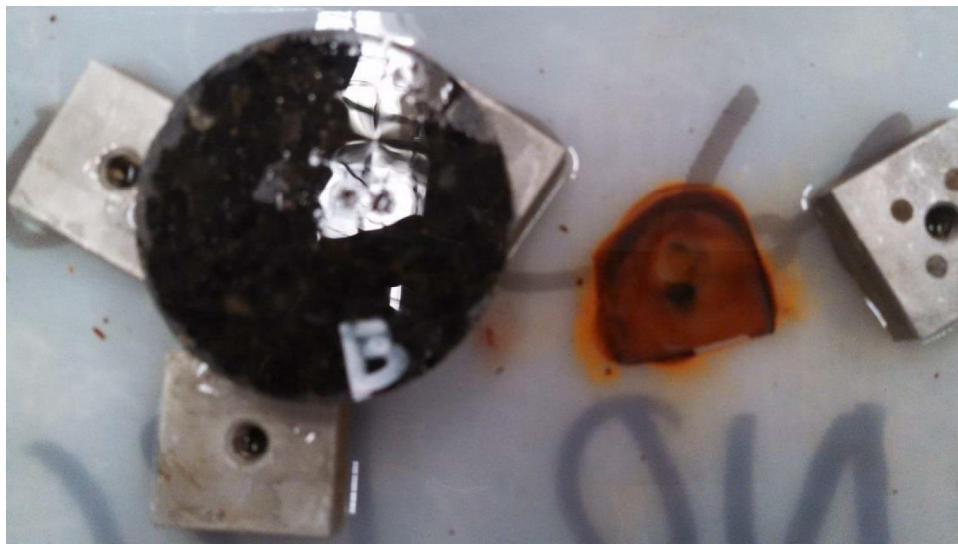
Figure 88 Claremont epoxy disk B/A after 3 months in moist air held at 100 °F (note: rust stain on bottom of plastic container)

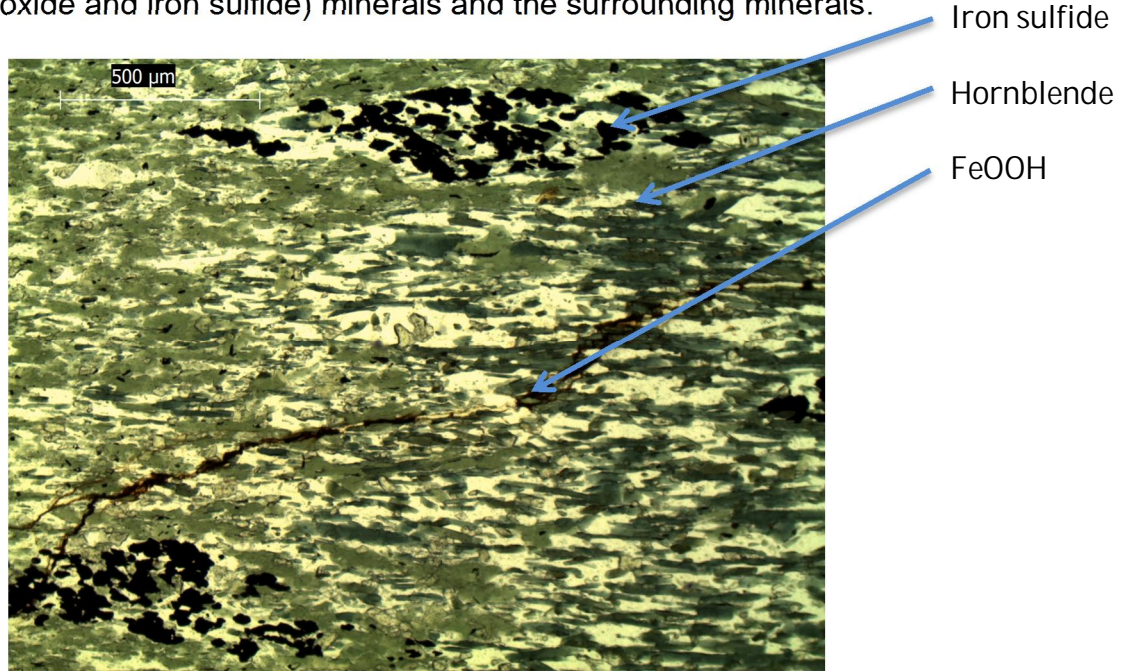
K-1-1 (Sample K-1, fragment 1) Strongly oriented green amphibole, clear quartz and feldspar, poikiloblastic pyrite (black) and cross cutting dark brownish black alteration fracture filling (probably FeOOH). 4X, PPL

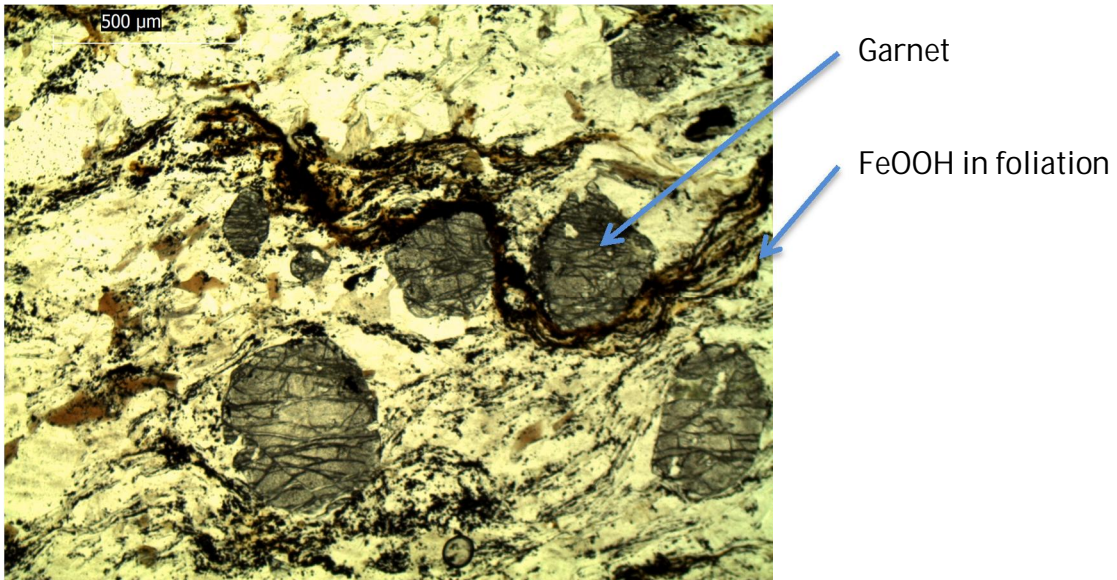
K-6-3 Garnet micaceous quartzite with ~5% opaque (likely magnetite as this fragment is weakly magnetic). Six garnet grains (porphyroblasts) stand out in this image. Biotite foliation is deflected around the garnet grains and is stained by iron oxide hydroxide (FeOOH). 4x, ppl

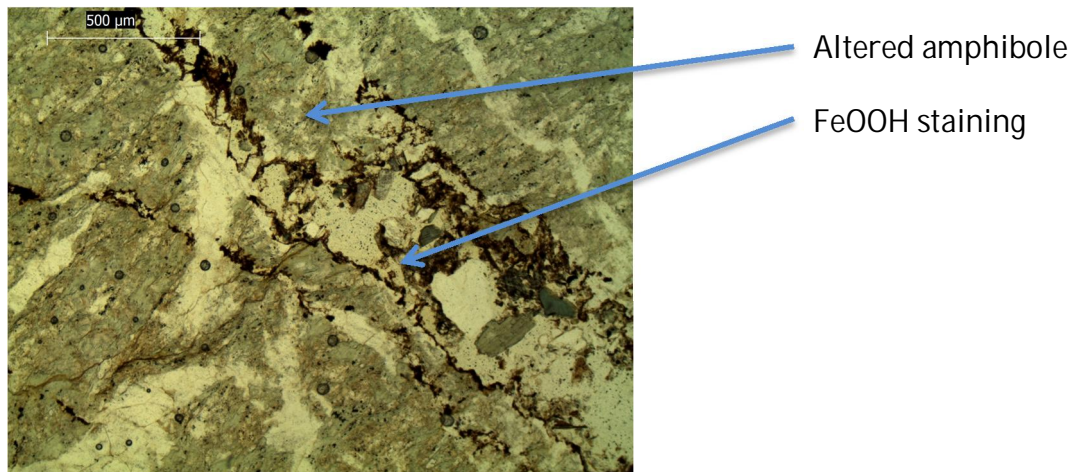
H-1-3 Amphibolite, probably metabasalt of the Ammonoosuc Volcanics, is altered to a chlorite-rich schist. FeOOH staining occurs along grain and vein boundaries. 4x, ppl

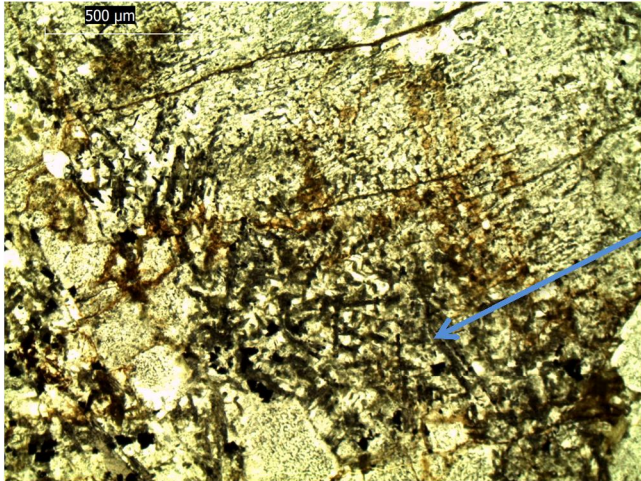
Highly altered zone
with FeOOH staining

H-1-5 Altered metavolcanic porphyry. Coarse plagioclase grains are zoned, mantled, and altered to fine-grained white mica, set in a fine-grained matrix. Ferromagnesian and opaque minerals are altered to iron oxide hydroxide
