Gilford Rapid Bridge Deck Replacement Project Summary

University of New Hampshire
Department of Civil Engineering

2/13/2017

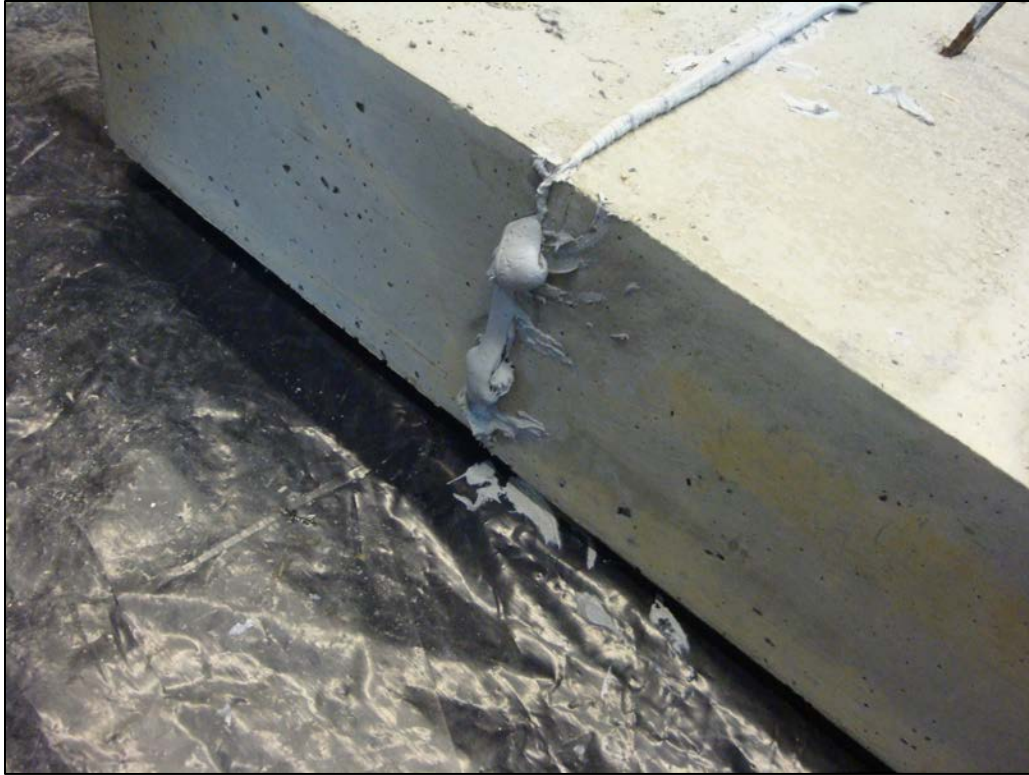
Figure 1 - Polymer forced out of a tested joint following initial joint stressing.

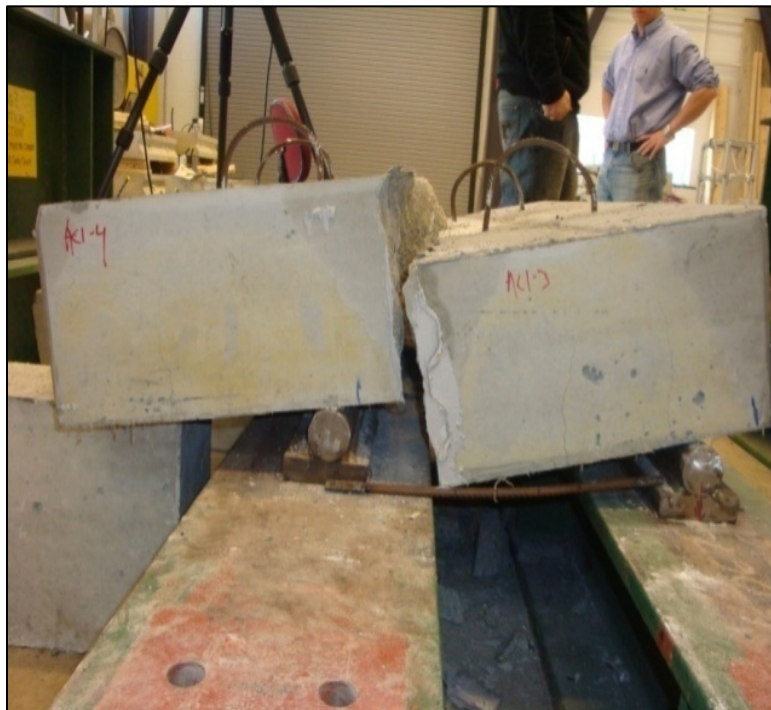
Figure 2 - Tested joint showing failure behind the sealed joint.

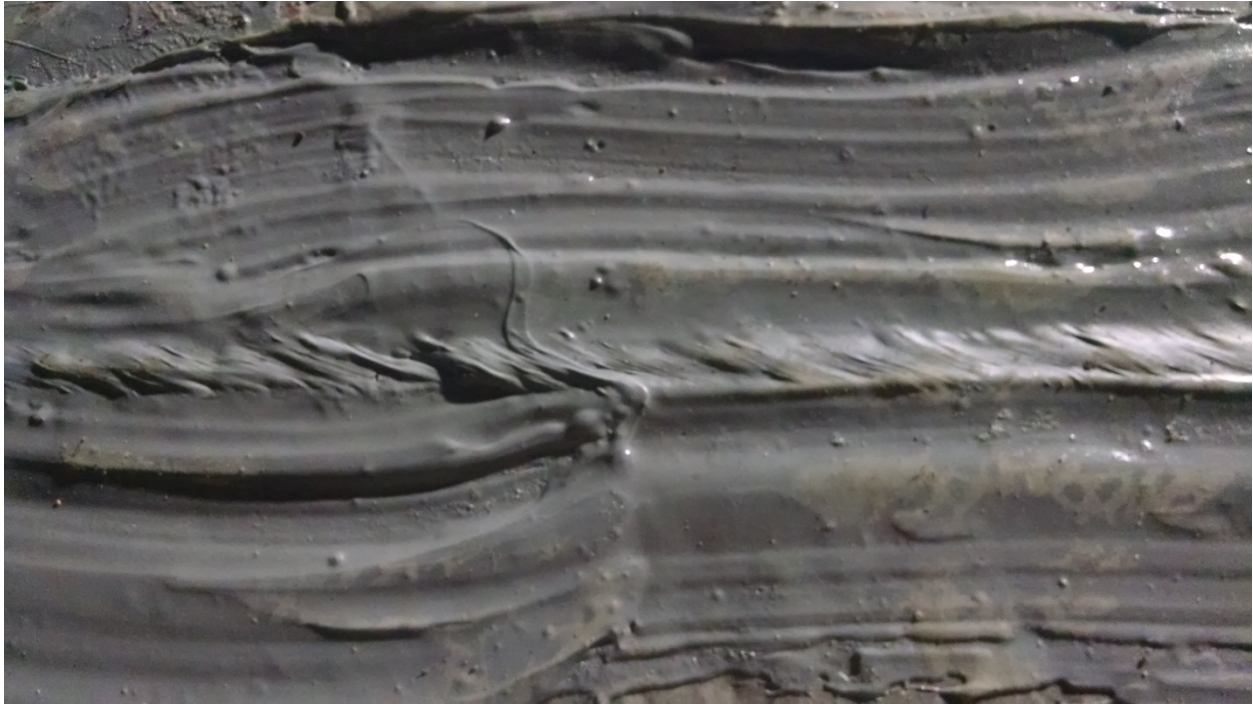
The third panel was set at 12:30 a.m. and the procedure was repeated. Due to crew experience and a greater quantity of applied polymer, a much larger portion of the joint showed excess

polymer being squeezed out after partial post-tensioning indicating improved joint bearing. At this point it was noted that the third panel had drifted to the east by roughly 3/4" after final post-tensioning. The fourth panel was set at 2:45 a.m. and efforts were made to adjust the panel location west and put the deck back on centerline. The crew had difficulty in making the post-tensioning bar couplings and required the panel position to be adjusted by the crane several times to complete them. It was also noted around 3:00 a.m. that striations were appearing in the previously completed joint polymer surfaces indicating lateral deflection due to the post-tensioning load. The fourth panel was mated and initially post-tensioned after a lateral position correction was successfully completed. Due to the previous joint deflections, it was decided to wait two hours before final post-tensioning to allow the polymer to cure longer. Around 5am, alignment marks were placed between panels 3 and 4 to monitor joint deflection as the joint was post-tensioned. A deflection of roughly 1/8" was noted after post-tensioning was completed.

Figure 22 - Joint 1 polymer striation.

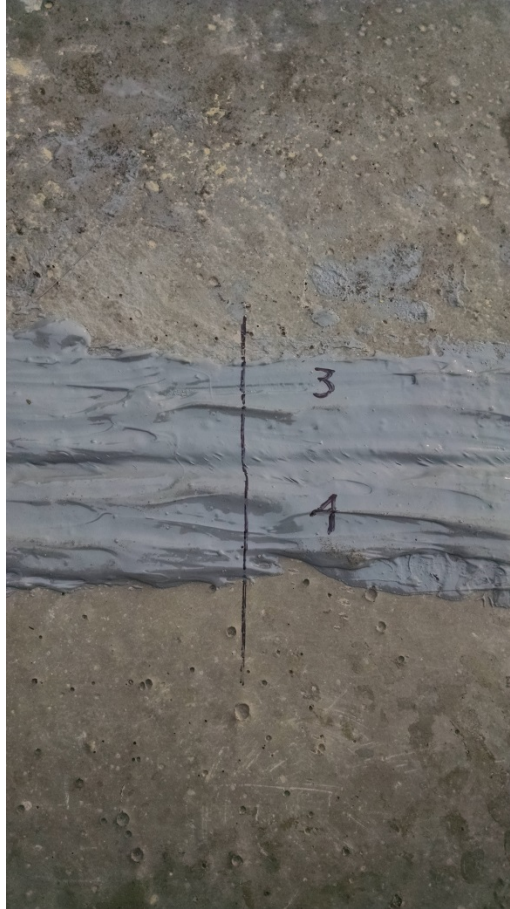
Figure 23 - Panels 3 and 4 joint deflection after post-tensioning (alignment line drawn prior to post-tensioning).

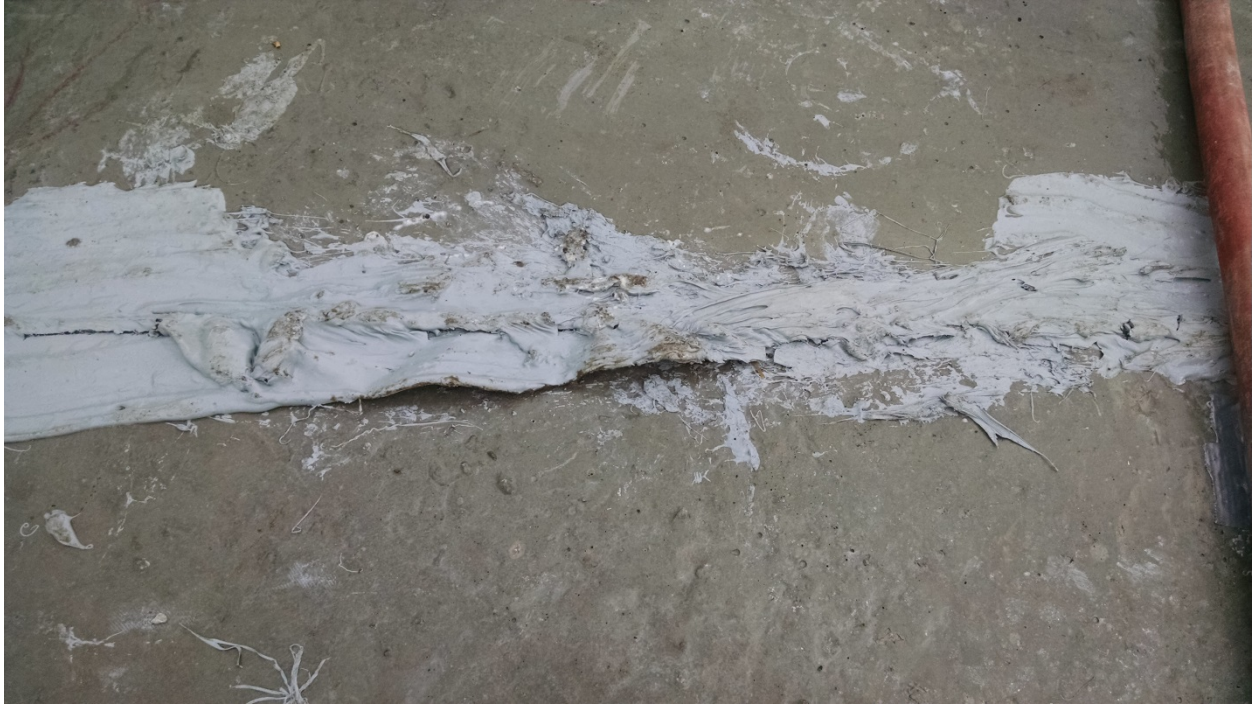
On the morning of June 6th, delamination, separation, and severe striation of the polymer was observed on most of the previously completed joints. The joint between panels 3 and 4, which had experienced the longest polymer curing time prior to final post-tensioning, was in the best visual condition, but the deflection between alignment marks had grown to nearly ½”.

Figure 24 - Polymer delamination due to continued deflection.

The behavior of the skewed joints indicates that post-tensioning loads should only be applied perpendicular to a joint unless shear keys or other mechanical means are provided to resist the lateral reactions. The liquid and semi-liquid polymer appeared to provide a lubricating effect when the panels were initially mated and continued to creep after elastic deformation when final post-tensioning was applied. This appears to show that polymer joint sealants should not be required to resist loads other than pure compression across the joint.

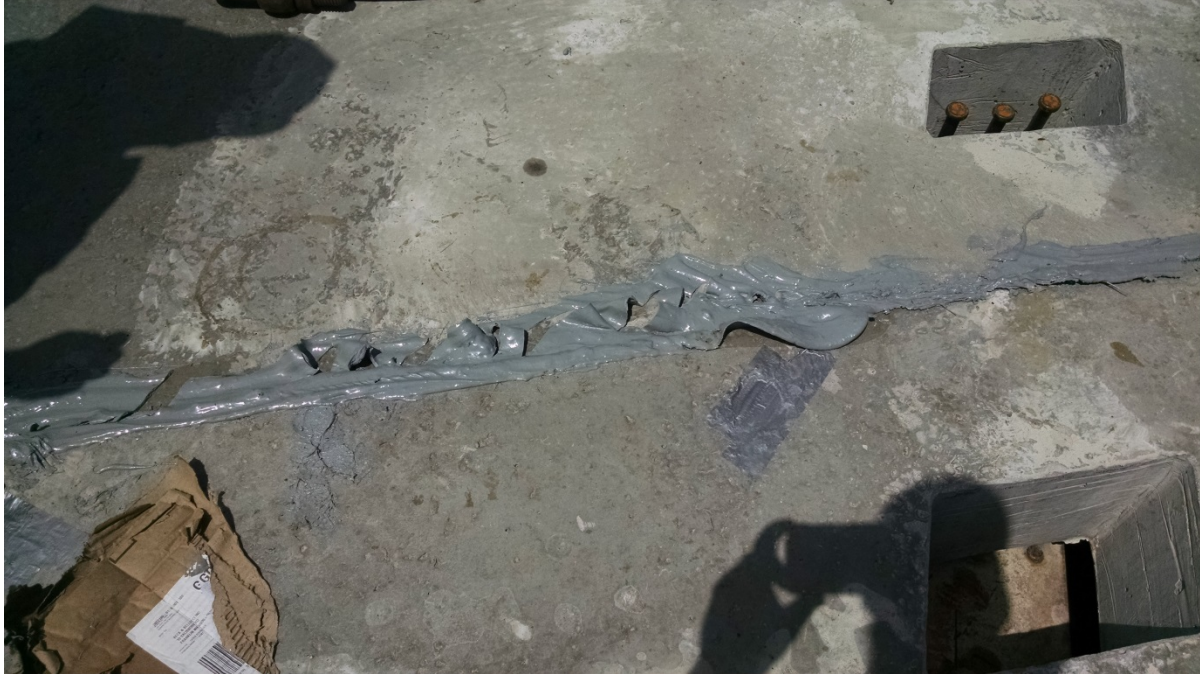
A basic grade check was performed between the staged panel 8 and the existing south approach roadway and was found to be nearly level; the leveling screws on panel 8 having been previously set with the UNH software. Panel 7 was mated with Panel 8 around 9:45 a.m. and the chain jacks were again used to compensate for lateral slippage. Alignment marks were made prior to initial post-tensioning and showed nearly ¼” of eastward deflection after initial post-tensioning. Panel 8 was mated at 12:15 p.m. After final post-tensioning of panel 8, the deflection between panels 6 and 7 grew to nearly ¾”. After final post-tensioning, the deflection was roughly 1 inch from the panel alignment when initially mated. At this time, significant failure of several previous joints was observed as lateral striations in the polymer broke into gaps of up to 1 inch.

Figure 25 - Apparent joint failure with large surface deformation and polymer break-up.

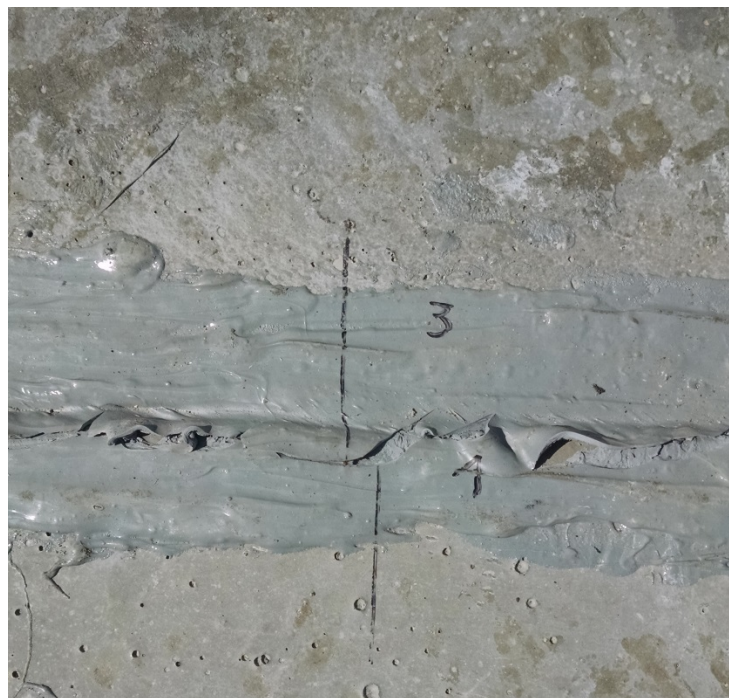
Panel 9 was hoisted to the bridge at 12:30 p.m. A section of the panel 6 surface was found to have spalled at the joint with panel 7 due to apparent uneven bearing between the panels and a resulting stress concentration. At 3:20 p.m., the joint between panels 3 and 4 was observed to have apparently failed with a total deflection of over 1 inch.

Figure 26 - Apparent failure of the Panels 3 and 4 joint (3:20pm 6/6/16).

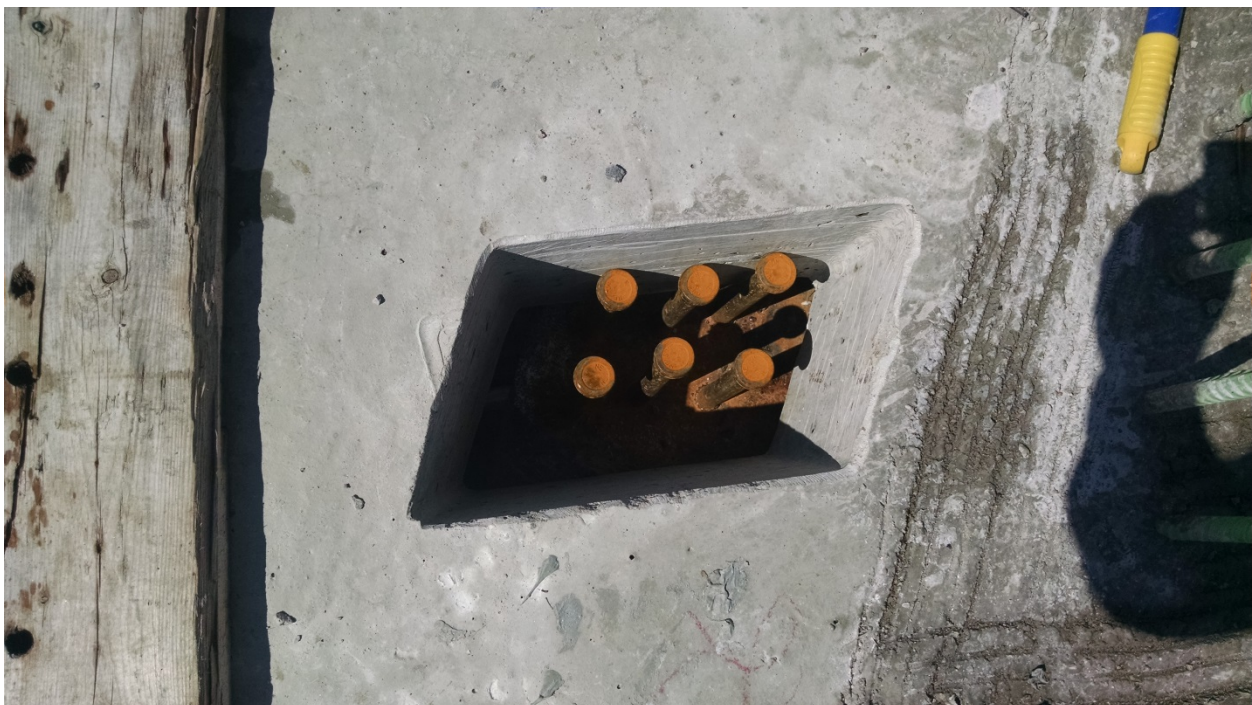
On the afternoon of June 7th, and prior to grouting, a “bang” was reported followed by noticeable movement of previously welded shear connector groups on the east side of the bridge to positions against the north side of their pockets. After evaluation of the residual post-tensioning force, which was determined to have been likely completely relieved, it was determined that the deflection was likely due to differential thermal expansion. The deflected shear connector groups were observed only on the northern end of the bridge, which is the expansion bearing end, and on the side of the bridge in sunlight for most of the day. Additionally, the deflections were in the range expected for the temperature fluctuations the bridge experienced over the previous 24 hours.

Figure 27 - Shear connector group after apparent girder expansion prior to grouting.
