**EVALUATION OF THE CRASHWORTHINESS OF THIN-WALLED  
ALUMINUM AND STEEL U-CHANNEL SIGN SUPPORTS**

TTI Project No. 405231-1F  
Final Report

June 1995

**Texas Transportation Institute  
Texas A&M University System  
College Station, TX 77843**

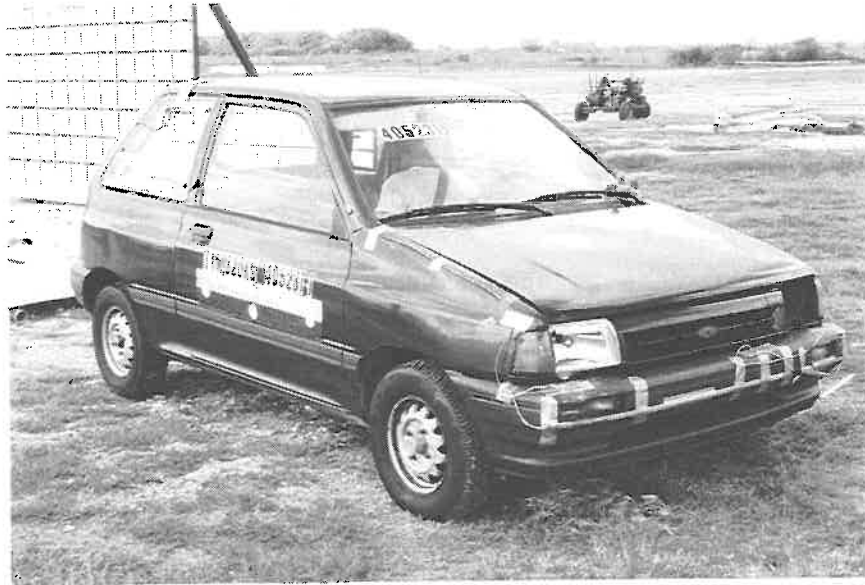
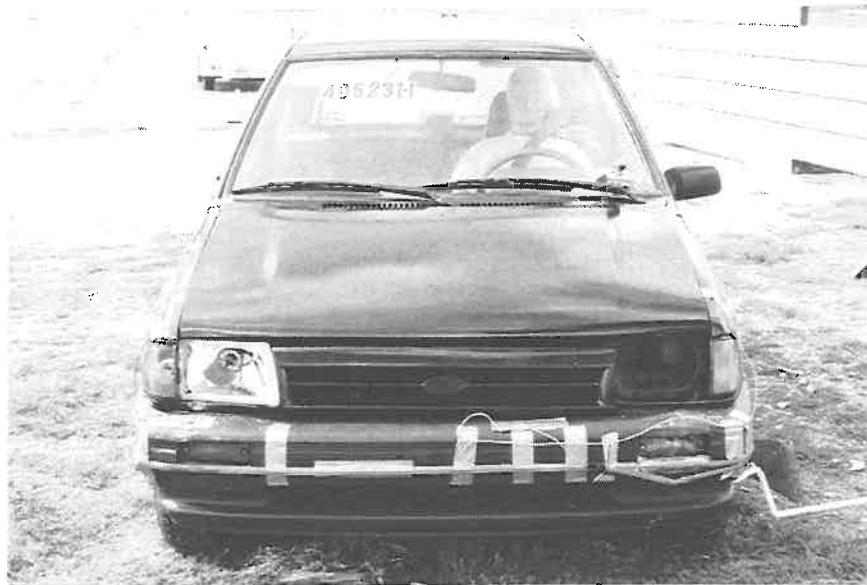
Figure 13 . Vehicle after test 405231-1.

reused in field renovation of this installation. Damage sustained by the vehicle during this test is shown in Figure 13. The vehicle sustained primarily cosmetic damage to the bumper and hood. The headlights were broken during the test, but the vehicle sustained no permanent deformation to the sheet metal. There was no deformation to the vehicle occupant compartment.

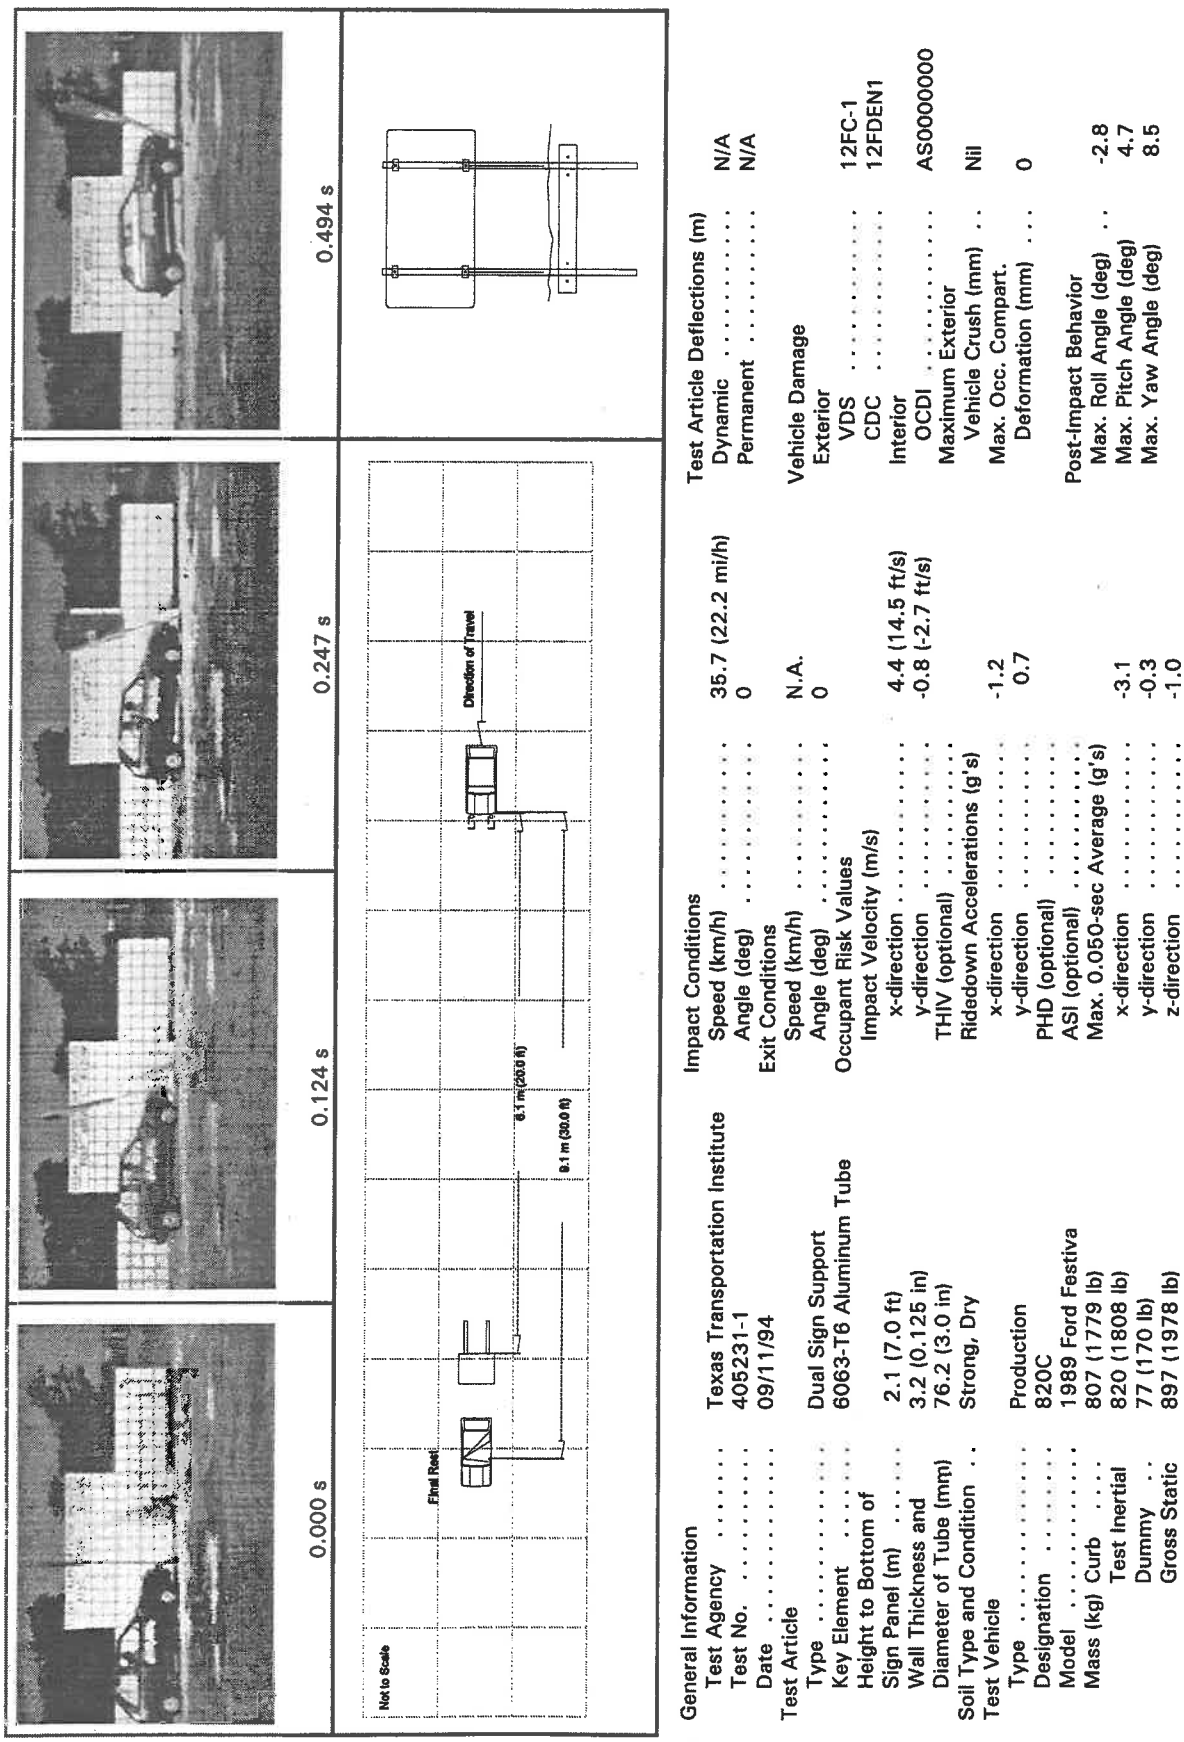
Figure 14. Summary of results for test 405231-1.

General Information		Impact Conditions		Test Article Deflections (m)	
Test Agency	Texas Transportation Institute	Speed (km/h)	35.7 (22.2 mi/h)	Dynamic	N/A
Test No.	405231-1	Angle (deg)	0	Permanent	N/A
Date	09/11/94	Exit Conditions		Vehicle Damage	
Test Article		Speed (km/h)	N.A.	Exterior	
Type	Dual Sign Support	Angle (deg)	0	VDS	12FC-1
Key Element	6063-T6 Aluminum Tube	Occupant Risk Values		CDC	12FDEN1
Height to Bottom of Sign Panel (m)	2.1 (7.0 ft)	Impact Velocity (m/s)		Interior	
Wall Thickness and Diameter of Tube (mm)	3.2 (0.125 in) 76.2 (3.0 in)	x-direction	4.4 (14.5 ft/s)	OCDI	AS00000000
Soil Type and Condition	Strong, Dry	y-direction	-0.8 (-2.7 ft/s)	Maximum Exterior Vehicle Crush (mm)	Nil
Test Vehicle		THIV (optional)		Max. Occ. Compart.	0
Type	Production	Ridedown Accelerations (g's)		Deformation (mm)	0
Designation	820C	x-direction	-1.2	Post-Impact Behavior	
Model	1989 Ford Festiva	y-direction	0.7	Max. Roll Angle (deg)	-2.8

B. The test article should readily activate in a predictable manner by breaking away, fracturing, or yielding.	The sign supports yielded by bending the aluminum tubes at ground level and fracturing in tension near bumper level.	Pass
<u>Occupant Risk</u>

D. Detached elements should not penetrate the occupant compartment, or present an undue hazard to other traffic, pedestrians, or personnel in a work zone. Deformations of the occupant compartment that could cause serious injuries should not be permitted.	The sign supports fractured but <b>did not</b> present a hazard to other travel lanes. There was <b>no</b> deformation of or intrusion into the occupant compartment.	Pass

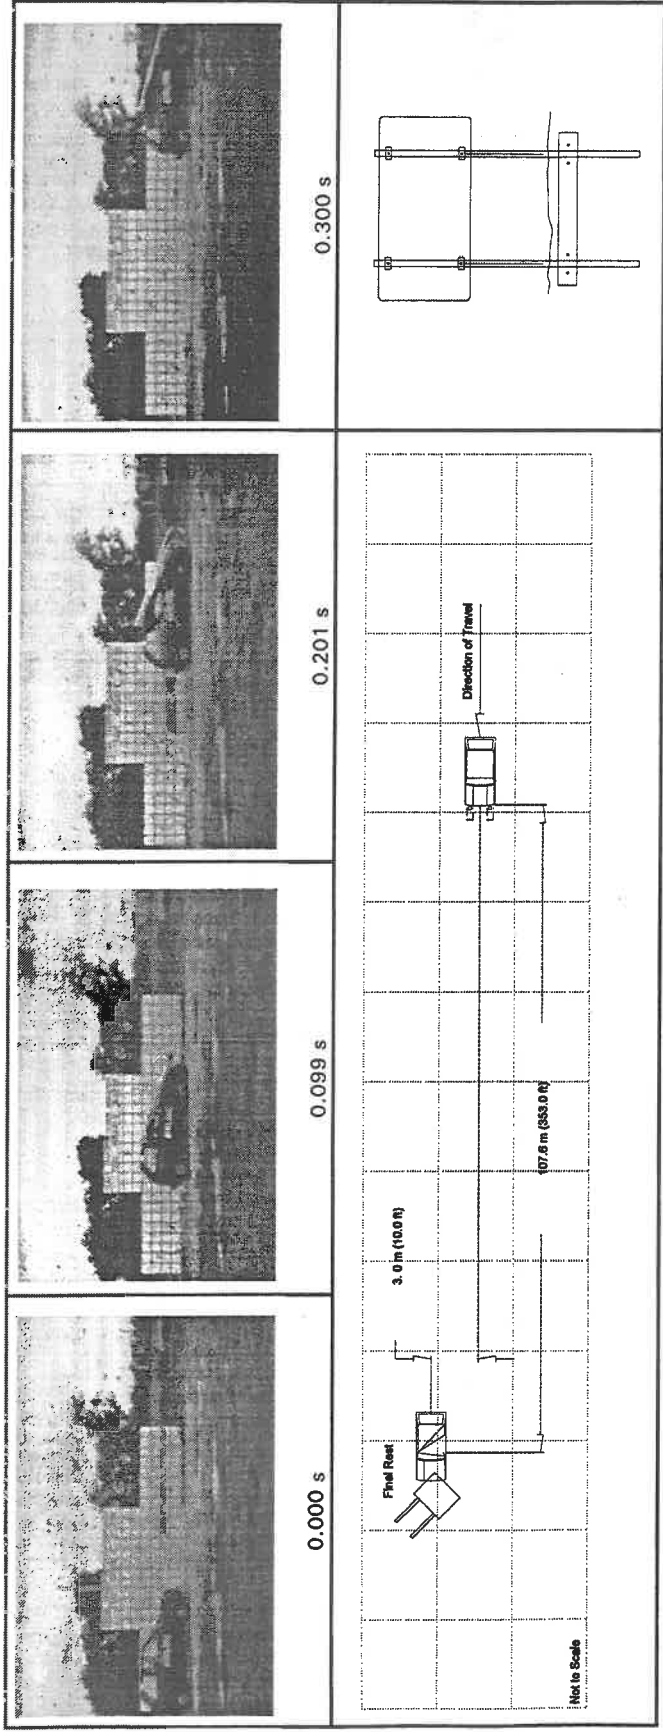
<b>General Information</b>	Texas Transportation Institute	Impact Conditions	Speed (km/h) . . . . .	99.9 (62.1 mi/h)	Test Article Deflections (m)	Dynamic . . . . .	N/A
Test Agency . . . . .	405231-2	Angle (deg) . . . . .	0	0	Permanent . . . . .	N/A	
Test No. . . . .	09/11/94	Exit Conditions	Speed (km/h) . . . . .	83.7 (52.0 mi/h)	Vehicle Damage		
Date . . . . .		Angle (deg) . . . . .	0	0	Exterior		
Test Article	Dual Sign Support	Occupant Risk Values	Impact Velocity (m/s)		VDS . . . . .	12FC-1	
Type . . . . .	6063-T6 Aluminum Tube	x-direction . . . . .	4.2 (13.8 ft/s)		CDC . . . . .	12FDEN1 & 12TDDW3	
Key Element . . . . .	2.1 (7.0 ft)	y-direction . . . . .	-1.3 (-4.4 ft/s)		Interior		
Height to Bottom of	3.2 (0.125 in)	THIV (optional) . . . . .			OCDI . . . . .	FS0200000	
Sign Panel (m) . . . . .	76.2 (3.0 in)	Ridedown Accelerations (g's)	x-direction . . . . .	-1.3	Maximum Exterior		
Wall Thickness and	Strong, Dry	x-direction . . . . .	y-direction . . . . .	1.0	Vehicle Crush (mm) . . . . .	10 (0.4 in)

B.	The test article should readily activate in a predictable manner by breaking away, fracturing, or yielding.	The sign supports yielded by bending the aluminum tubes at ground level and fracturing in tension near bumper level.		Pass	
<b>Occupant Risk</b>

D.	Detached elements should not penetrate the occupant compartment, or present an undue hazard to other traffic, pedestrians, or personnel in a work zone. Deformations of the occupant compartment that could cause serious injuries should not be permitted.	The sign supports fractured but did not present a hazard to other travel lanes. There was deformation of the front portion of the occupant compartment, but no actual intrusion into the compartment.		Pass

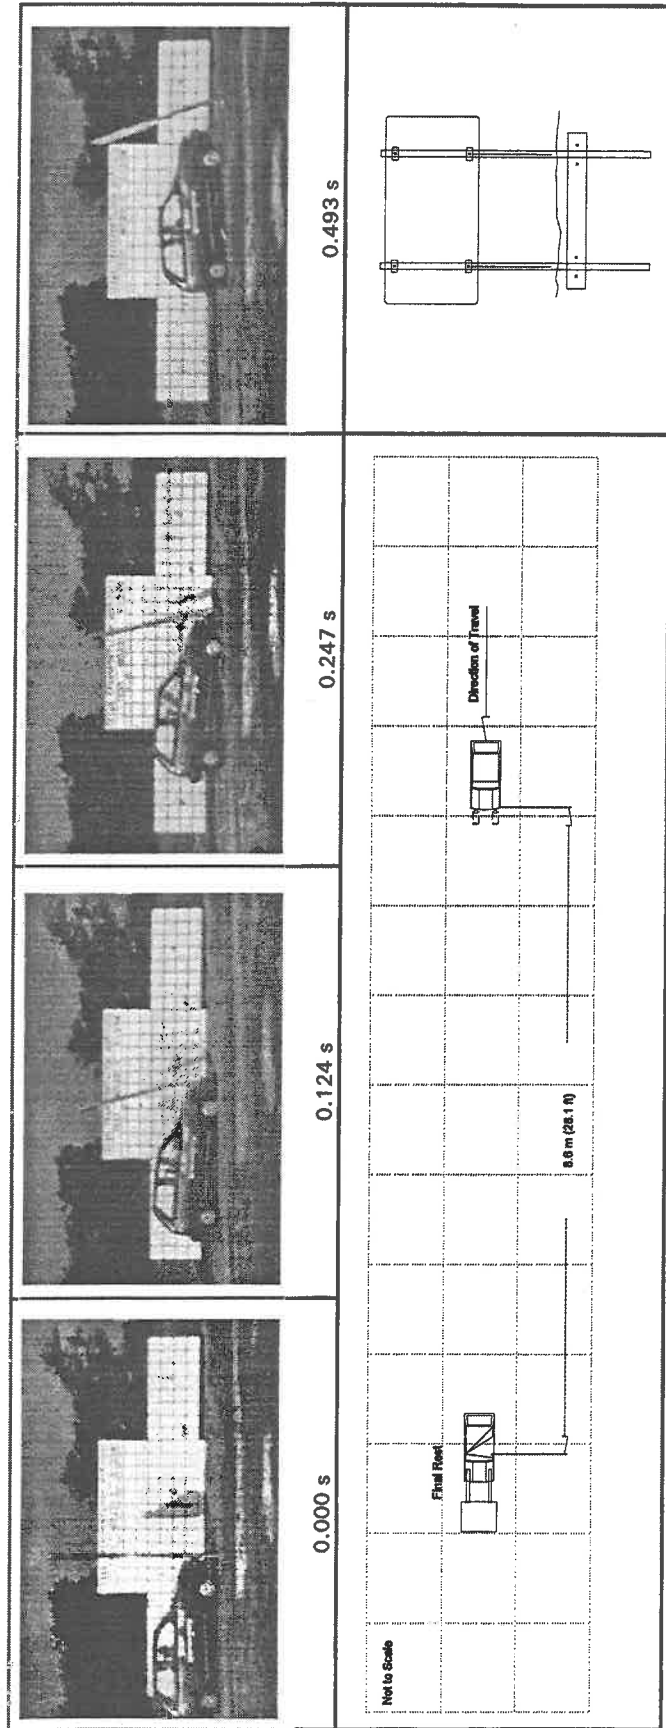
General Information		Texas Transportation Institute		Impact Conditions		Test Article Deflections (m)	
Test Agency	405231-3	Speed (km/h)	34.5 (21.4 mi/h)	Dynamic	N/A	Vehicle Damage	N/A
Test No.	09/13/94	Angle (deg)	0	Exit Conditions	N/A	Exterior	N/A
Date		Speed (km/h)	18.0 (11.2 mi/h)	Occupant Risk Values		VDS	12FC-1
Test Article		Angle (deg)	0	Impact Velocity (m/s)		CDC	12FDEN1
Type	Dual Sign Support	Occupant Risk Values		x-direction	4.7 (15.6 ft/s)	Interior	
Key Element	6063-T6 Aluminum Tube	Impact Velocity (m/s)		y-direction	N/A	OCDI	AS0000000
Height to Bottom of Sign Panel (m)	2.1 (7.0 ft)	x-direction		THIV (optional)		Maximum Exterior	
Wall Thickness and Diameter of Tube (mm)	3.2 (0.125 in) 76.2 (3.0 in)	y-direction		Ridedown Accelerations (g/s)		Vehicle Crush (mm)	Nil
Soil Type and Condition	Weak, Dry	x-direction		x-direction	-0.6	Max. Occ. Compant.	Nil
Test Vehicle		y-direction		y-direction	No contact	Deformation (mm)	Nil

B.	The test article should readily activate in a predictable manner by breaking away, fracturing, or yielding.	The sign supports yielded by bending the aluminum tubes at ground level and fracturing in tension near bumper level.		Pass	
<u>Occupant Risk</u>

D.	Detached elements should not penetrate the occupant compartment, or present an undue hazard to other traffic, pedestrians, or personnel in a work zone. Deformations of the occupant compartment that could cause serious injuries should not be permitted.	The sign supports fractured but did not present a hazard to other travel lanes. There was no deformation of or intrusion into the occupant compartment.		Pass

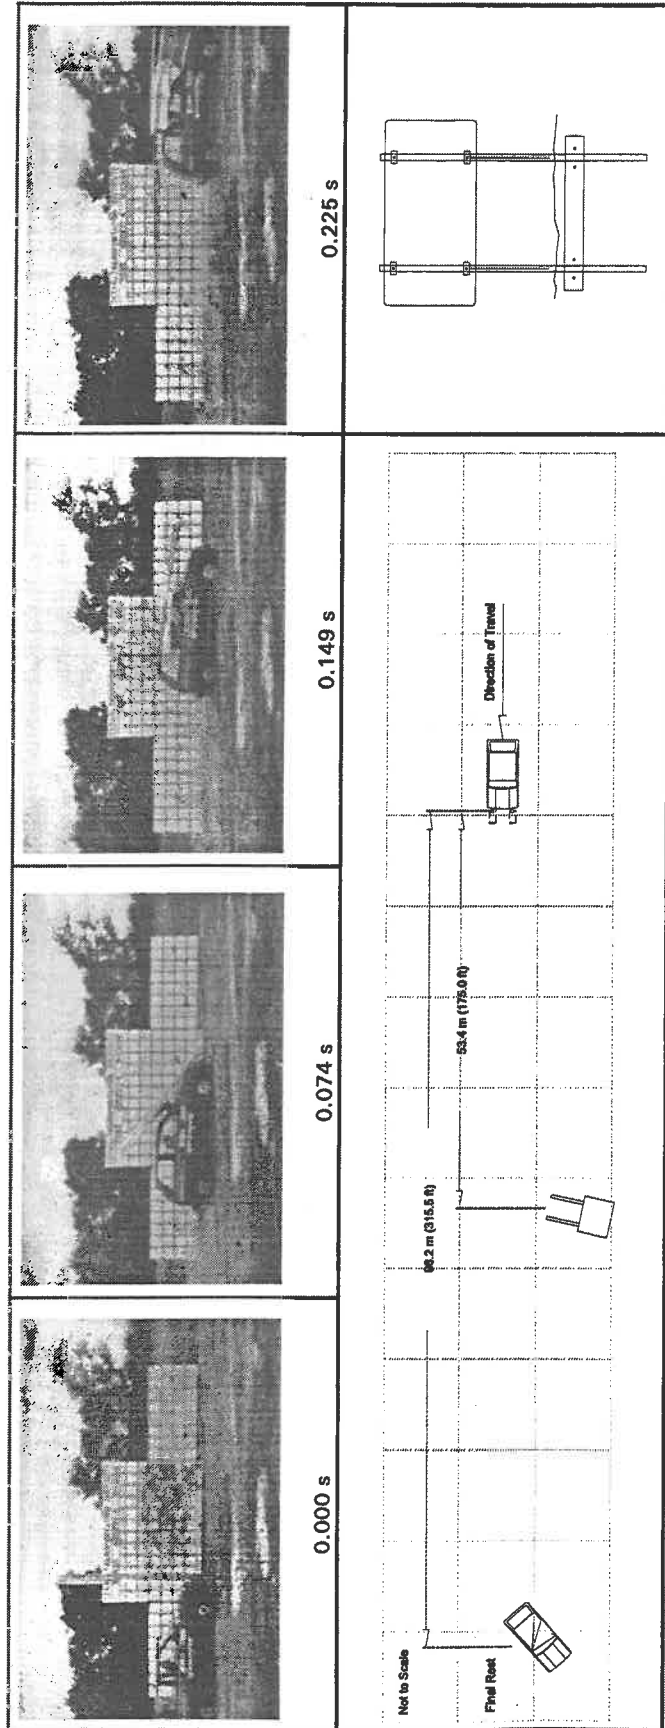
General Information		Impact Conditions		Test Article Deflections (m)	
Test Agency	Texas Transportation Institute	Speed (km/h)	103.3 (64.2 mi/h)	Dynamic	N/A
Test No.	405231-4	Angle (deg)	0	Permanent	N/A
Date	09/13/94	Exit Conditions		Vehicle Damage Exterior	12FC-1
Test Article	Dual Sign Support	Speed (km/h)	90.7 (56.3 mi/h)	VDS	12FDEN1 & 12TDDW3
Key Element	6063-T6 Aluminum Tube	Angle (deg)	0	CDC	
Height to Bottom of Sign Panel (m)	2.1 (7.0 ft)	Occupant Risk Values		Interior	FS0100000
Wall Thickness and Diameter of Tube (mm)	3.2 (0.125 in) / 76.2 (3.0 in)	Impact Velocity (m/s)		Maximum Exterior	
Soil Type and Condition	Weak, Dry	x-direction	3.7 (12.3 ft/s)	Vehicle Crush (mm)	30 (1.2 in)
Test Vehicle		y-direction	1.2 (3.9 ft/s)	Max. Occ. Compar.	90 (3.5 in)
Type	Production	THIV (optional)		Deformation (mm)	
Designation	820C	Ridedown Accelerations (g's)		Post-impact Behavior	
Model	1989 Ford Festiva	x-direction	-1.0	Max. Roll Angle (deg)	5.1

B.	The test article should readily activate in a predictable manner by breaking away, fracturing, or yielding.	The sign supports yielded by bending the aluminum tubes at ground level and fracturing in tension near bumper level.	Pass
<b>Occupant Risk</b>

D.	Detached elements should not penetrate the occupant compartment, or present an undue hazard to other traffic, pedestrians, or personnel in a work zone. Deformations of the occupant compartment that could cause serious injuries should not be permitted.	The sign supports fractured but <b>did not</b> present a hazard to other travel lanes. There was deformation of the front portion of the occupant compartment, but no actual intrusion into the compartment.	Pass

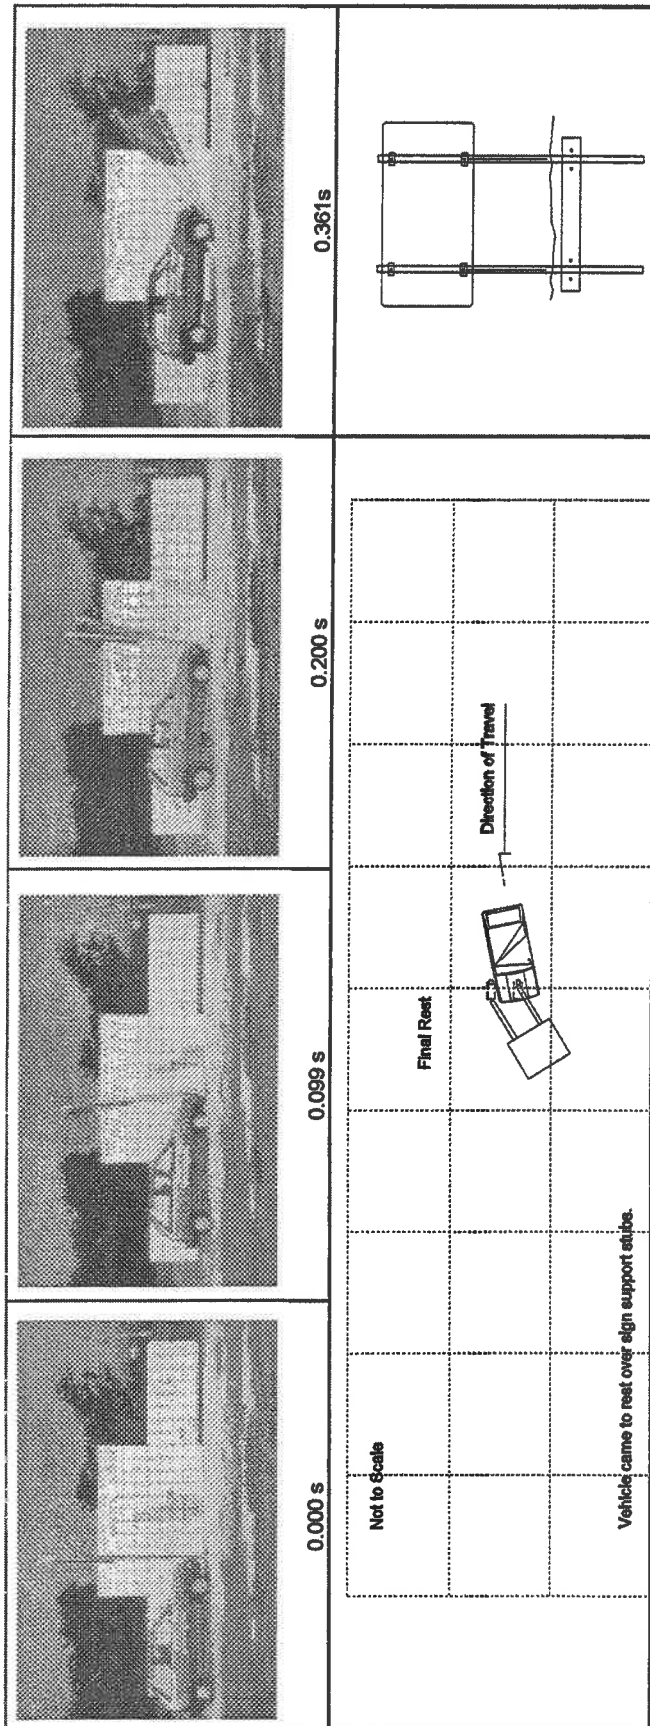
General Information		Impact Conditions		Test Article Deflections (m)	
Test Agency	Texas Transportation Institute	Speed (km/h)	36.1 (22.4 mi/h)	Dynamic	N/A
Test No.	405231-5	Angle (deg)	0	Permanent	N/A
Date	09/15/94	Exit Conditions		Vehicle Damage Exterior	
Test Article	Dual Sign Support	Speed (km/h)	10.8 (6.7 mi/h)	VDS	12FC-1
Type	6063-T6 Aluminum Tube	Angle (deg)	0	CDC	12FDEN1
Key Element		Occupant Risk Values		Interior	
Height to Bottom of Sign Panel (m)	2.1 (7.0 ft)	Impact Velocity (m/s)	7.1 (23.2 ft/s)	OCDI	AS0000000
Wall Thickness and Diameter of Tube (mm)	3.2 (0.125 in) / 101.6 (4.0 in)	x-direction	N/A	Maximum Exterior	
Soil Type and Condition	Strong, Dry	y-direction	-4.3	Max. Occ. Compart.	Nil
Test Vehicle	Production	THIV (optional)	No Contact	Deformation (mm)	Nil
Type	820C	Ridedown Accelerations (g's)		Post-Impact Behavior	
Designation	1988 Ford Festiva	x-direction	-5.2	Max. Roll Angle (deg)	5.1

Test No.: 405231-5	Test Date: 09/13/94	Test Agency: Texas Transportation Institute
Evaluation Criteria	Test Results	Assessment
<p><u>Structural Adequacy</u></p>		
<p>B. The test article should readily activate in a predictable manner by breaking away, fracturing, or yielding.</p>	<p>The right sign support yielded by bending the aluminum tube at ground level and fracturing in tension near bumper level. The left support bent at ground level, and only fractured part of the cross-section in tension.</p>	<p>Fail</p>
<p><u>Occupant Risk</u></p>		
<p>D. Detached elements should not penetrate the occupant compartment, or present an undue hazard to other traffic, pedestrians, or personnel in a work zone. Deformations of the occupant compartment that could cause serious injuries should not be permitted.</p>	<p>The sign supports yielded and <b>did not</b> present a hazard to other travel lanes. There was <b>no</b> deformation of or intrusion into the occupant compartment.</p>	<p>Pass</p>

<p>F. The vehicle should remain upright during and after collision although moderate roll, pitching and yawing are acceptable.</p>	<p>The vehicle remained upright and stable throughout the test period.</p>	<p>Pass</p>
<p>H. Occupant impact velocities should satisfy the following:</p>		
<p>Occupant Impact Velocity Limits (m/s)</p>	<p>Longitudinal occupant impact velocity: 7.1 m/s (23.2 ft/s)</p>	<p>Fail</p>
<p>Component</p>	<p>Preferred</p>	<p>Maximum</p>
<p>Longitudinal and Lateral</p>	<p>3</p>	<p>5</p>
<p>I. Occupant ridedown accelerations should satisfy the following</p>	<p>Lateral occupant impact velocity: N/A</p>	
<p>Occupant Ridedown Acceleration Limits (G's)</p>	<p>Longitudinal Occupant Ridedown Acceleration: -4.3 g's</p>	<p>Pass</p>
<p>Component</p>	<p>Preferred</p>	<p>Maximum</p>
<p>Longitudinal and Lateral</p>	<p>15</p>	<p>20</p>
<p><u>Vehicle Trajectory</u></p>		
<p>K. After collision it is preferable that the vehicle's trajectory not intrude into adjacent traffic lanes.</p>	<p>The vehicle trajectory was judged to be acceptable.</p>	<p>Pass</p>
