**BUREAU OF MATERIALS & RESEARCH**

**EXPERIMENTAL FEATURE 2004-2 and 2005-2  
Poly-Carb Flexogrid Bridge Deck Overlay System and Stirling Lloyd SafeTrack HW**

**Interim Report**

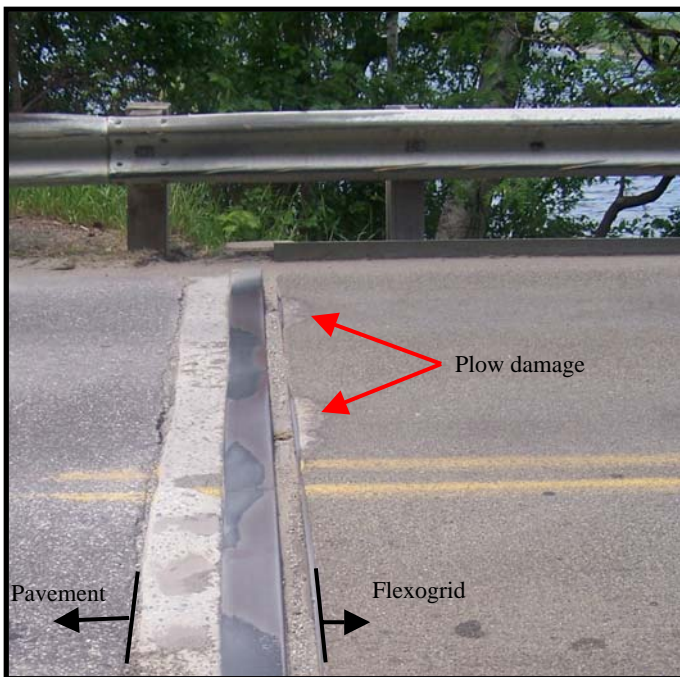
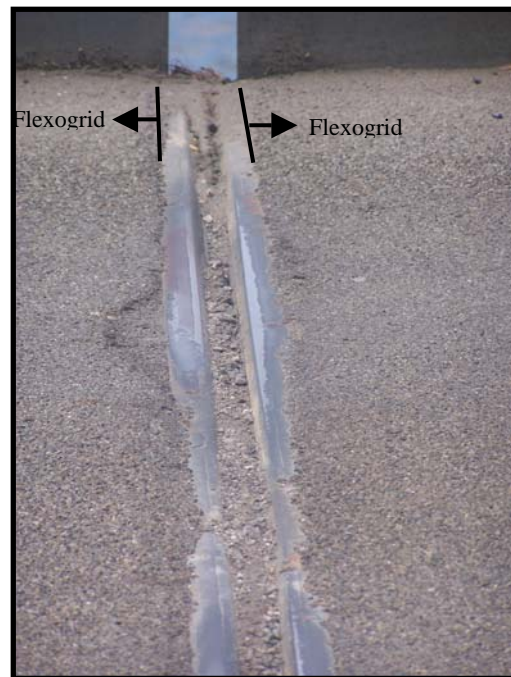
Although it appears that the majority of the Poly-Carb product is still in good condition, there has been some snowplow damage at expansion joints (see Figures 6 and 7). This loss is most likely due to the fact that the overlay was not inset at the joint but rather was applied over the existing deck surface and onto the top surface of the expansion joint as shown in Figure 8. Efforts were made to prevent the overlay material from running into the opening of the expansion joint. This left an unprotected edge of overlay material that could be snagged by snowplows.

Figure 6 – Flexogrid snowplow damage

Figure 7 – Flexogrid snowplow damage

Visual inspection of the Poly-Carb Mark-163 Flexogrid Bridge Deck Overlay system revealed that the overlay has been damaged by snowplows at the expansion joints. The overlay was placed over the edge of the expansion joint as shown in Figure 8, and it is expected that this type of damage could be avoided by inseting the overlay at the expansion joint to obtain a flush finish.

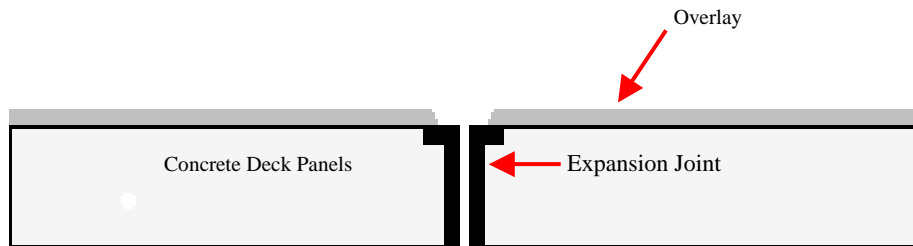
Figure 8 – Overlay at expansion joint

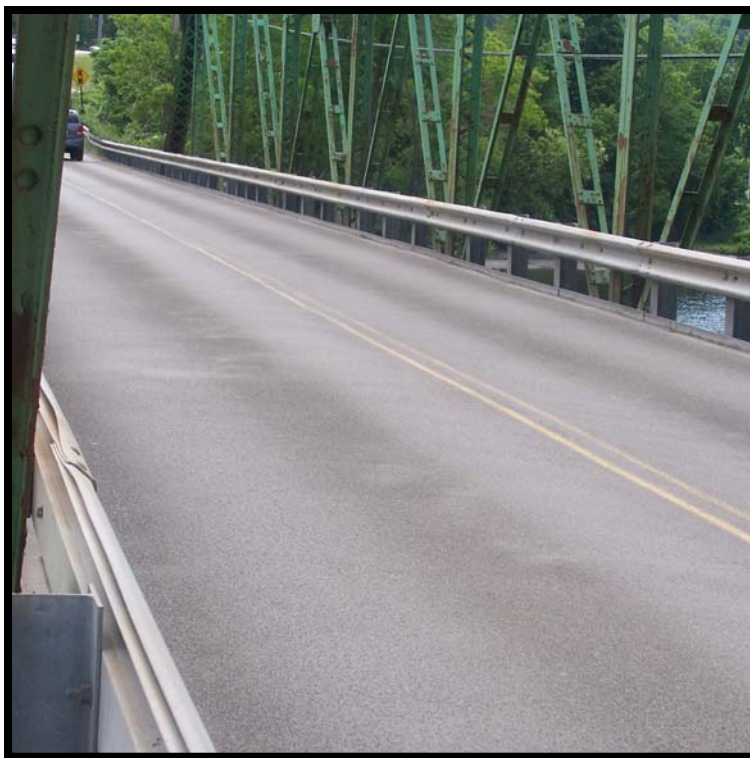
Between expansion joints, the overlay aggregate shows some signs of wear in that the surface appears to be discolored in the wheel paths (see Figure 9). Although this wear may indicate some loss of skid resistance, it did not seem to be slippery under foot or when subjected to normal driving actions.

Figure 9 – Flexogrid aggregate wear in wheel path

The surface of the Poly-Carb overlay shows some wear in the wheel paths, but no apparent loss of traction.

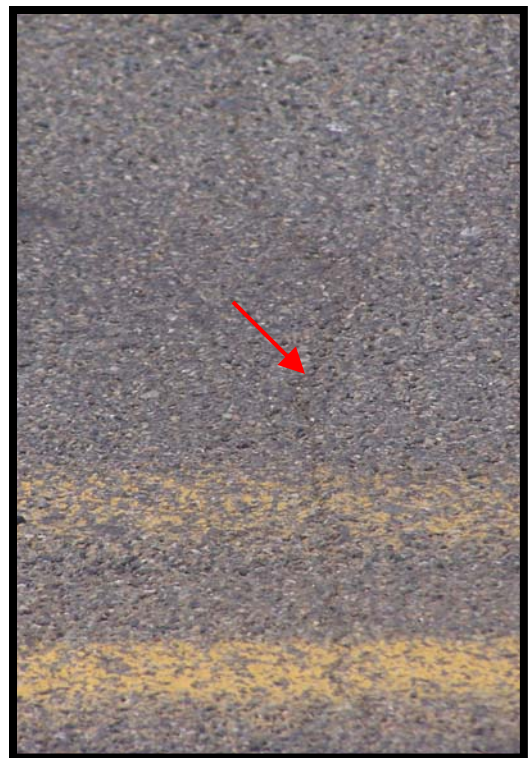
Figure 10 – Flexogrid cracking

There are several fine cracks in the overlay as shown in Figure 10. It is not clear if these cracks are reflective cracks over the joints in the bridge deck system, but this may be the case. The cracks are tight and there does not appear to be any loss of overlay material at these locations.

Fine, widely spaced cracks were observed in the overlay. These cracks may have reflected up from the joints between precast deck slabs. An underside inspection is recommended to determine if the cracks align with the panel joints or if any leakage is occurring in these areas.

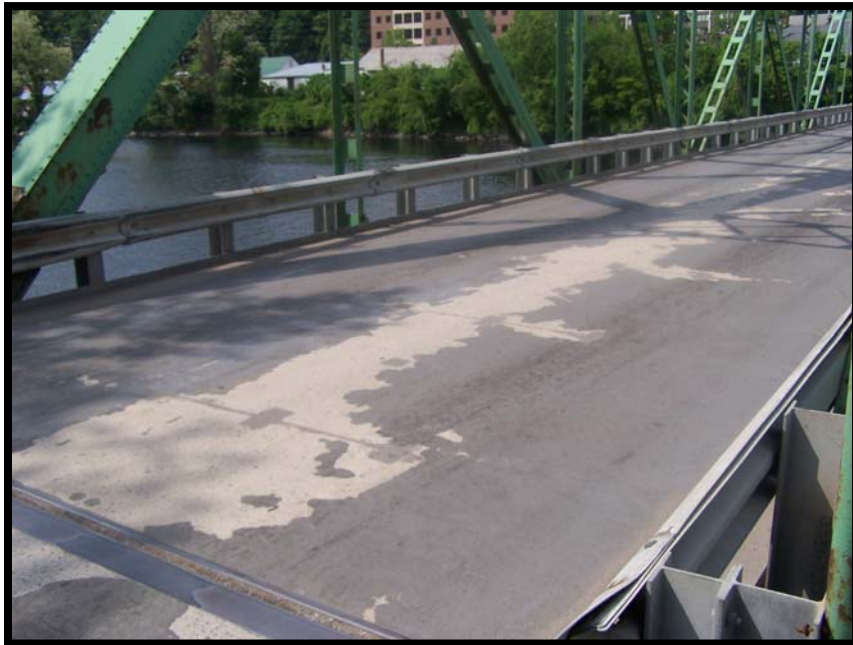
The Stirling Lloyd product has experienced significant areas of bond failure. Areas of missing overlay material can be seen in Figure 11. Pieces of separated overlay were lying in the roadway as seen in Figure 12.

Figure 11 - Failed Stirling Lloyd overlay

It is readily apparent that the Stirling Lloyd Safe Track HW overlay has suffered significant loss of bond with the underlying deck surface. Significant areas of overlay are missing and loose pieces of overlay material are evident.

As this product has not fared well over the 2-year evaluation period, further use is not recommended.

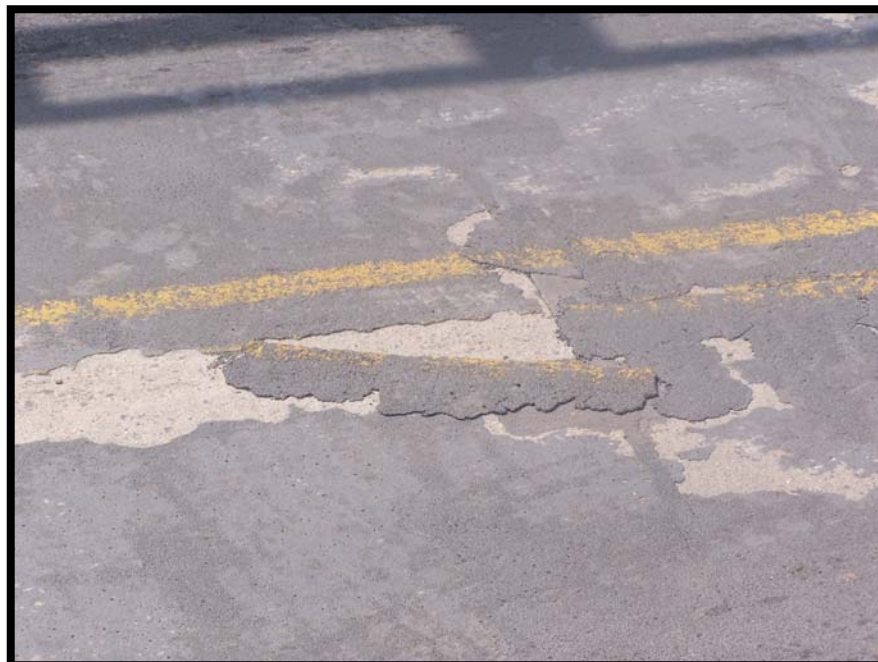
In addition, it appears that the remaining overlay material has suffered damage from wear. There are areas where aggregate and binder appear to have been scraped off as indicated by the light colored areas of the overlay surface in Figure 12.

Figure 12 – Separated pieces of Stirling Lloyd

Areas of the remaining overlay have experienced significant wear, presumably from traffic and/or snowplows. These areas appear to have lost aggregate and a portion of the binder material.
