Durability of Truncated Dome Systems (a.k.a. Detectable Warning Surfaces)

Evaluation Report

Prepared by the Materials & Research Bureau of the New Hampshire Department of Transportation

Report No. FHWA-NH-RD-MPS 2002-2

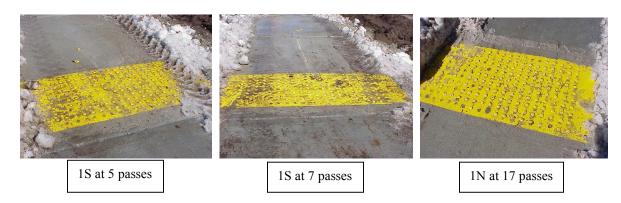
Section 1-SAFTI-TRAX Applied Domes

- System does **not** appear to comply with the ADAAG:
 - 1. Dome tops are 67 percent of the base dimension.
- Domes are surface mounted, extending above the plane of the sidewalk surface.
- Dome failure typically began by shearing at the contact face with the plow. Repeated cycles resulted in loss of top or of entire dome.
- The product material is soft and resilient, not very durable against plowing.

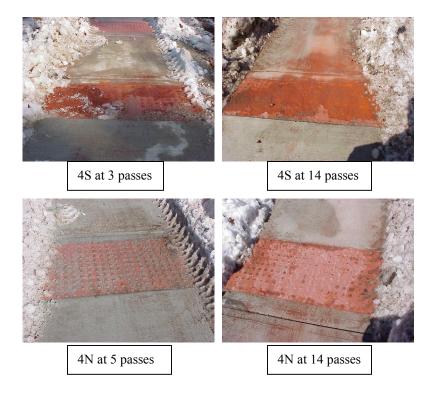
Section 4-ADA Retrofit Kit

- System specifications comply with the ADAAG.
- Installation occurs in a recess in the concrete; domes are below the sidewalk surface plane.
- Actual installation resulted in misshapen domes of varying height; some barely visible.
- 4S was totally destroyed in 5 plow passes. In spite of both panels being fabricated from the same batch of mix, this panel was easily damaged, even prior to plowing, as opposed to the sound condition of 4N.
- Color seal of 4N began peeling; top of domes wearing at 20 plow passes.

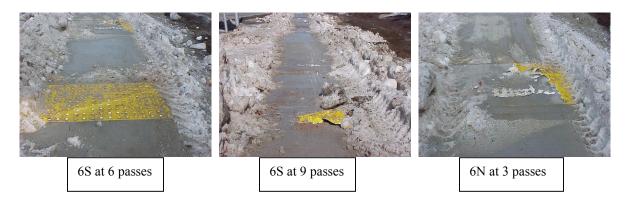
Section 6-SAFTI-TRAX Mats

- System does **not** appear to comply with the ADAAG:
 - 1. Base diameter is 0.84 inch.
 - 2. Dome top is 79 percent of the base dimension.
- Material is soft and resilient
- Early damage resulted due to the lack of a recess in the concrete surface; the plow caught the mat edge and peeled the system off the concrete.
