INTERIM EVALUATION REPORT, FALL 2007
DURABILITY OF TRUNCATED DOME SYSTEMS
at the "AIRPORT ROAD IMPROVEMENT PROJECT", CONCORD, NH

Prepared By:
Denis M. Boisvert, P.E., Chief of Materials Technology
Julie Fowler, Research Technician
(October 2007 Report)

NEW HAMPSHIRE DEPARTMENT OF TRANSPORTATION
BUREAU OF MATERIALS & RESEARCH
Box 483
Concord, NH 03302-0483
Phone (603) 271-3151
Fax (603) 271-8700
E-mail: dboisvert@dot.state.nh.us

October 19, 2007

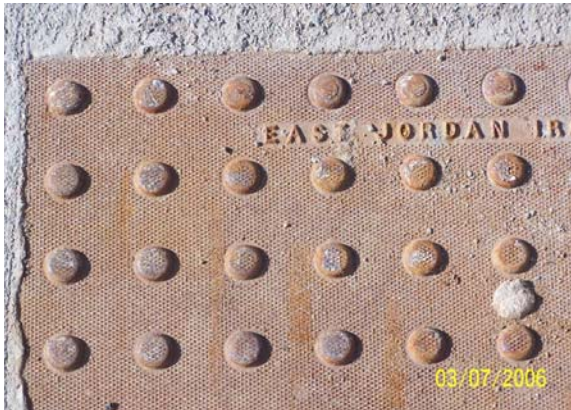
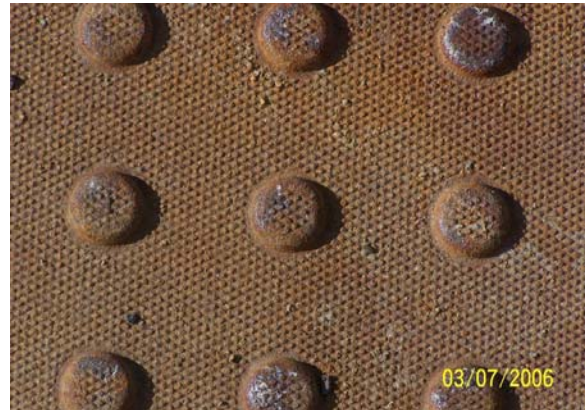
A close examination of these panels in the spring of 2006 revealed that plow contact had scuffed the textured pattern from the top of a few of the domes. The absence of a coating does not call attention to minor damage by casual observation. The panels appear generally unchanged since their installation.

Cast Iron Panels - East Jordan Iron Works in 2006

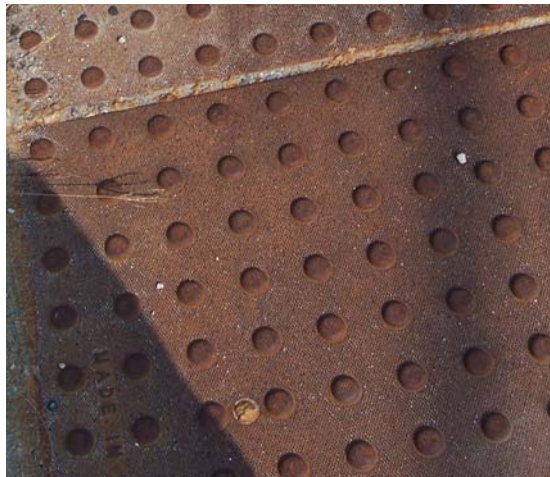
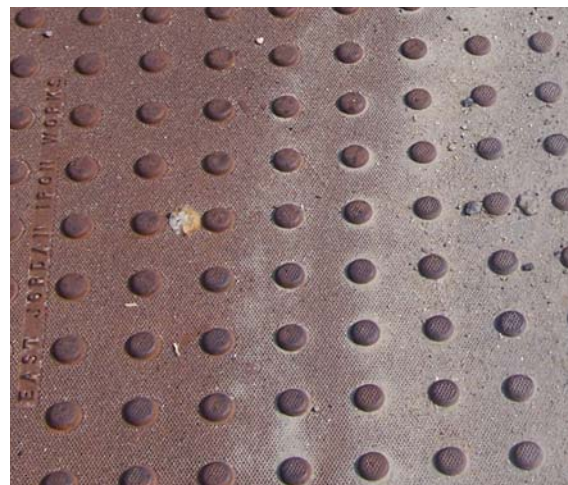
Additional examination on September 26, 2007 indicated little change in the **East Jordan Iron Works** panels, since the 2006 observations. There is some uneven scuffing along the top of some of the domes and there is minor rust staining on the concrete.

Cast Iron Panels - East Jordan Iron Works in 2007

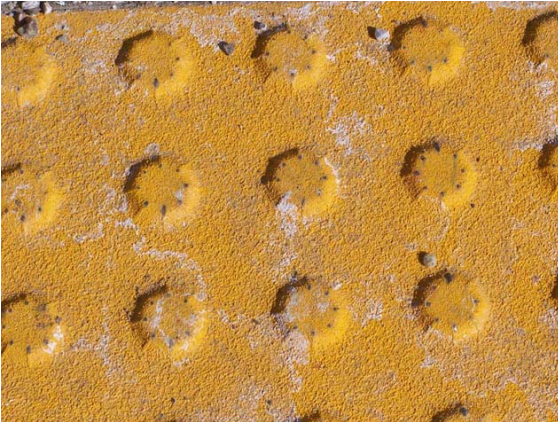
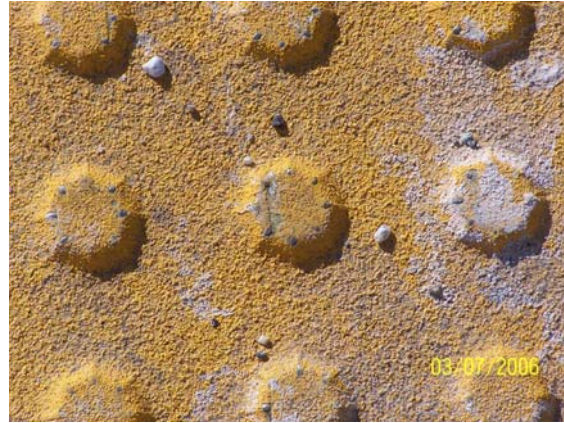
MetaPanel units were installed at the intersection of Regional Drive and Barrell Court. They are constructed of stainless steel and coated in yellow paint. The bottom side is made up of sheet metal shapes that interlock with the concrete to anchor the panel. The domes are shaped with vertical ribs along their sides as a means of prolonging the life of the coating. The two panels were in good general condition after one winter. No domes were chipped, broken or removed. However, about 10 percent of the domes were missing paint at the top of the dome ribs.

MetaPanel units - in 2006

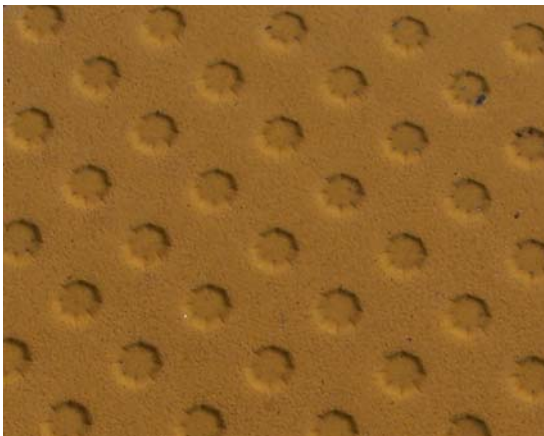
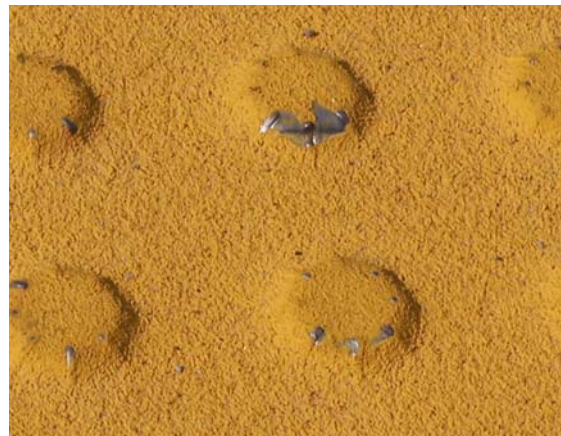
Examination of the **MetaPanel** units in September of 2007 indicated some minor changes in these stainless steel panels, since the spring of 2006. There are now a few dents and chips along the top of some of the domes and minor rust staining is visible.

MetaPanel units - in 2007

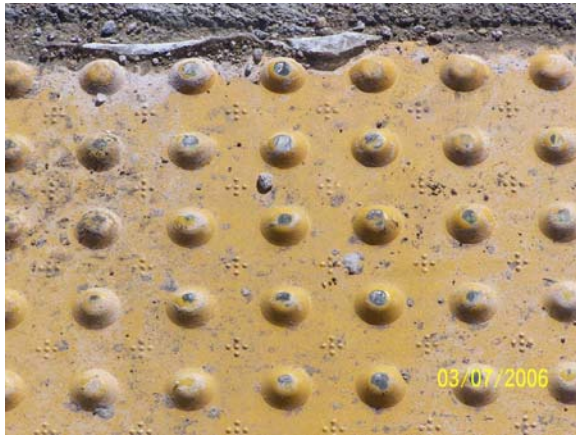
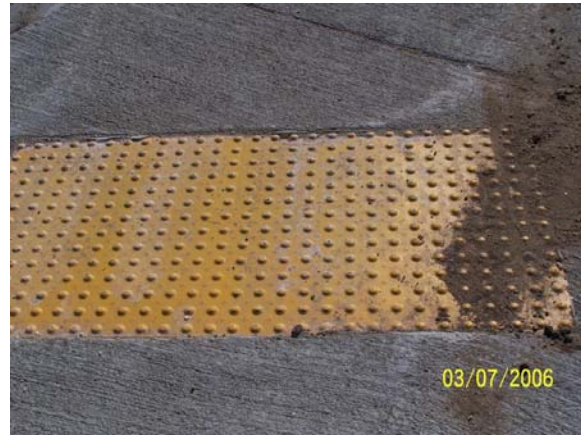
All of the panels were in good general condition with no broken or disfigured domes in 2006. Damage was limited to a wear pattern at the top of approximately 10 percent of the domes. The wear exposed the stainless steel surface.

Advantage panels - in 2006

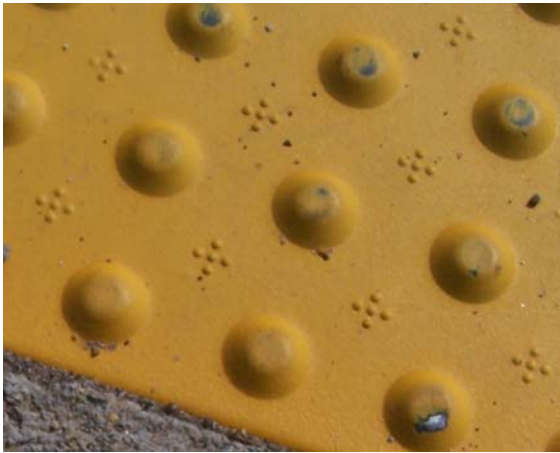
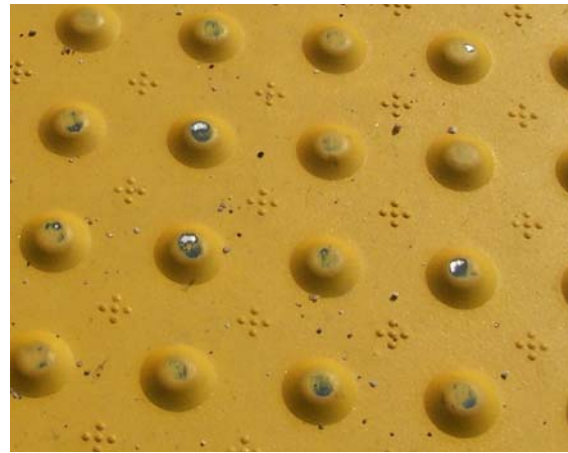
Examination of the **Advantage** panels in September of 2007 indicated some additional scuffing of the paint on these stainless steel panels, since the spring of 2006. Where this occurs, the sheet metal has become exposed.

Advantage panels - in 2007

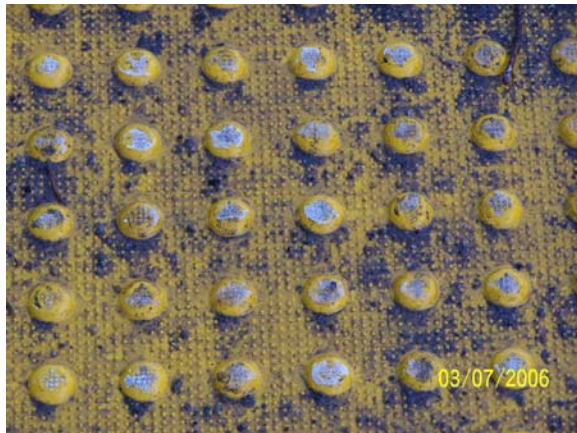
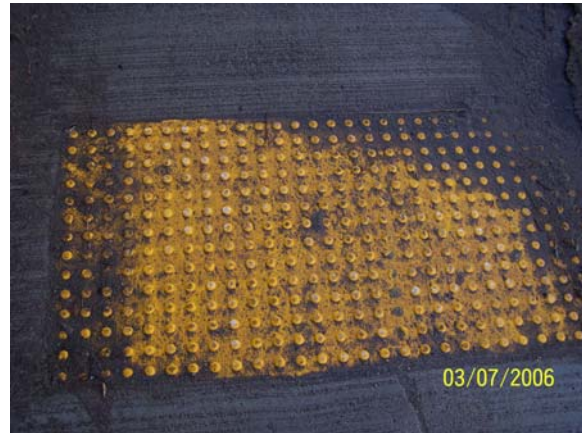
The **Armor-Tile** panels suffered no loss of domes after the first winter, but lost the yellow outer coating from the top of about 40 percent of the domes. The loss results in exposure of the white natural material color beneath the surface.

Armor-Tile panels - in 2006

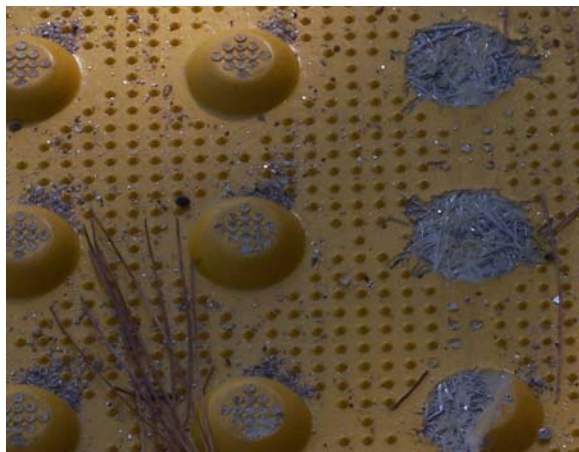
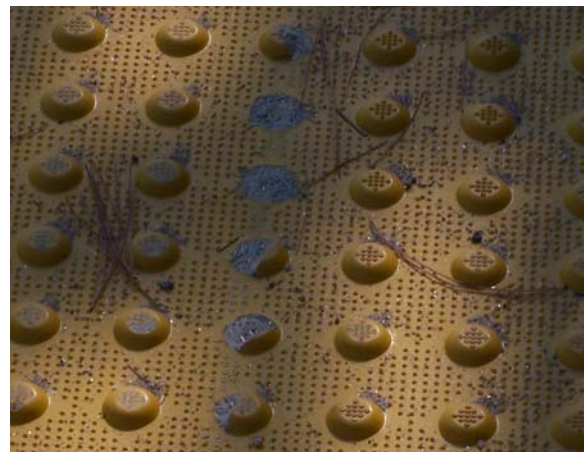
Examination of the **Armor-Tile** panels in September of 2007 indicated some additional loss of the yellow outer coating from these polymer composite panels, since the spring of 2006. There were five domes that had totally broken off, and one that was broken in half.

Armor-Tile panels - in 2007
