**BUREAU OF MATERIALS & RESEARCH**

**MISCELLANEOUS PROBLEM SOLVING PROJECT: MPS 2010-02**

**Performance of W-Beam Guardrail after Height Adjustment**

**Summary Report**

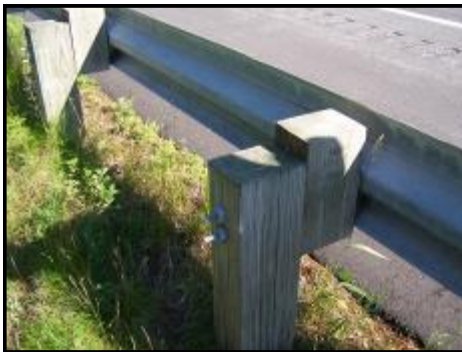
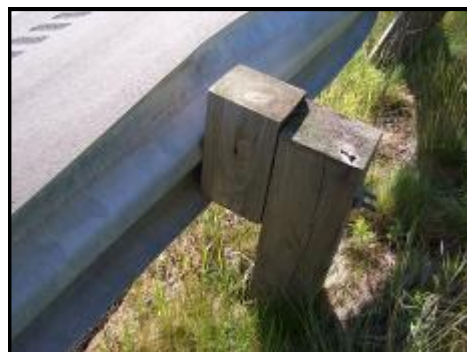
Initial field visits commenced during the summer of 2010. Figures 1 and 2 show the typical installation of reset guardrail that was observed during the initial inspection of Route 101. Figures 3 and 4 show an area near Mile Marker 122.6, eastbound, where an impact had occurred. Comment was made that even though the damage was noticeable, it was thought that the structural integrity of the guardrail had not been compromised.

Fig 1 and 2: Typical view of reset offset block

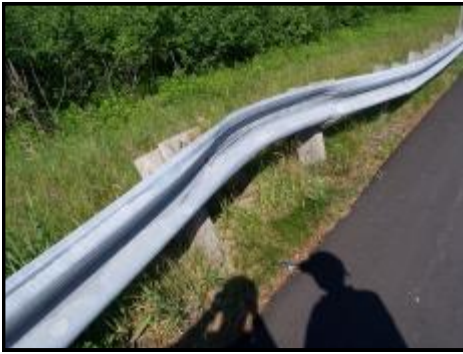
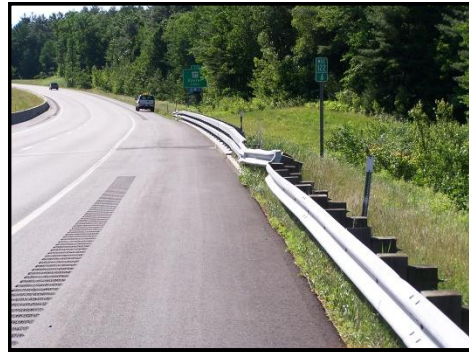
**Fig 3 and 4: Damage observed on Rte 101 at mm 122.6 during initial inspection in June 2010**

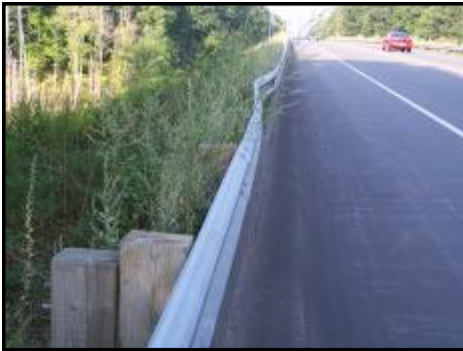
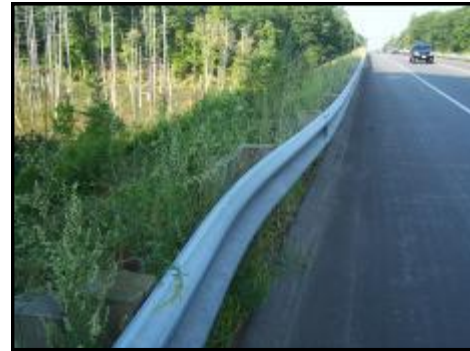
In September 2010 initial observations occurred on Route 111 in the Salem to Atkinson area. The study area was between Island Pond Road, and the intersections of Lakeside Drive and Hall Farm Road. One area of damage was observed at the end of the second run of guardrail, beyond Island Pond Road heading east, and is shown in Figures 5 and 6. It did not appear that the structural integrity of the guardrail was compromised by this hit and no other damage was observed while driving west. Mile Marker posts were not present during this initial site visit, but were subsequently installed.

**Fig 5 and 6: Damage observed on Rte 111 in September 2010 during the initial site visit**

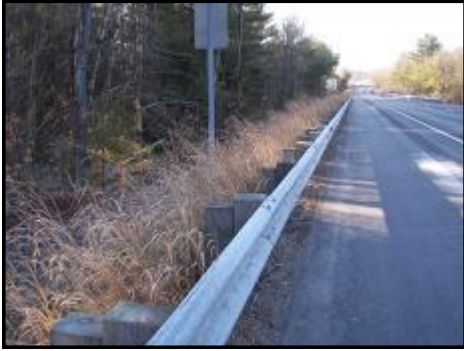
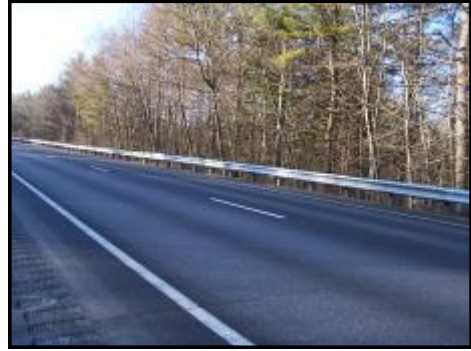
A second round of site visits took place in March 2011 at the end of the winter maintenance season. No damage was observed in the Concord area on Route 93 (northbound and southbound) between MM 41.6 and 43.0. Typical reset guardrail along I-93 is shown in Figures 7 and 8.

**Fig 7 and 8: Typical view of guard rail with no damage along Route 93 in the Concord area.**

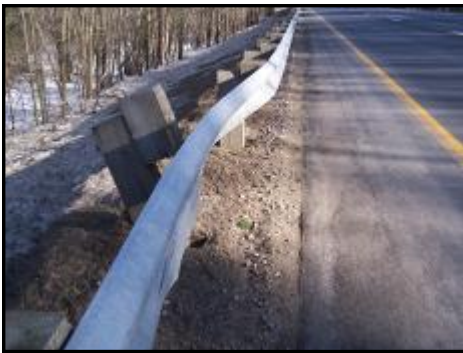
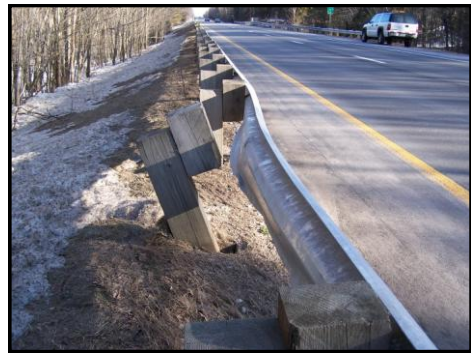
Continuing north damage was seen past Exit 20 along the high speed lane, at MM 63.4. The guardrail was detached from one block as seen in Figures 9 and 10, however the rail appeared stable.

**Fig 9 and 10: Damage on I-93 at MM 63.4 northbound, along the high speed lane in March 2011**

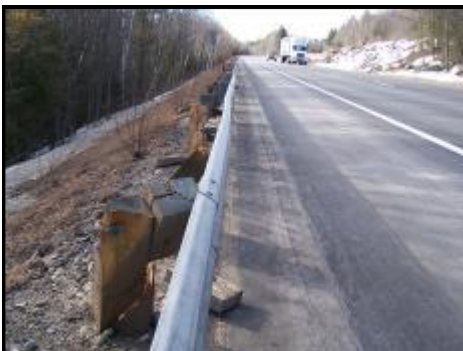
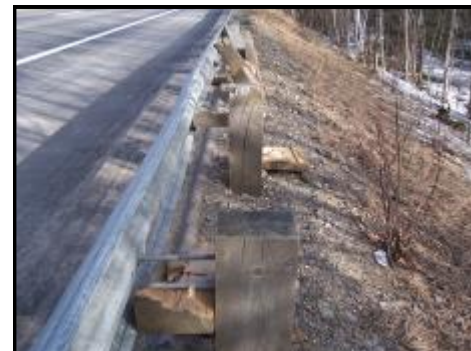
Damage was also observed along the travel lane at MM 65.4. Several posts were broken off however the guardrail itself showed little damage and appeared stable, as seen in Figures 11 and 12.

**Fig 11 and 12: Damage on I-93 at MM 65.4 in the northbound travel lane**

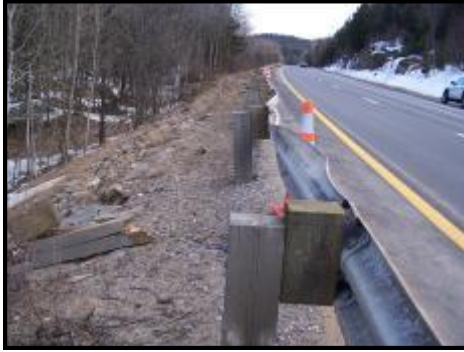
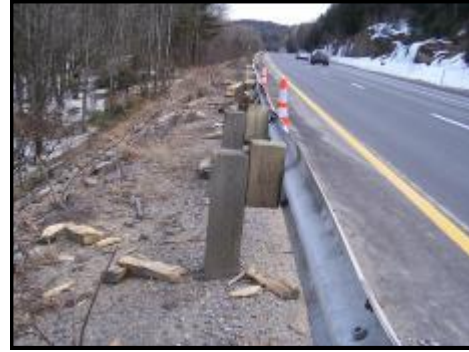
At MM 66.6, damage was seen along the high speed lane as shown in Figures 13 and 14. Several posts were detached from the guardrail. The guardrail appeared intact, though noticeably weakened.

**Fig 13 and 14: Damage on I-93 at MM 66.6 along the high speed lane northbound**

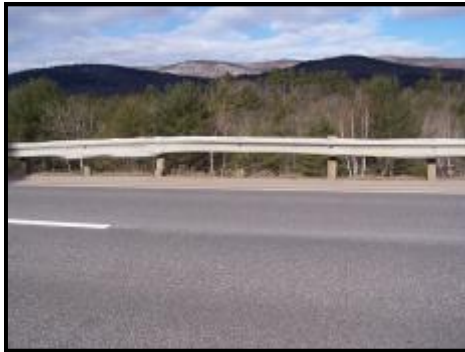
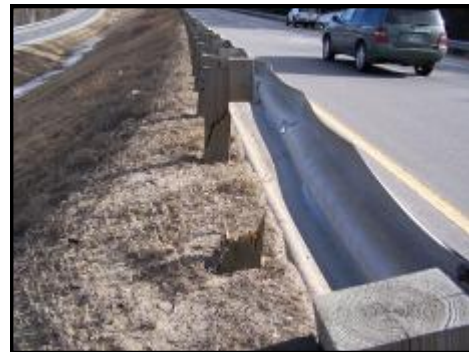
Continuing north to MM 70.8, damage was observed in both the travel and high speed lanes, as seen in Figures 15 and 16. No additional damage was observed continuing north.

**Fig 15 and 16: Damage on I-93 at MM 72.8 northbound along high speed lane**

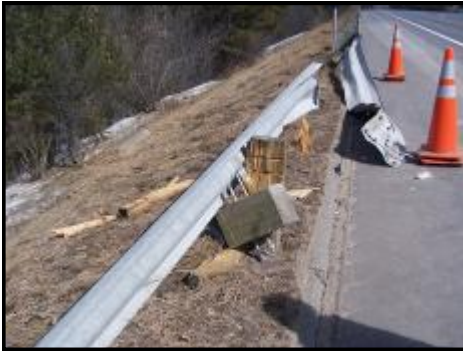
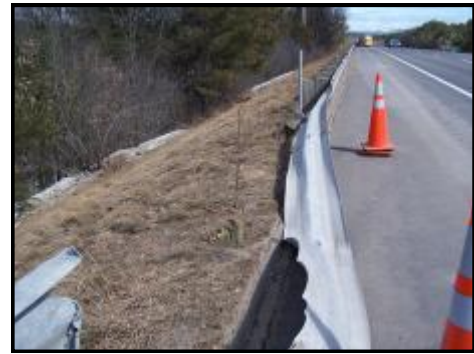
Traveling south, damage was observed at MM 72.8. Several blocks were broken off and/or detached from the guardrail which resulted in noticeable instability. The guardrail was separated from the blocks and was sitting on the pavement and ground, as seen in Figures 17 and 18. A State of New Hampshire Traffic Accident Report (attached to this report) was obtained and it suggests that the guardrail did perform as expected and does not indicate that the performance was out of the ordinary. As indicated in the report, the only vehicle involved was a 1995 Ford F150 pick-up truck. Mixed precipitation had fallen and the roads were slippery. The vehicle was traveling between 60 and 65 miles per hour in the high speed lane, along side another vehicle, and lost control. There was no contact with the other vehicle however the driver could not maintain control of the F150 which struck the guardrail, after which the vehicle came to a stop. There was no mention in the Accident Report that the F150 overturned. The operator of the vehicle was taken to the hospital and was treated and released. The officer concluded that “the operator’s speed was too fast for the conditions of the road surface.”

**Fig 17 and 18: Damage on I-93 at MM 72.8 along the southbound travel lane**
