Improve the Quality and Service Life of Water-based Pavement Marking Paints on Pavements with High-Iron Aggregates

NHDOT Bureau of Aeronautics

NHDOT Research Unit

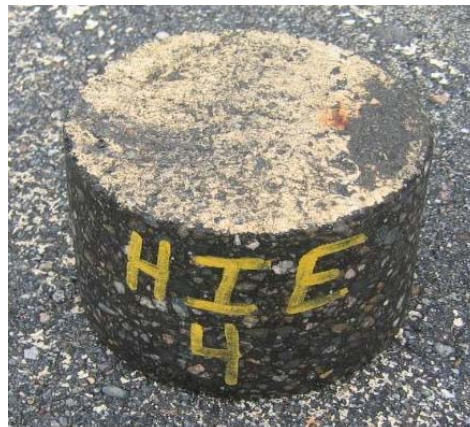
This paint should be white.

First, the study determined that the staining was caused by the rusting of iron compounds in the pavement aggregate. The study then considered different paint types (both solvent and water-based), various paint additives, and paint treatments (i.e., clear-coating). In addition, pavement treatments, such as sealers and grooves, were evaluated. Life-cycle cost evaluations determined the most cost-effective solution.
