Evaluation of Noise Levels due to Controlled Vehicle Pass-bys on Rumble Strips across New Hampshire

Final Noise Analysis Technical Report

Statewide Project No. 28534

HMMH Report No. 306610.003

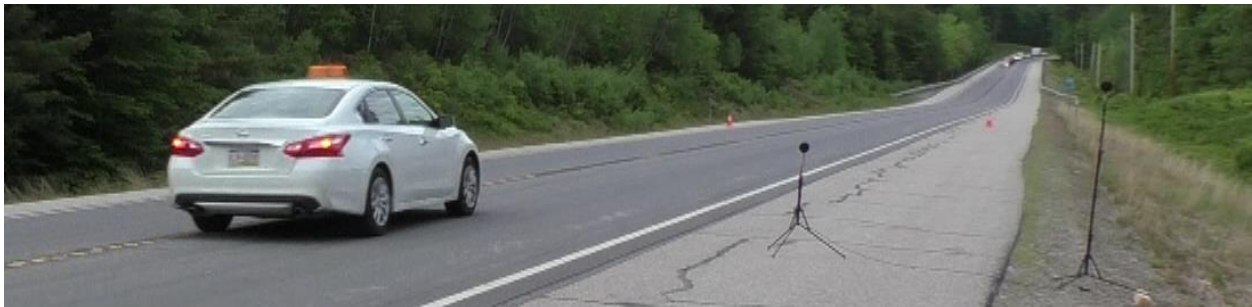
Figure 4 Continuous Vehicle Pass-by on the Center Rumble Strip (Near Lane) at Site 4 (Alton)

Figure 4 is a photograph at Site 4 (Alton) that shows a continuous pass-by on the center rumble strip traveling in the near lane. Note the locations/heights of the microphones (17 feet/3 feet and 25 feet/5 feet) adjacent to the near lane in the foreground. Orange traffic cones on either side of the road mark the end of the target zone (in the middle ground of the photograph). In the background of the photograph, the traffic queue in the northbound direction can be seen.

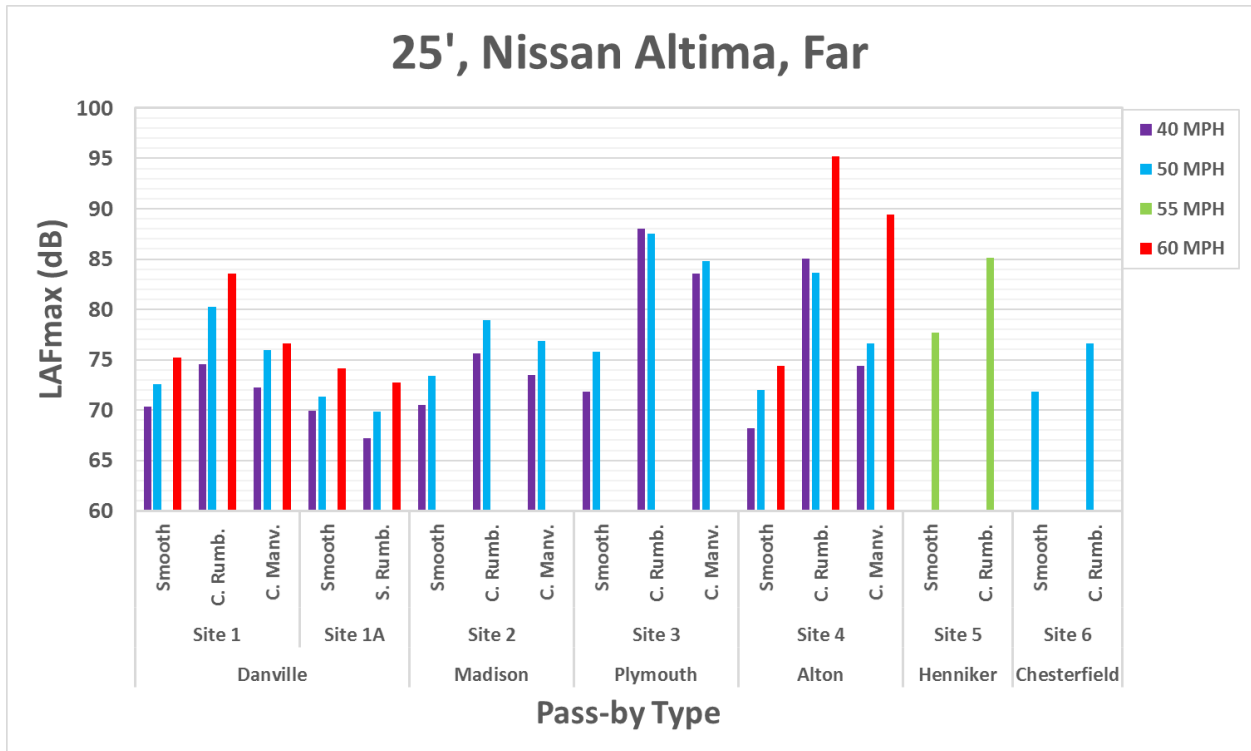
Figure 5 Measured LAF_{max} at 25 feet for the Nissan Altima in the Far Lane at All Six Sites

- At Sites 1 (Danville), 2 (Madison), 3, and 4, the pass-bys that performed a maneuver on the rumble strips produced *higher* noise levels than pass-bys on smooth pavement and *lower* noise levels than the pass-bys that were continuously on the rumble strip for the full length of the 400-foot target zone.

Figure 6 shows the corresponding results for vehicles traveling in the near lane. Many of the same trends are observed when these near-lane results are compared to the results of Figure 5 (pass-bys in the far lane).

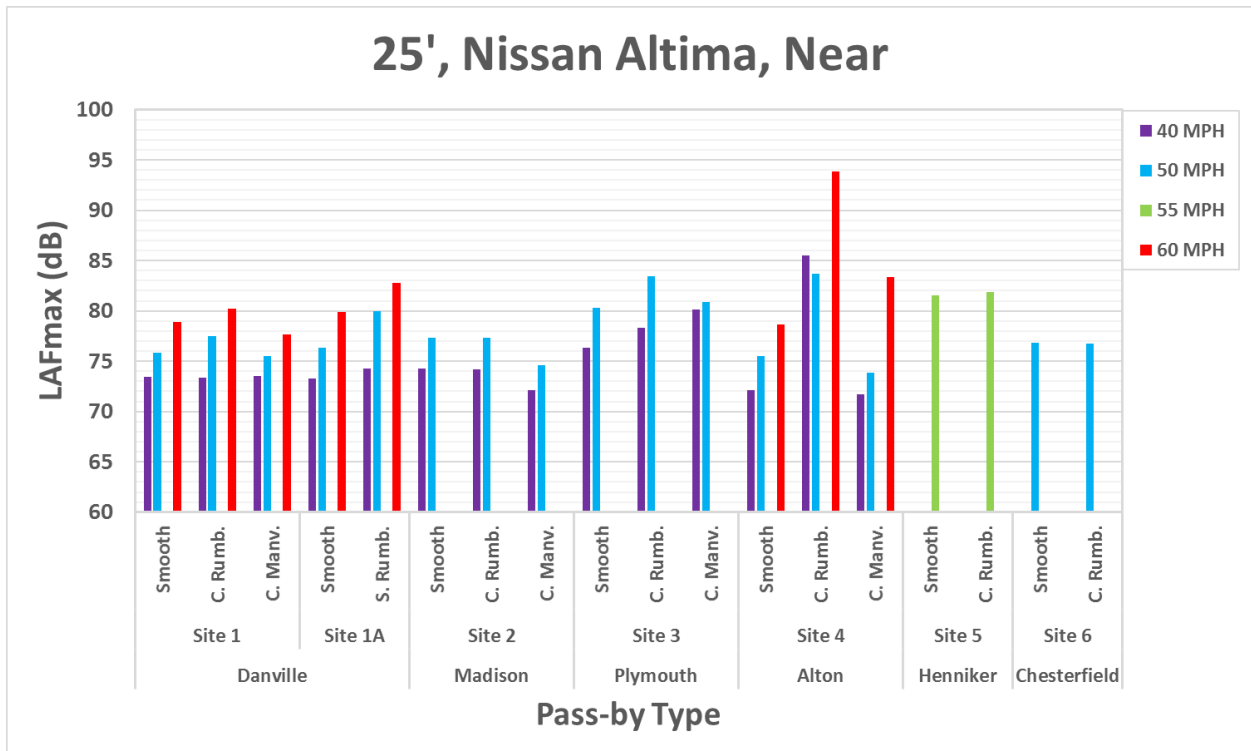
Figure 6 Measured LAF_{max} at 25 feet for the Nissan Altima in the Near Lane at All Six Sites

Figure 6 shows another phenomenon related to rumble strip noise. The measured LAF_{max} for the centerline rumble-strip pass-bys in the *near* lane (Figure 6) are all lower than the corresponding measured LAF_{max} for pass-bys in the *far* lane (Figure 5). The lower levels for the near lane pass-bys are attributed to the shielding between the tires on the rumble strips and the microphone position that is provided by the car body. For a vehicle pass-by in the far lane, the propagation path between the tire/rumble-strip interface is unshielded. These findings are generally consistent with those of Sexton in the WSDOT study – with one exception. At 40 and 50 mph, the near lane pass-bys on centerline rumble strips are the same as, or slightly higher than, the far lane pass-bys at Site 4 (see Events 102 to 107 in the table in Appendix B).^x

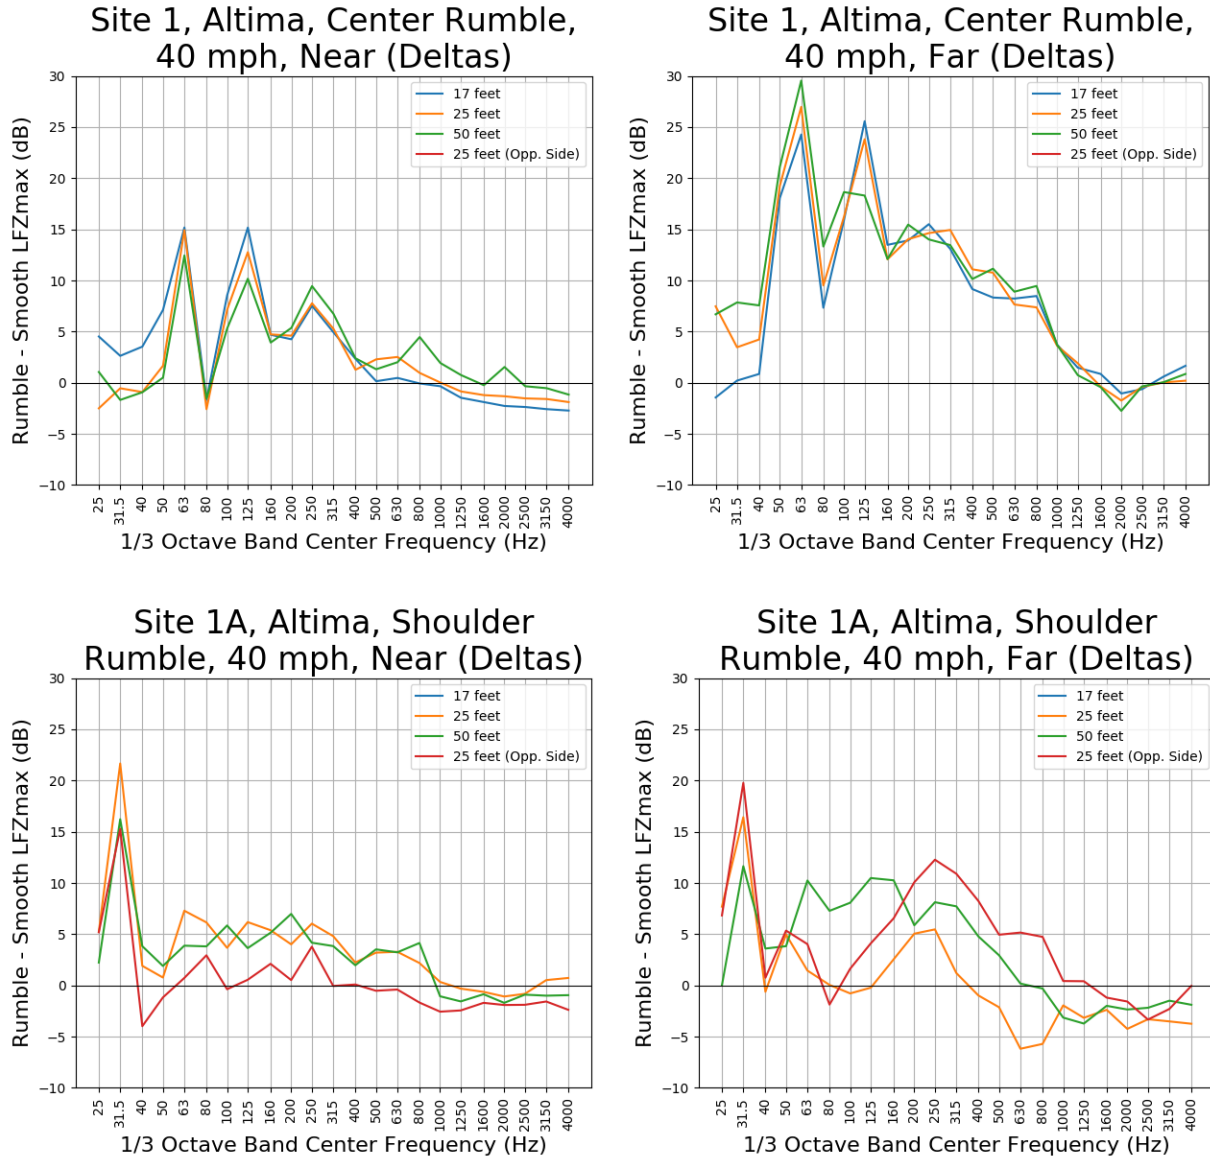
Figure 9 Difference Spectra for Pass-bys at 40 mph at Sites 1 and 1A

The fundamental frequencies of the rumble strip pass-bys are dependent upon the speed of the test vehicle and the on-center spacing of the rumble strip (i.e. the peak-to-peak distance). Table 9 provides a summary of the 1/3 octave bands that contain the fundamental frequency for a range of typical vehicle speeds and a range of spacing values. As the rumble strip spacing increases, the fundamental frequency decreases. A doubling of the rumble strip spacing, halves the fundamental frequency.

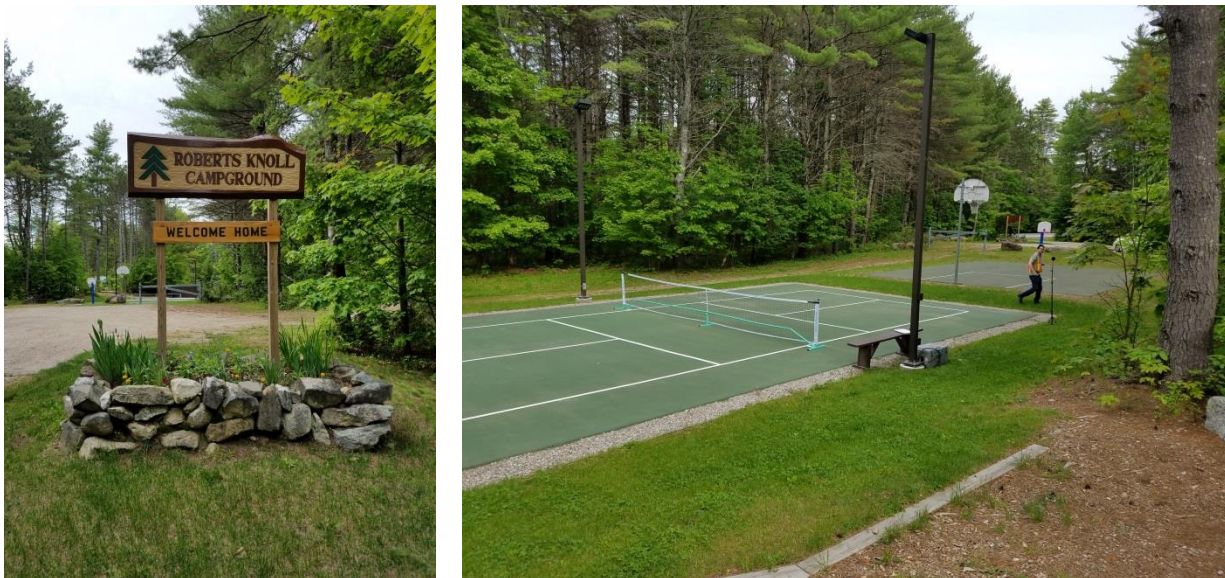
Figure 11 Unattended Noise Monitoring near the Pickle Ball Court at Roberts Knoll Campground

In the late afternoon on June 8, 2017, HMMH personnel installed a long-term noise monitor on the grounds of the Roberts Knoll campground in Alton for unattended monitoring. The monitor was located approximately 1,475 feet north of Site 4 and 250 feet from the centerline of NH Route 28. The long-term monitor was used to continuously sample and store various A-weighted noise metrics for the overnight period from June 8 to June 9, including the period on the morning of June 9 during which HMMH personnel measured controlled vehicle pass-bys on the rumble strips at Site 4. The monitor also was programmed to sample and store sound levels in 1/3 octave bands and to make continuous audio recordings. Figure 11 shows the location of the microphone on the right side of the photograph – in the middle ground near the southwest corner of the pickle ball court.

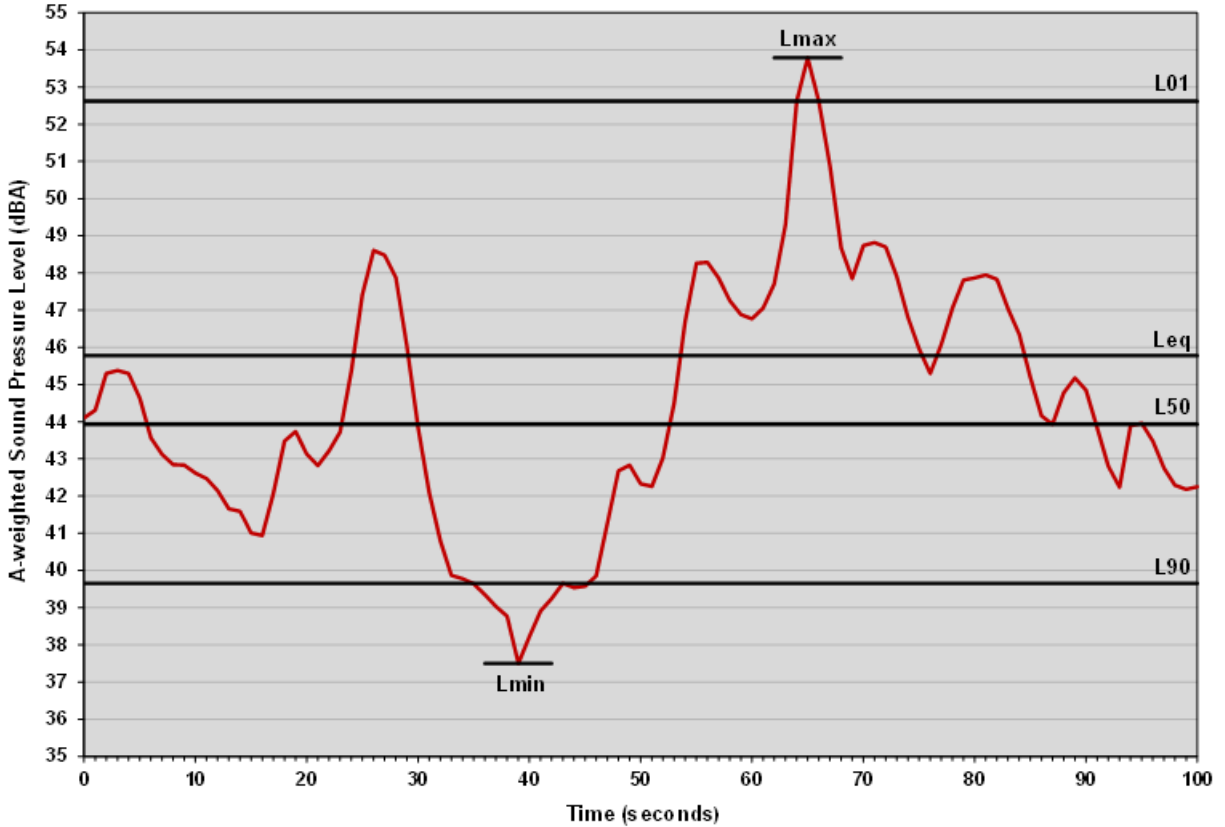
Figure A-2. Sound Metric Calculations for an A-weighted Sound Level Time History

Statistical descriptors of the time-varying sound level are often used to provide more information about how the sound level varied during the time period of interest. The descriptor includes a subscript that indicates the percentage of time the sound level is exceeded during the period. The L_{50} is an example, which represents the sound level exceeded 50 percent of the time, and equals the median sound level. Another commonly used descriptor is the L_{01} , which represents the sound level exceeded 1 percent of the measurement period and describes the sound level during the loudest portions of the period. The L_{90} is often used to describe the quieter background sound levels that occurred, since it represents the level exceeded 90 percent of the period. In Massachusetts, the Department of Environmental Protection's noise policy specifies the L_{90} metric as the appropriate sound level metric to describe the "ambient" background sound level.

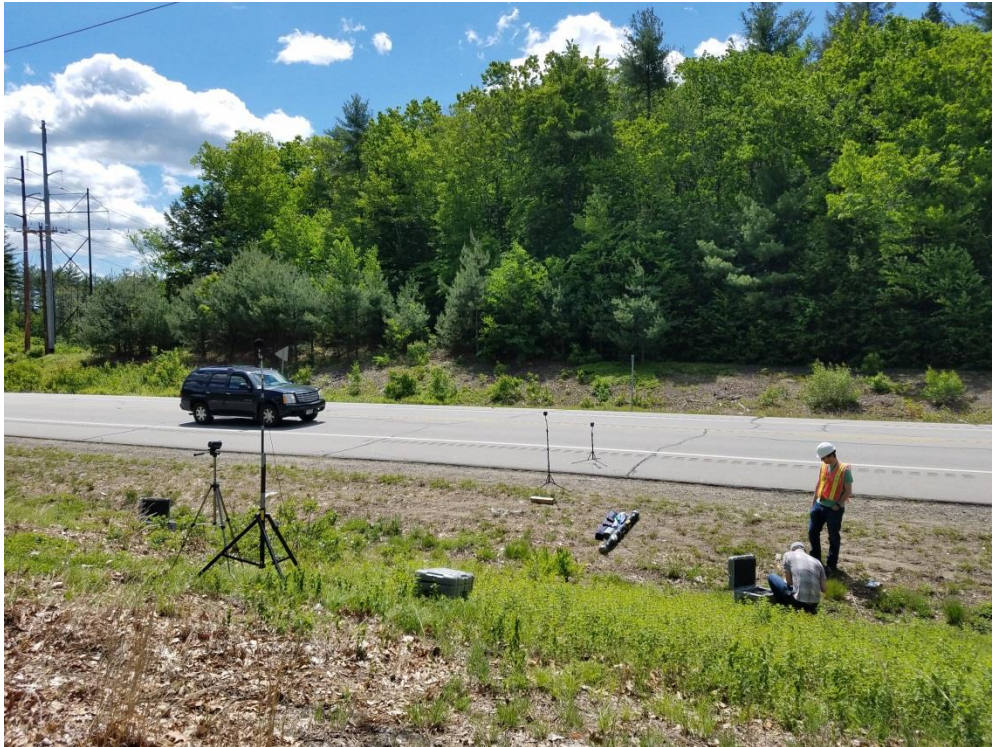
Site 1 – Microphone locations along southbound lane (near lane)

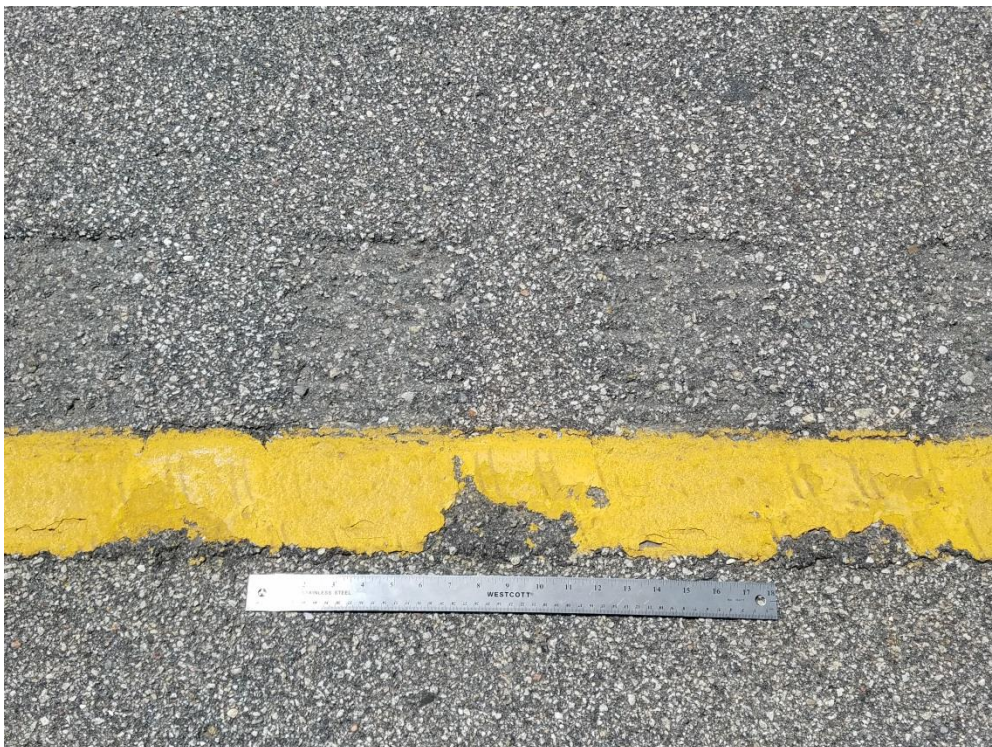
Site 1 – centerline rumble strip

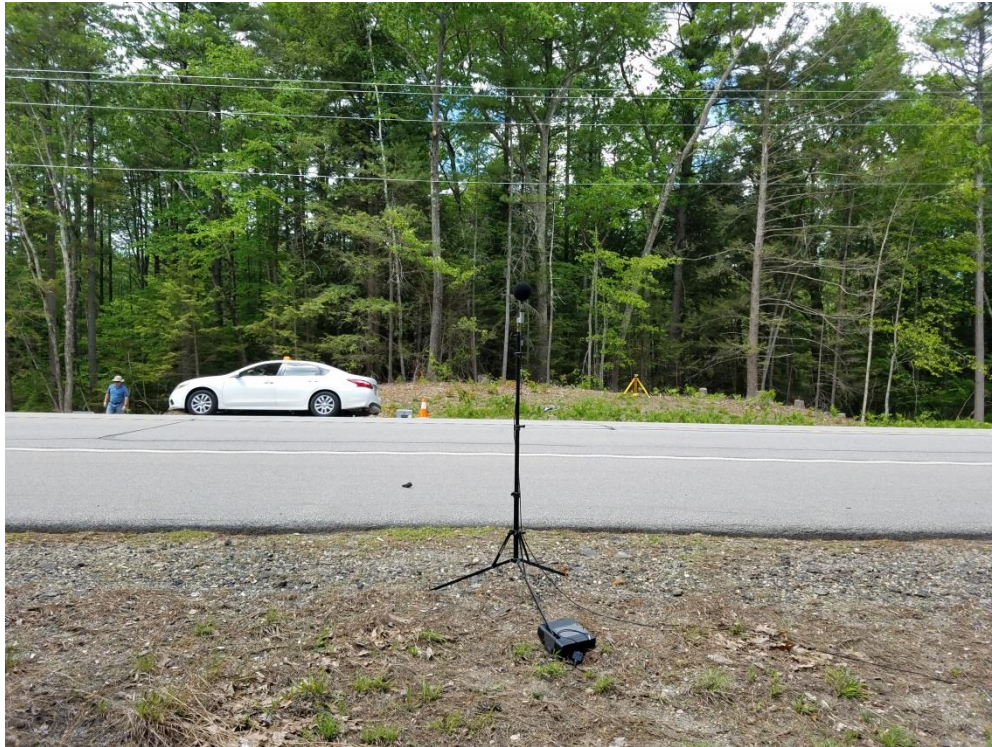
Site 1A – 25-foot (opposite) microphone location

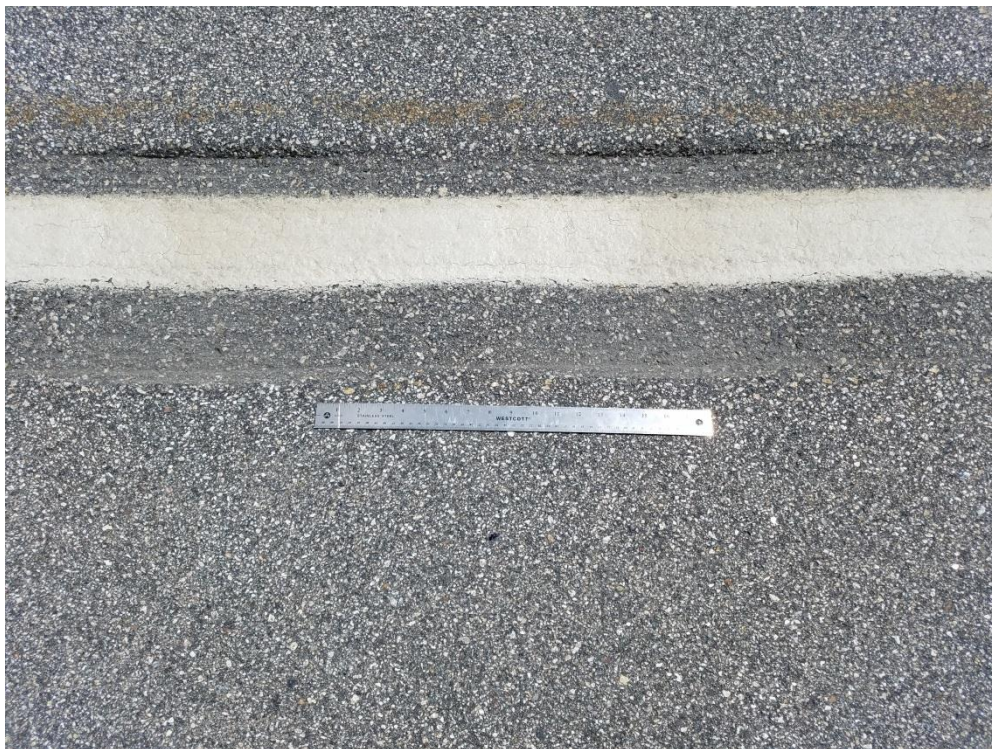
Site 1A – shoulder rumble stripe along near lane (southbound side)

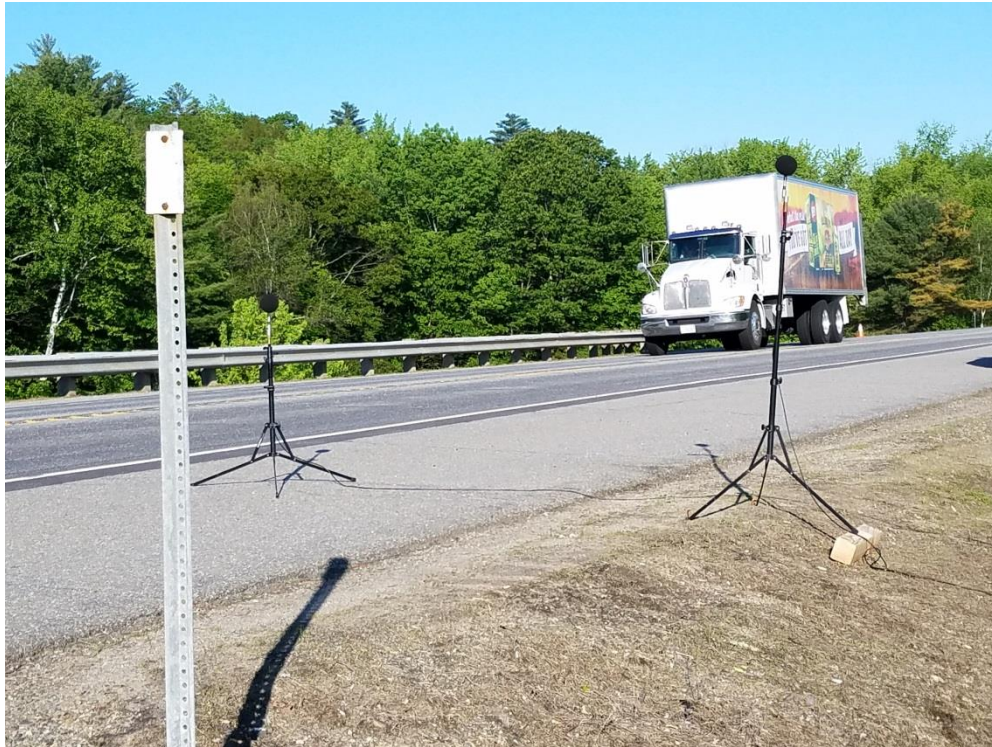
Site 3 - microphones at the 17-foot and 25-foot position; truck in far lane

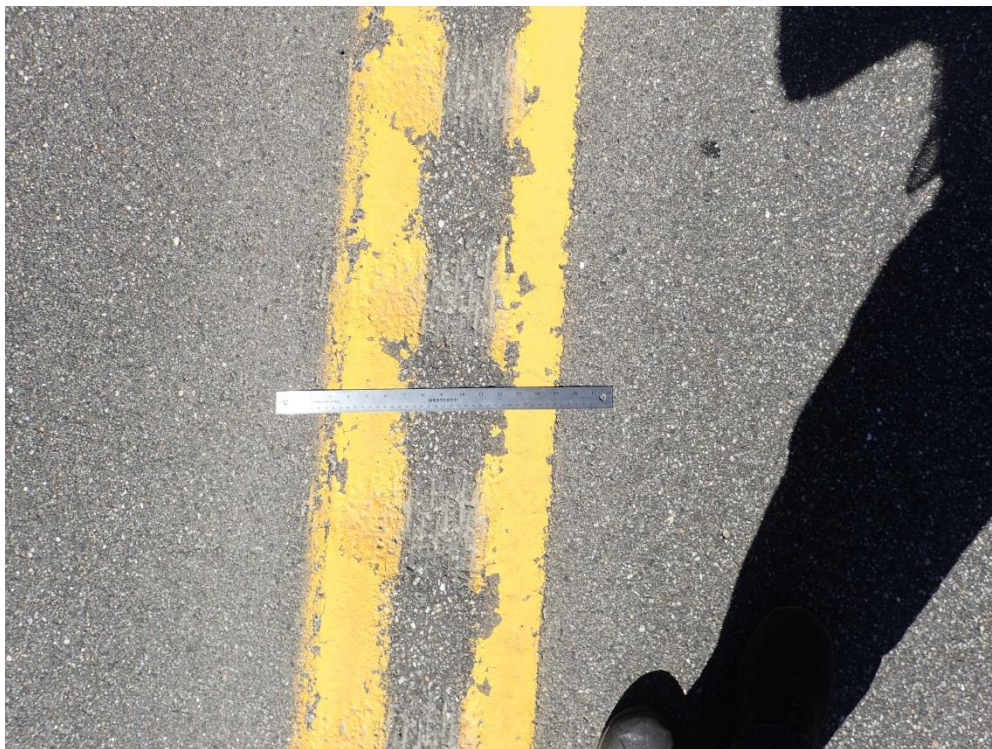
Site 3 – centerline rumble strip

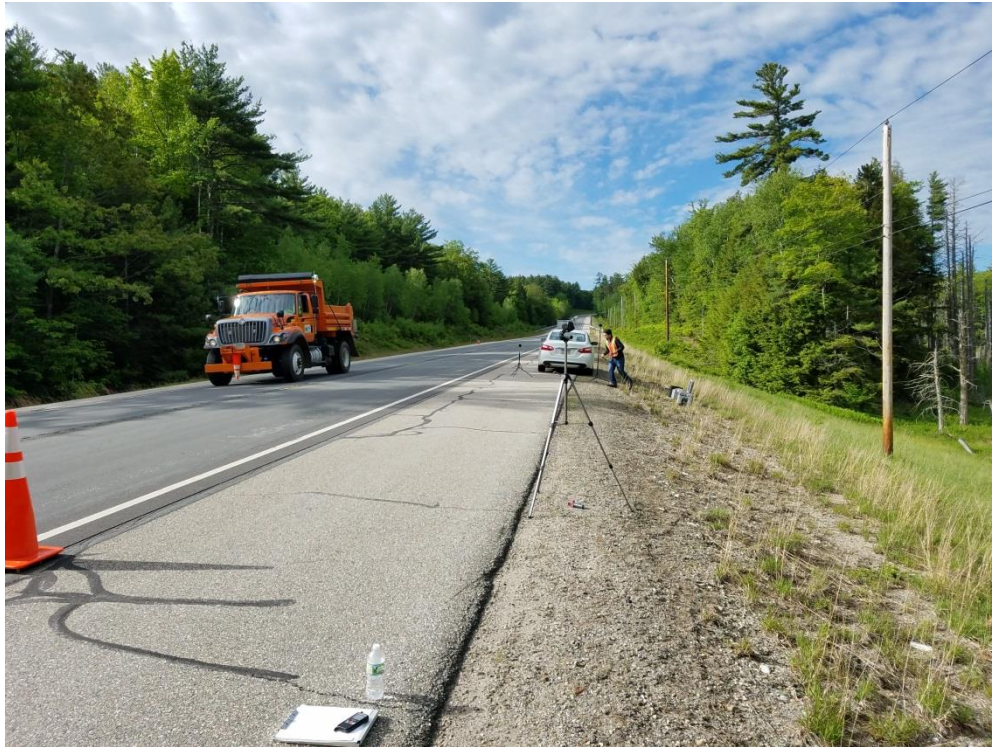
Site 4 – looking south with NHDOT truck in far lane

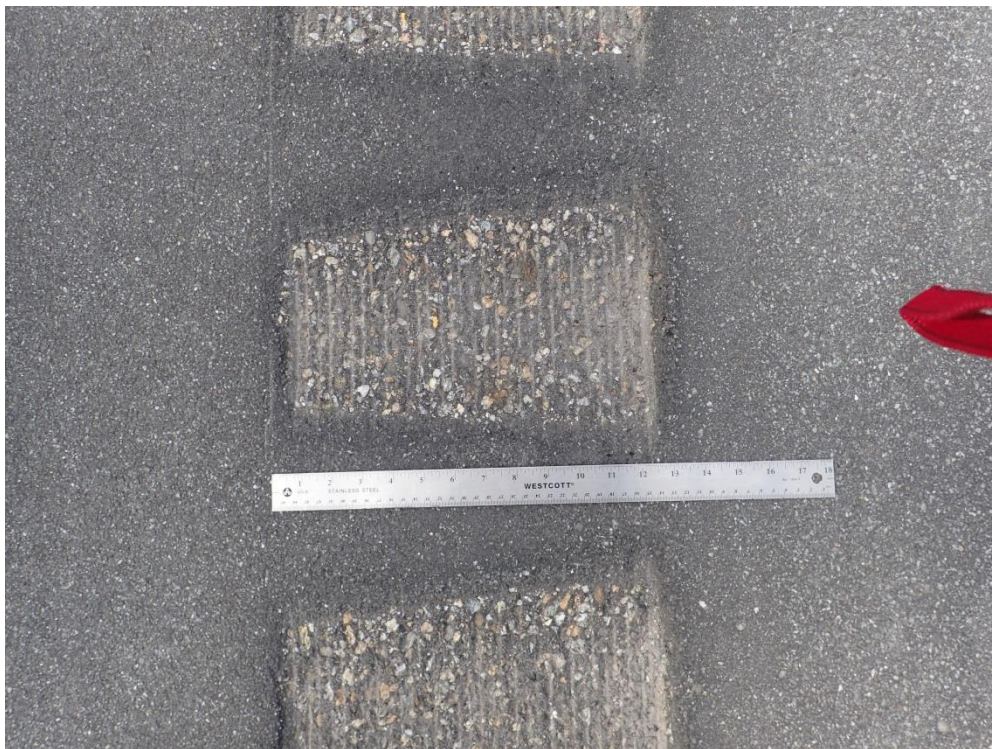
Site 4 – centerline rumble strip

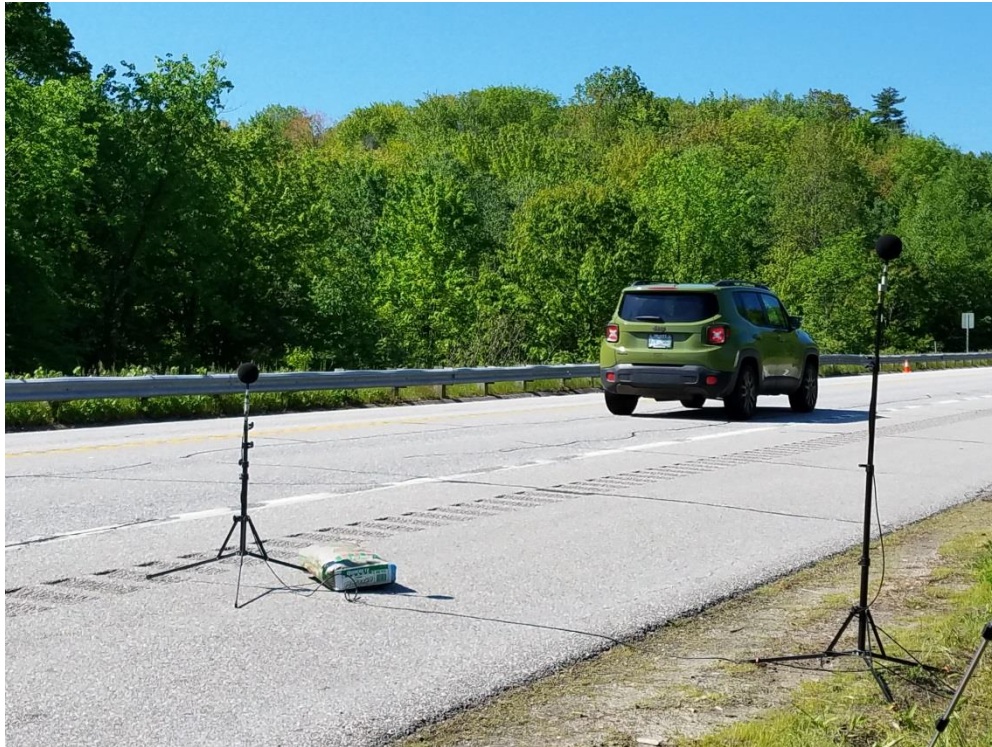
Site 5 – microphones at the 17-foot and 25-foot positions

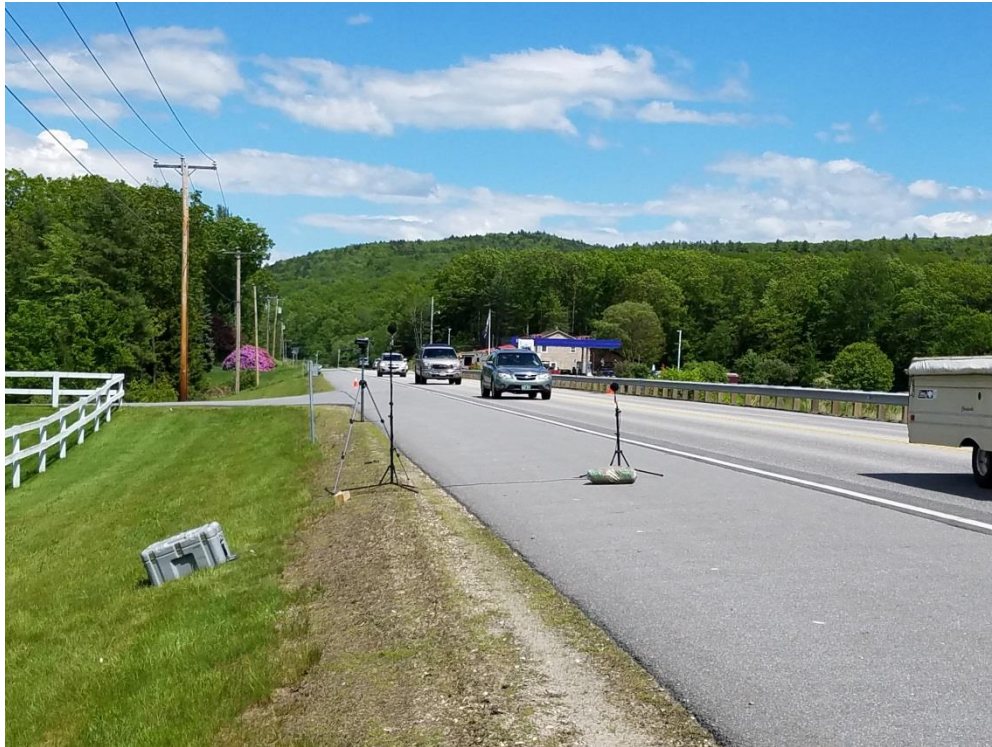
Site 6 – microphones at the 17-foot and the 25-foot positions

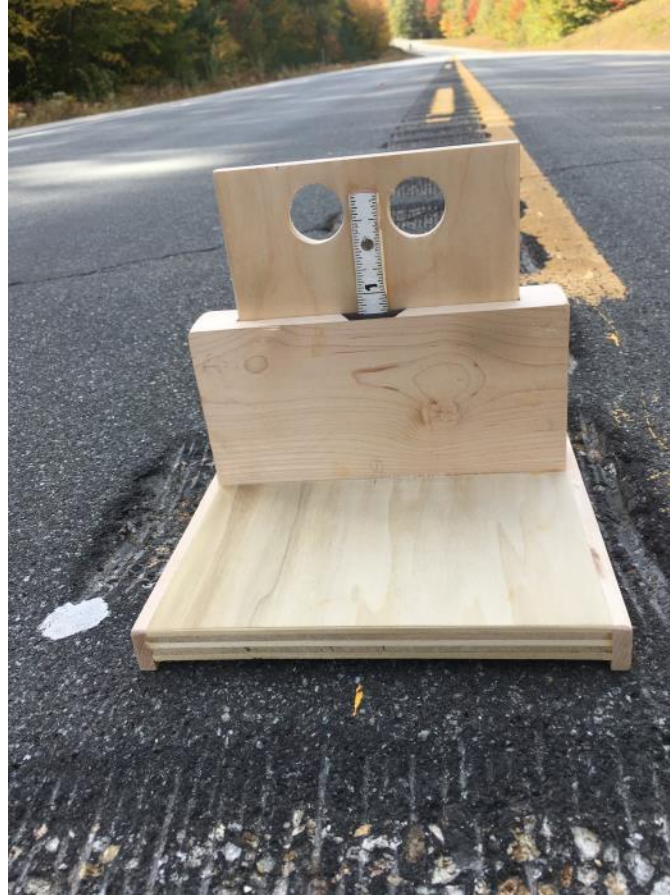
NHDOT's Custom Depth Gage
