Gusset-less Truss Connection Physical and Structural Model to Aid Bridge Inspection and Condition Assessment

Project Number: NHDOT 26962M

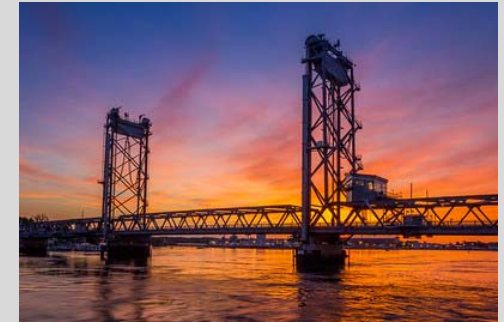
In 2013, the Memorial Bridge, located between Portsmouth, NH, and Kittery, ME, was opened to traffic. The structural system of the bridge is composed of truss elements with a unique "Gusset-less" connection which utilizes curved steel to transition from the chords to the diagonals where splice plates join the members. With such a unique connection, it is important to verify the design assumptions and assess its performance. In this study, the fatigue performance of the Gusset-less connection is primarily investigated through an experimental fatigue test of a scale model of the connection.

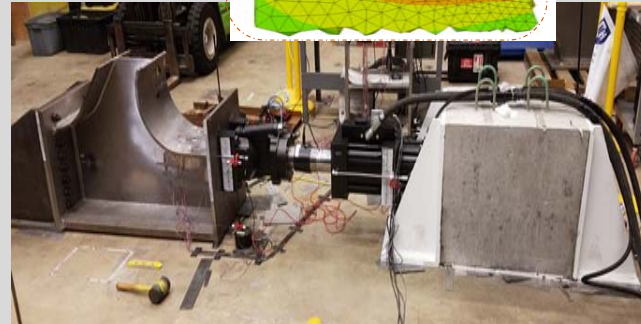
The main goal was to design an experimental setup system capable of supporting the specimen on one side and the actuator on the other.

Comparisons were also made between the Finite element model (FEM), the strain rosettes and strain collected via digital image correlation (DIC). This comparison showed an overall difference was 6.4% on average between the FEM and the strain rosettes and 3.7% between the FEM and DIC.
