TECHNICAL SUMMARY

Pavement Markings: Stain Resistant Additive Improves Paint Performance, Bead Loss Reduced in Thicker Paint

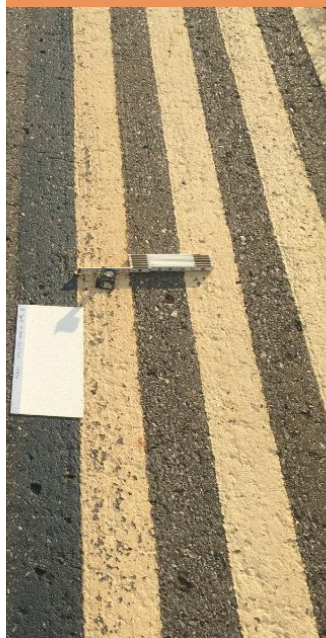
White runway paint turns yellowish color in as soon as 6 months. Original white color panel next to the field applied stained paint is shown.

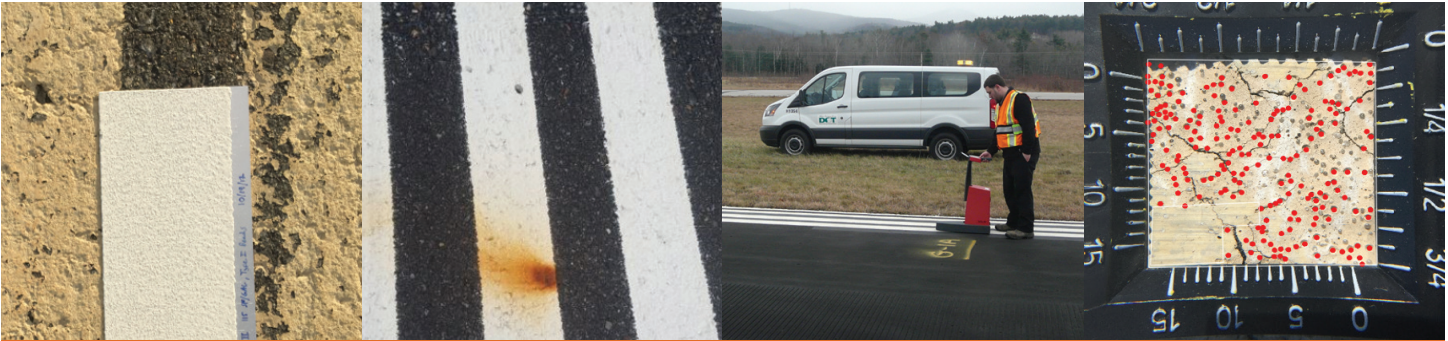
Paint color comparison made with original white control panels placed next to field stained paint.

Bottom-up Rust Stain Spots were counted within the study areas.

Reflectivity of paint and beads were measured in the study areas.

Magnified images of each study area were imported into CAD and the loss of beads were counted. Red dots are bead losses.

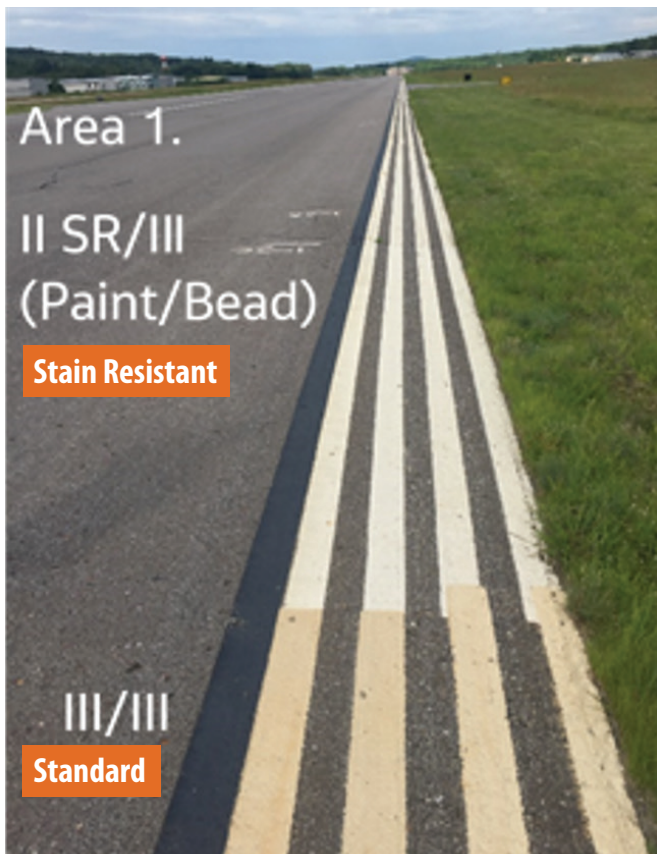
Type II paint with stain resistant additive (IISR) and Type III beads remains whiter after 24 months compared to the standard FAA control paint (above).

The stain resistant additive incorporated into the FAA specification P-620 Type II or III paint kept the runway pavement markings whiter over the study period as compared to paint with rust inhibitor or no additive. This appears to be due to the reduced porosity of the stain resistant paint. The reduced paint pores lowered the potential for iron to cling to the stain resistant paint during periods of stormwater sheet flow over the paint.

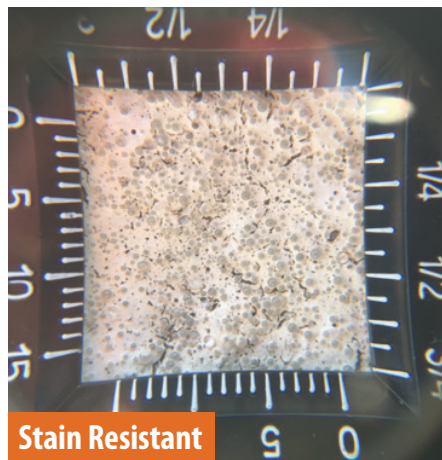
Stain Resistant

Magnified images of paint after 24 months indicates paint with a stain resistant and thickness 20% greater than the FAA standard (on left) maintained its color and had fewer bead losses compared to the standard FAA paint and thickness application (on right).
