ENGINEERED LOG JAM MONITORING

along NH Route 16 in Errol, New Hampshire

UNH Project Researchers: Dr. Thomas P. Ballestero, P.E. and Joel C. Ballestero

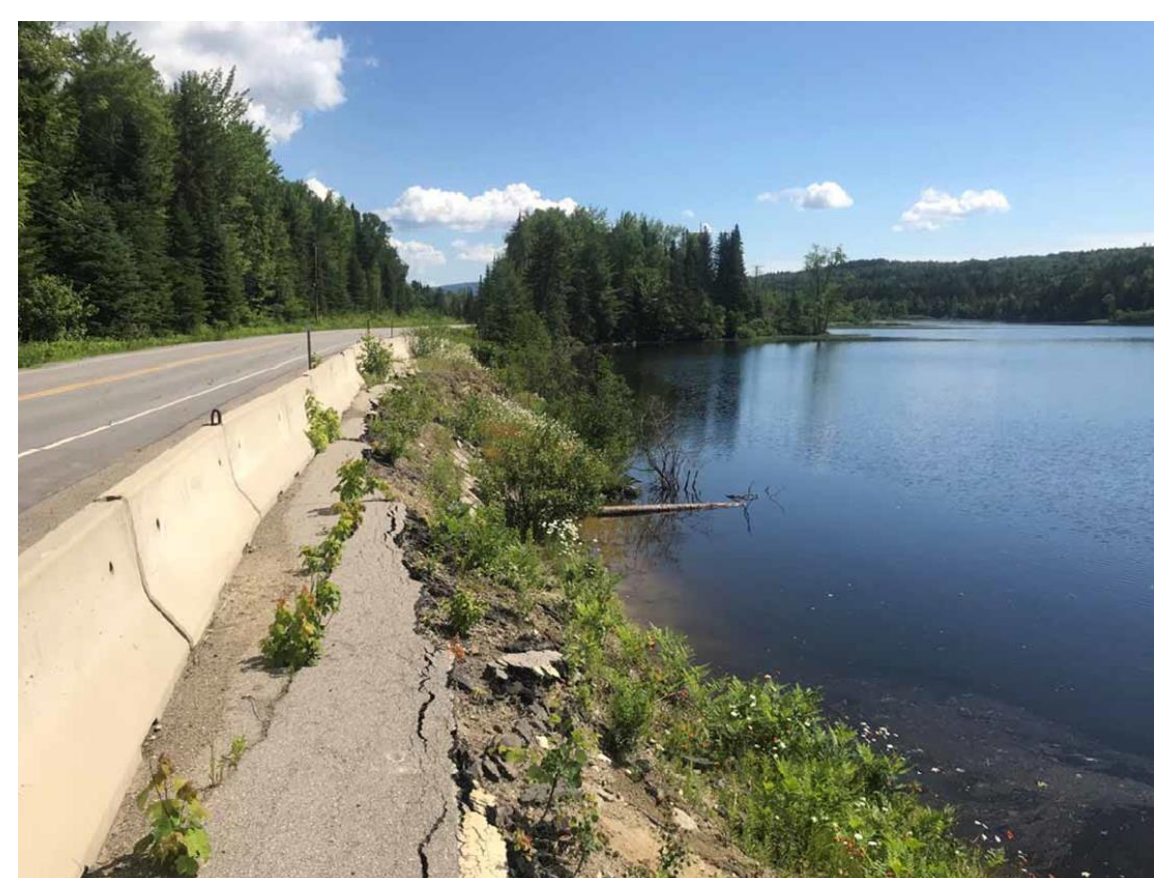
Pre-construction

Construction of a 200-foot Engineered Log Jam (ELJ) for permanent slope stabilization of the Magalloway riverbank in Errol, New Hampshire.

6/26/2020

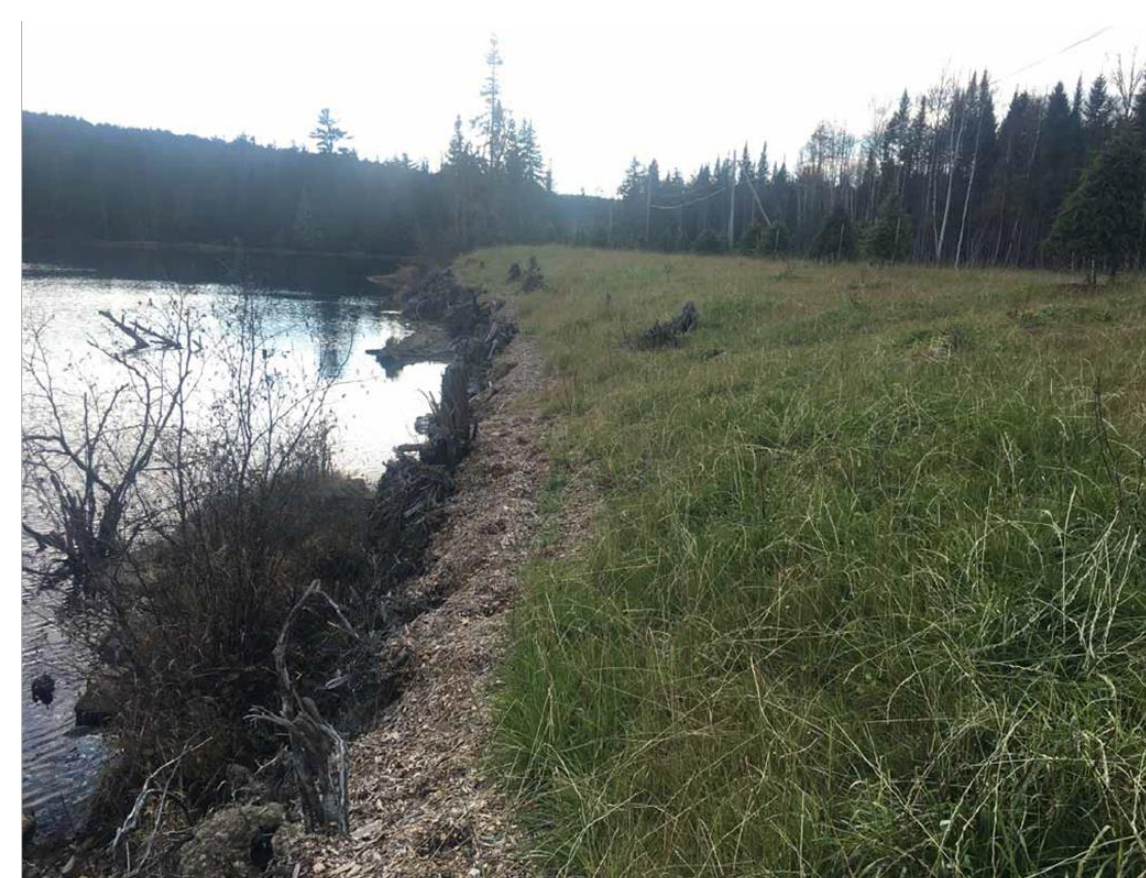
Post-construction

11/8/2021

The ELJ along the Magalloway River has arrested streambank erosion and greatly improved the terrestrial ecosystem characteristics. There is more numerous wildlife use of the terrestrial part of the streambank post-construction (insect, avian, mammal). The ELJ now creates a wildlife corridor at its location where previously none realistically existed. There is insufficient data to determine if the ELJ had any impact on aquatic resources. The ELJ does not appear to have dramatically altered near bank hydraulics. Episodically the ELJ is an armored feature capable of withstanding the near bank shear stresses that occur at the site. From observations, the ELJ also withstands the increased wave attack from boat wakes.

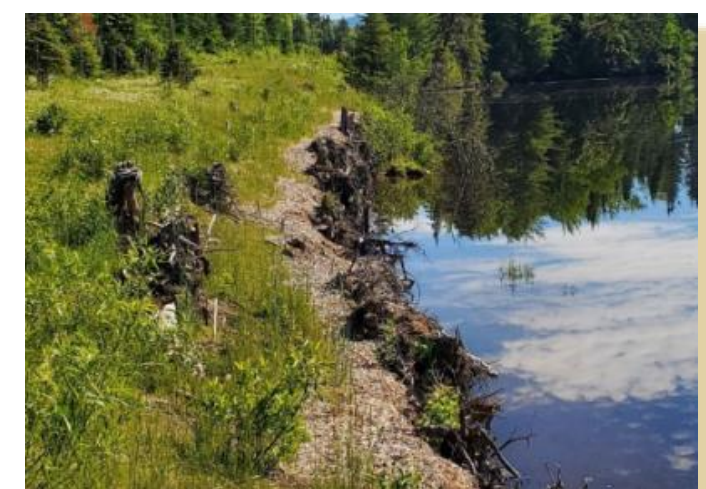
Pre-Construction observations:

- Burrowing animals
- Insects
- Mostly inhospitable streambank

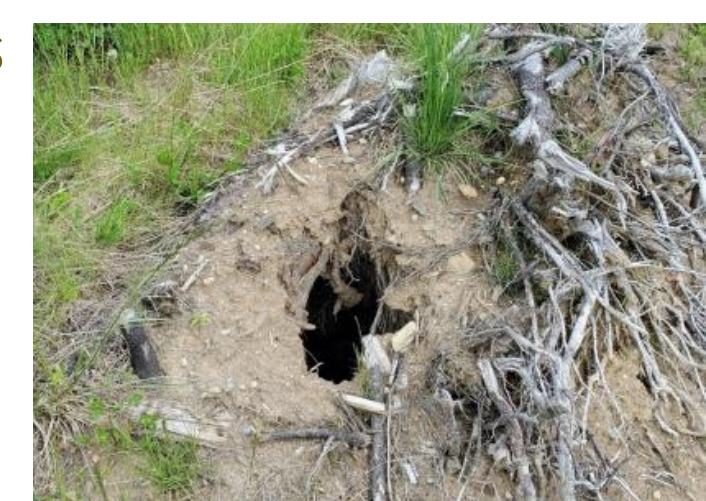
Post-Construction activity includes:

- Hoof and footprints
- Burrowing
- Herbivory
- Droppings

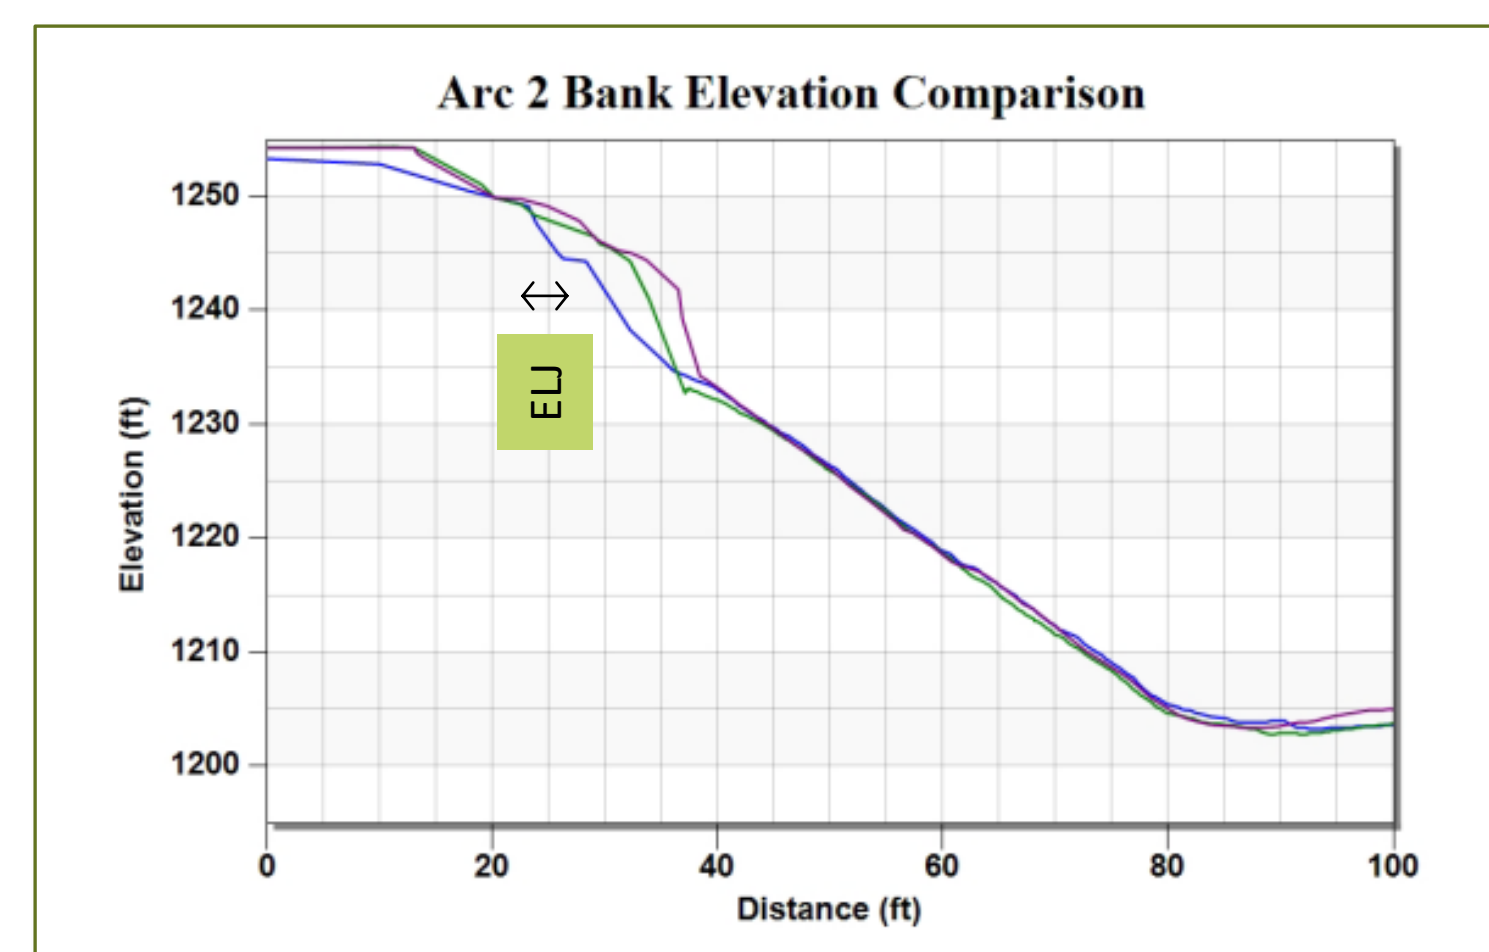
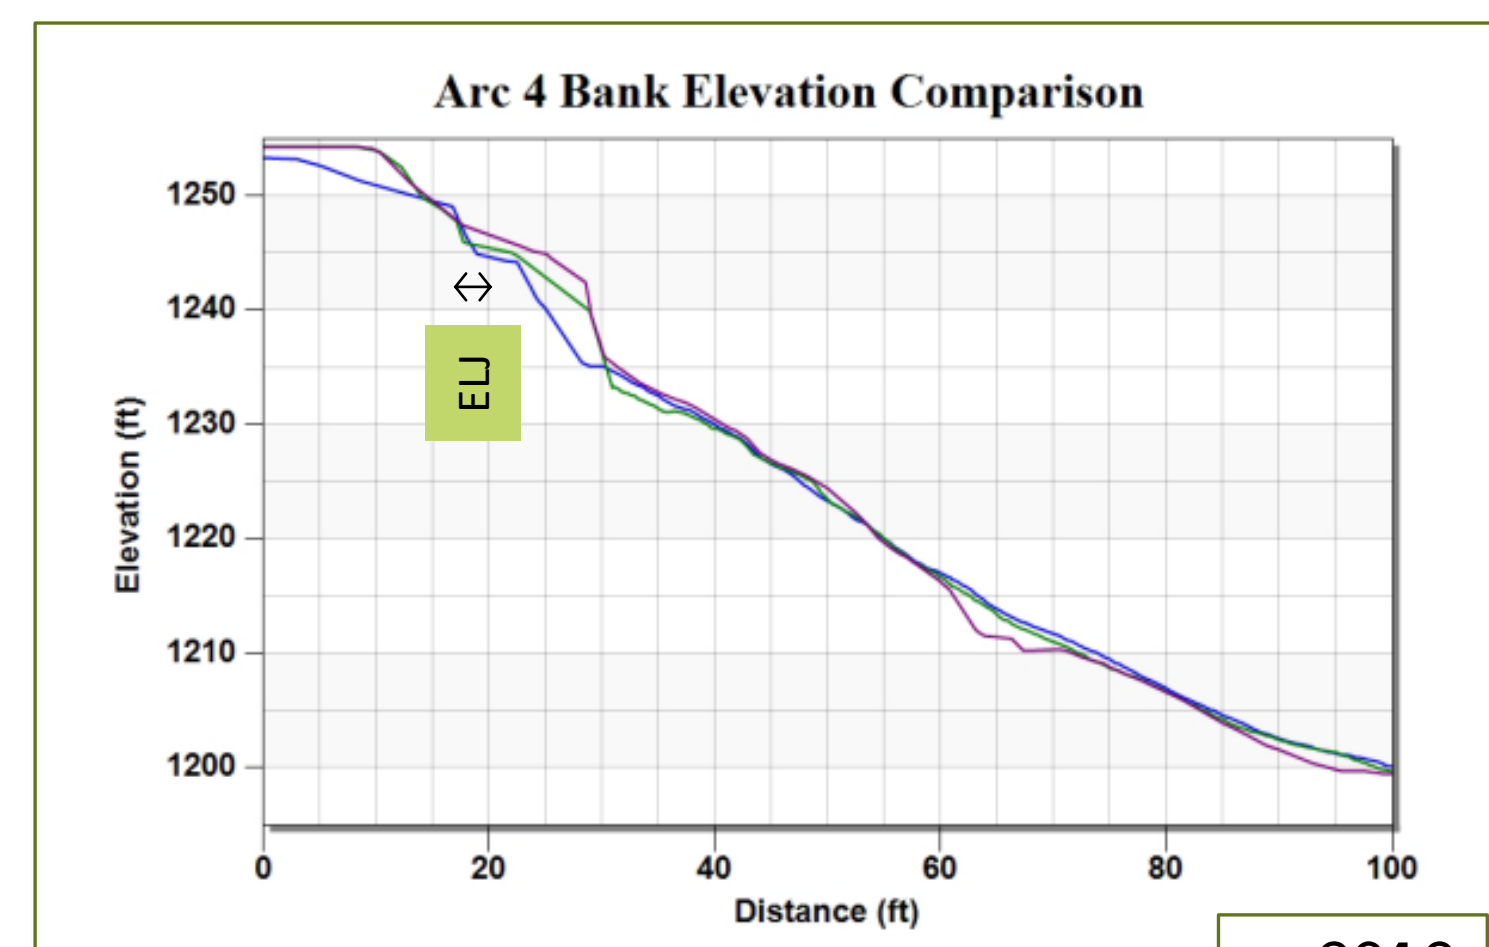
Hydraulic Topography

Bathymetric data is plotted below for the three transects, magnifying the ELJ stream bank from pre- to post-construction.

Note: For each Arc, the ELJ is at a varying distance: Arc 2, 23.25ft to 26.25ft; Arc 3, 16.25ft to 18.25ft; and Arc 4, 16.75ft to 19.0ft.

— 2019
— 2020
— 2022

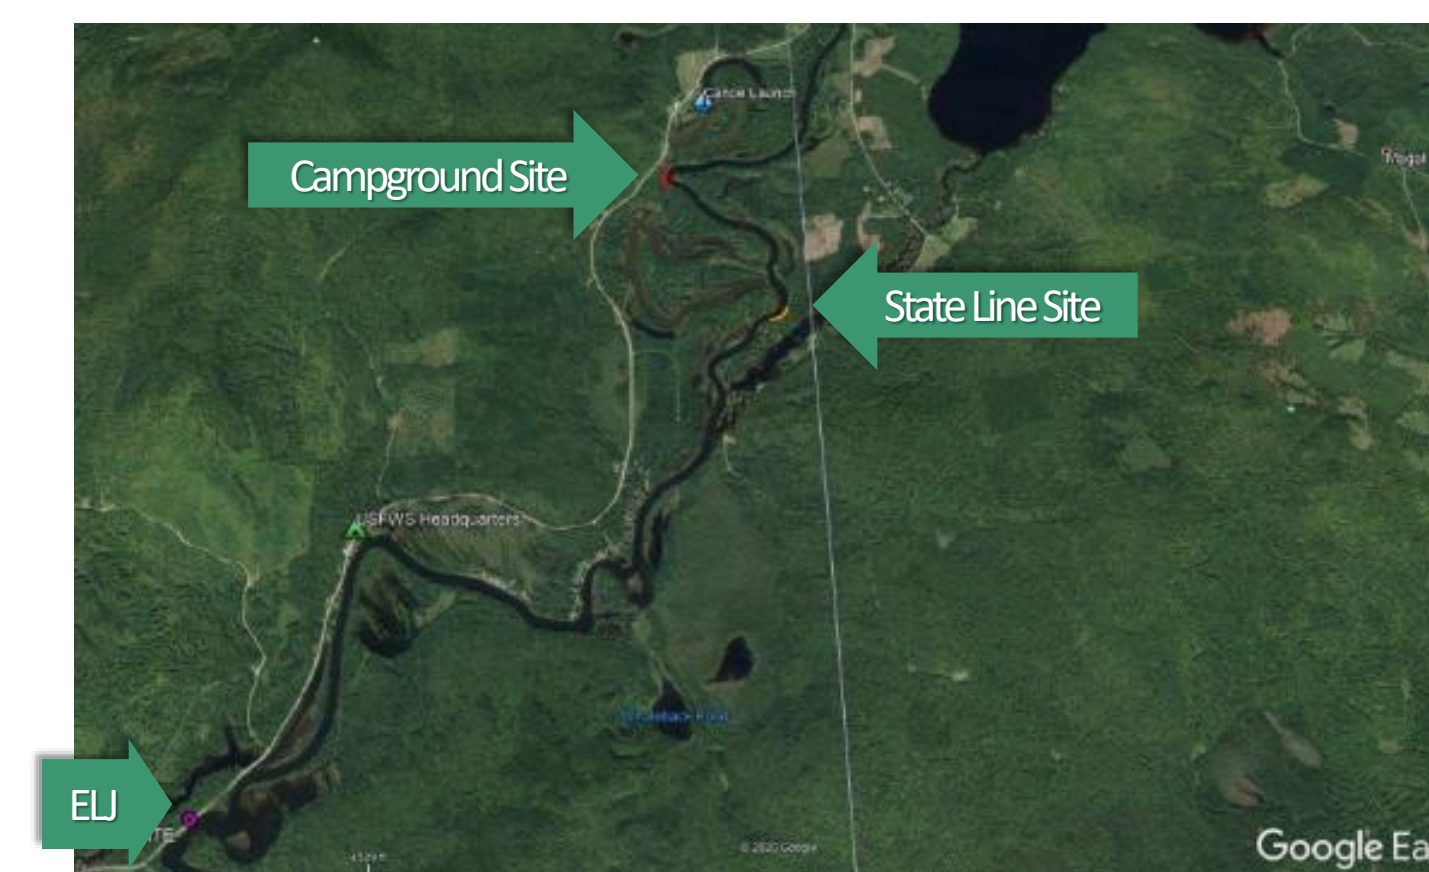
In 2019, two sites upstream of the ELJ were selected for erosion comparison.

1. **Campground Site:** located on a tight meander bend like the ELJ with unvegetated, failed banks and fallen trees
2. **State Line Site:** includes a bank height greater than the ELJ with excessive erosion evidenced by undercut, unvegetated, steep banks and fallen trees

Campground	0-1.0 ft/year
State Line	1.5 ft/year
ELJ	1.0 ft/year

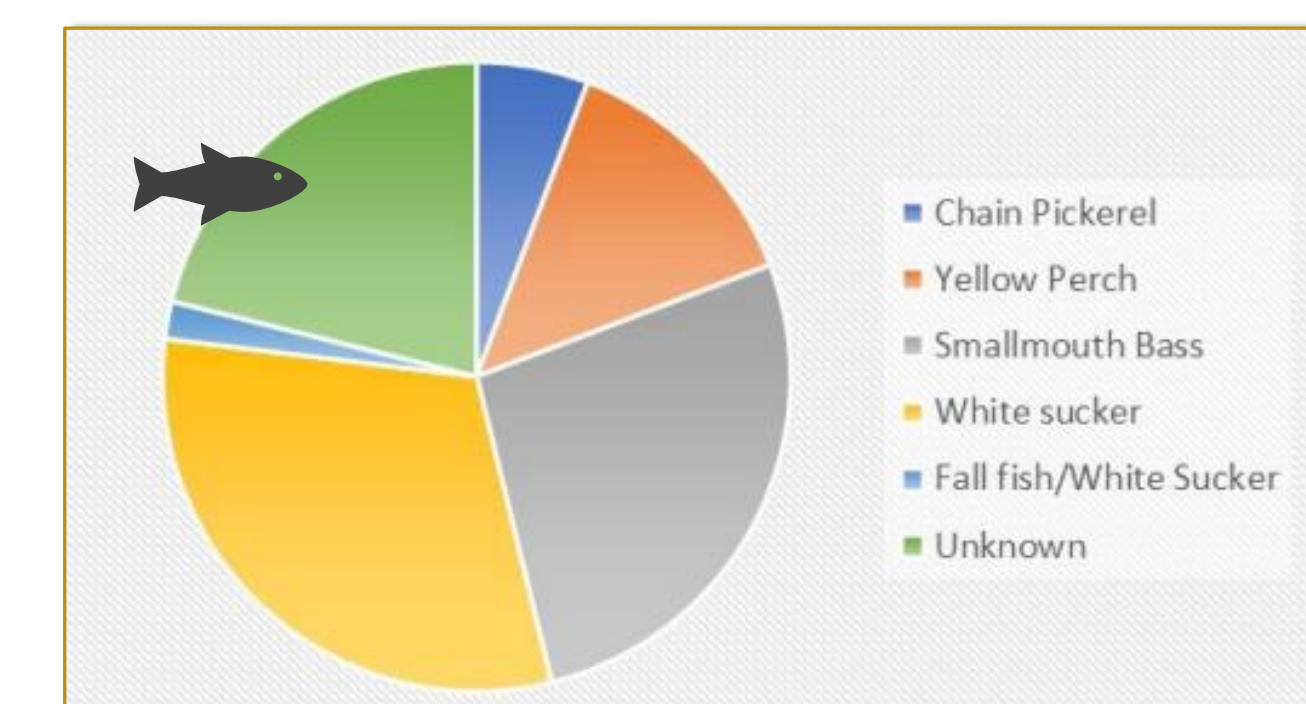
Aquatic Wildlife

Note: Aquatic wildlife was not observed post-construction due to poor water clarity.
