NASHUA-MANCHESTER 40818 (CAPITOL CORRIDOR)

APPENDIX A Natural Resources Technical Report

NASHUA-MANCHESTER 40818 CAPITOL CORRIDOR RAIL

NATURAL RESOURCES TECHNICAL REPORT

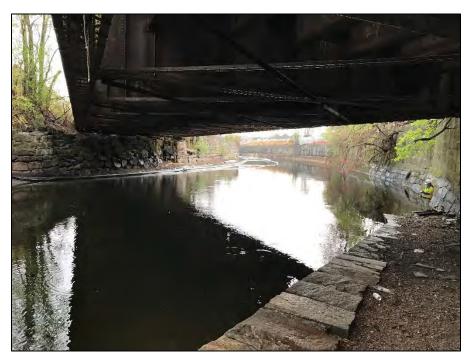
Pawtucket Canal Crossing at MP 26.20 in Lowell

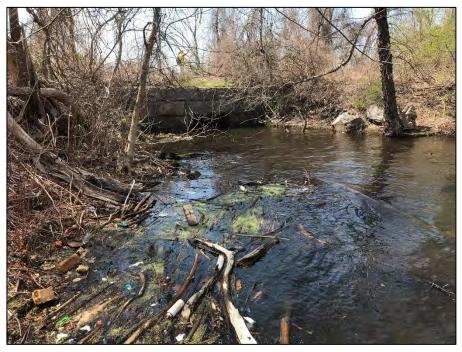
Black Brook Crossing (Wetland LO9) in Lowell

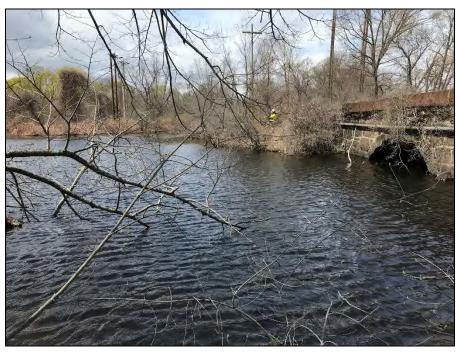
Stony Brook Crossing and Wetland CH9 in Chelmsford

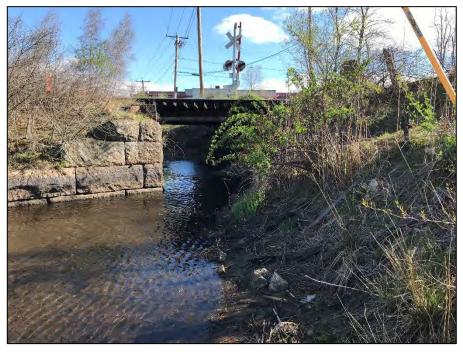
Deep Brook Crossing in Chelmsford

MassWildlife indicated that Deep Brook is designated as a Coldwater Fish Resource but the lower reach of the stream that is crossed by the project doesn't provide habitat and water temperatures suitable for coldwater fish. MassWildlife recommended that the proposed repairs to the railroad bridge ensure fish and wildlife passage upstream and downstream of the crossing during and after construction. They also mentioned that erosion and sediment controls are crucial for all phases of construction, as well as after construction is completed.

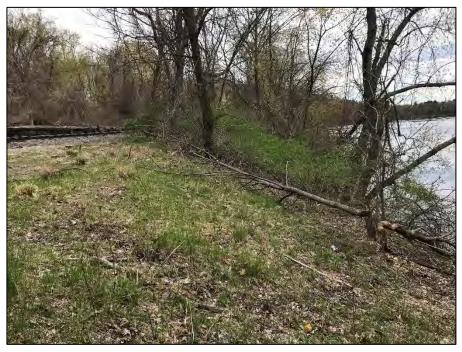
Merrimack River bank in Tyngsborough (Flag Series TY1)

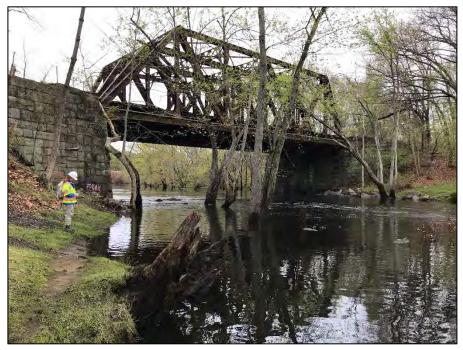
Nashua River Bridge in Nashua

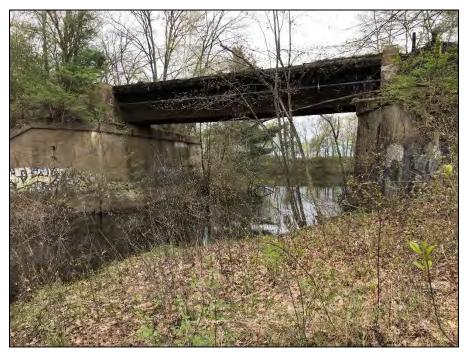
Pennichuck Brook Bridge in Nashua/Merrimack

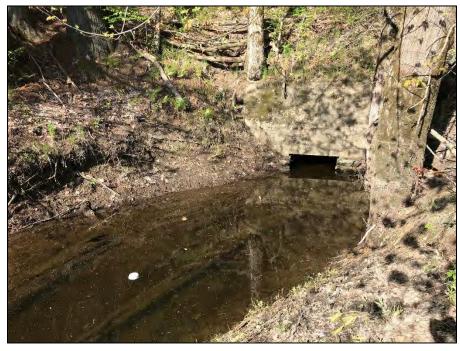
Perennial Stream ME6 in Merrimack (culvert outlet under rail line)

During field reviews of the project corridor, it was noted that many of the culverts which carry the small perennial streams are either undersized or partially filled in and do not provide aquatic organism passage. If any culverts are to be replaced, potential improvements to aquatic organism passage should be evaluated.

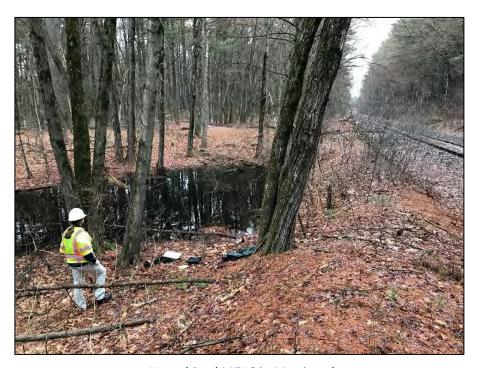
Vernal Pool ME16 in Merrimack

Within New Hampshire, one wetland (ME16) was identified as having potential vernal pool habitat (refer to Figure 2.8 in Appendix A). This wetland was field reviewed in November 2021 and a follow up site visit occurred in April 2022. Twelve wood frog egg masses were observed, confirming that ME16 functions as a vernal pool. A USACE Vernal Pool Characterization Form was completed for vernal pool ME16 and is included in the Wetland Report Addendum prepared by GM2.

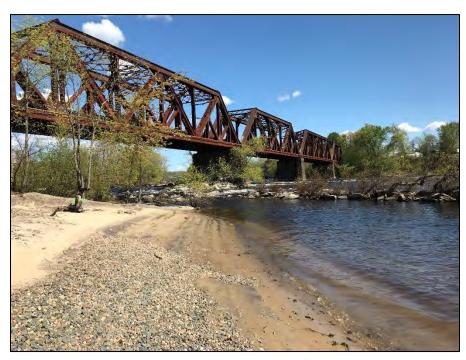
Merrimack River Bridge in Bedford/Manchester

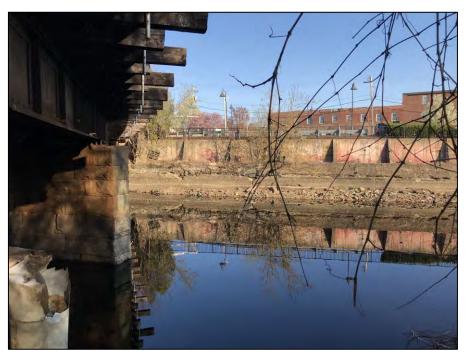
Flag series LO1, LO2, LO3, LO4, LO5, LO10, and LO14 correspond to the banks where the rail corridor crosses the Pawtucket Canal in the study area. The banks are human-made and consist of stone retaining walls. Flag series LO1, LO2, LO3, and LO4 are located at the Pawtucket Canal crossing at mile post 25.69, approximately 1,000 feet north of the Lowell MBTA Station. Flag series LO5, LO10, and LO14 are located at the Pawtucket Canal crossing at mile post 26.2 ("Red Bridge"), approximately 500 feet east of Walker Street. Each individual flag series number corresponds to a segment of the bank at each bridge quadrant with the exception of LO14, which crosses under the bridge on a lower retaining wall.

Wetland LO1 taken from LO2 (Pawtucket Canal Crossing at MP 25.69)

The banks of the Pawtucket Canal have a 100-foot buffer zone, but no Riverfront Area (in accordance with 310 CMR 10.58(2)(a)(1)(g)).

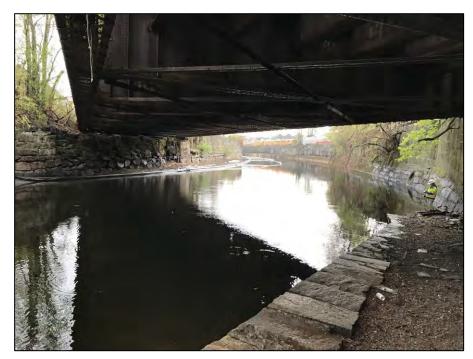
Wetland LO14 facing LO5 and LO10 (Pawtucket Canal Crossing at MP 26.2)

The banks consist of stone retaining walls and do not have much vegetation. Plant species observed at the tops of the retaining walls include sumac (*Rhus sp.*), garlic mustard (*Alliaria petiolata*), and box elder (*Acer negundo*).

Within the study area, the Pawtucket Canal does not provide any functions at a principal level since it is a constructed feature, has a high level of human disturbance, and is located in an urban area. It provides uniqueness/heritage functions at a lower level due to its historic significance in the region.

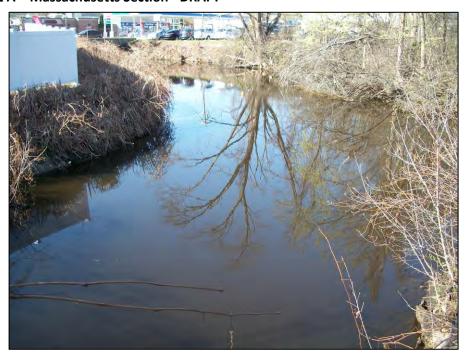
Wetland LO6 (Black Brook)

Dominant vegetation along the banks includes multiflora rose (*Rosa multiflora*), river birch (*Betula nigra*), Japanese knotweed (*Reynoutria japonica*), speckled alder (*Alnus incana*), Asian bittersweet (*Celastrus orbiculatus*), and maple (*Acer sp.*). Beaver sign and a snapping turtle were observed during the field review.

Black Brook provides various functions and values including floodflow alteration, fish habitat, sediment retention, nutrient removal, shoreline stabilization, and wildlife habitat. All of these functions and values are provided at the principal level, except for fish habitat.

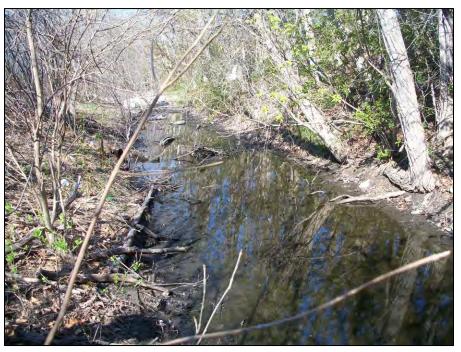
Wetland LO7

Wetlands LO7, LO11, and LO12 are BVWs located east of Rourke Bridge between a developed area, a park, and the rail corridor. They are small, flat, and appear to be seasonally inundated.

Functions provided by LO7 and LO12 include floodflow alteration, nutrient removal, and wildlife habitat. None of these are considered principal functions. Wetland LO11 may provide some floodflow alteration, but this is at a lower level due to the narrow width of the wetland.

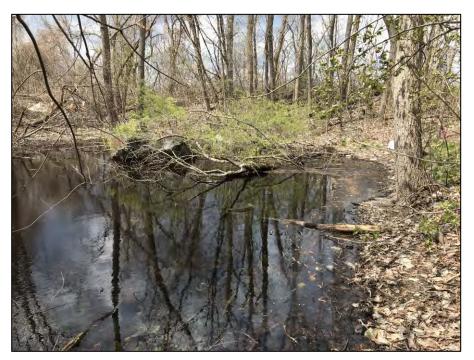
Wetland LO12

LO12 resides between LO7 and LO11 at the opposite end of the recreational field from LO11. It is classified as PUBHx. Dominant vegetation includes red maple (*Acer rubrum*), willow (*Salix*), unknown grasses, box elder (*Acer negundo*), green ash (*Fraxinus pennsylvanica*), and garlic mustard. Most of the vegetation is located around the edge of the wetland and the central portion had standing water at the time of the field review (April 2021).

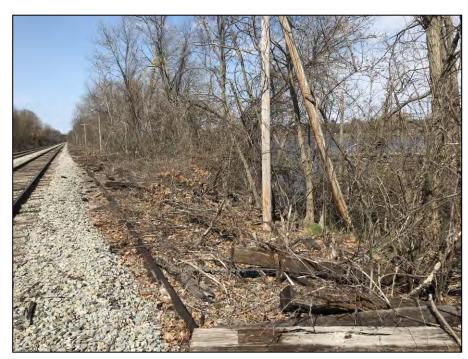
Flag series LO8 and LO13 correspond to the bank of the Merrimack River in Lowell and Chelmsford, where it is located within 100 feet of the rail line. LO8 begins approximately 2,000 feet east of Rourke Bridge and connects to LO13. LO13 continues into Chelmsford and ends at the bridge crossing of Stony Brook.

LO8 and LO13 both have a 100 foot Buffer Zone. Within Lowell, the Merrimack River has a 25 foot Riverfront Area. Within Chelmsford, the Riverfront Area is 200 feet.

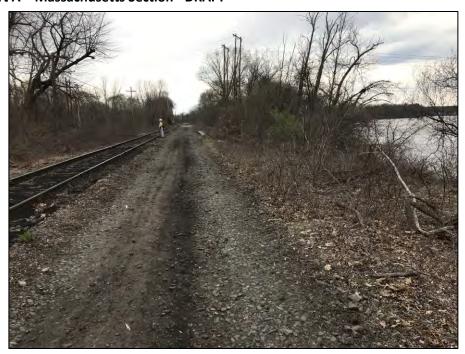
LO13 (Merrimack River bank)

Dominant vegetation includes Asian bittersweet, locust (*Robinia sp.*), gray birch (*Betula populifolia*), speckled alder, poison ivy (*Toxicodendron radicans*), red maple, glossy buckthorn (*Frangula alnus*), and red oak (*Quercus rubra*). The banks are generally 10 to 15 feet tall. Seagulls, gray squirrel, and signs of beaver activity were observed along the river.

The Merrimack River and its bank provide many functions including groundwater recharge, floodflow alteration, fish habitat, production export, shoreline stabilization, wildlife habitat, recreation, uniqueness/heritage, visual quality, and endangered species habitat. Of these, groundwater recharge, fish habitat, production export, shoreline stabilization, wildlife habitat, uniqueness/heritage, and endangered species habitat are considered principal functions.

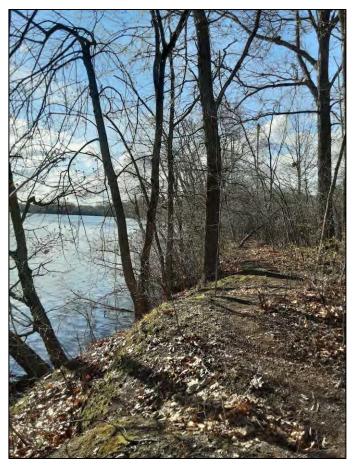
CH1 (Merrimack River bank)

CH1 and CH17 have a 100-foot buffer zone. Within Chelmsford, the Merrimack River has a 200-foot Riverfront Area.

Dominant vegetation includes red maple, red oak, Asian bittersweet, glossy buckthorn, locust, gray birch, speckled alder, poison ivy, white pine (*Pinus strobus*), and Canadian mayflower (*Maianthemum canadense*). The BVW within CH17 has silky dogwood (*Cornus amomum*), sensitive fern, speckled alder, skunk cabbage (*Symplocarpus foetidus*), and areas with saturated soils.

The Merrimack River and its bank provide many functions including groundwater recharge, floodflow alteration, fish habitat, production export, shoreline stabilization, wildlife habitat, recreation, uniqueness/heritage, visual quality, and endangered species habitat. Of these, ground water recharge, fish habitat, production export, shoreline stabilization, wildlife habitat, uniqueness/heritage, and endangered species habitat are considered principal functions.

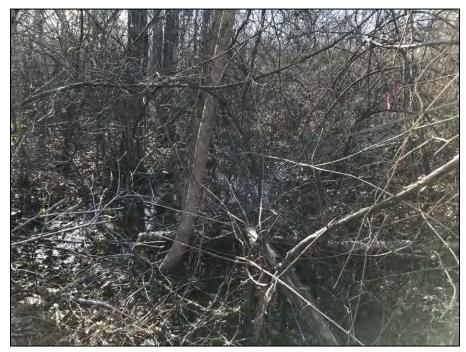
Wetland CH2

CH2 provides groundwater recharge, floodflow alteration, sediment retention, and wildlife habitat. None of these functions are provided at a principal level due to the small size of the wetland.

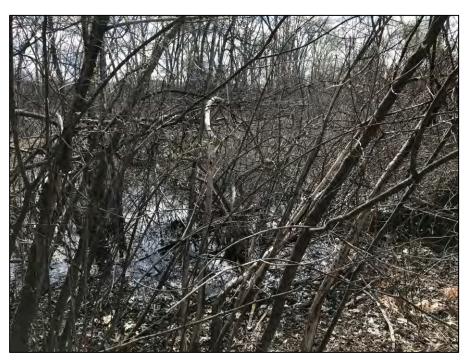
Wetland CH3

CH3 provides groundwater recharge, floodflow alteration, sediment retention, nutrient removal, and wildlife habitat. Floodflow alteration, sediment retention, and nutrient removal are performed at the principal level.

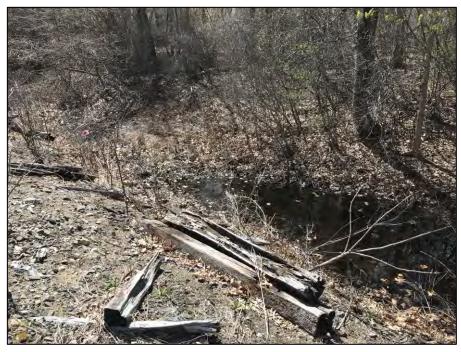
Wetland CH6

CH6 is primarily vegetated by silky dogwood, purple loosestrife, and various shrubs. It provides some nutrient removal and wildlife habitat, however these functions are limited by the small size of the wetland and lack of connection to other wetland systems. Wetland CH7 is predominately vegetated with common

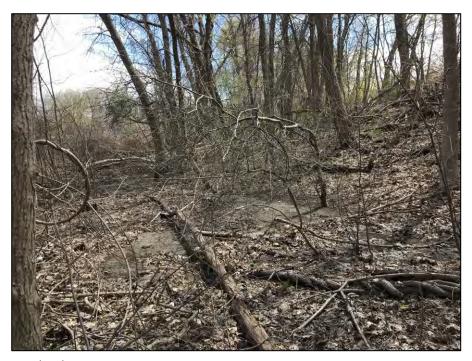
Wetland CH7

reed (*Phragmites australis*), silky dogwood, Asian bittersweet, and arrowwood. CH7 provides some sediment retention, nutrient removal, and wildlife habitat but none of these functions are provided at a principal level.

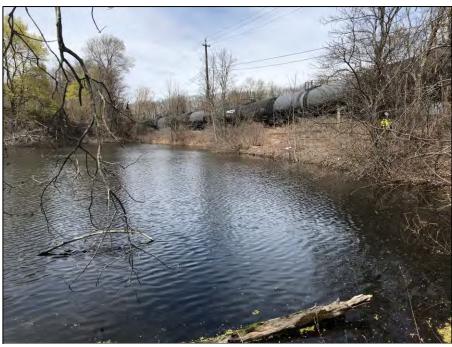
Wetland CH8

<u>Massachusetts Regulated Wetland Areas</u>: BVW, 100-foot buffer zone <u>Federal classification</u>: palustrine, unconsolidated bottom, permanently flooded, diked/impounded (PUBHh)

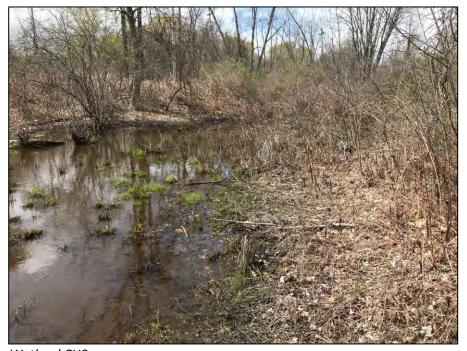
Wetland CH9

Flag series CH9 and CH10 correspond to the banks of Stony Brook. CH9 also includes a BVW located adjacent to Stony Brook on the southwest side of the rail corridor. Both areas are located approximately 2,300 feet southeast of Wotton Street. The banks are vegetated with red oak and maple. The BVW within CH9 is vegetated with red maple, silky dogwood, and sedges (Carex sp.). Stony Brook has a 200-foot Riverfront Area. Its adjacent banks and BVW have a 100foot buffer zone.

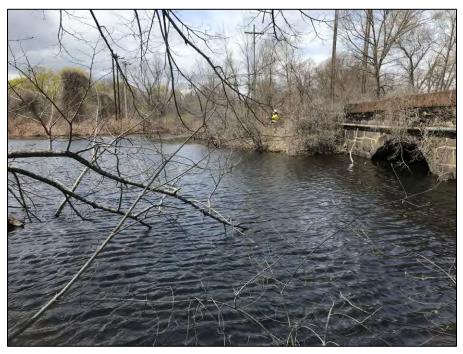
Stony Brook and CH9

groundwater recharge, floodflow alteration, fish habitat, sediment retention, shoreline stabilization, wildlife habitat, and uniqueness/heritage. Of these, floodflow alteration and fish habitat are performed at the principal level. CH9 also performs nutrient removal and sediment retention at the principal level whereas CH10 does not provide nutrient removal and doesn't provide sediment retention at the principal level. This is because CH10 is a small bank with no wetland edge to retain water.

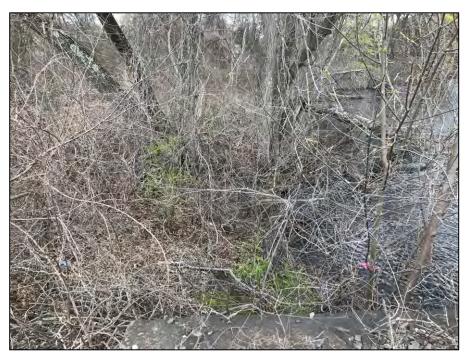
Stony Brook bank (CH10)

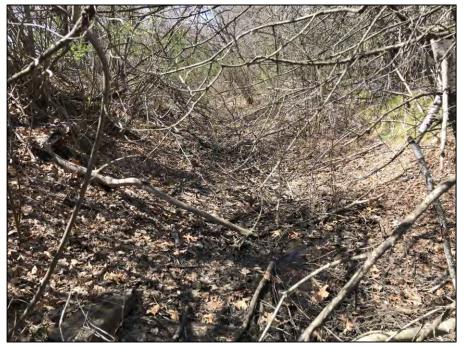
Wetland CH11

Wetlands CH11 and CH12 are located on the northern side of the rail line just west of Wotton Street, near Deep Brook. They are both narrow, excavated swales. CH11 drains east into Deep Brook. CH12 does not appear to have a direct hydrologic connection to Deep Brook or other wetland resources.

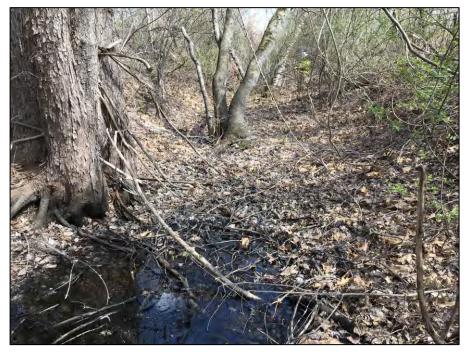
Wetland CH12

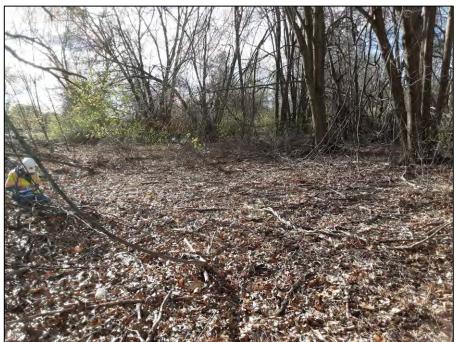
Wetland CH13

CH13 is located approximately 500 feet southeast of Wellman Avenue and south of the rail corridor in Chelmsford. It has a 100 foot Buffer Zone. Dominant vegetation includes red maple, silky dogwood, glossy buckthorn, sensitive fern, and jewelweed. At the time of the field review (April 2021) the wetland had little herbaceous cover. CH13 appears to be isolated and doesn't have hydrologic connections to other wetland resources.

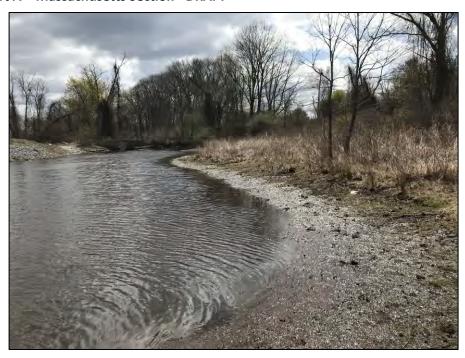
Wetland CH5

The western end of CH5 contains a concrete retaining wall and 2 culvert pipe inlets. Dominant vegetation for CH5 includes silky dogwood, jewelweed, autumn olive (Elaeagnus umbellata), oak, Asian bittersweet, and honeysuckle. CH5 provides various functions including floodflow alteration, sediment retention, nutrient removal, shoreline stabilization, wildlife habitat, and uniqueness/heritage. The functions performed at the principal level are sediment retention, nutrient removal, and wildlife habitat.

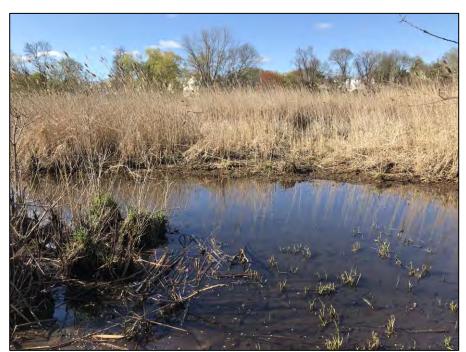
Wetland CH14

CH14 is primarily vegetated with common reed. It contains areas with shallow open water, as well as shrub areas along the edge. CH14 provides the same functions at the same levels as CH5, including floodflow alteration, sediment retention, nutrient removal, shoreline stabilization, wildlife habitat, and uniqueness/heritage. Sediment retention, nutrient removal, and wildlife habitat are provided at a principal level.

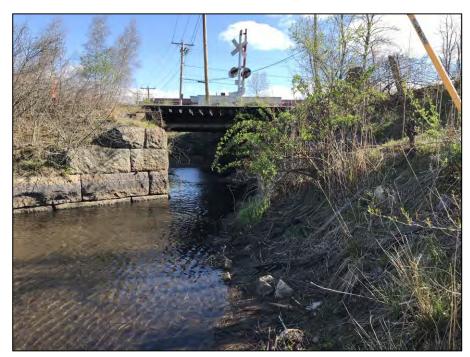
Wetland CH15

CH15 corresponds to the bank of Deep Brook located near Wotton Street. It is vegetated with silky dogwood and honeysuckle. The only function provided by CH15 is shoreline stabilization. This is provided at a lower level due to the steep bank, location next to the road, and lack of dense vegetation.

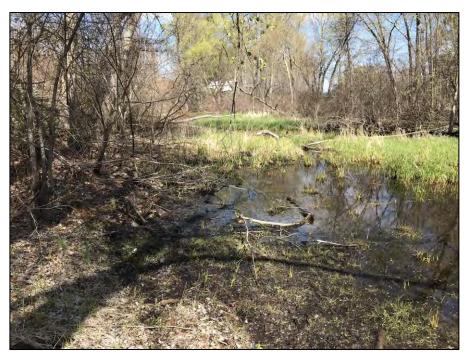
Wetland CH16

CH16 is located at mile post 29.87, approximately 1,400 feet northwest of Wellman Avenue. It has a 100-foot buffer zone. CH16 is associated with the Merrimack River and appears to be periodically flooded. At the time of the field review (April 2021) there was several inches of standing water in the wetland. Dominant vegetation includes red maple, gray birch, silky dogwood, speckled alder, and sensitive fern.

The functions CH16 provides include floodflow alteration, sediment retention, nutrient removal, wildlife habitat, and endangered species habitat. Of these, sediment retention and endangered species habitat are considered principal functions. Portions of CH16 are located within mapped Priority Habitat and Estimated Habitat.

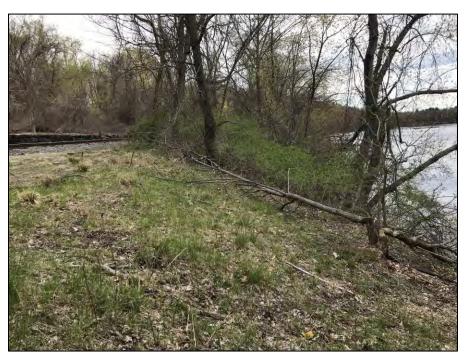
Dominant vegetation within TY1 and TY6 includes American beech, red oak, white pine, speckled alder, Canada mayflower, Asian bittersweet, honeysuckle, and barberry. A section of TY1 located south of the Tyngsborough Bridge (MA Route 113) consists of a stone retaining wall.

TY1 (Merrimack River bank)

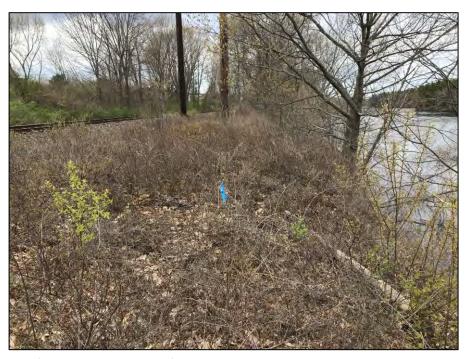
TY6 (Merrimack River bank)

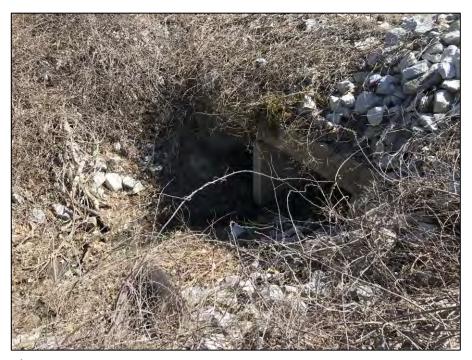
Flag Series TY2

Flag series TY2 is an excavated drainage channel located approximately 2,000 feet southeast of Westford Road at mile post 31.76. There is stone riprap on the banks. At the time of the field review (April 2021), vegetation was relatively sparse and consisted of Asian bittersweet at the edge and purple loosestrife (*Lythrum salicaria*) in the channel. Due to a lack of vegetation and limited natural substrate, TY2 has been classified as an unregulated drainage channel rather than a stream or BVW.

TY2 does not provide any functions due to its small size and limited vegetation. It is located within mapped Priority and Estimated Habitats, however it doesn't appear that this wetland resource contains habitat that would be utilized by the listed species (bald eagle and riverine clubtail).

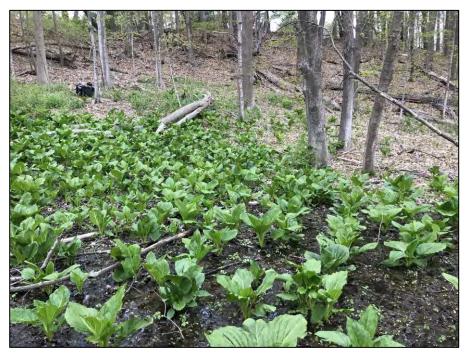
Wetland TY3 is a BVW located approximately 1,000 feet north of MA Route 113 in Tyngsborough on the western side of the rail corridor. The wetland is predominantly vegetated with red maple and skunk cabbage. The wetland had saturated soils at the time of the field review and appears to form from a hillside seep. The wetland does not have an outlet and is not directly connected to other wetland resources.

The functions Wetland TY3 provides include groundwater recharge, floodflow alteration, wildlife habitat, and endangered species habitat. Of these, groundwater recharge and endangered species habitat are considered principal functions. TY3 is primarily fed by groundwater discharge. It is located within mapped Priority Habitat and Estimated Habitat.

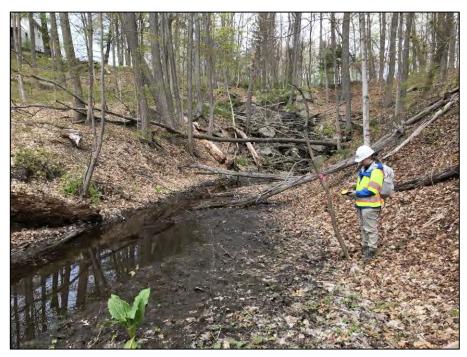
Wetland TY4

The intermittent stream in TY4 contained approximately 1 to 3 inches of flowing water at the time of the field review (April 2021). The substrate consists of sand and muck, with bedrock located upstream of the study area. A small BVW borders the stream. The stream banks and BVW are vegetated with red maple, creeping-jenny (*Lysimachia nummularia*), jewelweed (*Impatiens capensis*), and skunk cabbage. The functions

provided by TY4 include floodflow alteration, shoreline stabilization, wildlife habitat, and endangered species habitat. Of these, shoreline stabilization and endangered species habitat are considered principal functions. TY4 is located within mapped Priority Habitat and Estimated Habitat.

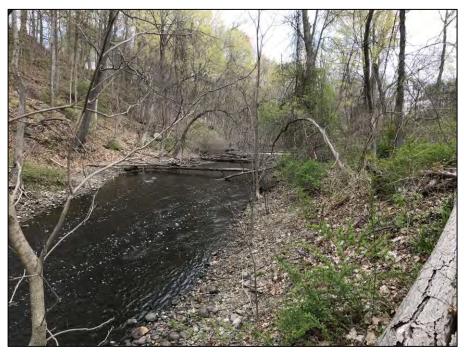
Wetland TY5

TY5 (Bridge Meadow Brook) includes both a perennial stream channel and an impounded area with standing water. Flag series TY5 corresponds to the delineated bank, which ranges from 3 to 15 feet in height. The substrate includes a mix of

cobbles and sand. The bank is predominantly vegetated with honeysuckle, multiflora rose, Asian bittersweet, maple, barberry (*Berberis thunbergii*), and burning bush (*Euonymus alatus*). Similar to TY4, TY5 performs sediment retention, shoreline stabilization, and endangered species habitat at the principal level. TY5 also provides floodflow alteration, fish habitat, nutrient removal, and wildlife habitat.

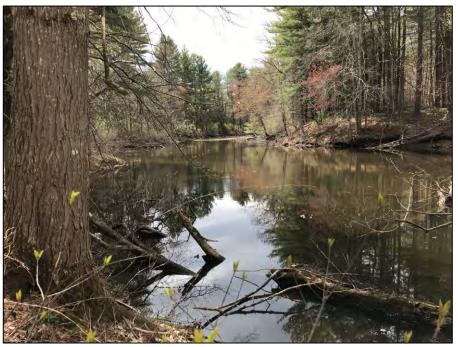
Mill Brook (TY7)

Flag series TY7 represents the outlet of Mill Brook just before it crosses under the rail corridor and empties into the Merrimack River. Mill Brook is located approximately 2,700 feet south of the NH/MA state border, west of the railroad. It is vegetated with fringed loosestrife (Lysimachia ciliata), red maple, silky dogwood, honeysuckle, and Asian bittersweet. The stream contains standing water and not much flow was observed. The stone culvert under the railroad is undersized and appears to restrict flow into the Merrimack River. Mill Brook has a 200-foot Riverfront Area. Its adjacent

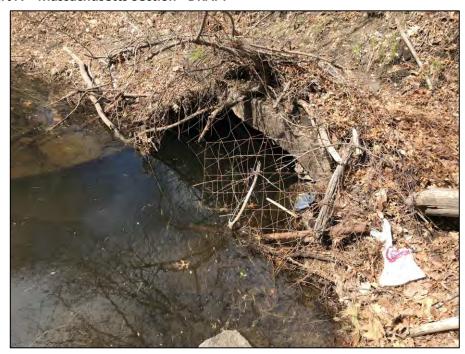
Mill Brook (TY7) culvert under railroad

Functions provided by Mill Brook include floodflow alteration, fish habitat, sediment retention, nutrient removal, shoreline stabilization, and wildlife habitat. All but fish habitat are provided at the principal level.

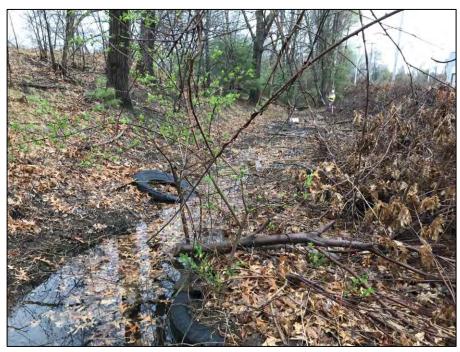
Wetland TY8 is a narrow BVW located approximately 3,700 feet north of the Chelmsford/Tyngsborough town line between a commercial development and the rail line. There are culverts at either end of the wetland, which is located in an excavated swale. It is vegetated with red maple, green ash, sedges (Carex sp.), and goldenrod (Solidago sp.). The functions performed by TY8 include floodflow alteration, sediment retention, nutrient removal, and endangered species habitat. None of these are provided at a principal level.

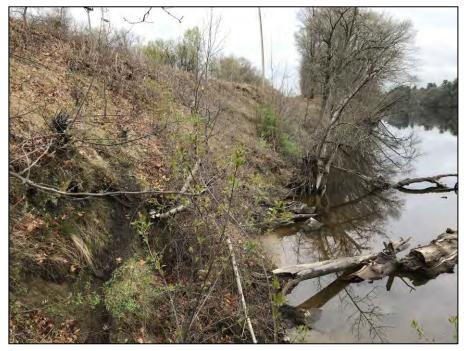
Merrimack River Bank (NA1)

Flag series NA1, NA2, NA7, NA22, NA24, and NA25 correspond to segments of the Merrimack River bank located adjacent to the rail right-ofway in Nashua. Top of bank (TOB) was delineated in the field and located with GPS. Ordinary high water (OHW) was not located with GPS.

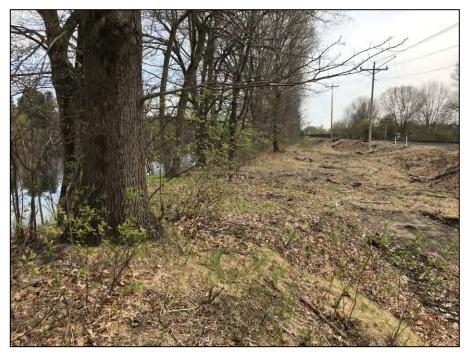
Merrimack River Bank (NA7)

Dominant vegetation along the bank includes red maple (Acer rubrum), Asian bittersweet (Celastrus orbiculatus), Tatarian honeysuckle (Lonicera tatarica), white pine (Pinus strobus), red oak (Quercus rubra), birch (Betula sp.), poison ivy (Toxicodendron radicans), glossy buckthorn (Frangula alnus), box elder (Acer negundo), and multiflora rose (Rosa multiflora). Within the study area, the bank is relatively steep and tall, with some eroded segments. Signs of beaver activity were noted.

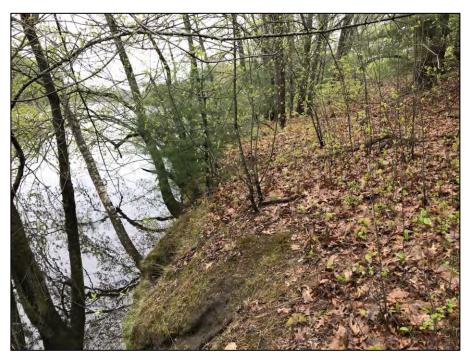
Merrimack River Bank (NA24)

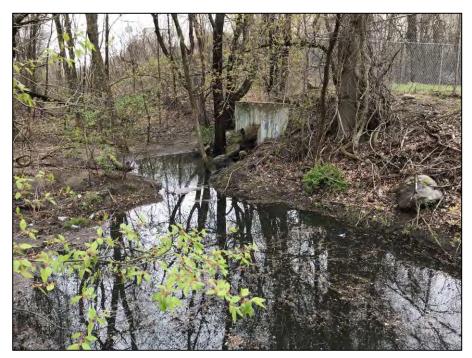
Wetland NA3

Wetlands NA3, NA4, NA5, NA6, and NA6A are relatively small, urban wetlands. All are located on the western side of the rail corridor between commercial development and the rail line. They all have areas that are periodically inundated with shallow water.

Wetlands NA3, NA4, NA5, and NA6 provide only flood storage and not at the principal level due to their size/width. The wetlands show evidence of human disturbance and are small and narrow, which limits their ability to provide other functions.

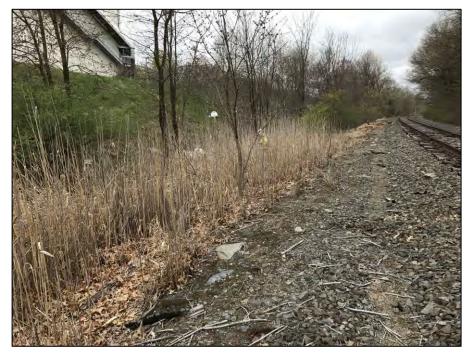
Wetland NA4 is approximately 375 feet long and is located behind the Webster Square commercial development south of East Spit Brook Road. It is an emergent wetland located in a swale. Vegetation includes grasses, poison ivy, purple loosestrife (*Lythrum salicaria*) and areas with dense common reed (*Phragmites australis*).

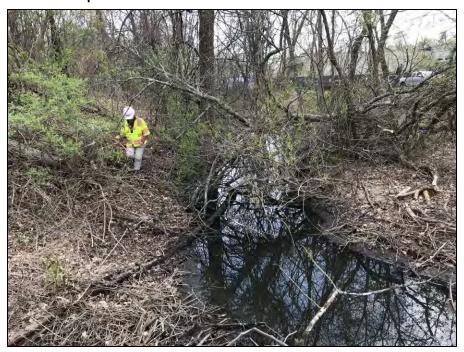
Wetland NA6 begins between East Spit Brook Road and the railroad corridor and extends for approximately 540 feet to the south. It is a wetland swale that contained areas with at least 12 inches of ponded water at the time of the wetland delineation (April 2021). Dominant vegetation is comprised of Tatarian honeysuckle, poison ivy, Asian bittersweet, and red oak. Water from NA6 flows north across a dirt path at the end of East Spit Brook Road. Flag series NA6A was delineated north of East Spit Brook Road and connects to NA6 via flow over the road. NA6A contains similar vegetation and provides the same functions as NA6.

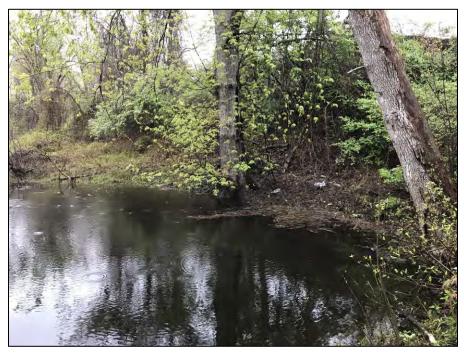
Flag series NA8 and NA9 correspond to the banks of Salmon Brook and the Merrimack River on the eastern side of the rail corridor while NA10 and NA11 correspond to the banks of Salmon Brook on the western side of the rail corridor. The Salmon Brook crossing is located at mile post 37.87,

Salmon Brook upstream of railroad (NA10)

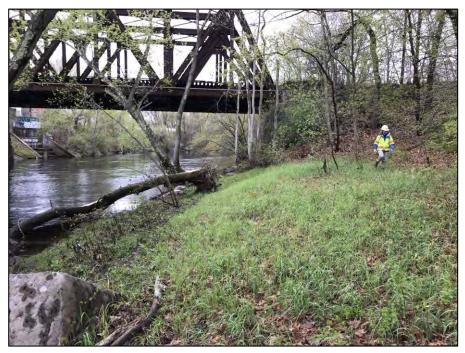
Nashua River (NA13)

NA13 contains a small wetland bench that is vegetated with glossy buckthorn, grasses, poison ivy, fringed loosestrife (Lysimachia ciliata), silver maple (Acer saccharinum), and deer tongue grass (Dichanthelium clandestinum). There were also signs of beaver activity noted.

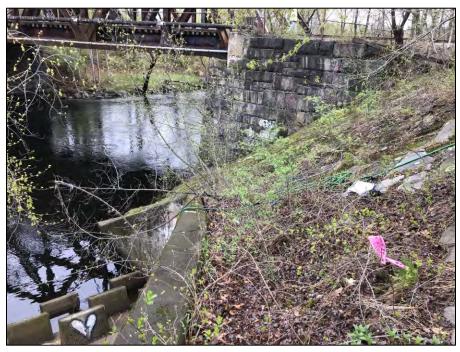
Nashua River (NA14)

Flag series NA12, NA13, NA14, and NA15 correspond to the bank of the Nashua River near the railroad crossing. NA12 and NA14 are located on the western side of the railroad and NA13 and NA15 are located on the eastern side. The Nashua River railroad crossing is located approximately 900 feet north of Bridge Street in Nashua. The Nashua River has a regulatory floodway and an associated Zone AE (100-year) floodplain. It is also considered Prime Wetland and, as such, is categorized as Priority Resource Area.

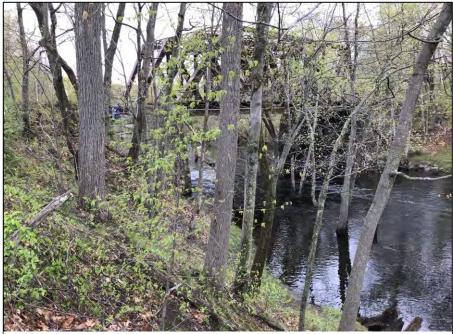
Salmon Brook (NA15), looking toward railroad bridge

NA15) provide many functions including ecological integrity, fish habitat, flood storage, groundwater recharge, production export, shoreline anchoring, uniqueness/heritage, and wildlife habitat. Of these, ecological integrity, fish habitat, flood storage, and uniqueness/heritage are considered to be principal functions.

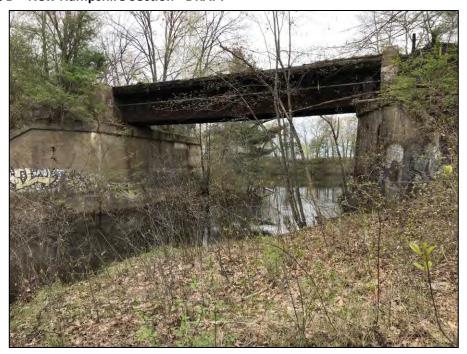
Pennichuck Brook (NA16, looking toward ME3)

Pennichuck Brook and its associated banks and wetland (NA16, NA17, ME2, and ME3) provide various functions including ecological integrity, fish habitat, flood storage, groundwater recharge, production export, sediment trapping, shoreline anchoring, uniqueness/heritage, and wildlife habitat. Of these ecological integrity, fish habitat, and wildlife habitat are provided at the principal level.

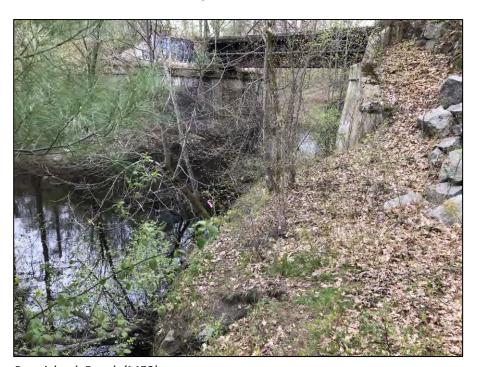
Pennichuck Brook (ME3)

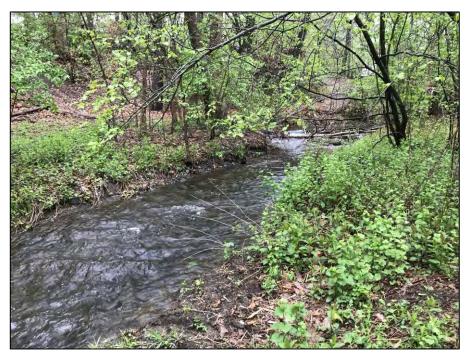
Wetland/perennial stream NA19

Flag series NA18, NA19 and NA23 correspond to a small perennial stream and associated wetland. NA18 is a forested wetland located approximately 600 feet north of Circumferential Highway in Nashua. It connects to NA19 beyond the study area. NA19 includes a small perennial stream and adjacent wetland. Both wetland resource areas are located to the west of the railroad. The stream flows from NA19 under the railroad through a culvert into NA23, which drains into the Merrimack River.

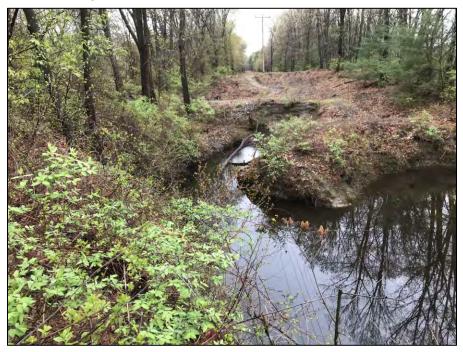
Wetland NA23

NA18 and NA19 are vegetated with fringed loosestrife, speckled alder, silky dogwood, multiflora rose, garlic mustard (*Alliaria petiolata*), and green ash. NA23 is vegetated with poison ivy, speckled alder, Asian bittersweet, Tatarian honeysuckle, and some silky dogwood. Functions provided by NA18 and NA19 include flood storage, nutrient trapping, sediment trapping, and wildlife habitat. All except for wildlife habitat are provided at the principal level. NA23 provides fish habitat, flood storage, nutrient trapping, sediment trapping, shoreline anchoring, and wildlife habitat. Similar to NA18 and NA19, NA23 performs flood storage, nutrient trapping, and sediment trapping at the principal level.

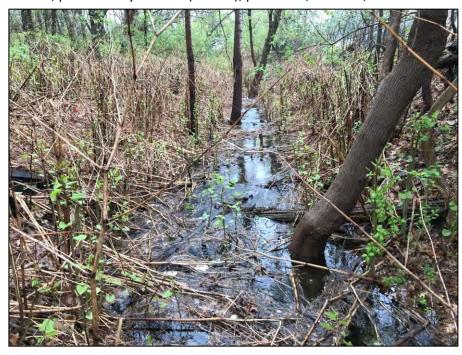
Wetland/Intermittent Stream NA20

NA20 includes an intermittent stream and forested wetland located approximately 1,300 feet south of Circumferential Highway on the western side of the railroad. The stream is approximately 5 to 6 feet wide and had 2 to 6 inches of flowing water at the time of the site visit (May 2021). Its substrate consists of sand and the banks are approximately 2 to 3 feet tall. The stream flows under the railroad corridor via a culvert into NA21, where it has been classified as a perennial stream. NA21 has banks that are approximately

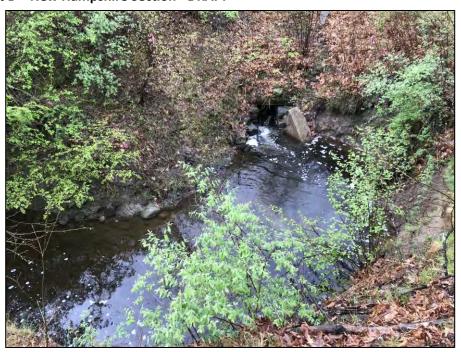
Perennial Stream NA21

6 to 15 feet tall and the stream had at least one foot of water during the site visit (May 2021). The stream channel is approximately 10 to 15 feet wide and has a sandy substrate. There was not much flow near the Merrimack River but standing water was present. Water from the river appears to flow into the NA21 stream channel.

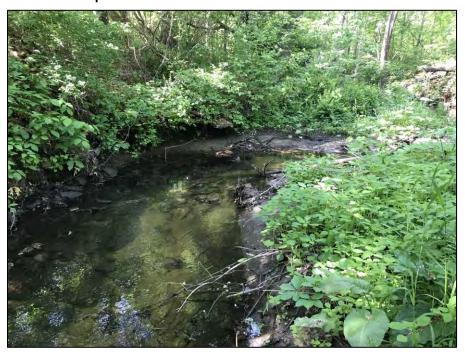
Spit Brook (NA26) view upstream

NA26 is the portion of Spit Brook located just upstream of a culvert that carries it underground to the Merrimack River. It is located on the former Hampshire Chemical property between Daniel Webster Highway and the rail corridor in Nashua, adjacent to a potential rail station site (South Nashua Station). Spit Brook is a perennial stream with a water depth of approximately 8 to 12 inches at the time of the site visit (June 2021). The stream channel is approximately 8 to 10 feet wide with a 3-foot bank on the southern edge. The northern edge of the stream is a wetland. The stream substrate is a mixture of sand and silt with some rocks. A Zone AE floodplain and regulatory floodway is mapped just south of Spit Brook. It appears that this floodplain and floodway should correspond to Spit Brook and that the mapped floodplain and floodway may not be in the correct location. Since Spit Brook is a Tier 3 watercourse, the adjacent floodplain wetland is categorized as a Priority Resource Area.

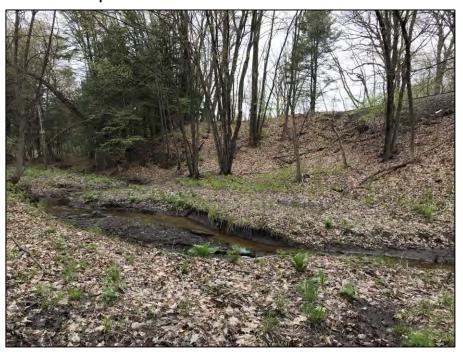
Wetland/Intermittent Stream ME1

ME1 is an intermittent stream and wetland located approximately 900 feet south of Mast Road in Merrimack. The stream channel is approximately 3 to 4 feet wide and has a sandy/silty substrate. At the time of the field visit in May 2021, there was 3 to 4 inches of flowing water. The stream in ME1 flows through a small stone culvert under the railroad into ME5, which drains into the Merrimack River. ME5 is classified as a perennial stream with a silt substrate and steep, eroded banks. At the time of the field visit, there was approximately 1 to 2 feet of water but not much flow was observed.

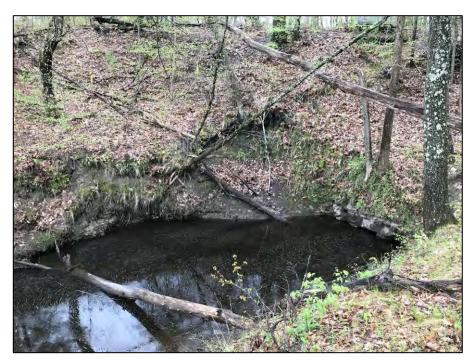
Perennial Stream ME5

The functions provided by ME1 include flood storage, groundwater recharge, nutrient trapping, sediment trapping, shoreline anchoring, and wildlife habitat. Due to its location in a developed area, none of the functions are performed at the principal level. ME5 provides fish habitat, flood storage, shoreline anchoring, and wildlife habitat. Similarly, due to its location, limited vegetated, and eroded banks, none are principal.

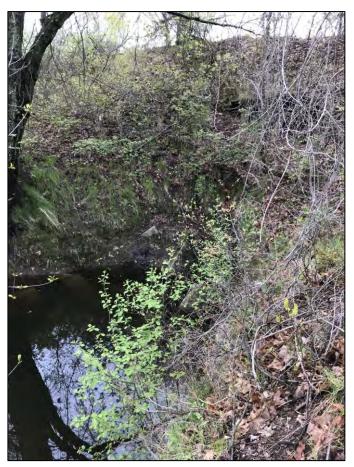
Perennial Stream ME4

Flag series ME4 corresponds to the bank of a small perennial stream located at a railroad culvert outlet at mile post 42.21. The stream flows into the Merrimack River approximately 30 feet downstream of the culvert outlet. It is located approximately 1,600 feet south of Mast Road on the eastern side of the rail corridor in Merrimack. The banks are approximately 10 to 15 feet tall and steep. There is standing water and little flow.

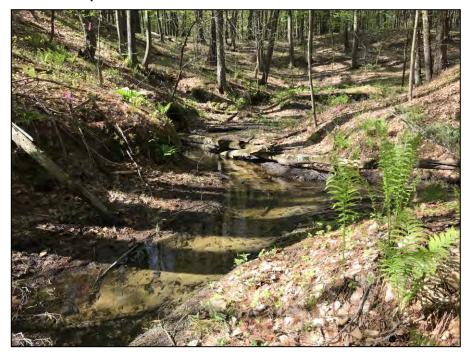
Wetland/Perennial Stream ME7

ME7 is a small perennial stream and wetland located just south of Anheuser Busch in Merrimack. It is located west of the railroad. The stream had 3 to 10 inches of flowing water during the time of the site visit (May 2021) and was approximately 3 feet wide with 3- to 4-foot-tall banks. The stream substrate is sand with organic debris (leaves, sticks). It flows through a small culvert under the railroad to ME6 (a perennial stream), which drains into the Merrimack River. There was very slow flow into the Merrimack River and the water was at least 1 foot deep at the time of the field review. The banks of the perennial stream ME6 are very steep and approximately 10 to 15 feet tall.

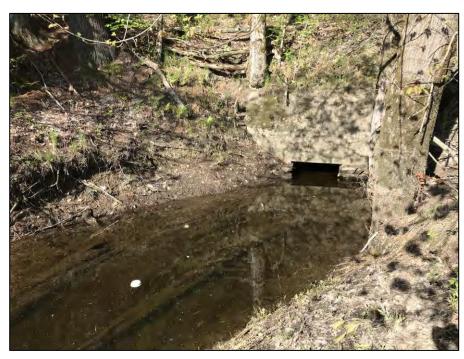
Perennial Stream ME6

ME6 provides fish habitat, flood storage, nutrient trapping, sediment trapping, shoreline anchoring, and wildlife habitat. Of these, all except fish habitat are performed at the principal level. ME7 provides flood storage, groundwater recharge, nutrient trapping, production export, sediment trapping, shoreline anchoring, and wildlife habitat. Of these, all except groundwater recharge and production export are considered principal functions.

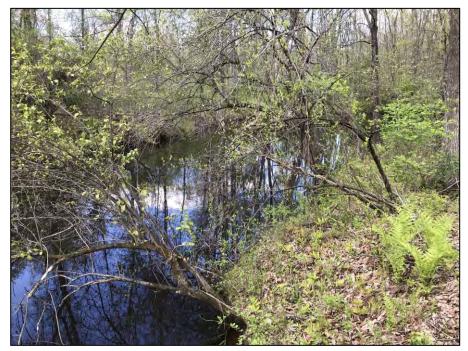
Naticook Brook (ME9) upstream of railroad bridge

Flag series ME8, ME9, ME10, and ME11 correspond to the wetland system and banks of Naticook Brook at the railroad crossing in Merrimack. Naticook Brook is located just south of Horseshoe Pond. The railroad bridge crosses the river at mile post 44.92. ME9 is the northern bank of Naticook Brook and includes a small forested/scrub-shrub floodplain wetland. ME10 is the southern bank. ME8 is an inundated wetland (PUBH) that connects to Naticook Brook beyond the study area. It is located north of the crossing and continues north beyond the study area. ME11 is a forested wetland located southwest of the railroad bridge and connects to ME10.

Naticook Brook has a mucky substrate and banks that are approximately 3 to 5 feet tall. There was approximately 1 to 2 feet of water in the stream at the time of the field review (May 2021). A beaver dam was observed on the upstream side of the crossing. The southern bank (ME10) contains some stone slabs near the railroad bridge but the bank is otherwise well vegetated. A sewer pipe bridges the stream on the east side of the railroad bridge.

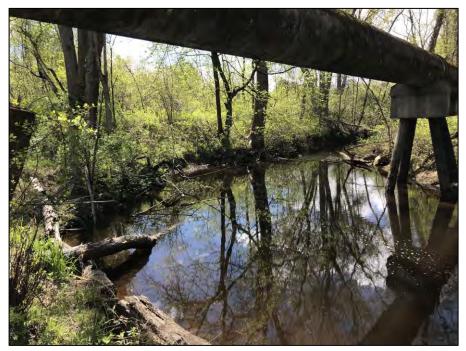
Naticook Brook (ME9 and ME10) view downstream showing sewer pipe bridge

The edge of Wetland ME8 is vegetated with sensitive fern (*Onoclea sensibilis*), silky dogwood, birch, and Japanese barberry. The central portion of the wetland is inundated and does not contain vegetation. The northern bank of Naticook Brook and its associated wetland (ME9) is vegetated with Asian bittersweet, multiflora rose, poison ivy, arrowwood (*Viburnum recognitum*), fringed loosestrife, glossy buckthorn, and meadow rue (*Thalictrum pubescens*). The southern bank of Naticook Brook (ME10) is heavily vegetated with Asian bittersweet, multiflora rose, poison ivy, sensitive fern, silky dogwood, ash, box elder, and ferns. Wetland ME11 is vegetated with box elder, speckled alder, multiflora rose, sensitive fern, arrowwood, and Asian bittersweet.

Functions provided by
Naticook Brook and its
associated wetlands include,
ecological integrity, fish
habitat, flood storage,
groundwater recharge,
nutrient trapping, production
export, sediment trapping,
shoreline anchoring, and
wildlife habitat. Of these, all
but groundwater recharge
and production export are
considered principal
functions.

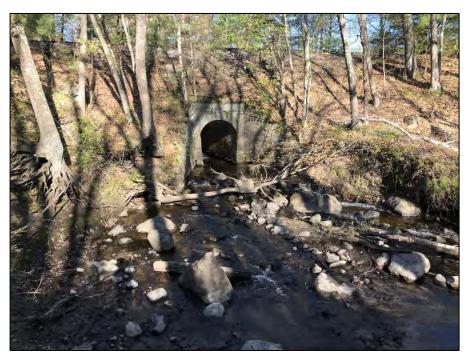
Sebbins Brook (BE1 and BE2)

Flag series BE1, BE2, BE11, and BE12 correspond to the banks of Sebbins Brook at the railroad crossing in Bedford. Sebbins Brook is located approximately 350 feet south of Raymond Wieczorek Drive, at mile post 50.21. Flag series BE11 also include an emergent wetland that is connected to Sebbins Brook via an ephemeral stream/erosion channel. BE1 and BE2 are located on the east side of the railroad, where Sebbins Brook enters the Merrimack River. BE1 is the northern bank and, BE2 is the southern bank. BE1 and BE2 are vegetated with red maple, red oak, Asian bittersweet, poison ivy, ash samplings, and some burning bush (*Euonymus alatus*).

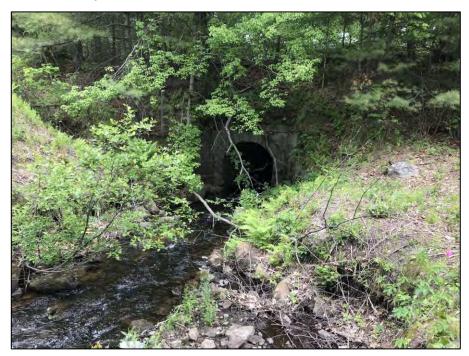
Sebbins Brook (BE11 and BE12)

BE11 and BE12 are located on the western (upstream) side of the rail crossing. BE11 is the northern bank and also includes an emergent wetland and ephemeral stream/erosion channel. At the time of the site visit in May 2021, the channel had no water, was filled with leaves, and had steep, eroded banks. Vegetation within the emergent wetland includes royal fern, sensitive fern, and cinnamon fern. A small culvert inlet is located at the northern edge of the wetland, near a paved bike path. Vegetation within and adjacent to the ephemeral stream was limited to a few ferns and red maple saplings.

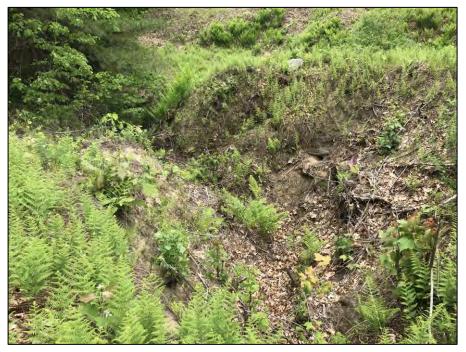
Ephemeral stream/erosion channel (BE11)

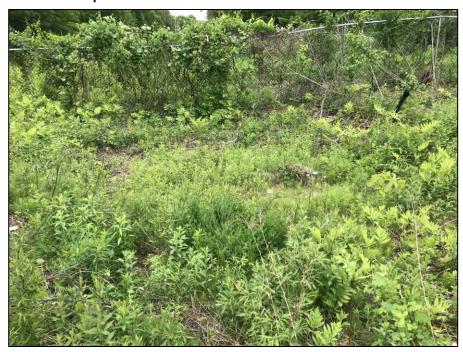
Emergent wetland (BE11)

Functions provided by Sebbins Brook and its banks includes fish habitat, flood storage, groundwater recharge, production export, shoreline anchoring, and wildlife habitat. Of these, only wildlife habitat is considered a principal function. The emergent wetland located north of Sebbins Brook (BE11) provides some nutrient trapping and sediment trapping, although overall the functions provided by this wetland are limited by its small size, location, and lack of dense/diverse vegetation. The ephemeral stream/erosion channel portion of BE11 does not provide any functions at a notable level.

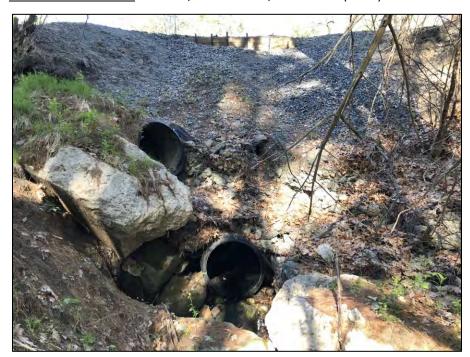
Headwall erosion of intermittent stream BE3 and BE4

BE3 and BE4 correspond to the banks of an intermittent stream located downstream of the railroad culvert crossing at mile post 50.45. The stream is located approximately 850 feet north of Raymond Wieczorek Drive in Bedford. BE3 is the southern bank and BE4 is the northern bank. The culvert headwall is heavily eroded and several concrete blocks have collapsed into the stream. The railroad embankment is also eroded. The stream is approximately 1 to 2 feet wide with 1 to 2 inches of flowing water at the time of the field review (May 2021). The stream substrate is a mix of sand and cobbles.

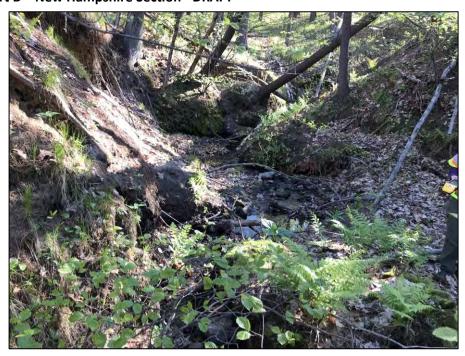
BE3 and BE4, view downstream

The banks are approximately 4 to 6 feet tall on the southern side (BE3) and as tall as 8 feet on the northern side (BE4).

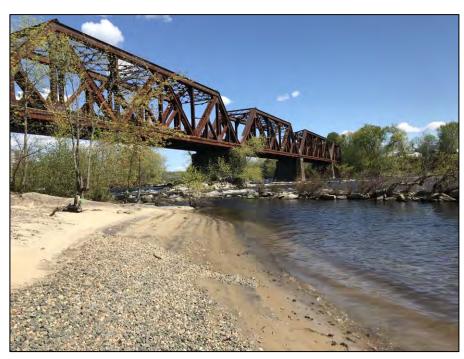
Merrimack River Bridge, southern bank (BE6)

The southern bank (BE6) is sandy and rocky with some bedrock. It slopes gradually, with the top of the bank approximately 3 to 4 feet vertically above Ordinary High Water. The bank is vegetated with autumn olive, glossy buckthorn, Canada mayflower, mosses, and red maple.

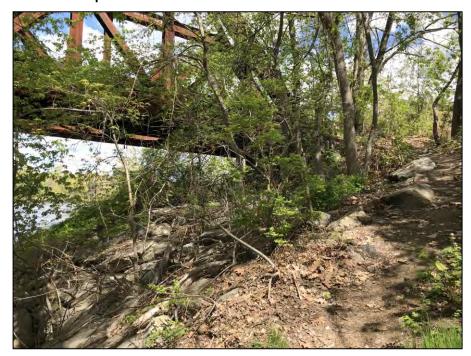
Merrimack River Bridge, northern bank (MA1)

The northern bank (MA1) is approximately 4 to 8 feet tall with stone rip rap. It is vegetated with Japanese knotweed, autumn olive, Asian bittersweet, Tatarian honeysuckle, poison ivy, maple species and aspen species. In some places the stone rip rap extends to the river.

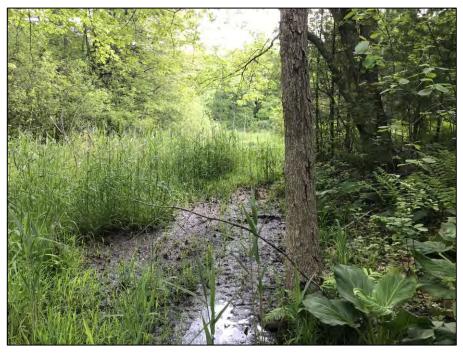
Wetland BE7 is forested and contains a small intermittent stream channel that begins within the wetland. The stream is approximately 2 to 3 feet wide with no banks and a mucky substrate. At the time of the field review, (May 2021), there was approximately 2 to 3 inches of slowly flowing water. A small culvert that is mostly buried is located at the southern end of BE7. It appears that this culvert connects to BE9 under Somerville Drive. Red-winged black birds were observed within BE7. Dominate vegetation includes glossy buckthorn, common reed, royal fern, and sensitive fern. BE8 is an emergent wetland with saturated soils in some areas. It is vegetated by skunk cabbage, common reed, purple loosestrife, and some sedges.

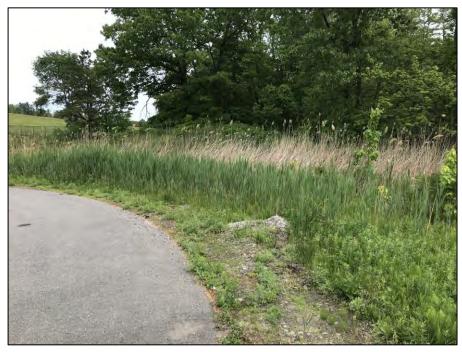
Wetland BE8

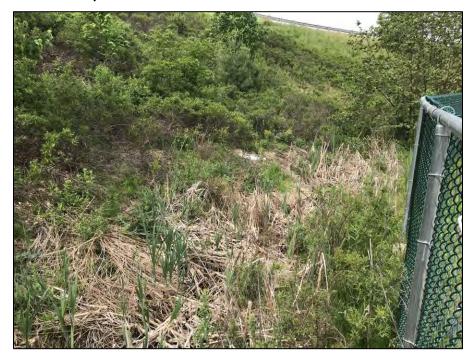
Wetland BE9

Wetland BE9 is a 3- to 4-foot-wide wetland swale located between Somerville Drive and Raymond Wieczorek Drive. BE9 is classified as PEM/SS1E. It contains cattail, purple loosestrife, and some speckled alder.
