NASHUA-MANCHESTER 40818 (CAPITOL CORRIDOR)

APPENDIX A Natural Resources Technical Report

NASHUA-MANCHESTER 40818 CAPITOL CORRIDOR RAIL

NATURAL RESOURCES TECHNICAL REPORT

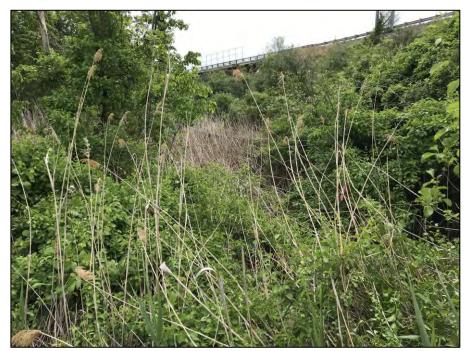
Wetland BE10

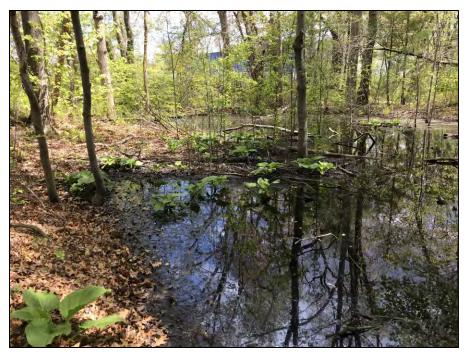
Wetland MA2

Wetlands MA2 and MA3 are located north of the Merrimack River Bridge in Manchester at mile post 52.11. MA2 is to the east of the railroad and MA3 is across the railroad to the southwest. MA2 includes a narrow ditch that runs parallel to the railroad and drains into a small, flooded wetland area. The wetland is vegetated with skunk cabbage, maple, poison ivy, Tatarian honeysuckle, slippery elm, burning bush, and Asian bittersweet. MA3 is a scrub-shrub/forested wetland swale with saturated soils. Two culverts were noted, one under the railroad and one under Pine Island Road.

The functions provided by MA2 and MA3 include flood storage, nutrient trapping, and sediment trapping. MA2 also provides wildlife habitat. None of these functions are provided at a principal level due to the small size of the wetlands and fragmentation.

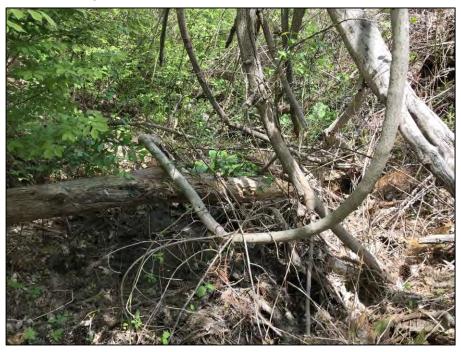
Wetland MA3 is vegetated with skunk cabbage, silky dogwood, burning bush, and jewelweed. Red oak, white pine, and Norway maple (*Acer platanoides*) are located along the edge of the wetland.

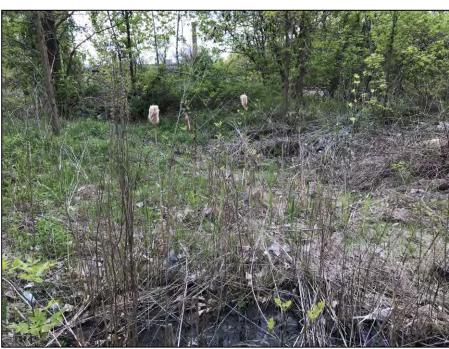
Wetland MA4

Wetlands MA4 and MA5 are located near mile post 55, north of Queen City Avenue, in Manchester. Both are located east of the rail corridor. They are small, disturbed, low functioning wetlands. MA4 is classified as PEM1Ex and is vegetated with purple loosestrife, cattail, ash seedlings, and horsetail (Equisetum sp.). The wetland has saturated soil in areas and some rocks/fill. MA5 is an emergent/forested wetland with common reed, cattail, purple loosestrife, and quaking aspen (at the edge). Water-

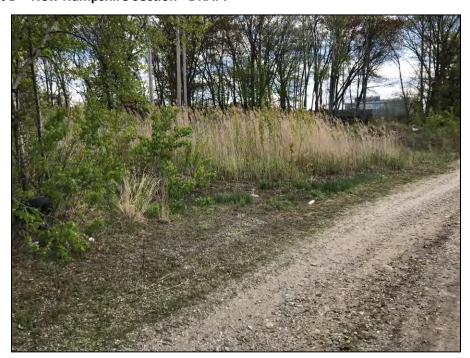
Wetland MA5

stained leaves provided evidence of recent inundation but no water was observed at the time of field review. Wetland MA5 continues east beyond the study area.

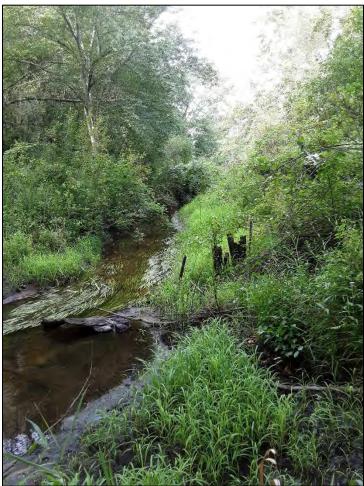
Wetland BE13 near flag BE13-27

Flag series BE13 (BE13-1 to BE13-72) and BE14 (BE14-1 to BE14-17) correspond to floodplain wetlands along the northern bank of Sebbins Brook, which is located south of the proposed MHT-Bedford Station site (refer to Figure 2 in Appendix A). In some areas, the wetland flags correspond to top of bank (TOB)

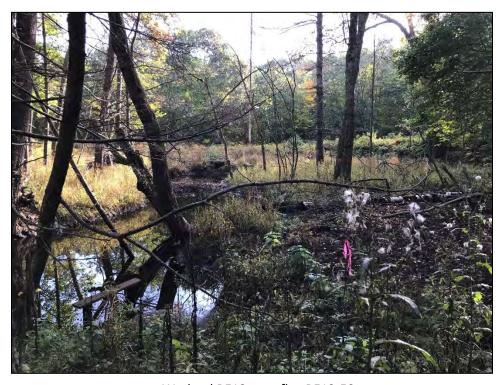
Wetland BE13 near flag BE13-59

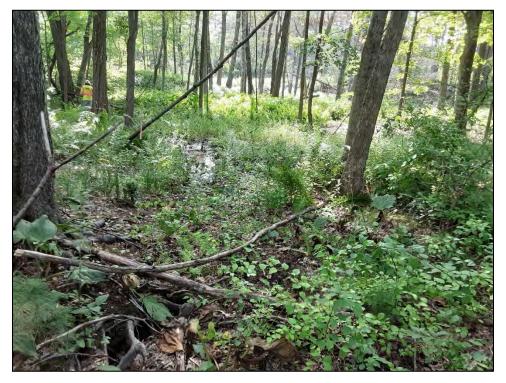
Wetland BE14 near flag BE14-9

Flag series BE14 (BE14-1 to BE14-17) corresponds to a forested wetland and sections of the Sebbins Brook bank located south of the proposed Bedford Station site. The forested wetland corresponds to flags BE14-1 to BE14-12. Top of bank of Sebbins Brook corresponds to BE14-12 to BE14-17. The bank is 4 to 10 feet tall and steep with thick vegetation. Flag series BE14 connects series BE11 to BE13.

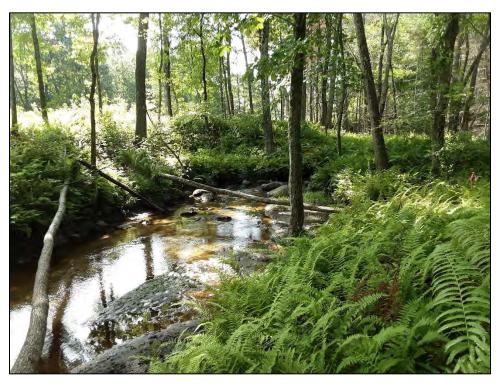
Wetland BE14 near flag BE14-14

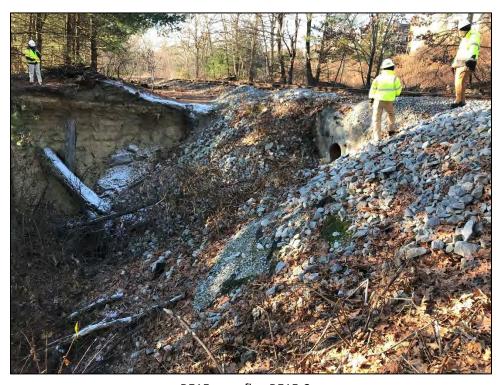
BE15 near flag BE15-3

Flag series BE15 (BE15-1 to BE15-9) corresponds to an intermittent stream crossing located at mile post 51.02 (refer to Figure 3 in Appendix A). At the time of the site visit (November 30, 2021) there was no flow. The banks are 20+ feet tall, very steep, and heavily eroded. The surrounding land and stream substrate is sandy. The intermittent stream flows into the Merrimack River approximately 105 feet downstream of the railroad tracks. A Zone AE floodplain is mapped just downstream of the culvert, on the east side of the railroad.

Vegetation along the bank of Intermittent Stream BE15 includes white pine (*Pinus strobus*), red oak, grasses, and an unidentifiable fern. The intermittent stream and bank do not provide many functions due to their location and eroded nature. The stream is fragmented by the rail line and nearby residential development and may be fed by stormwater runoff more than groundwater. It provides only some floodflow alteration but not at the principal level.

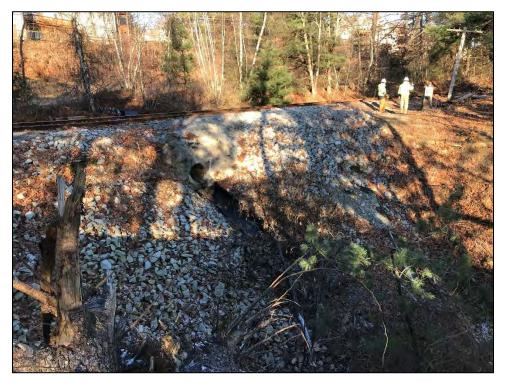
BE15 near flag BE15-7

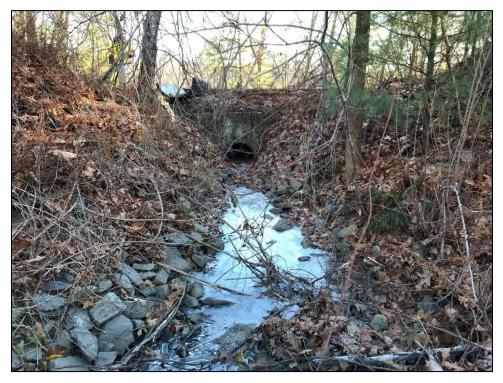
BE16, view toward railroad

Flag series BE16 (BE16-1 to BE16-4) corresponds to a small intermittent stream channel across the railroad from BE15 (refer to Figure 3, Appendix A). A culvert at the edge of the powerline corridor feeds BE16 and at the time of the site visit (November 30, 2021) there was some frozen ponded water in the stream channel. The water then flows through a culvert under the railroad and outlets into Intermittent Stream BE15. There is stone rip rap in the channel of BE16.

The banks of Intermittent Stream BE16 are vegetated with gray birch (*Betula populifolia*), white pine, red oak, goldenrod (*Solidago spp.*), and an unidentifiable fern. The functions that BE16 provides are groundwater recharge/discharge and floodflow alteration. Neither of these are provided at the principal level.

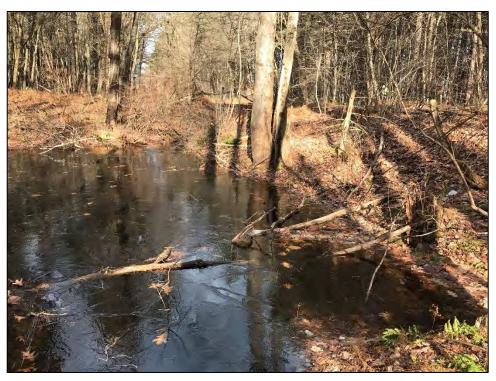
ME16 (November 2021)

The functions provided by Wetland ME16 are ecological integrity, flood storage, groundwater recharge/discharge, production export, and wildlife habitat. Of these, ecological integrity and wildlife habitat are considered principal functions due to the vernal pool.

Within New Hampshire, one wetland (ME16) was identified as having potential vernal pool habitat (refer to Figure 2.8 in Appendix A). This wetland was field reviewed in November 2021 and a follow up site visit occurred in April 2022. Twelve wood frog egg masses were observed, confirming that ME16 functions as a vernal pool. A USACE Vernal Pool Characterization Form was completed for vernal pool ME16 and is included in the Wetland Report Addendum prepared by GM2.

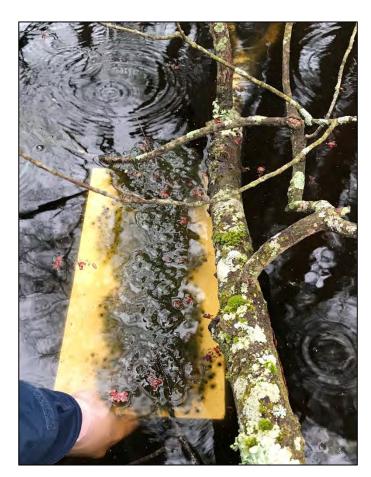
Wood frog egg masses within Vernal Pool ME16 (April 2022)

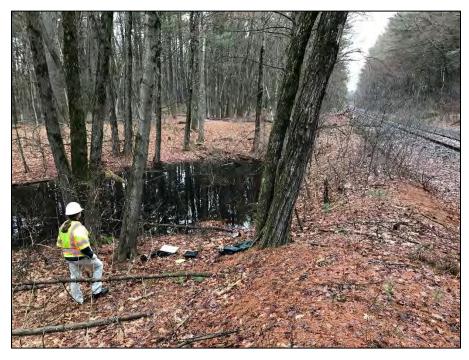
Vernal Pool ME16 in relation to railroad corridor (April 2022)

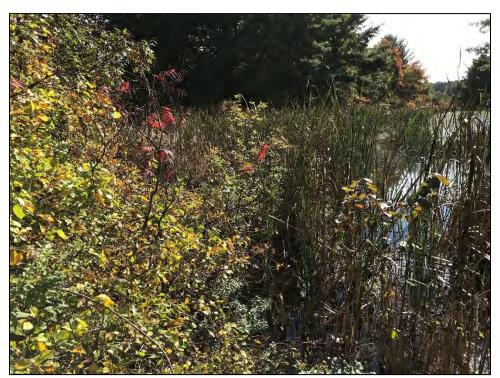
Wetland TY9 near flag TY9-8

Flag series TY9 (TY9-1 to TY9-20) corresponds to a created wetland area located near the proposed Pheasant Lane Mall-South Nashua station (refer to Figure 5 in Appendix A). Two culverts on the western side of the wetland feed stormwater runoff into the large emergent wetland located just south of the Pheasant Lane Mall and the New Hampshire-Massachusetts state border. The northern side of the emergent wetland was field delineated due to potential improvements along the Mall access road and parking lot north of the wetland. A second wetland area is located east of TY9, however it is located more than 100 feet from the parking lot and rail corridor, so it was not field-delineated.

At the time of the site visit (October 12, 2021), there was approximately 6 inches of standing water within the wetland and flowing water at the culverts. Rock and riprap are located at the edge of the wetland. Wetland TY9 provides various functions including floodflow alteration, sediment/toxicant retention, nutrient removal, production export, and wildlife habitat. Of these, floodflow alteration, sediment/toxicant retention, and nutrient removal are considered principal functions.

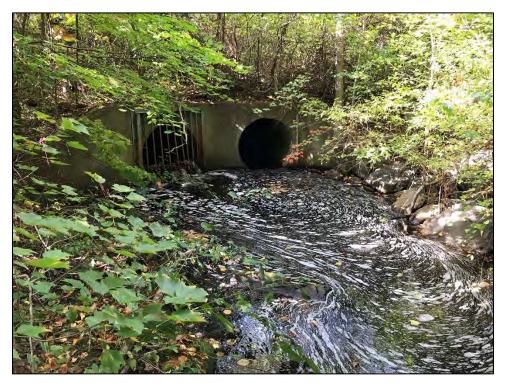
Wetland TY9 near flag TY9-20

Vegetation within the emergent portion of the wetland includes cattail (Typha latifolia), common reed (Phragmites australis), and purple loosestrife (*Lythrum* salicaria). Vegetation within the forested/scrub-shrub portion includes speckled alder (Alnus incana) and Asian bittersweet with Tatarian honeysuckle (Lonicera tatarica), white pine, and autumn olive (Elaeagnus umbellata) at the edge.

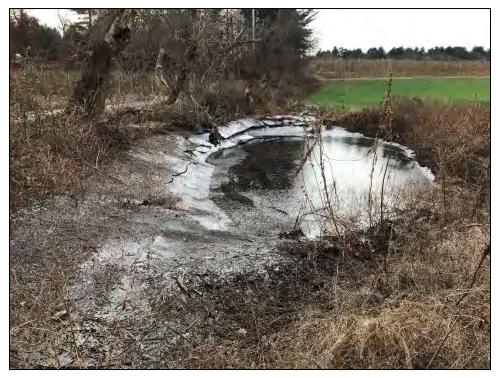
Flag series TY10 corresponds to a small pond/emergent wetland located west of the River Road railroad crossing at MP 33.50 (refer to Figure 6 in Appendix A). At the time of the site visit (November 30, 2021) there was approximately one to two feet of standing, partially frozen, water. Evidence of a varying water level was observed. The pond is fed by a small stream that flows through a nearby farm.

The edge of the ponded area is vegetated with evening primrose (*Oenothera biennis*) and yellow foxtail (*Setaria pumila*). The functions provided by TY10 are groundwater recharge/discharge, sediment/toxicant retention, nutrient removal, and wildlife habitat. None are considered principal functions.
