SUBJECT Dredge & Fill Application
Andover, 40392

Forwarded herewith is the application package prepared by NH DOT Bureau of Bridge Design for the subject major impact project. The proposed project involves the replacement of the existing bridge (Bridge No. 143/077) that carries US Route 4 over the Blackwater River in the Town of Andover. Proposed work includes the replacement of the existing 70-foot span bridge with a 104-foot span bridge (100.5-foot clear span). The new abutments will be constructed behind the existing abutments. The bridge will be widened 8 feet and approximately 500 feet of roadway widening will occur at each end of the bridge. The roadway will also be raised 4.5 feet near the bridge. In addition, an existing farm access driveway will be relocated further west and a stormwater treatment swale is proposed in the northwest bridge quadrant.

**US ROUTE 4 OVER THE BLACKWATER RIVER
BRIDGE REPLACEMENT
ANDOVER 40392**

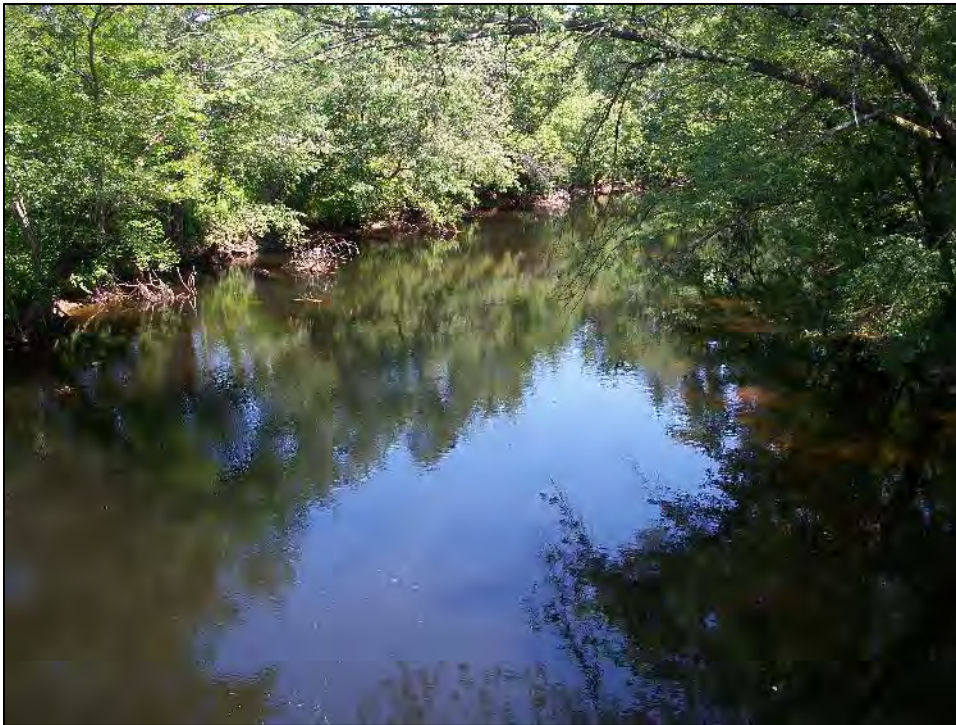
Blackwater River
View northeast (upstream)
from bridge
Photo taken 7/19/19

Top of bank (TOB) and ordinary high water (OHW) of the Blackwater River was delineated as it flows from north to south at the crossing. The segment of the Blackwater River channel under and adjacent to the bridge varies from approximately 70 feet to 90 feet wide with banks approximately 5 to 7 feet high. During the site visit in July 2019, the water was approximately 3 to 5 feet deep. The substrate is muddy and mostly consists of sand.

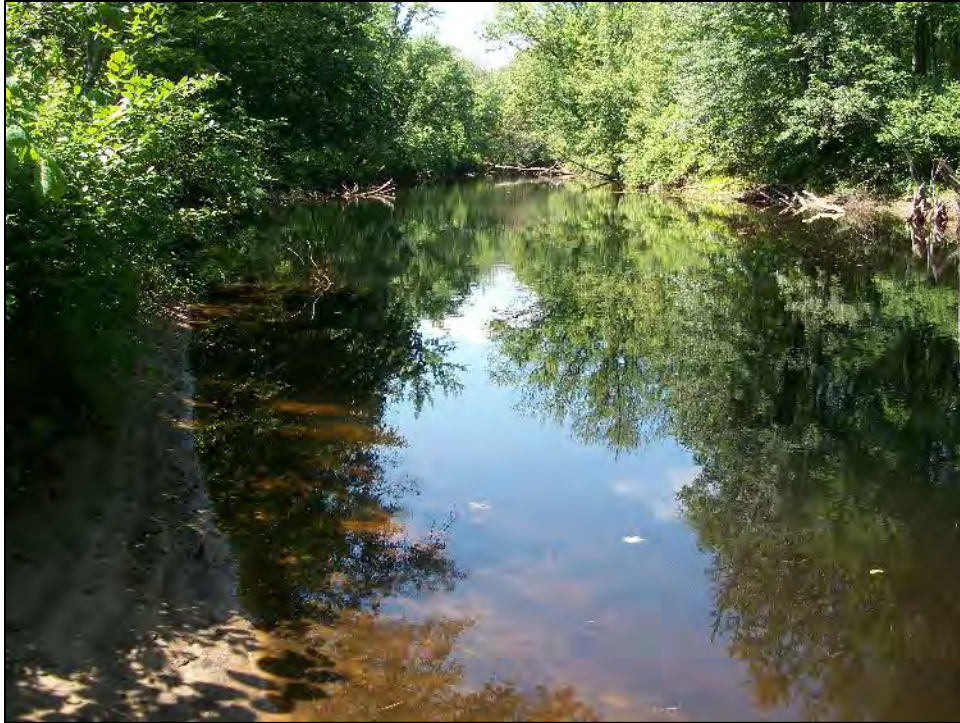
Blackwater River
View southwest
(downstream) of bridge
Photo taken 7/19/19

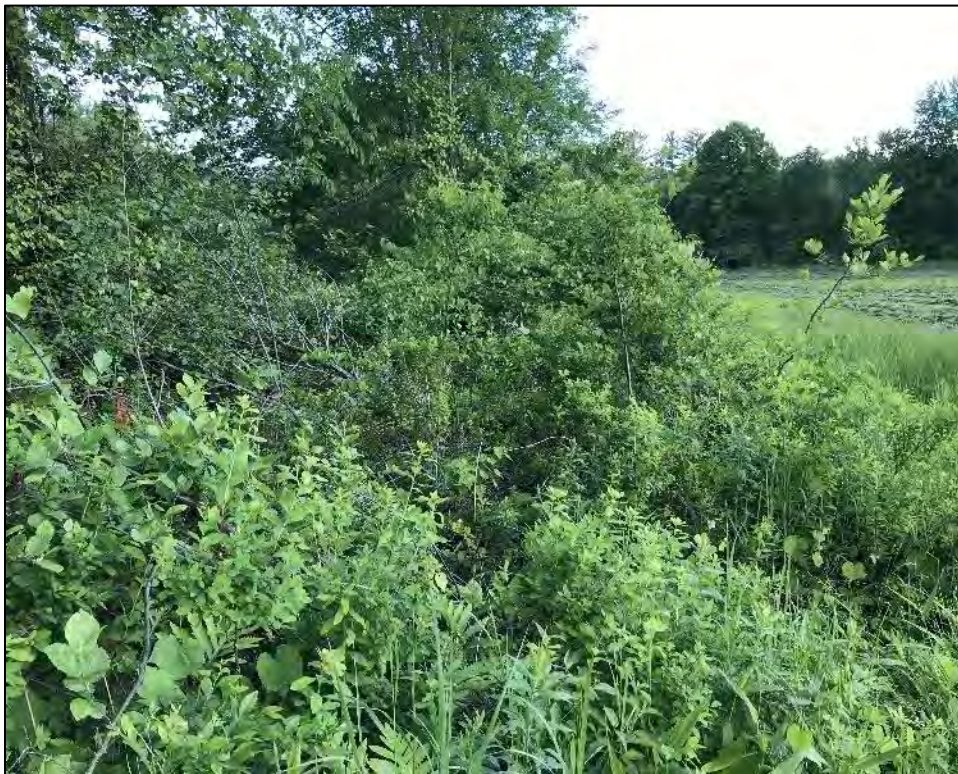
Wetland 1 (Flag Series H)
View northeast
Photo taken 6/10/22

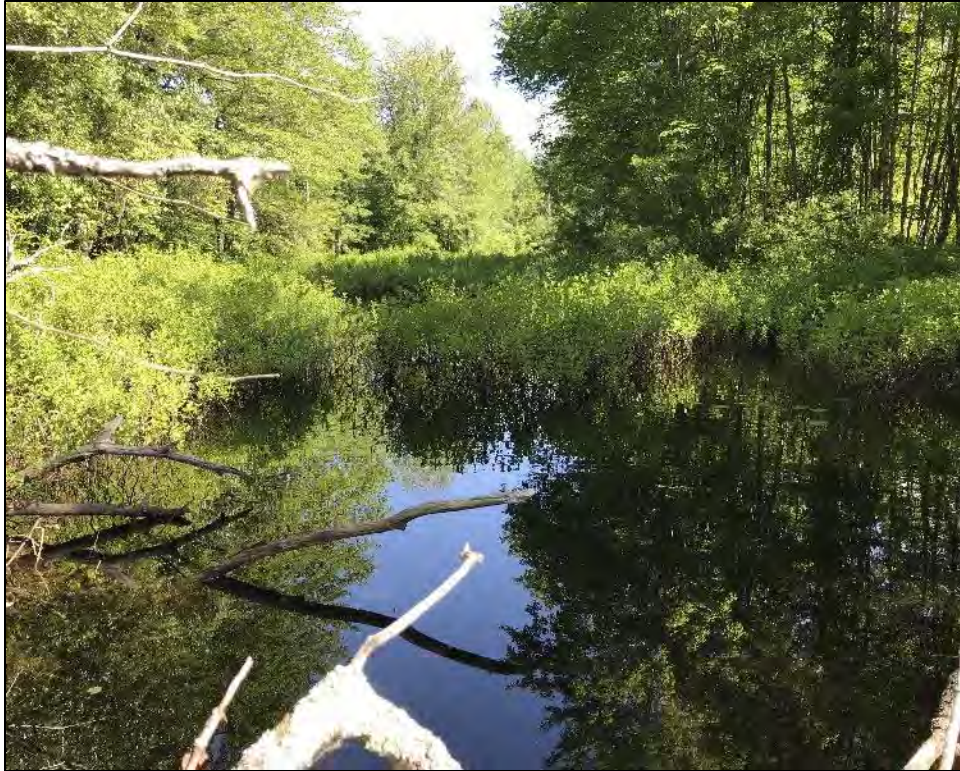
Wetland 1 (Flag Series H)
View northeast
Photo taken 6/10/22

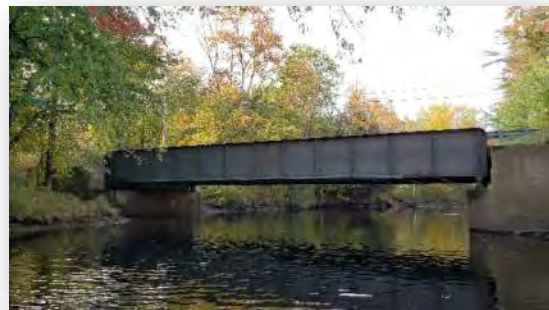
Upstream (North) Elevation

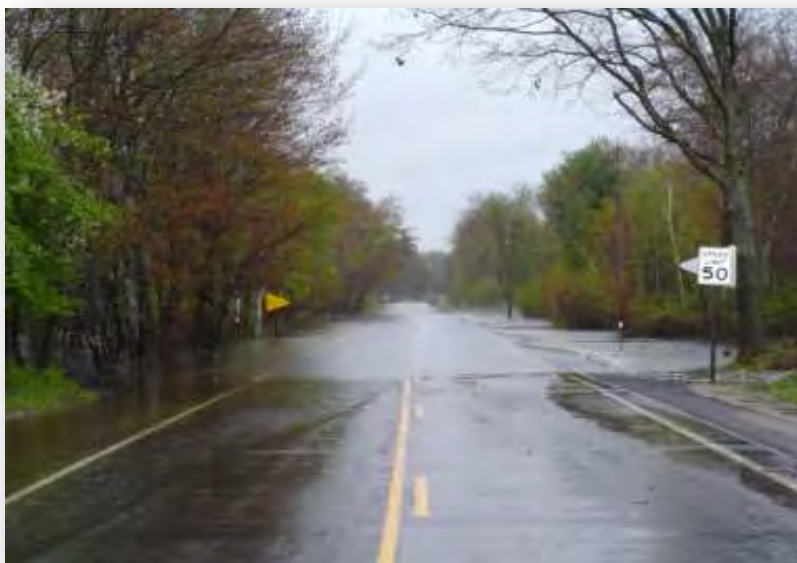
US Route 4 Looking Southeast:
Water Over Roadway – Road Closed and Barricaded (May 16, 2006)

According to discussions between GM2 and NHDOT, the roadway approaches to the US Route 4 bridge overtop during major storm events. The most recent significant flood event at this crossing was the May 2006 flood, and the photo below (taken during an NHDOT inspection) shows roadway overtopping of the east approach during this event. This photo illustrates well the elevation of the bridge relative to the roadway approaches, with the roadway overtopping but not the bridge. Information on the high-water elevation and peak discharge of the 2006 flood at the project site were not discovered in the research performed for this Study.

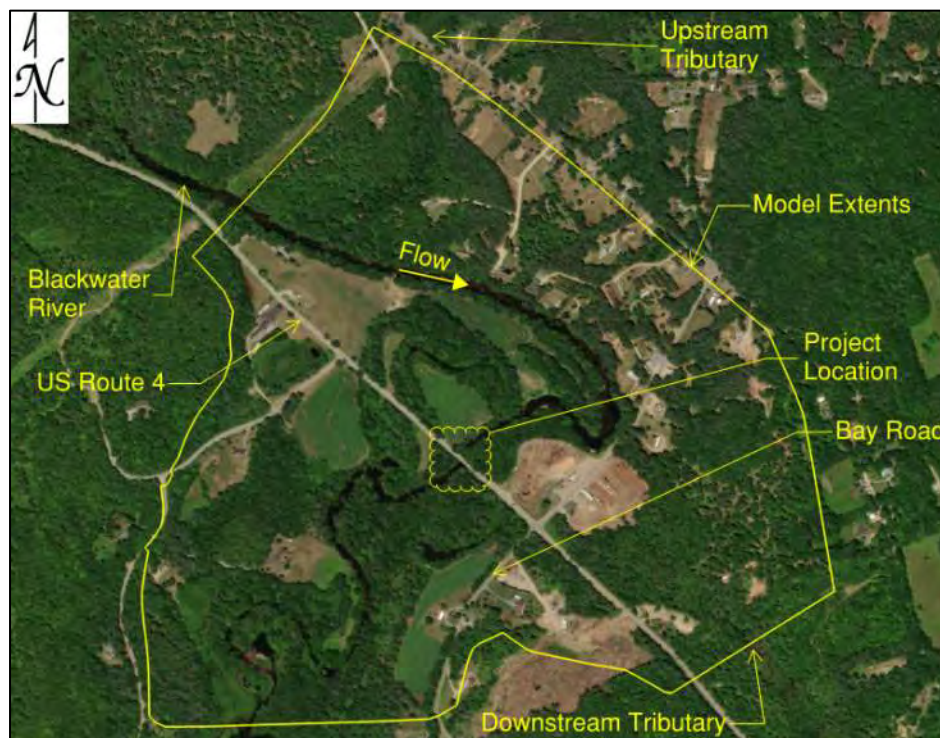
2D Hydraulic Model Extents

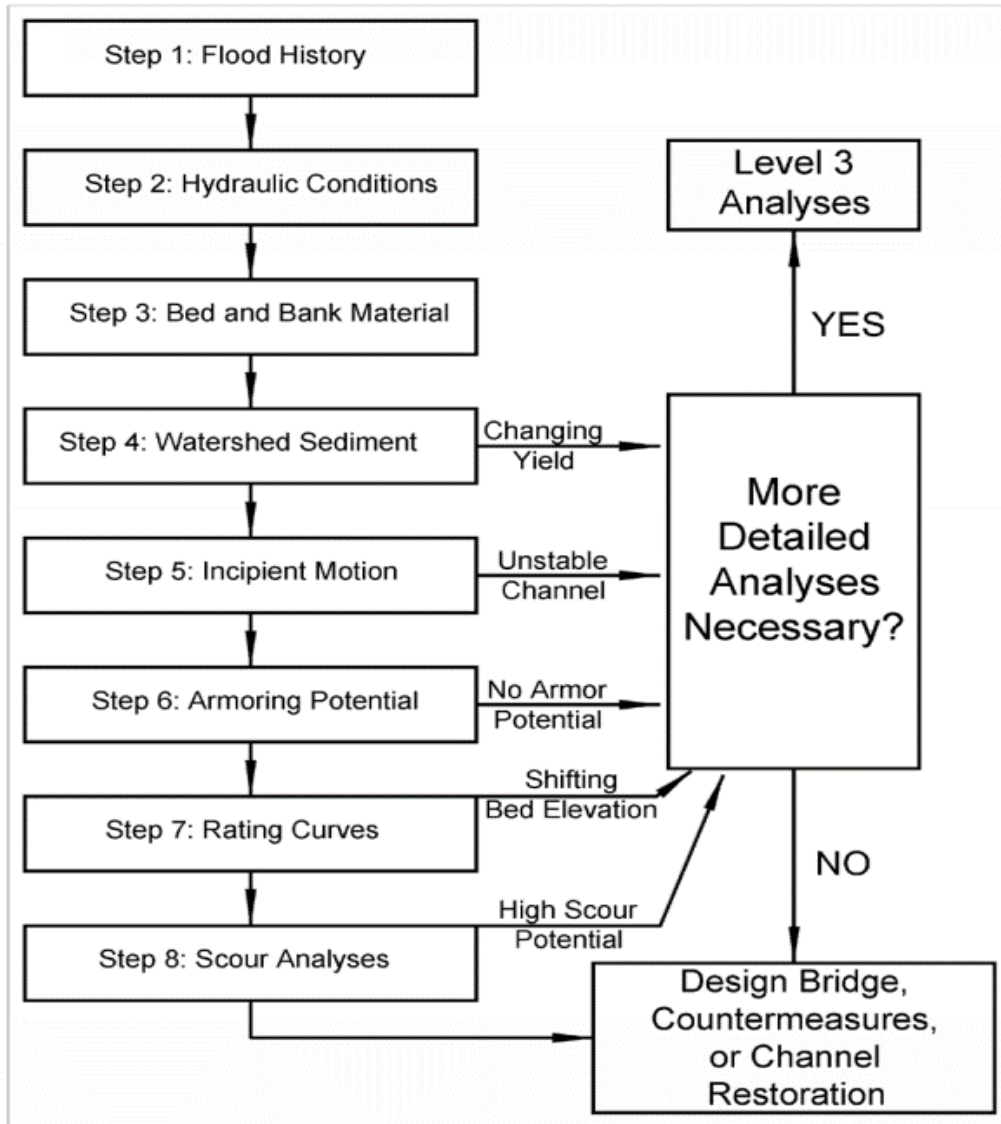
Figure 4.4. Flow chart for Level 2: Basic Engineering Analyses.
