NEW HAMPSHIRE'S CONCRETE AGGREGATE AND ALKALI-SILICA REACTIVITY

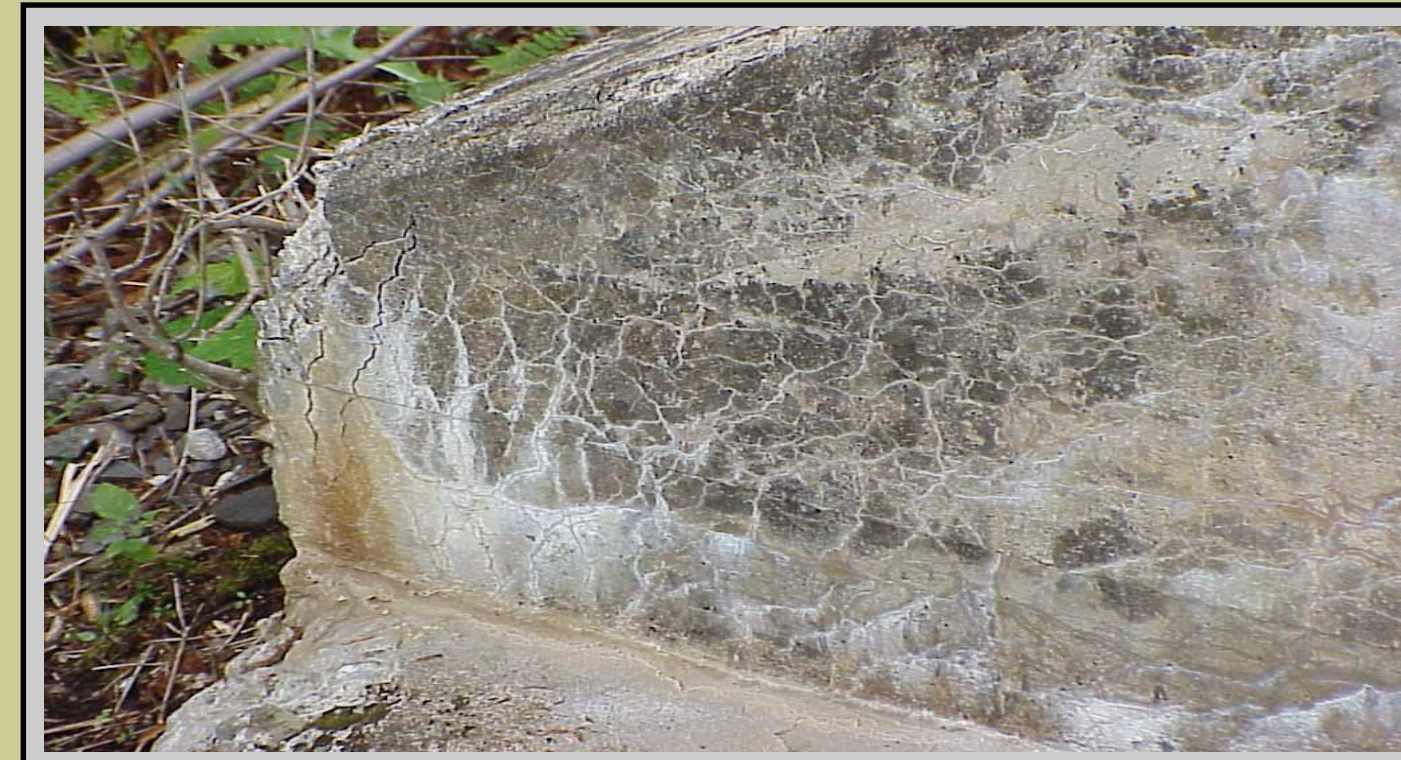
White precipitate exuding from map cracking of abutment wing wall, Frankenstein Trestle, Crawford Notch

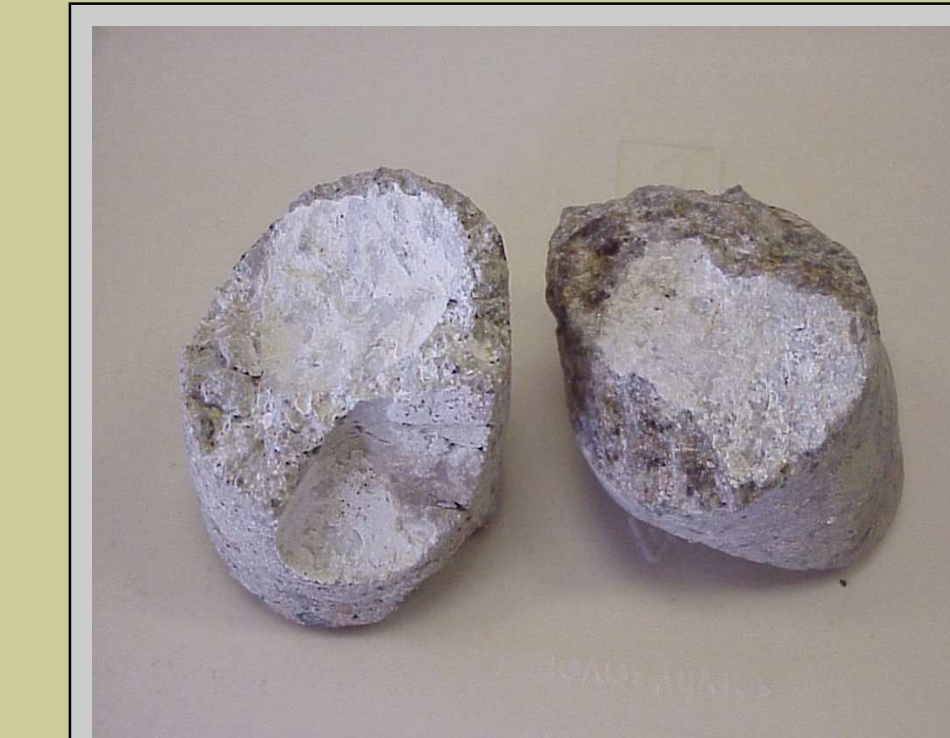
White precipitate lining pop-outs Swimming Hole Bridge, Woodstock

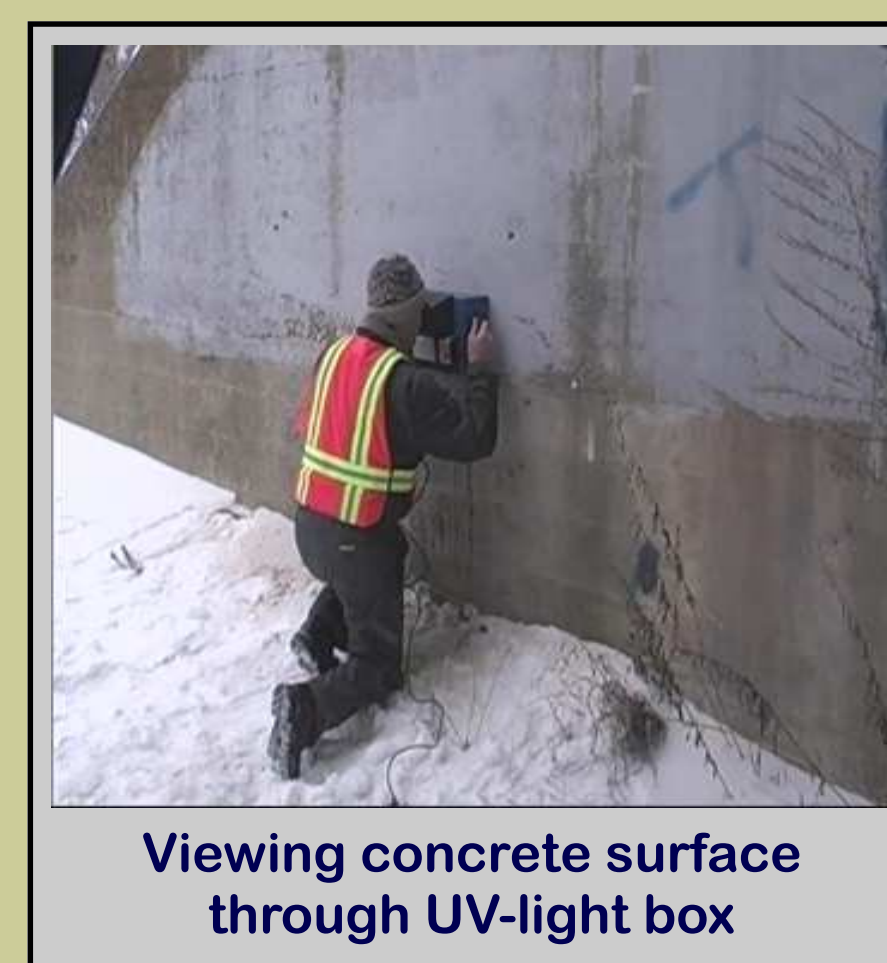
Viewing concrete surface through UV-light box
