**SUBJECT:** Dredge & Fill Application  
Nashua-Bedford-Merrimack 13761D

**F.E. Everett Turnpike  
Widening  
Northern Segment**

**NH Standard Dredge & Fill Application**

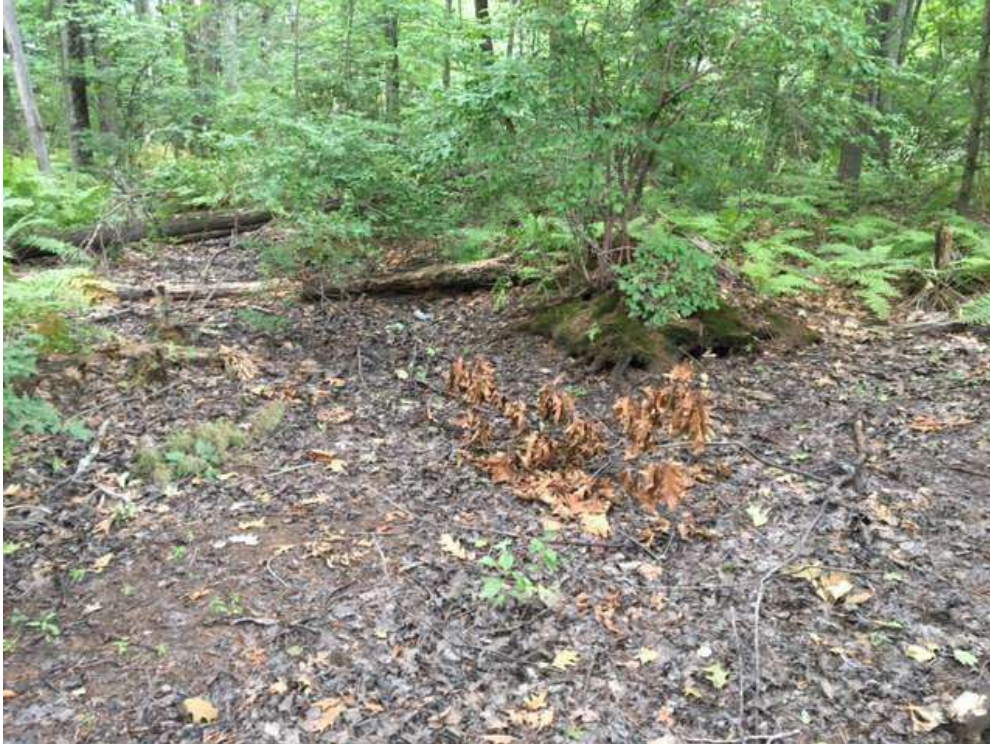
*Photo 1: Wetland 33 (W-33) – PFO; Wetland Impact Locations A & B (August 2016)*

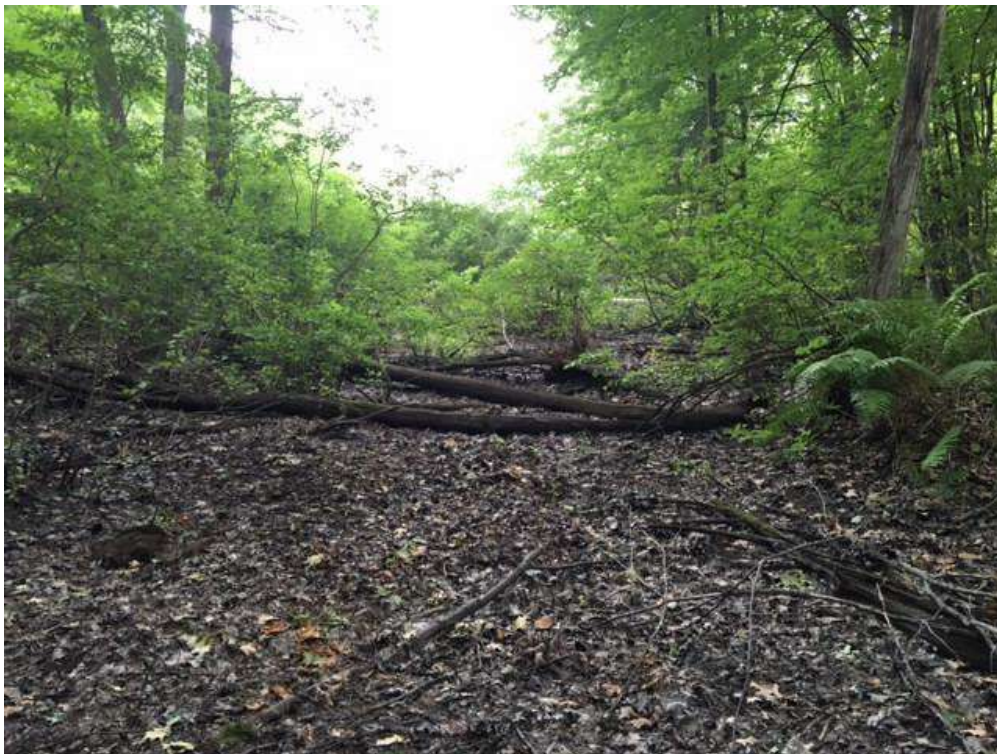
*Photo 2: Wetland 33 (W-33) – PFO; Wetland Impact Locations A & B (August 2016)*

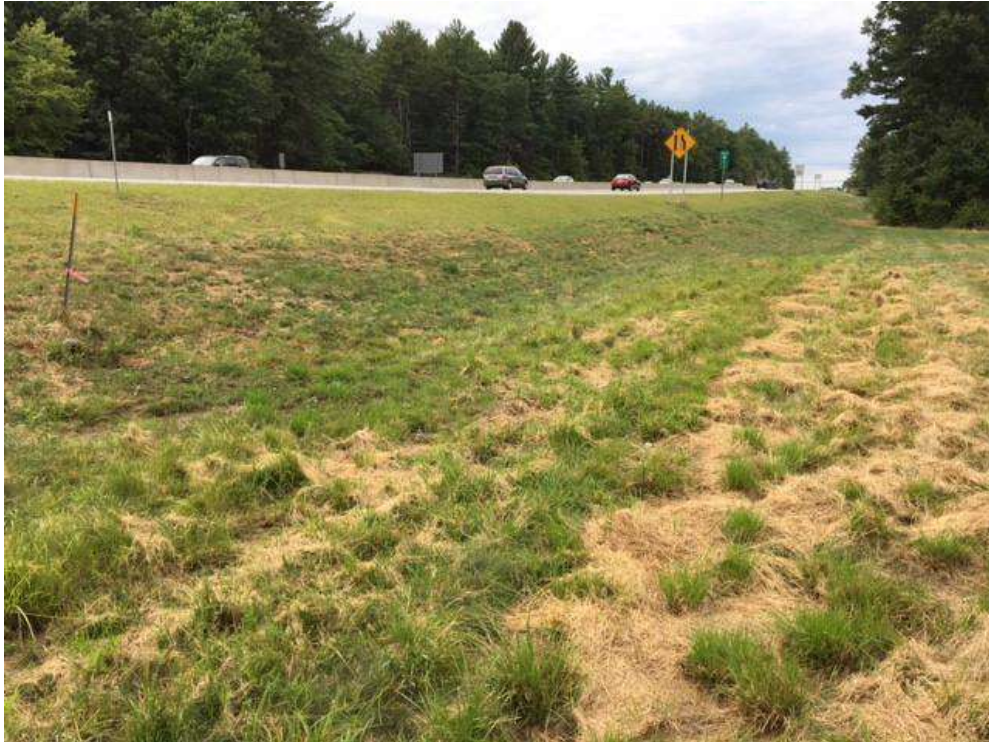
*Photo 3: Wetland 36 (W-36) – PEM; Wetland Impact Location C (August 2016)*

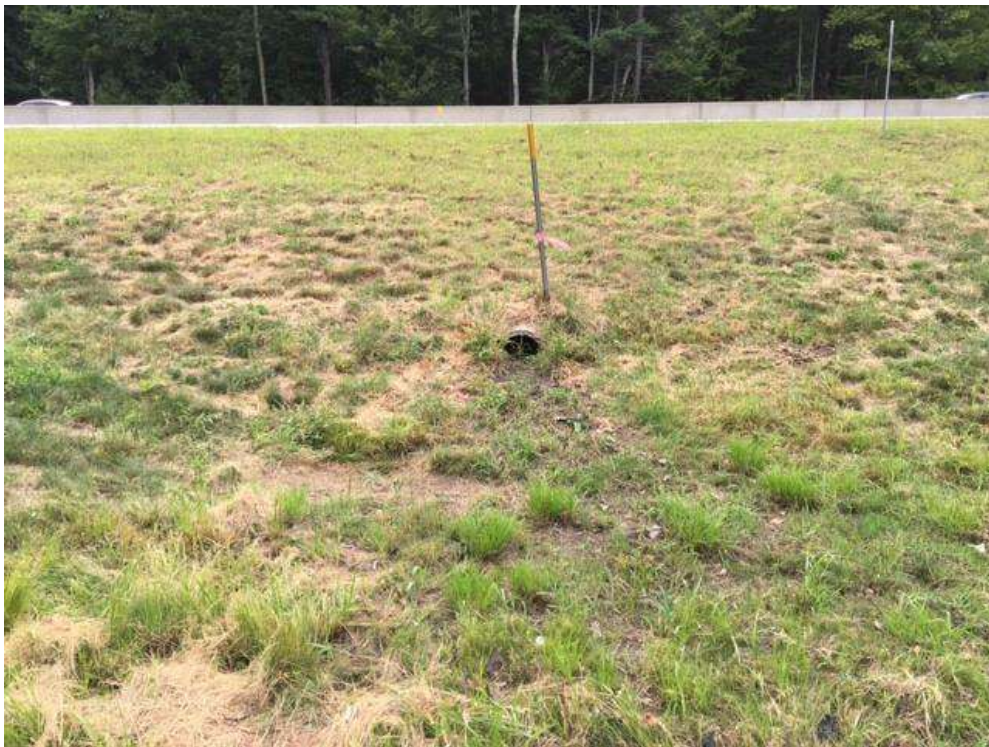
*Photo 4: Wetland 36 (W-36) – PEM; Wetland Impact Location C (August 2016)*

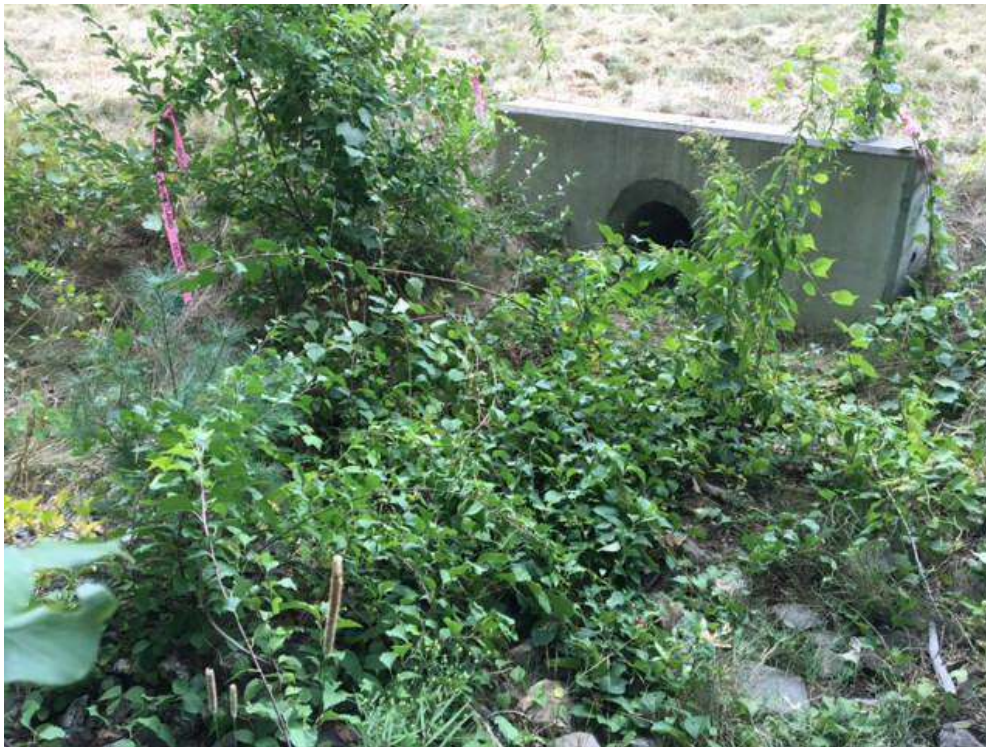
*Photo 6: Wetland 37 (W-37) – PFO; Wetland Impact Location D (August 2016)*

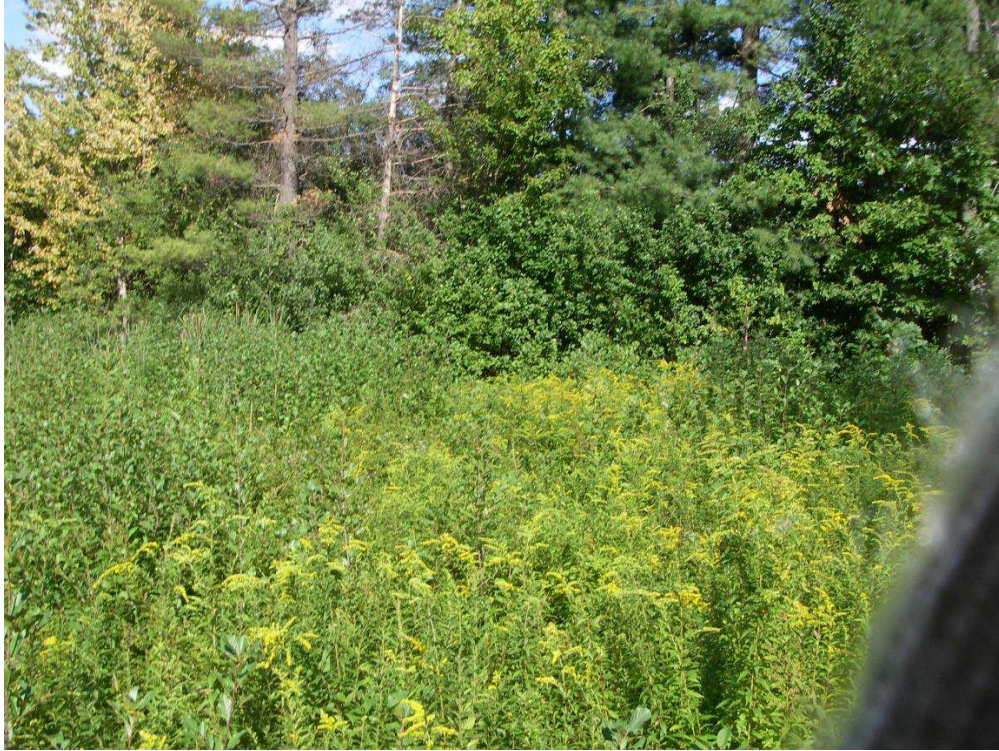
*Photo 7: Wetland 41 (W-41) – PEM/PFO; Approximate Wetland Impact Location E (August 2016)*

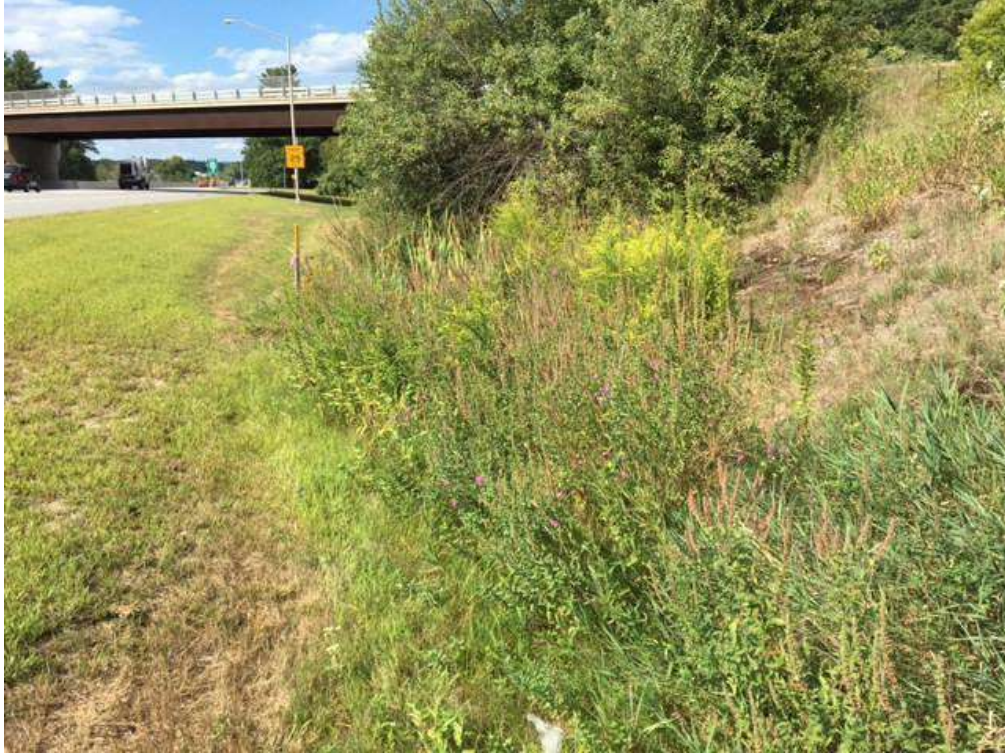
*Photo 9: Wetland 43 (W-43) – PEM; Wetland Impact Location F (August 2016)*

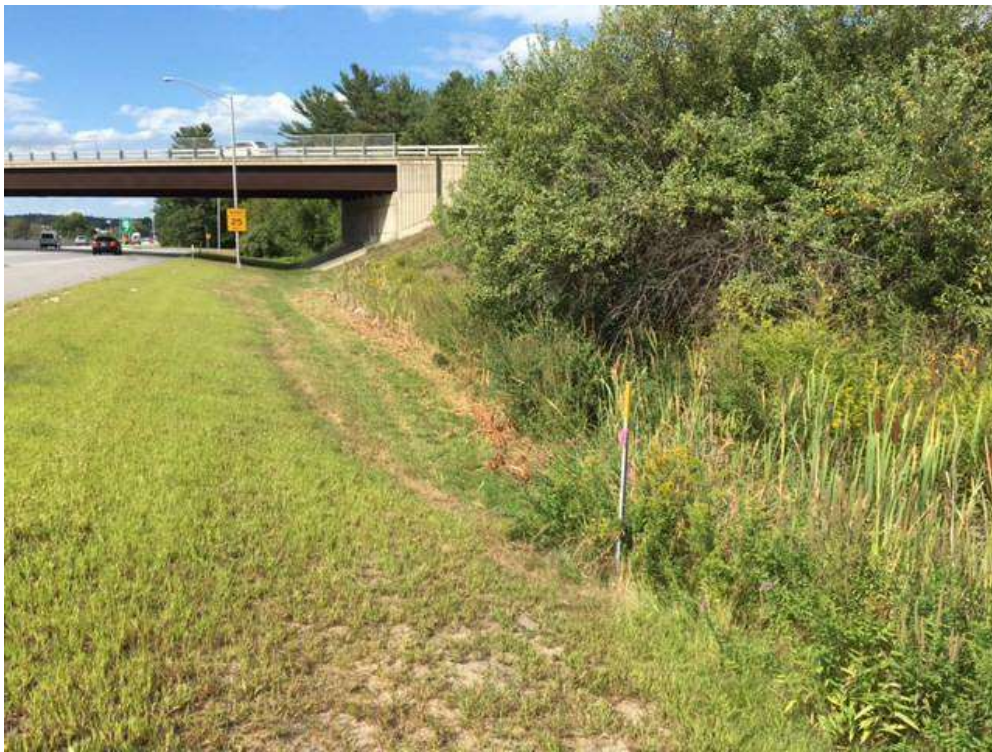
*Photo 10: Wetland 43 (W-43) – PEM; Wetland Impact Location F (August 2016)*

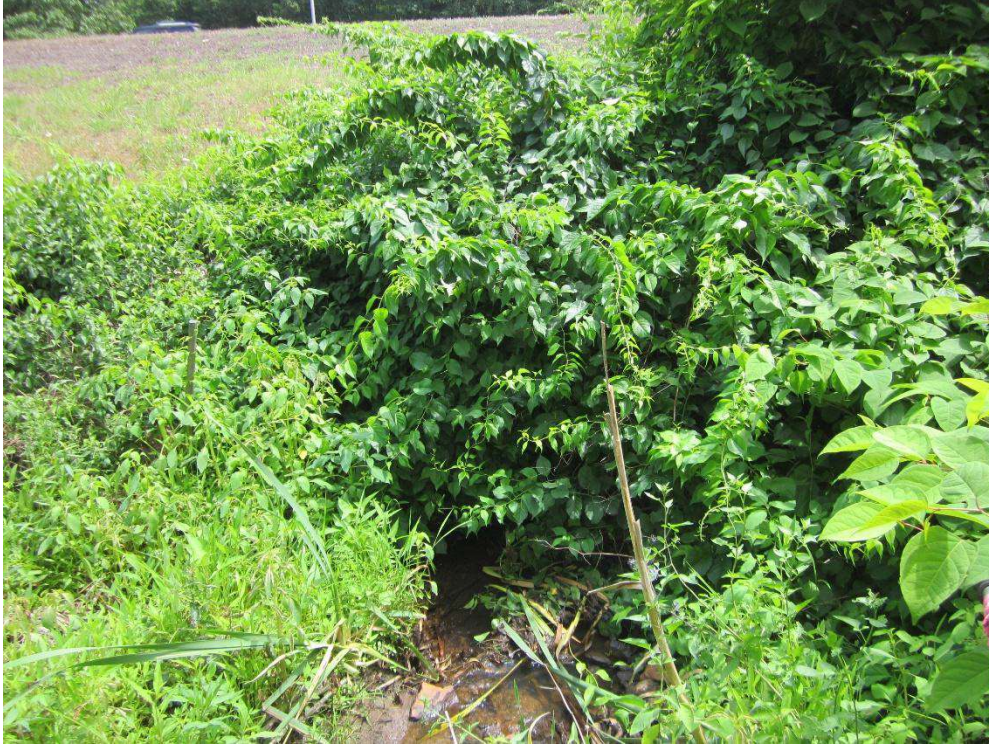
Photo 11: Wetland 45 & Stream 15 (W-45 / S-15) – PEM/PFO & R4SB4C; Wetland Impact Location G, H, I (June 2020)

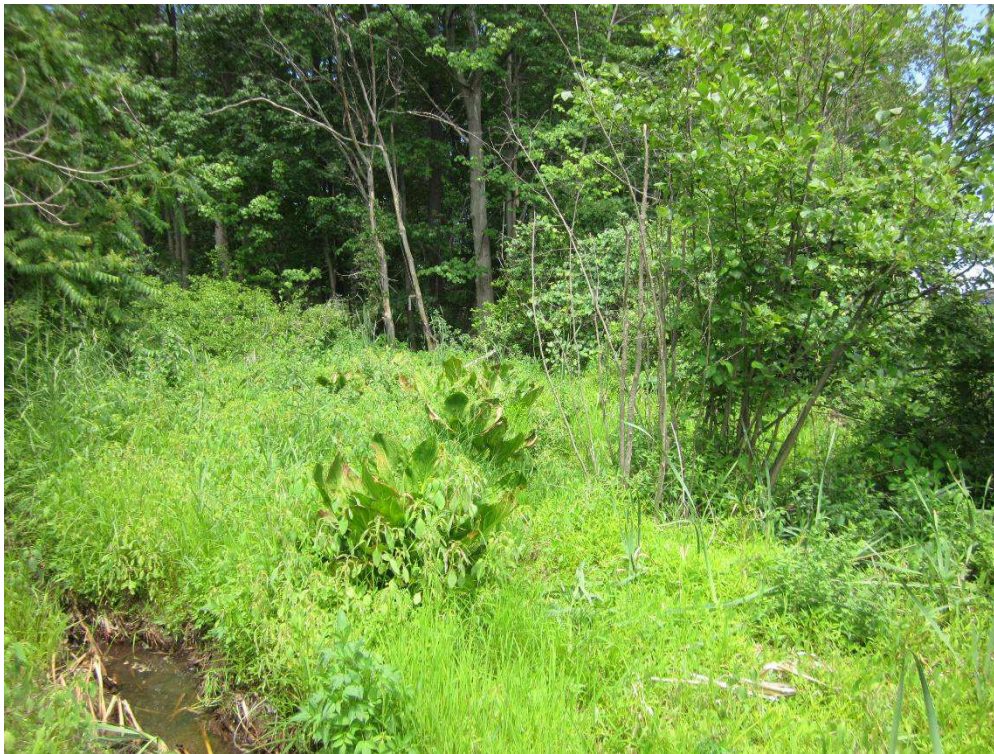
Photo 12: Wetland 45 & Stream 15 (W-45 / S-15) – PEM/PFO & R4SB4C; Wetland Impact Location G, H, I (June 2020)

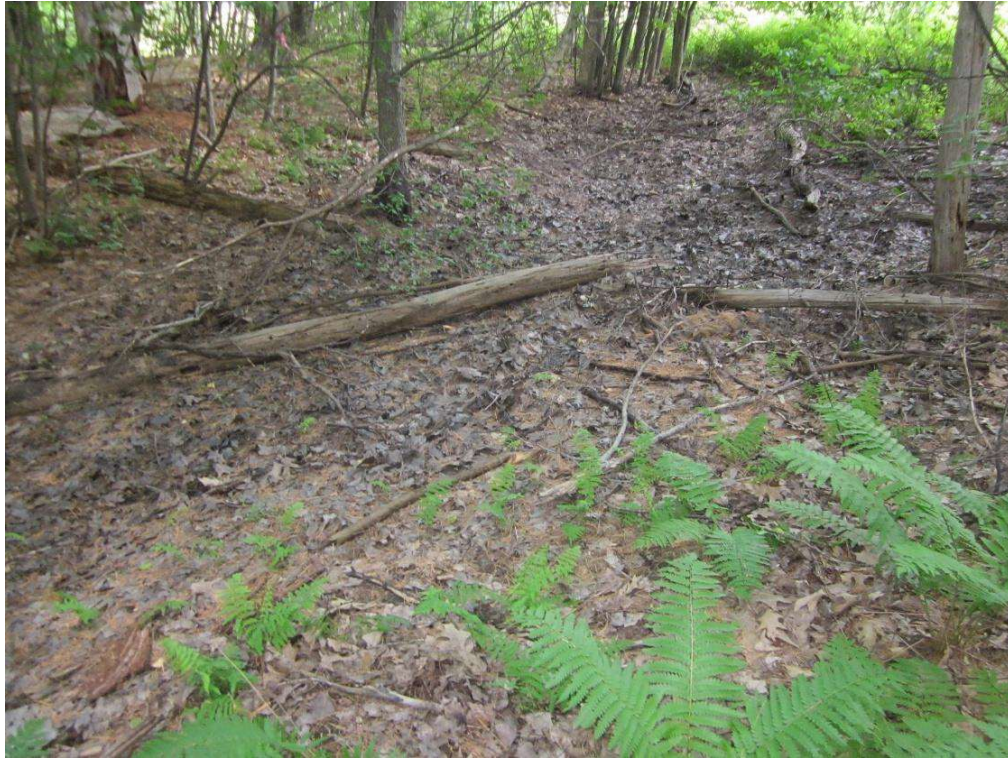
*Photo 13: Wetland 46 (W-46) – PFO; Wetland Impact Location J (June 2020)*

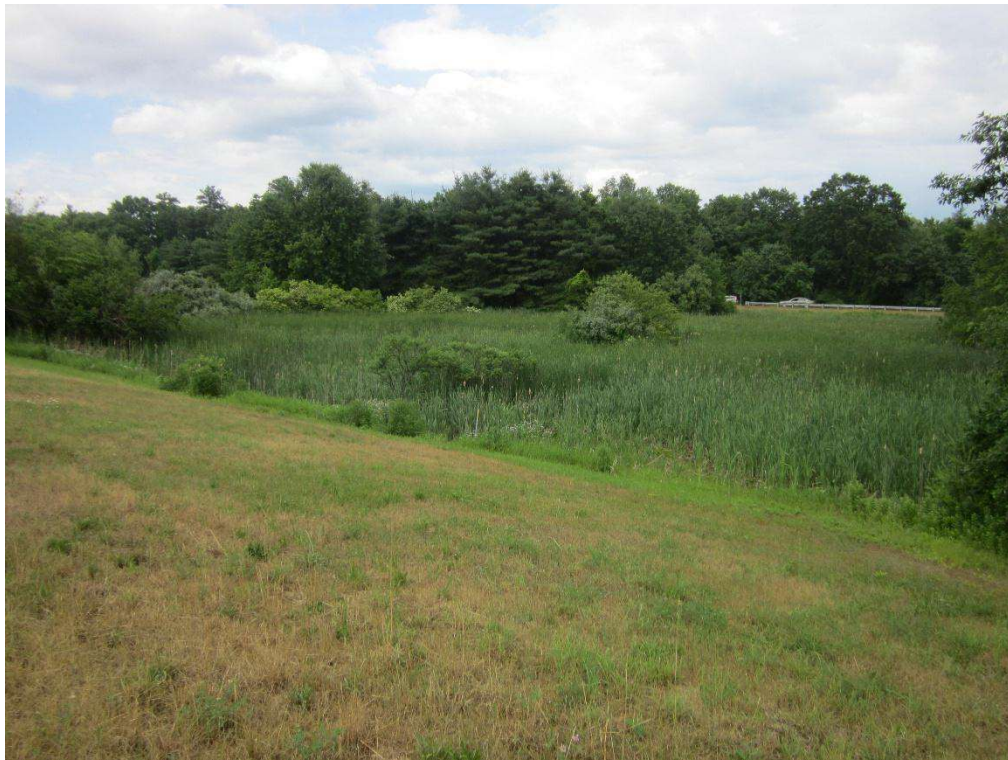
*Photo 14: Wetland 47 (W-47) – PEM; Wetland Impact Location K, L, M (June 2020)*

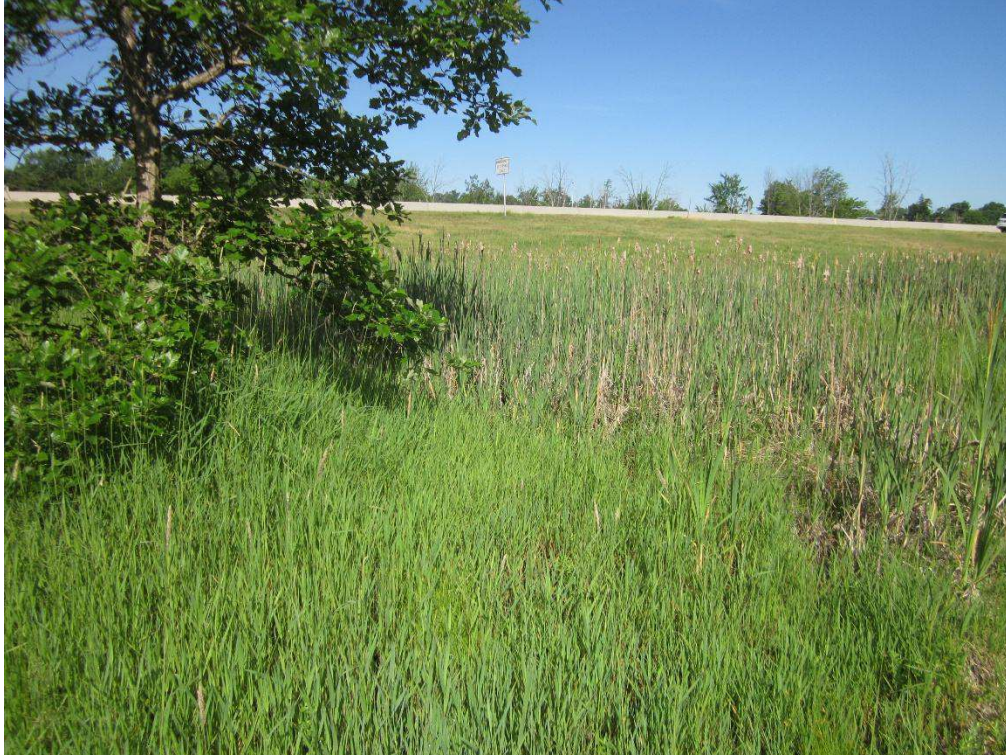
*Photo 15: Wetland 47 (W-47) – PEM; Wetland Impact Location N, O, P (June 2020)*

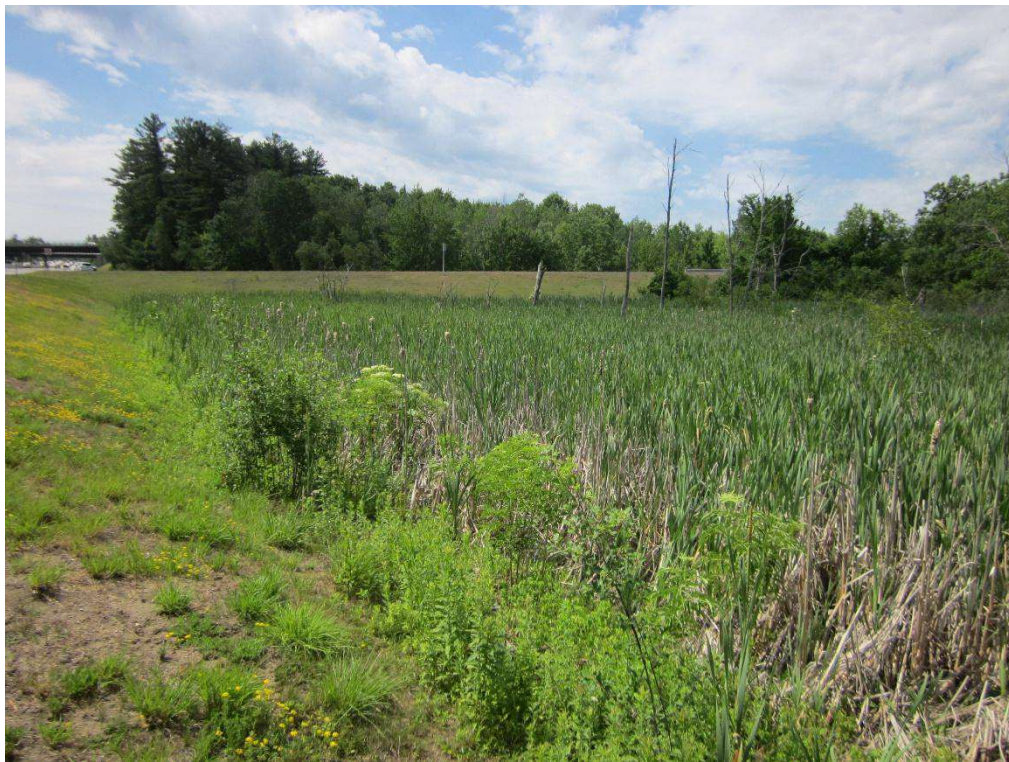
*Photo 16: Wetland 49 (W-49) – PEM; Wetland Impact Location Q (June 2020)*
