## Winter Tenting of Highway Pavements

1. Report No. FHWA-NH-RD-12323C		2. Gov. Accession No.	3. Recipient's Catalog No.
4. Title and Subtitle <b>Winter Tenting of Highway Pavements;</b> Test Program and Discussion of Causes and Mechanisms		5. Report Date Oct 28, 2000

# **Winter Tenting of Highway Pavements; Test Program and Discussion of Causes and Mechanisms**

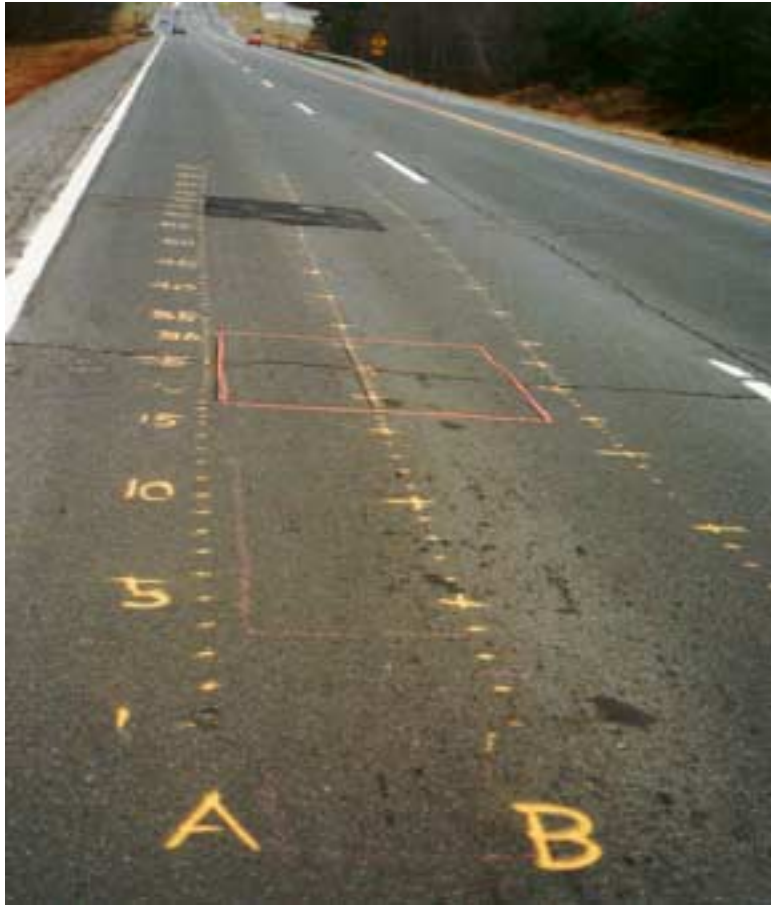
Figure 4. Test site and excavation pit.

*Test pit excavation:* Transverse pavement cracks, test pit markings, and a pavement surface elevation survey grid at Site 1, but typical of all test sites, is shown in Figure 4a. Test pit excavation necessitated removal of the 11 and 23 cm (4 and 9 in.) thick HMA layers at Sites 1 and 2, respectively, with minimal disturbance to the surface of the underlying base course. The surface of the base course at Site 1 immediately following HMA removal during the first pit excavation is shown in Figure 4b. A well-defined ridge-line conforming to the path of the crack was exposed. Observations resulting from the pit excavation follow discussion of frost susceptible soils:

- a. Site 1 – transverse cracks and surface elevation grid (longer than typical 30 ft grid).

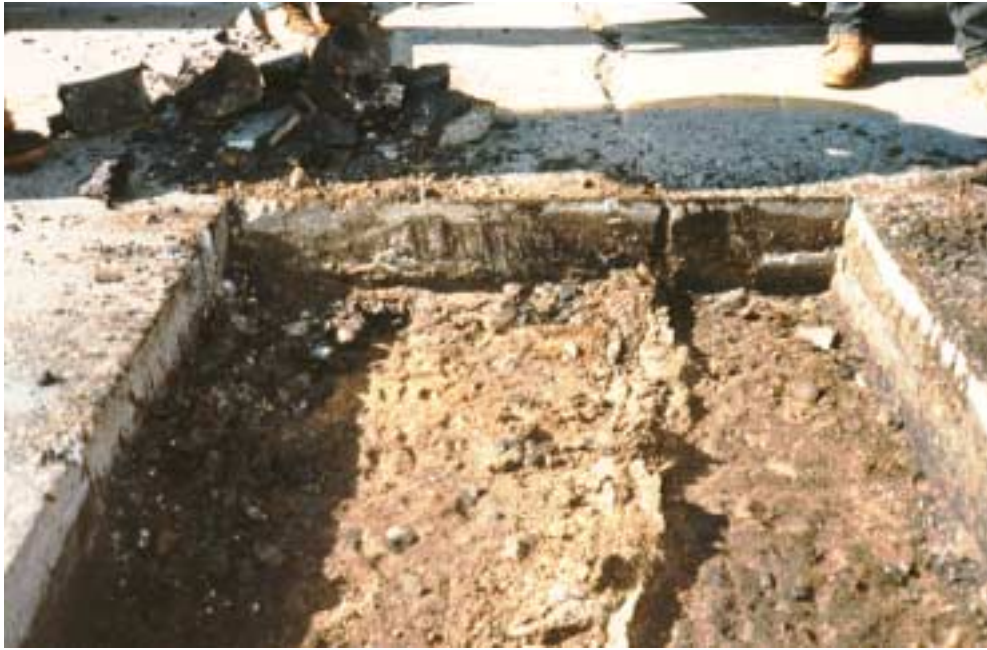
Figure 4. Test site and excavation pit.

b. Site 1 – surface of base course during pit excavation.

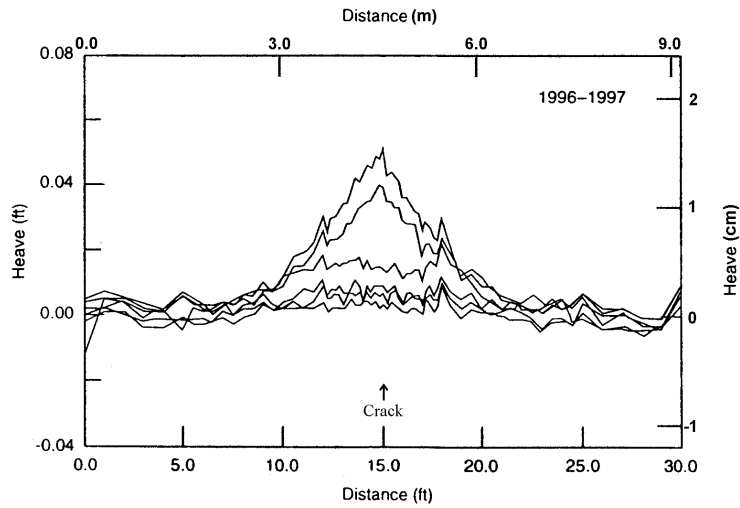
Figure 6. Vertical displacement at Site 4 during the 1966-1997 winter.

*Surface manifestation:* Site 4 pavement elevations through the 1996-1997 winter are shown in Figure 6. Maximum vertical displacement was 1.5 cm (0.6 in). While the magnitude of heave is lower than values observed in the past, data show nearly an order of magnitude more displacement immediately adjacent to the crack than at distances over 2 m (6.6 ft) away. This clearly indicates heave activity by some winter-related phenomenon. Appendix C provides figures showing progression of tenting at each of the site 4 cracks (labeled as 4c northbound, 4c[2] northbound, 4b [a series of cracks on the southbound lane], 4a[1] southbound, and 4a[2] southbound) throughout the 1995-1996 and 1996-1997 winters. Note that the cracks on the southbound lane of I-89 had been sealed with a crack sealer. The magnitude of tenting was slightly less than open cracks. However, it is assumed that some salt still remained in the base course in the vicinity of the crack from before the cracks were sealed, and also that additional salt infiltrated into the cracks where the crack was not perfectly sealed.

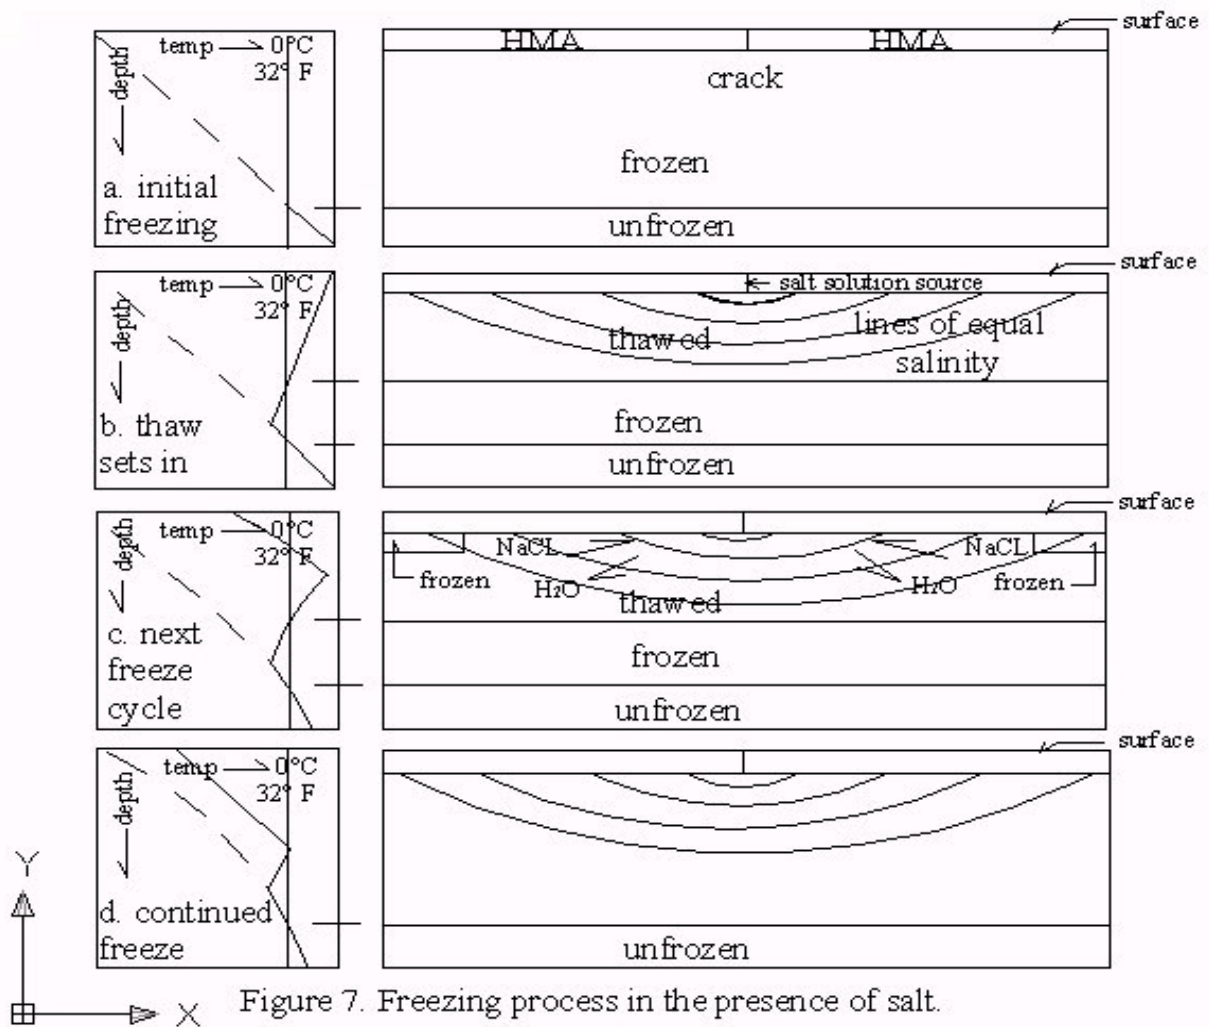
Figure 7. Freezing process in the presence of salt.

The following is based on Shober's work (1971). Subsurface temperatures, frozen/non-frozen ground conditions, and salinities from the NH field test sites conform to such rationale: Figures 7a-d are a simplification of a figure provided by Shober: Curves on the left side show subsurface temperature gradients as freezing and thawing occur. Progressive cross sections of the soil are provided on the right. Figure 7a shows an initial freezing gradient (left) and corresponding state of ground (right). Then assume a thaw

sets in. The new freezing gradient and corresponding state of ground are shown in Figure 7b. Figure 7b (right) also shows a superimposed salinity concentration at time t, after the salt-laden surface water (carrying the salt-sand mix) enters into the crack in the pavement surface, and infiltrates into the thawed base course. Now assume another freeze cycle. The progressive freezing gradient and state of ground are shown in Figure 7c. Note, because of the presence of salt and the associated freezing point depression, the soil no longer freezes uniformly downward and perpendicular to the temperature gradient. Rather the freezing front proceeds in a non-linear fashion with different regions of base course freezing at different temperatures as shown by hashed shading. Figure 7d shows temperature gradient and state of ground as freezing continues. If freezing were to occur from the surface downward, as in the absence of a freezing point depressing agent, the source of water would be cut off from the crack, and the tenting process could not occur. However, in the presence of this ongoing water source, small ice lenses, which are responsible for heaving (or, in this case, tenting because it occurs only at the crack), accumulate at the freezing front.

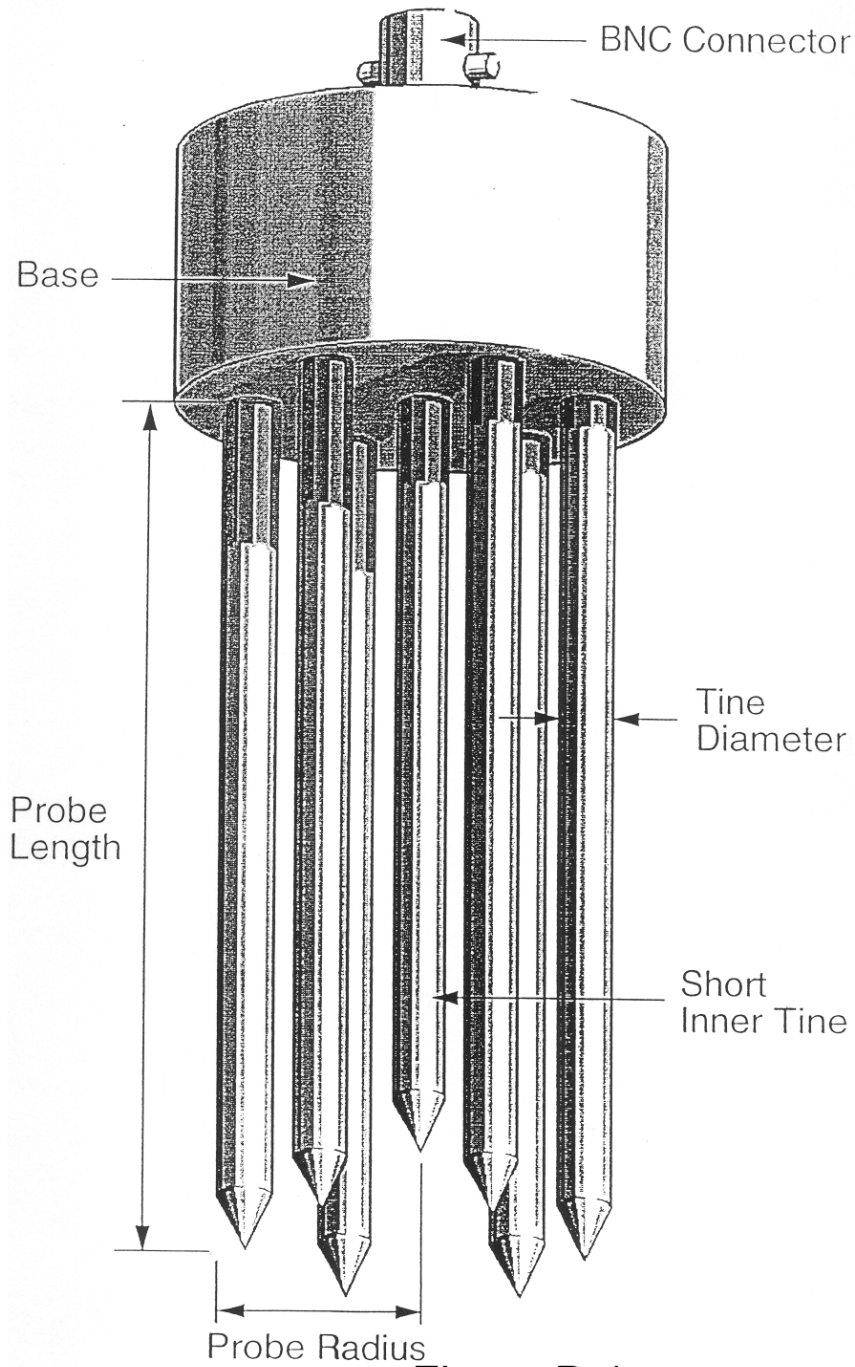
Figure B-1.

The Vitel probe measures the dielectric constant of a soil which has been shown by a long line of researchers to be related to the soil's volumetric water content (Roth et al. 1990, Schofield, et al. 1994, Kaya et al. 1994, Topp et al. 1994). Because the dielectric constant of water (80) is so much greater than that of soil particles (4) or air (1), the contribution of water dominates the overall dielectric constant of the soil-water-air mixture. Because the soil's contribution to the overall dielectric constant does not change (only the amount due to water changes as the moisture changes), soil moisture content can be readily determined. A thorough discussion of dielectric properties of moist soils is provided in Campbell (1988).

# Coaxial Probe Configuration

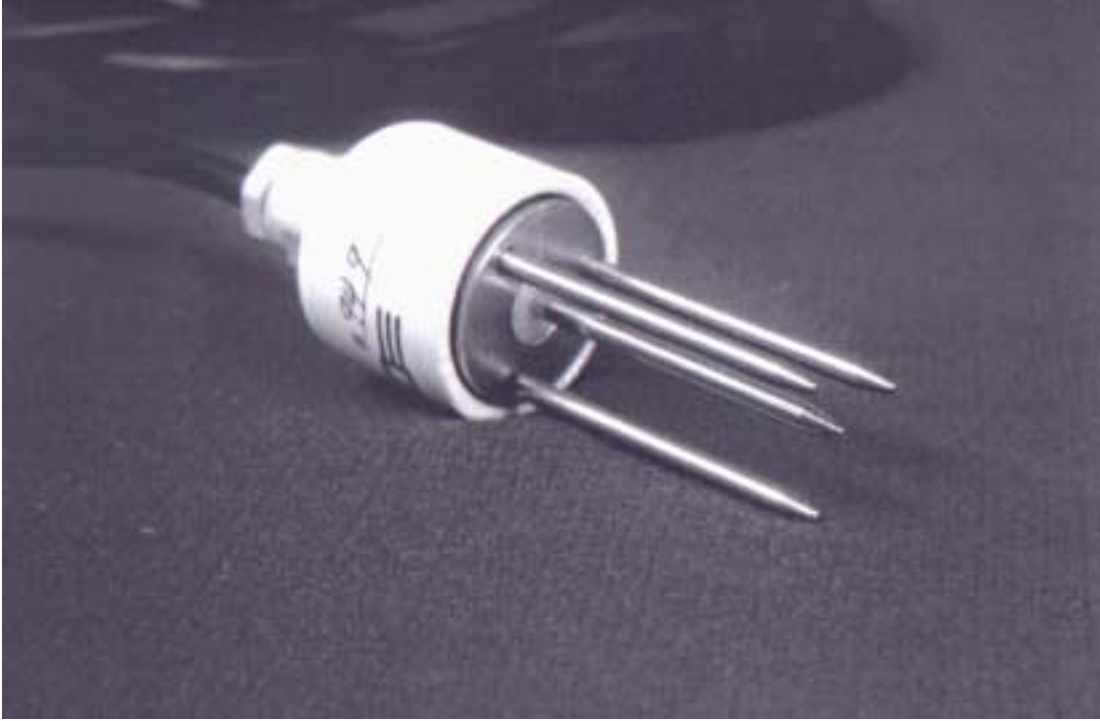
Figure B-2. Radio frequency (RF) probe.

Shown in Figure A-1, the moisture sensor / probe was originally developed by Dartmouth College and the US Army Cold Regions Research and Engineering Laboratory (CRREL), both located in Hanover, NH, in the 1980's. It was then further modified by, and is now commercially available from, Vitel, Inc. (Vitel, 1994) (Figure A-2). In the ensuing discussion, the original probe is referred to as the CRREL-Dartmouth probe, and the commercially available probe as the Vitel probe or sensor.
