## New Hampshire's Concrete Aggregate and Alkali-Silica Reactivity

Statewide Assessment of Fine and Coarse Concrete  
Aggregate

Final Report

Prepared by the New Hampshire Department of Transportation, in cooperation with the  
U.S. DOT, Federal Highway Administration

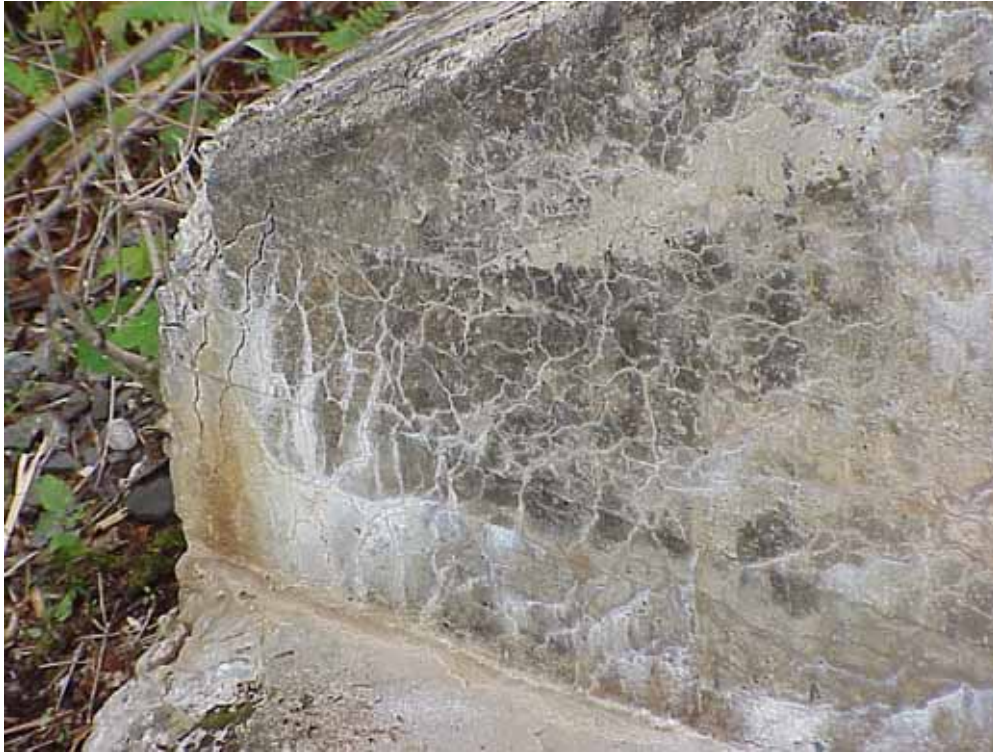
*Figure 3 – Frankenstein Trestle, Crawford Notch, southeastern abutment, wingwall.  
Map cracking with white precipitate exuding from cracks (August 2001)*

Harts Location	Railroad Bridge	Frankenstein Trestle	Tested southern abutment and southern pier; large rounded coarse aggregate particles; concrete in very poor condition; severe crumbling and spalling of concrete (C/S)	Severe	A few reaction rings around coarse aggregate particles and large section of matrix florescence
Keene	120/076 (1967)	NH Rte. 9/10/12 over West Street	Spalling upper center of northern abutment, rebar exposed; white precipitate (IBC)	Moderate	Peripheral of several coarse dark mafic aggregates (metamorphic rock ?); microcracks between coarse aggregate particles; several milky white quartz particles are greenish-yellow; estimated 15-20% of surface
Landaff	074/159 (1920)	Syms Noyes Road over Mill Brook	Large open cracks in abutments and underneath deck; large amount of white precipitate; cement is soft; soil washed out in southwestern corner (ARCH)	Moderate	Dull green over entire background (fine aggregate); a few coarse particles (quartz) are bright yellow-green; portion of periphery of one coarse aggregate particle

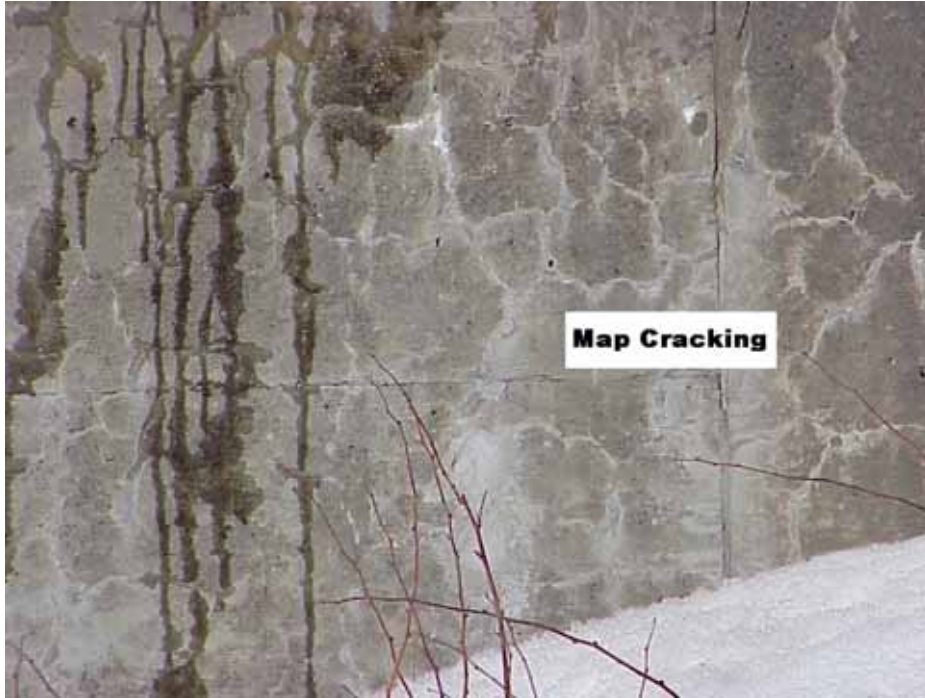
Photo 1 – Map cracking on wing wall, I-89 Northbound bridge over Frye Lane, Grantham, NH.

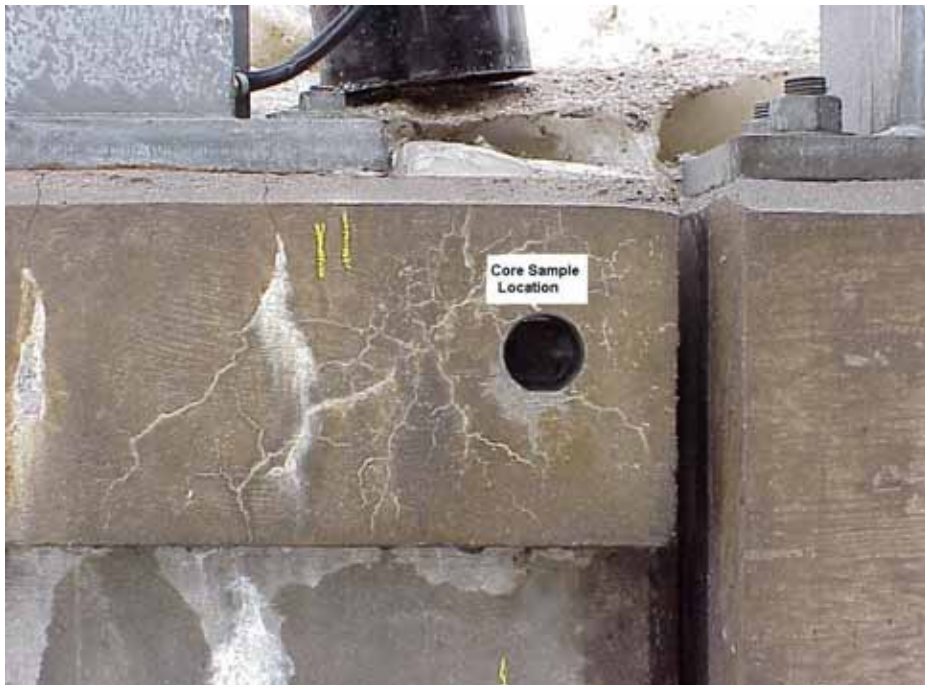
Photo 2 - Map cracking on facies, bridge over I-89 in Grantham, NH.

<b>TABLE 4 (continued)</b>					
<b>TOWN</b>	<b>BRIDGE #</b>	<b>ROUTE</b>	<b>GENERAL CONDITION</b>	<b>ASR PRESENT</b>	<b>DESCRIPTION ASR GEL DEPOSIT</b>
Grantham	125/070	Bridge over I-89	Map cracking on sidewalk and northwest facing bridge facies; white precipitate exuding from some cracks; core samples taken from sidewalk and facies (IBC)	Severe	UV test conducted on concrete cores only; some florescence on interior of coarse aggregates and reaction rims around some coarse aggregates; extensive florescence on portions of the cement paste; coarse aggregate particles are granitic and metamorphic rocks; a few voids lined with clear to milky white precipitates; a few small microcracks in matrix
Grantham	112/147	I-93 NB Bridge over Fyre Lane	Map cracking on abutments and wing walls; white precipitate exuding from some cracks (BOX)	Moderate	Florescence of fine aggregate matrix; peripheral bands around some coarse aggregate particles; ASR gel in microcracks in matrix

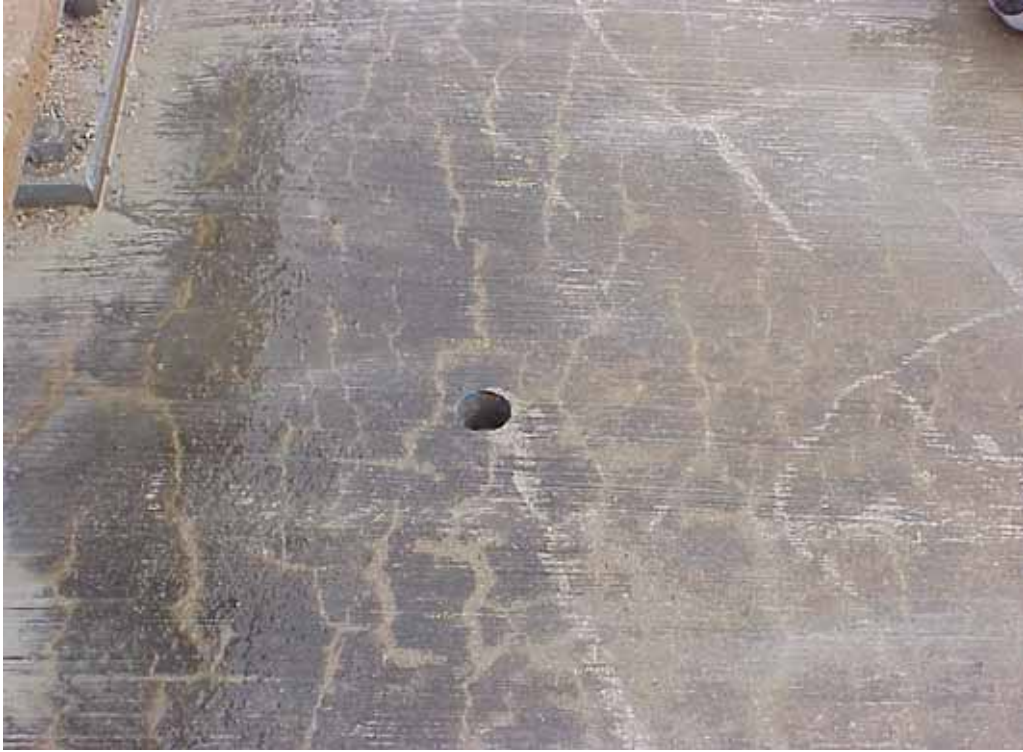
Photo 3 - Map cracking on sidewalk, bridge over I-89 in Grantham, NH.

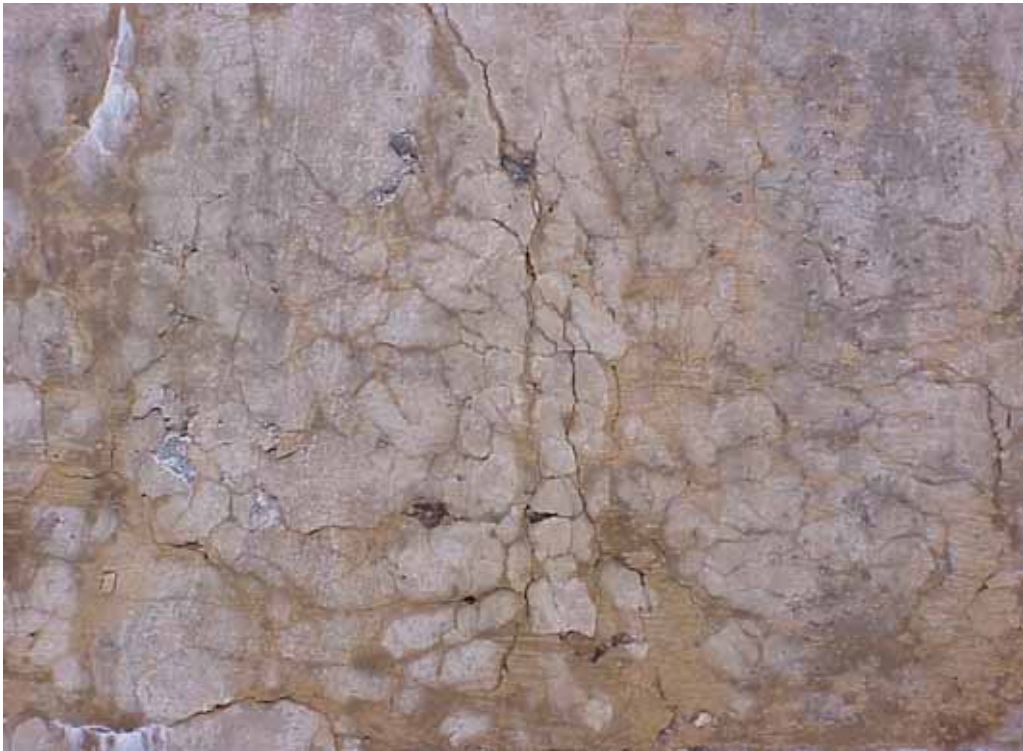
Photo 4 – Map cracking on bridge pier over Connecticut River in Monroe, NH.

Monroe NH/Barnet VT	110/125	Bridge over Connecticut River	Severe map cracking on both abutments and center pier; white precipitate exuding from cracks; severe cracking on center pier (C/S)	Moderate	A few coarse aggregate particles, florescence of cracks in the surrounding cement paste and sections of the fine aggregate matrix
Nashua-Hudson	157/059 (1973)	Circum. over Merrimack River	Very minor cracking at abutment corner; no spalling; minor white precipitate (IBC)	Severe	A dull green film over 30-35% of fine aggregate matrix; a few quartz or granitic particles are yellow-green
Newington	112/107 (1956)	Spaulding Turnpike over Woodbury Ave.	No visible cracks at test location; spalling and white precipitate at southern abutment (IBC)	Slight	Only a few specks of bright yellow green (quartz particles)
Ossipee	175/238 (1969)	NH Rte. 16 over NH Rte 25	Arcuate pattern leading to spalling; exposed rebar; white precipitate (IBC)	Severe	Yellow green film surrounds and intersects a cement like aggregate (15-20% of surface); greenish-yellow over fine aggregate matrix, estimated 50% of surface area

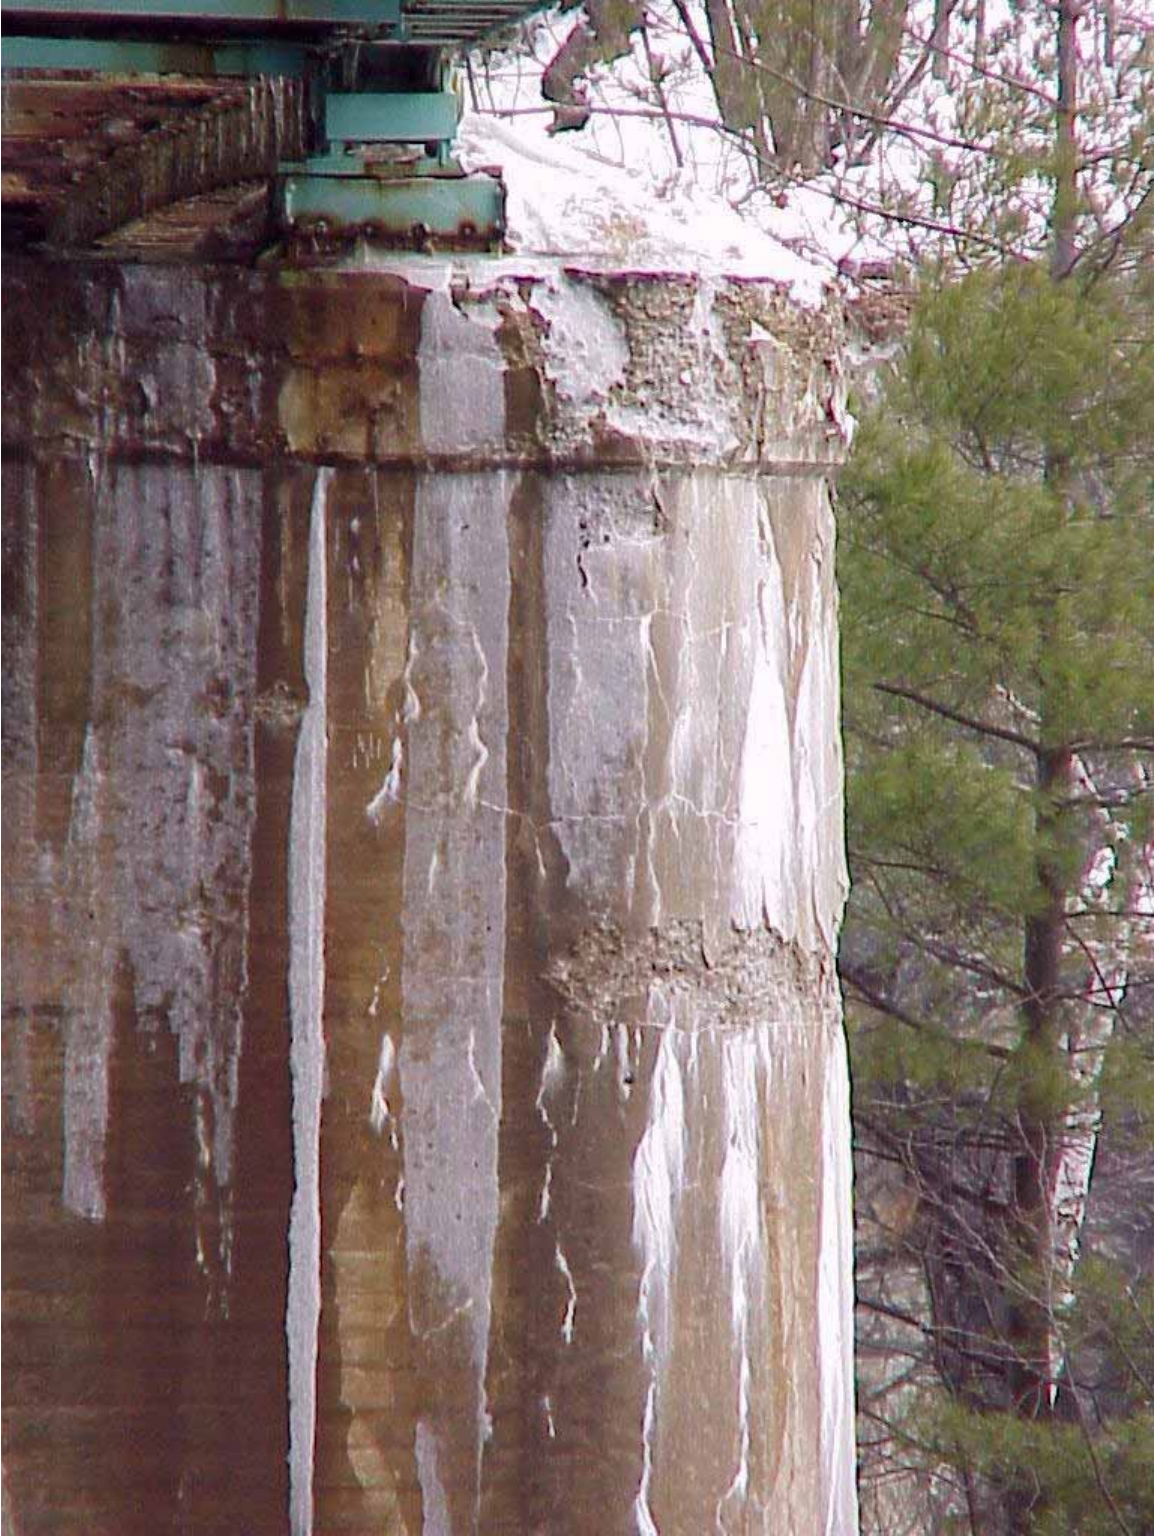
Photo 5 – Map cracking and deterioration of concrete on Connecticut River bridge pier in Monroe, NH.

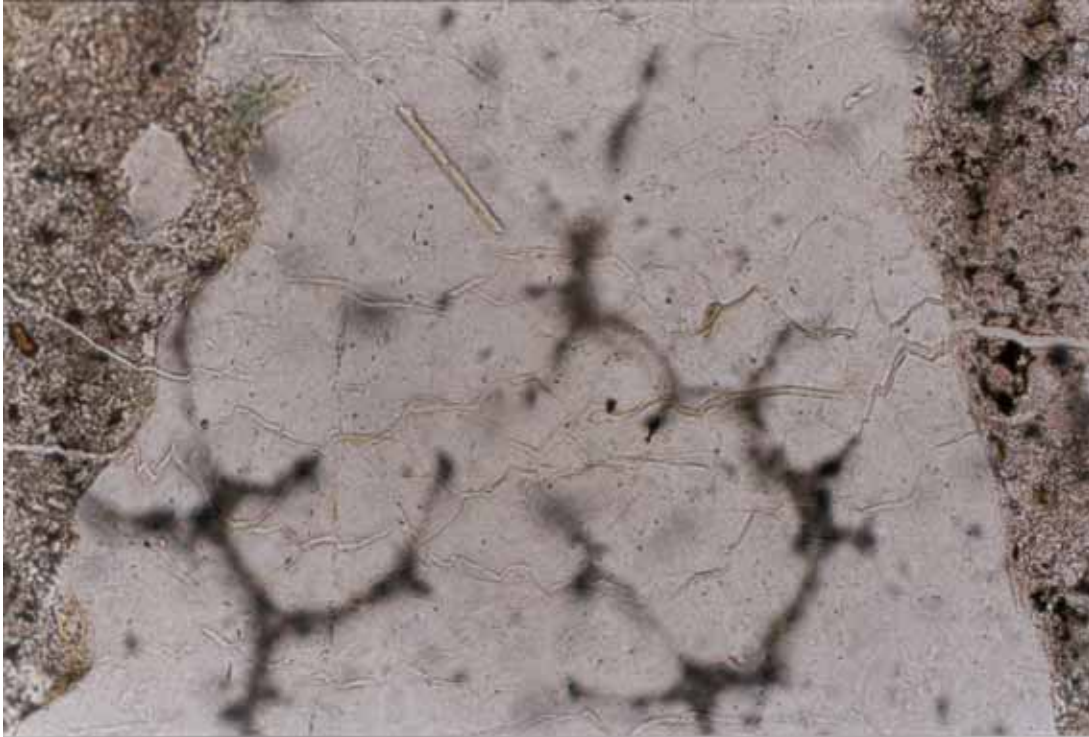
Photo 8 – ASR gel filled micro cracks extending from quartz particle into surrounding cement paste, plane light, 200X, southern abutment, Plymouth railroad bridge.

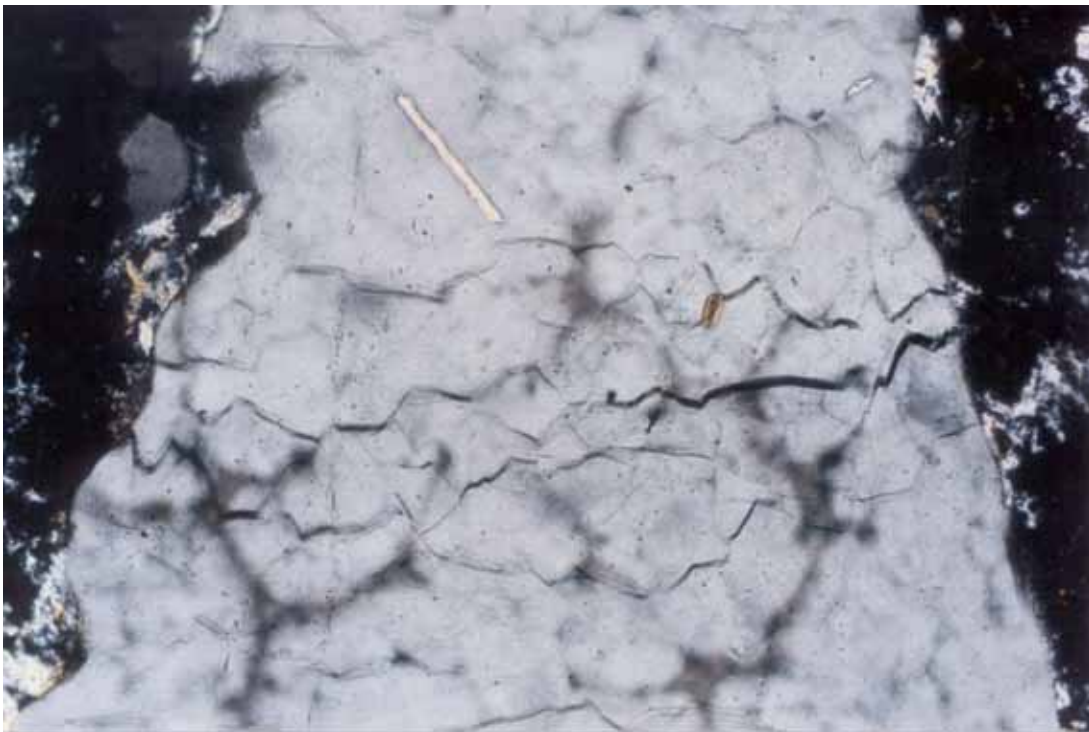
Photo 9 – Same as photo 8, cross-polarized light.

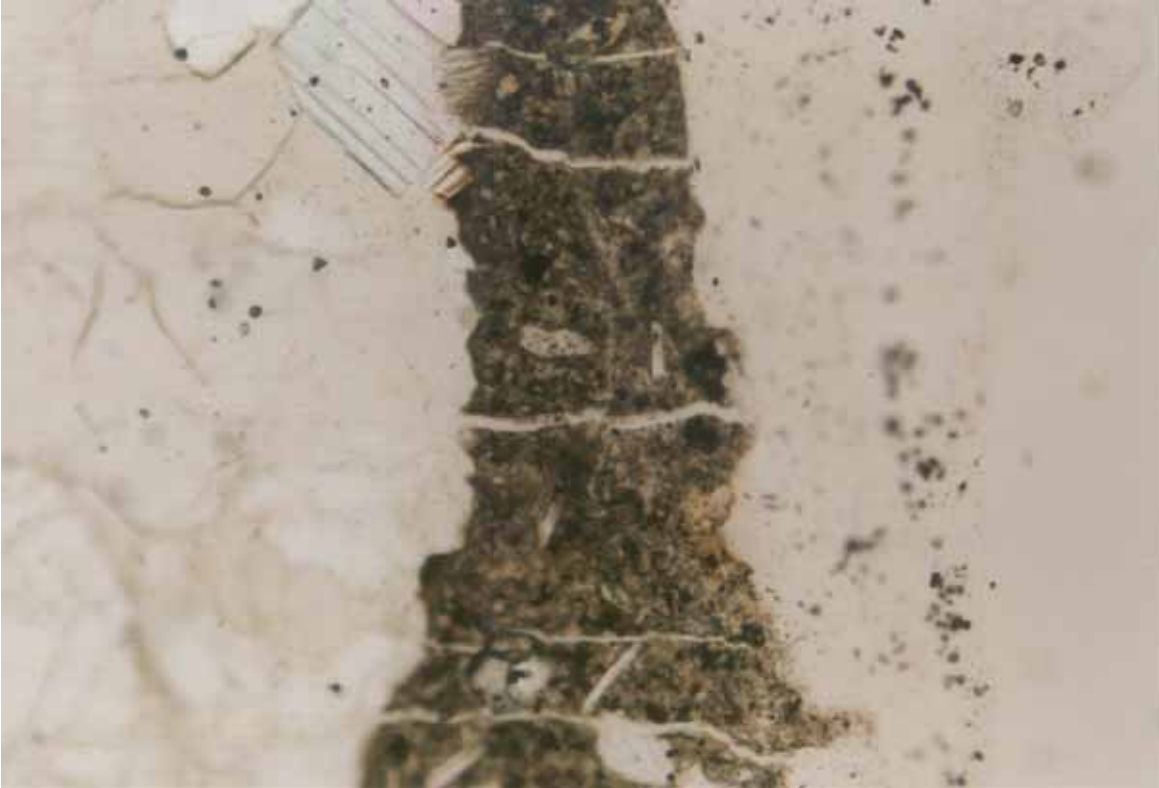
Photo 10 – Micro cracks filled with ASR gel and calcium hydroxide, cracks extending from granite particle, through cement paste and into another granite particle, plane light, 100X.

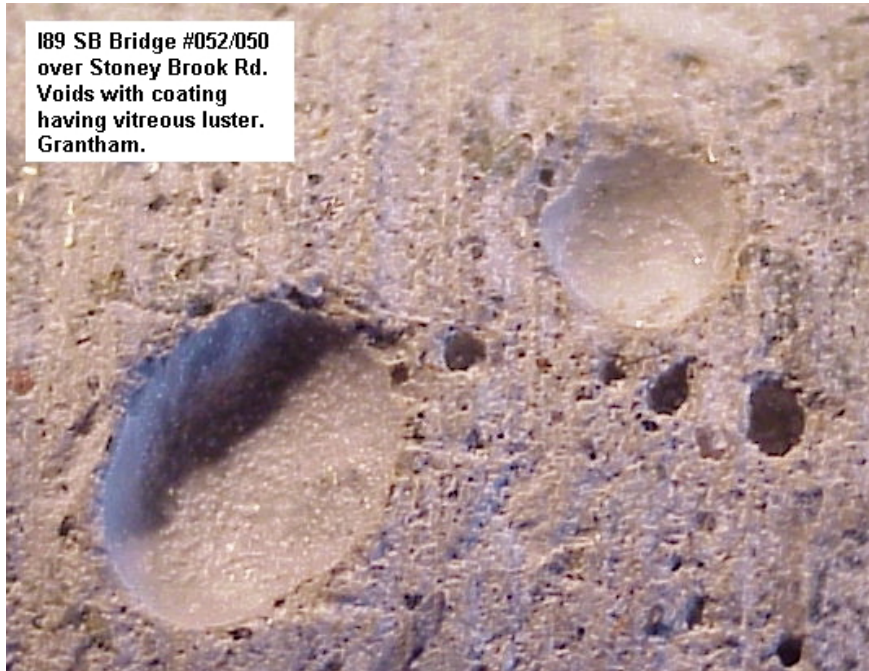
Photo 11 – Voids coated with precipitate having vitreous luster, stereoscopic view, 10X, I-89 southbound bridge over Stoney Brook Road in Grantham, NH.

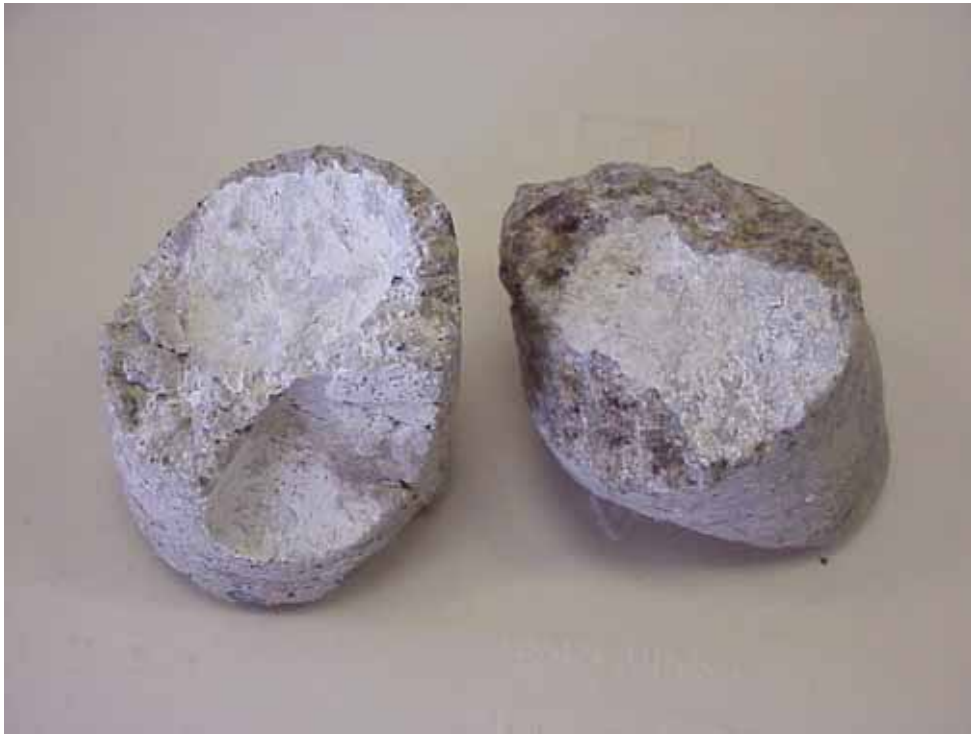
Photo 13 – White precipitate lining pop outs in concrete core taken from southern abutment of Swimming Hole Bridge over Pemigewasset River in Woodstock, NH.

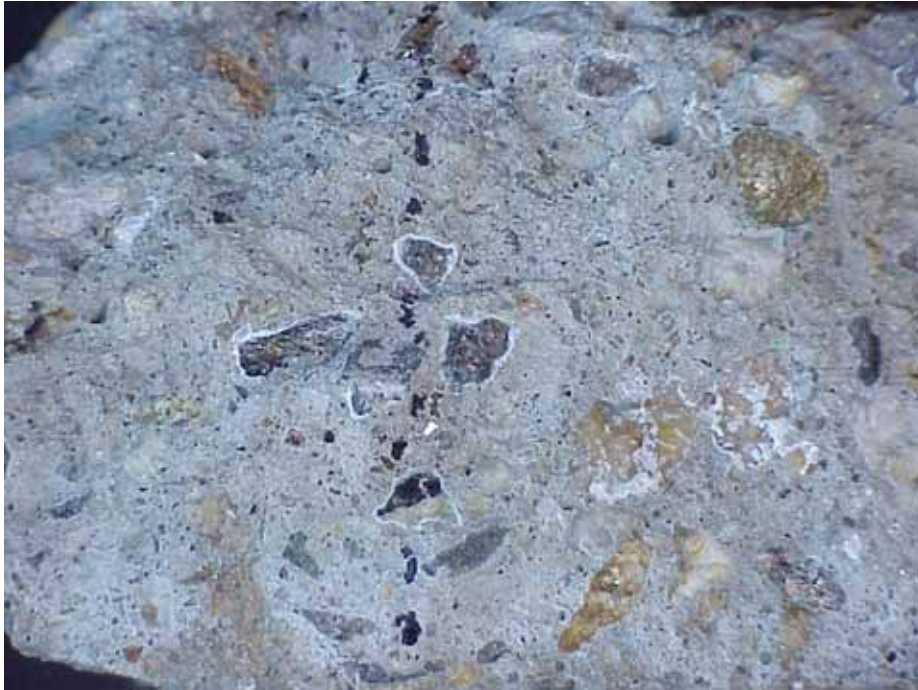
Photo 14 – Reaction rims around aggregate particles in piece of concrete from bridge over I-93 in Salem, NH, plane light.

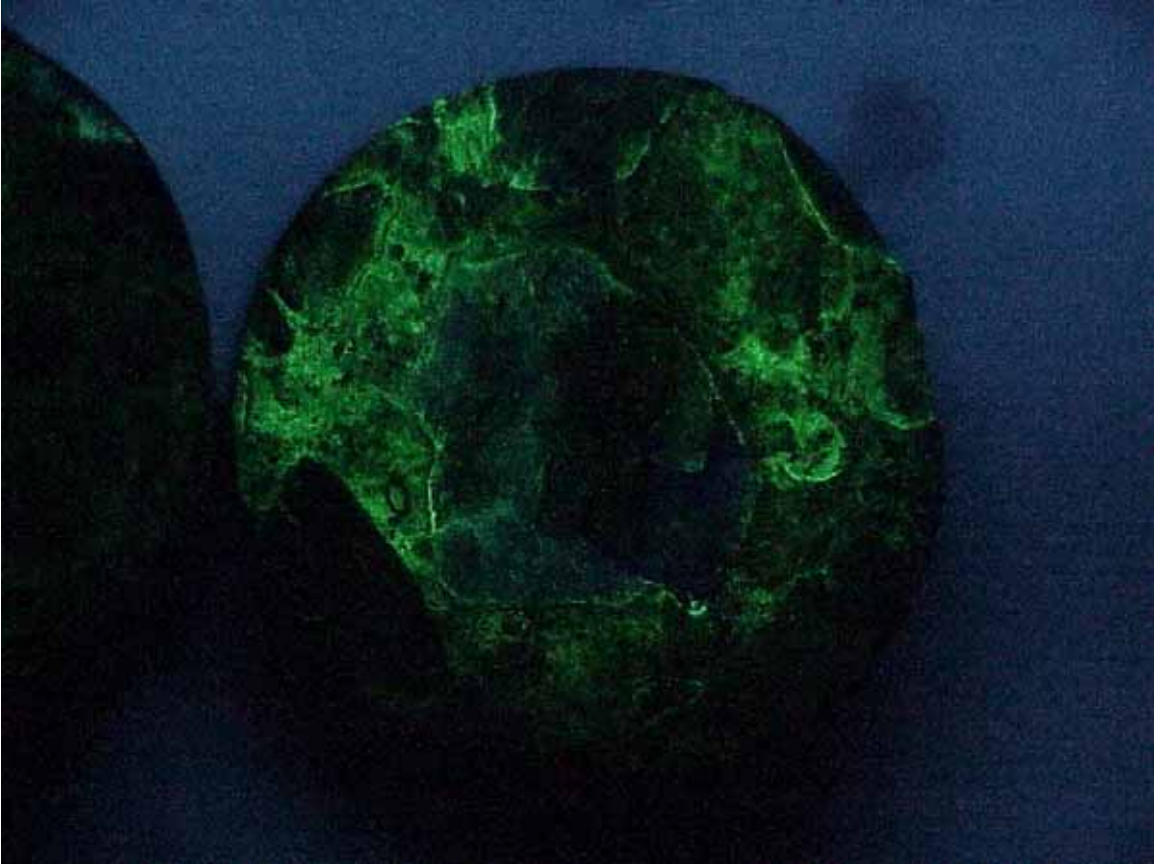
Photo 16 – Concrete core sample treated with uranyl acetate; concrete paste and rim around large aggregate particle fluoresce under UV light, I-89 bridge in Grantham, NH.

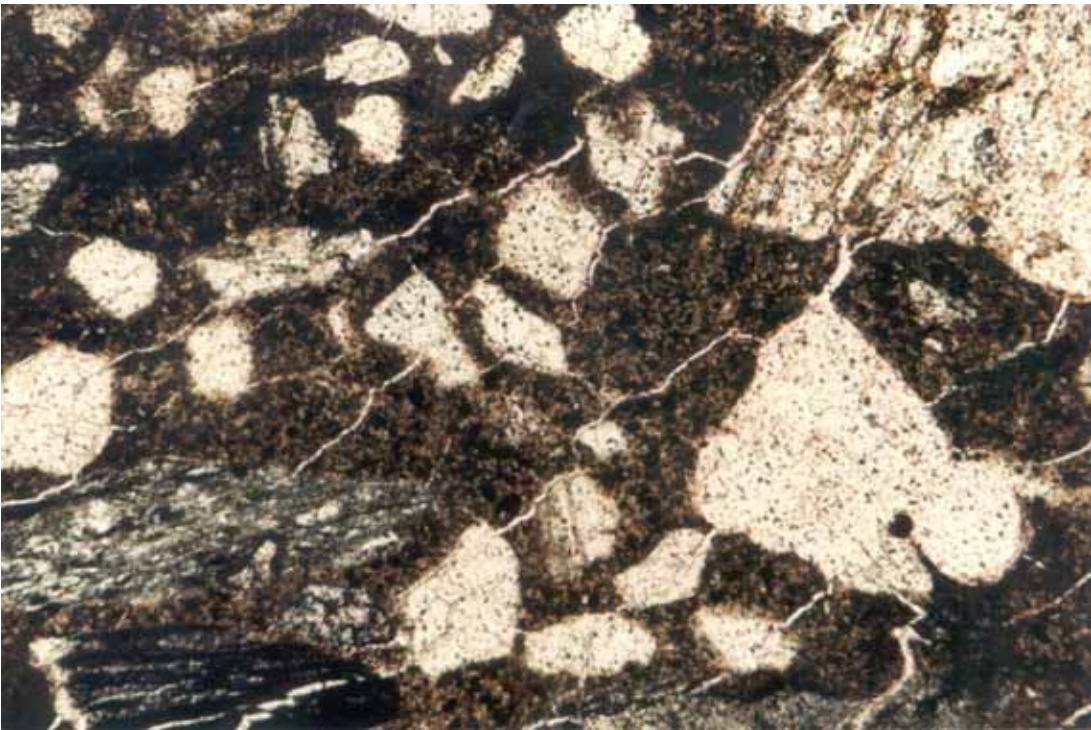
Photo 18 – Micro cracks extending from aggregate particles (igneous and metamorphic rocks), through cement paste and into other aggregate particles, plane light, 50X, pit #33 fine aggregate, Lebanon, NH.

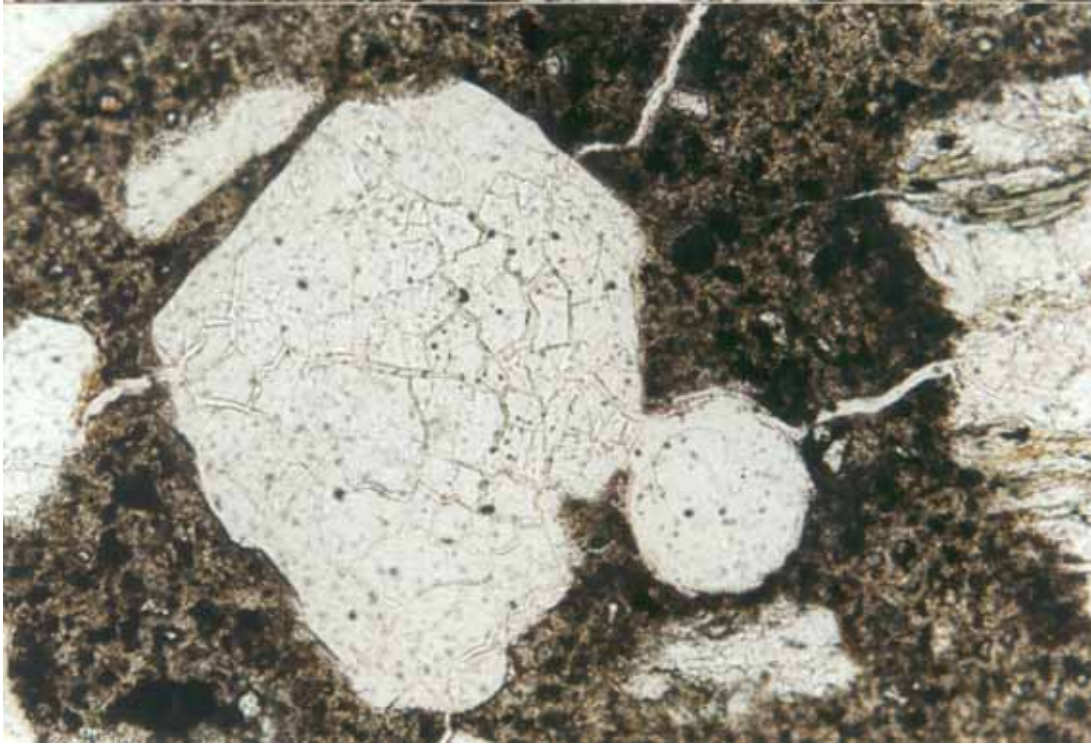
Photo 19 – Micro cracks extending from granite and quartz particles into cement paste, plane light, 100X, pit #33 fine aggregate, Lebanon, NH.

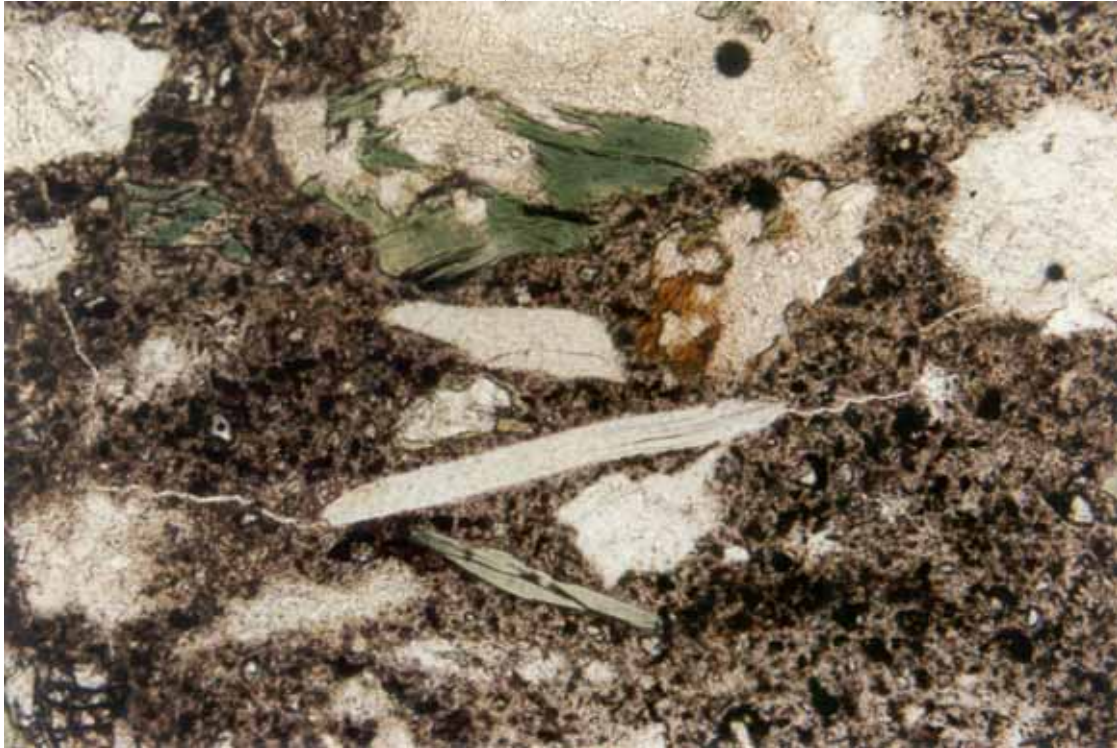
Photo 23 – Micro cracks in quartz and muscovite particles, through cement paste, plane light, 100X, quarry A, manufactured sand, Wilton, NH.

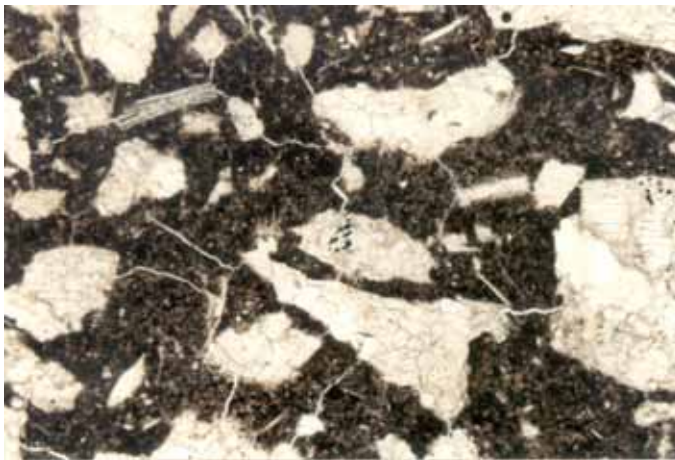
Photo 29 – Micro cracks in cement paste, muscovite and granite aggregate particles, plane light, 50X, quarry M, coarse aggregate.
