GIS and the New Hampshire Rock Cut Management System

Final Report

Prepared by the New Hampshire Department of Transportation, in cooperation with the U.S. Department of Transportation, Federal Highway Administration

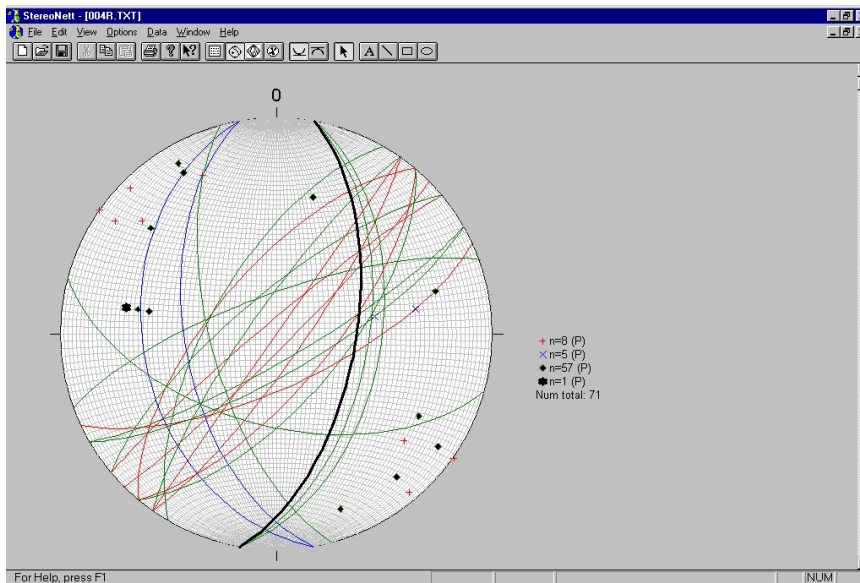
Figure 6. The stereonet, representing the structural data collected on the rock cut, can be selected by turning on the great circles and assigning a color, line width, and symbol to each type of structural condition.

The rock cut structural data was collected using a Brunton compass and was converted to dip direction and dip angle for input into the relational database. Each structure type, including the orientation of the existing rock slope, was input into a specific table through a form. Once all the structural data was in the relational database it could be exported, in text format, by “clicking-on” a button. The stereonet program can read the text file and develop density plots, rose diagrams and stereonet by “clicking-on” the great circles (Figures 5 & 6).

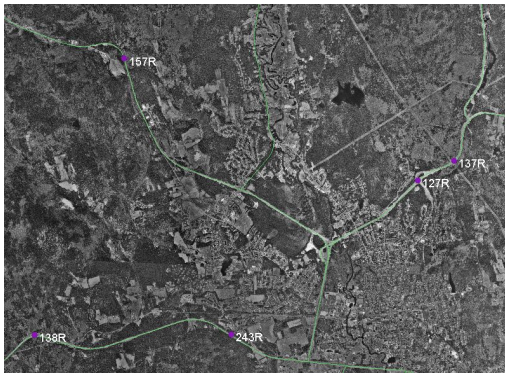
Figure 9. Aerial photography can be used as a base map for the Rock Cut GIS. The resolution is not high enough to see actual details on the rock cut. The secondary data layers (i.e. roads) can also be used to help locate the rock cut point features.

The NHDOT Bureau of Planning houses the Department's GIS server. Multiple data layers, which have statewide coverage, can be obtained through this server. These data layers can be utilized as both base layers and secondary layers. All the information within the Rock Cut Management System, including secondary data layers, can be placed onto a base layer. Possible base layers might include: Topographic maps, aerial photographs, town and county polygons, bedrock and soils maps, and surficial geology maps. Secondary layers, which are placed on top of a base layer, might include: Roads and highways, town and county lines, glacial features, and water bodies. Both the base and secondary data layers can be used to help locate and describe the rock cut point features. A wide variety of maps can be made using the rock cut point features with different data layer combinations. For instance, all "A" rated rock cuts along a specific road, all rock cuts within a specific district, or all rock cuts with icing problems can be depicted (Figure's 9 & 10).
