Integrated Geophysical Methods for Geotechnical Subsurface Investigations

Final Report

Prepared by the New Hampshire Department of Transportation in cooperation with the
U.S. Department of Transportation, Federal Highway Administration

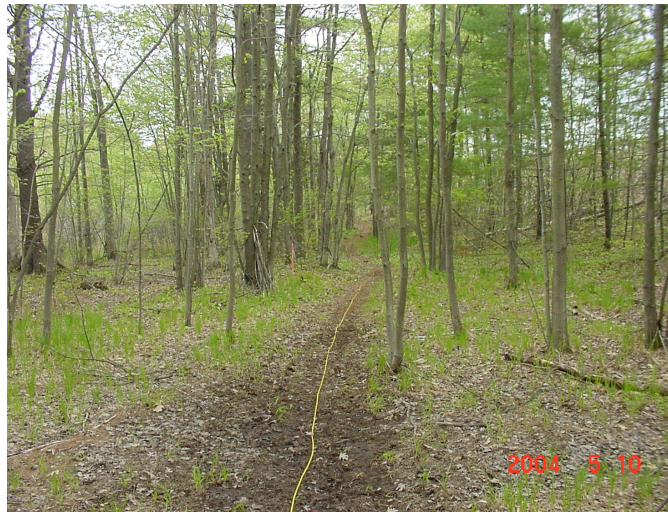
Figure 1: Path along alignment of proposed Exit 12 southbound on-ramp.

To map the subsurface, a path was cleared along the centerline of the new on-ramp (Figure 1). Forty-eight nodes at five-meter spacing were set up as a Wenner-Schlumberger array with 520 quadrapoles capable of obtaining an exploration depth of 38 meters. The multi-electrode unit automatically switched on and off two sets of current and potential electrodes throughout the length of the array until all 520 quadrapoles were read over a period of approximately one hour. The readings were then downloaded from the resistivity imaging unit onto a desktop computer where the results could be analyzed using the RES2DINV software.

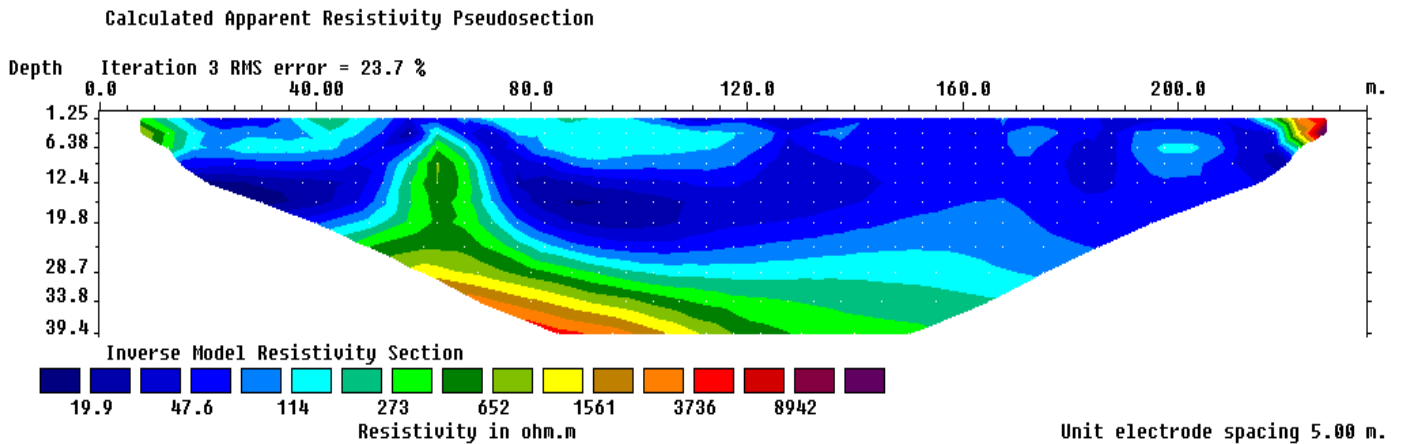
Figure 2: Wenner-Schlumberger resistivity array

Using the analysis software and a least squares type of inversion, the resistivity data were inverted and the results displayed as shown in Figure 2. A large portion of the profile consists of material with resistivity values below 100 ohmmeters, which according to Table 1 are typical of silts and clays. To ground truth the results of the resistivity imaging a second round of test borings was conducted along the same line as the resistivity profile. By comparing the resistivity values to a fence diagram created from the test boring data (Figure 3), a strong correlation can be observed.

The resistivity profile shows the glacial marine clays (blues) to a depth of 20 to 28 meters below ground surface with an area towards the middle of the profile showing slighter higher resistivity values (green). It is possible that these higher values indicate the presence of an old river channel that had previously cut through the glacial marine sediments as the river meandered over time. A fence diagram was created from the

The resistivity results from the Spaulding Turnpike on-ramp project ground truthed well with the test borings. A section of the profile revealed an area of higher resistivity values close to the ground surface. This area could represent an abandoned river channel within the Cocheco River flood plain. This demonstrates that test borings alone can miss areas that could be significant to the geotechnical aspects of a project. For this site, an important question is: Where would you interpret the bottom of the marine clay deposit if test boring data could not be used as a ground truth? On the right side of the resistivity profile, the blues (20–114 ohm-meters) transition into the greens (200-650 ohm-meters) over a depth range of 20 to 28 meters below ground surface. Without test boring data it would be difficult to accurately determine the bottom of the marine clay deposit.

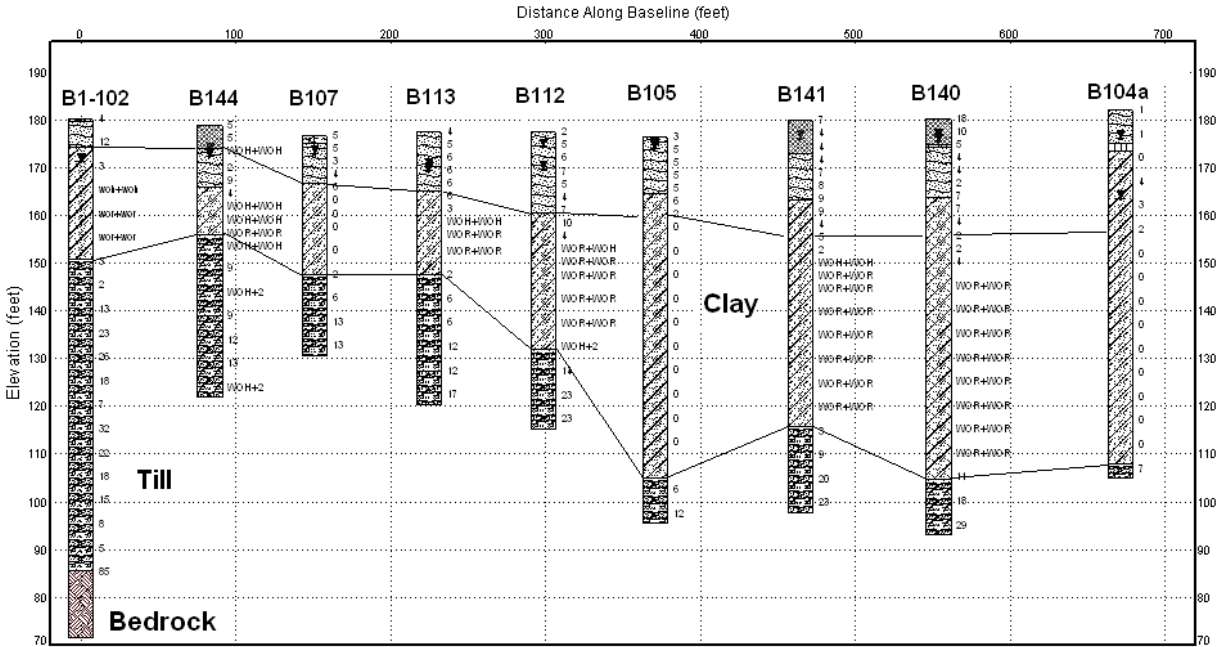
Figure 3: Fence diagram of test boring logs from Exit 12 southbound on-ramp

test boring data showing the glacial-marine clays (zero blow count material) to a depth of 21 to 23 meters below ground surface. By using the known depths of the glacial-marine clays, a bedrock surface could be interpreted on the resistivity profile as somewhere close to the top of the light blue color.

The subsurface conditions beneath the proposed Exit 12 southbound on-ramp were accurately mapped and analyzed by a combination of resistivity imaging and a series of test borings. The data were used to design a large embankment fill over the soft soils encountered directly beneath the alignment.

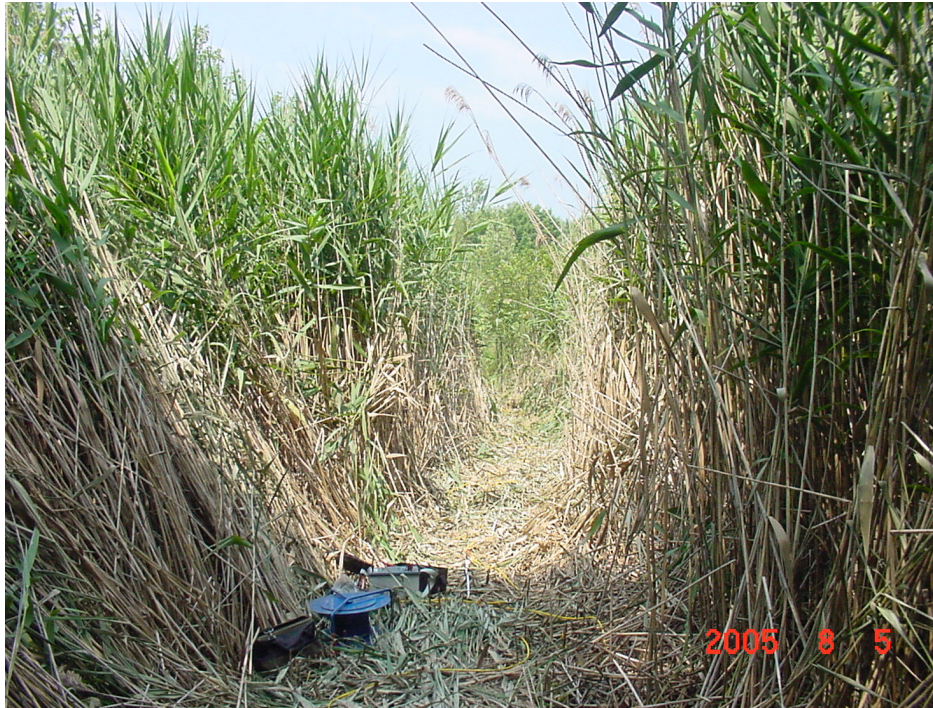
Figure 4: Photo of area with suspected organic deposits.

To facilitate the geophysical investigation, a path was cleared through tall cattails (Figure 4) near the proposed centerline of the new southbound on ramp. Forty-eight stainless steel electrodes were placed at five-meter intervals and a Wenner-Schlumberger array with 360 quadrapoles capable of obtaining an investigation depth of 20 meters was created. The water table was near the ground surface in the area where the electrodes were placed. The data were collected, readings were downloaded onto a desktop computer, and the RES2DINV analysis software was used to analyze the data. Using a least squares type of inversion, the data were inverted and a resistivity profile was created (Figure 5).

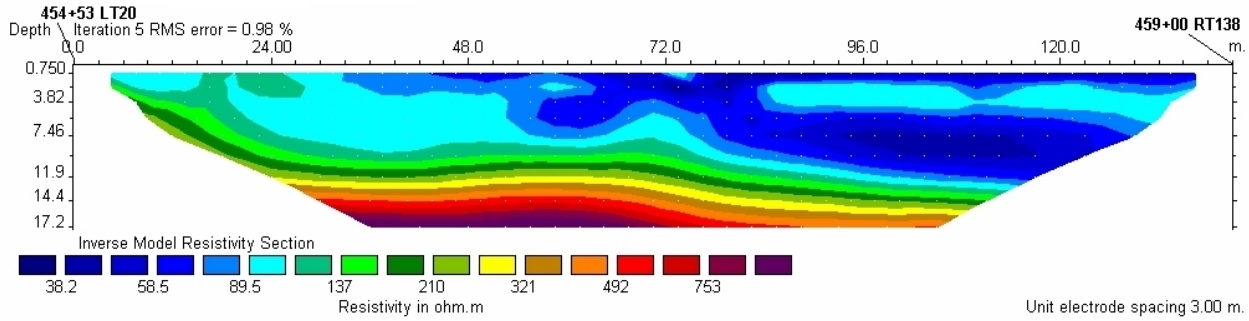
Figure 5: Wenner-Schlumberger array

The inversion results indicated that a large portion of the profile is characterized by a material with low resistivity values (less than 90 ohm-meters). As indicated by Table 1, low resistivity values are typical of wet organic and clayey soils. Based upon the results indicated by the resistivity survey, a series of hand auger probes was conducted to collect soil samples for laboratory analysis and to further map the extent of the deposit. Figure 6 displays the on-ramp alignment, the resistivity line, and the locations of the hand auger probes. Table 2 displays the laboratory results of the soil samples collected through the hand auger probes. This deposit is characterized by soils with high moisture and organic contents to a maximum depth of 35 feet below ground surface.

The hand auger results compared well with the resistivity profile collected for the proposed I-93 Exit 3 southbound on-ramp. The resistivity data was able to confirm suspicions that deep soils with high moisture and organic content were most likely present beneath the area of the proposed high embankment fill. The difficulty was how to confirm the results of the resistivity imaging. The ground was too soft for drilling conventional test borings, so hand auger probes were used to confirm the extent of the deposit and to collect soil samples for laboratory analysis. The use of geophysics on this project was different from that of the other case histories. Resistivity imaging was used as a preliminary type of investigation in an attempt to locate problem soils within the limits of the project. By using resistivity imaging to locate soft soils prior to developing an exploration plan, test borings, test pits, or hand auger probes can then be taken at locations where they will best collect subsurface data key to the design of the project.

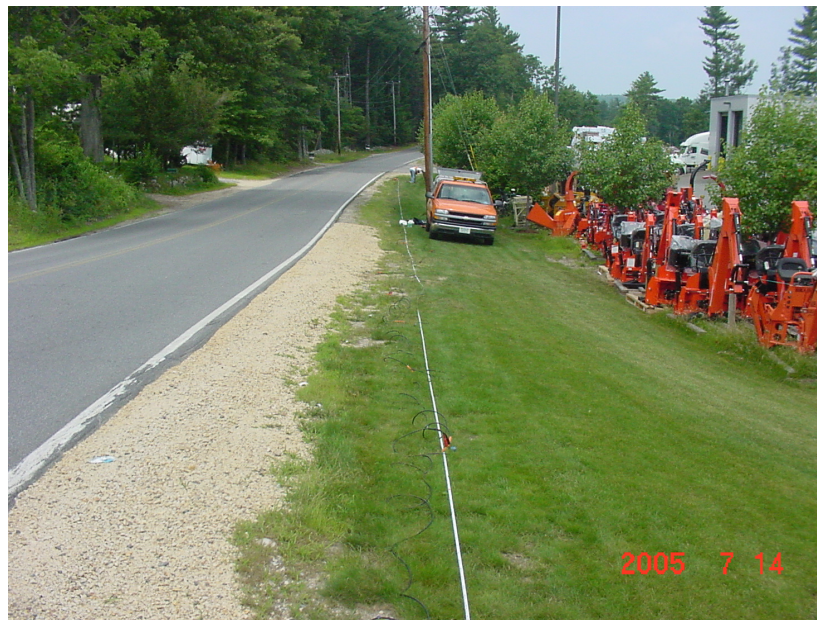
Figure 7: Photograph of Old Country Road, which intersects NH Route 125.

Figure 7 is a photograph looking away from the intersection and down Old Country Road. A seismic line containing 24 geophones was set up at a three-meter spacing over a distance of 69 meters along the roadway shoulder. A Betsy Gun with a 400-grain charge was used as an energy source. Two end shots, two quarter shots, and one middle shot were fired. For each shot, the first arrivals were picked at each geophone and the velocities were calculated for a two-surface model. Figure 8 displays the velocity profile for the seismic line that was run along this section of Old Country Road.

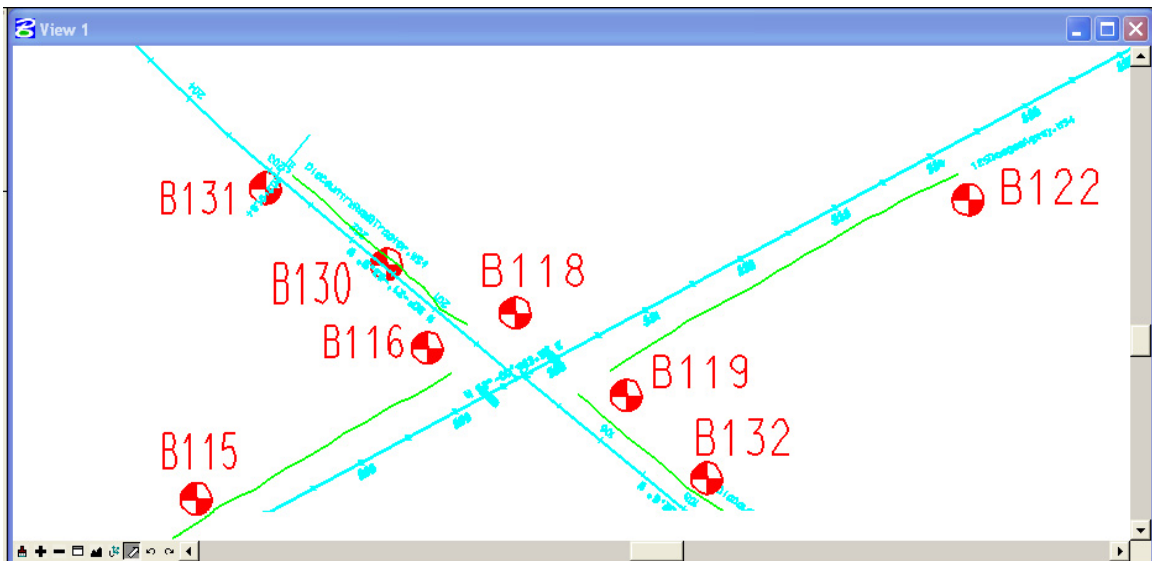
Figure 9: Plan of Old Country Rd & NH Route 125 showing test borings & seismic lines.

Figure 9 is a plan view of the intersection displaying the locations of the test borings and the seismic lines. For the seismic profile displayed in Figure 8, seismic shot S1 was closest to test boring B131 and seismic shot S5 was closest to test boring B118. The yellow and green velocities represent the bedrock while the blue velocities are the overburden soils. The test borings were used to ground truth the seismic profiles.

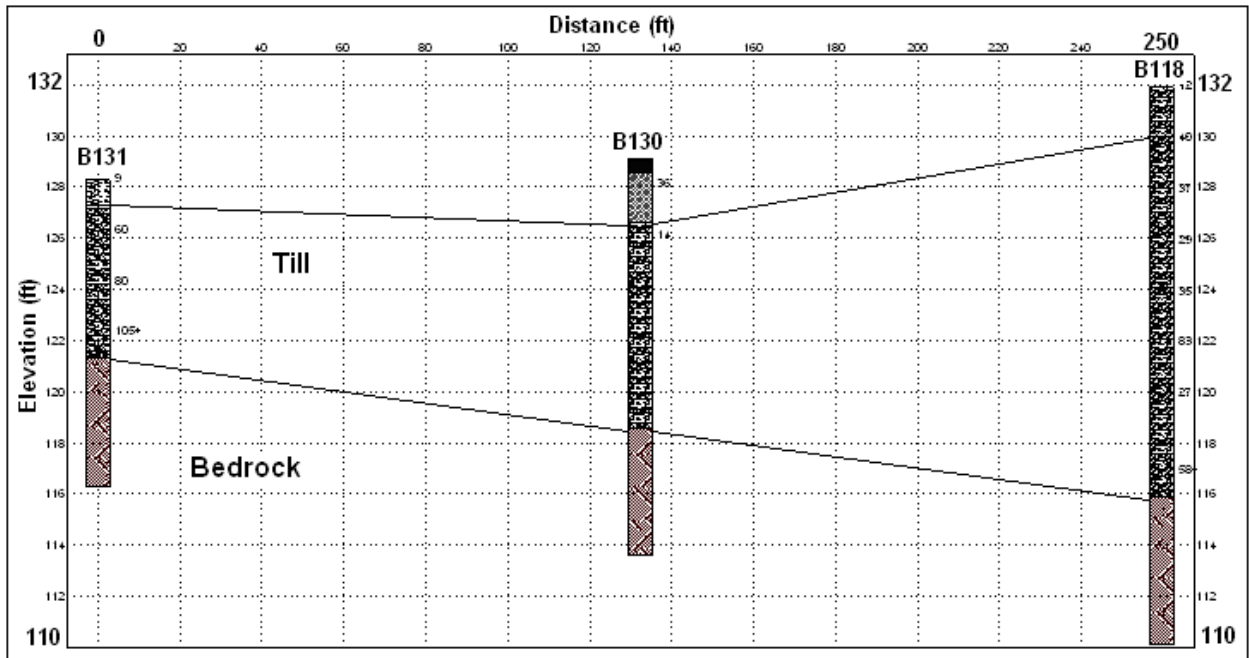
Figure 10: Fence diagram of test borings along a section of Old Country Road.

Displayed in Figure 10 is a fence diagram of the test boring data moving away from the intersection. The ground surface can be seen dropping in elevation by

approximately one meter (4 ft) as the bedrock surface increases in elevation by approximately one-and-a-half meters (5 ft). Similar depths to bedrock are displayed on the seismic profile in Figure 8.

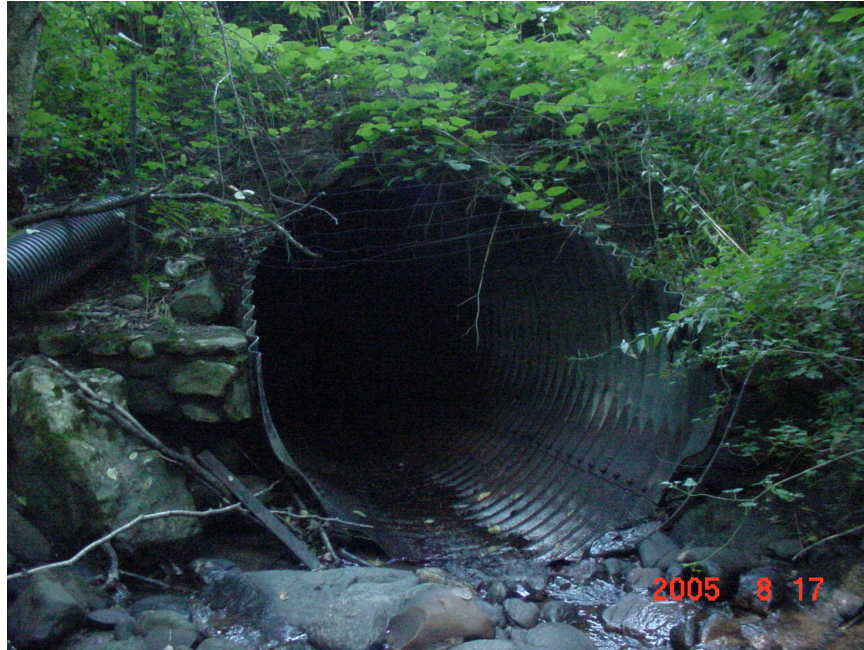
Figure 11: 1.5 meter metal pipe buried beneath 18 meters of roadway fill.

This project involved the use of resistivity imaging and ground penetrating radar (GPR) to investigate possible voids beneath NH Route 12A in the vicinity of a failed 1.5 meter diameter metal pipe located under approximately 18 meters of roadway fill and asphalt (Figure 11). A project was scheduled to slip-line the failed pipe to stop settlement of the southbound travel lane caused by fine-grained soil moving through a break in the existing pipe. NHDOT maintenance forces planned to place new fill beneath the failed section of roadway but needed to accurately identify the location and extent of the voids to avoid a large open cut in the pavement.

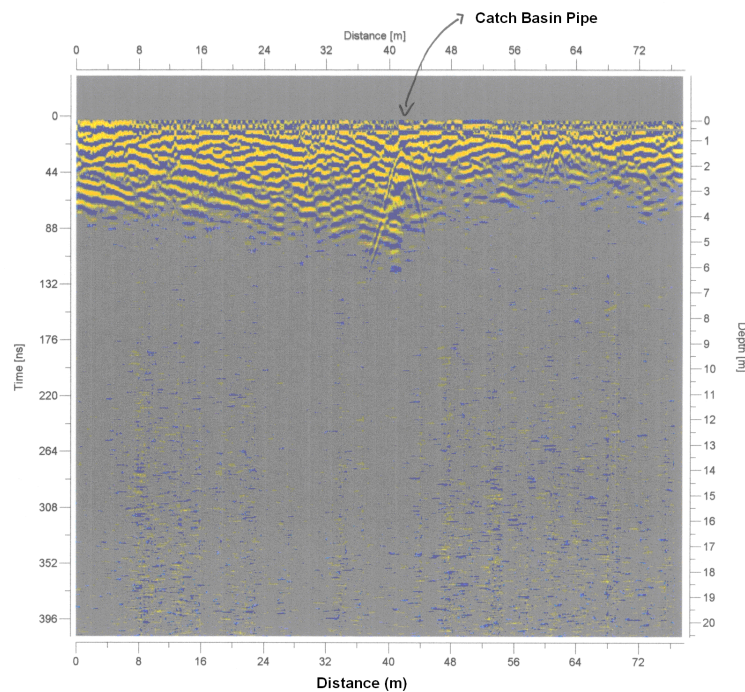
Figure 13: GPR profile showing catch basin pipe.

Figure 13 is one of six GPR profiles that were collected at the site. This profile was collected near one of the catch basins just south of the failed roadway section. A 100 MHz shielded antenna was used to collect data displayed in this profile. As shown in

Figure 13, the maximum depth of penetration was approximately six meters, which was about a third of the depth needed to reach the buried (1.5 meter diameter) metal pipe. A reflection from the catch basin pipe is observed in the profile, but voids or other subsidence are not observed. The remaining GPR profiles were similar to that of Figure 13, voids were not detected and the 1.5-meter diameter buried pipe was not observed.

The geophysical investigation that was conducted to locate the buried 1.5-meter diameter pipe in Walpole was considered to be less successful. It was known ahead of time that trying to obtain a depth of 18 meters with GPR would be difficult. The Maintenance Engineer was informed that GPR would probably only be able to locate near-surface voids and not voids that surrounded the pipe buried at a depth of 18 meters. This proved to be partially correct because GPR was only able to reach a depth of approximately six meters before the signal attenuated. It did not detect any near-surface voids. In order to detect voids, there must be a difference in the dielectric constants between the material surrounding a void and the material filling a void. In this case, either the near-surface voids did not exist, the material that filled these voids and the material that surrounded these voids had similar dielectric constants, or the voids were beyond the resolution of the antennas. The resistivity results also could not locate the buried pipe at a depth of 18 meters. Both the Wenner-Schlumberger and the Dipole-Dipole arrays were centered on the pipe and should have been able to reach a depth of 18 meters. Although the pipe was not detected, the results were somewhat useful because a near-surface area with low resistivity values was observed. Unfortunately, this area of low resistivity did not correlate well with the area of roadway subsidence. To obtain the maximum depth penetration and a higher resolution, a pair of additional arrays should have been designed using all 48 nodes. These arrays should have set the electrode spacing at two-and-a-half meters and at five meters. The combination of these additional arrays would have increased the near-surface resolution as well as the depth penetration of the profiles. With these additional arrays, the buried pipe and any near-surface voids might have been detected.

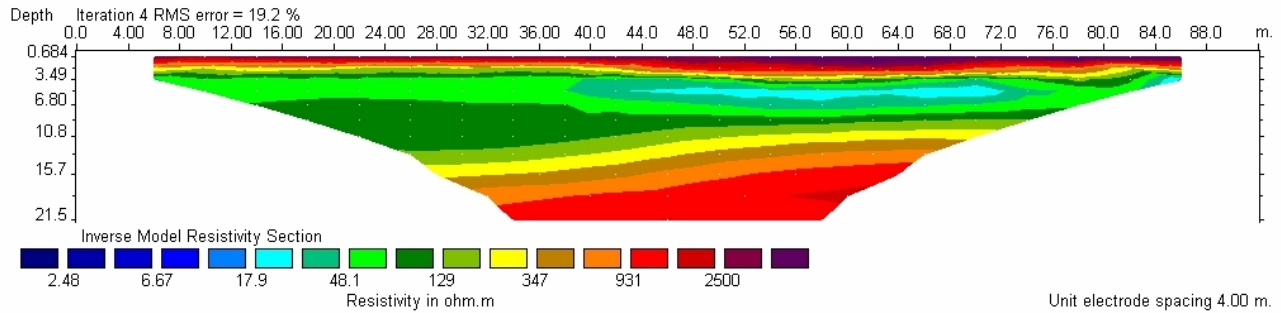
Figure 14: Dipole-Dipole array looking for 1.5-meter metal pipe at a depth of 18 meters.

Figure 14 is a resistivity profile that was collected on the southbound shoulder of the roadway adjacent to where the failed surface is located. Twenty-four electrodes were placed at four-meter spacing and a Dipole-Dipole array was set up. The metal pipe buried at 18 meters was not encountered even though the array was designed to reach a depth of 21.5 meters. However, an area with low resistivity values (less than 20 ohm-meters) possibly composed of loose silty fine material (i.e. area of concern in Figure 12) was located and could be a contributing factor to failure of the roadway.

A second resistivity profile was collected in the same location using a Wenner-Schlumberger array with the same number of electrodes and spacing as the previous array. The results from this array were similar to that of the first, and neither the buried pipe nor any other voids were observed in the resistivity profile. As a result of the geophysical investigation, the project was designed to include a large open cut in the pavement for the placement of new material.

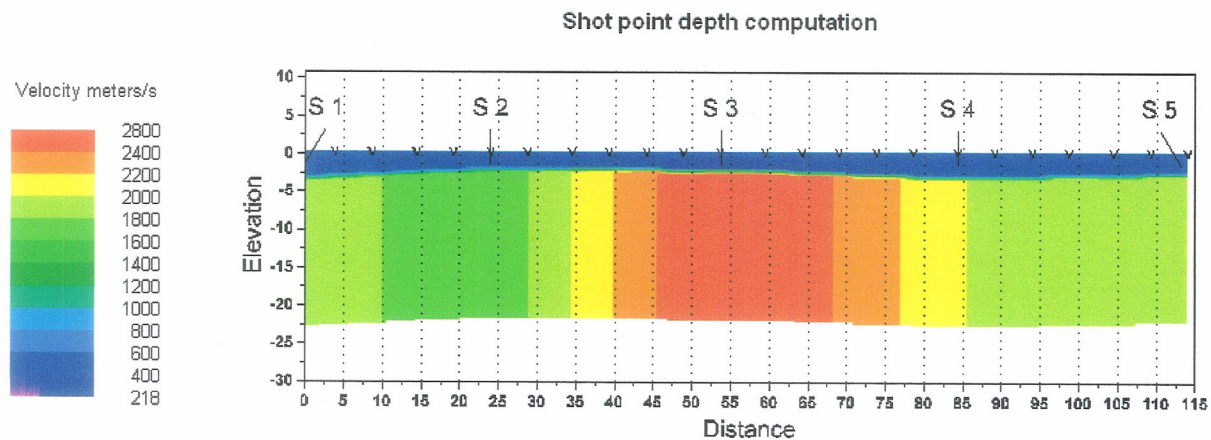
Figure 15: Typical seismic refraction profile along southern side of roadway

Seismic refraction was conducted along the southern side of N.H. Route 25 covering 460 meters of roadway. Figure 15 is a typical seismic profile for the project area. 24 geophones were placed at five-meter spacing intervals and five shots at locations S1 through S5 were fired. The shallow bedrock displayed in the profile agreed well with the test borings and test pits that were conducted along this side of the roadway.

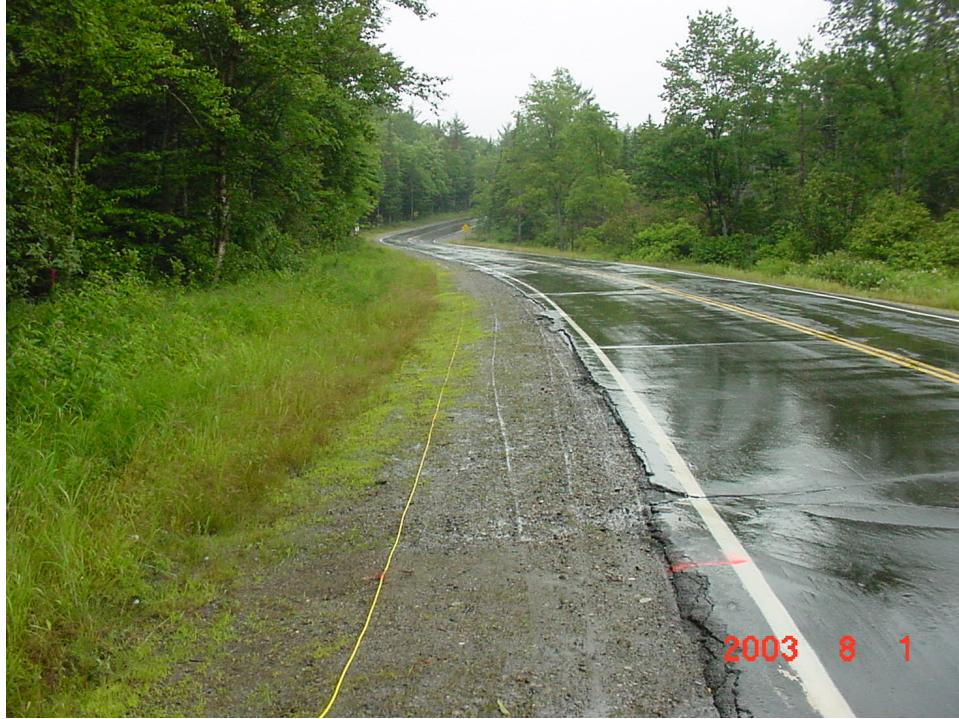
Figure 16: Resistivity line set up along the southern side of the roadway.

Resistivity profiles were collected along the southern side of the road for 470 meters (Figure 16) and along the northern side of the road for 23.5 meters. Figure 17 displays two resistivity profiles collected along the southern side of the road with five-meter electrode spacing. These profiles display soils with relatively low resistivity values over shallow bedrock with higher resistivity values. Figure 18 is similar to Figure 17 except that the bottom profile has an electrode spacing of one half meter. This profile is different from the others in that it displays data only to a depth of 1.2 meters but is at a much higher resolution.

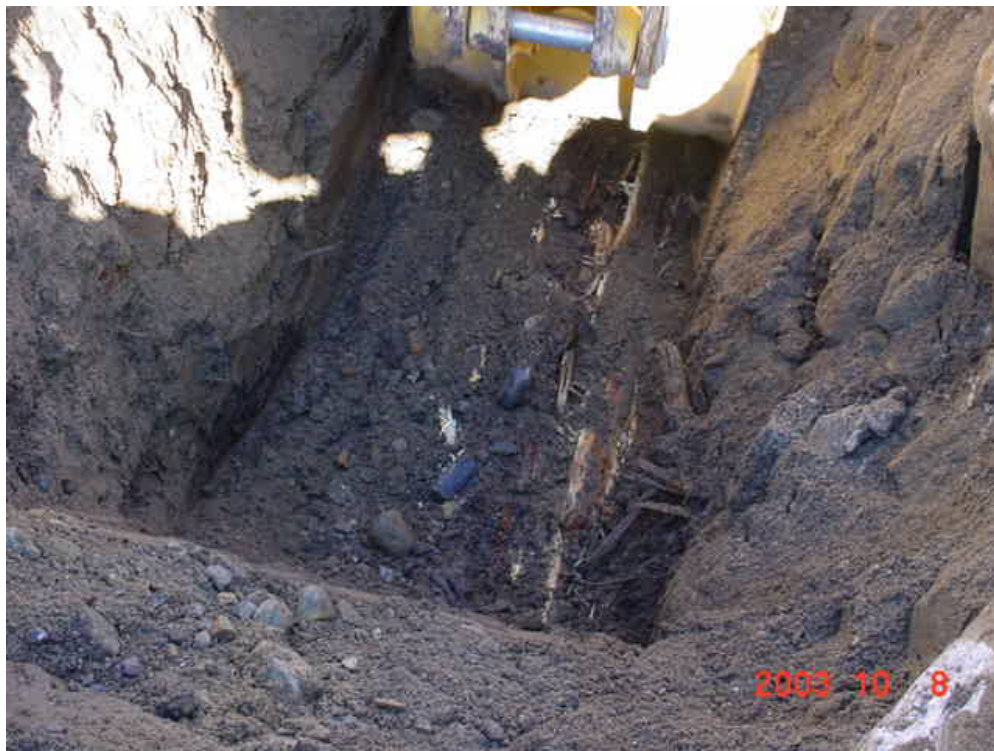
Figure 19: Test pit showing corduroy road.

Figure 19 is a shallow test pit that was dug to a depth of two meters along the northern section of the roadway where resistivity imaging and GPR were conducted. The test pit helped to ground truth these profiles and confirmed the presence of the corduroy road. The logs that compose the corduroy road were smaller in diameter than expected and are placed parallel to the roadway alignment instead of perpendicular. In addition, small branches were found along with the logs.

The geophysical investigation in Warren easily detected the soft soils, shallow bedrock, and water table, but it is questionable whether it detected the corduroy road. The logs used to construct the road had a relatively small diameter and were placed parallel with the roadway as observed in some of the 1.5 to 2 meter deep test pits (Figure 19). The direction of the geophysical investigation was parallel with the roadway which made it difficult for the ground penetrating radar unit to obtain cross-sectional reflections of the small logs buried to a depth of approximately 1.5 meters. The GPR profiles collected using the 500 MHz antenna (Figure 20) display some shallow reflections that could be from the logs, but it would be difficult to confirm the presence of the corduroy road solely based upon these GPR profiles. The resistivity profile collected along the northern side of the road with half-meter electrode spacing (Figure 18) clearly displays the water table beneath the roadway sands. This profile was taken very near the test pit displayed in Figure 19, but the buried logs cannot be detected within the water-saturated soils.

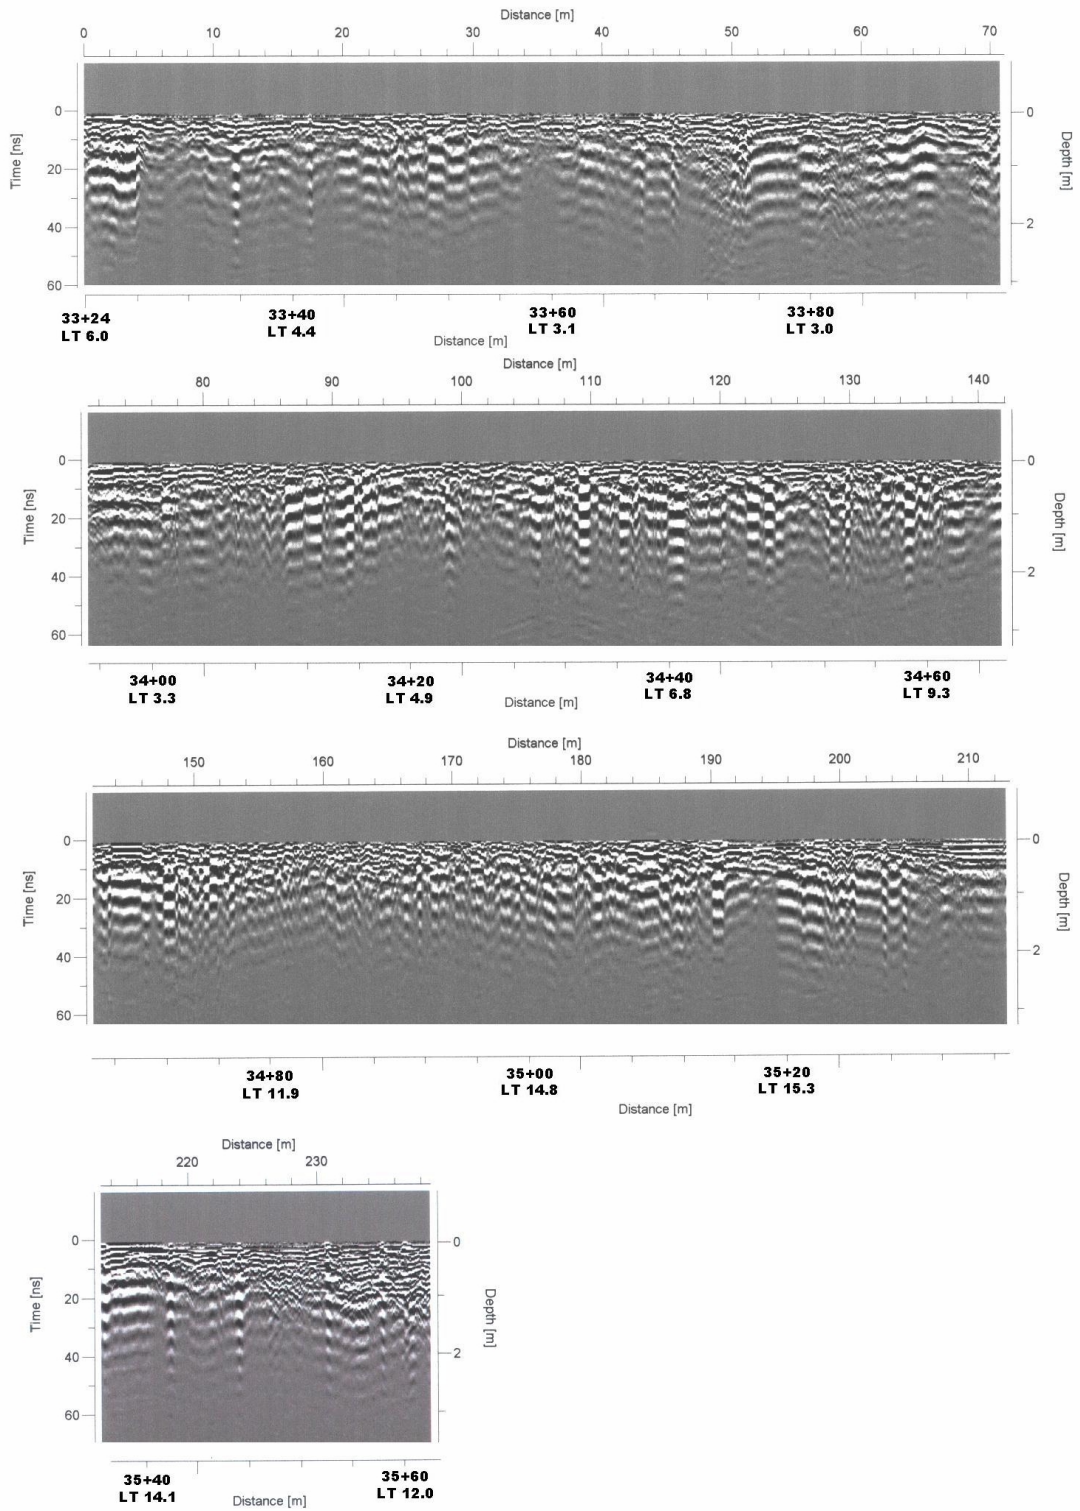
Figure 20: GPR profiles using 500 MHz antenna.

Ground penetrating radar (GPR) was conducted along the southern side of the road for 460 meters, along the northern side of the road for 250 meters, and over the central part of the road for 240 meters. A shielded 100 MHz antenna was used to collect the data for the southern and northern sides of the road, and a 500 MHz shielded antenna was used to collect the data from the central part of the road. Figure 20 displays GPR profiles taken along the section of roadway where the corduroy road was expected. These profiles were collected with the 500 MHz antenna with a depth penetration of approximately two meters.
