New Hampshire
DOT
Research

**Spring Thaw Predictor & Development of Real
Time Spring Load Restrictions**

Final Report

SP&R Research Project No. 14282K

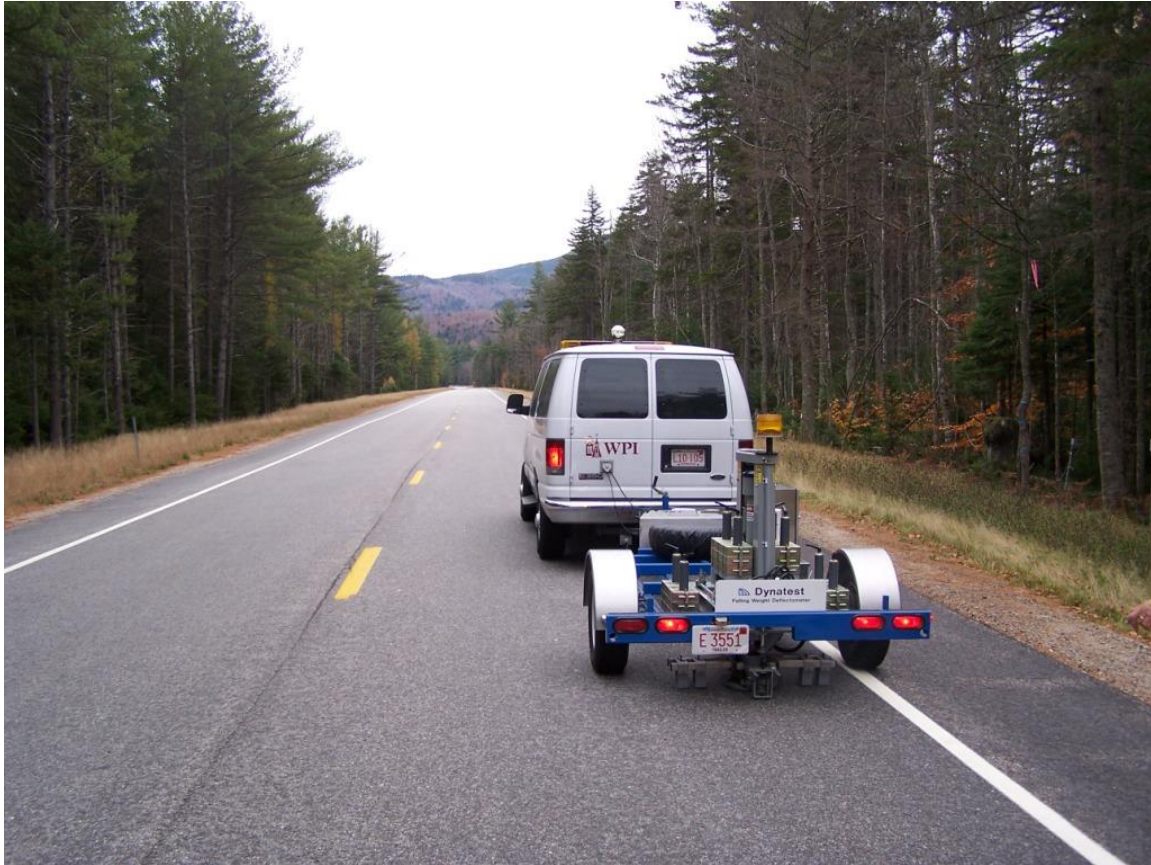
Kanc 3 is immediately to the east of Kanc 2 on NH 112. The site was reclaimed in 2005 with no stabilizer added. The reclaim was 8" deep and 3.5" of pavement was placed over

the reclaimed base. The material underneath the reclaimed base of both sections was characterized as sand with bedrock encountered at a depth of 11 feet.

Figure 2: Typical Kancamagus Highway Site (Kanc 2) looking east

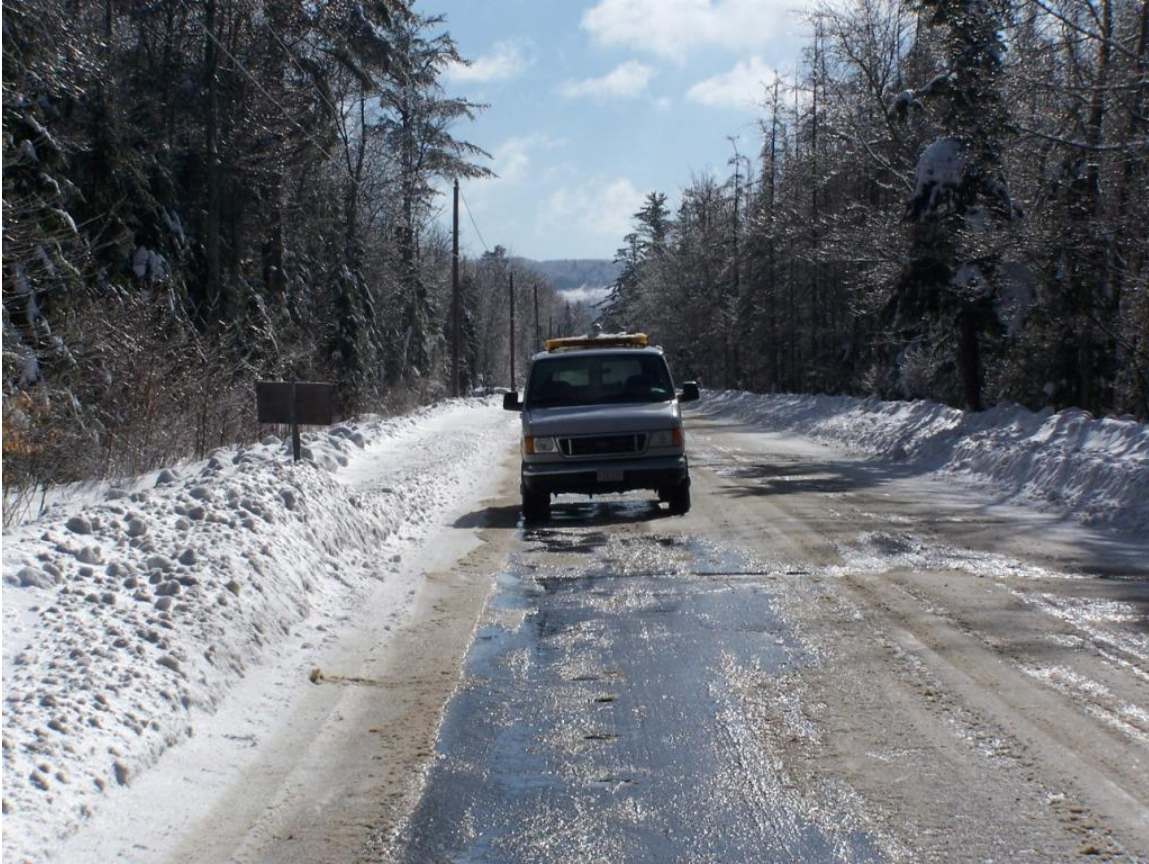
The Lake Tarleton (LT) site is located in Piermont on an eastbound section of NH 25C that runs through a boggy area and is heavily forested on both sides (Figure 3). The road is elevated above the surrounding area approximately 3 to 4 feet and has a gravel shoulder approximately 1 to 2 feet wide. The ditch line is 3 to 4 feet from the edge of the pavement. A cross pipe carrying a small stream runs under the eastern end of the site. The pavement is cracked and about 9 inches thick. Below the pavement is a 6-inch layer of sand, followed by a 3-inch layer of coal tar and then 1-foot layer of silt and some organics classified as fill. Below this is silt and fine sand with some wood fragments encountered in the wash water during instrumentation installation at a depth of 5 feet. Exploration was stopped at a depth of 11 feet.

Figure 3: Lake Tarleton Site (in front of van) looking east

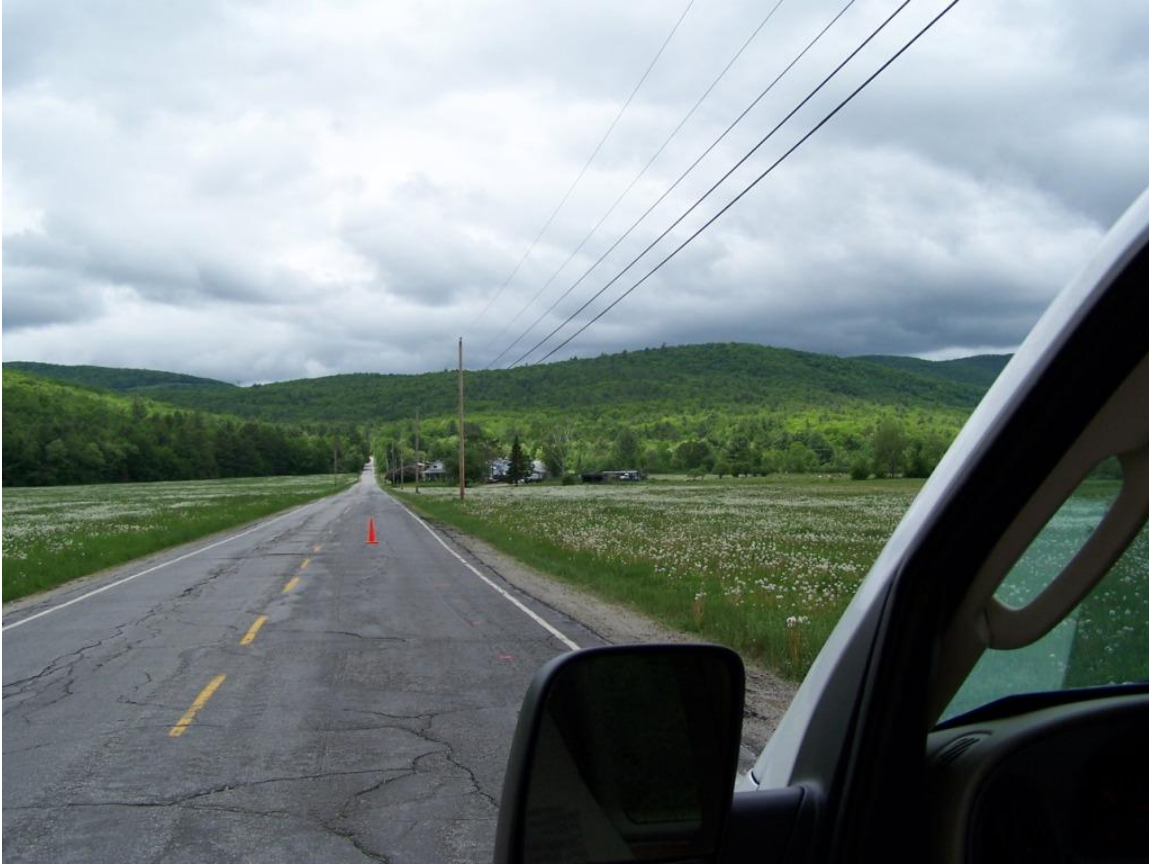
The Warren Flats (WF) site is located in Warren in the westbound lane of a section of NH 25C that runs through the middle of a field that gently slopes downwards from west to east (Figure 4). The road is level with and sometimes slightly below the field elevation, and the ditch line is immediately adjacent to the edge of the roadway. The roadway has a gravel shoulder approximately 1 to 2 feet wide. The field was actually a lakebed prior to a natural dam failure in the early 1800's. The pavement here is cracked and about 8 inches thick. The layer below the surface is characterized as coarse to fine sand to a depth of 2 feet. Below that there is loose silt, and fine sand characterized as glacial fluvial to the bottom of the exploration at a depth of 11 feet. This site has a highly variable water table (from 70 to 18 inches) and gets significant differential frost heaving.

Figure 4: Warren Flats site (between van and cone) looking west

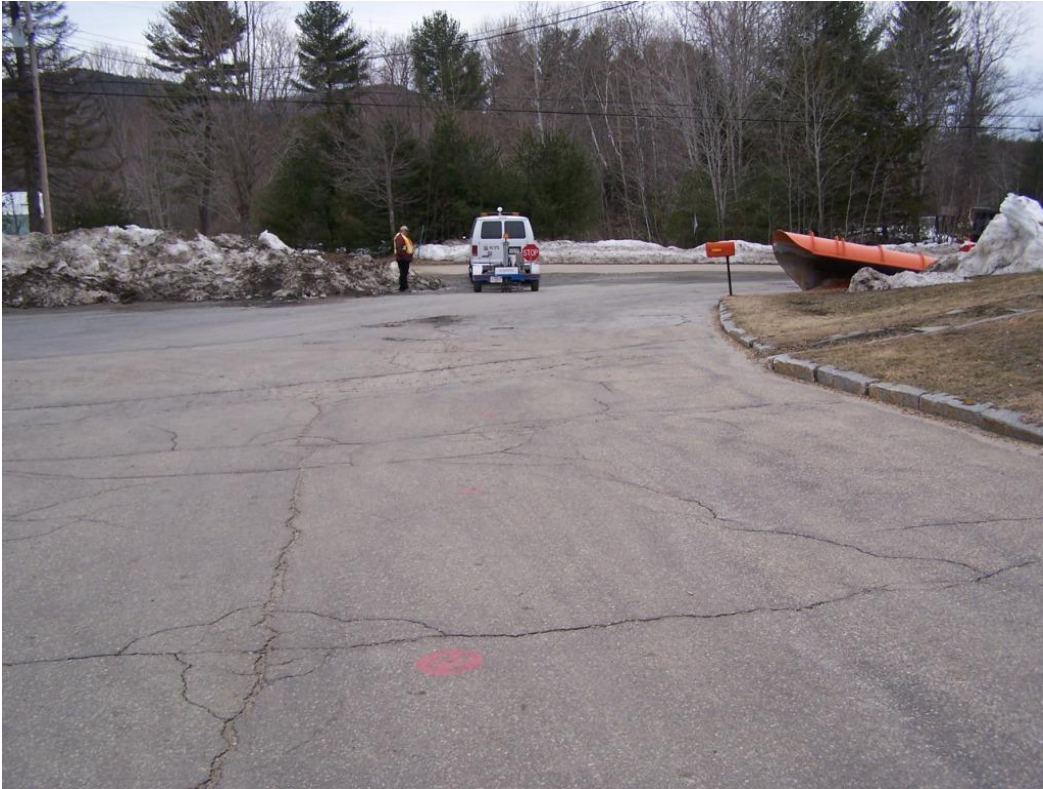
The Rumney Shed (RS) site has approximately 6 inches of pavement above fine sandy to gravelly fill with traces of silt and debris to a depth of 4.5 feet. Below this is glacial till. The pavement at the Rumney Shed is in poor condition with many cracks, but not as extensively cracked as the Wentworth Shed (Figure 5).

Figure 5: Rumney Shed looking towards the road from the parking lot

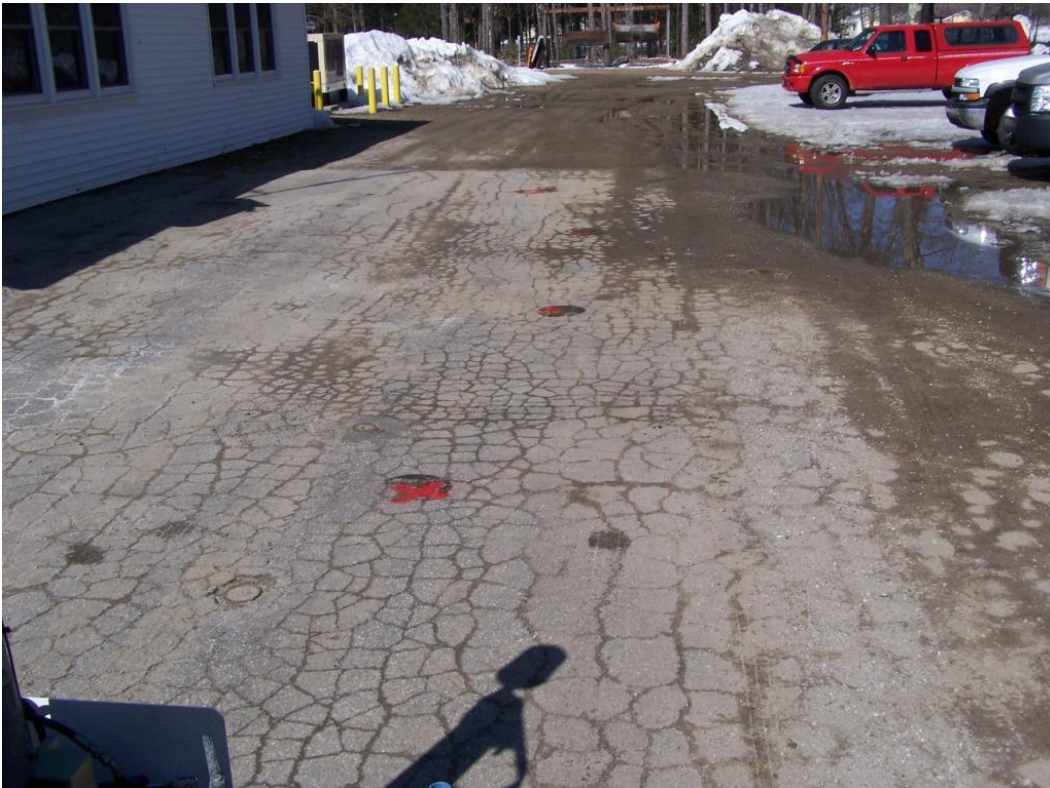
The Wentworth Shed (WS) site has approximately 6 inches of pavement and then coarse sandy fill with traces of silt to a depth of 2.5 feet. Below this is glacial till. The pavement at the Wentworth Shed site is extremely heavily cracked, and due to this fact, it was eventually abandoned because of the errors it caused with the FWD (Figure 6).

Figure 6: Wentworth Shed looking away from the gas pumps

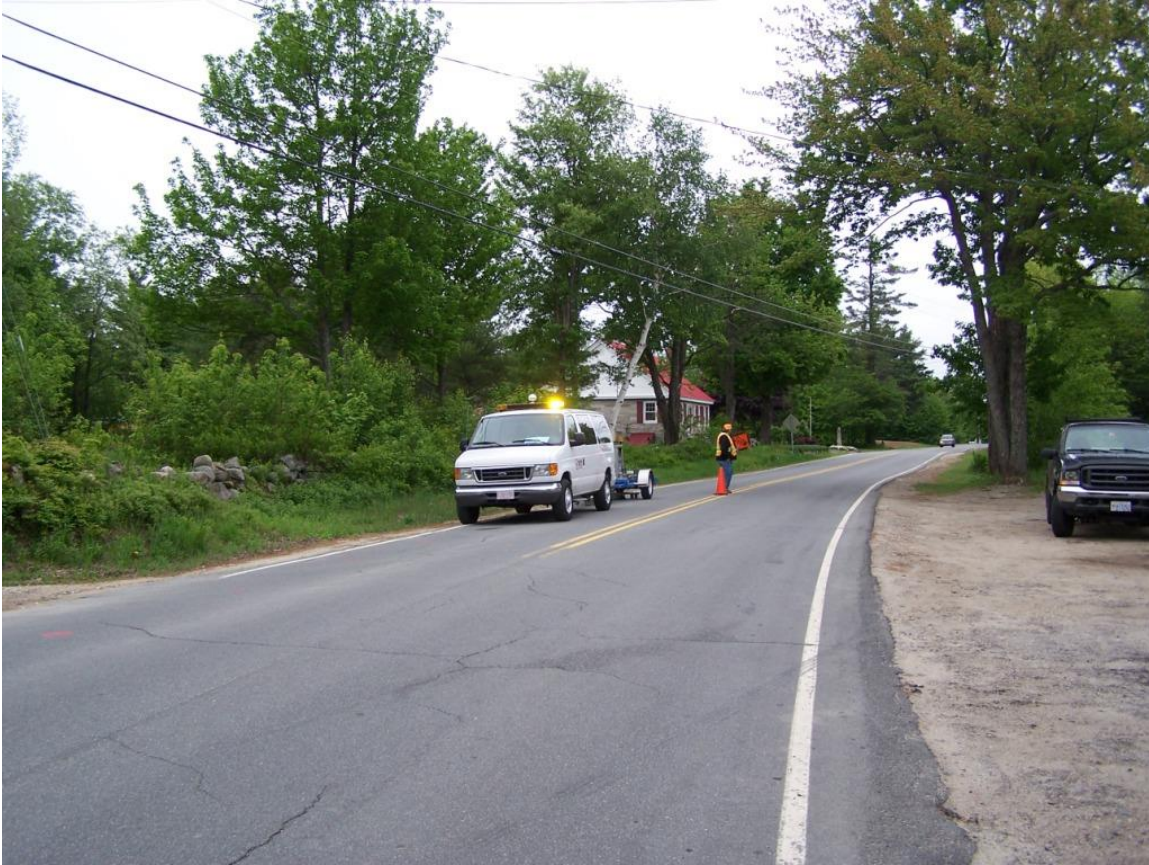
Figure 7: North Groton Road Site looking east

The North Groton Road (NGR) site is located in North Groton along a flat area at the top of a hill in the westbound lane (Figure 7). The roadway does not have a shoulder and there is a stone wall and a shallow ditch line one to three feet from the pavement edge. The roadway is a fairly recent four inch overlay on four inches of broken up pavement. The subsurface is noted as a two and one half foot layer of fill consisting of silt and fine sand over seven and one half feet of fine sand characterized as glacial till. Exploration was stopped at a depth of 11 feet.

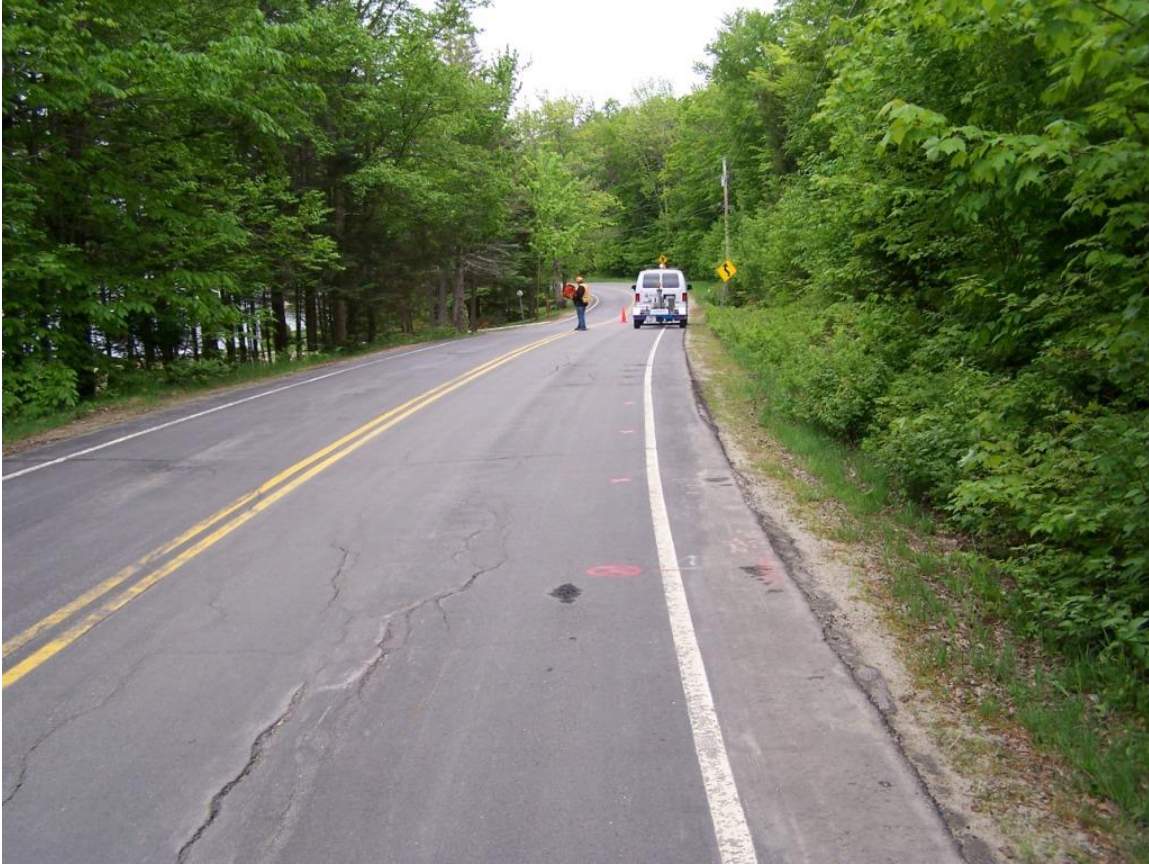
The Stinson Lake Road (SLR) site is located in Rumney and was chosen because of its shallow ledge. The site is in the southbound lane (Figure 8). Boring logs show that the pavement at the site is 10 inches thick and the subsurface is layers of medium dense sand characterized as fill, glacial outwash, boulders, and glacial till. Refusal was encountered at 9.9 feet. The site is located at the base of a hillside about 100 yards from the lake. It is level with deciduous forest on either side of the site. The ditch line is immediately adjacent to the edge of the roadway and the roadway lacks a paved shoulder.

Figure 8: Stinson Lake Road Site looking south

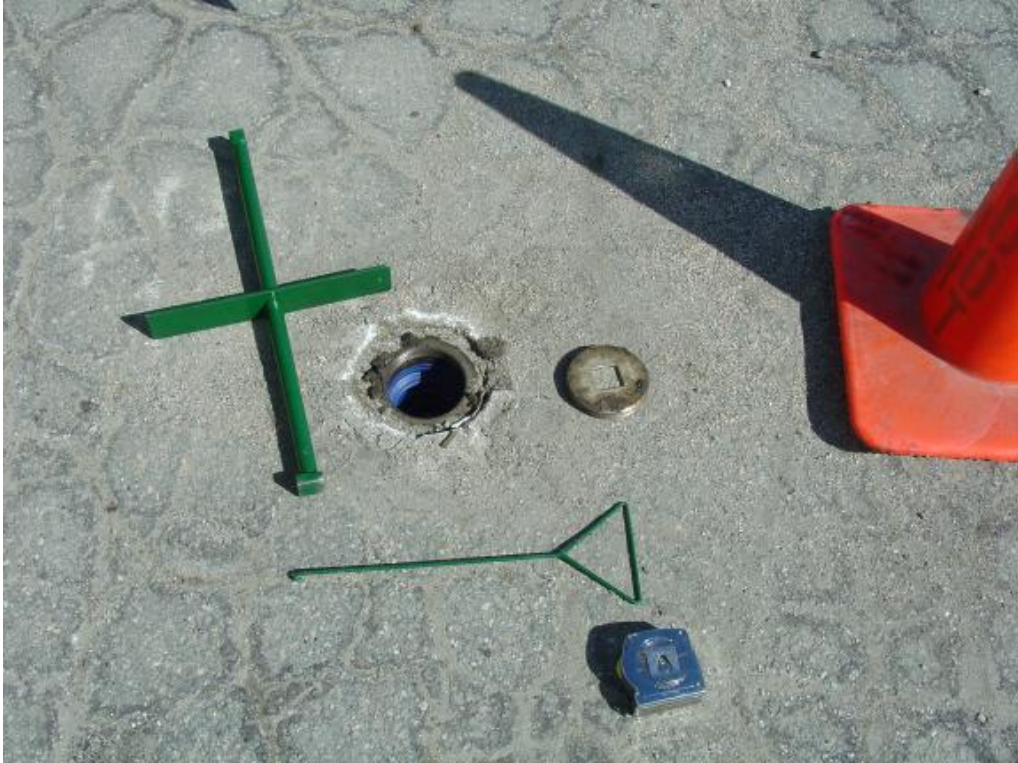
The frost tubes are tubes made out of clear plastic and filled with water and methyl blue dye. The frost location is determined visually by looking at color changes in the tube. As the water in the tube freezes the methyl blue turns clear, indicating frozen soil. As the ground thaws from the surface in the spring, the methyl blue turns blue again. The tubes are installed from the surface to a depth of 6 feet at all of the sites. The depths to the start and end of the frozen section of the frost tube are measured from the road surface and then recorded in a logbook. Figure 10 shows the typical access cap for a frost tube, and Figure 11 shows a partially frozen frost tube at the Wentworth Shed site.

Figure 10: Typical frost tube chamber at a site, the interior necks down to be just larger than the frost tube diameter to minimize the air space around the frost tube.

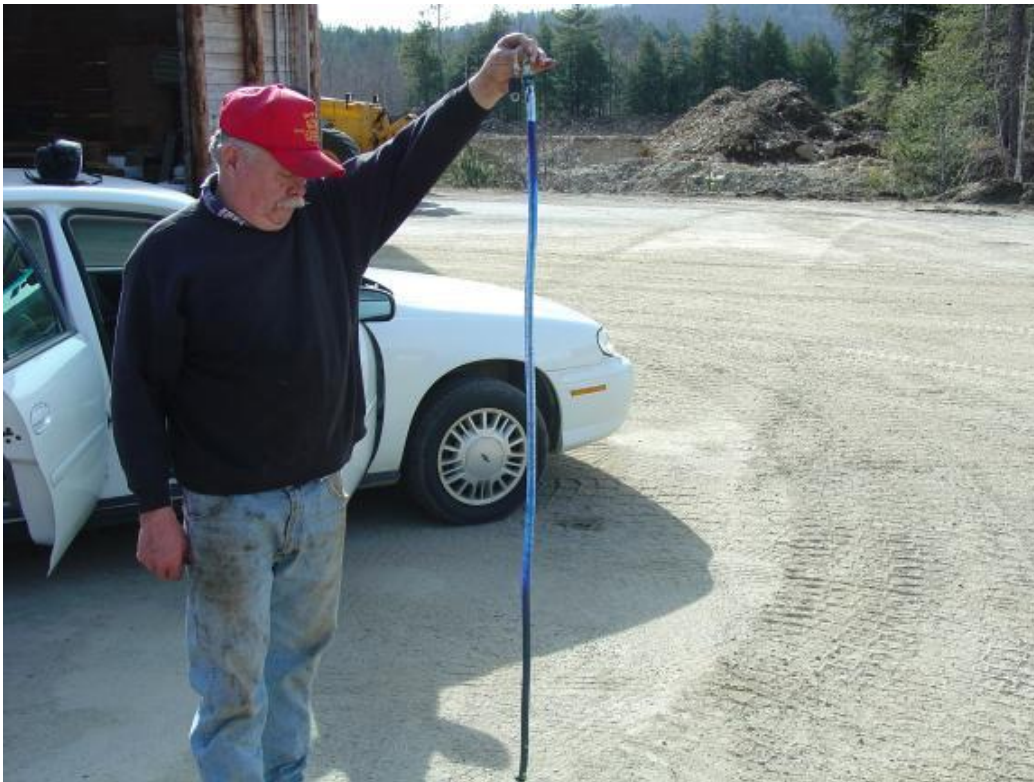
Figure 11: Frost tube with clearer colored frozen liquid in the top two-thirds and darker colored thawed liquid in the lower third.

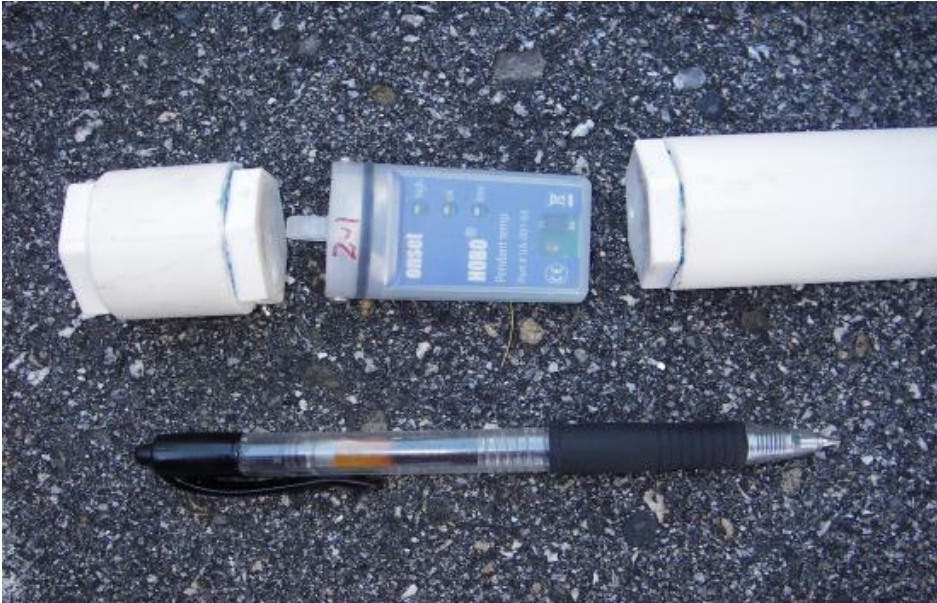
Figure 12: HOBO® data logger

Subsurface instrumentation consists of temperature sensors and moisture sensors. Figure 12 shows the typical temperature sensor. These are HOBO® data loggers manufactured by Onset. At each site, six of these loggers were placed in a sealed tube spaced out at depths of 6, 12, 18, 30, 54, and 78 inches as measured from the surface and illustrated in Figure 13. This was done in March of 2007. In December of 2008, three sensors were added to each site and the depths were changed to 6, 12, 18, 24, 36, 42, 54, and 78 inches. Temperatures were recorded once per hour and the data is downloaded about every six months.

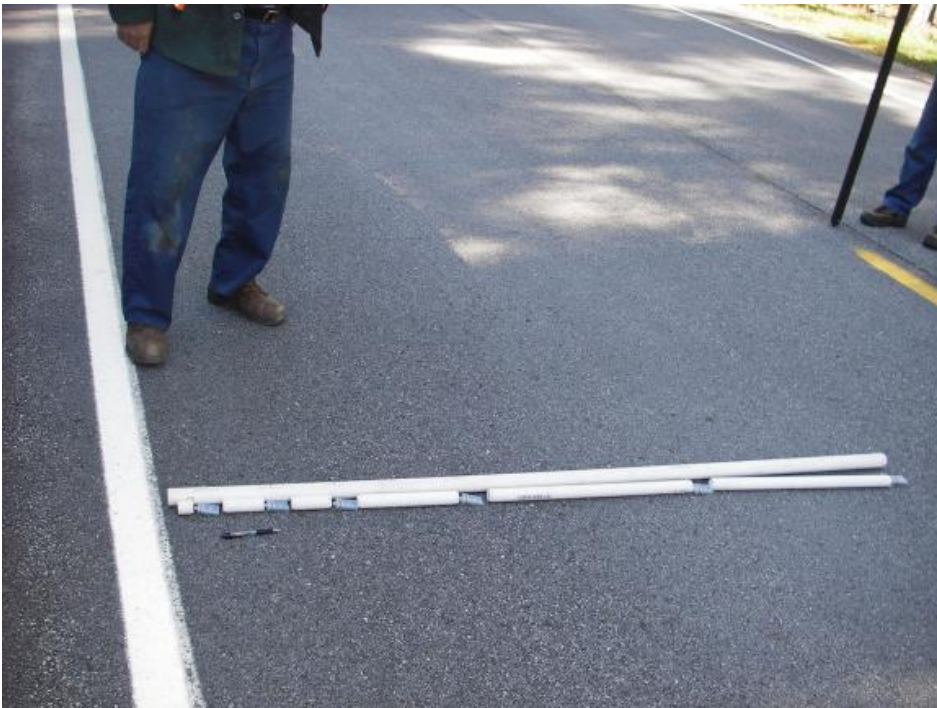
Figure 13: HOBO® setup (HOBO® and spacers in the foreground and the tube that holds the setup is in the background)

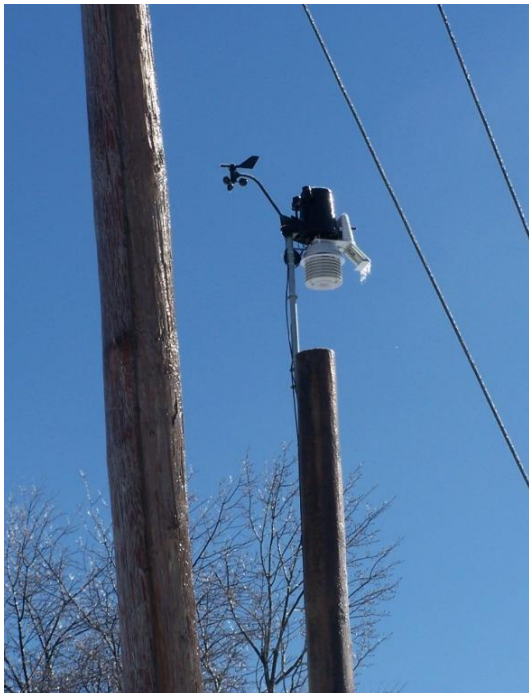
Surface instrumentation consists of a pavement surface temperature sensor, a temperature sensor at 18" below the surface, and a Davis® Weather Station. The pavement surface temperature sensors take the roadway surface temperature and the 18" subsurface temperature. The Davis® Weather Station and logging device records the wind speed, wind direction, air temperature, incoming solar radiation, humidity, and amount of precipitation at a set interval. The data from each weather station is downloaded periodically simultaneously with the data from the HOBO® sensors. Figure 14 shows a typical weather station installation.

Figure 14 Davis® Weather Station at North Groton Road

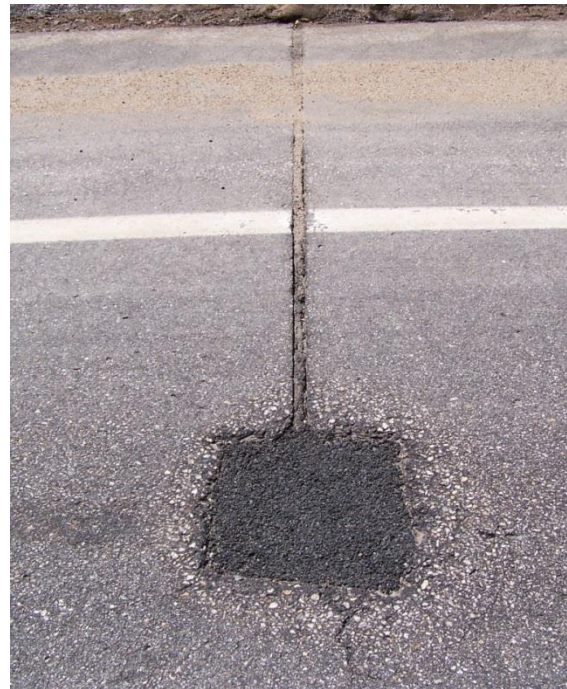
Figure 15 Pavement surface temperature sensor at North Groton Road

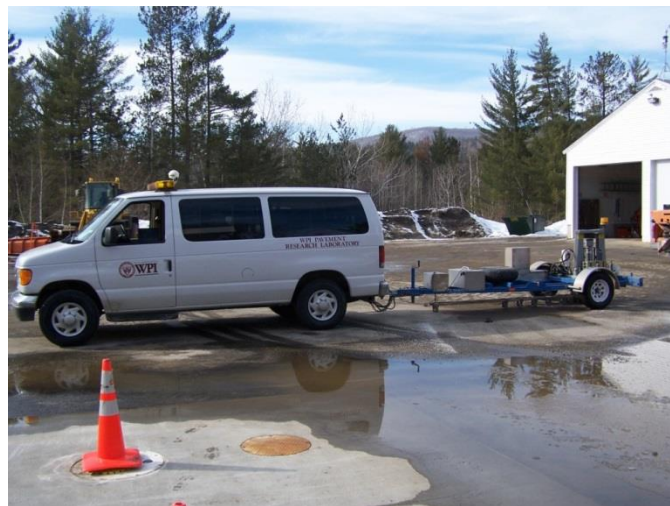
Pavement deflection data is important in the formation of correlations between roadway conditions and roadway strength. Prior to the start of the 2008 thawing season, the use of a Falling Weight Deflectometer (FWD) owned by Worcester Polytechnic Institute was obtained through a rental agreement. The FWD used was a Dynatest 8002 lightweight FWD. The FWD is trailer mounted and towed behind a van.

Figure 16 Worcester Polytechnic Institute's FWD

The FWD applies an impact force to the roadway and then measures maximum deflections at various points resulting from the impact. A weight is allowed to fall onto a load plate that rests on the pavement. The distance the weight is allowed to fall, and the magnitude of the weight allows the operator to vary the impact to whatever force is desired. The deflections are measured by sensors that are in contact with the pavement at set distances from the load plate. The number of sensors and the distance from each sensor to the load plate are variable. The vertical deflections are measured in mils (1 mil

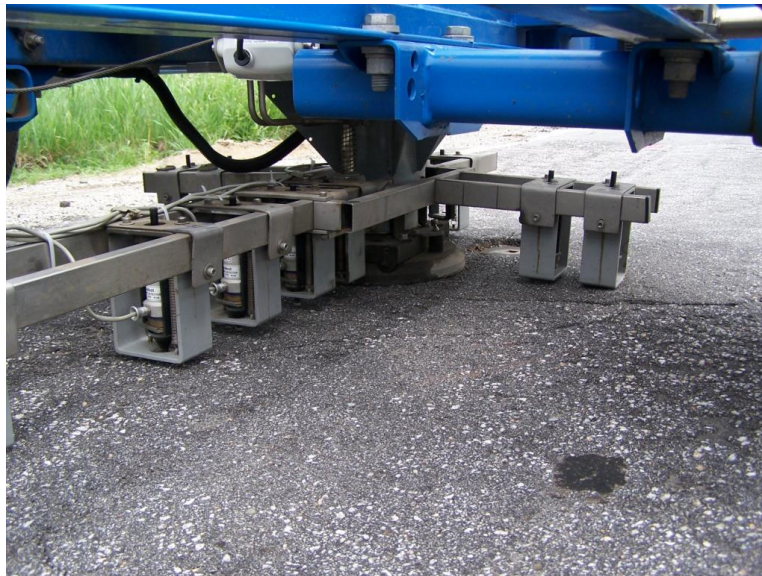
The particular setup used for the testing on this project was four load levels and an arrangement of nine sensors. The four load levels were 6 kips, 9 kips, 12 kips, and 16 kips. Three drops were made at each load level at each of the stations at each site. The deflections for the three drops at each load level were averaged to get an average deflection for each load level. The 9 kip load level simulates the loading from the dual wheels on one side of the American Association of State Highway and Transportation Officials [AASHTO] Equivalent Single Axle Load (ESAL) of 18 kips. The area of the load plate is equivalent to the contact area of the dual wheels. The nine sensors were in a fixed arrangement that was used for every test site. The spacing from the center of the load plate is provided in Table 4.

Figure 17 Sensors and the load plate of the FWD

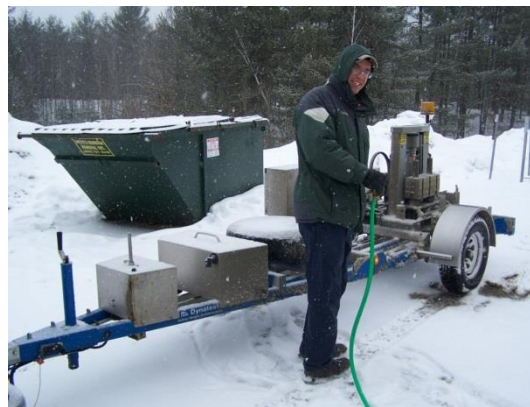
Each day, before the start of testing, at least one buffer warm-up sequence was performed. This is a series of two drops each at load levels of approximately 6 kips, 10 kips, 14 kips, and 19 kips. On colder days when temps were below 30° F, the buffer warm-ups were often performed at each site and multiple times at the first site of the day. This was done to warm up the rubber buffers and the hydraulic system that operates the FWD. Additionally, the sensor holders were lubricated with a silicone spray and the lubrication of the moving parts and cables on the FWD was checked. The FWD was rinsed as needed when coated with slush.

Figure 18 Rinsing slush off of the FWD

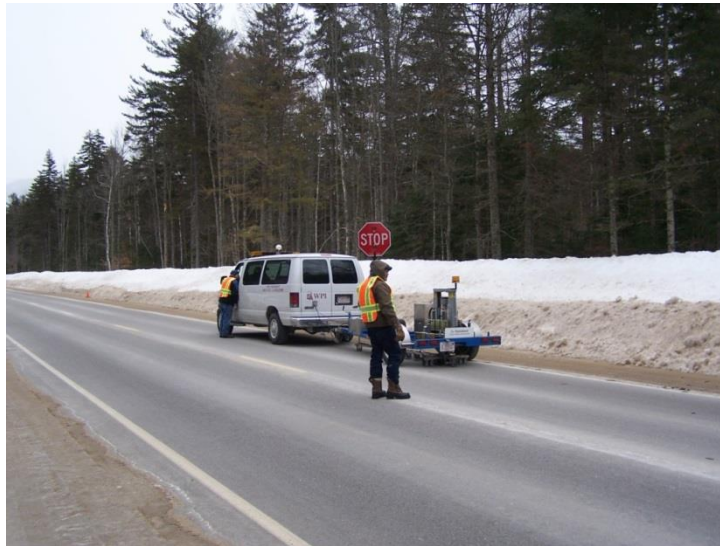
The Kanc sites were much stronger roadways than those in District 2. This was expected because of reconstruction and reclamation work in 2005. There were not any pavement cracks at the three sites and the FWD readings could be taken without incident. All exhibited the same behavior of losing stiffness to a certain point as they thawed, and then rebounding a minimal amount and leveling out. The reconstructed section at Kanc 1 proved to be the stiffest by a marginal amount over the other two sites. Kanc 2, the reclaim with cement stabilization, was slightly stiffer than Kanc 3, the regular reclaim. Thawing at the Kanc sites lagged behind the District 2 sites by about a month due to the more severe winters at the Kanc. The temperatures were always lower than those in District 2, and the snowfall was much heavier. In 2008, the snowbanks at the Kanc sites were higher than the roof of the 1-ton van that was used to tow the FWD. Normal thawed condition readings were taken with the FWD in October.

Figure 20 FWD testing at Kanc 2 on February 2008

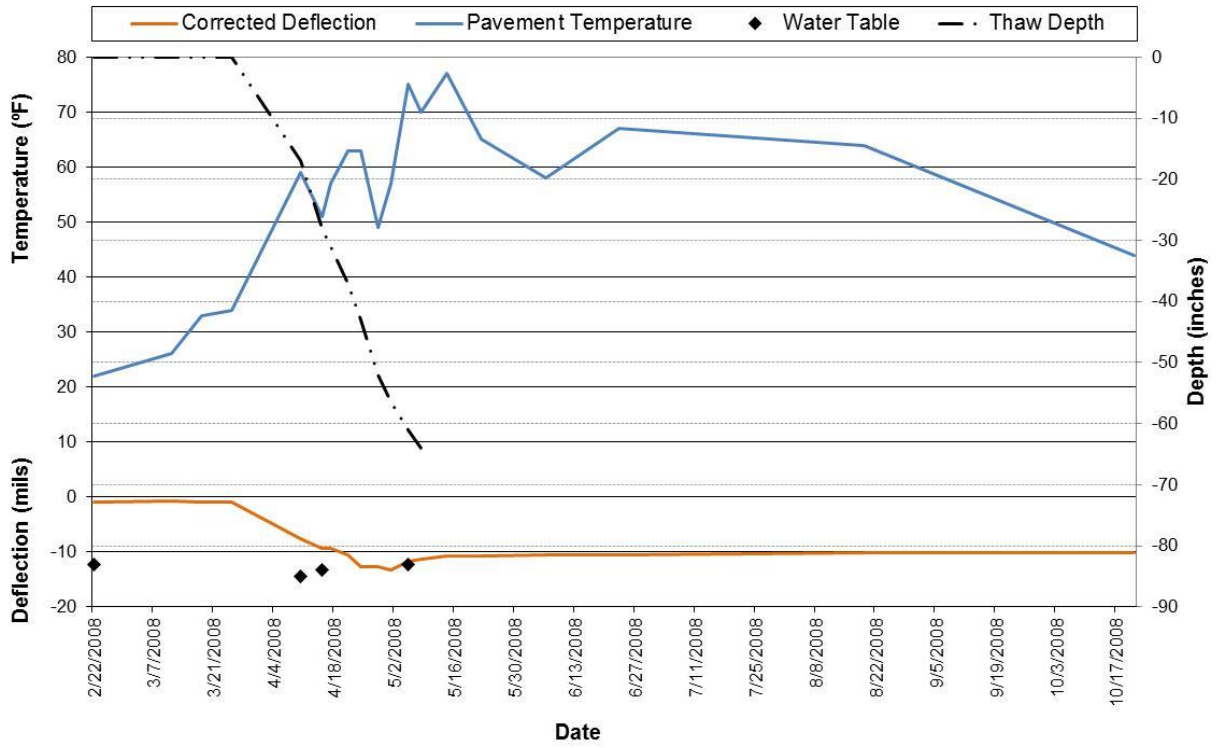
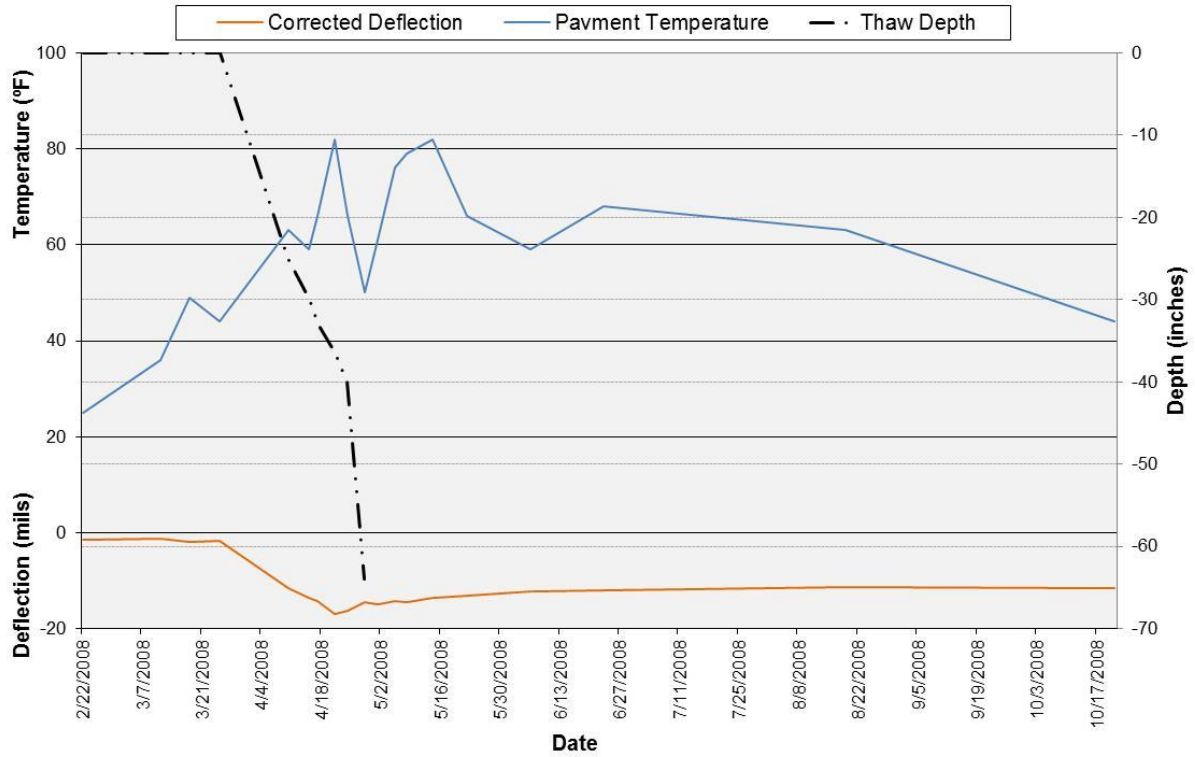
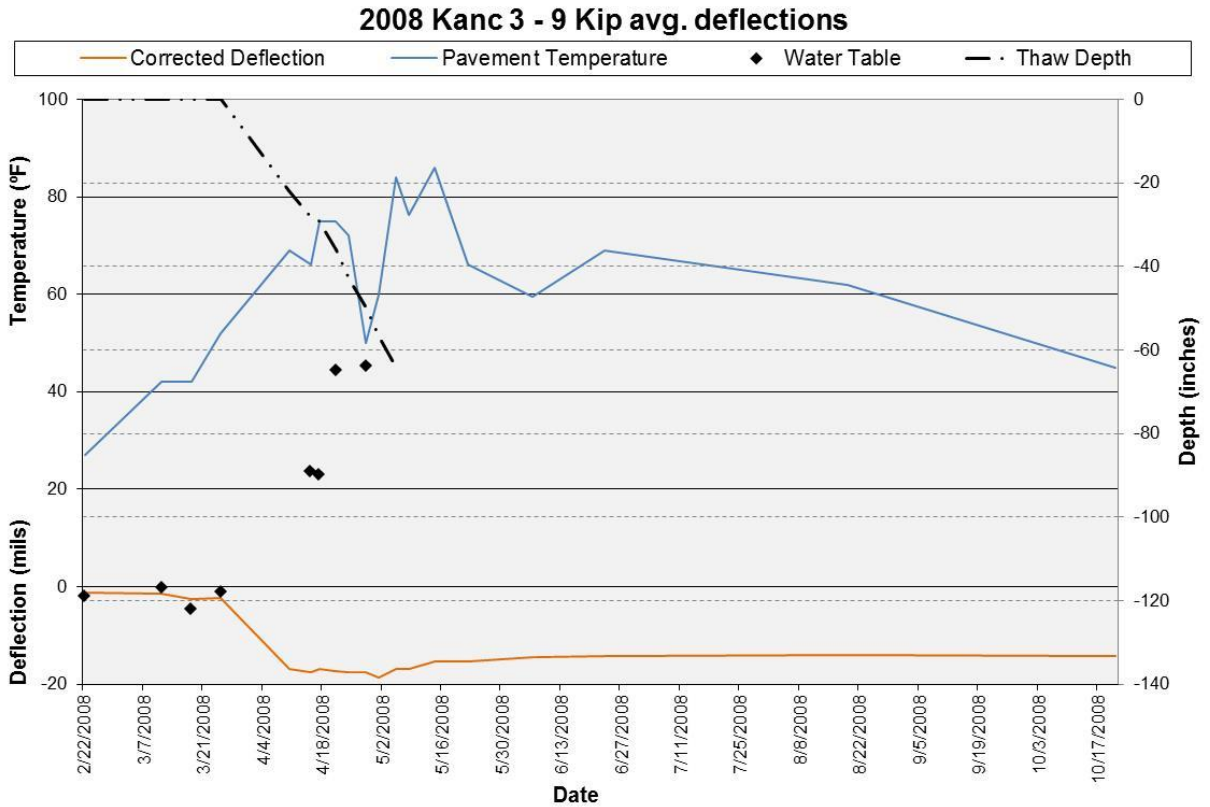
Chart 1: Kanc Sites 1, 2, and 3 in 2008

In 2009, Kanc 1 and Kanc 2 tested very similarly to 2008 testing. Kanc 3 sustained its maximum deflection on April 8 almost a full month earlier than in 2008. Its next maximum deflection was April 14th. Table 5 and Charts 1 and 2 provide the 2008 and 2009 deflection data for the Kanc sites.

2008 Kanc 1 - 9 Kip avg. deflections

2008 Kanc 2 - 9 Kip avg. deflections

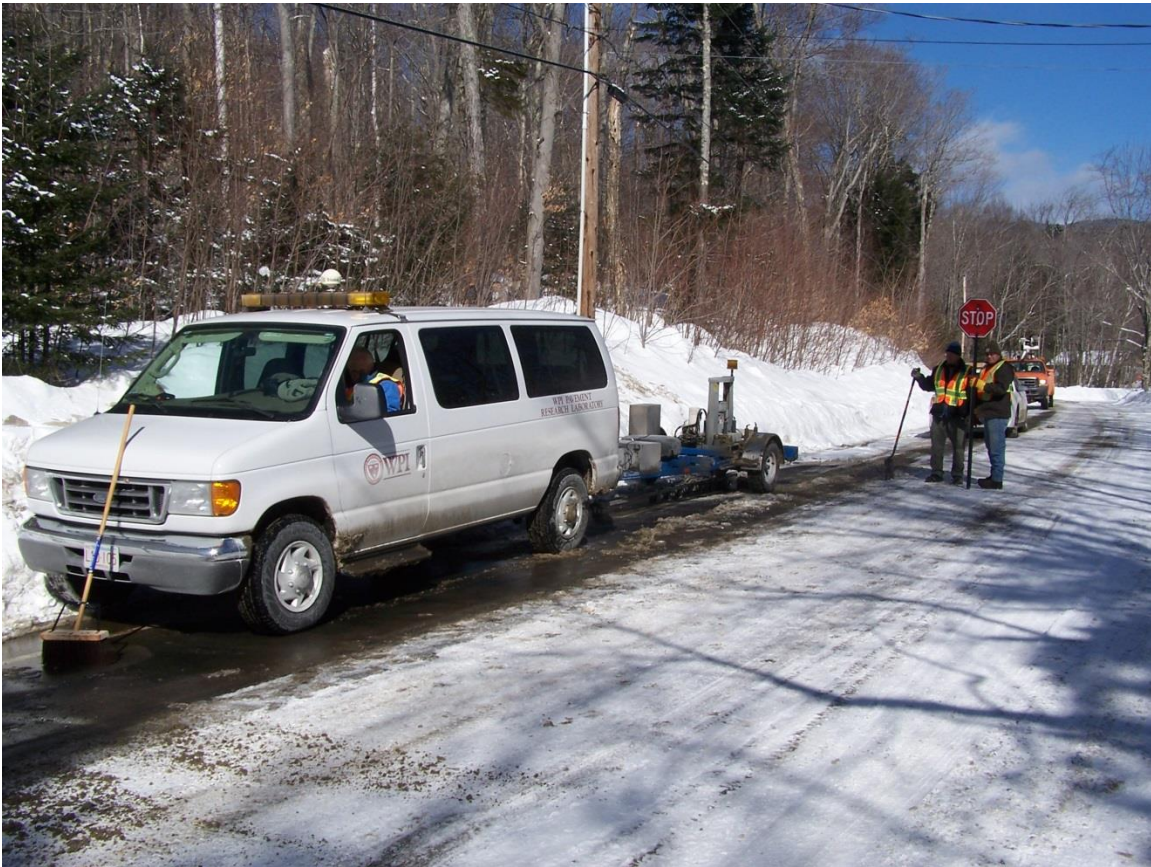
In 2009, the site tested similarly to 2008. It remained the stiffest site in District 2 and there was no differential heaving or increase in noticeable cracking. In 2009, the road was not posted. The weakest point may have been missed due to the FWD being down for repairs in mid-April. Table 6 and Charts 3 and 4 provide the data for the deflections at this site.

Figure 21 Late February 2008 at Stinson Lake Road

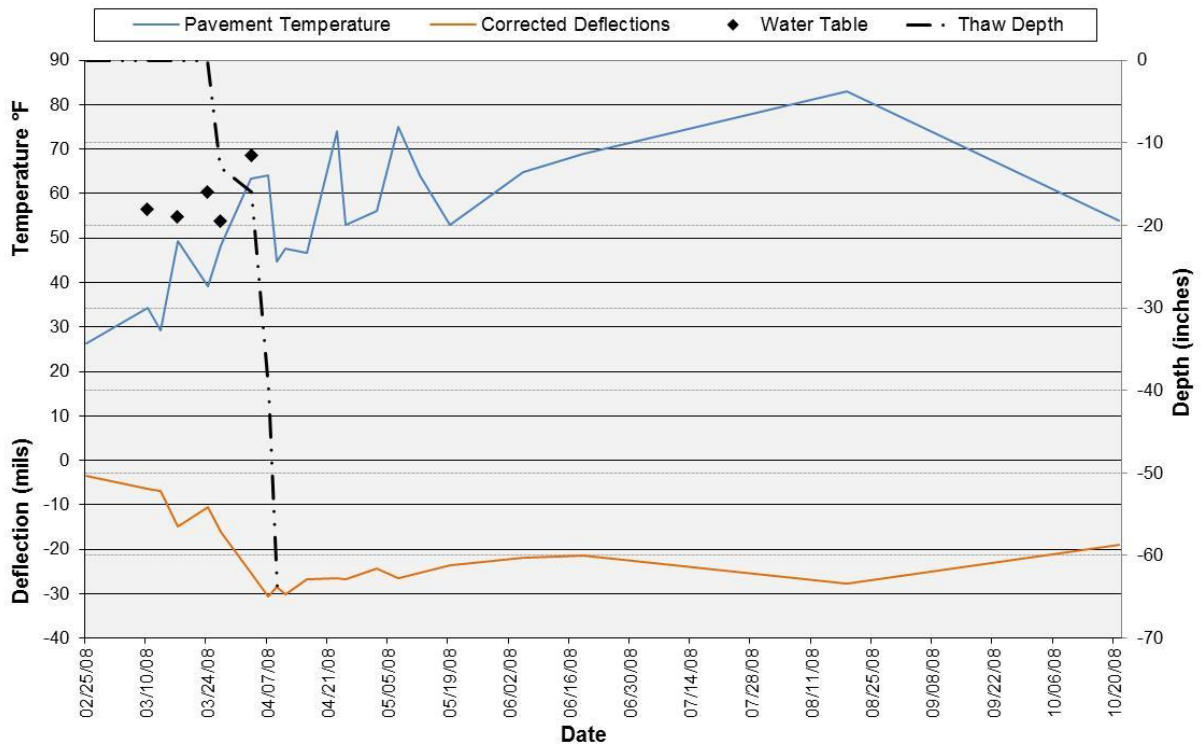
Chart 3 Stinson Lake Road in 2008

2008 Stinson Lake Road 9 Kip avg. deflections

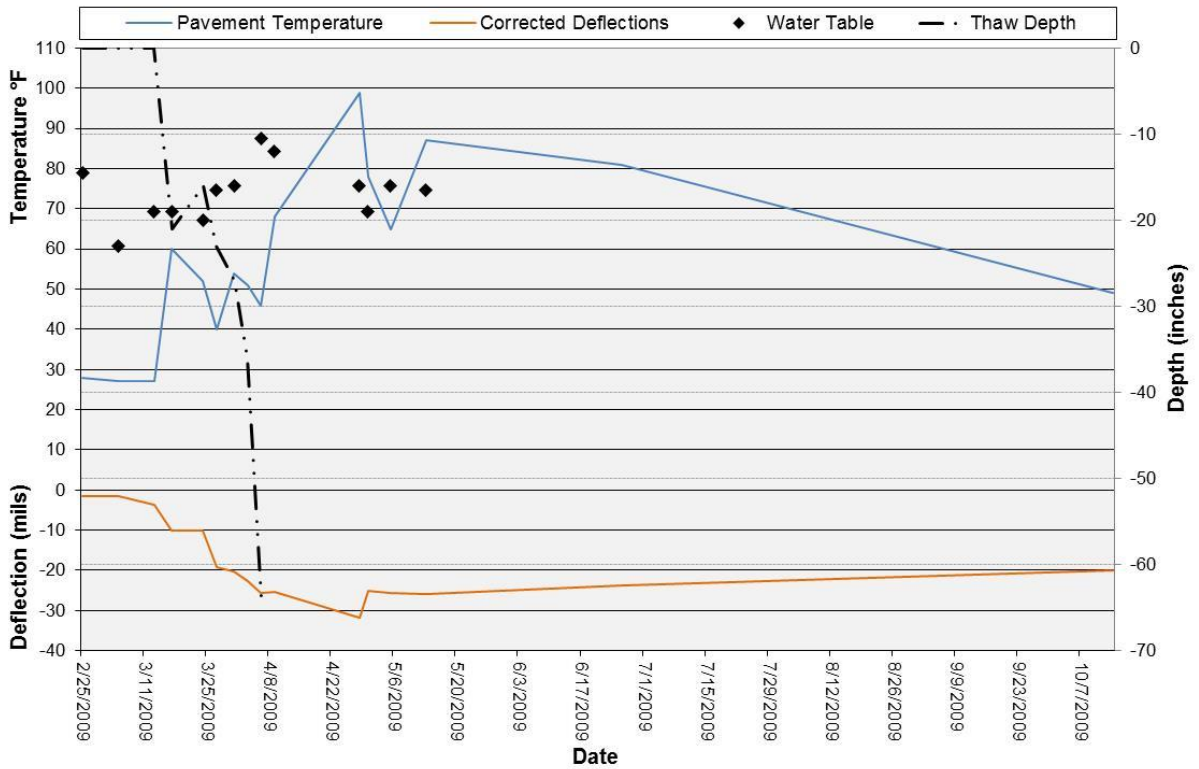
Chart 4 Stinson Lake Road in 2009

2009 Stinson Lake Road 9 avg. deflections

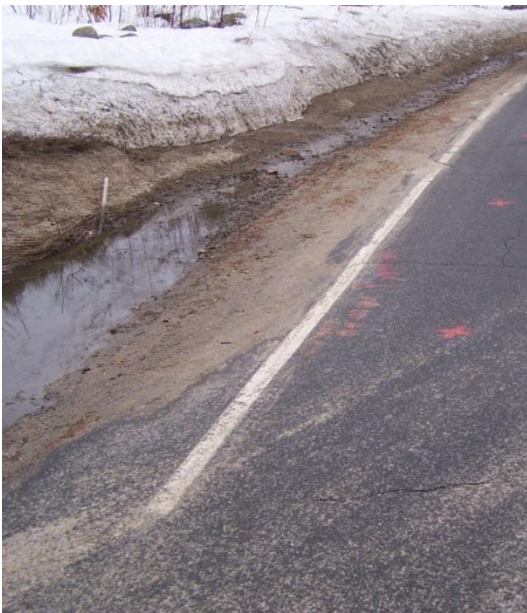
There was water in the ditchline at various times in 2009, but it did not stand there like it did in 2008. There were no out-of-range errors in 2009. The water table spiked here up to a depth of 20 inches during mid-April for no apparent reason. One possible explanation is that water somehow got trapped in the measuring hole. The road was not posted in 2009. Table 7 and Charts 5 and 6 provided the data for the deflections at this site.

Figure 22 Standing water in ditchline alongside of North Groton Road site in April 2008

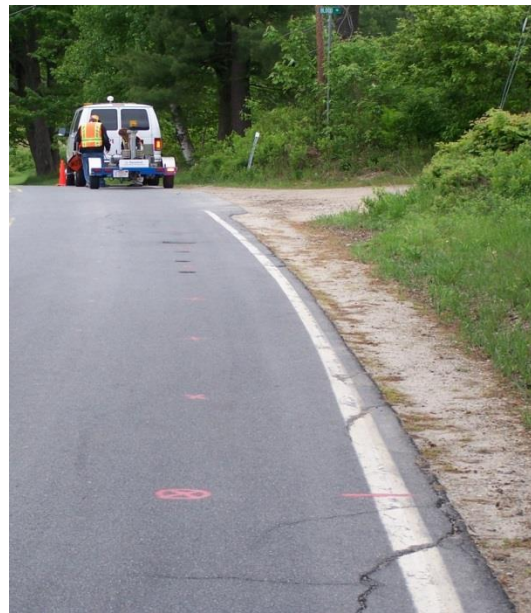
Figure 23 The FWD is over the last station at the North Groton Road site

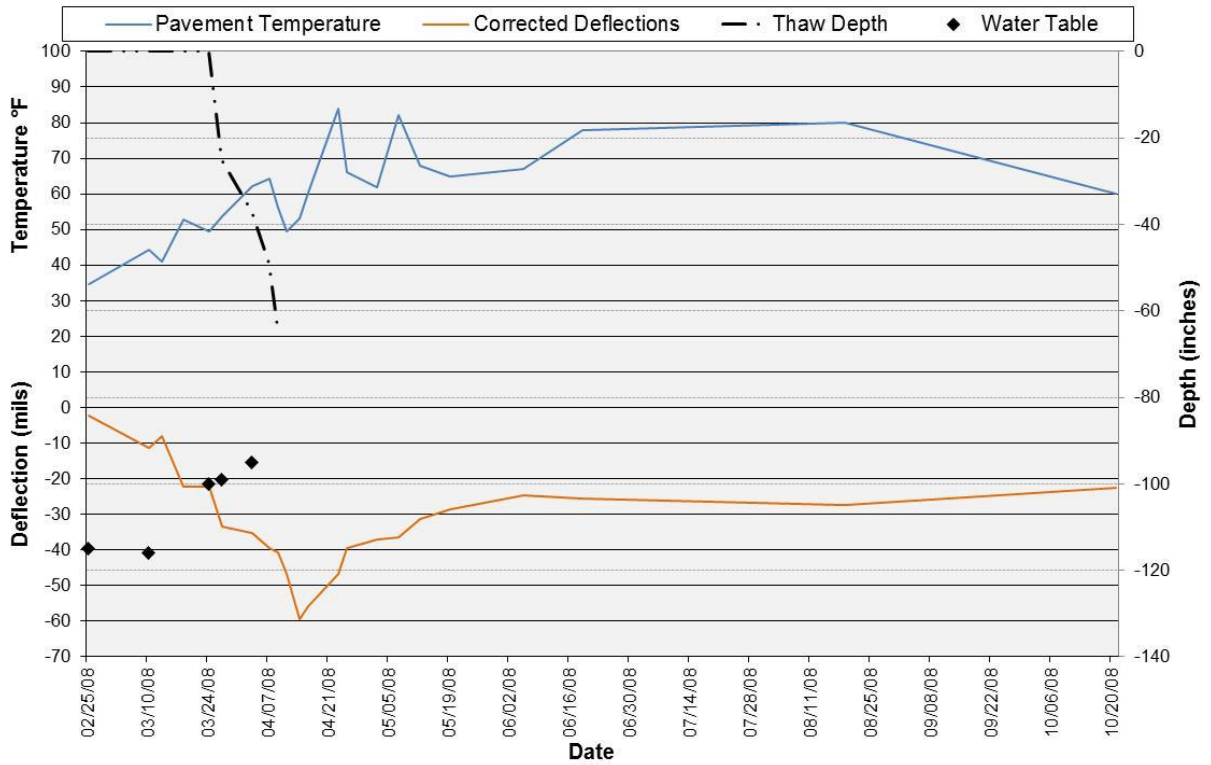
Chart 5 North Groton Road in 2008

2008 North Groton Road 9 Kip avg. deflections
