New Hampshire
DOT
Research

**Spring Thaw Predictor & Development of Real
Time Spring Load Restrictions**

Final Report

SP&R Research Project No. 14282K

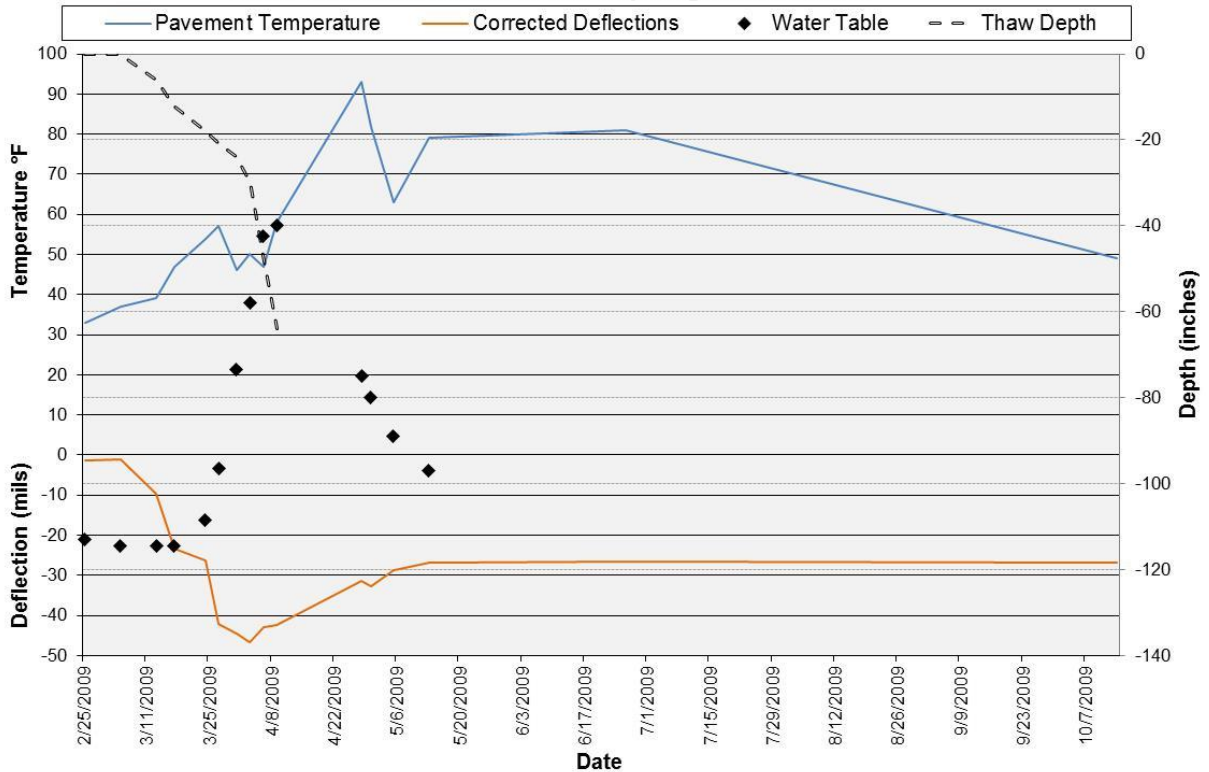
Chart 6 North Groton Road in 2009

There was water in the ditchline at various times in 2009, but it did not stand there like it did in 2008. There were no out-of-range errors in 2009. The water table spiked here up to a depth of 20 inches during mid-April for no apparent reason. One possible explanation is that water somehow got trapped in the measuring hole. The road was not posted in 2009. Table 7 and Charts 5 and 6 provided the data for the deflections at this site.

2009 North Groton Road 9 Kip avg. deflections

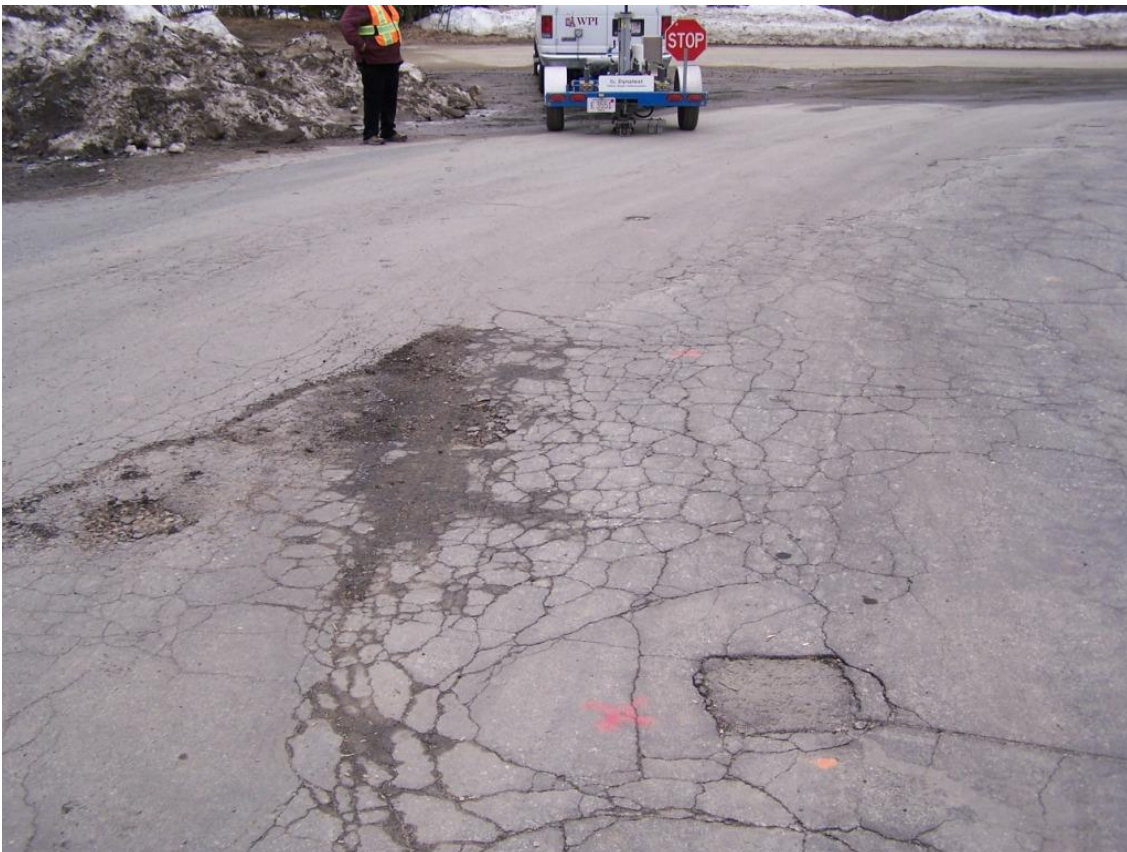
In 2009 the site behaved very similarly and as in 2008, only Stations 8-10 were used. The October test was conducted successfully in 2009. Since the site is in a shed driveway it was not posted in either year. Table 8 and Charts 7 and 8 provide the deflection data for this site.

Figure 24 Rumney Site showing the difference in pavement conditions between Stations 6 and 7 in the foreground and Stations 8-10 in the background. The FWD is on Station 10.

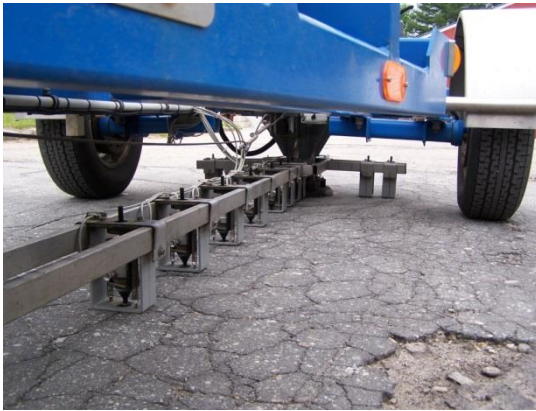
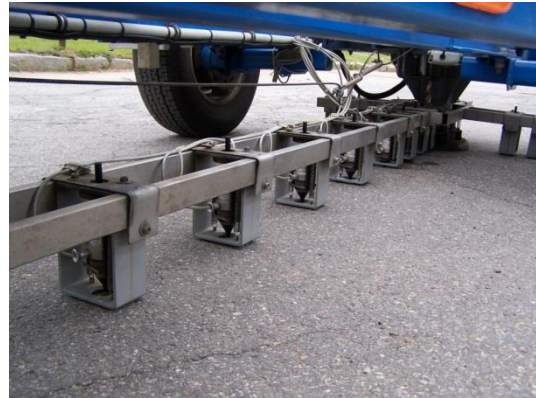
Figure 25 Showing the difference in pavement condition between Rumney 6 (left) and Rumney 8 (right)

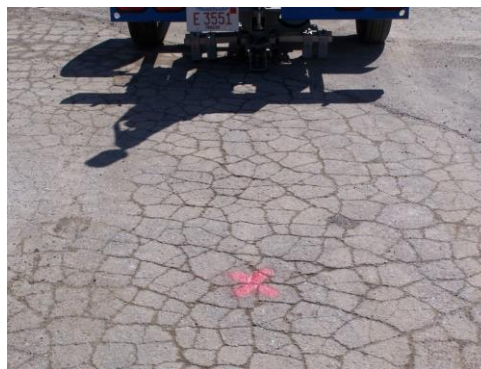
This site had the worst pavement of all of the District 2 sites. It was heavily cracked except for where trench work for the new gas pumps had resulted in repaving of a portion of the site. After a few attempts at testing during thawing conditions, the decision was made to abandon this site because the heavy cracking and puddled water were causing numerous time-consuming FWD errors and restarts. Relative movement between the independent chunks of pavement was actually visible during one attempt.

Figure 26 Heavy cracking typical at Wentworth shed site

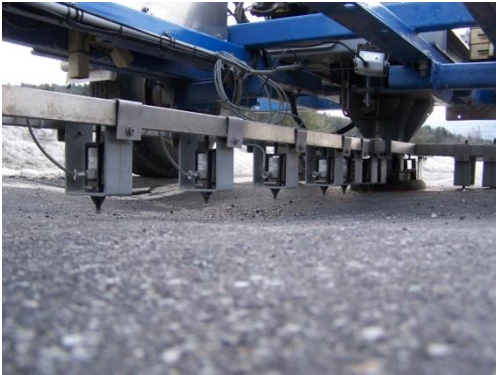
In 2008, this site exhibited such severe differential frost heaving that occasionally some of the stations were inaccessible to the FWD because not all of the sensors could touch the pavement when the array was lowered (Figure 27). From early to mid-March the frost heave action appeared to be at its worst. In early March, a vertical step of 3 inches formed at a crack in the left wheel path at about the midpoint of the site (Figure 28). This crack was shimmed with sand and the differential recessed as the season progressed. The postings at this site were posted on March 10 and lifted on April 16 about a week after the largest deflection even though the road was still in a weakened state.

Figure 27 Sensors not touching uneven pavement at Warren Flats

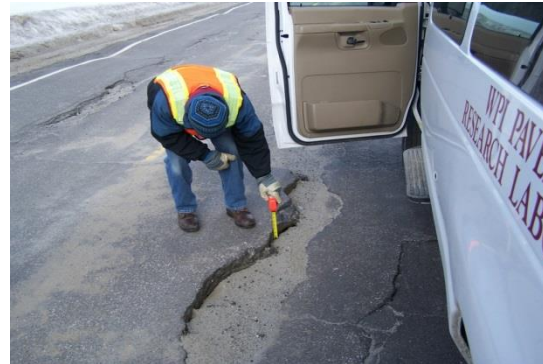
Figure 28 Three-inch differential heaving at Warren Flats

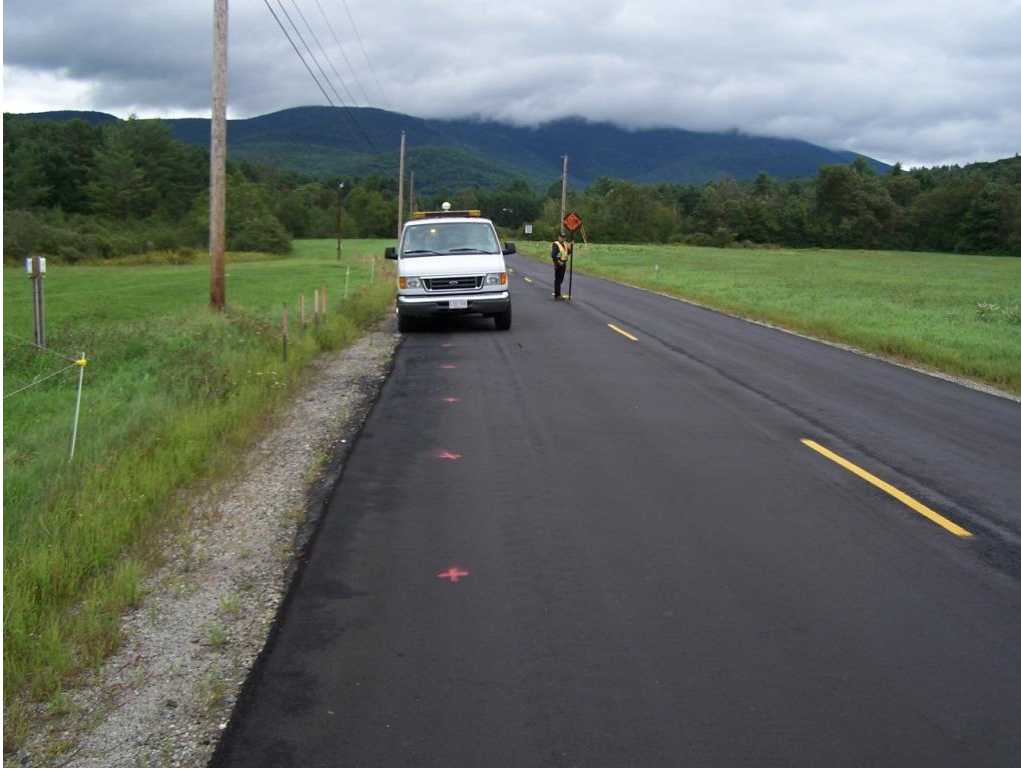
In the summer of 2008, a paver shim treatment was placed at the site. Crack sealing did not take place before the shim and almost all of the major cracks reflected back through the shim by the time we started 2009 testing. The site again revealed excessive frost heaving. The frost layer was a foot deeper and the water table rose to 14 inches below the surface as opposed to 19 inches below the surface in 2008. Even though this season's testing included the paver shim treatment, the site was not as stiff as in 2008. This illustrates that this treatment did not contribute much to strength as the existing cracks reflected through. Table 9 and Charts 9 and 10 provide the deflection data for this site.

Figure 29 Warren Flats site in August of 2008 shortly after being shimmed

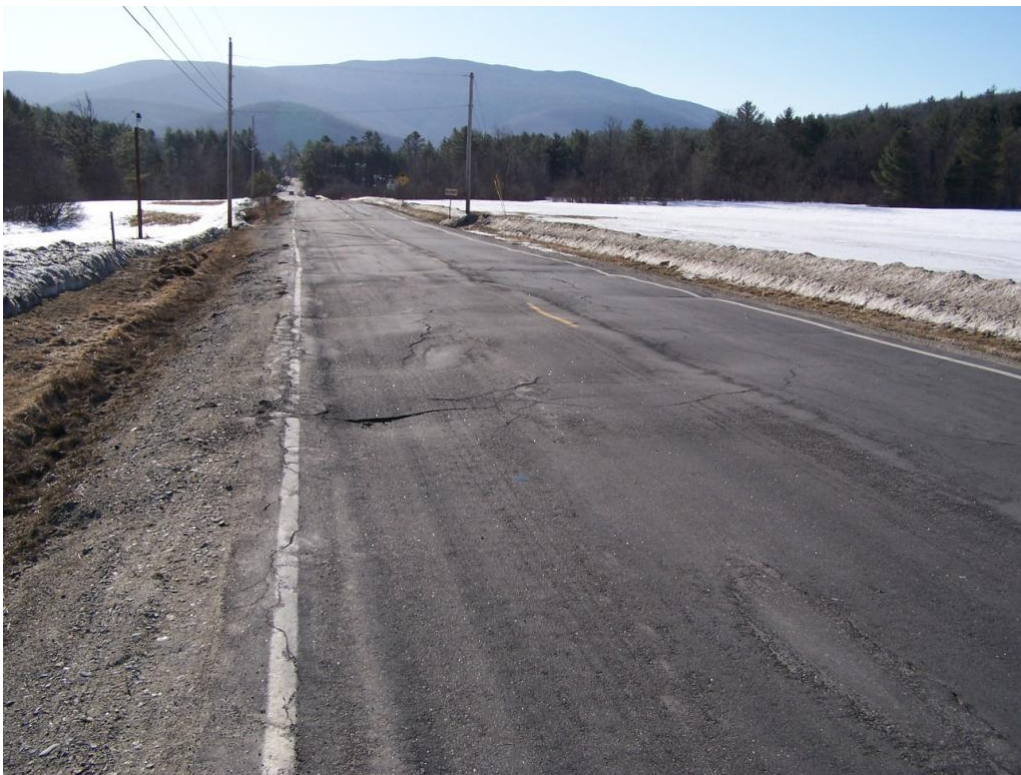
Figure 30 Warren Flats site in the spring of 2009 with heavy reflective cracking through the shim and the same heaving problems

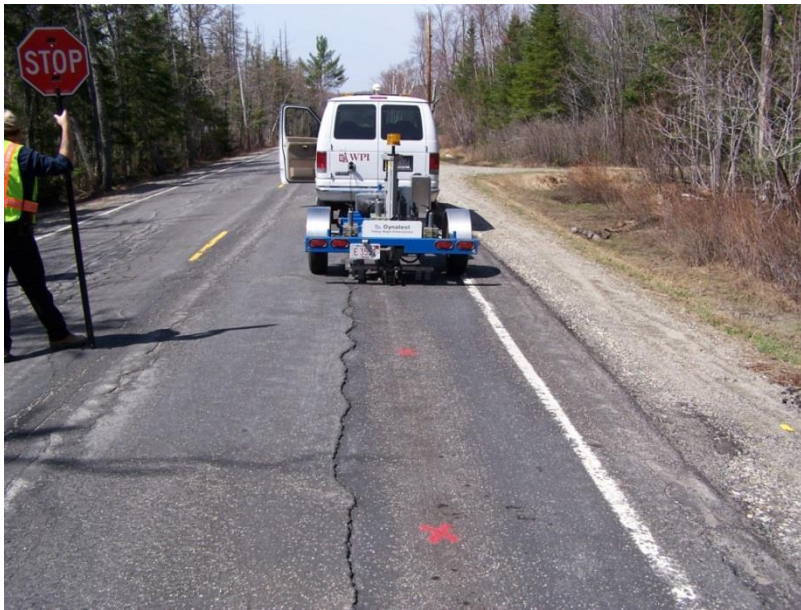
Sections of this site received a paver shim in the summer 2008. In 2009, the site tested similarly to 2008. The pavement cracks reflected through the shim and the longitudinal crack offset from Stations 7-10 again affected the non-frozen state readings. The weakest period may have been missed here due to FWD downtime. Table 10 and Charts 11 and 12 provide deflection data for the site.

Figure 31 Longitudinal crack at Lake Tarleton running alongside Stations 7 to 10
