Investigation of the Performance of Self-Consolidating Concrete in Drilled Shafts

Final Report

Prepared by the New Hampshire Department of Transportation in cooperation with the U.S.  
Department of Transportation, Federal Highway Administration

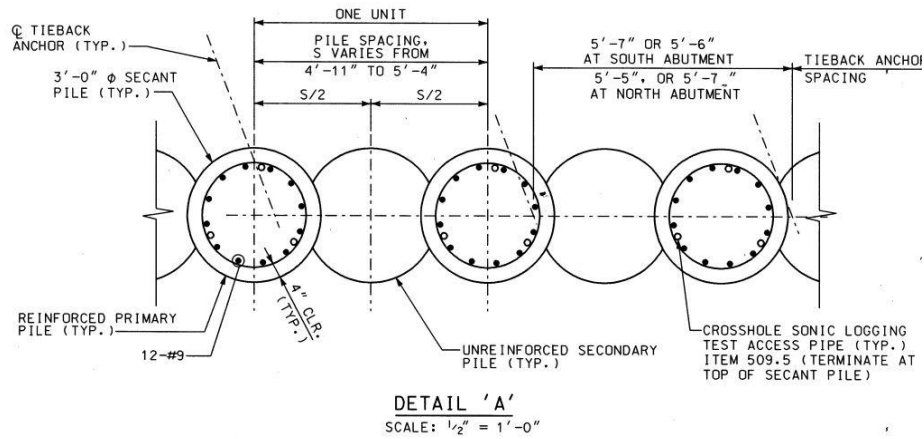
Figure 2: Plan view of secant pile wall showing primary and secondary pile interlock

The secant wall that forms the abutment was constructed by drilling a series of shafts 3 feet in diameter at 2.5 feet center-to-center spacing. These shafts, called secondary shafts, did not receive reinforcement and were filled with concrete and allowed to cure. After curing, primary shafts 3 feet in diameter were drilled in between the secondary piles. The primary shafts overlap the secondary shafts and this arrangement causes the piles to interlock forming a wall. The interlock is illustrated in Figure 4. Reinforcement cages were put into the primary shafts and then concrete was placed. The bridge was constructed in three phases, and the piles evaluated by this project were constructed at the northern abutment during the third phase of the project. Three primary piles were constructed using SCC and the remaining primary piles were constructed using CC with a very high slump (9 to 11 inches). All of the secondary piles were constructed using CC with high slump.

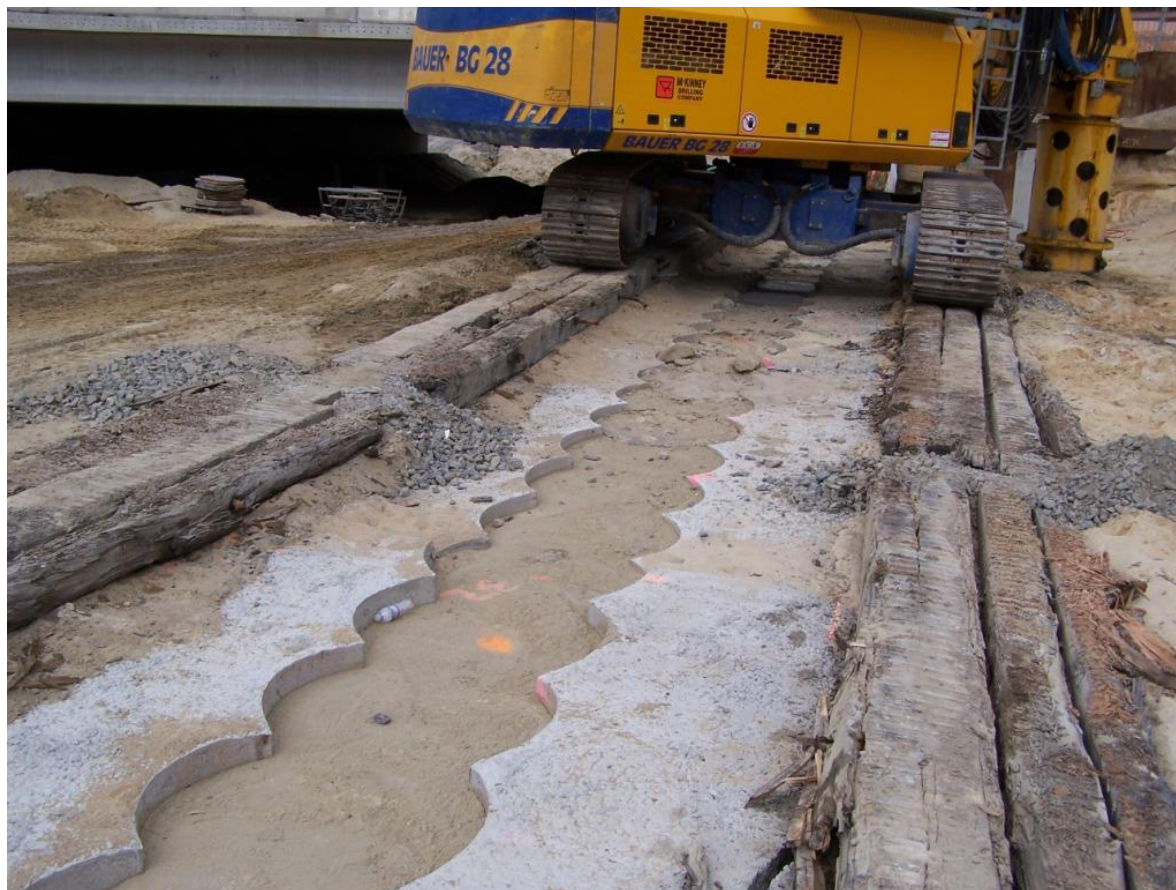
*Figure 4: Interlocking pile template showing the outline of the secant wall.*

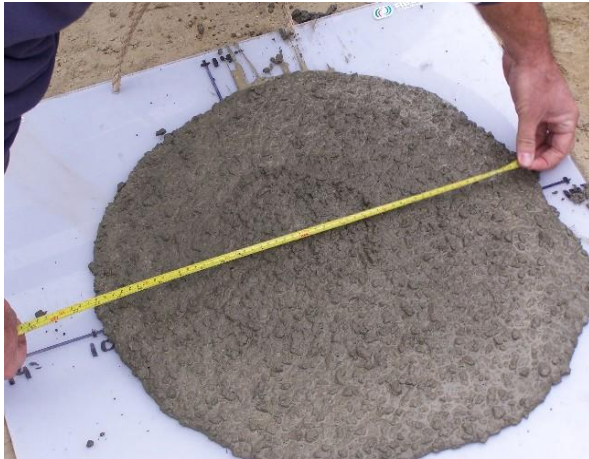
Figure 5: Measuring the spread of SCC

On September 18, 2009, the first three primary secant piles were poured using SCC. The SCC mix was a 4000 psi mix with an aggregate size of 3/8" and a water cement ratio of .38. The water-reducing admixture used was Glenium 7500 and the unit weight was approximately 145 pcf. The mix design report is available in Appendix 1. Four concrete trucks were used to fill the three shafts. Testing was done on the first two trucks. Admixtures and water were added into the drums of the trucks after they arrived at the site, and additional mixing occurred until the RediMix Companies representative was satisfied. The SCC from the first truck spread 22 inches and had an air content of 5.5%. Fifteen gallons of water were added to the second truck and about 178 ounces of Glenium admixture. The SCC from the second truck spread to a "tight" 20 inches and had an air content of about 4.3%.

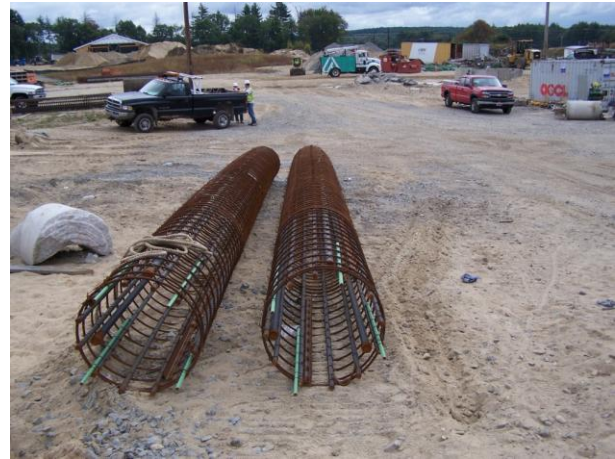
Figure 6: Rebar cages before installation

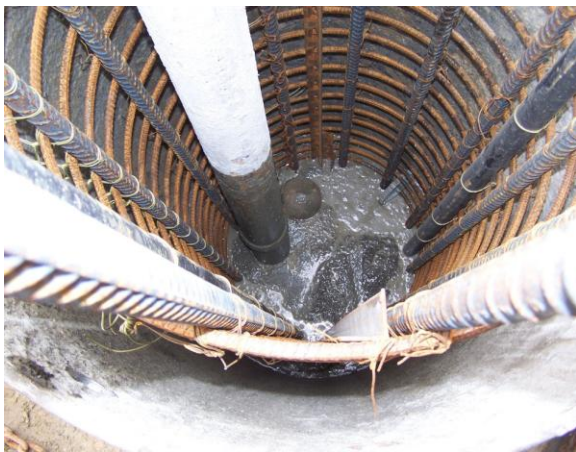
Figure 7: Pumping SCC into Shaft

The concrete was placed using a pump truck and the tremie method of placement. The pump tube was inserted all the way down to the bottom of the shaft and the concrete was pumped up from there. The original plan was for the shafts to be full of water, but after the crews cleaned out the shafts, the shafts did not refill with water. The concrete was placed starting with the westernmost shaft and proceeding east. The piles were designated according to position as N3PX standing for north abutment, construction phase 3, primary pile X.

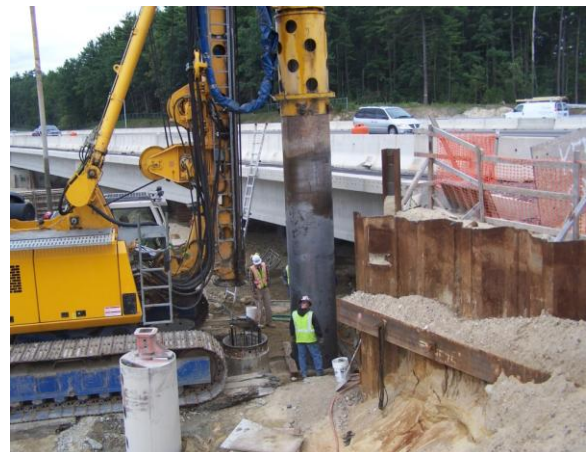
Figure 8: Removing a section of casing

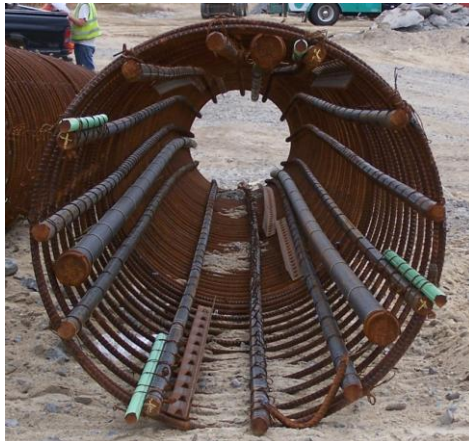
*Figure 9: Sonic crosshole logging tubes*

Tom Cleary of the NHDOT's Geotechnical Section performed the sonic crosshole logging. Sonic crosshole logging is prepared for by installing tubes at predetermined locations within the shaft. After the concrete has been poured and cured, a signal generator and a receiver are lowered into different tubes and the time that it takes for the receiver to get the signal is recorded. This is done throughout the shaft using different combinations of tubes so that an estimate of the soundness of the concrete in the pile can be formed.

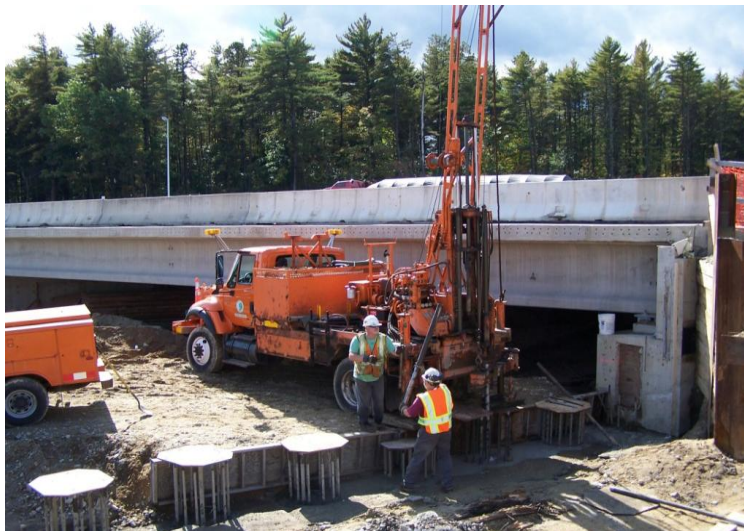
*Figure 10: Coring secant piles*

The five shafts were cored on October 7-9, 2009. Audley Construction built a gravel platform in front of primary drilled shafts N3P1 through N3P9 and the NHDOT drill crew was able to get a truck-mounted drill rig up onto this platform and in position to core the shafts. The shafts were cored with a 2-inch diamond bit in sections approximately 4.8 feet in length. The cores were taken from the top to within 6 inches of the bottom of each shaft. The bottoms of the shafts were not penetrated so that the core holes would be easier to patch with grout. The drilling process went smoothly and the drill crew noted that the concrete was harder to core as they neared the bottoms of the shafts.

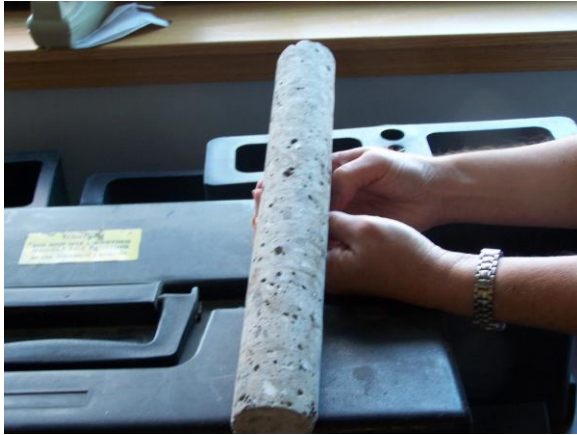
*Figure 11: N3P3 SCC 1 to 3 ft depth (more voids)*

The cores were taken back to the lab for inspection. The cores were looked at for evidence of channelization, segregation, and any other abnormalities. One thing that was immediately obvious was that the cores from all five piles contained numerous voids bigger than 1 mm in diameter. This is indicative of entrapped air rather than the evenly distributed voids of 1 mm or less in diameter formed by entrained air. Figures 11 through 16 shows, from visual comparison of the cores, that the SCC shafts appeared to have larger and more air voids near the top of the pile than the cores from the CC shafts. The cores from the SCC also appeared to have slightly more voids in the mid-section of the pile than the CC cores. Near the bottom of the pile the situation was reversed and the CC cores appeared to have more voids than the SCC cores. “Appeared” is not quantitative so one SCC core and one CC core were selected for further study.

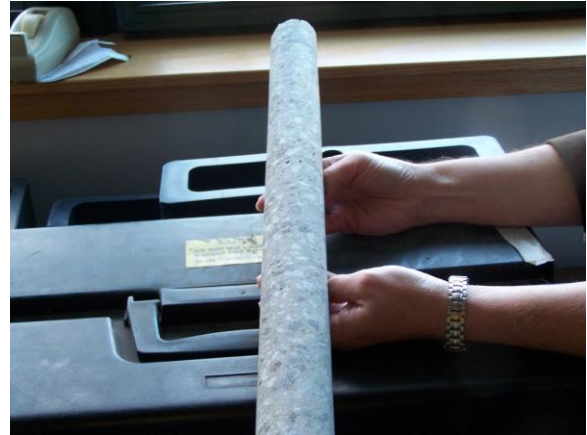
*Figure 13: N3P3 SCC 26-27 (less voids)*

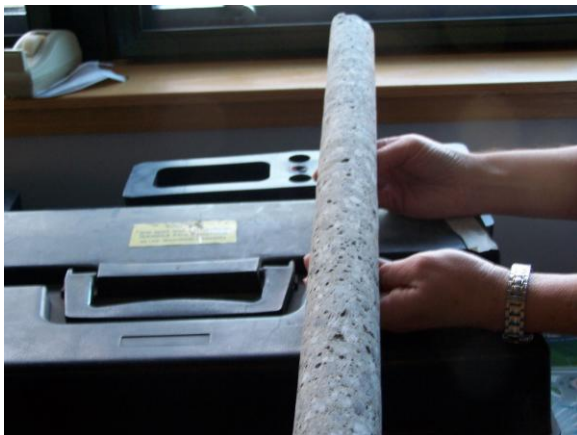
*Figure 12: N3P3 SCC 17-18 ft depth (several voids)*

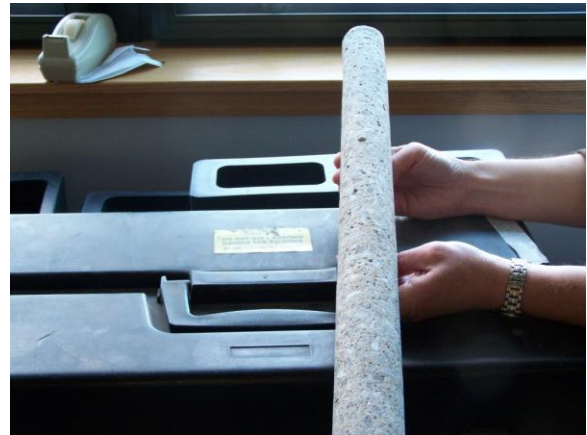
*Figure 14: N3P7 CC 1 to 4 ft depth (less and smaller voids)*

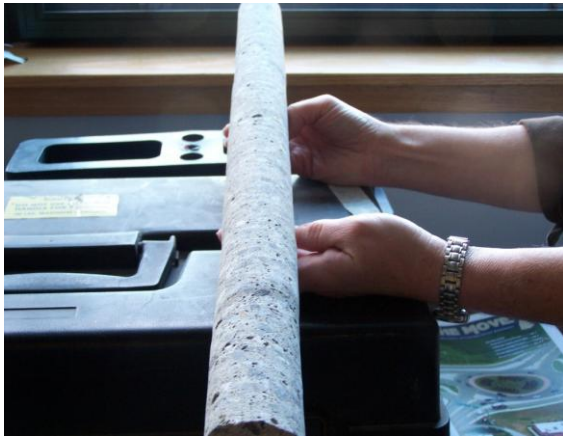
Figure 15: N3P7 CC 17-18 ft depth (several voids)

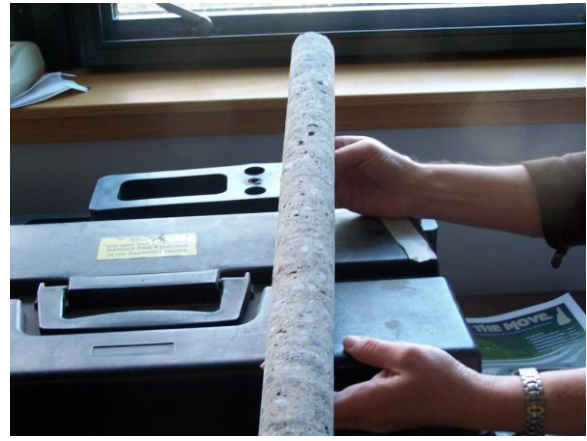
Figure 16: N3P7 CC 26-27 ft depth (more voids)

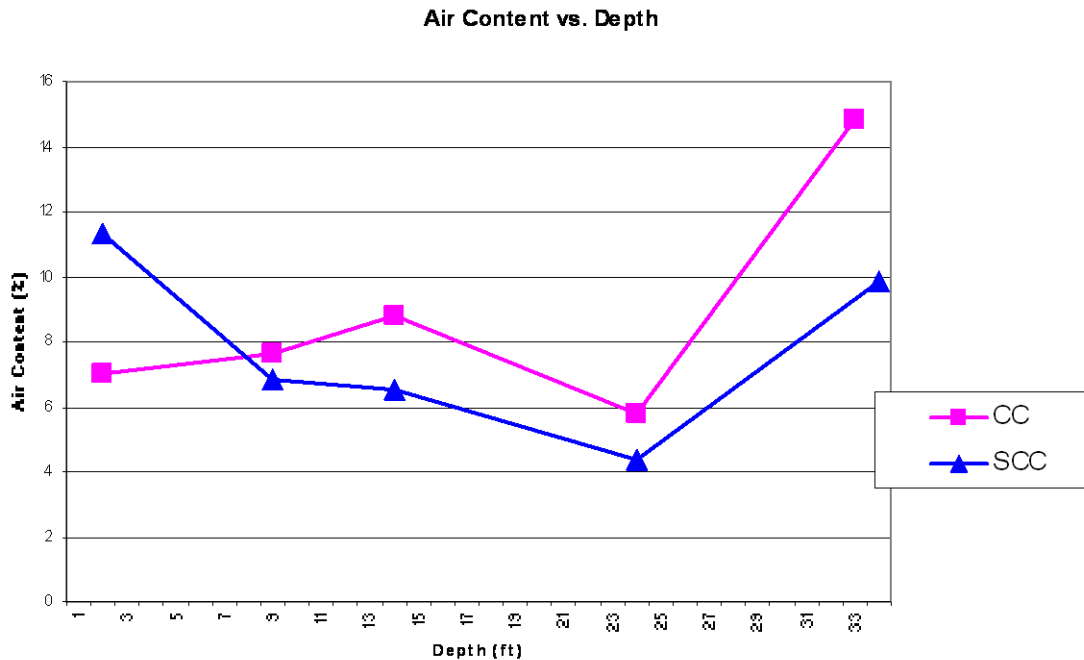
Figure 17: Air Content vs. Depth

The effort to quantify and qualify the air content in the hardened concrete was undertaken by students from the University of New Hampshire under the direction of Professor David Gress. The students analyzed the cores from two of the piles according to ASTM C 457 *Microscopical Determination of Parameters of the Air-Void System in Hardened Concrete*. The full report prepared by the students is attached to this report as Appendix 2. The cores were from N3P1, which was a SCC pile, and N3P9, which was a CC pile. The students used Procedure B, the Modified Point Count method. The cores were divided into 6-inch lengths and then sections at similar depths from each core were analyzed. All of the sections in each core were not analyzed due to the intense effort and labor required. In general terms, the air content of both cores was not uniform throughout the pile length and did not vary linearly with depth.

The air content of the cores from the two piles is shown graphically in Figure 17. In SCC pile N3P1, air content was at its maximum value of 11.33% at the top of the pile, at its minimum of 4.4% at 22.5 feet and then rose to 9.82% at the bottom of the pile. The air content for CC pile N3P9 was at 7.0 % at the top of the pile, at its minimum at 5.8% at 22.5 feet, and then at its maximum of 14.86% at the bottom of the core. Figures 18-20 show core sections that were prepared and analyzed by the UNH students. The differences in air void content can be seen in the photos.

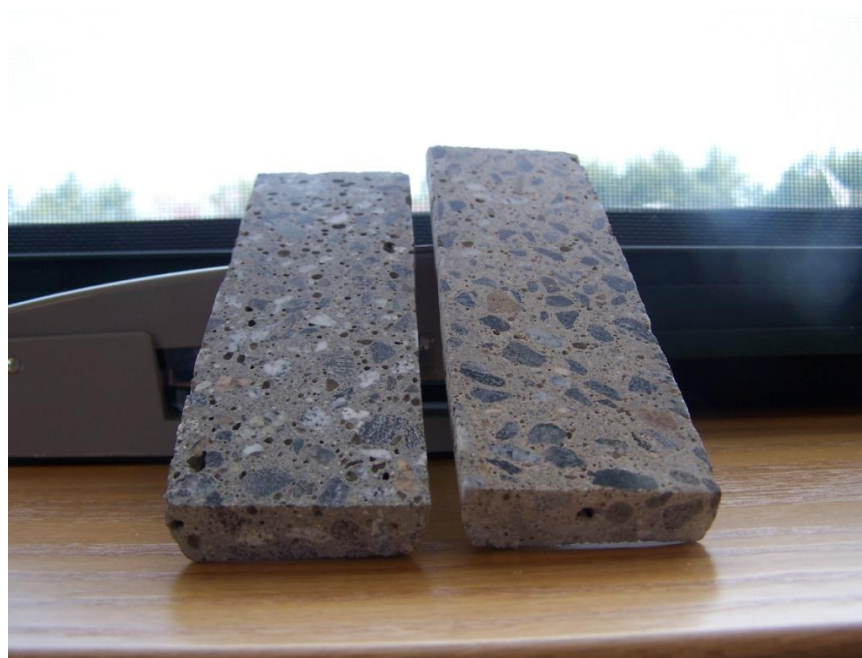
*Figure 18: Sections from the 1-foot depth of the piles (SCC on left, CC on right) this was the section of the SCC pile with the highest air content.*

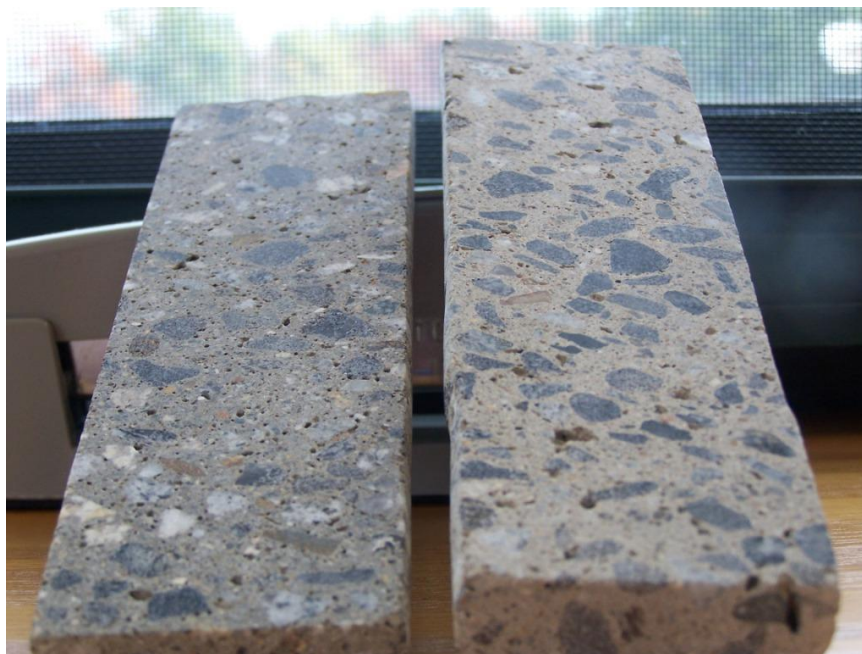
*Figure 19: Sections from the 23-foot depth of the piles (SCC on left, CC on right). This was the section with the lowest air content for both piles.*

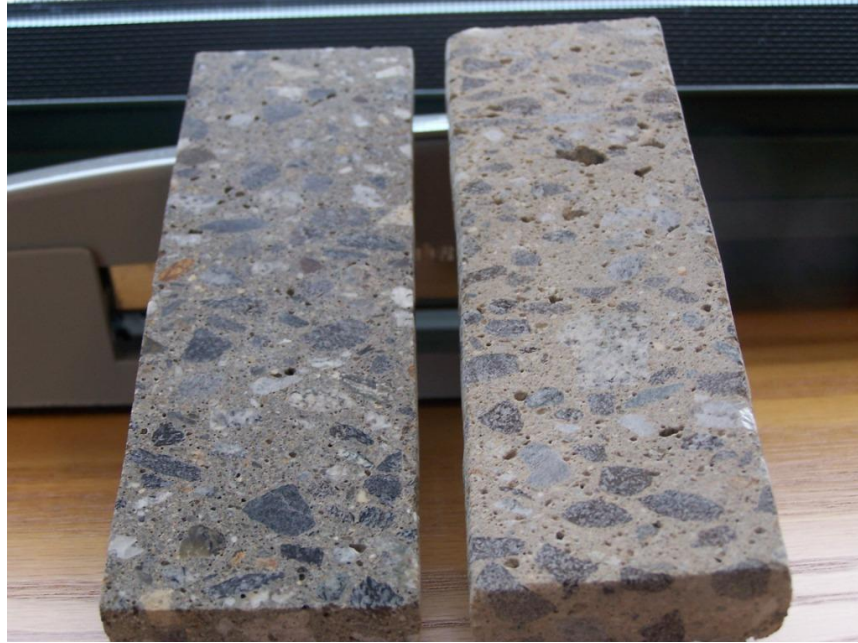
Figure 20: Sections from the 28-foot depth (SCC on left, CC on Right.). This was the section with the highest air content for the CC pile.

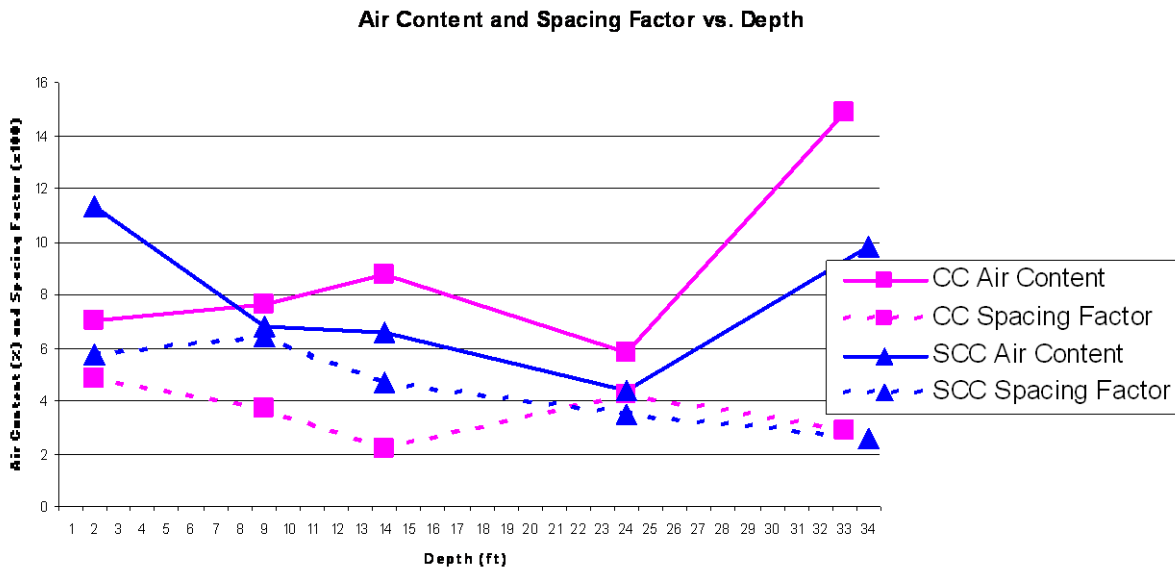
Figure 21: Air content and spacing factor vs. depth

The UNH students also calculated the spacing factor of the voids as part of the evaluation. The spacing factor is a measure of the maximum distance in the cement paste from the perimeter of an air void. The spacing factors in the core samples evaluated ranged from 0.02 in up to 0.06 in. A maximum spacing factor of .008 is the general target for good freeze thaw durability. In this case, the concrete is not directly exposed to the elements and freeze thaw durability was not a major consideration. One might think that the highest spacing factor would correspond to the area with the lowest air content. This was not the case as seen graphically in Figure 20, probably because of the random nature of entrapped air.

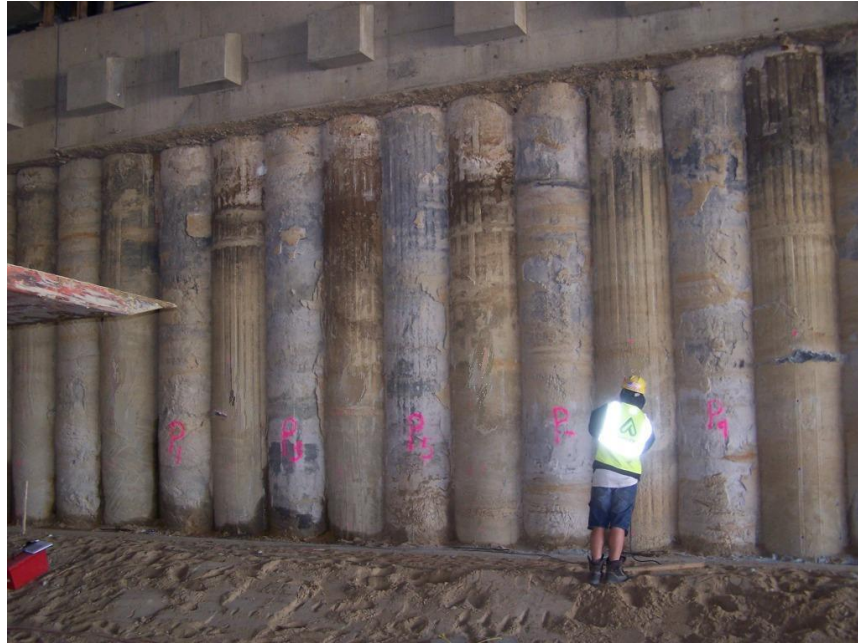
*Figure 22: Primary piles are marked in pink paint*

In the spring of 2010, the secant pile wall was partially excavated for construction of the underpass allowing for inspection of the secant piles. In general visual appearance, there was not an easily discernible difference between the appearance or texture of the SCC piles and the CC piles. Both types of concrete filled in completely around the reinforcement cages for the visible lengths of the piles. If one did not know the identity of the piles, it would have been impossible to visually tell which piles used which type of concrete.

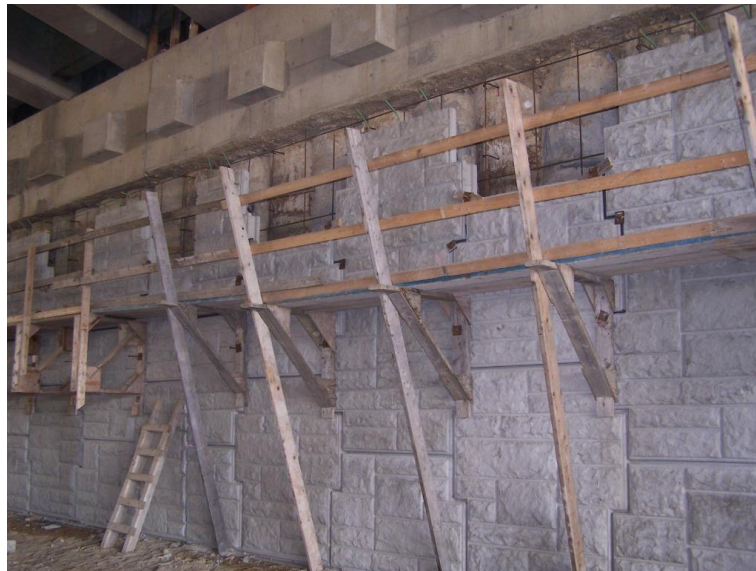
*Figure 23: Architectural wall that conceals secant pile wall*

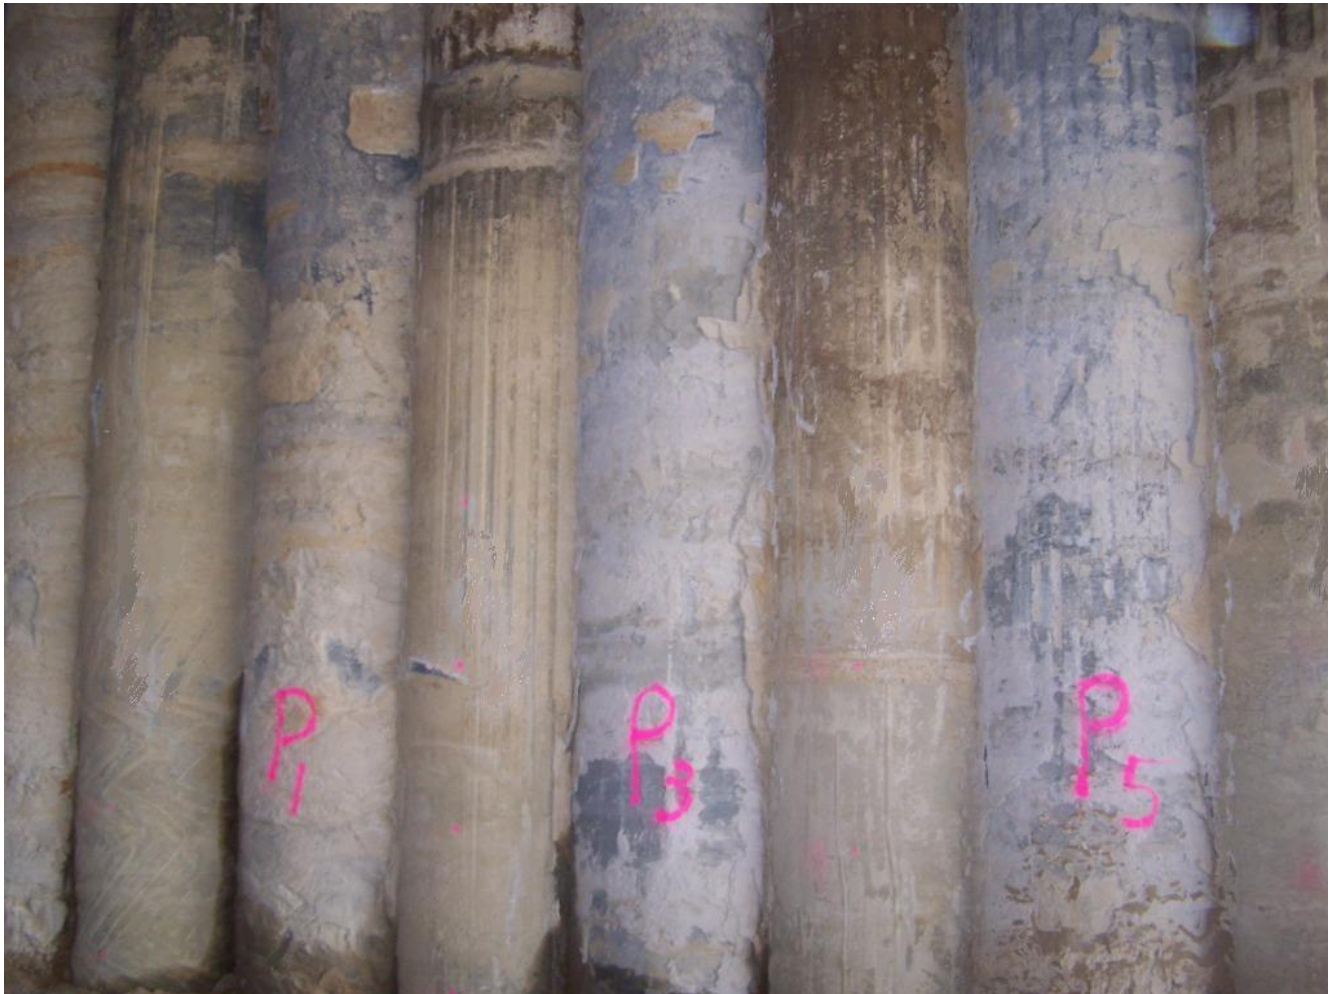
*Figure 24: Primary SCC piles N3P1, N3P3, and N3P5*

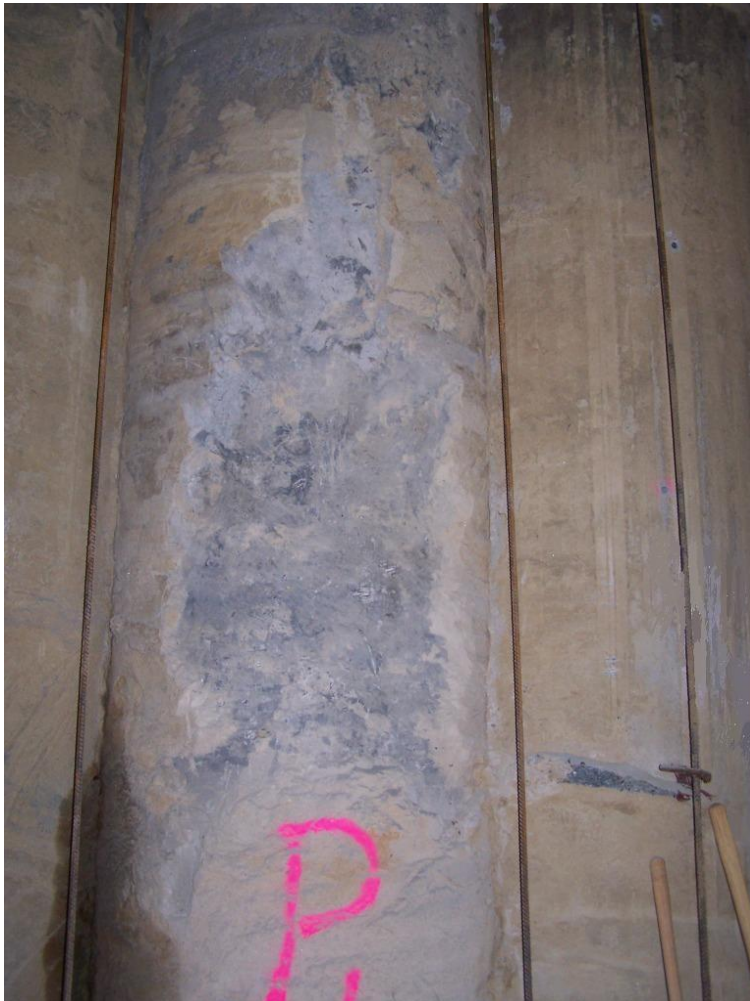
*Figure 25: N3P1 chipped down to concrete*

**SCC Pile N3P1** was encased for most of its length in a hard layer of material that appeared to be a mixture of soil and cementitious material from the concrete. This hard layer was about two inches thick and changed in color from tan to the same color as the concrete as one chipped through it towards the concrete. The other SCC piles did not exhibit this. The only difference between this pile and the other two SCC piles was the presence of 2 feet of water over the concrete in this pile when the concrete was placed. An ice pick and a masonry hammer were used to chisel down to the surface of the concrete in the pile. The material had the consistency of hardened clay and considerable effort was needed to chip through it. The material appeared to be in addition to the concrete, meaning that from what the observer could tell, it did not infringe into the three-foot diameter of the pile. In Figure 25 below, the color differences can be seen. The tan outer layer has been chipped through to the grey inner layer. In Figure 26, two areas of exposed hardened concrete are pointed out. The picture shows how the grayish material needs to be scraped or chipped away to expose the concrete. The fingers are pointing directly at the exposed concrete (very light grey to white colored); most of the rest of the picture shows the grey colored hardened material. The concrete that was exposed was hard and sound as evidenced by striking it with the masonry hammer. No reinforcement or evidence of blockage caused by reinforcement was visible.

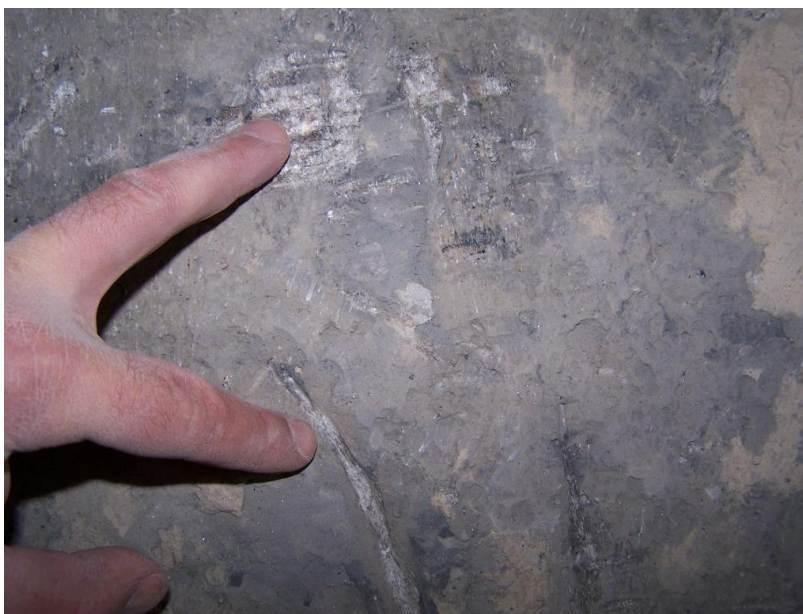
*Figure 26: Fingers pointing to slits of exposed light grey concrete on N3P1, darker gray material around concrete is part of the hard layer that formed around the pile*

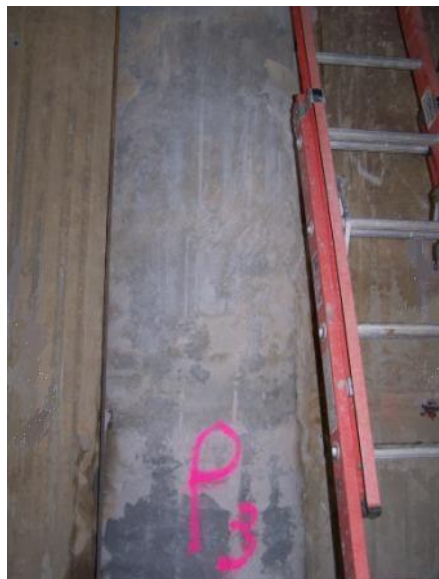
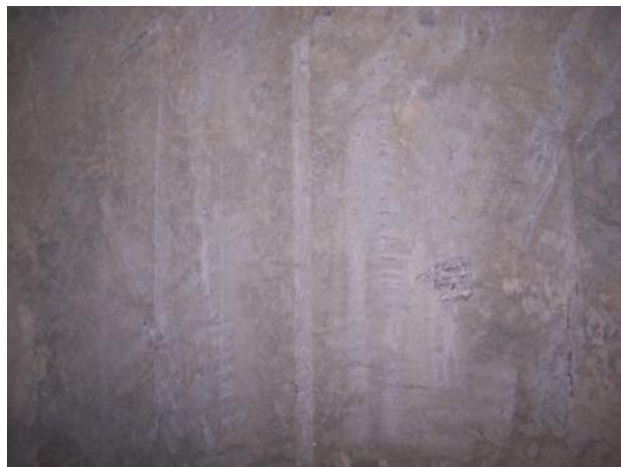
*Figure 27: N3P3*

*Figure 28: Close up of N3P3*

**SCC Piles N3P3 and N3P5** were not encased in a layer of hard material like N3P1. The material adhering to these piles was easily scraped away and the surface of the concrete did not reveal any “bug holes”. The surfaces of the piles were defined enough to show the vertical striations left by the casing when the shafts were drilled. N3P3 had between 6 inches to a foot of water in the shaft when it was placed, and N3P5 had a dry shaft when it was placed. This might account for the lack of a hard layer such as was at N3P1. The concrete in both N3P3 and N3P5 was hard and sound when struck with a masonry hammer. No reinforcement or evidence of blockages caused by reinforcement was visible.

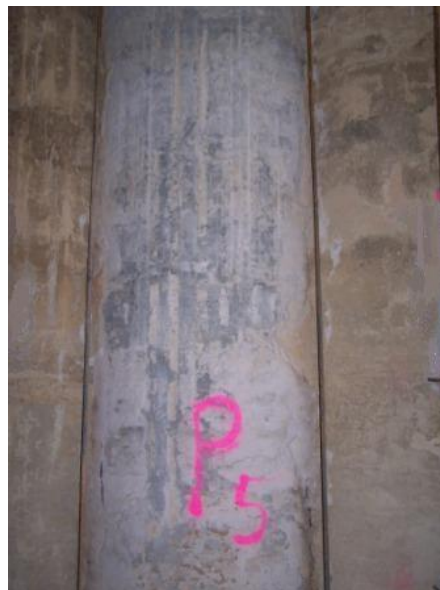
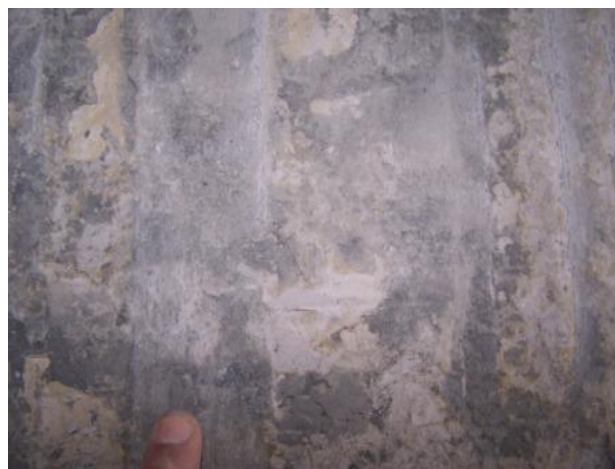
*Figure 29: N3P5*

*Figure 30: Close up of N3P5*

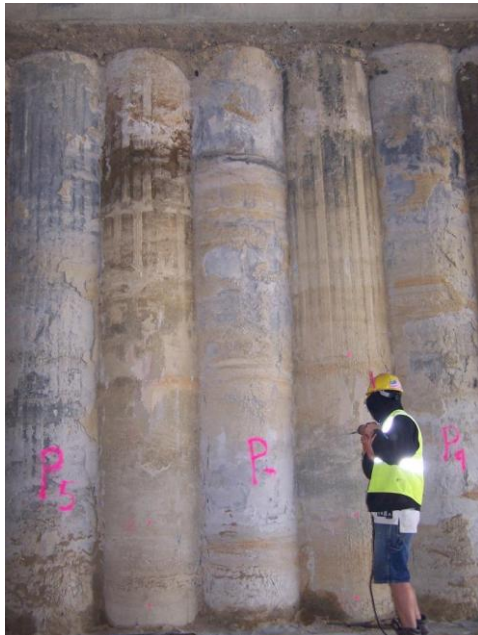
Figure 31: Primary CC piles N3P7 and N3P9

**CC Piles N3P7 and N3P9** looked very similar to SCC Piles N3P3 and N3P5. Any material adhering to these piles was easily scraped away and the surface did not reveal any “bug holes”. The concrete in these piles was also hard and sound when struck with a masonry hammer. No reinforcement or evidence of blockages caused by reinforcement was visible.

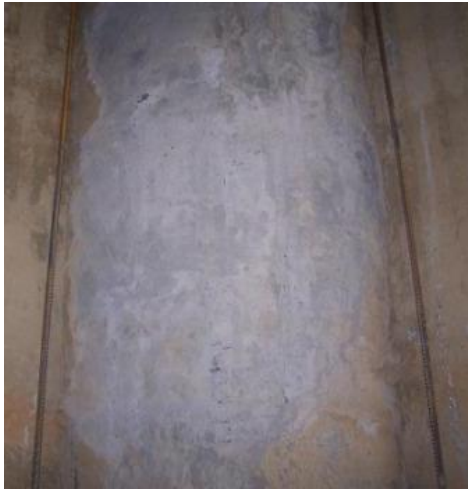
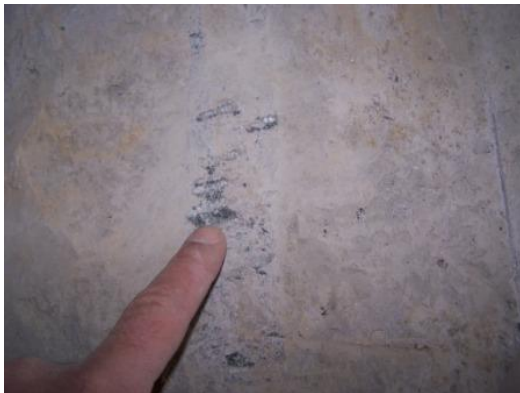
Figure 32: N3P7

Figure 33: Close up of hammer marks on N3P7

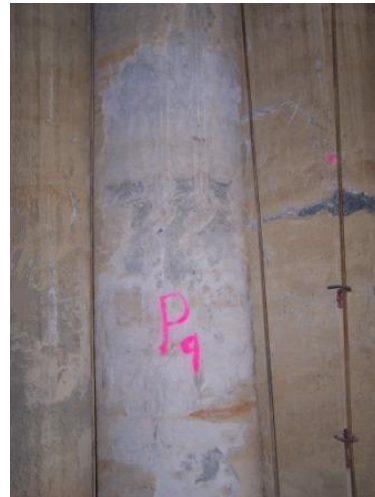
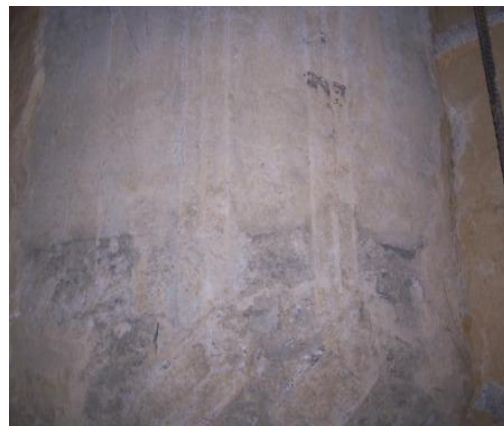
Figure 34: N3P9

Figure 35: Casing impression marks in N3P9

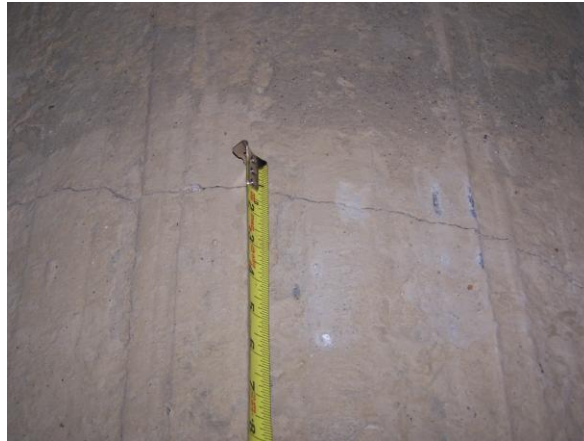
When inspecting the secant wall, horizontal cracks were noticed in several of the secondary piles. The cracks varied in width from hairline to big enough to stick a dime into. There was no reinforcing steel placed in secondary piles, so the cracks are probably the result of shrinkage. The primary piles that were evaluated in this report did not exhibit such cracking.

*Figure 36: Horizontal crack in secondary pile*

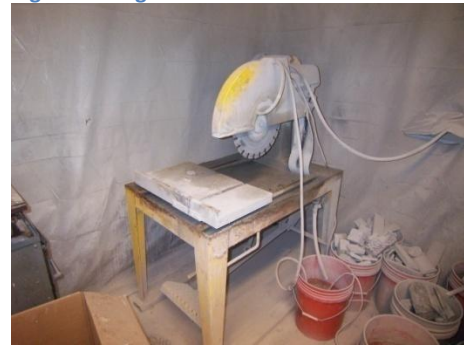
Figure 1: Large Wet Saw

The first wet saw we used was to cut the long cores from the box into the 6" samples needed for testing. This larger saw, shown in Figure 1, was used for this task because it had a large clear area in which to place the long cores and would make the cut fast and clean. After using the large saw to cut the long cores the samples were brought to a smaller wet saw for two final cuts.

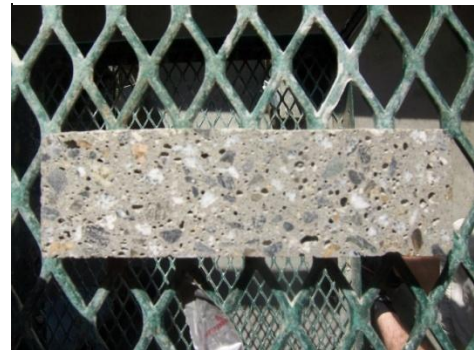
Figure 2: Final Sample

This smaller wet saw was used to transform the circular core into a rectangular shape shown in Figure 2. Figure 3 shows how the last two cuts were taken to achieve this sample. Two cuts were taken close to each side such that a rectangular testable sample was created by the two cuts. Cutting the cores in this fashion provided the testing environment with a level sample that makes it easier to keep in focus during microscope testing.

It should also be noted that many of the air voids in the sample appeared to be entrapped air instead of entrained air. The average void size appeared larger than 1mm suggesting they were the result of entrapped air. These large air voids can be seen in figure 2.

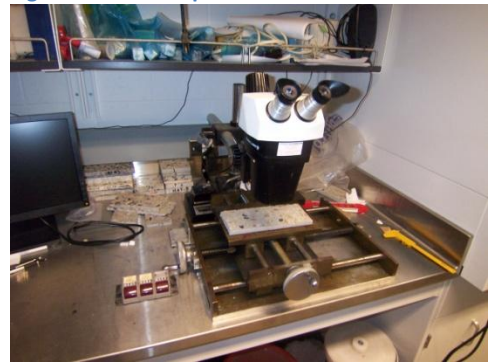
Figure 4: Microscope

For the ASTM 457 testing each cut and polished sample had to be looked at in order to determine the air content within that sample. This was done using a microscope, shown in Figure 4, that would allow the tester to see in inner-makings of the sample at a magnified level. Each sample had to be checked for amount of paste, aggregate, and air voids that made up that particular section of concrete. This was done to determine the air percentage in the sample of the concrete.

Before the inspection process begins the plate in which the sample sits on under the micro scope must be leveled. This is done to keep the sample in focus through the entire inspection. The sample is also squared on the plate using markings painted onto the plate. This is done to ensure that while inspecting the sample the test is moving along a straight line across the sample.

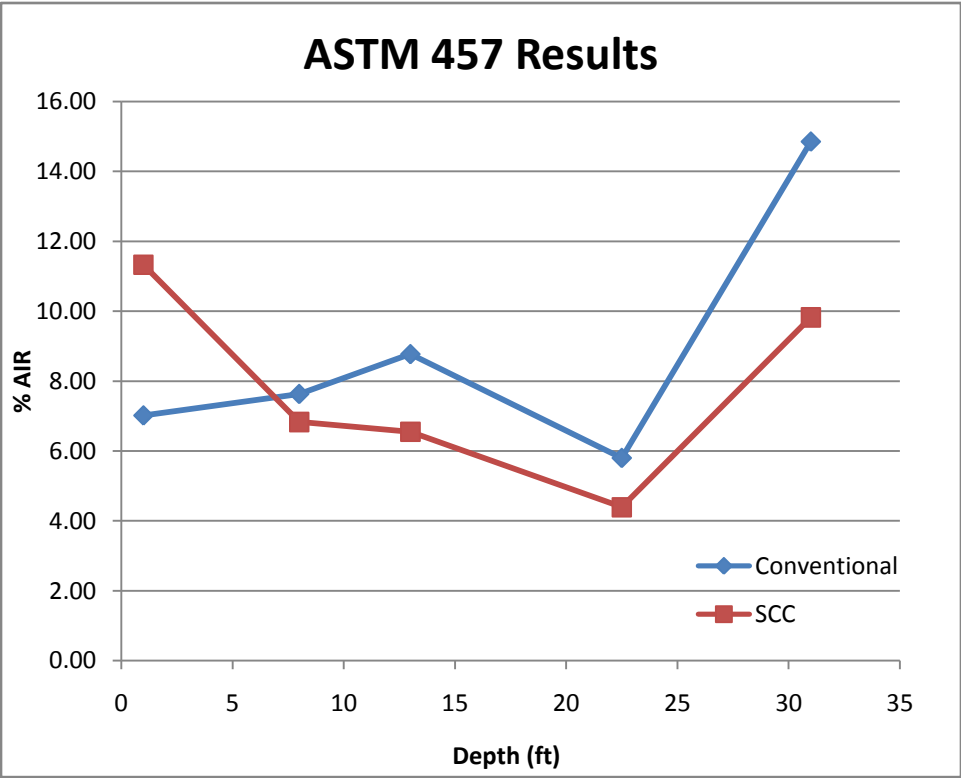
Figure 5: Test Data

After completing the ASTM 457 test on 5 samples for each concrete there is a clear similarity between both samples. There were also several oddities found in the two samples of concrete after testing. The data from the tests are shown in Figure 5. The graph shows the different air percentage found in each sample throughout the entire depth of each core.

The most notable find from this testing is that the air content of both samples is not predictable and doesn't vary linearly with depth.

The sudden rise in air content could be attributed to standing water in the forms of the piers. It was noted that for the initial 10' or so of the pour that water was present on the surface and could of attributed water void cavities. Water voids also appear near the surface of any surface that was compacted for finishing. This would explain the high air content near the surface of the SCC sample. Taking this into consideration if both samples are compared to each other from 8.0' to 22.5' the air content of SCC is 1-2% less than that of conventional concrete, but follows a similar pattern as seen in figure 5.
