Polyurethane Foam for Roadway Stabilization
NH Route 129, Loudon, NH

Final Report

EVALUATION REPORT, OCTOBER 2011 TO JUNE 2014
POLYURETHANE FOAM
FOR ROADWAY STABILIZATION
NH ROUTE 129, LOUDON, NH

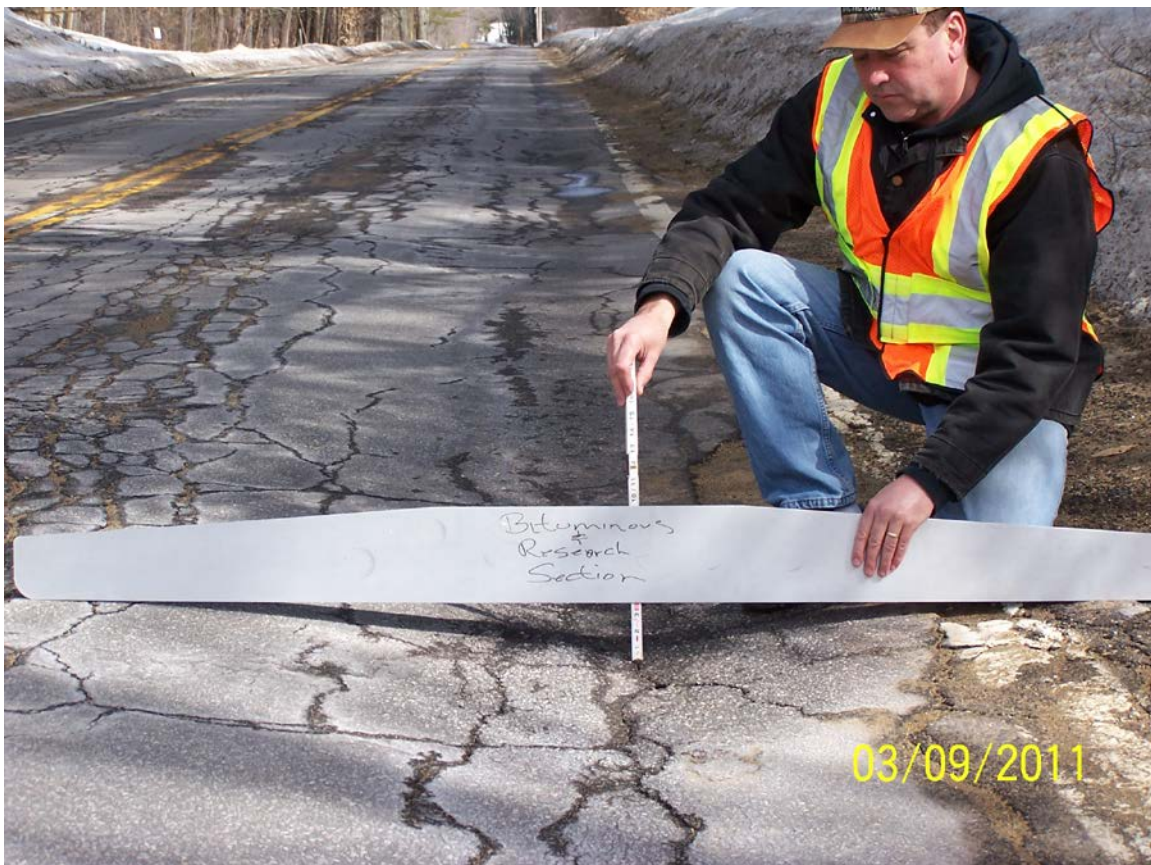
Existing Conditions – Deep ruts during frost heave season

This site was identified by Highway Maintenance District 3 as a section of roadway exhibiting severe frost heaving. Severe ruts up to four inches in depth form in the wheel paths during the winter months. The asphaltic roadway surface was uneven and cracked, with poor drainage. These conditions create extremely poor winter driving conditions, which dissipate with the return of warmer temperatures. The cyclic behavior deforms and deteriorates the pavement and driving conditions, and requires repaved about every six years to restore the surface. The selected test site was in a wooded area with a moderate cross slope. A brook parallels the roadway about 50 feet to the west, and crosses the roadway by culvert both north and south of the test site.

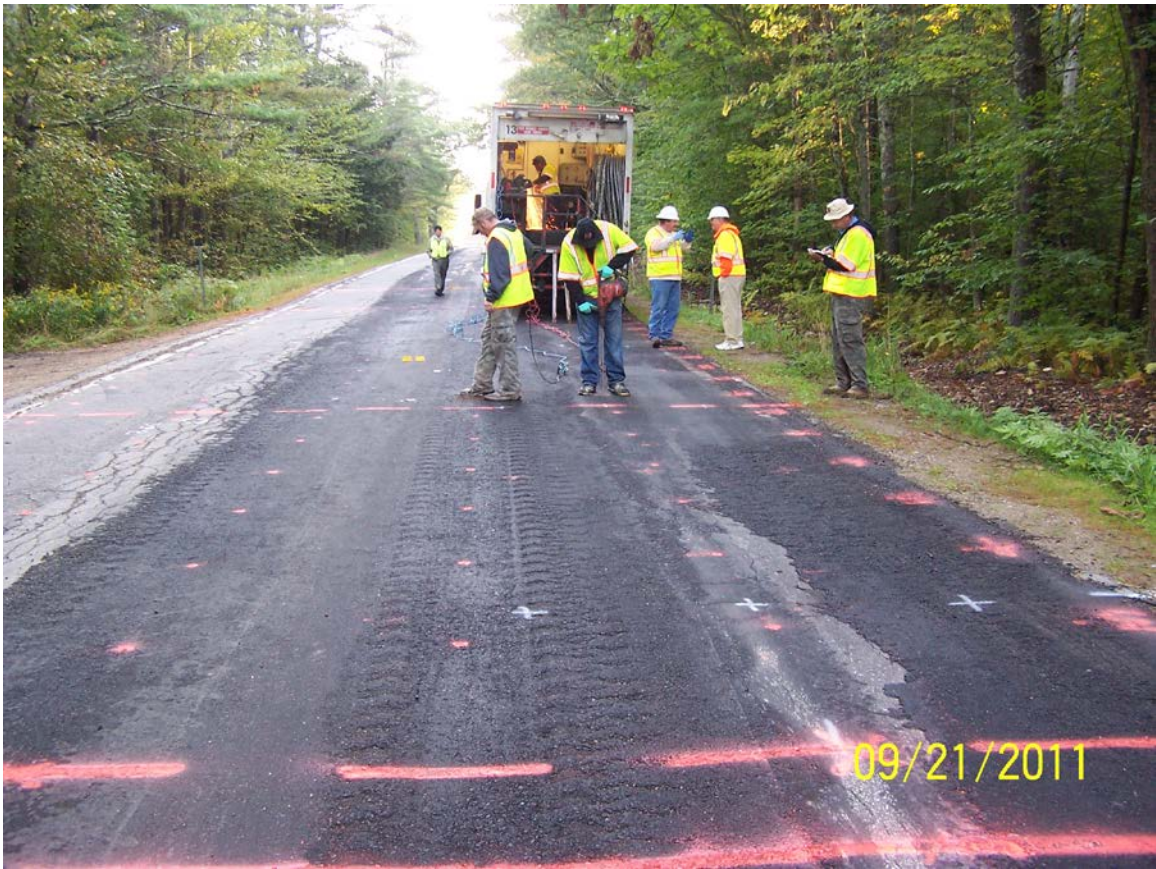
Red paint indicates 4-foot polymer injection grid on HMA shimmed surface
Foreground is the southerly transition zone
Workers standing in the full treatment area

- A 50 LF full treatment area, consisting of rows of three injection points wide per lane located longitudinally every four feet. Polymer was injected at depths of 48 inches and 24 inches.
- A 25 LF transition area at each end of the full treatment zone. Polymer was injected only at 24 inches deep at the same layout in these locations.

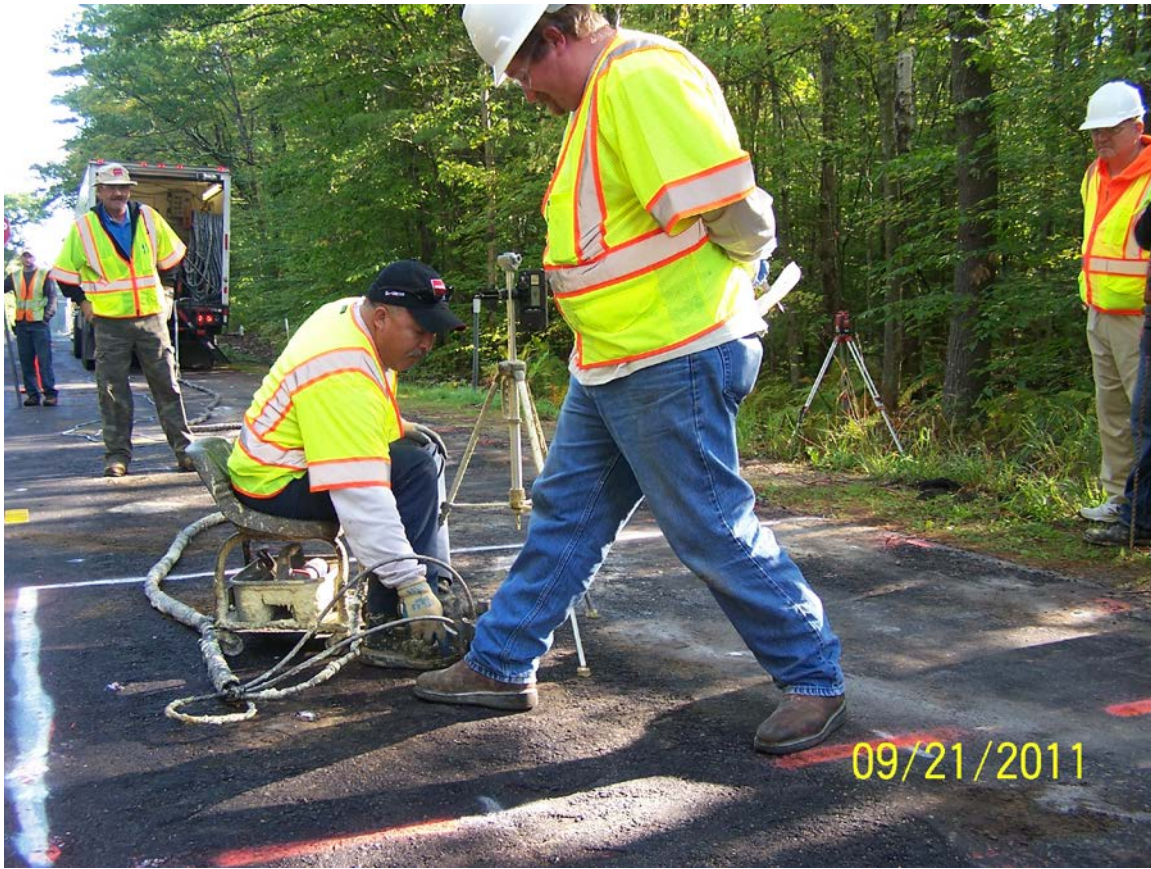
Injection of two-part polymer formulation
1-mm vertical pavement movement measured by laser level

The installation crew used electric hammer drills equipped with 4-foot long auger bits to drill two holes at each injection location to the respective design depths for injection. A half-inch diameter steel tube with an end cap was then inserted into each hole. An injector gun (patented by Uretek USA) was then placed at the top of each of the deeper steel tubes to inject the two-part polyurethane foam formulation. Injection continued until the local pavement surface raised one millimeter. A laser level measured the pavement movement. The polymer expanded into the voids in the soil and displaced pore water until it cured into a solid in 20 to 30 seconds. Once the deeper injection points were completed, foam was then injected into the shallow points until the pavement again rose by one millimeter. When completed, excess polymer expanding from the injection points was removed and the tubing was driven below the pavement surface.

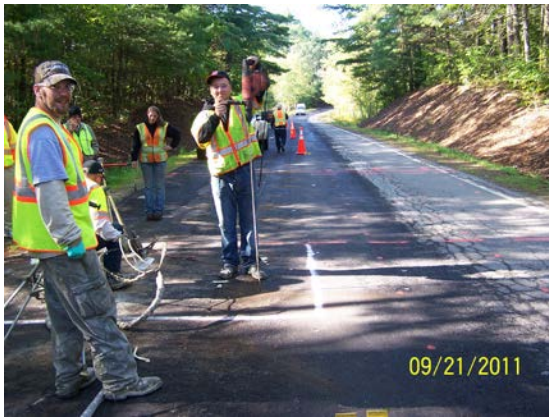
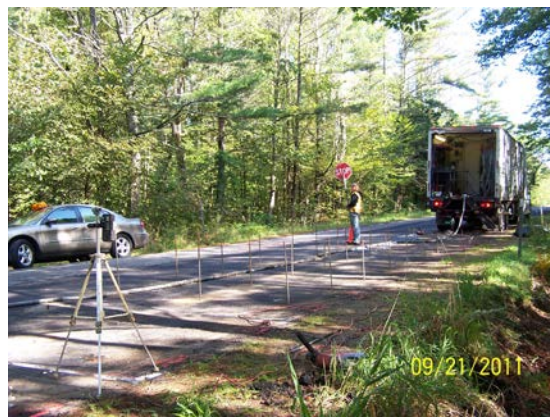
Left: 4-ft. auger bits and hammer drills prepare holes for injection.
Right: Steel pipes are inserted to direct polymer to the bottom of the holes.

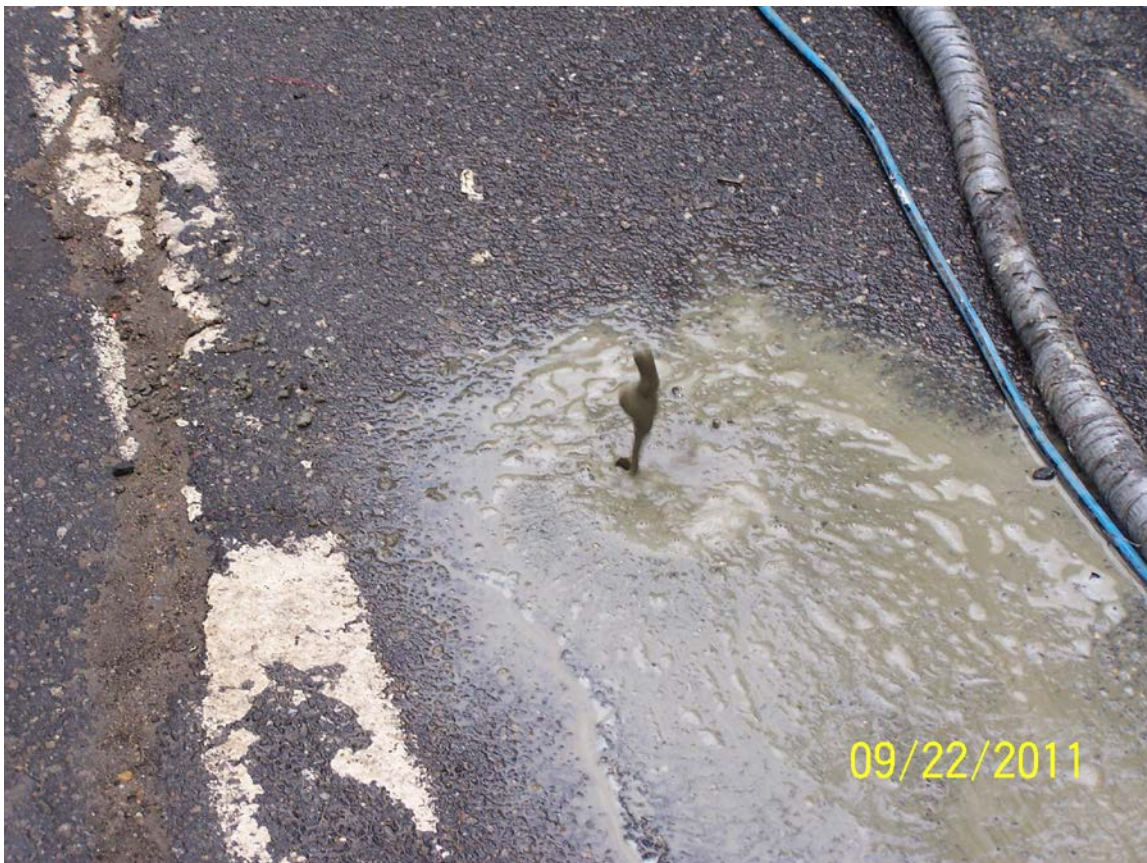
Southbound lane injection forced groundwater to shoot from prepared holes.

The northbound injections on Sept. 21 were uneventful. However, many of the southbound injections on Sept. 22 resulted in water squirting up from adjacent prepared holes. This may have been due to the elimination of the treated northbound subbase materials as a drainage path. The water was sometimes clear and sometimes dark brown and muddy. In some cases the water streamed as high as 10 inches above the pavement, or pulsed intermittently. Although flowing water could not be seen, the gravel area within the shoulder at the intersection of Captain French Road was observed to glisten from the excess moisture moving laterally through the material.

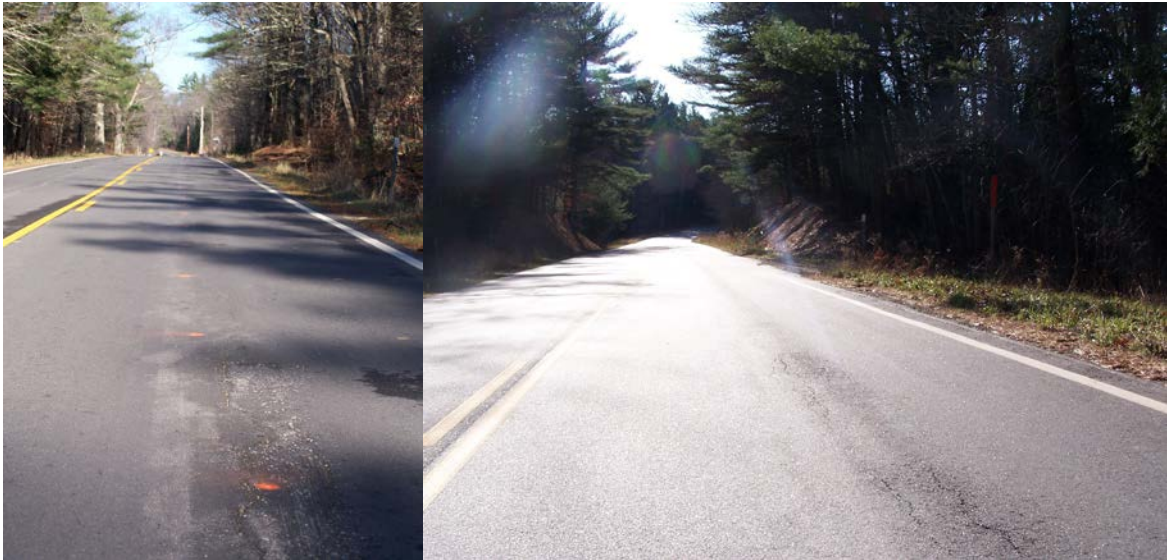
Conditions 1 year after installation: Northbound (left), Southbound (right). Note that inadequate pavement thickness at center of lanes provided marginal structure.

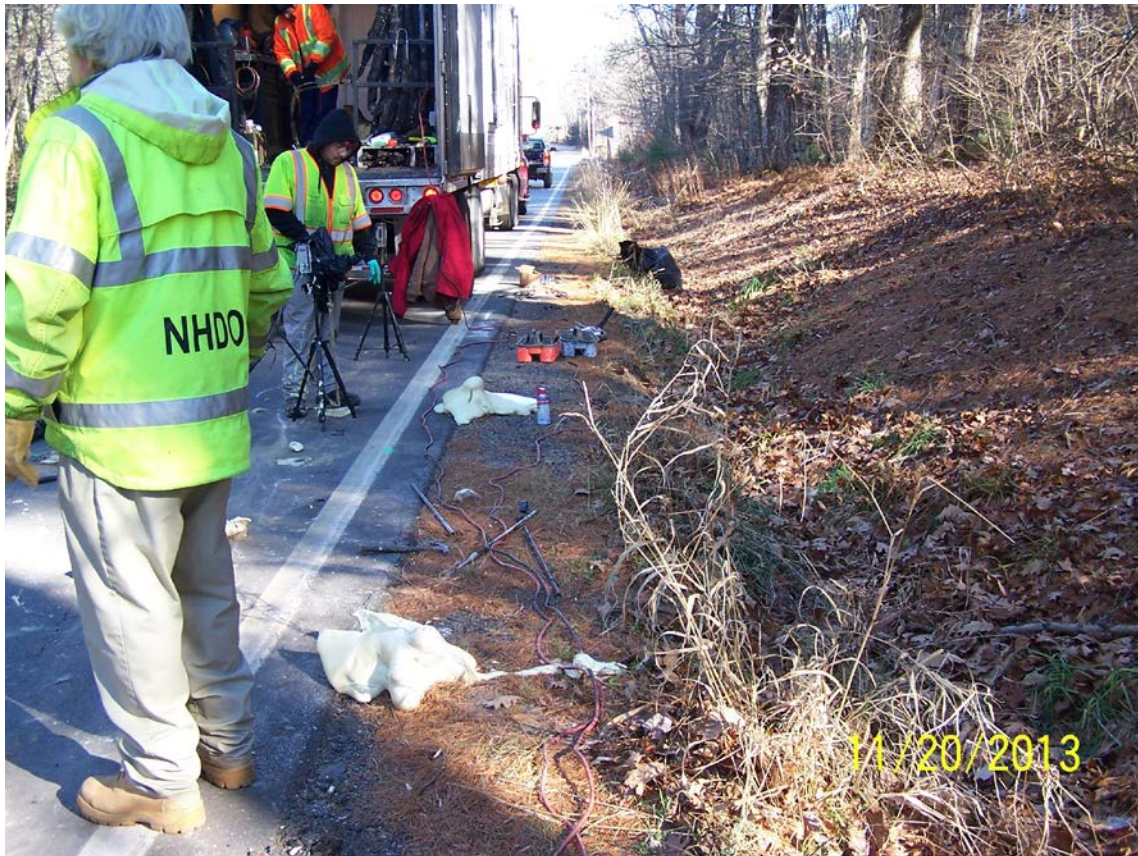
Expanding foam breaking through shoulder adjacent to injection points

Phase II injections were located from Station 6+55 to Station 7+55 inclusively. Two-level injections on a four-foot grid were again implemented; this time at 24 inches and 15 inches deep. Polymer was again injected until a pavement rise of 1 mm was indicated by laser level. Occasionally, foam broke out through the shoulder, indicating that it sometimes expanded to the pavement surface. The shallower depth allowed for the steel piping to be easily withdrawn to perform the shallow injection. Both injection depths were completed in the same drill hole. The piping was fully withdrawn after the shallow injection. Frost heaving measured during the 2013-14 winter season indicated a 31.7% reduction when compared to the control area.

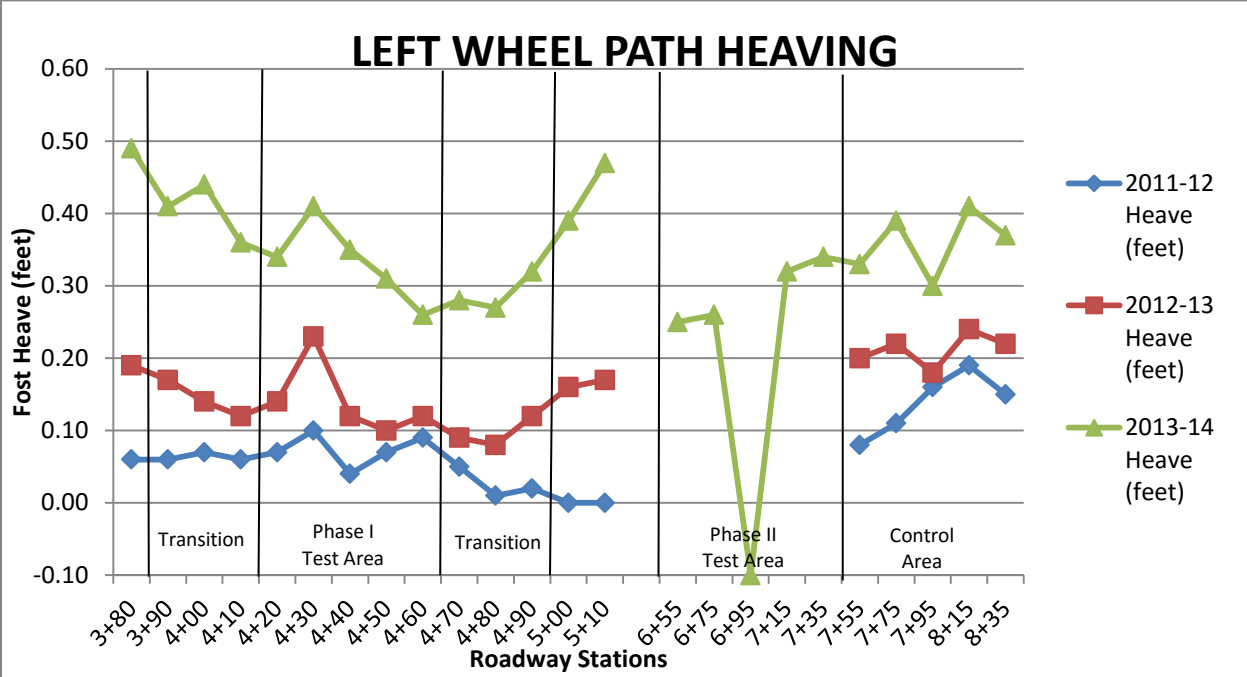
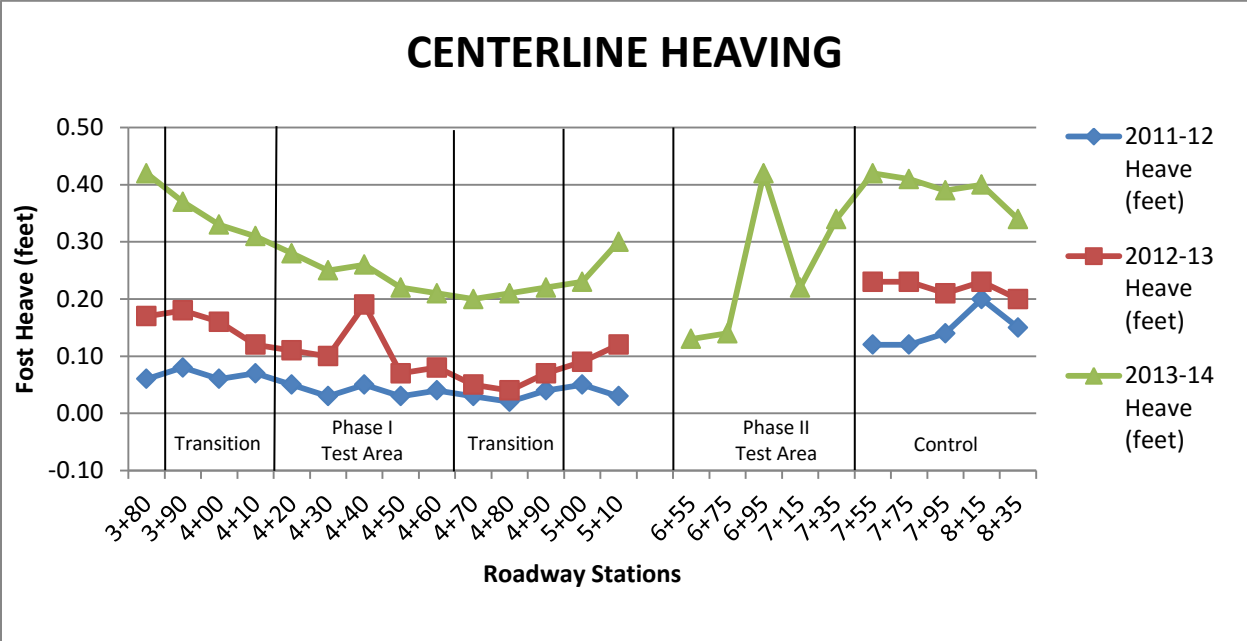
PHASE I and II FROST HEAVE DATA PLOTS BY AMOUNT OF HEAVE

RIGHT WHEEL PATH HEAVING
