**Instrumentation, Digital Image Correlation,  
and Modeling to  
Monitor Bridge Behavior and Condition**  
**Final Report**

Prepared by the University of New Hampshire Department of Civil Engineering for the  
New Hampshire Department of Transportation in cooperation with the U.S.  
Department of Transportation, Federal Highway Administration

# **Instrumentation, Digital Image Correlation, and Modeling to Monitor Bridge Behavior and Condition Assessment**

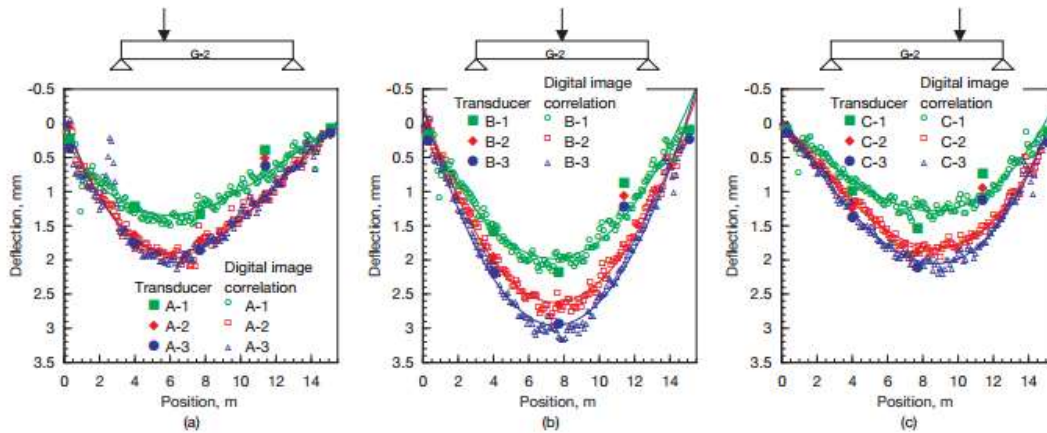
**Figure 12: Yoneyama et al. deflection comparison between displacement transducer and DIC (credit: (Yoneyama, et al. 2007))**

DIC has been used in various civil engineering field applications many of which relate to bridges. Researchers in Canada successfully monitored crack propagation in a concrete bridge beam during a load test in order to better understand fatigue behaviors (Kuntz, et al. 2006). Japanese researchers loaded a new simple span steel girder bridge using a 44 kip (196 kN) cargo truck and measured deflections with cameras (Yoneyama, et al. 2007). Figure 12 shows the comparison between camera deflections and displacement transducers. The two methods agreed well.

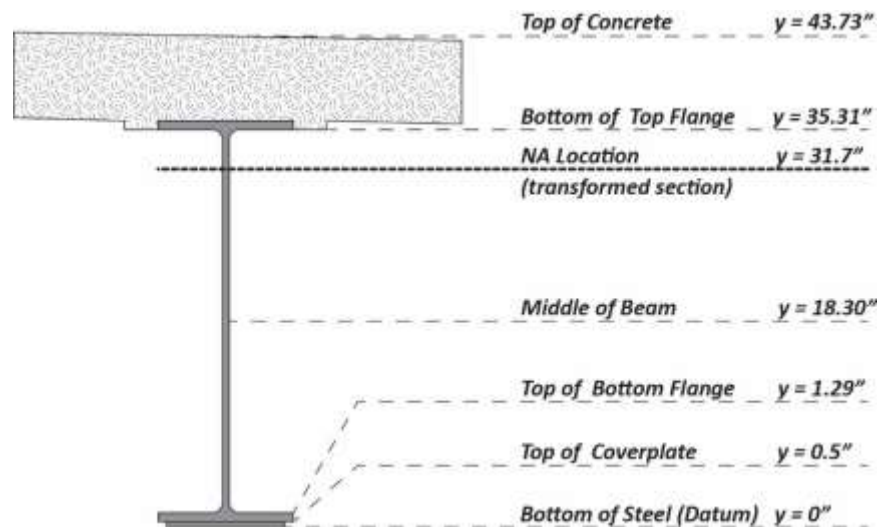
Figure 25: Diagram of Points of Interest Throughout Depth of Composite Section

Using a structural mechanics approach, the location of the neutral axis was calculated using transformed section properties and was 31.7" from the bottom of the steel, as shown in Figure 25. The bottom of the steel in this case is the bottom of the cover plate. By hand calculation (see appendix E) both Beams D and E are assumed to have the same neutral axis location because the curb is taken as outside of the effective width of Beam E and, therefore, does not contribute to the cross sectional properties.

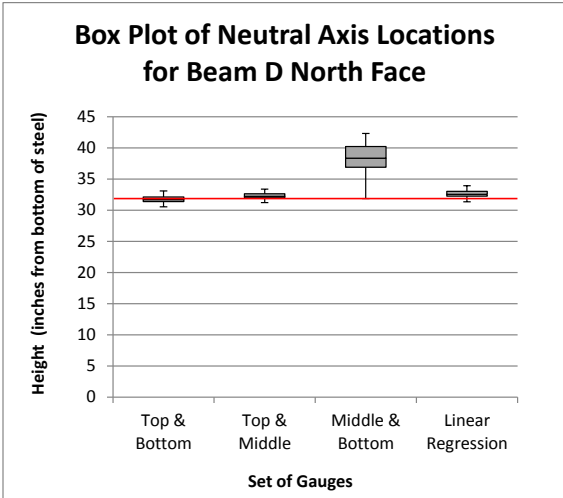
**Figure 28: Box Plot of Neutral Axis Locations Calculated for the North Face of Beam D**

These results have interesting implications for the SHM system at the Bagdad Road Bridge and structural health monitoring systems in general that rely on neutral axis positioning. The positions that were derived using the gauges on the web of Beam D highlight a weakness in SHM systems that use only two gauges per cross section because the readings were shown to be artificially increased through web compression in Appendix H, and yet the resulting feature extractions produced believable values. Beam E is of interest for the system at the Bagdad Road Bridge because the results from the north face indicate the neutral axis is high enough that damage may have occurred, however the south face of the beam indicates a healthy section. This raises questions about the differences that could be occurring on the two faces of Beam E. Two distinct possibilities exist that could be causing the difference; either the top gauge on the north face of Beam E is malfunctioning, or the process of excluding outliers from results using the quarter bridge gauges created samples that on average have erroneously low neutral axis locations.

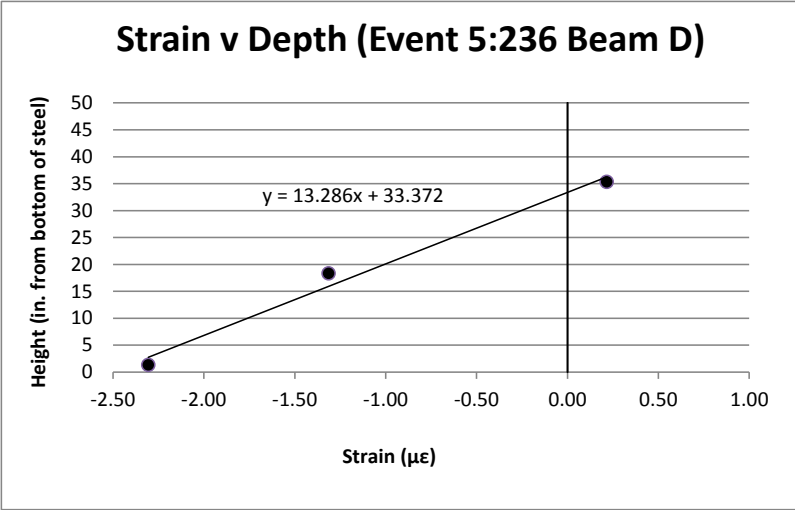
**Figure 32: Example Strain Diagram Derived from a Negative Bending Event**

An example strain diagram is shown in Figure 32 using the negative bending event that caused the largest peak strain in either beam of any negative bending event. As opposed to a positive bending example strain diagram, the strain diagram is drawn on the compressive side during negative bending events, indicated by the negative strain values. Also note that although this was the largest negative bending event of the twelve, it caused less than a three microstrain reading in the bottom flange, which was actually the limit used to remove small, and considered more noise influenced, samples from the Live Load Event Database.

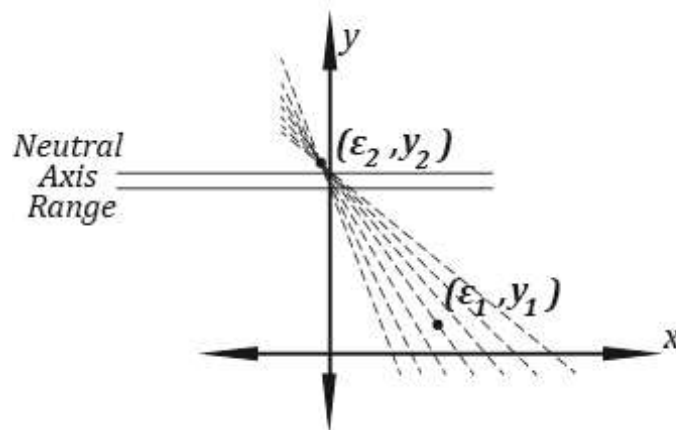
**Figure 33: Illustration of Gauge Error on Neutral Axis Location When Strain Gauge is Located Near NA**

The results from Beam E highlight an interesting concept. If a gauge is placed close to the neutral axis, then the small readings will cause the strain diagram to always pass close to the neutral axis, as shown in Figure 33. The dashed lines in the figure represent strain diagrams produced by erroneous values in a strain gauge located at  $y_1$ . The wide range of erroneous values produces a small shift in neutral axis locations. This could pose a problem for SHM systems with strain gauges installed on or near the neutral axis. In this case, if the strain gauge were to malfunction and no longer collect meaningful values, the calibration routine would zero the strain gauge. This would produce an expected zero value and if movement of the neutral axis actually had occurred for any reason, for example damage, it would go undetected.

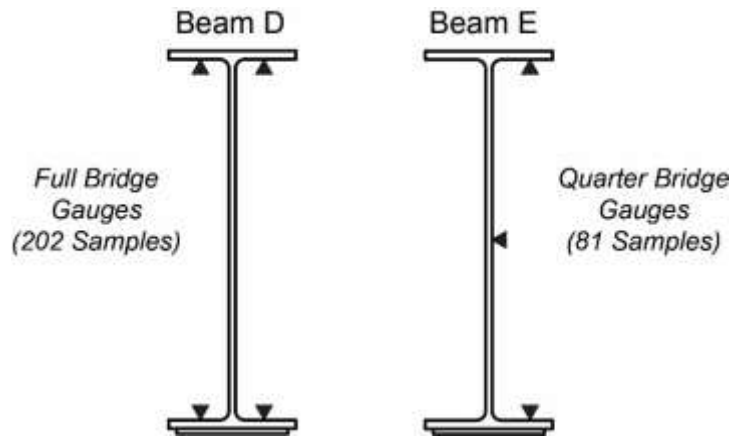
**Figure 34: Location of Gauges Used to Determine Baseline Neutral Axis**

Figure 34 labels the gauges used for determining baselines. The omitted gauges leave the only sets of the top and bottom gauges on both faces of Beam D and all sets on the south face of Beam E. The baseline neutral axis location for Beam D is therefore derived from a sample size of 202 events measured by the pair of top and bottom gauges on each side. The baseline neutral axis for Beam E is determined by using the results from the linear regression of all three readings because combining results from the individual pairs would involve counting some individual readings multiple times, and the set of three readings contains the most amount of data. Furthermore, a single outlier that fell below 12" from the location of the neutral axis determined by structural mechanics, 31.7", was omitted to balance the effect of omitting outliers that were over 12" above the location. This resulted in a sample size of 81.

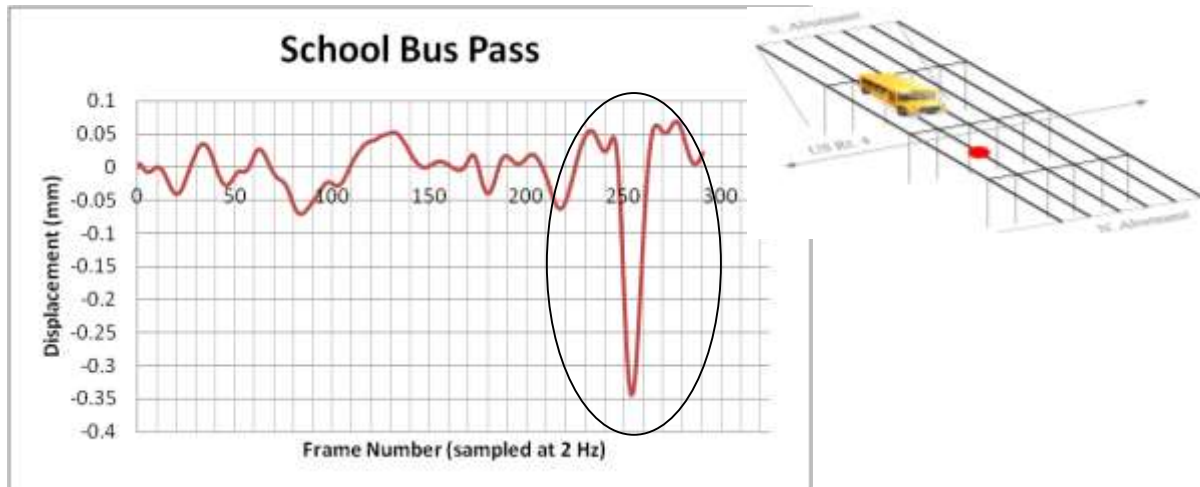
**Figure 37: Time history for displacement of interior beam (Station 4 Girder 5) from bus loading.**

The Bagdad Road Bridge is located adjacent to Oyster River High School and sees school bus traffic twice daily. The buses provide a measurable deflection. Car deflections have been found to be drowned out in the vibrations of the bridge and, therefore, are undetectable. Bus deflection data was collected prior to the load test. A sample of this data is shown in Figure 37.

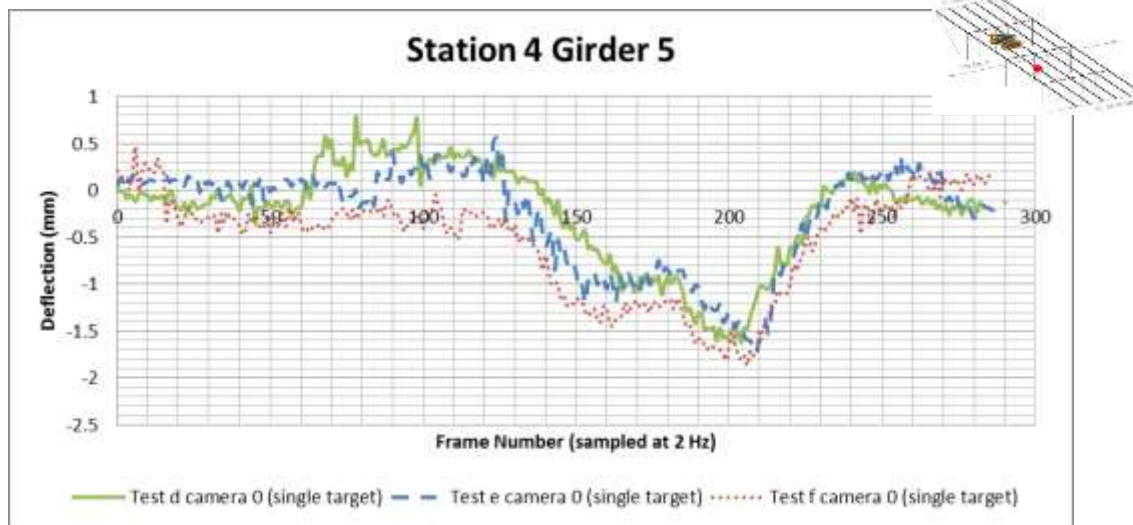
Figure 46: Raw displacements from Bagdad Road load test for Station 4 Girder 5.

Figure 46 through Figure 50 show the displacements at Station 4. The graphs are essentially influence lines for the load test truck. Girder 5 has the most variability at this station. This is attributed to its proximity to the exterior of the bridge and exposure to variable lighting conditions. Overall, the filter improved the clarity of the data, as shown in Figure 46 and Figure 50. However, even after filtering, Station 4 Girder 5 still produced erratic data when the truck was in the spans preceding and following the span of interest. The average deflection of the filtered data for Station 4 Girder 5 is 1.62 mm.

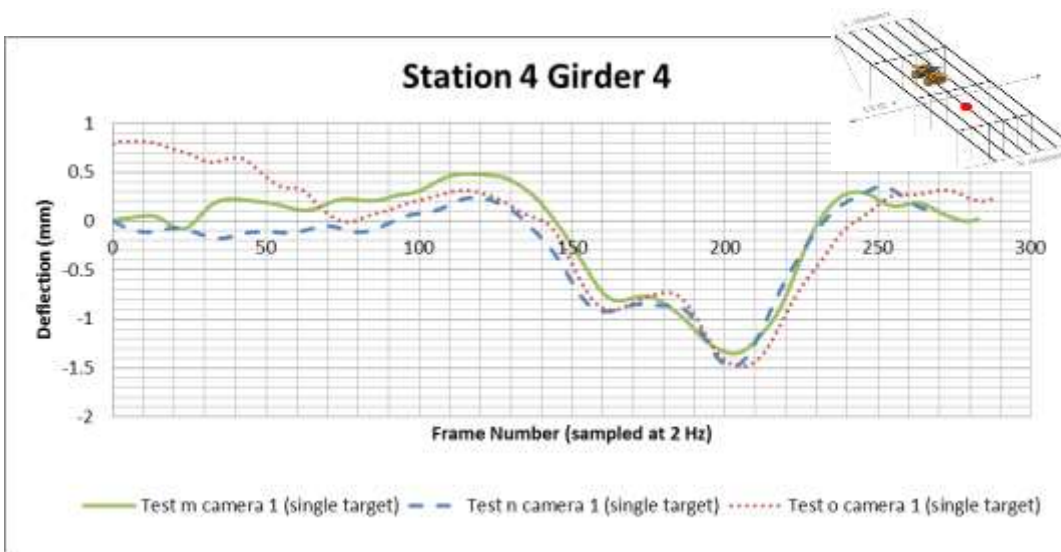
**Figure 48: Filtered and shifted displacements from Bagdad Road load test for Station 4 Girder 4.**

the truck entered the bridge. The displacement did not return to zero after the truck left the bridge, suggesting a permanent deformation. This change was most likely due to some environmental influence such as temperature. June 20<sup>th</sup> 2012 was a typical late spring day with a low of 62 degrees F and a high of 96 degrees F producing a daily swing of 30 degrees F. The deformation may also have been caused by someone bumping into the camera system and tilting the camera upward. Since the focus of this data is on the response of the live load, the initial deformation was removed from the data. The average of 10 data points from just before the truck entered the bridge was subtracted from each data point within the test in order to remove the initial downward drift.

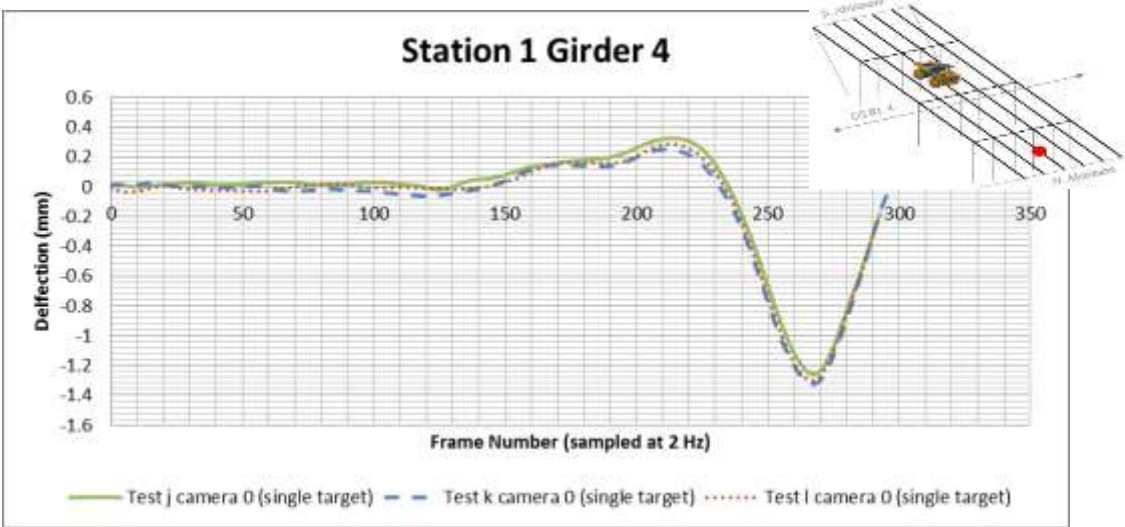
Figure 51: Filtered displacements from Bagdad Road load test for Station 1 Girder 4.

Station 1 Girder 4 was the closest target to the camera system and provided the cleanest data. It is so clear that the slight downward displacement from the truck being two spans away is visible. The average displacement of filtered data for Station 1 Girder 4 was 1.30 mm.

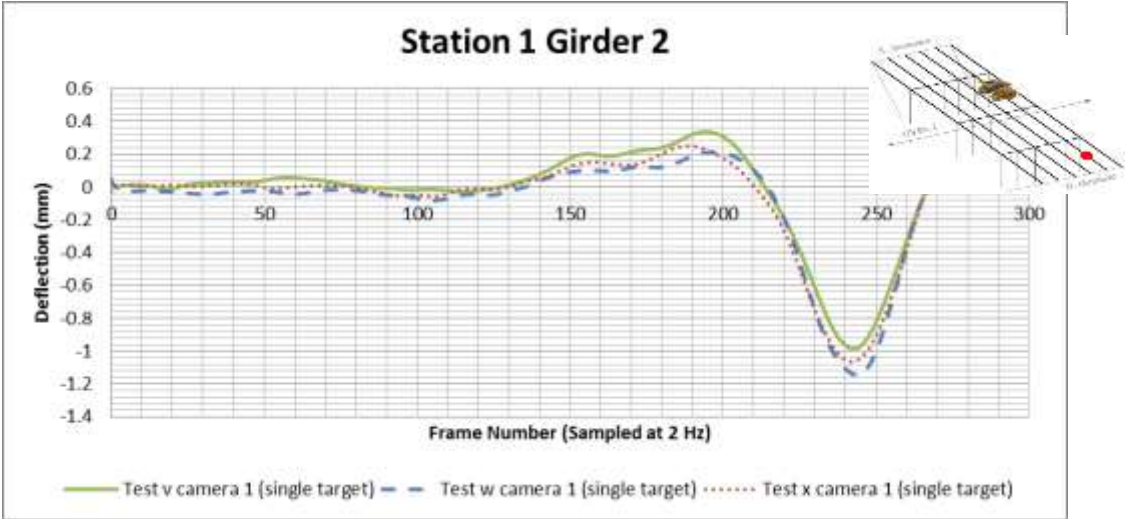
The average deflection of filtered data for Station 1 Girder 2 was 1.07 mm. This exactly equals the average deflection for Station 1 Girder 5. This is encouraging. It shows that despite variables such as truck position and lighting conditions the DIC technique can provide reliable results. The average maximum displacement in Girders 2 and 5 at Station 4 did not match perfectly (1.54 mm in Girder 2 and 1.62 mm in Girder 5). This difference is attributed to the resolution and clarity of the data.

Figure 52: Filtered displacements from Bagdad Road load test for Station 1 Girder 2.

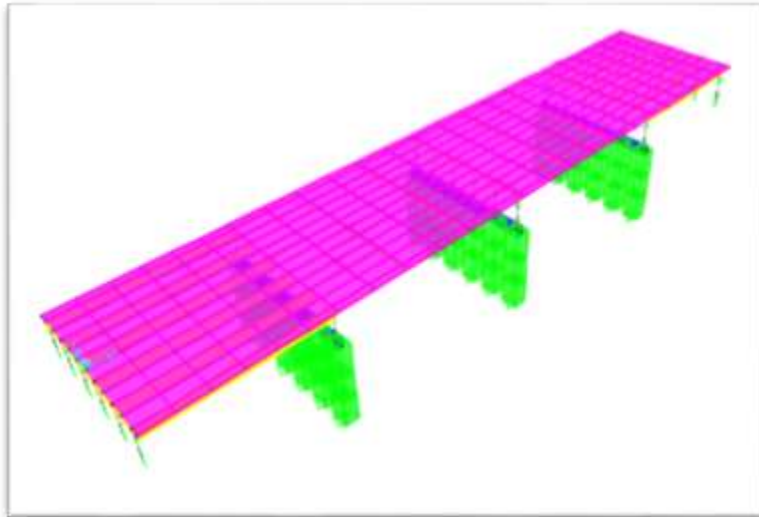
Figure 55: Structural model of Bagdad Road Bridge created in CSiBridge® 15.

A structural model was created in CSiBridge® to compare the results. CSiBridge® is a bridge wizard program that operates within SAP2000®. It is a user interface that compiles the components necessary to efficiently create a structural model of a bridge, and all of the components of the wizard can be found within SAP2000®. The two programs are made by Computers and Structures Inc. and are capable of performing the same analyses. The Bridge was modeled using frame elements since displacement was the only parameter of concern. See Figure 55 for an extruded view of the model. This model was named Base FEM.

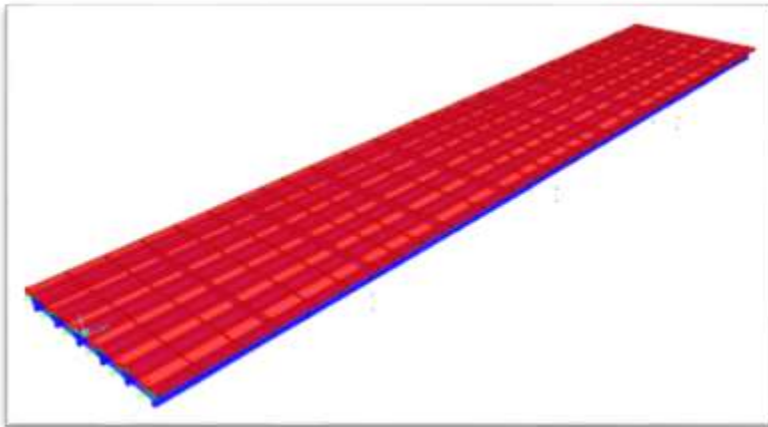
**Figure 59: Calibrated FEM. This model includes the camber, cover plate, and rotational spring refinements. Note that the supports were removed to add the foundation springs.**

The results of Refined FEM did not significantly differ from the results of Base FEM. The deflections for Station1 remained roughly the same, and therefore the percent difference between the DIC results and the model for the average maximum displacement was 34 percent for this span. The deflections for Station 4 decreased by about 0.25 mm, and the percent difference between the average of the maximum displacements decreased from 10.4 to 7.7 percent. Calibrated FEM is a further refinement of Refined FEM. See Figure 59 for an extruded view of the Calibrated FEM model.

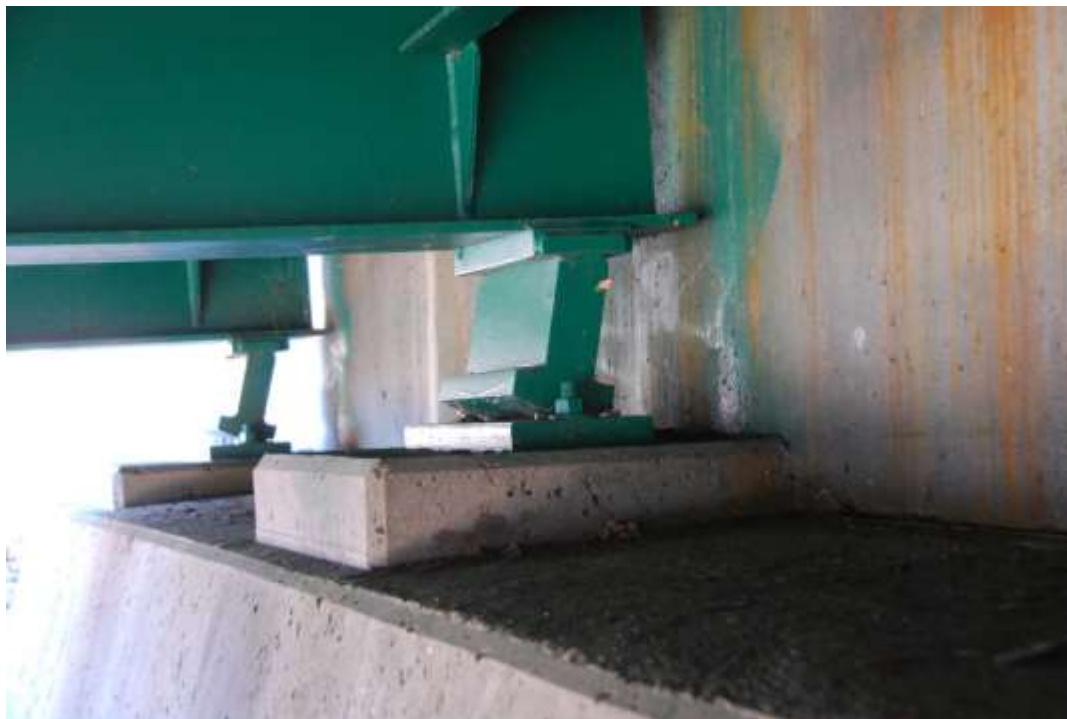
**Figure 60: Fully tipped rocker bearings at North Abutment.**

The idea was to reasonably adjust the rotational fixity of the rocker bearing supports until the displacements resembled the measured displacements. Given that the rocker bearings were mostly tipped at the bents, it is logical that the supports provide more rotational restraint than a roller support. The condition of the rocker bearings has been documented in NHDOT inspection reports since 2006 and is visible in Figure 60.

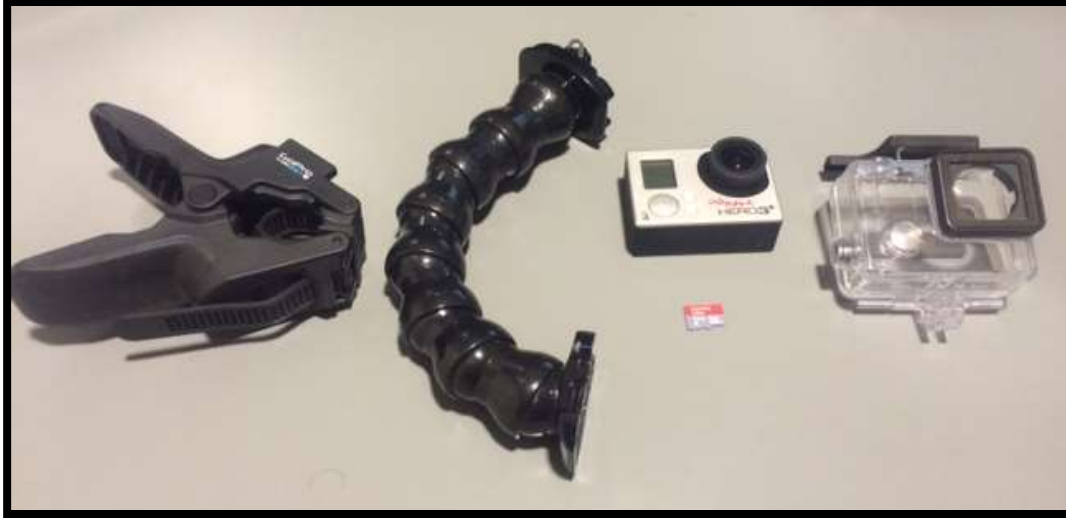
**Figure 68: The collection of parts necessary for assembling the 2D GoPro® DIC sensor**

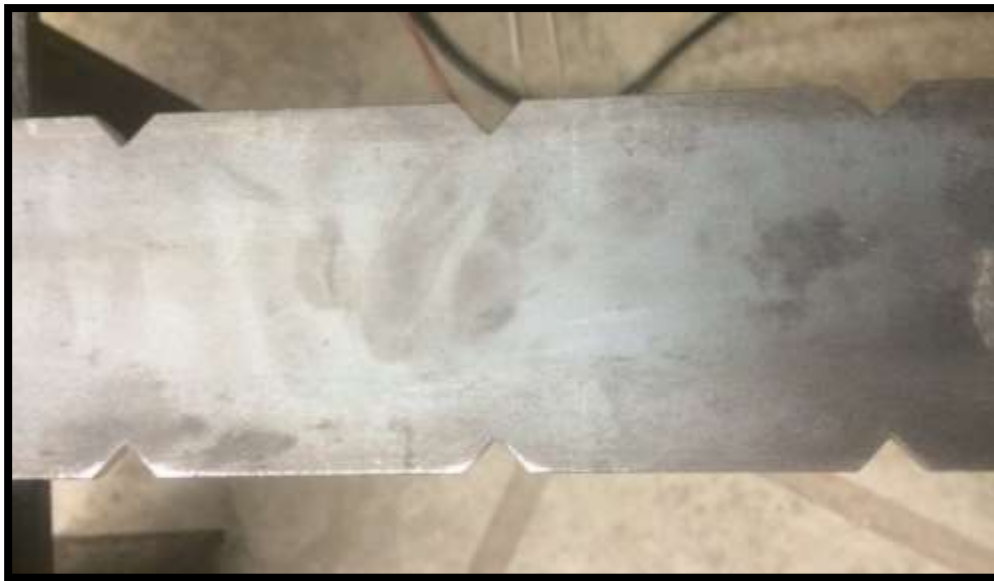
**Figure 73: Photo showing the machined notches on one side of the test beam**

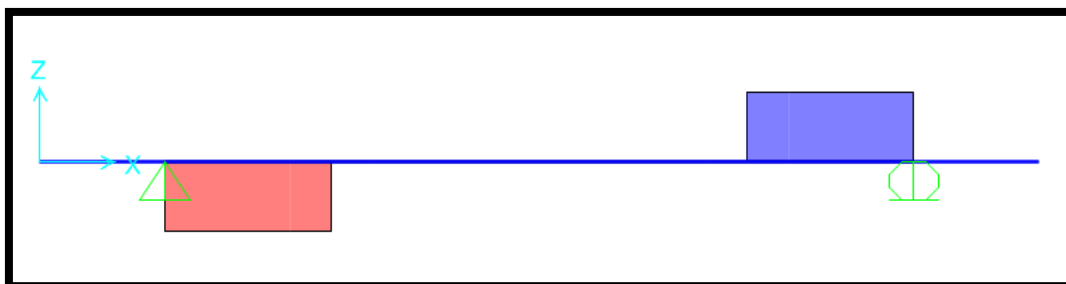
**Figure 74: Shear diagram of the laboratory test apparatus (SAP2000, 2014)**

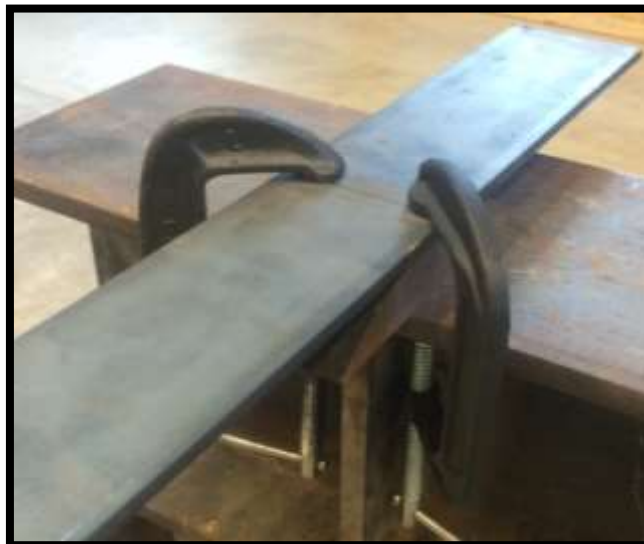
**Figure 76: Picture displaying the clamps used to create fixed conditions for the supports of the test apparatus**

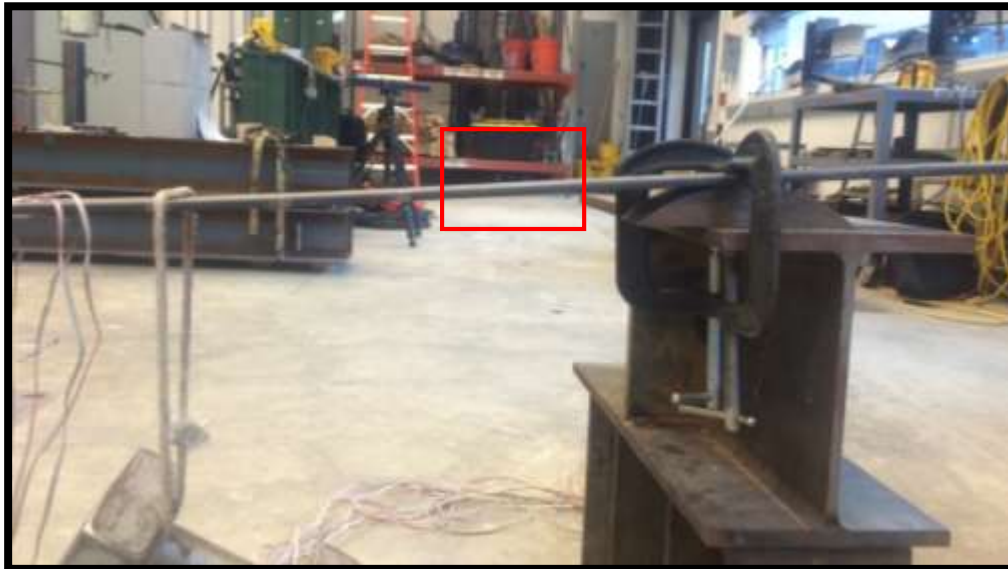
**Figure 77: Photo showing the point of inflection in the curvature of the test beam under fixed conditions**

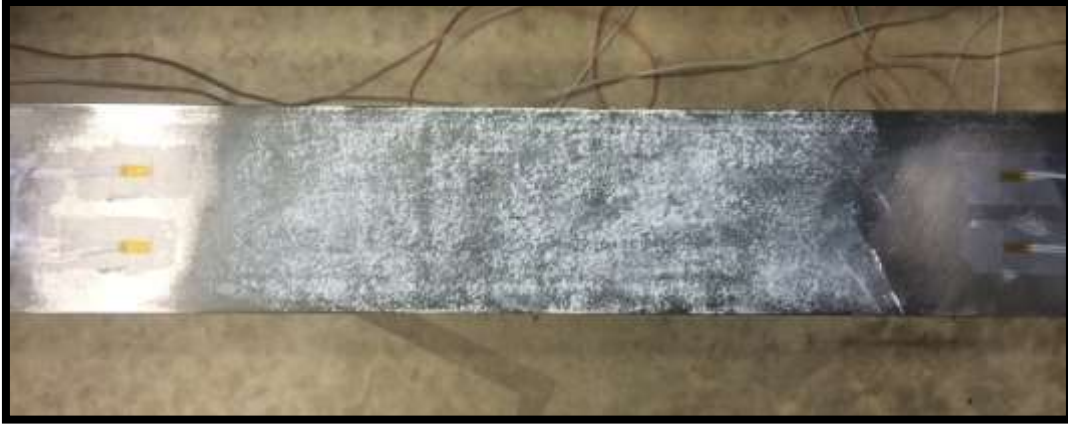
**Figure 78: Top-down view of the test apparatus showing the placement of the foil gauges on either side of the speckle pattern on the center span**

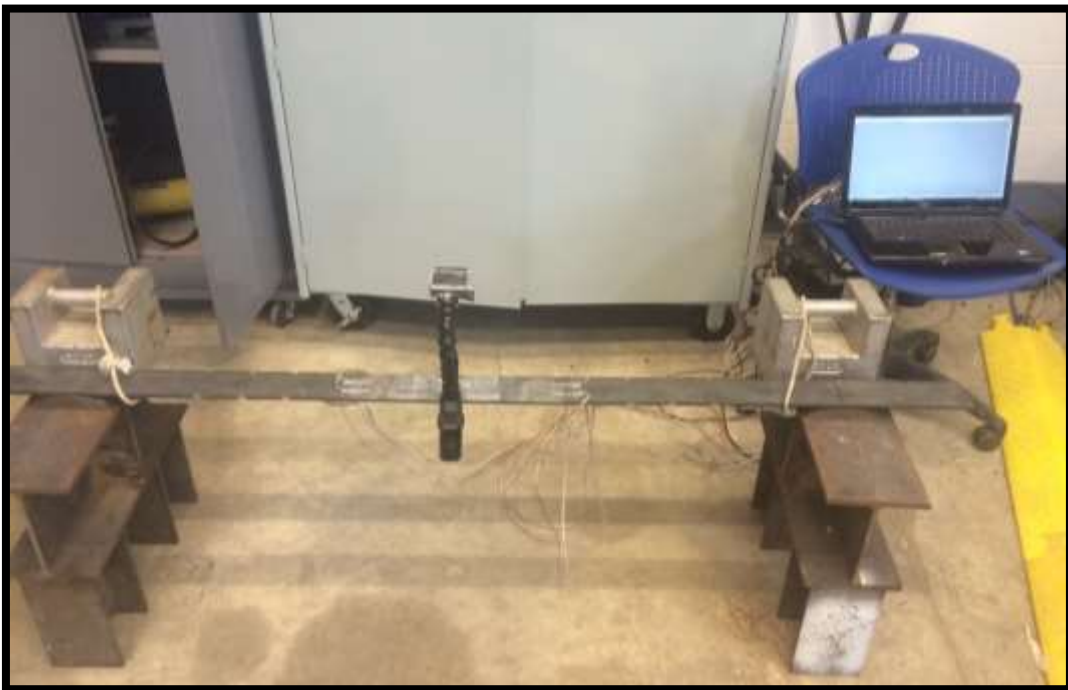
**Figure 79: Fully assembled lab testing apparatus showing both the GoPro® DIC and foil gauge strain measurement systems**

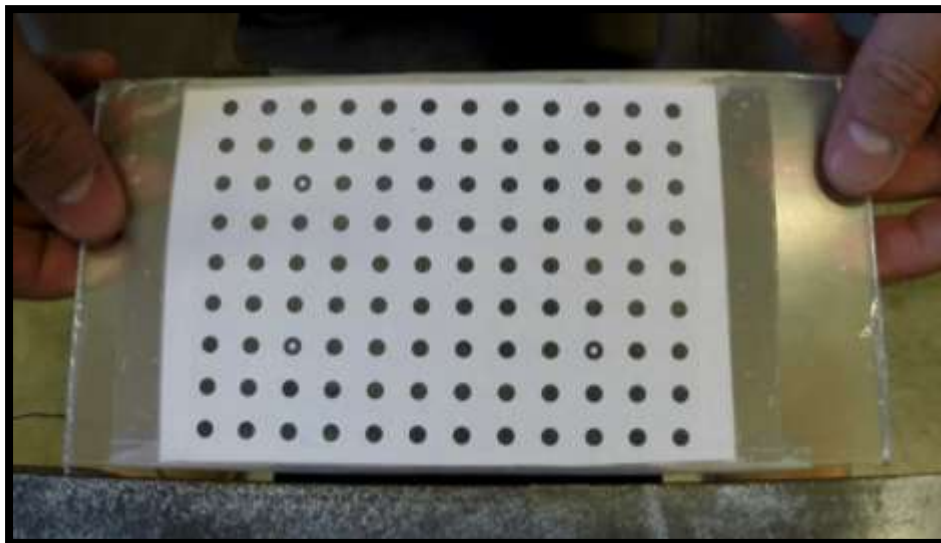
**Figure 81: Sample photo of the calibration target grid used in testing**

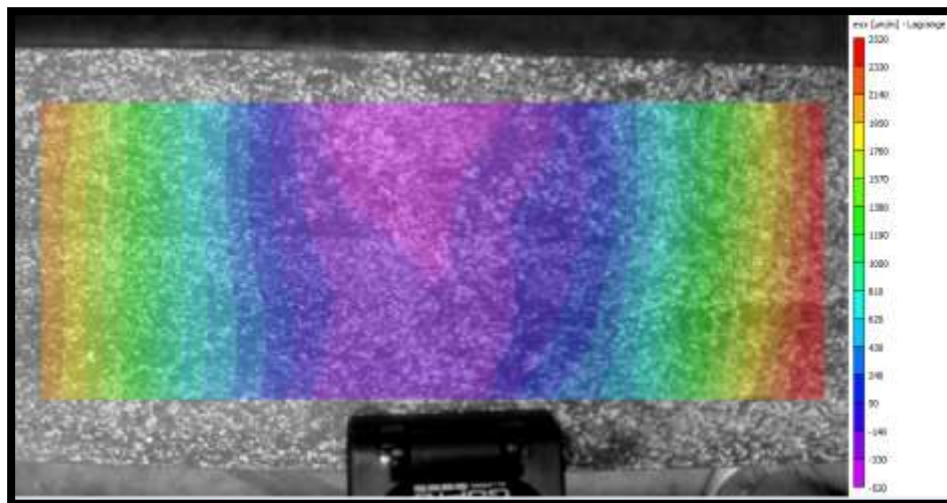
**Figure 82: Sample strain field calculated from the lab test showing the unexpected strain distribution**

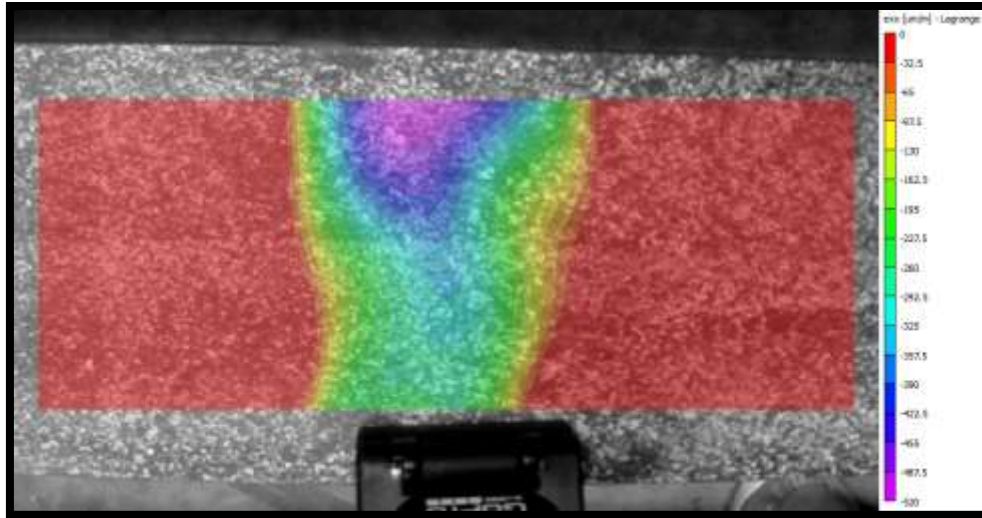
**Figure 83: Sample strain field with the contours adjusted to only show the regions in compression**

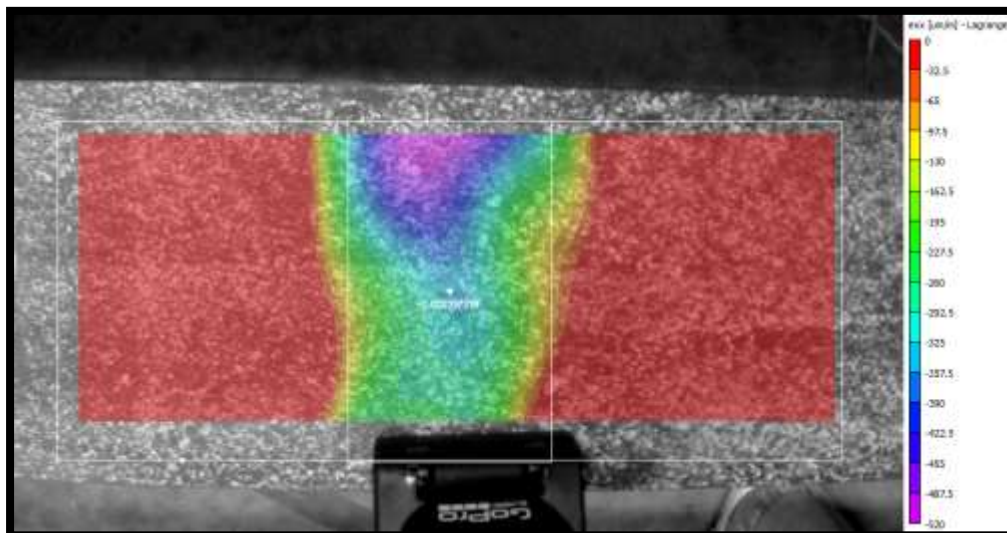
**Figure 84: Snip showing the AOE's, shown as white boxes, used for data extraction. The larger one extracts data from the entire AOI, while the other only extracts from the region in compression**

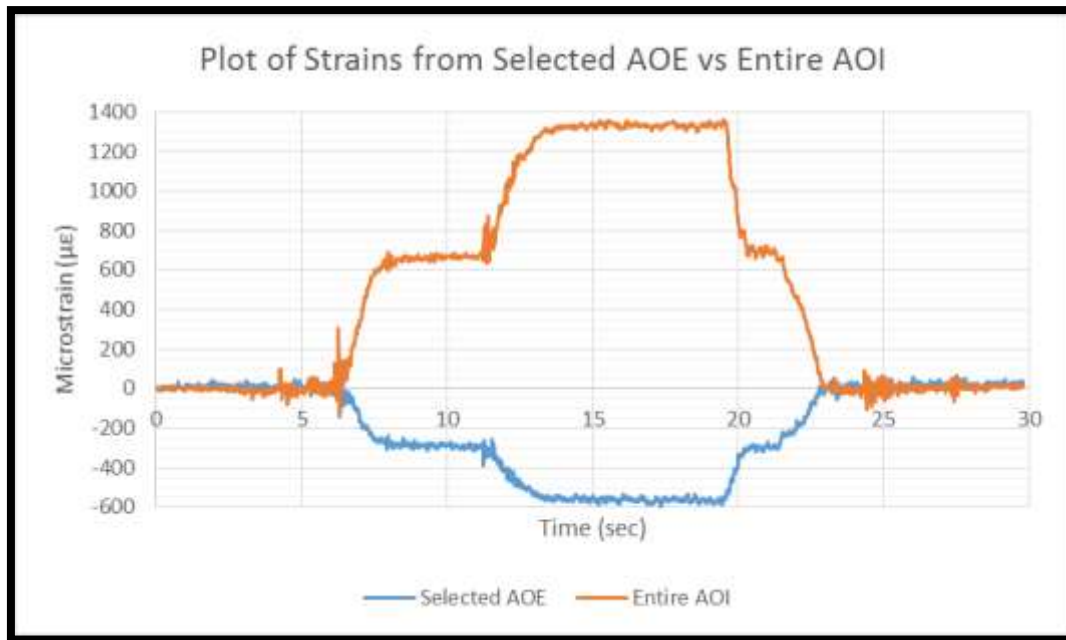
**Figure 85: Plot showing the comparison of measured strains from DIC between using a selected AOE or the entire AOI**

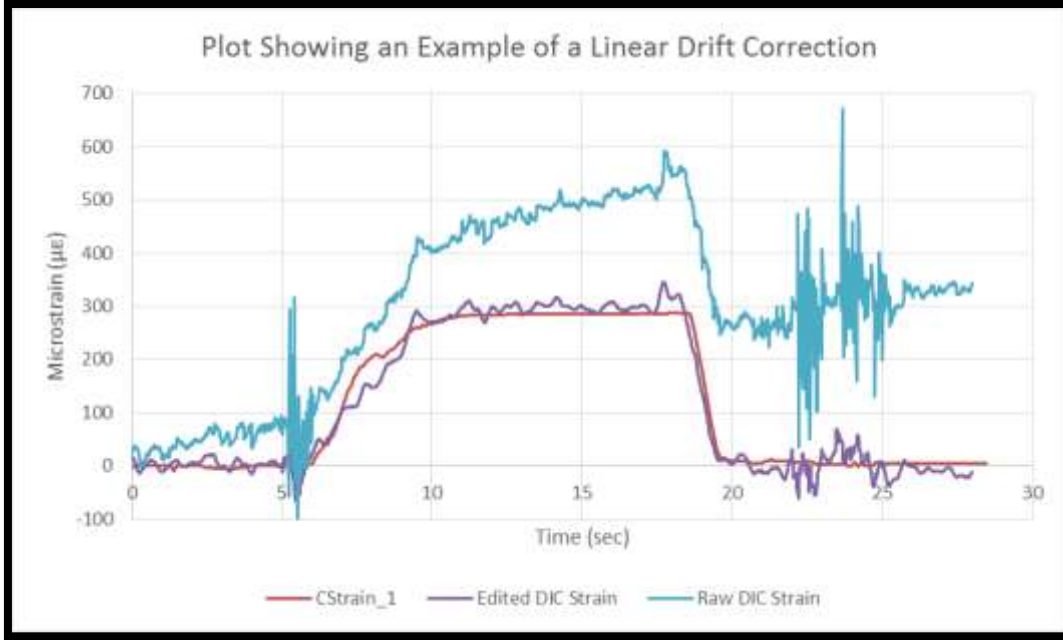
**Figure 87: Plot showing the effects of using the combination of the rolling average and the linear drift correction**

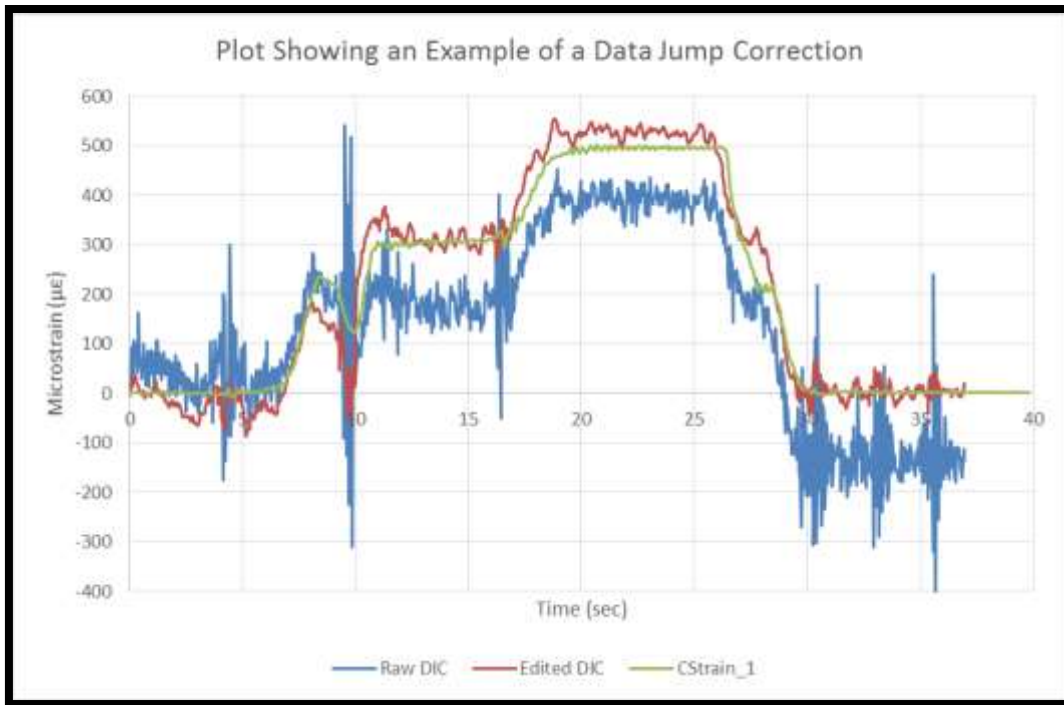
**Figure 88: Plot showing an example of a correction for a data jump caused by bumping the test set up**

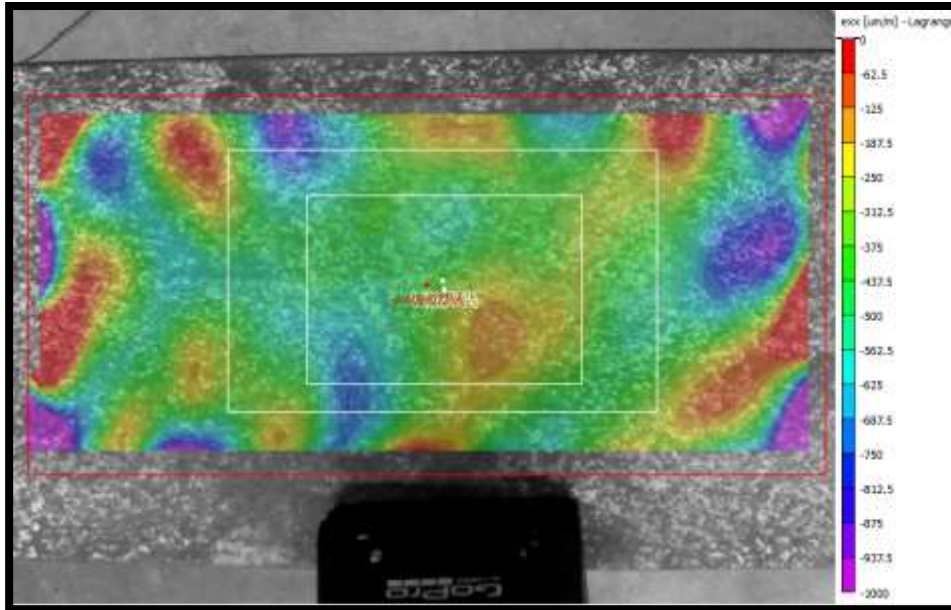
Figure 89: Snip displaying the method of AOE selection used in 3D Trial 3 (Vic-3D, 2012)

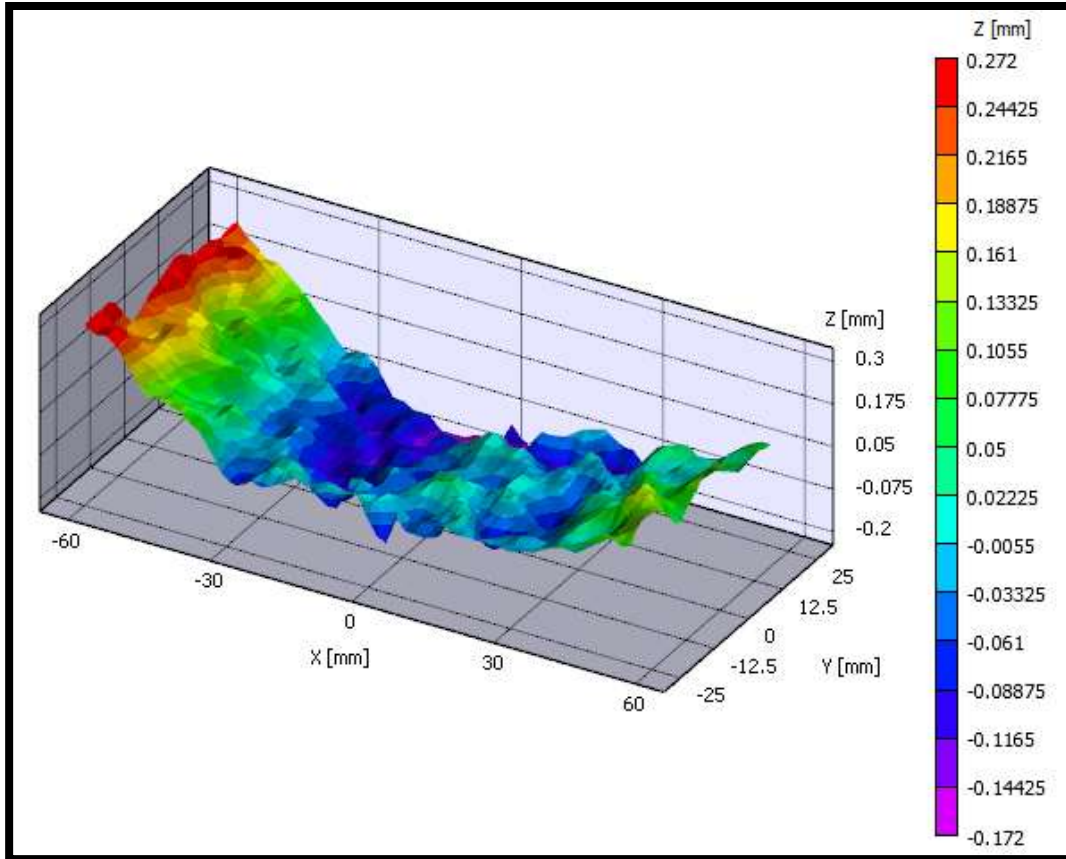
**Figure 91: Snip showing a sample 3D projection of the beam surface under maximum loading (Vic-3D, 2012)**

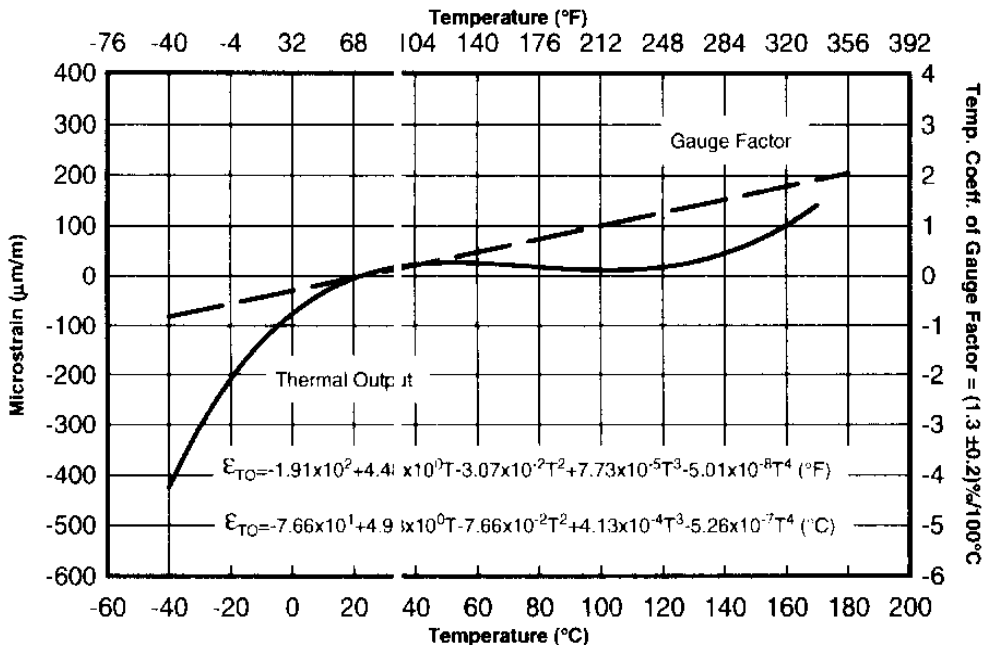
Figure B-11: Thermal Effects on Full Bridge Axial Strain Gauge

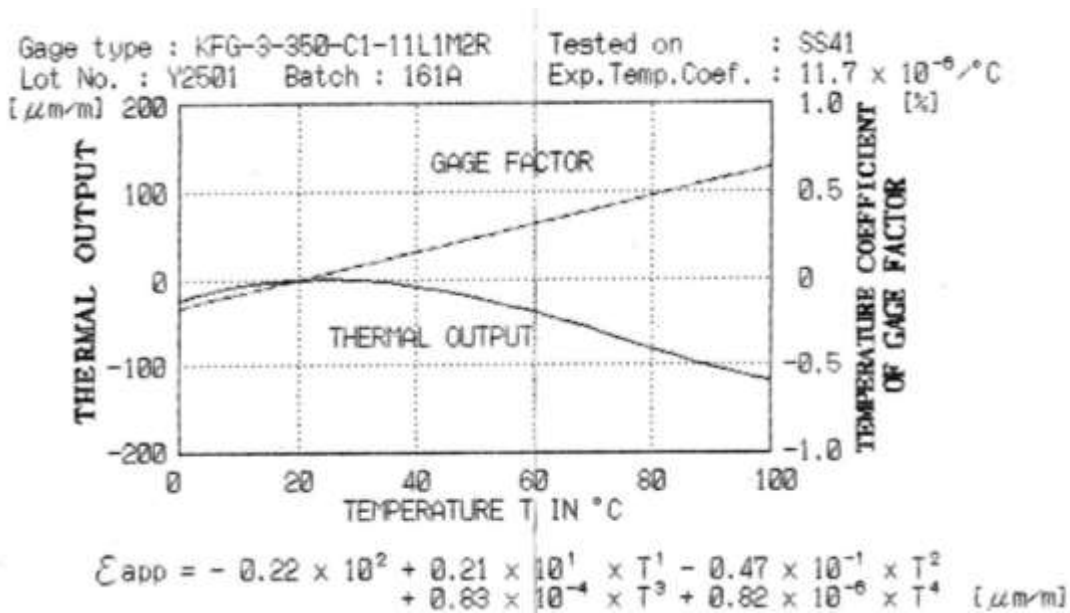
Figure B-12: Thermal Effects on Quarter Bridge Strain Gauge

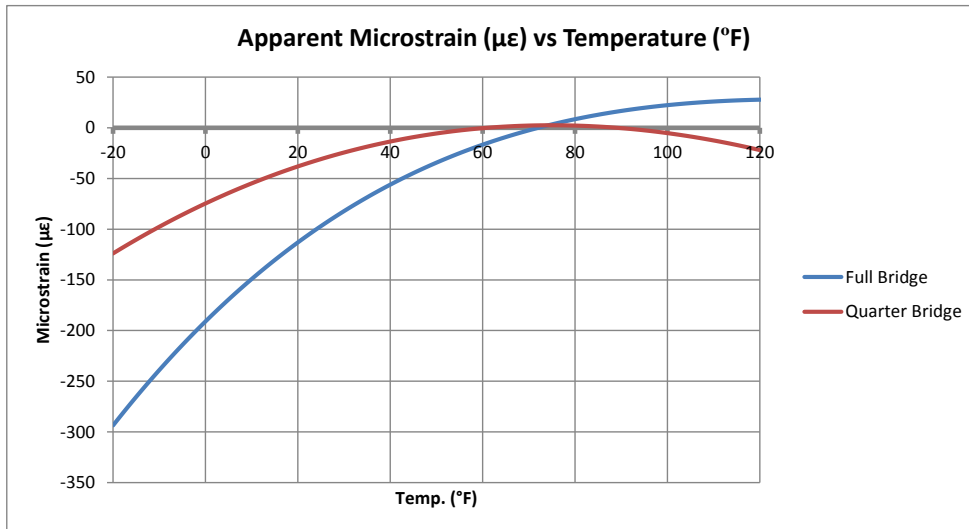
**Figure B-13: Apparent Microstrain Curves of Full and Quarter Bridge Gauges**

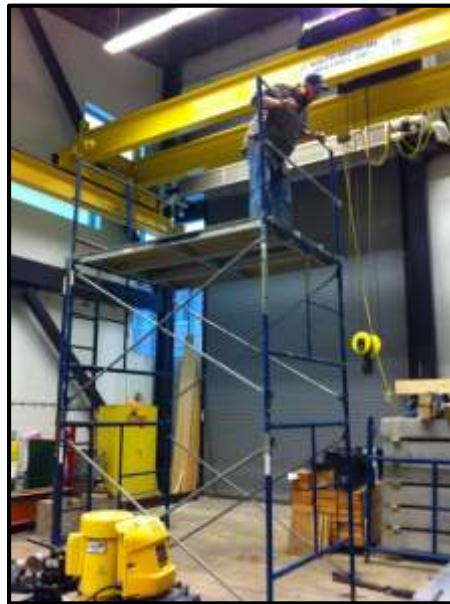
Figure C-3: Photo of Scaffolding Assembled during Practice Run

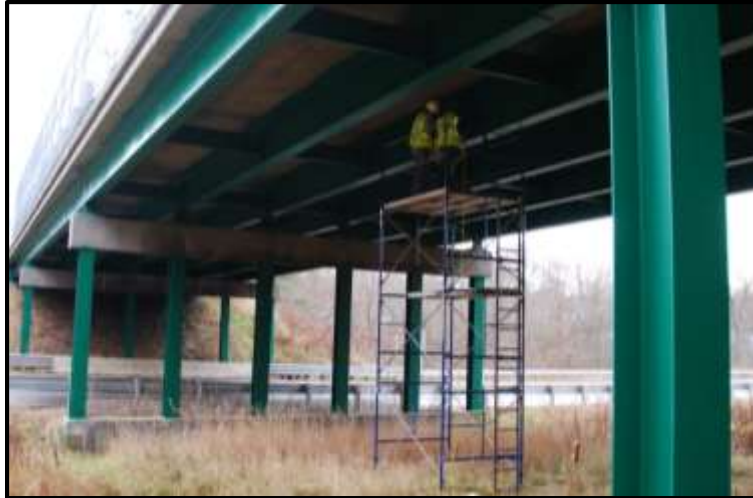
**Figure C-5: Scaffolding Assembled at Bagdad Rd Installation Site**

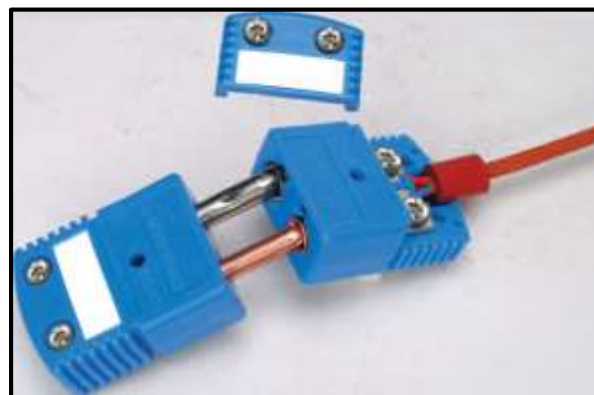
**Figure C-6: Thermocouple Plug Connectors**

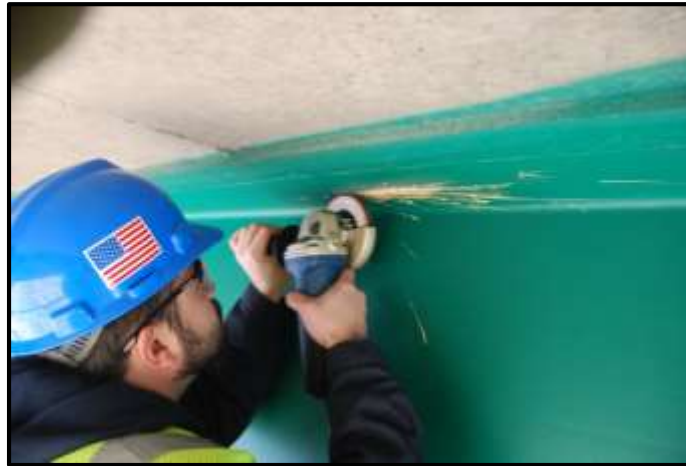
**Figure C-7: Photo of the Grinding Step of the Strain Gauge Installation Process at the BRB**

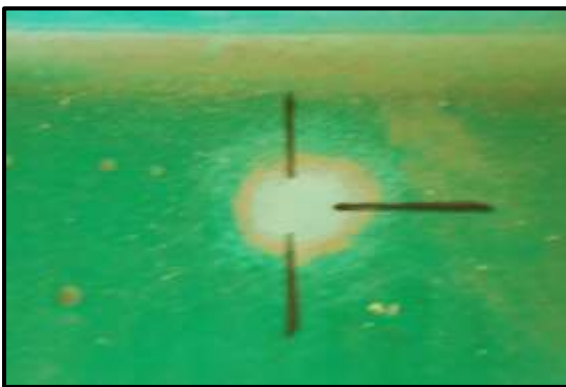
**Figure C-8: Photo of Prepped Gauge Installation Site**

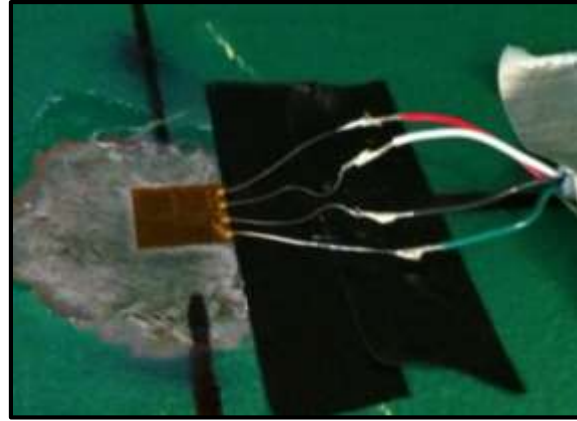
**Figure C-14: Photo of Gauge Installation – Soldered Without Terminal Strip**
