**Instrumentation, Digital Image Correlation,  
and Modeling to  
Monitor Bridge Behavior and Condition**  
**Final Report**

Prepared by the University of New Hampshire Department of Civil Engineering for the  
New Hampshire Department of Transportation in cooperation with the U.S.  
Department of Transportation, Federal Highway Administration

# **Instrumentation, Digital Image Correlation, and Modeling to Monitor Bridge Behavior and Condition Assessment**

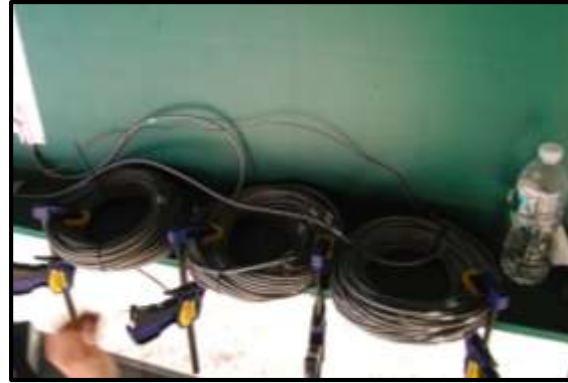
**Figure C-18: Photo of Gauge Installation – Wires Clamped to Bottom Flange**

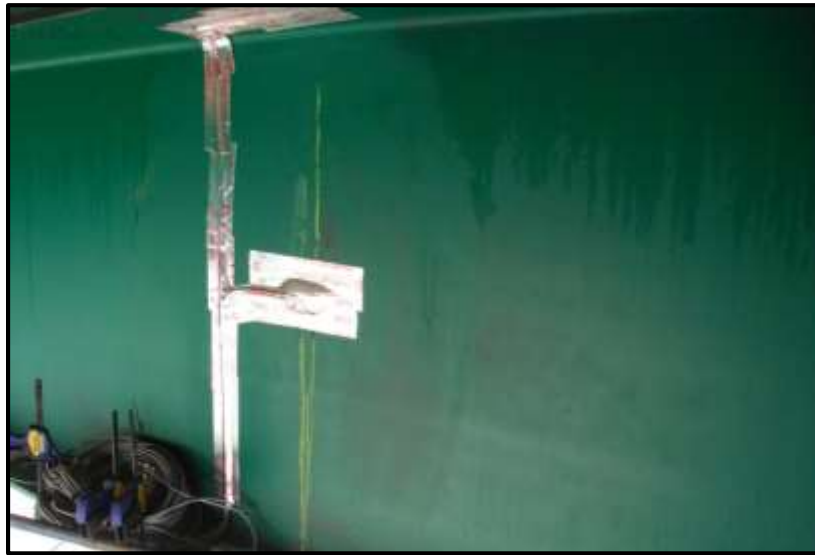
**Figure C-22: Photo of Condensation on Beam Surface**

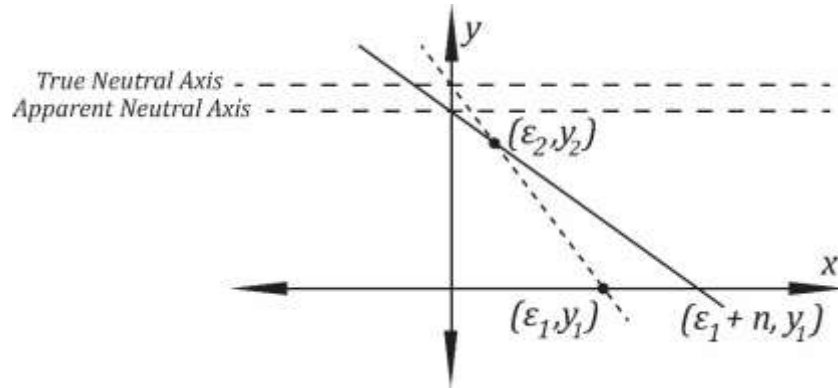
**Figure E-5: Illustrated Effect of Noise on Apparent Neutral Axis Location**

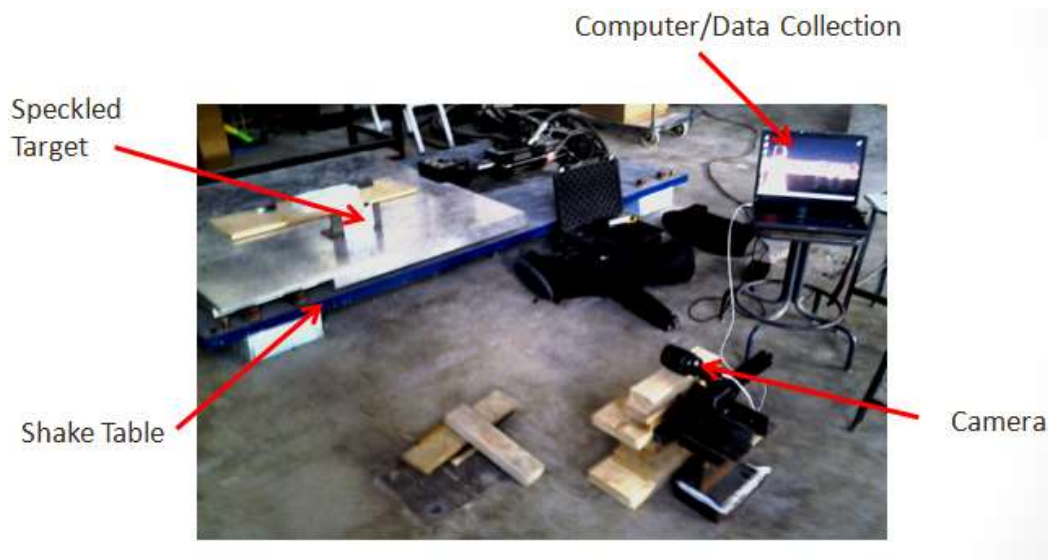
**Figure F-1: Lab testing setup using a shake table with a known displacement.**

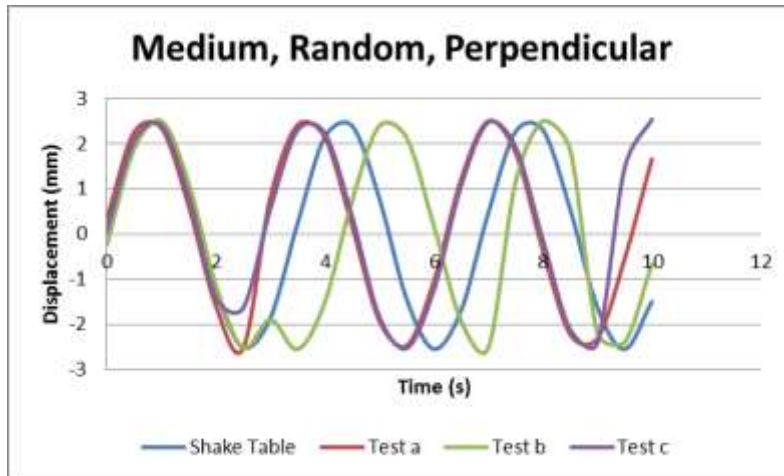
**Figure F-7: Shake table test results for a medium size speckle pattern, random lighting, and the camera perpendicular to the target.**

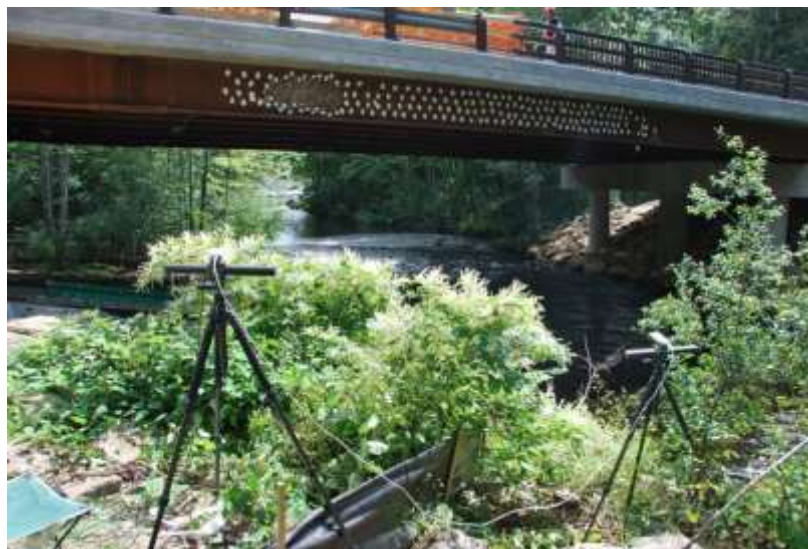
**Figure F-11: Cameras not setup level with girders. Note: this photo is of previous research performed at UNH.**

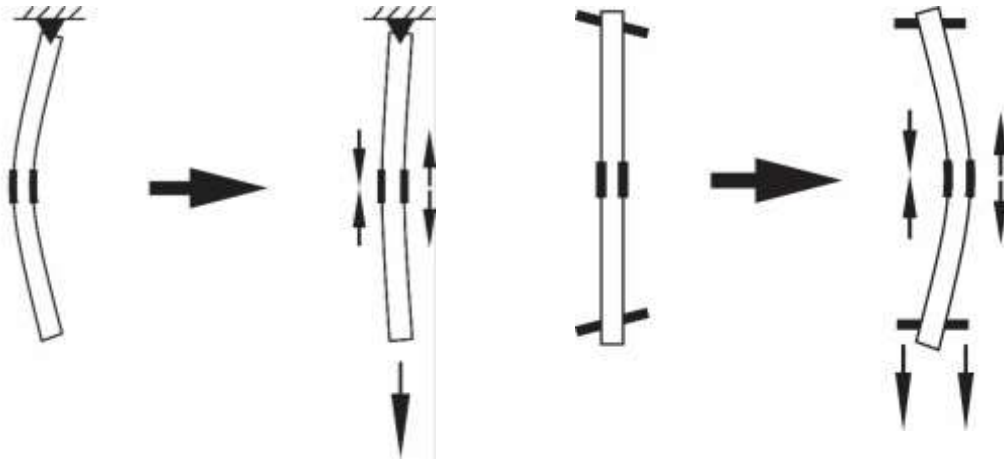
**Figure H-5: Illustration of Flat Bar Straightening**

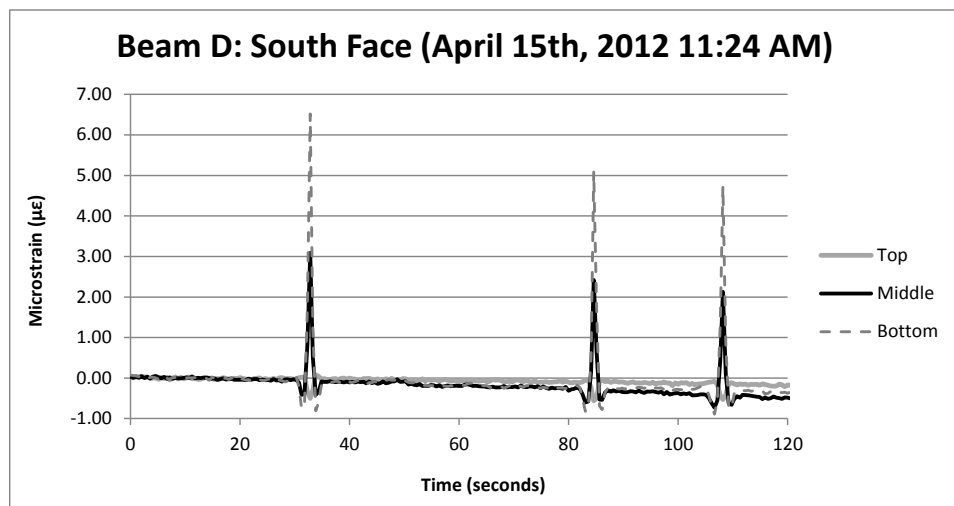
**Figure H-10: Graph of Data Collected During Initial Gauge Evaluation after Installation**

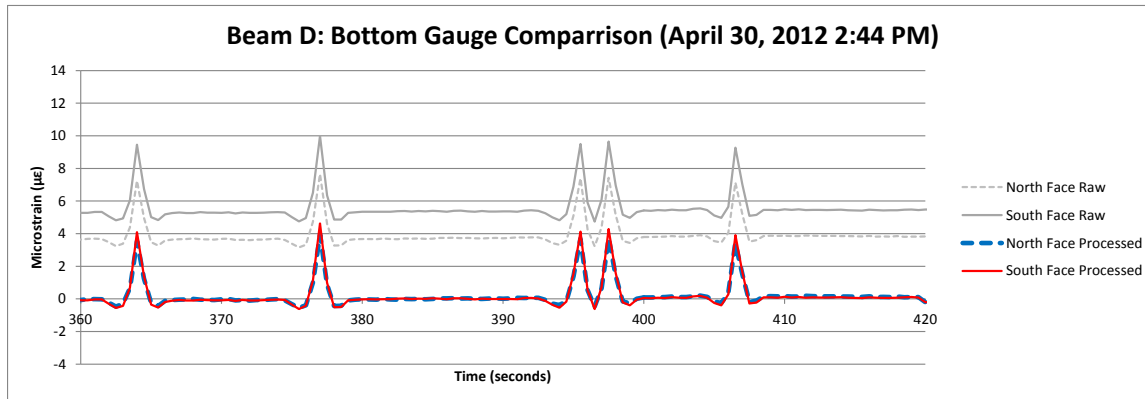
**Figure H-7: Comparison of Measurements from Bottom Flanges of Beam D**

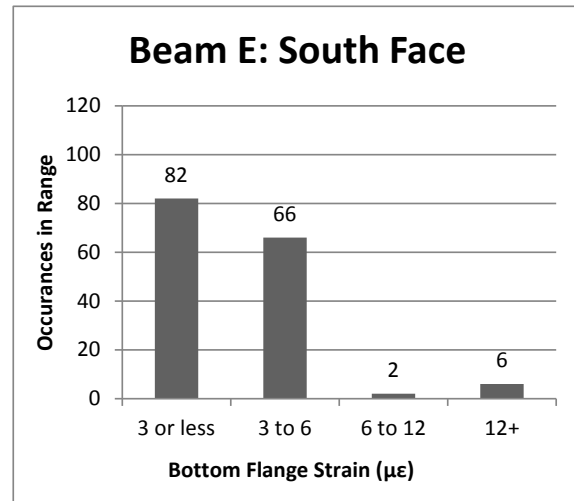
**Figure H-11: Histogram of Bottom Flange Strain Values on South Face of Beam E**

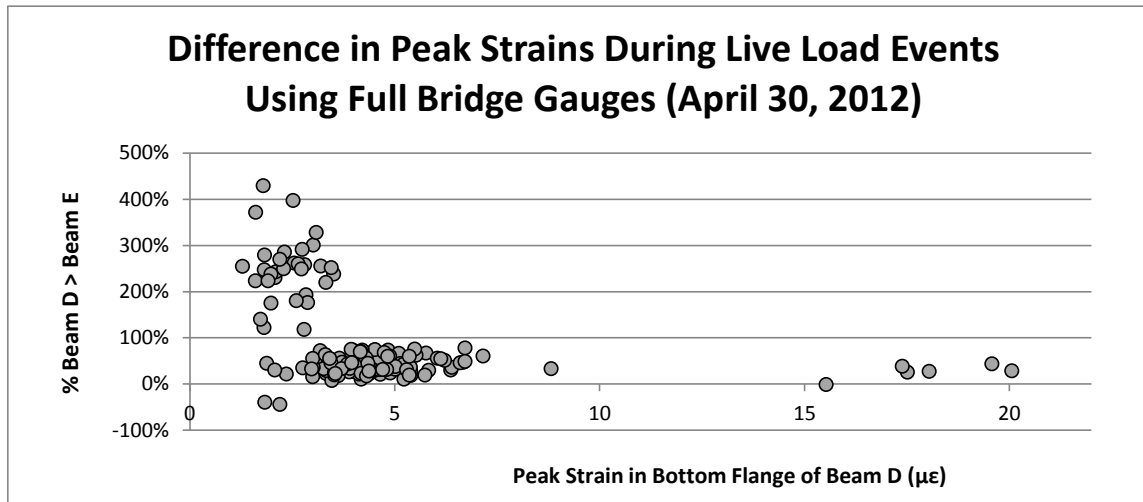
**Figure H-12: Scatter Plot of Percent Difference between Peak Strains Beam to Beam**

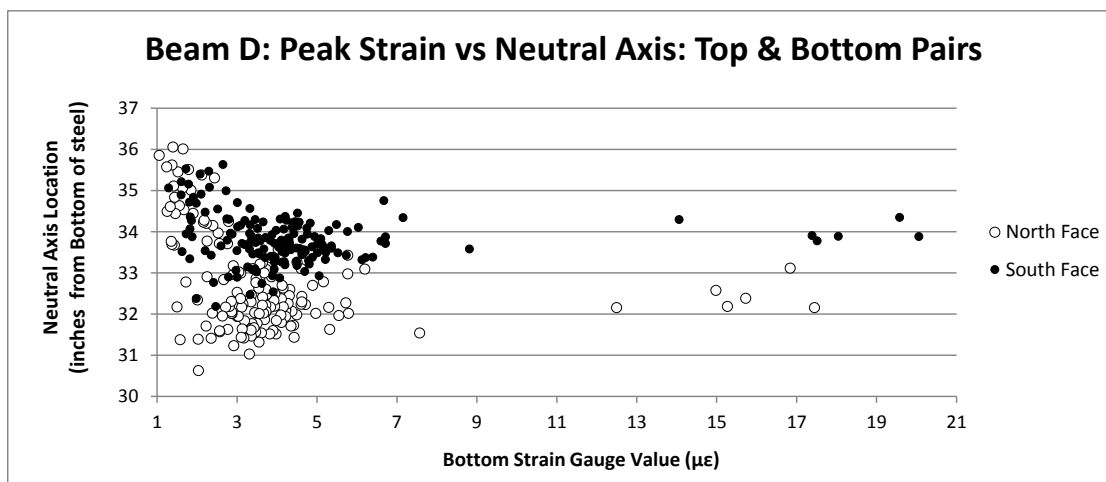
**Figure H-18: Scatterplot of Neutral Axis Locations versus Peak Strains for All Live Load Events Using Top & Middle Strain Gauge Readings on North & South Faces of Beam D**

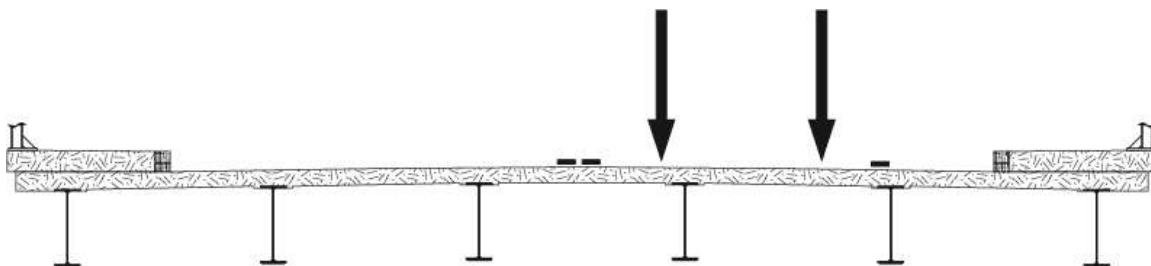
**Figure H-139: Deck Cross Section with Highlighted Lane Lines and Likely Vehicle Path on the Bagdad Road Bridge**

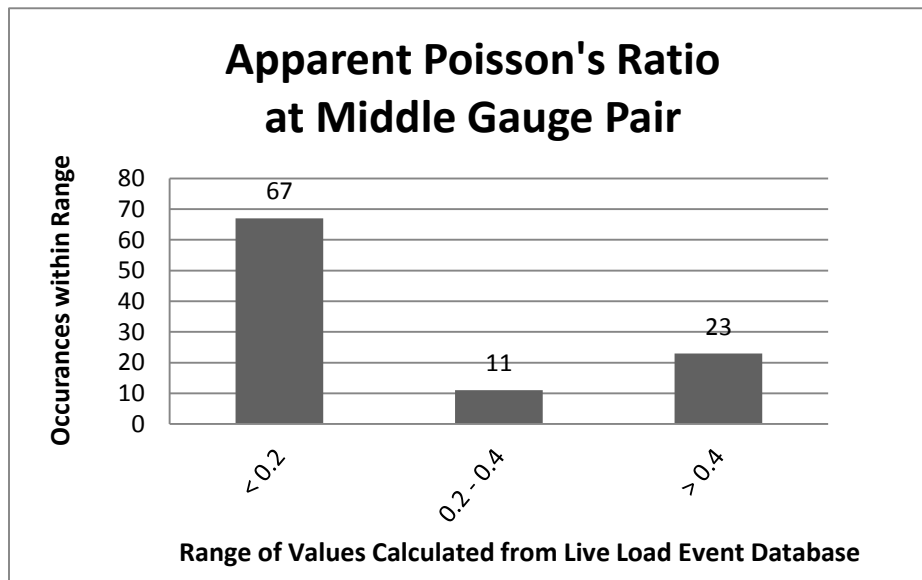
**Figure H-20: Histogram of Apparent Poisson's Ratio Results Calculated from Gauges on the Web**

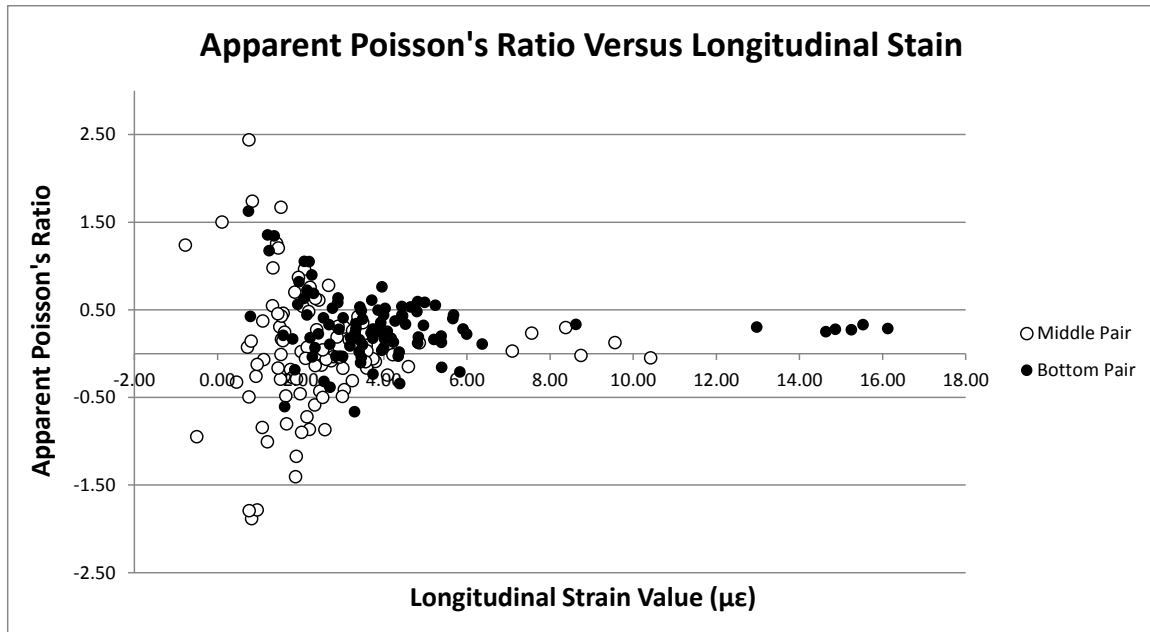
**Figure H-15: Scatterplot of Apparent Poisson's Ratio's Versus Longitudinal Strains from Middle and Bottom Gauges**

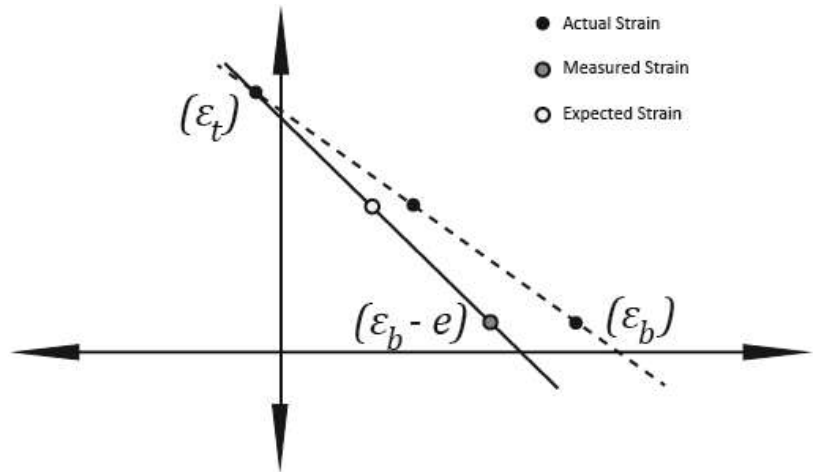
**Figure H-17: Illustration of Gauge Error on Strain Diagram**

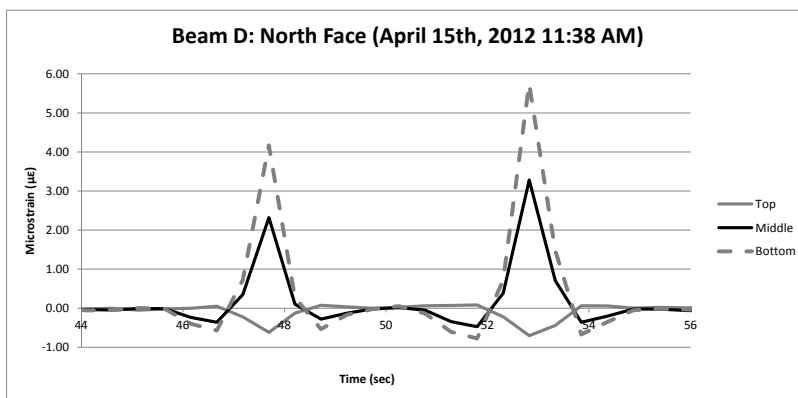
**Figure H-19: Graph of Strain Measurements on North Face of Beam D during Initial Evaluation**

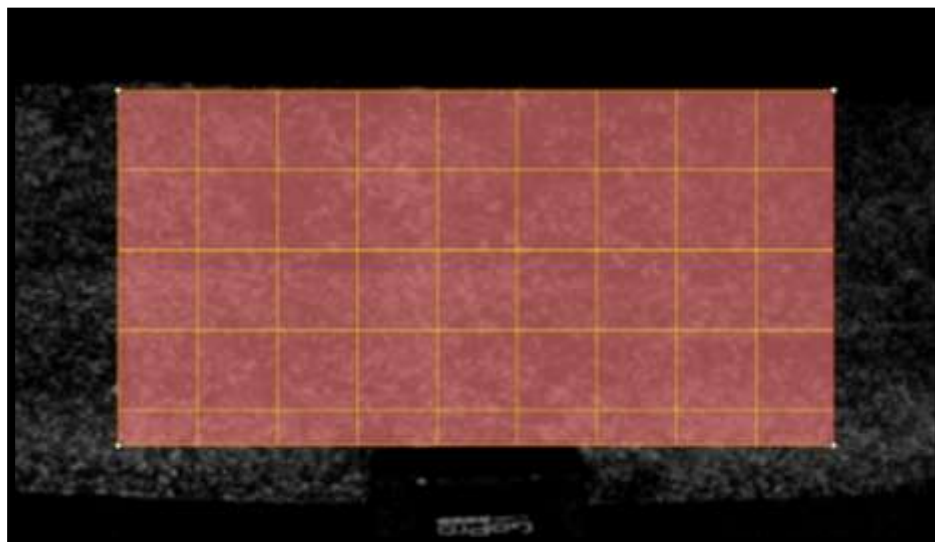
**Figure K-2: Recommended subset mesh for 2D Trial 1 in Light 1 conditions**

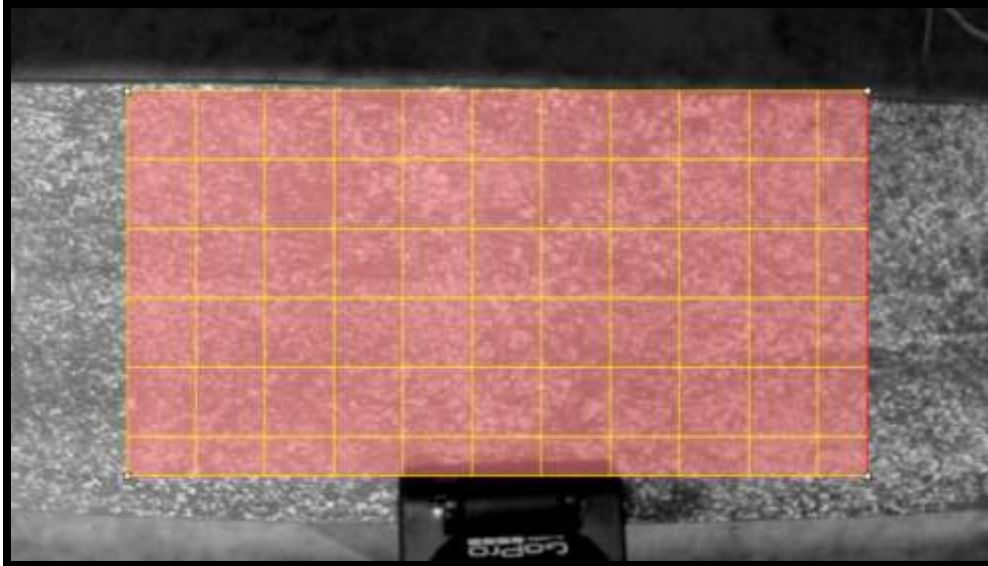
**Figure K-3: Recommended subset mesh for 2D Trial 1 in Light 2 conditions at 720p resolution (Vic-3D, 2012)**

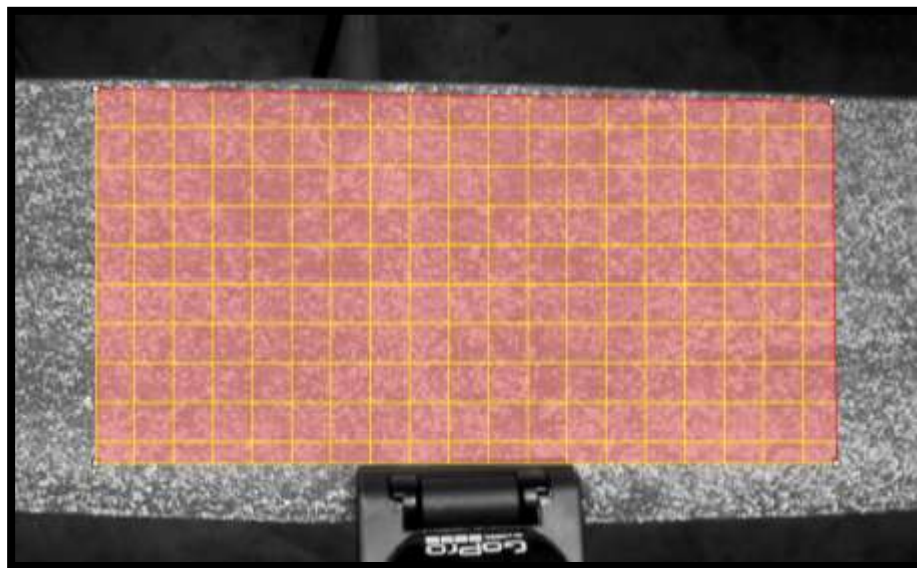
**Figure K-4: Recommended subset mesh for 2D Trial 1 in Light 3 conditions at 720p resolution (Vic-3D, 2012)**

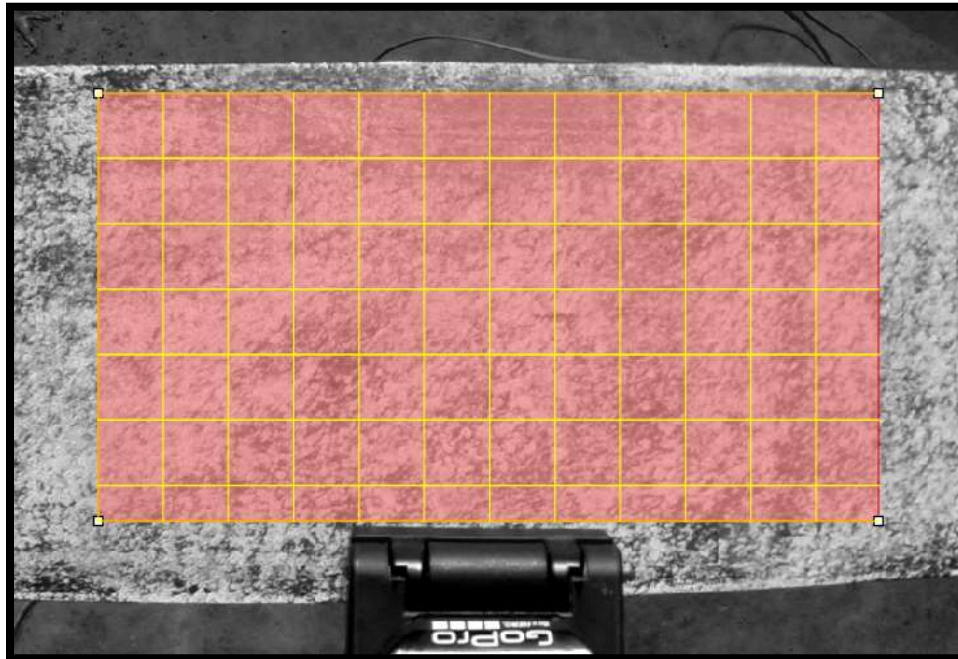
**Figure K-5: Recommended subset mesh for 2D Trial 1 in Light 3 conditions at 720p resolution at Height 1 (Vic-3D, 2012)**

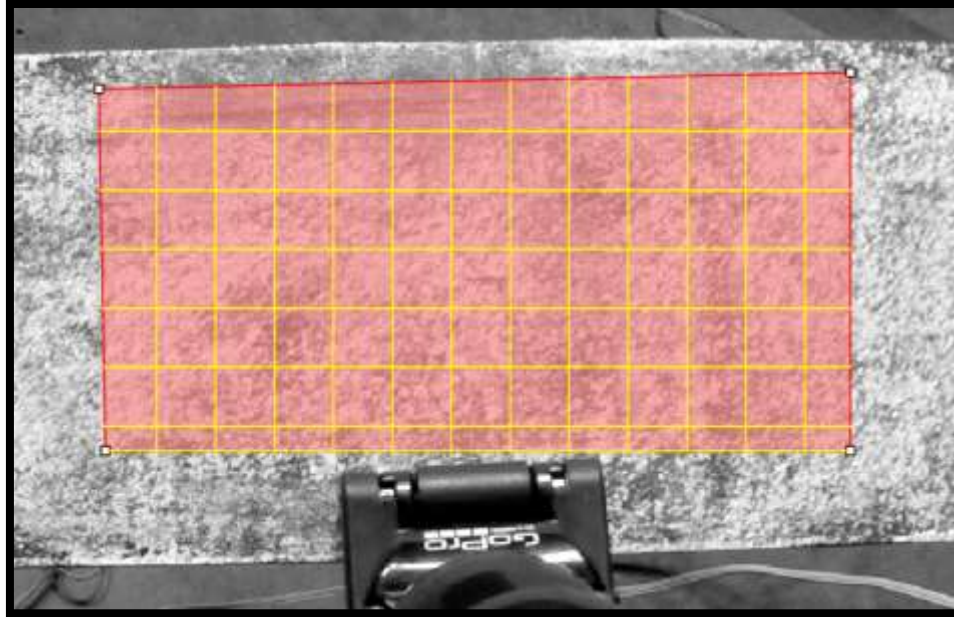
**Figure K-6: Recommended subset mesh for 2D Trial 1 in Light 3 conditions at 720p resolution (Vic-3D, 2012)**

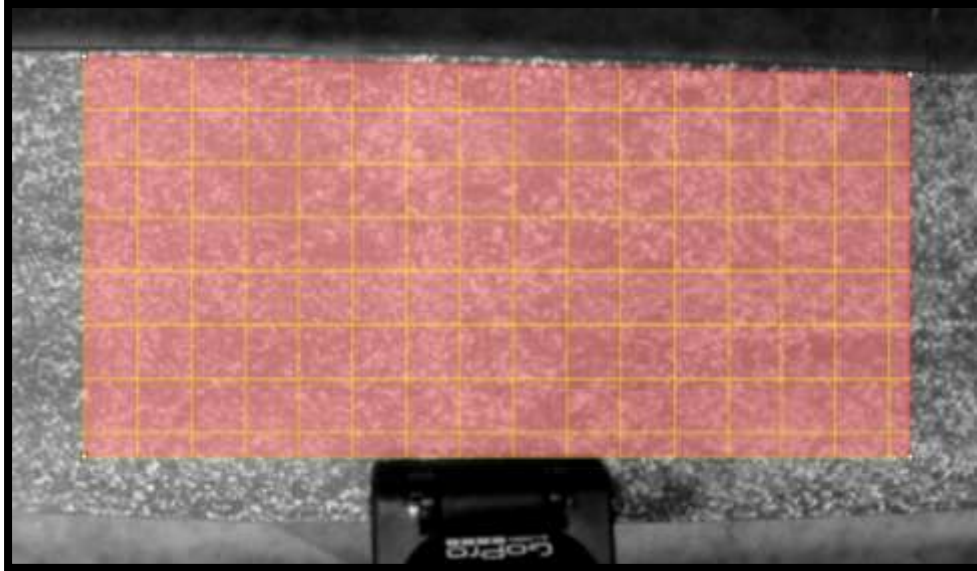
**Figure K-7: Recommended subset mesh for 2D Trial 1 in Light 2 conditions at 1080p resolution (Vic-3D, 2012)**

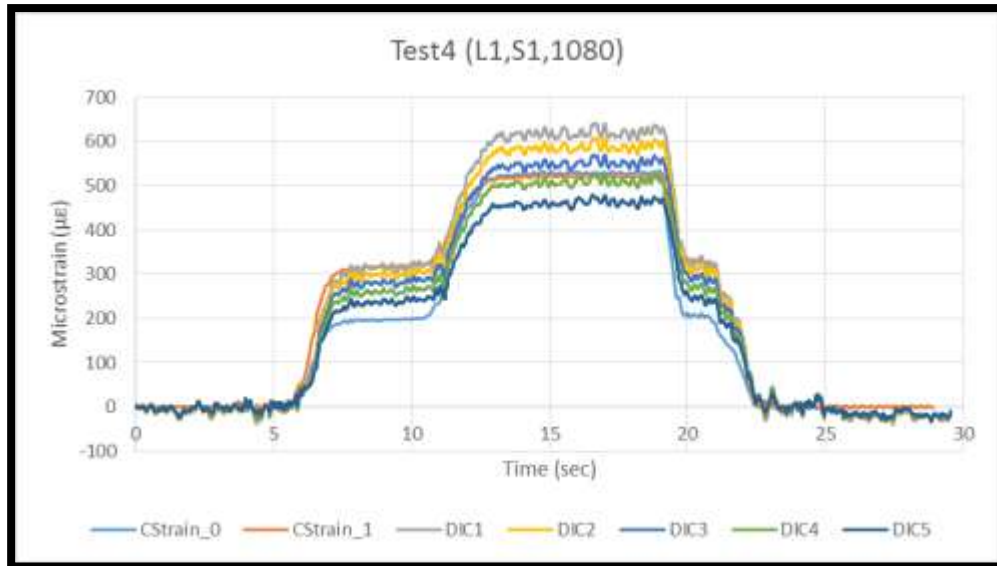
**Figure K-8: Sample plot of the data collected for one test in 2D Lab Testing Trial 2**

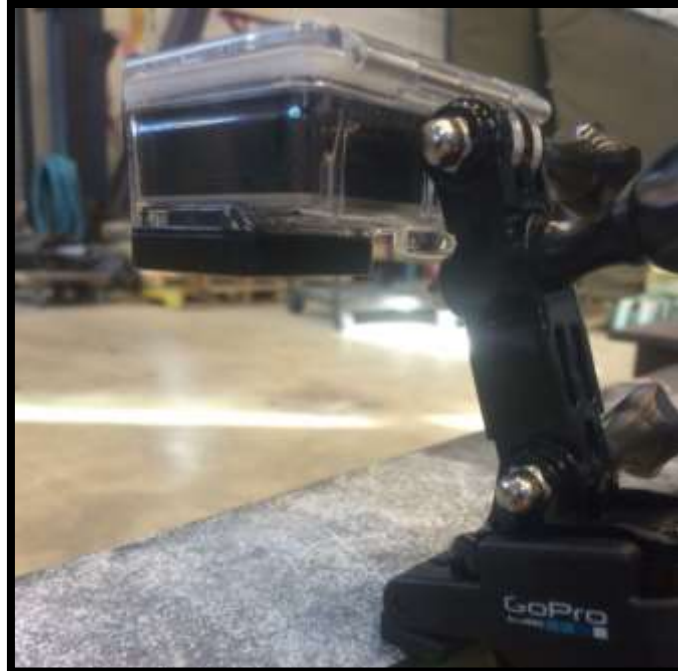
**Figure K-9: Experimental DIC sensor that tests the short range capabilities of the GoPro® camera**
