Evaluation of Corrosion and Corrosion Control on Interstate 89 Bridges #30 and # 31

Project #14511

Report #2010-10-3/062415

Evaluation of the Cathodic Protection System on Interstate 89 Bridge #30 and Comparing the Corrosion to Control Bridge # 31

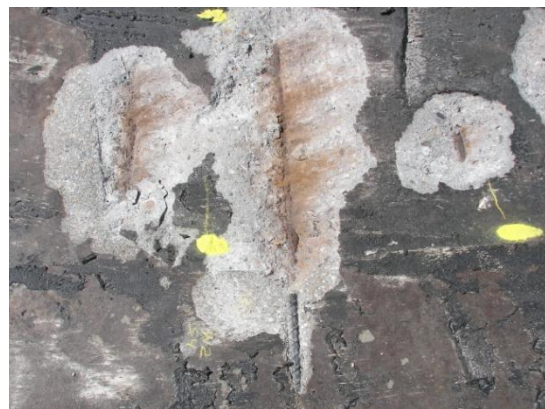
Figure 2. Anodic and cathodic rebar

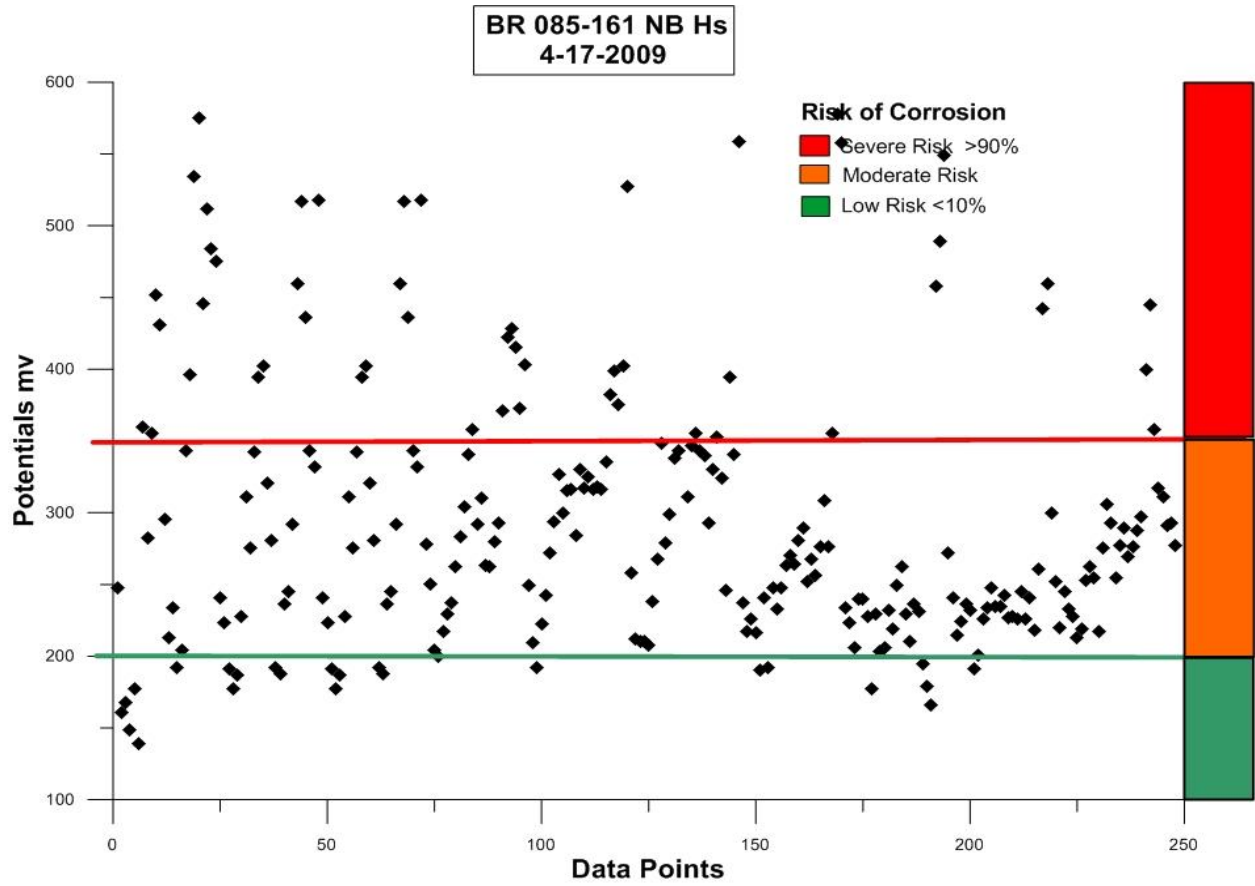
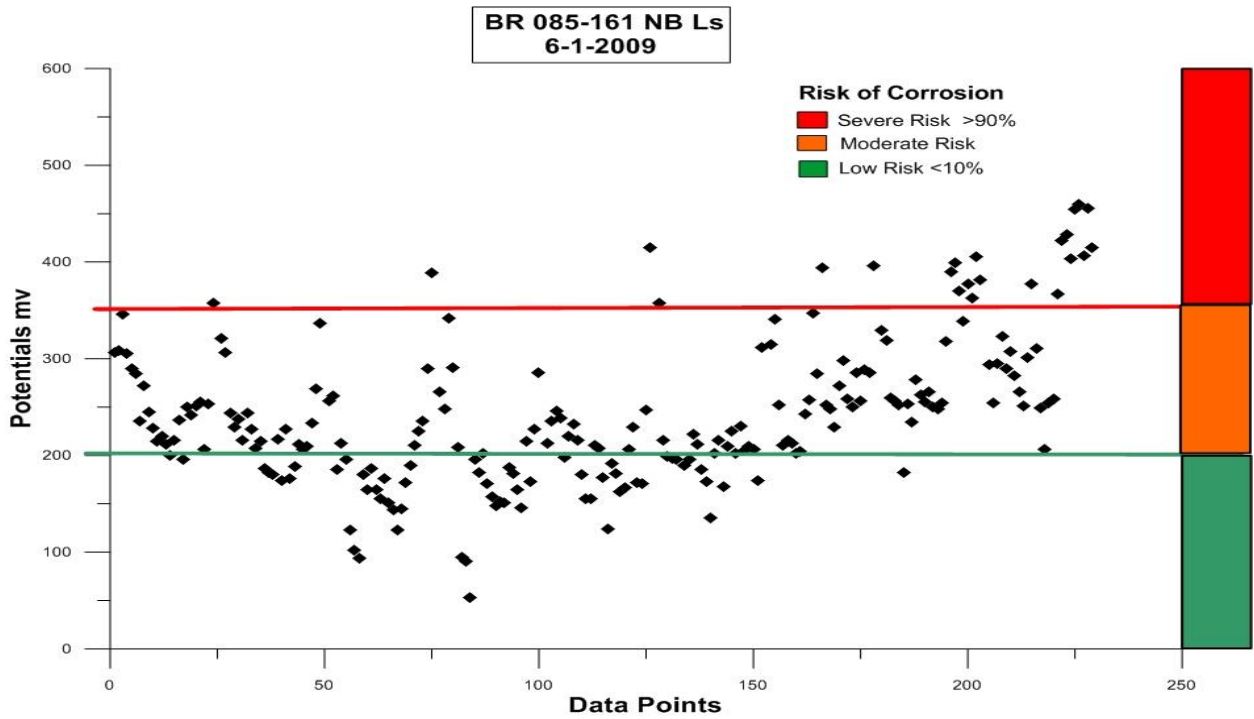
The graphs below of the data points on all three bridges tested show the corrosion probability based on the guidelines of ASTM C-876.

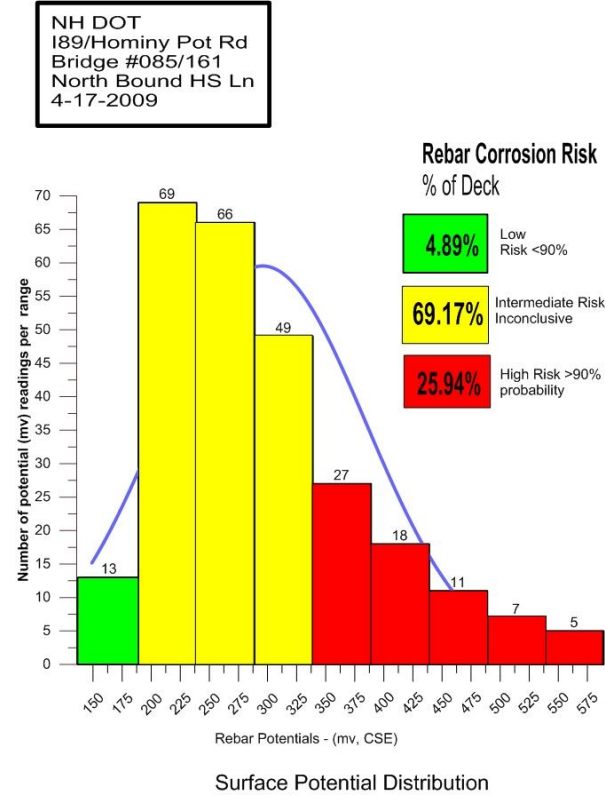
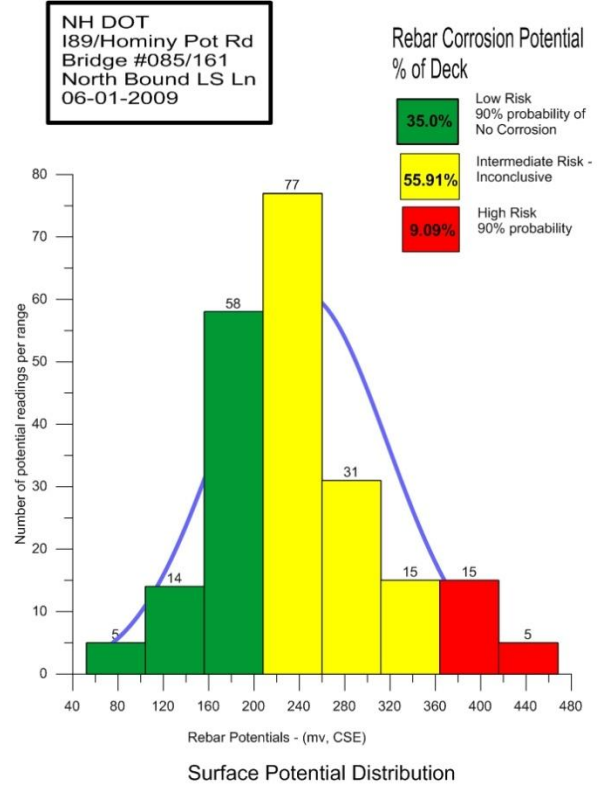
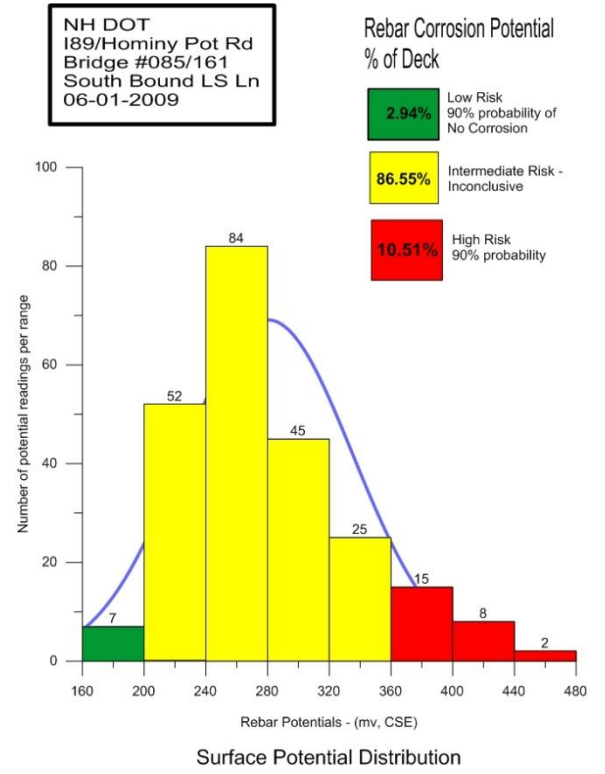
The histograms below show the corrosion probability based on ASTM C-876

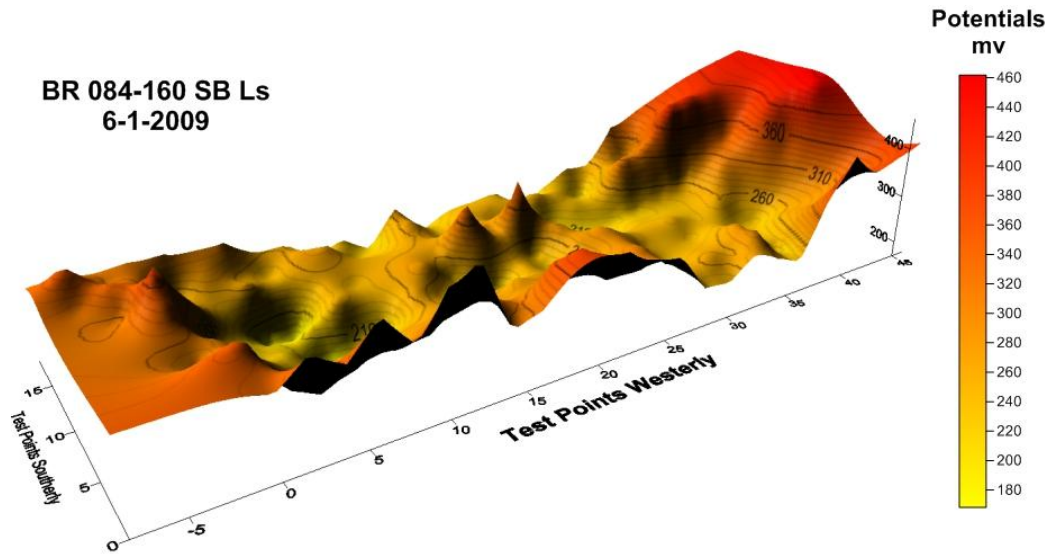
The surface potential contour map of the southbound low-speed lane of the Hominy Pot Road bridge is shown below in three dimension.

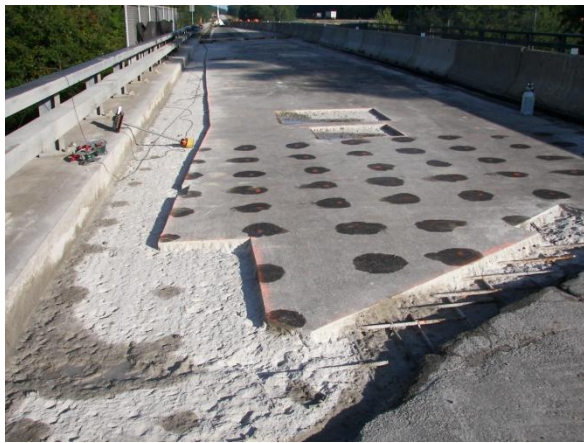
This deck had no membrane applied and was in good overall condition with the exception of the South curb where rotted concrete was noted the full-length of the deck. Three longitudinal cracks were noted at mid deck.

South curb concrete removed

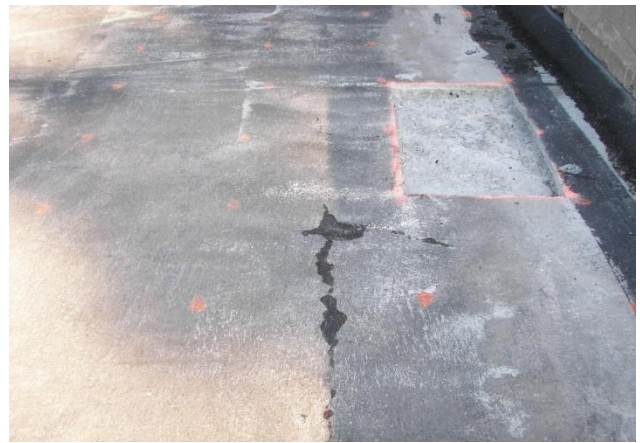
longitudinal cracks at mid deck

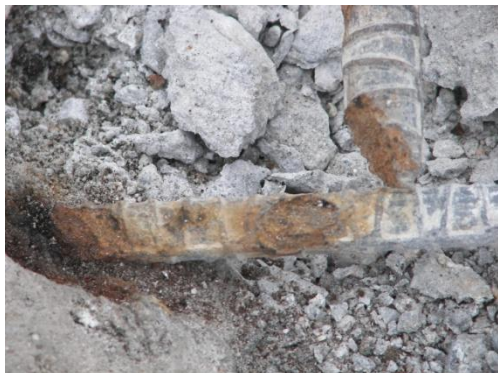
Electrical continuity test were conducted at the rectifier panel and at any exposed rebar where the concrete was removed. These tests indicated that the reinforcing steel was electrically continuous. In a couple of small isolated areas there were poor bonds between rebar causing pickup and discharge areas. (see photo below)

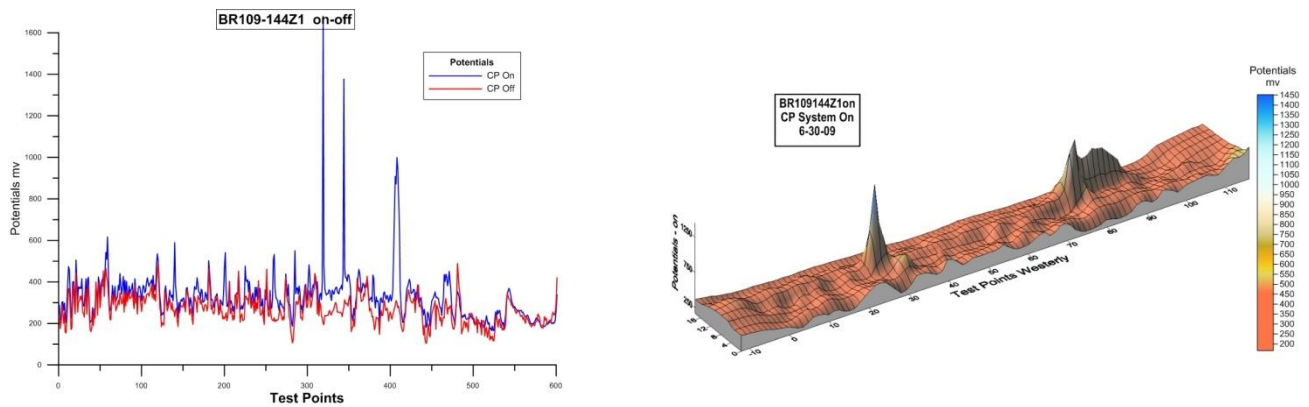
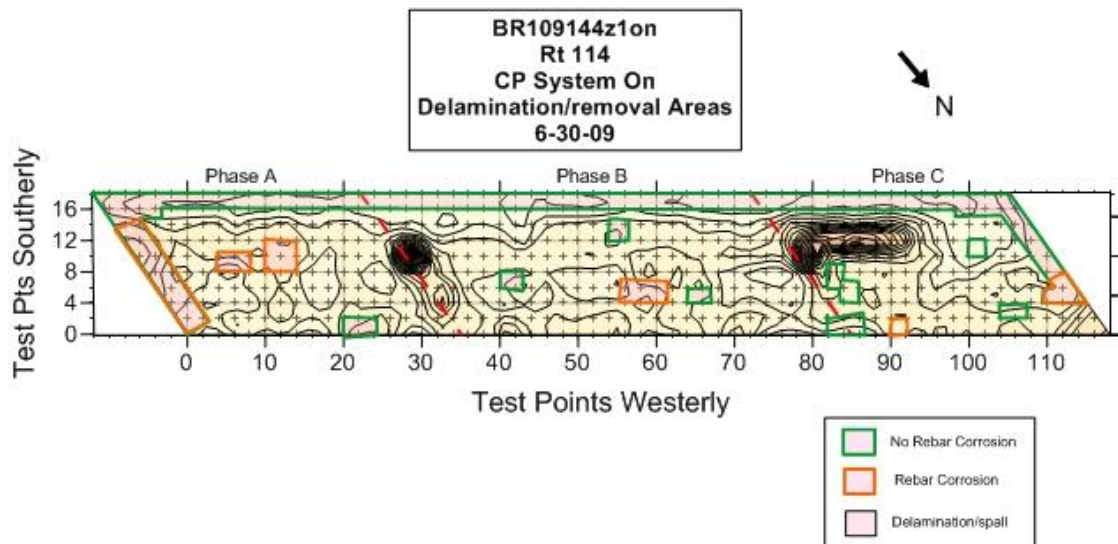
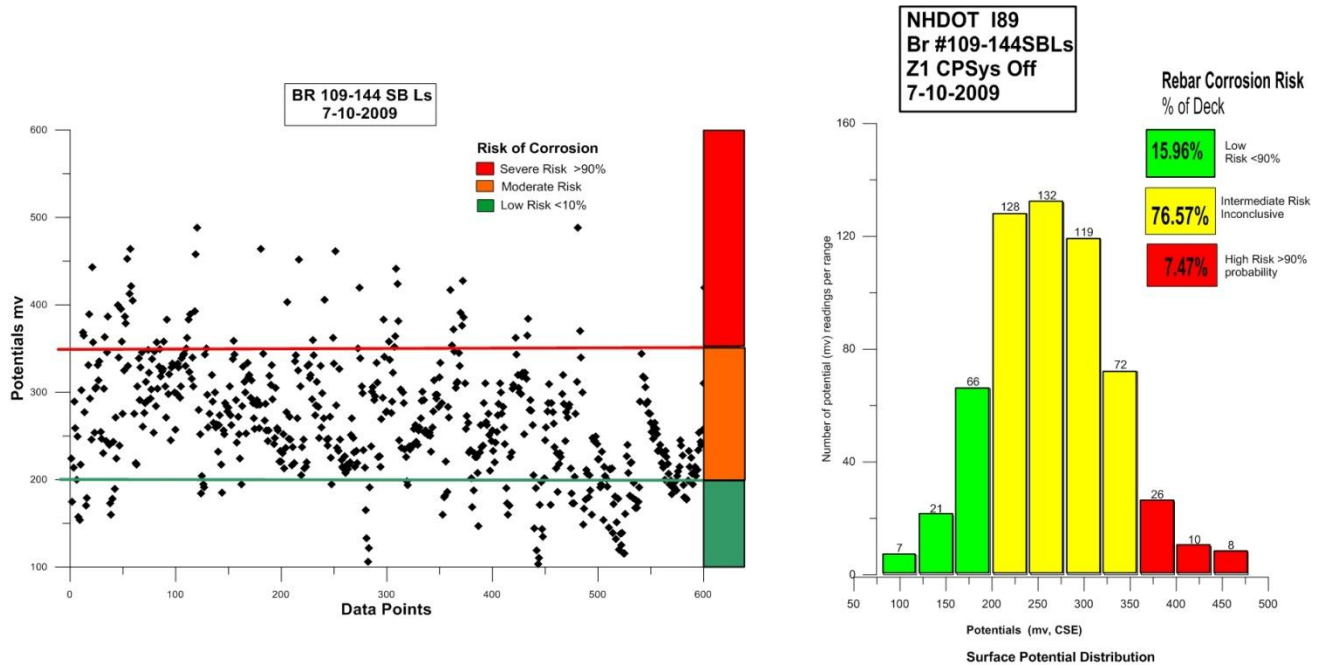
Surface potential surveys were conducted with the cathodic protection system on and off. The graph on the left shows the “off” readings in red and the “on” readings in blue. The 3-D image on the right shows the three peaks with the cathodic protection system on. Note that in the surface potential contour and delamination map below the only areas receiving protection are at the phase lines A/B and B/C.

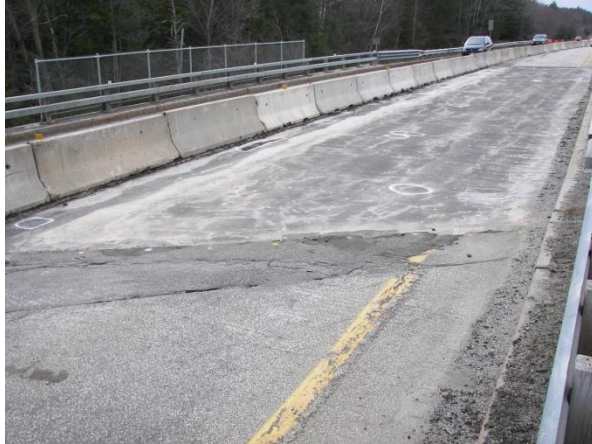
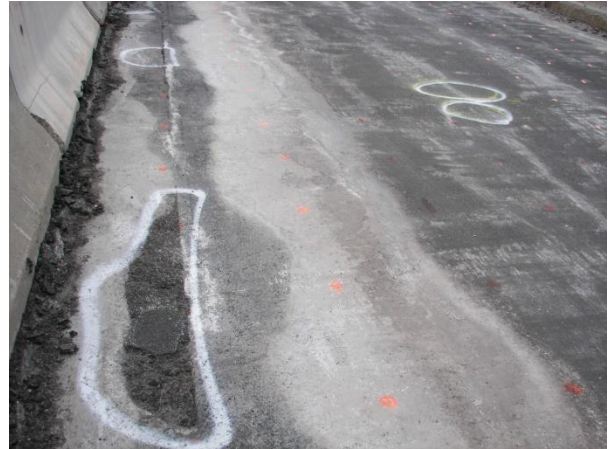
This deck had no membrane applied and was in good overall condition with the exception of the curb where rotted concrete was noted almost the full-length of the deck. The most significant crack was along the joint between the two decks. This was also the area of most delamination and most concrete removal.

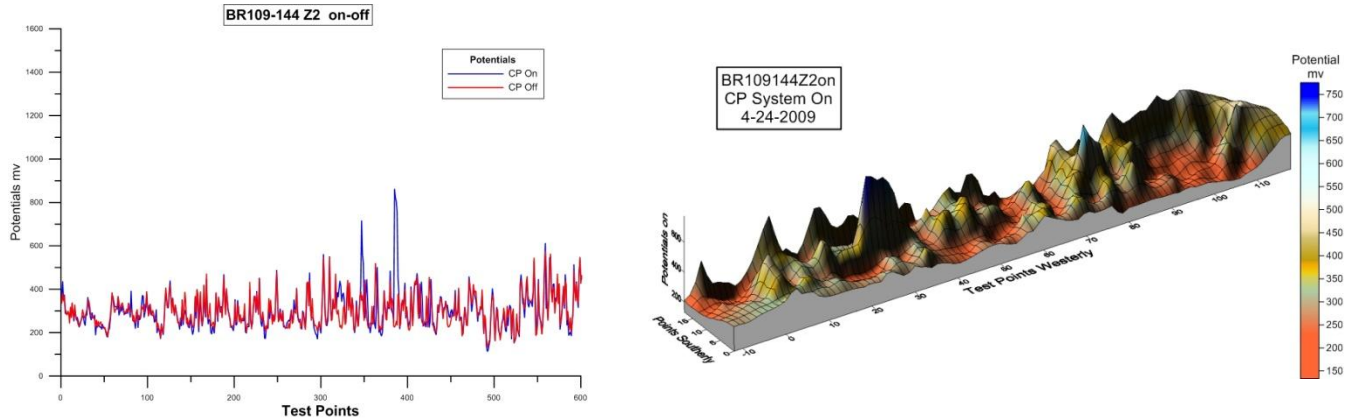
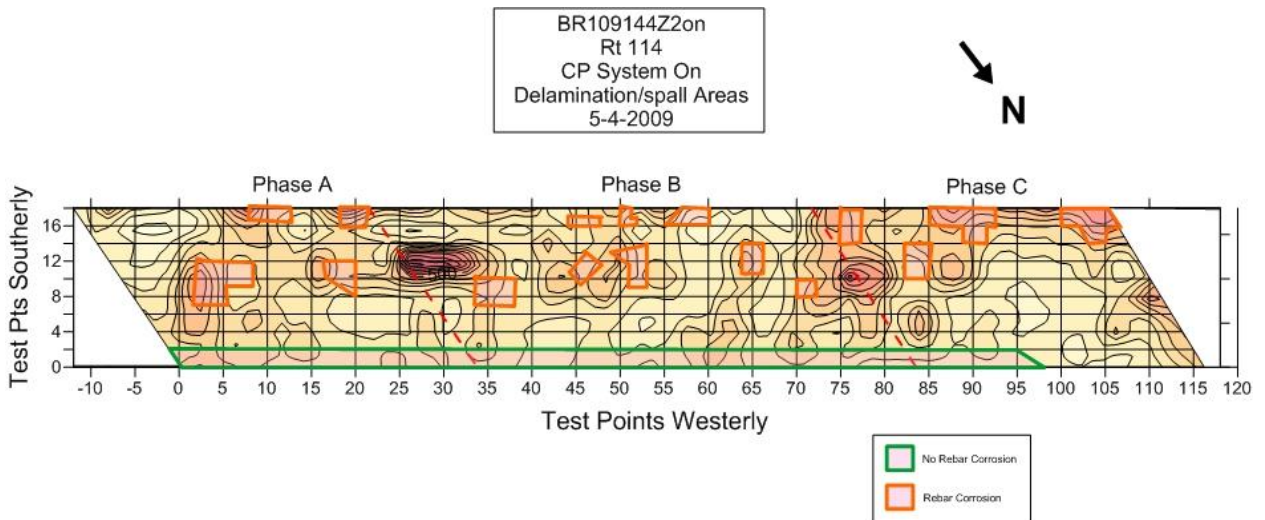
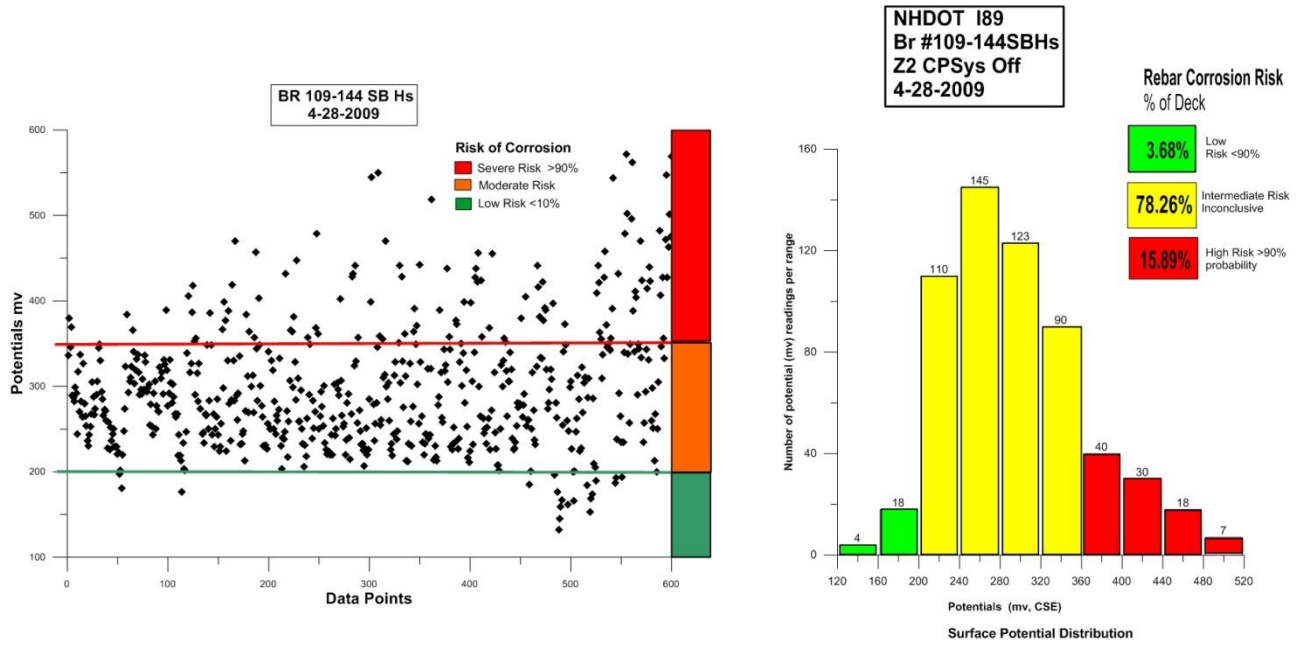
Surface potential surveys were conducted with the cathodic protection system on and off. The graph on the left shows the “off” readings in red and the “on” readings in blue. The 3-D image on the right shows only two peaks with the cathodic protection system “on”. Note that in the surface potential contour and delamination map below the only areas receiving protection are at the phase lines A/B and B/C.

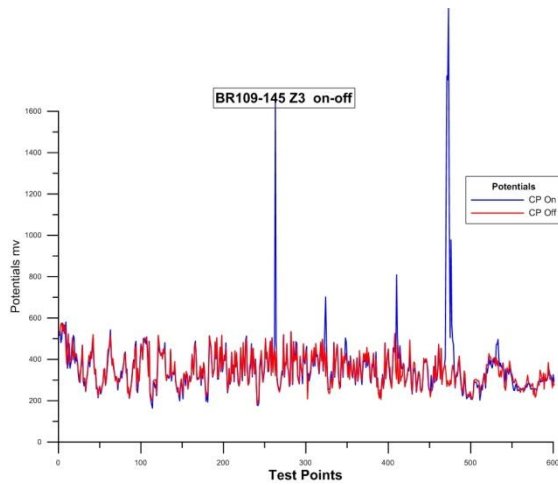
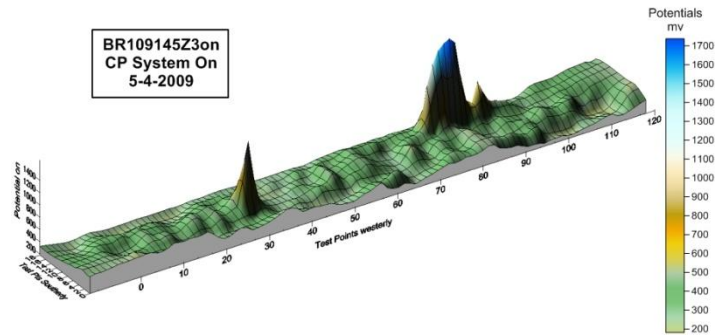
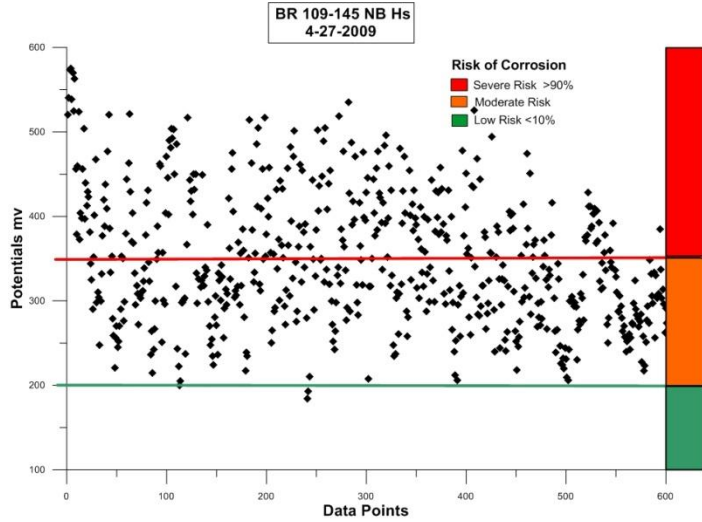
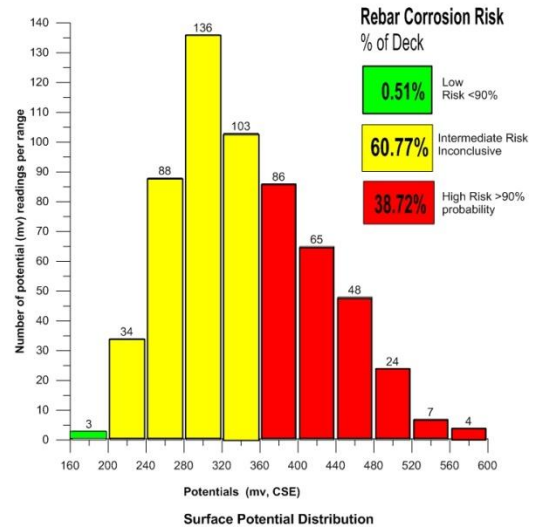
NHDOT I89
 Br #109-145NBHs
 Z3 CPSys Off
 4-27-2009

Surface potential surveys were conducted with the cathodic protection system on and off. The graph on the left shows the “off” readings in red and the “on” readings in blue. The 3-D image on the right shows only three peaks with the cathodic protection system “on”. Note that in the surface potential contour and delamination map below the only areas receiving protection are at small areas in phases B and C.

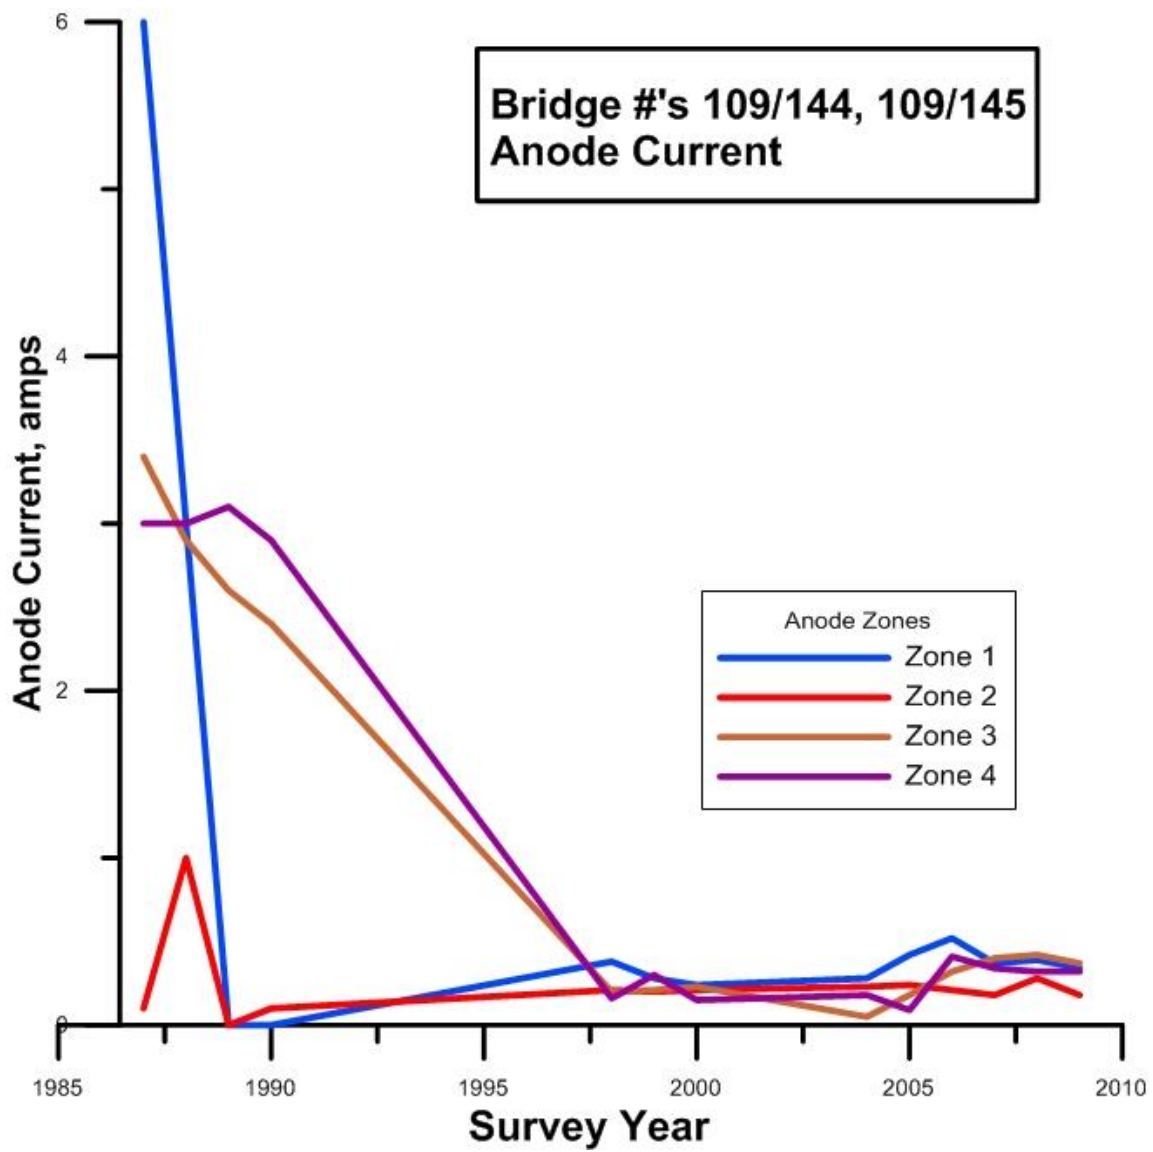
Based on field data generated by NHDOT and CD Engineering (see Appendix C), protection current to the anode system failed before 1990 in two zones with complete system failure by 1998.

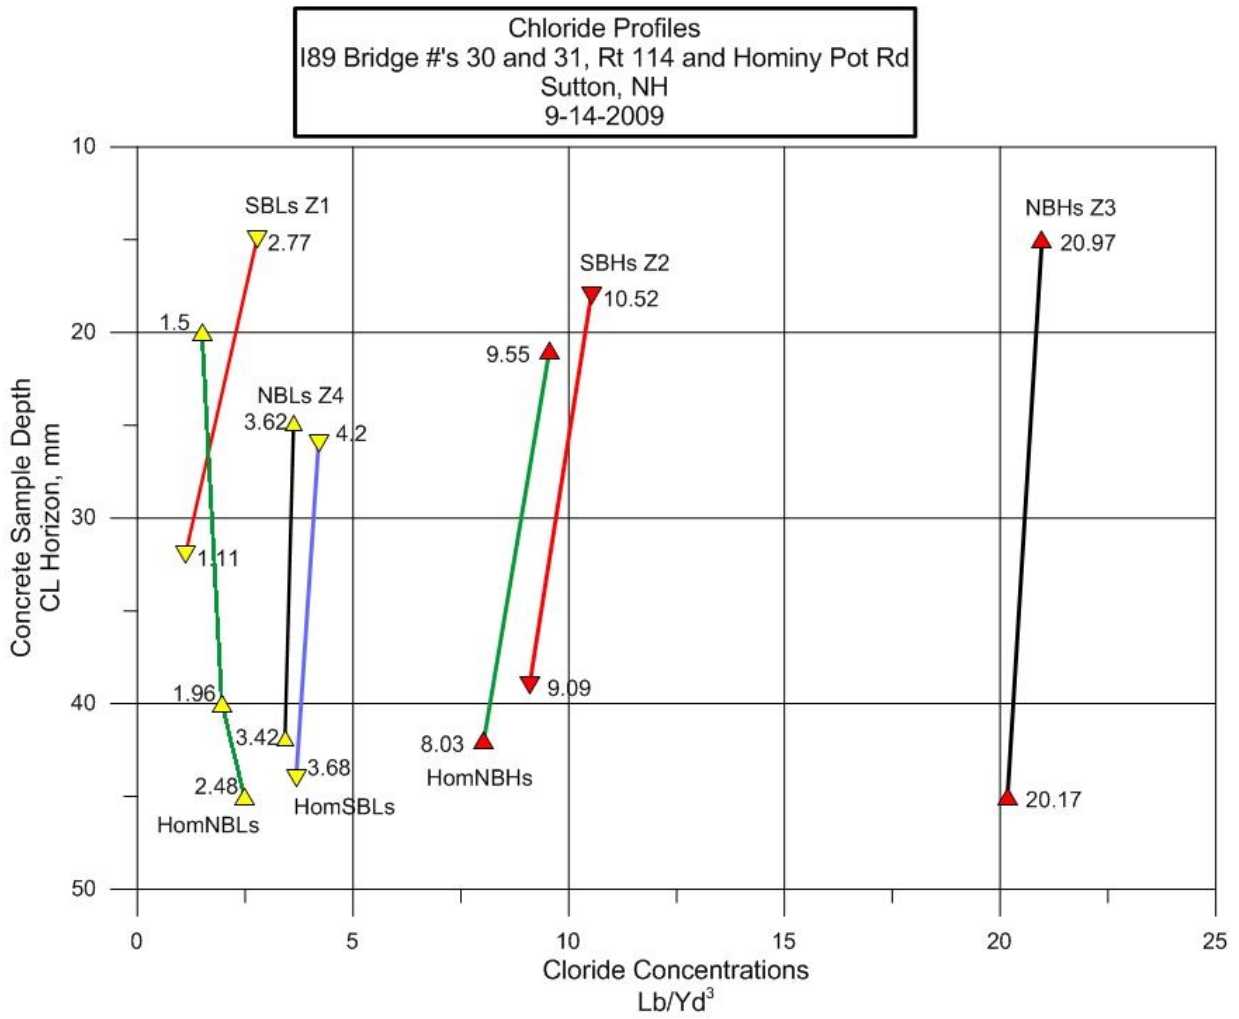
Chloride profiles or bridges 30 and 31 (see Appendix D) for lab analysis

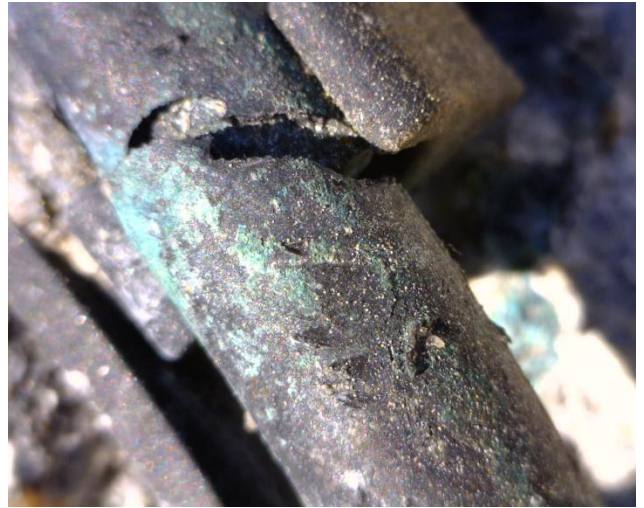
The photo on the left shows the degradation of the jacket and conductive polymer. The photo on the right also shows cracking and leaching of the copper conductor through the jacket.

It was known that the FEREX wire material would deteriorate rapidly if overpowered but could provide long life if the anode current density was limited to the design value. Although initial tests were promising in a number of installed systems, the material proved somewhat susceptible to become brittle, causing breaks especially at bends. (SHRP-S-337, Pg. 54)
