**Reducing Cracking in
New Bridge Curbs**

Final Report

Prepared by University of New Hampshire Department of Civil and Environmental Engineering
for the New Hampshire Department of Transportation, in cooperation with the
U.S. Department of Transportation, Federal Highway Administration

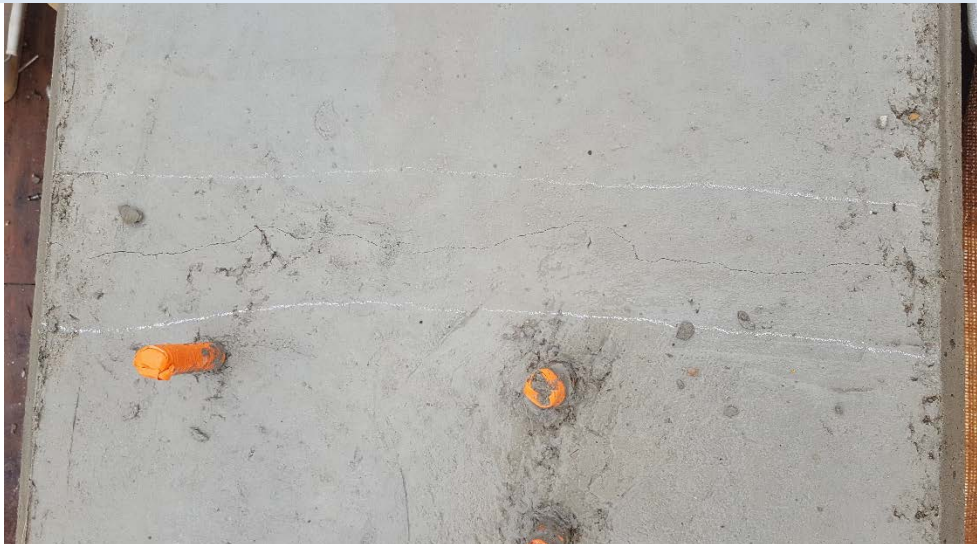
Figure 1: Crack in a bridge curb 5 days after placement.

Bridge curbs that experience large amounts of cracking, particularly at an early age, may facilitate accelerated deterioration of the curb. This results in a curb replacement that needs to be conducted before the deck replacement. The early-age cracking that has been seen by the BoBM has been noticed, in some cases, as soon as three days after placement.

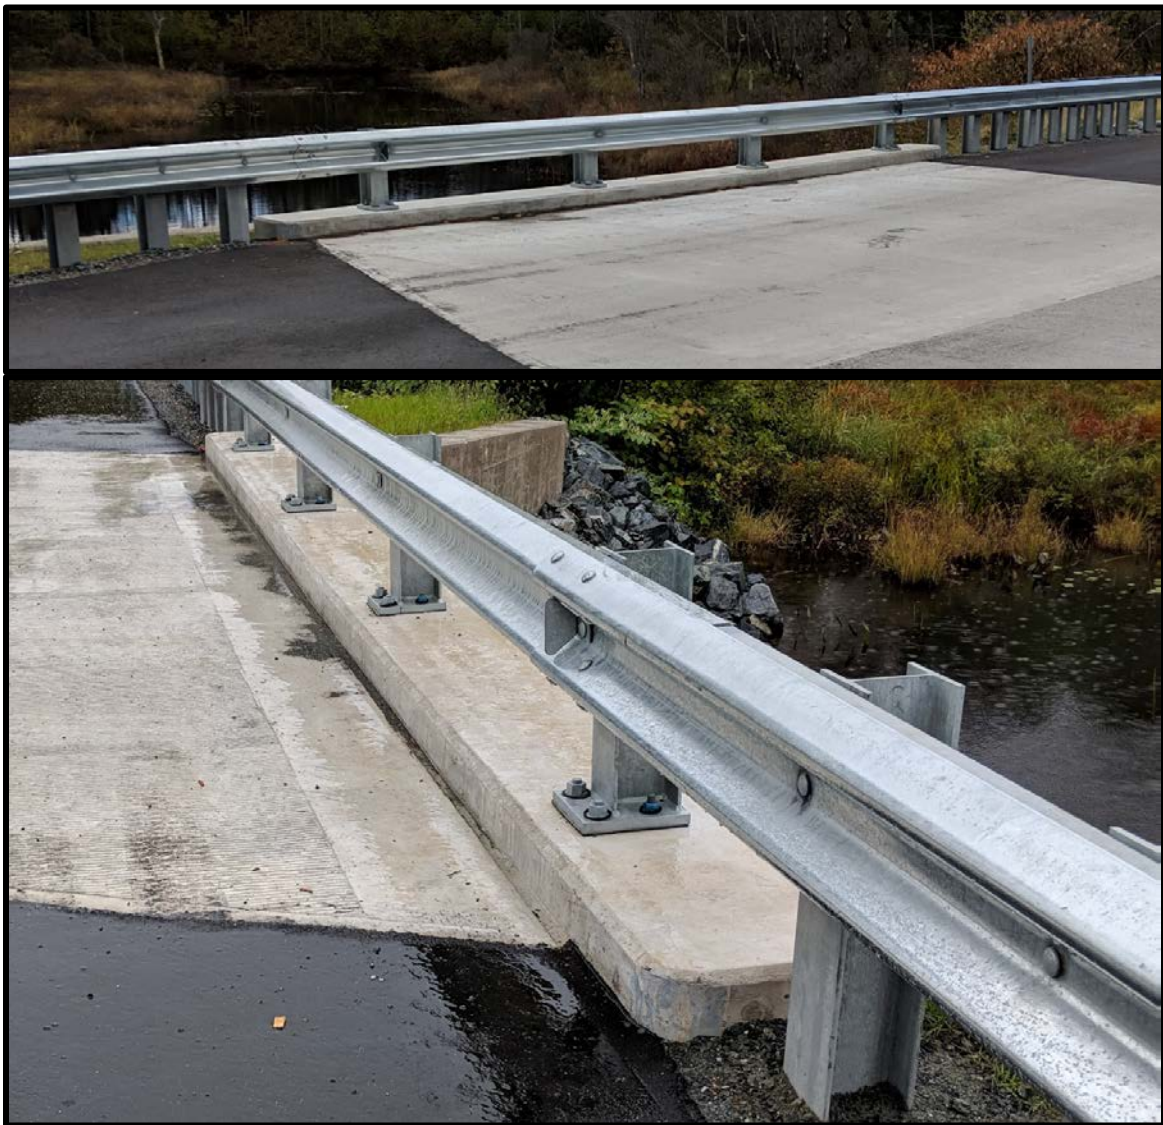
Bridge curbs, similar to the one in Figure 3, provide a place for guardrail to be mounted as well as provide drainage characteristics to the bridge. As vehicles drive over the bridge dust and debris may be deposited on the roadway. When it rains, water flows down from the center of the roadway to the edges parallel to the direction of travel. The curbs prevent runoff, which can be carrying debris, from flowing directly off the side into the roadway or waterbody below. Runoff moves down toward the ends of the bridge or is intercepted by a drainage system implemented in the bridge. Debris that collects at the edge of the curb can then be cleaned up by maintenance personnel.

Figure 3: Example of a concrete bridge curb. This curb is approximately 29 ft. long and is located on NH 113 in Grantham, NH.

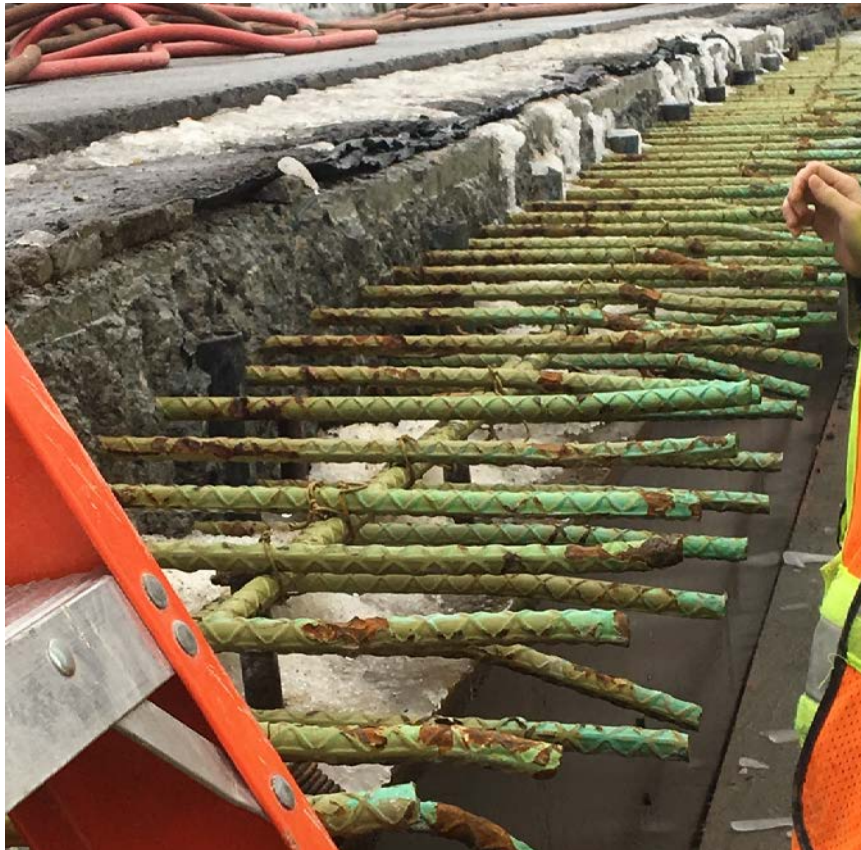
Figure 4: Exposed rebar extending out from a bridge deck after the former curb had been demolished.

Replacement frequently includes the replacement of the entire longitudinal ends of the bridge deck, as shown in Figure 4, and not simply removing only the visible few inches of the curb rising above the deck. The figure also shows the steel beam and shear studs that were once buried underneath the old curb concrete. Once the curb has been demolished new reinforcement can be installed and tied to the existing deck reinforcement as shown in Figure 5. The guardrail anchor systems are also placed with the reinforcement. Additional hoop reinforcement is placed near the guardrail post locations to provide additional strength in case of a vehicle collision with guardrail. The additional reinforcement and anchor system can be seen in Figure 6.

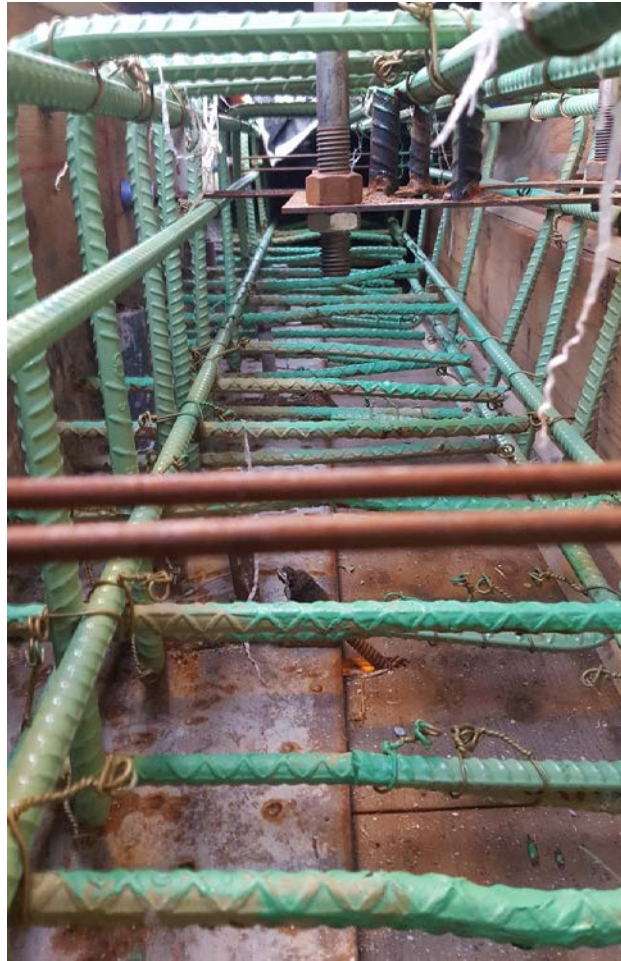
Figure 5: Curb formwork and reinforcement on a curb replacement project.

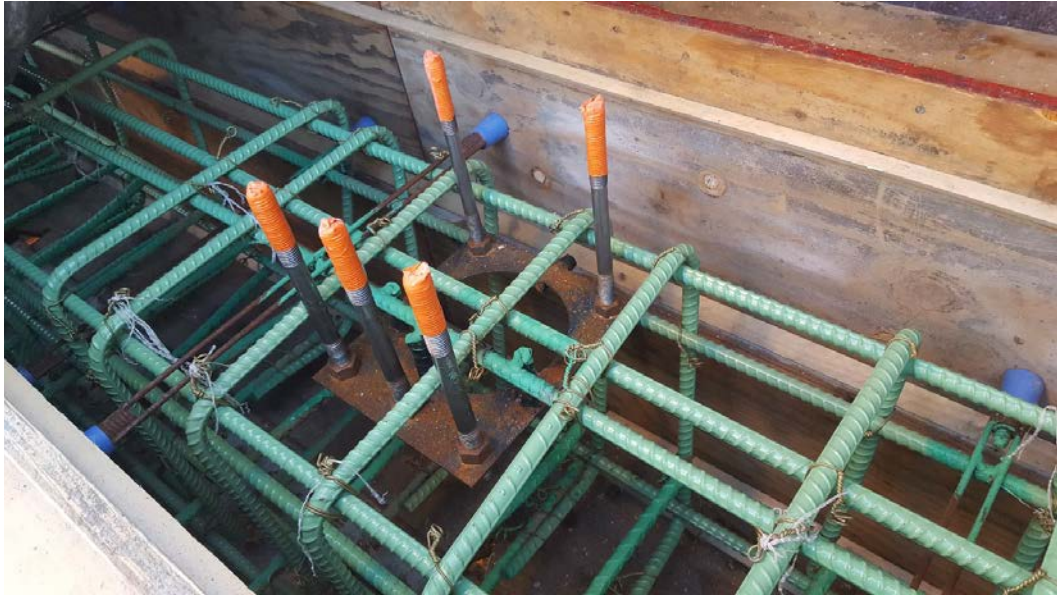
Figure 6: Guardrail anchorage and reinforcement in curb formwork. Tape on the top of the anchoring system keeps threads clean during concrete placement.

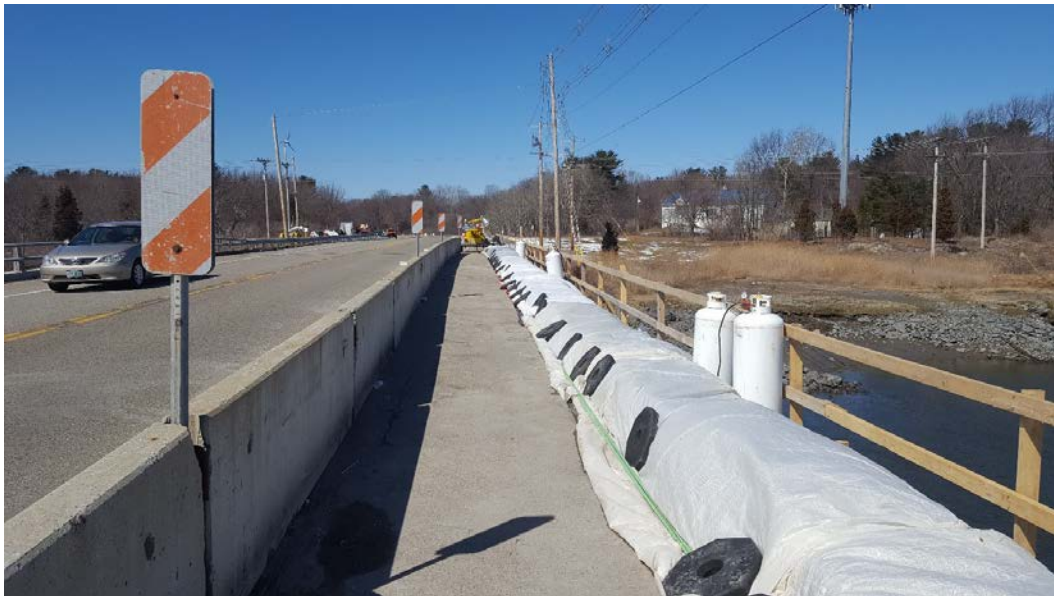
method, show in Figure 7, involves using insulated wraps that are placed over the wet burlap. Hot air is blown underneath the wraps. The second method involves construction of a heated enclosure like the one shown in Figure 8. Heating is often performed by propane heaters. Even distribution of heat to concrete during winter months poses a challenge. It should be noted that NHDOT Standard Specifications calls for a minimum wet cure of 7 days.

Figure 7: Insulated wrap and heaters on a bridge curb after cold weather placement.

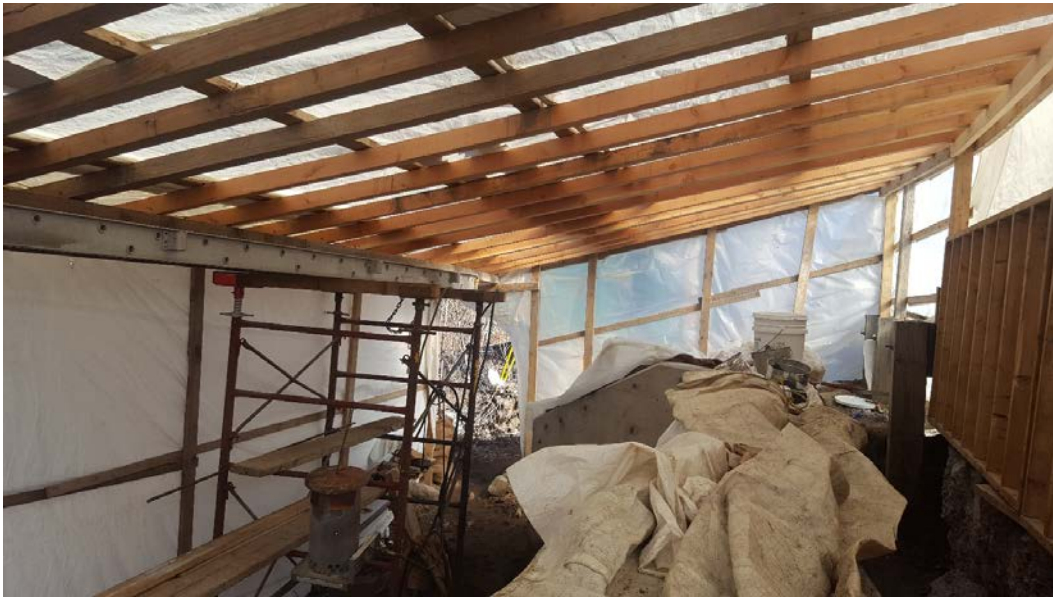
Figure 8: A heated enclosure constructed over a bridge to prevent concrete from freezing during curing.

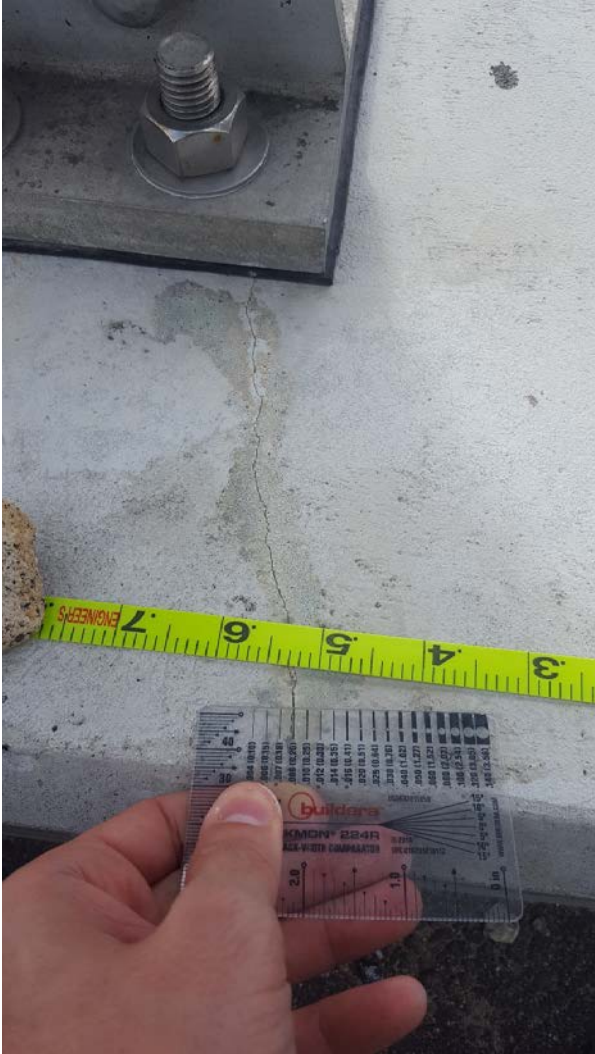
done in any way that is convenient to the surveyor. Initially during this study, photos of every crack were taken. While this method is beneficial when creating a visual record of the cracks it is much more time consuming, requires a significant amount of data storage, and on cold days may become difficult as batteries tend to lose their charge quickly without being kept warm. A common method used in this study was to use a voice recorder to verbally note crack location, width, and length.

Figure 9: Crack comparator used to aid in crack width determination.

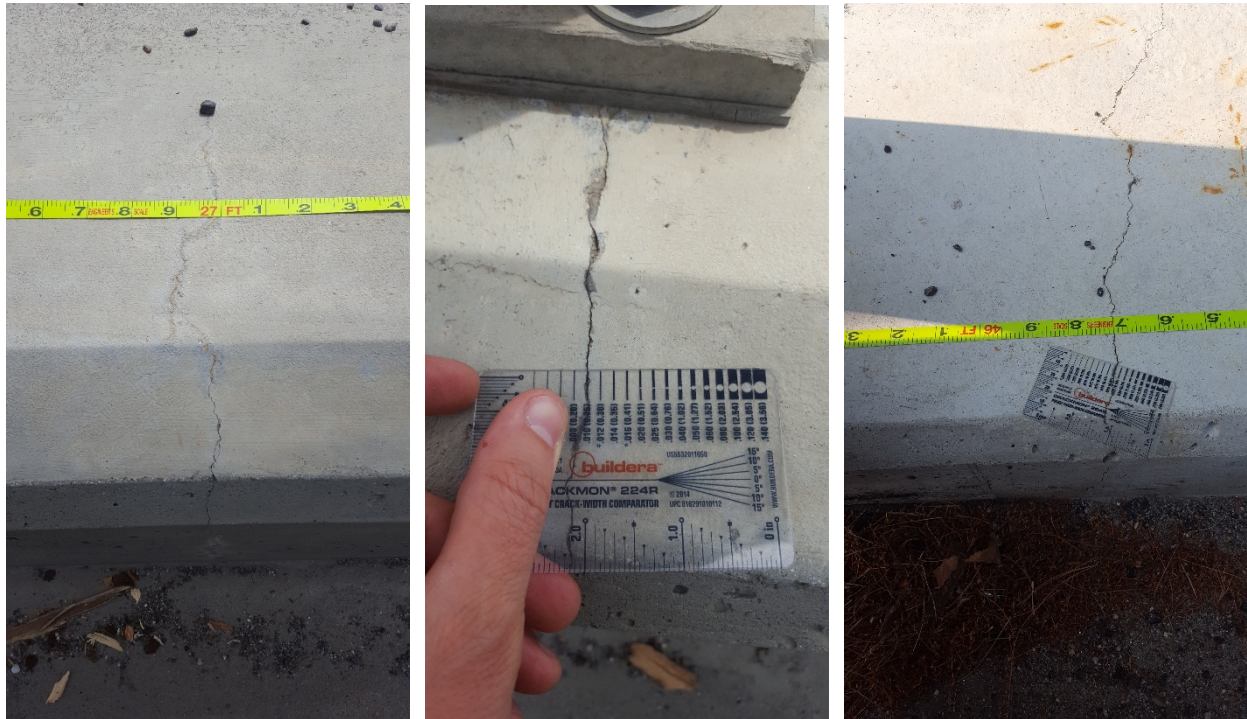
Intensity Index 1

Another important consideration is that an intensity index value of 1 does not mean the crack does not adversely affect the curb. Furthermore, a crack that has an initial intensity of index of 1 may very well become an intensity 2 or 3 at a later date. An example of the crack intensities can be shown in Figure 12.

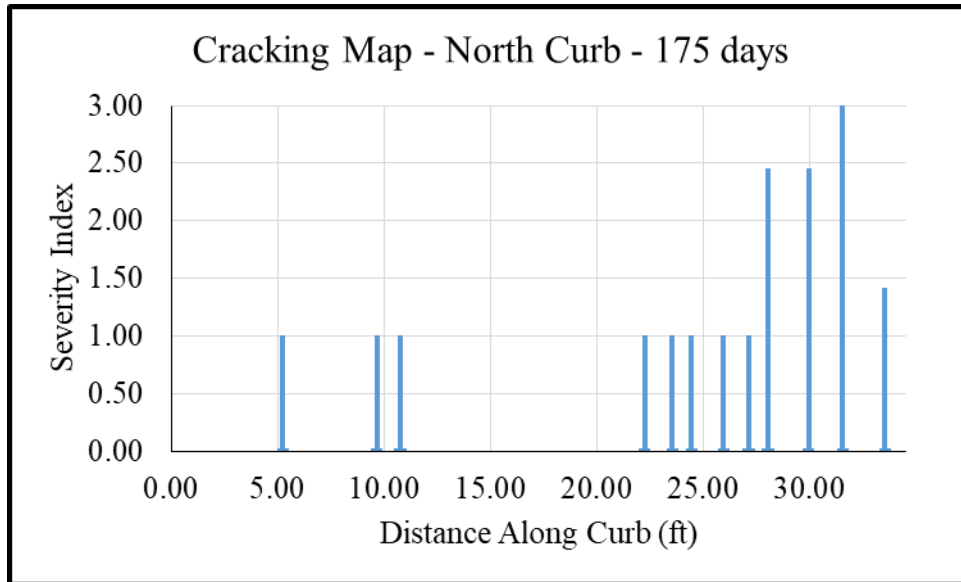
Figure 13: Graph showing crack location and severity index.

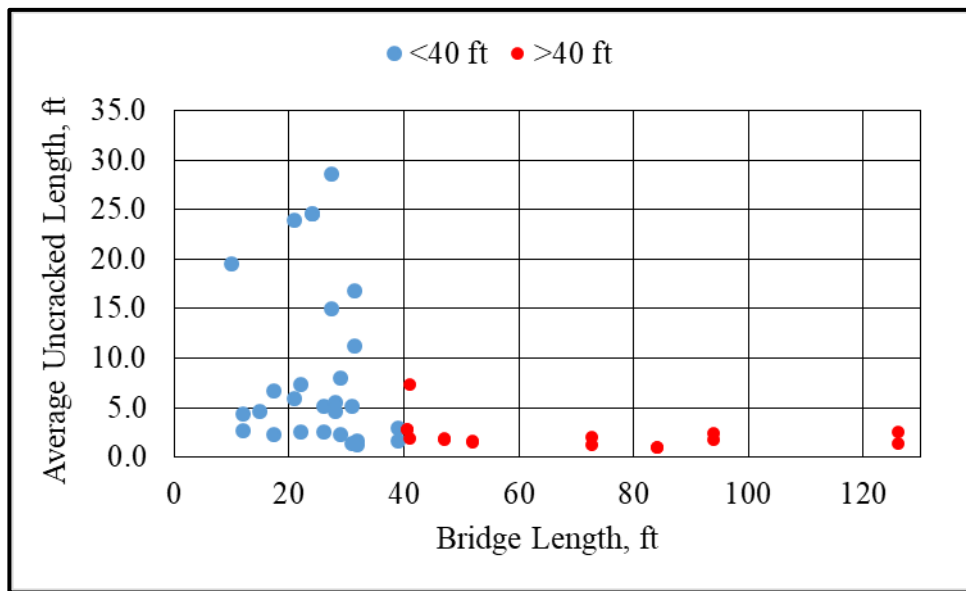
The effect of bridge length on the average uncracked length of the curb can be seen in Figure 17. It can be seen that curbs less than approximately 35 ft exhibit a larger range of values for average uncracked length. The high average uncracked length is attributed to minimal cracking. Even ignoring data points that have an average uncracked length greater than 10 ft, the remaining shorter bridge curbs tend to have a higher average uncracked length compared to bridges over 40 ft in length. Performing a t-test on average uncracked length, see Table 6, indicates that the difference between shorter and longer bridges is significant.

Figure 17: Effect of bridge length on average uncracked length.

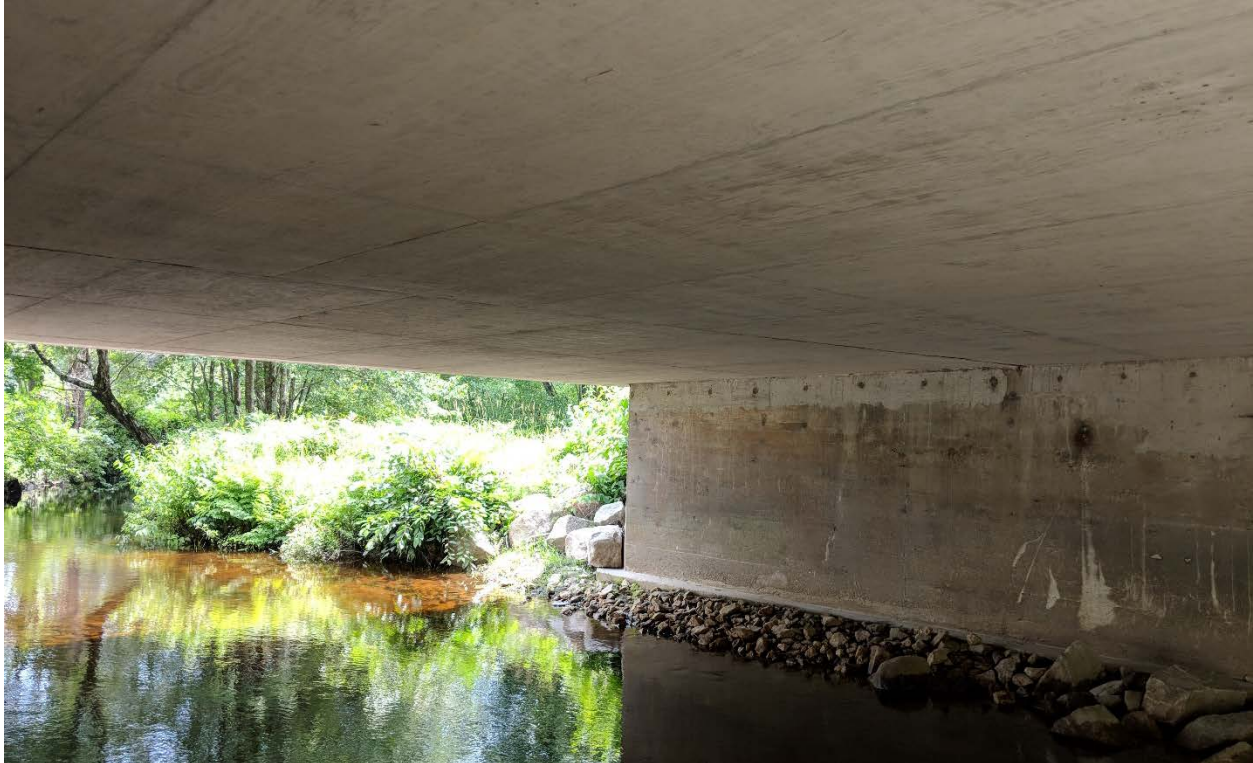
One thing to consider in addition to the length of the bridge effecting cracking is the type of bridge structure the curb is on. The majority of the bridge curbs surveyed in this study were either concrete slab (CS) bridges or steel I-beam with concrete deck (IB-C) bridges. Typically, for shorter spans the concrete slab bridge structure, Figure 20, is used. As bridge spans become larger there is a tendency to use steel I-beams, Figure 21, for the structure.

Figure 20: Concrete slab bridge structure example in Alexandria, NH.

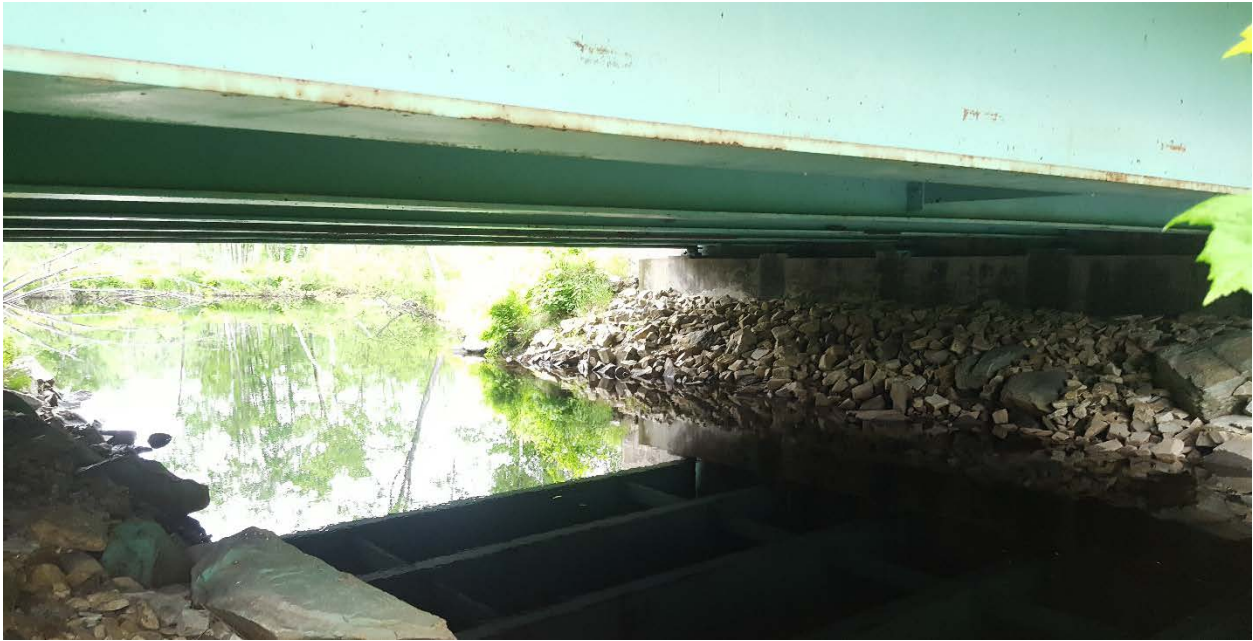
Figure 21: Steel I-beam with concrete deck bridge structure example in Wakefield, NH.

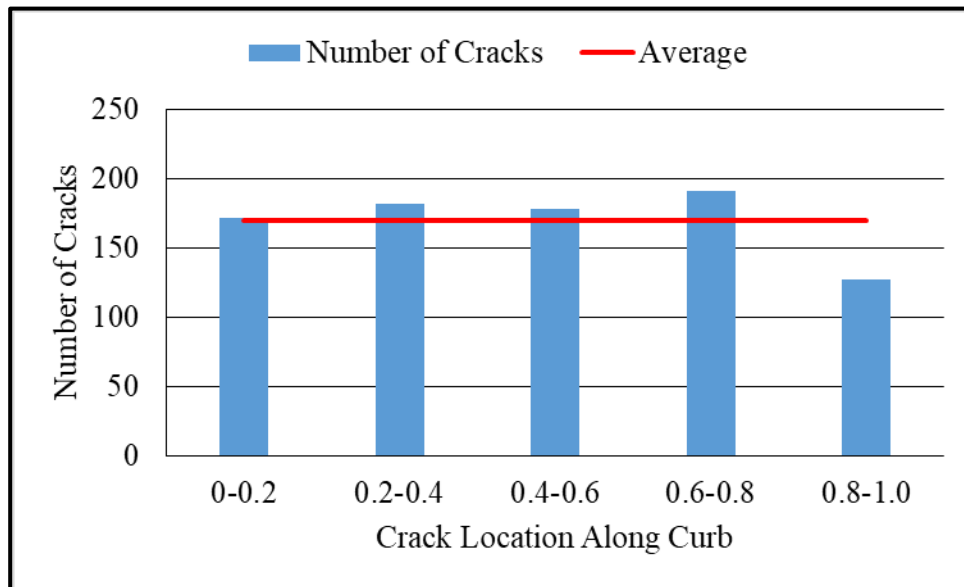
The results of the t-tests can be seen in Table 7. It can be seen that the length index or intensity index does not change significantly from one section to another. It will be noted that the end section of the bridge, furthest from midspan, experiences a lower average uncracked length than the rest of the curb. The difference in the amount of cracking can be seen in Figure 26.

Figure 26: Amount of cracking at various sections along the curb. Zero refers to the center of the span and one to the ends of the curb.

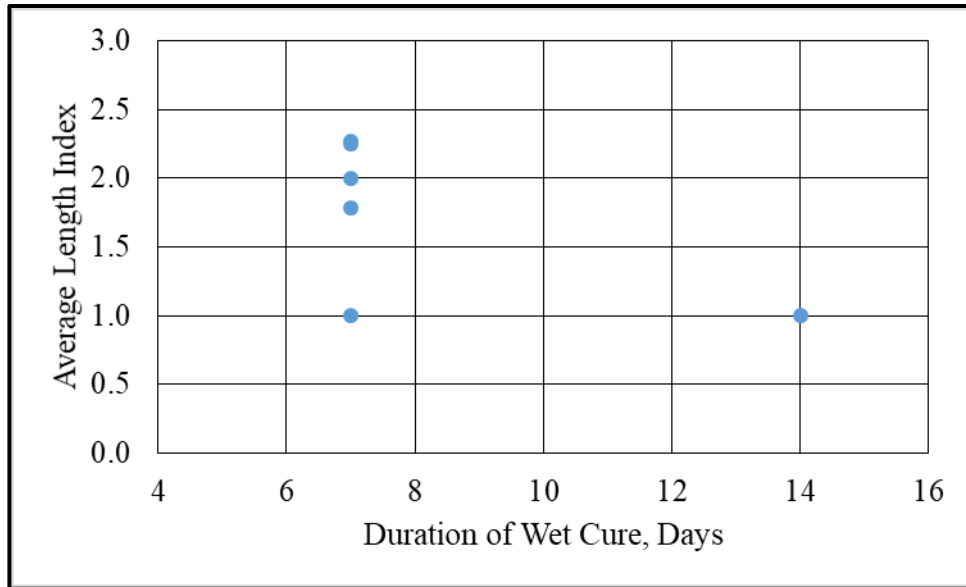
Wet cure duration may have an effect on average crack length and width as can be seen in Figure 30 and Figure 31. In both figures the average index value is lower for the curb placed with a 14-day wet cure compared to those with 7-day wet cures. Again, these graphs show only curbs that have experienced any cracking at all. The difference in wet cure duration is more pronounced for the average length index compared to the average intensity index.

Figure 30: Average length index compared to wet cure duration.

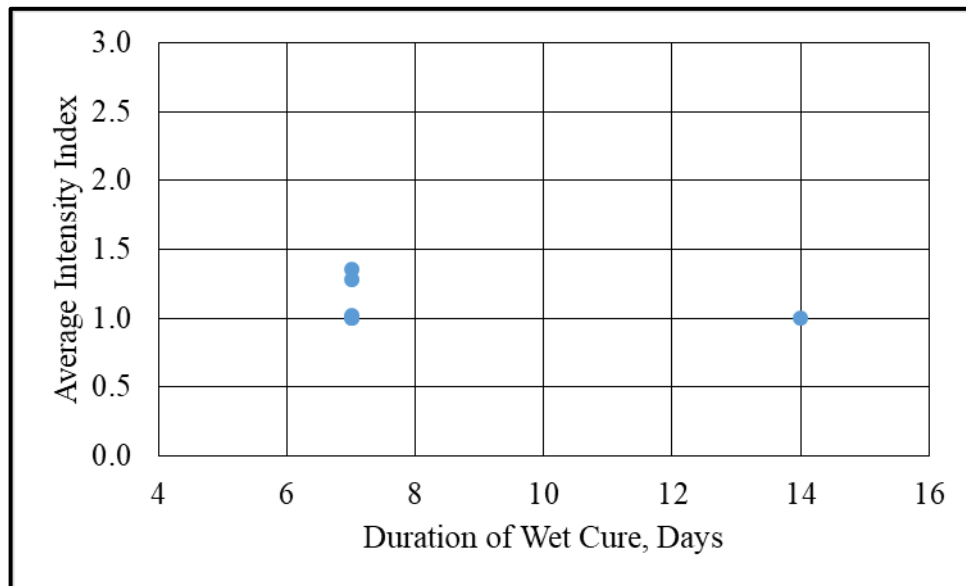
Figure 31: Average intensity index compared to wet cure duration.

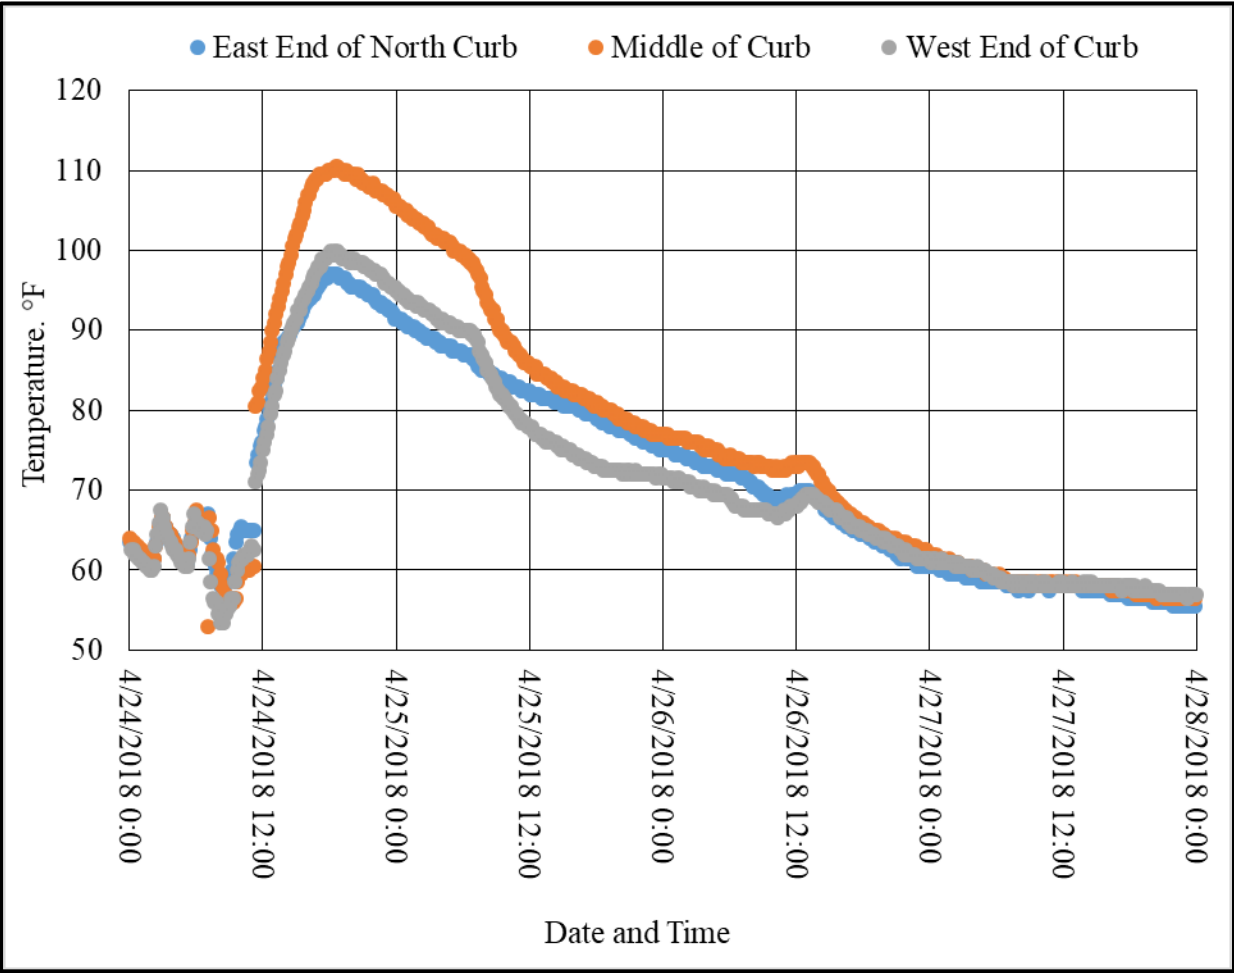
Figure 33: Thermocouple temperature measurements from inside a curb placed on a day with a high of 73°F.

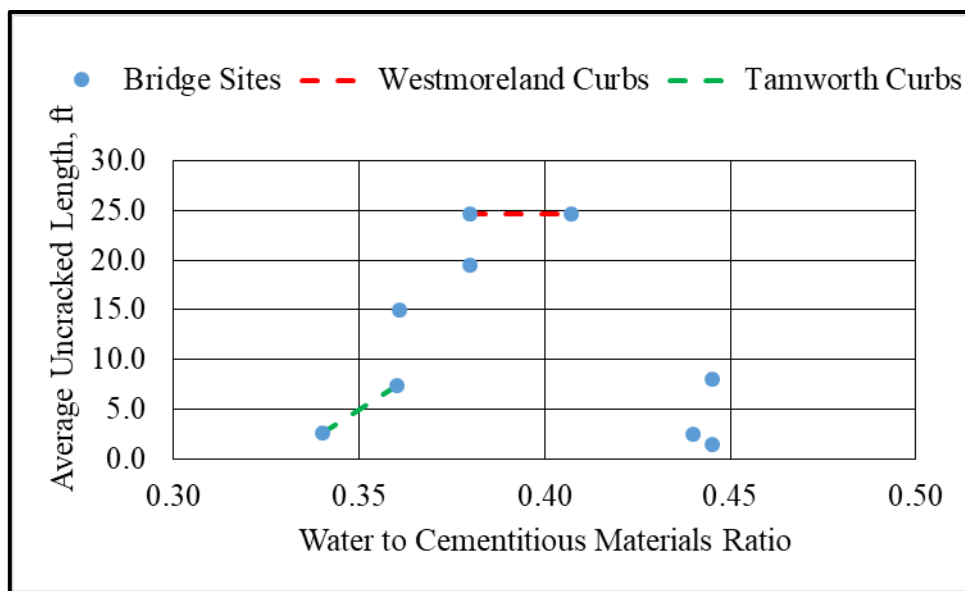
Graphs on all curbs placed during the study with known water to cementitious content ratio (w/cm) were created. t-tests were not conducted on w/cm since no clear separation in the graphically expressed data existed t-tests were not conducted on w/cm. This can be seen in Figure 34. The graph does not appear to have a linear trend but may have a trend corresponding to a second order polynomial function with a w/cm of about 0.39 corresponding to the greatest average uncracked length. The graph of the average length index, Figure 36, only consists of six data points and lack a clear trend. If the general shape of a second order function is overlaid over Figure 36 it may hypothesized that a pessimum for the average length index of the curb corresponds to the optimum w/cm of average uncracked length. When looking at the average intensity index compared to w/cm, Figure 37, it appears that different w/cm do not produce large variations in the average intensity index.

Figure 34: Average uncracked length compared to w/cm.

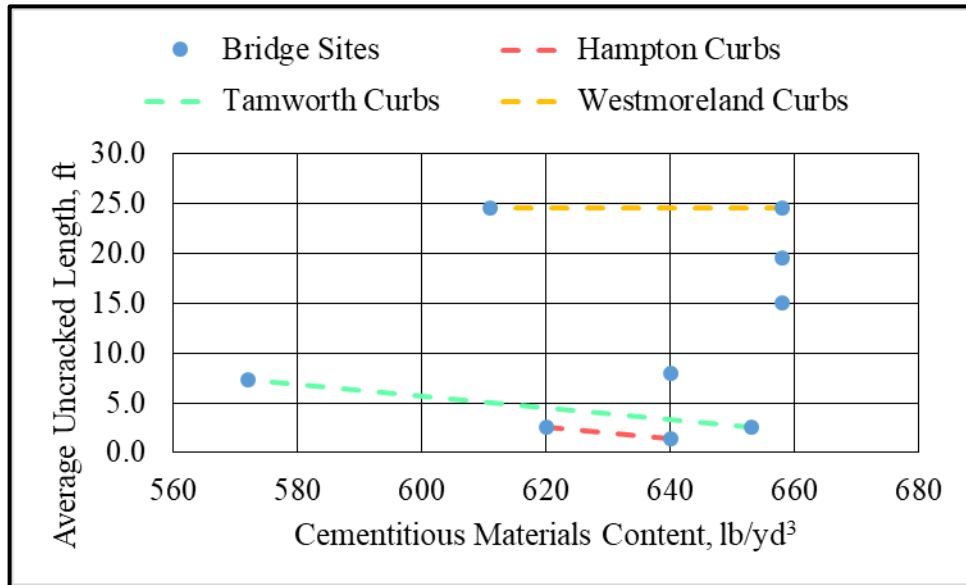
The total cementitious material content per cubic yard of several curbs placed during the study were compared to cracking. When the total cementitious content is compared against average uncracked length, as shown in Figure 35, no trend is apparent. Further data is required in order to determine if the lower average uncracked lengths between 620 lbs/yd³ and 640 lbs/yd³ are significant or are the result from other factors. When comparing curbs placed on the same bridge, curbs with a higher cementitious content tend to exhibit a smaller average uncracked length.

Figure 35: Cementitious content compared to average uncracked length.
