**Airport Pavement Paint Study
Implementation & Evaluation
Final Report**

Prepared by Jacobs Engineering Group, Inc., for the
New Hampshire Department of Transportation, in cooperation with the
U.S. Department of Transportation, Federal Highway Administration

1. Report No. FHWA-NH-RD-26962T		2. Gov. Accession No.	3. Recipient's Catalog No.
4. Title and Subtitle Airport Pavement Paint Study - Implementation & Evaluation		5. Report Date July 2020

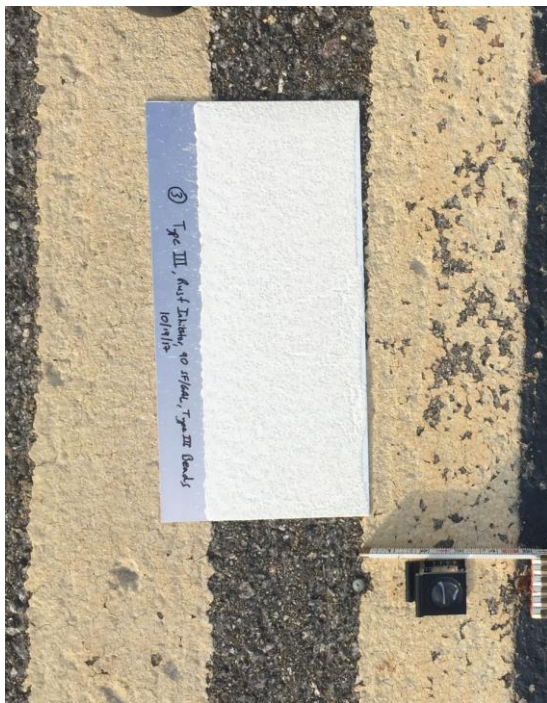
Figure 1: Control Sample Comparison

The first study objective compared control samples placed adjacent to the field painted surfaces. Control samples consisted of aluminum sheets, one for each area that were painted over during the 2017 installation of the study's pavement markings. The control samples were not exposed to sunlight or weather over the study period. This objective also evaluated bottom up rust spot stains that were observable on the surface of the paint and were counted in each of the sample areas.

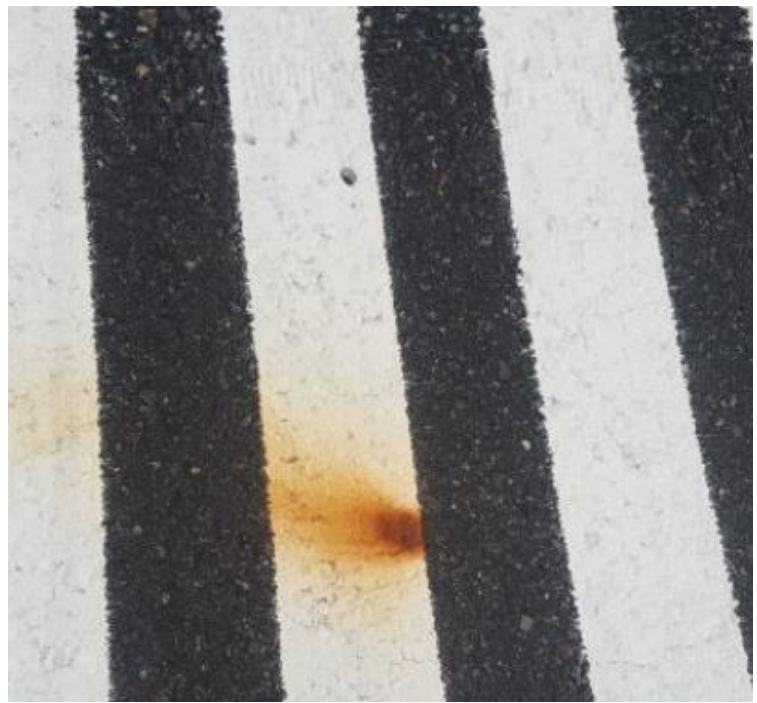
Figure 2: Bottom-up Rust Spot Stain Counting

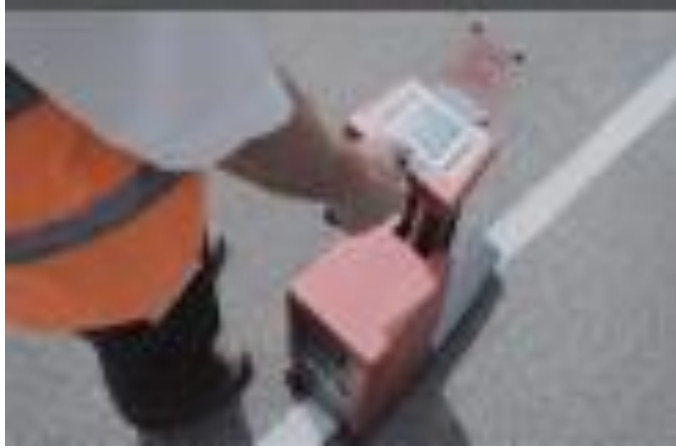
Figure 3: Retroreflectometer Measurement

The second study objective, paint bead performance, was evaluated by field reflectivity readings. Reflectivity readings were conducted using trained staff from the NHDOT and their retroreflectometer at the same time the color comparison and rust spot stains counts were made. A second analysis of the bead performance was the measurement of bead loss. Bead loss was measured from magnified photographs of the field samples. 'Craters' in the paint surface where a bead had been embedded were counted from magnified photographs in an office setting.

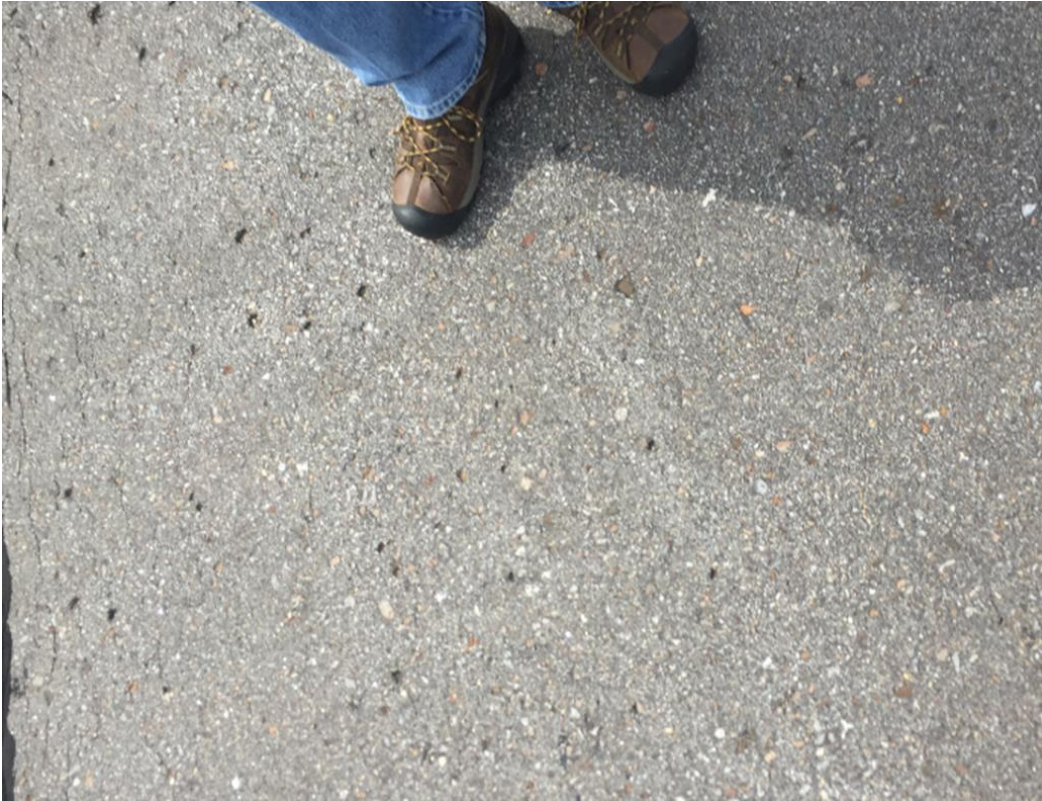
The runway pavement condition index (PCI) values were obtained in 2012. The PCI study indicated low to moderate raveling of the pavement aggregates. The raveling is shown in Figure 5. In the figure, the dark spots in the pavement are the small holes (i.e., raveling) where the pavement aggregate has eroded. The raveling is attributed to deleterious pre-weathered aggregates in the bituminous concrete surface⁴. These aggregates decomposed when exposed to the elements. The result of the aggregate weathering are small pockets or holes in the pavement surface. In the Runway 26 seal coat area of the study (area G), the 2012 PCI was estimated at a 46 rendering the pavement in fair condition prior to application of the seal coat. In study areas 1 through 4, the PCI ranged from 74 to 95. These values describe a very good pavement condition.

Figure 5: Loss of Aggregate in Runway Surface

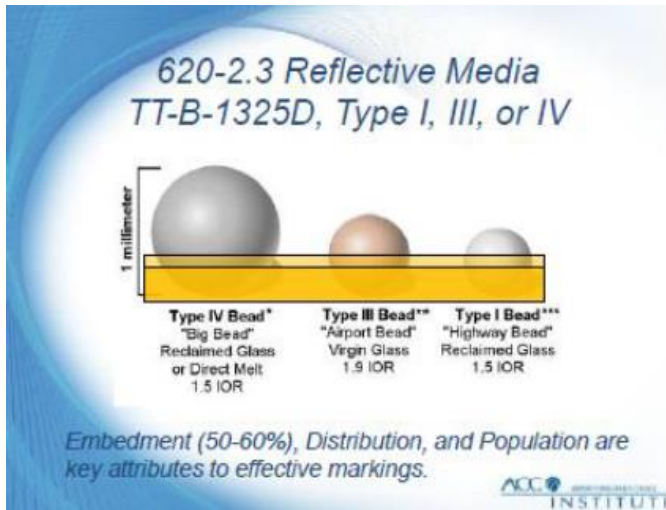
Figure 6: Bead Diameters

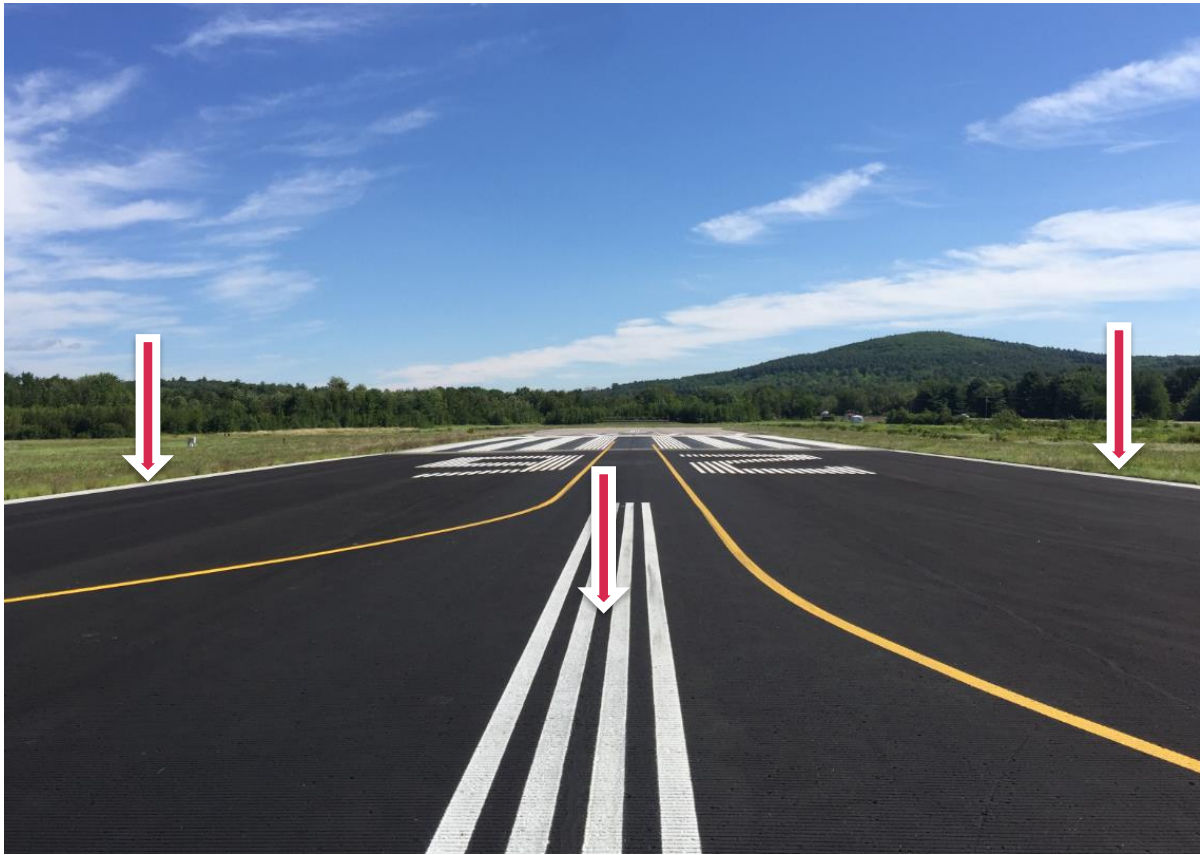
Of all the runway markings, the edge stripes have the largest volume of stormwater flowing over them. The runway is normally crowned with the high point along the runway centerline. The edge stripes start 47 feet away from the runway centerline and the pavement at the edge stripes is 6 inches lower than the runway centerline. This makes it a worst-case location as it has the highest rust loading from the stormwater flowing over one half the width of the runway pavement as well as the opportunity for bottom up rust spot staining. Additionally, if the study paint resulted in significant color changes, the edge stripes were considered as lower priority markings on the runway and therefore a lower safety issue.

The location of the edge stripes is on un-grooved pavement. The runway is grooved with grooves extending 40 feet on both sides of the centerline. The runway grooves expose the aggregates in the pavement from the saw blade cuts. This exposure causes direct contact between the iron in the aggregates and the stormwater. This contact increases the opportunity for the rust to become a solute in the stormwater and flow over the study's paint in areas 1-4. Area G's runway grooves were coated with the P-608 seal coat which reduced the concentration of rust in the stormwater flowing over the area G paint.

Figure 8: Relationship of Runway Centerline to Edge Stripes

Area G ('G' for the Gilsonite in P-608) or the fifth area was selected for its application on the seal-coated surface. The black seal coat is evident in Figure 8. Area G is approximately 900 feet east of the areas 1 through 4 and was paved under the same project as areas 1 through 4.

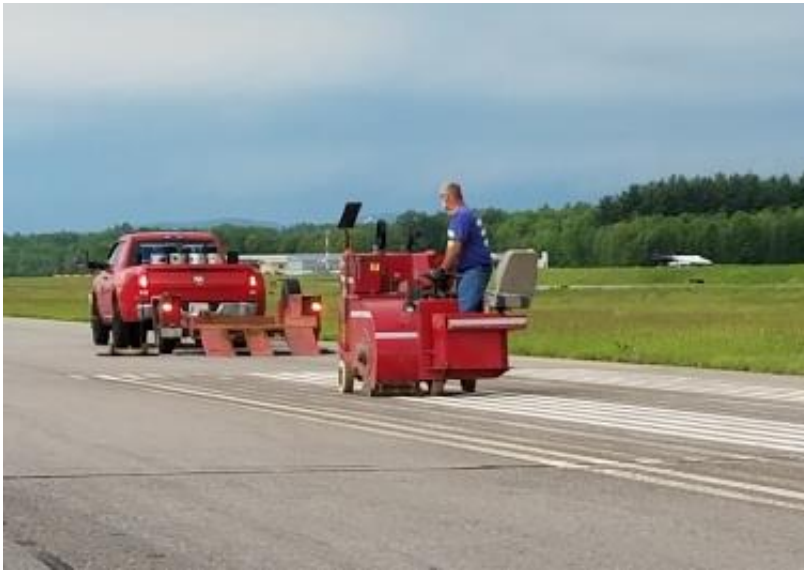
In study areas 1 through 4, the bituminous surfaces were prepared by grinding the existing paint. The surfaces where the paint was removed were further prepared by sweeping and blowing prior to painting. In area G, the existing paint was removed by grinding and then seal coated with the FAA Specification P-608 seal coat by APS under the airport-contracted project. The seal coat cured 115 days before the study’s paint was applied, well beyond the FAA P-620 30-day typical cure time.

Figure 10: Runway Paint Removal

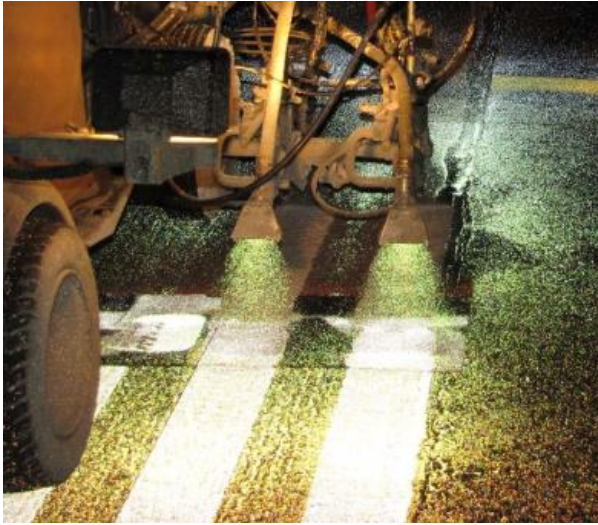
Prior to the installation each paint applicator was calibrated to the specified paint and bead application rates on the airport's abandoned runway pavement. Paint was installed with self-propelled, ride-on Graco paint machines that were equipped with automatic, pressurized glass bead dispensers.

Figure 11: Paint and Bead Installation

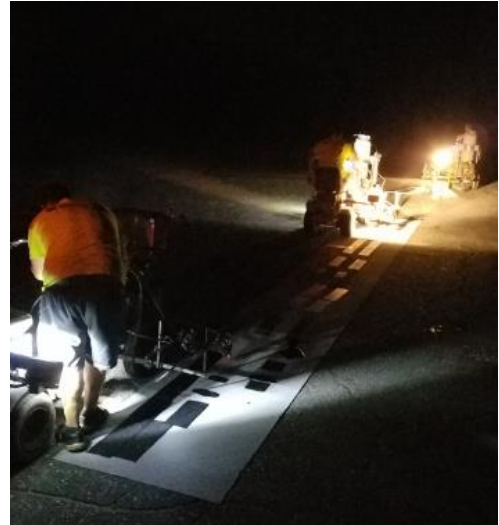
Figure 12: Paint and Bead Application Equipment Calibration

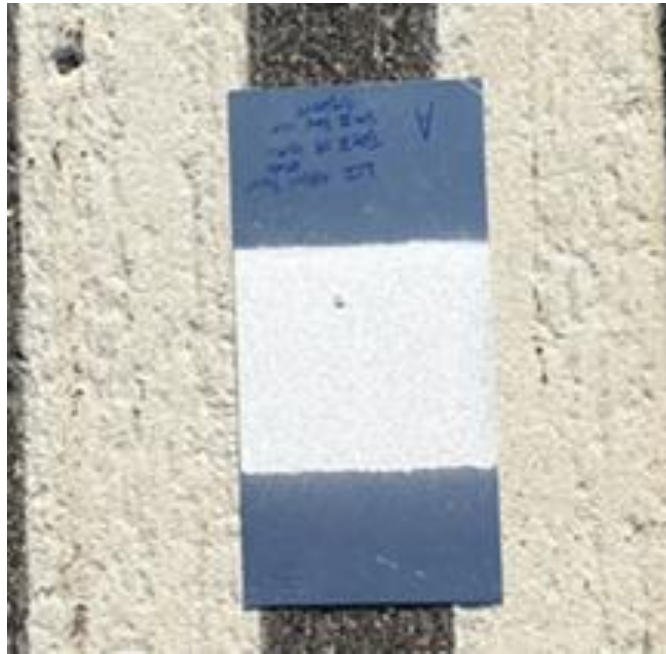
At each visit the paint color was photographed using an iPhone 6. The control panel collected during the paint installation was brought in its protective envelope from Jacobs’ office to the field. The sample was placed on the pavement next to the sample paint location and photographed. Each area had its own control sample for that area’s paint and bead type. The same sample was placed at all four sample locations in each area. The time of year and time of day provided different light intensities for the photographs. Some photographs with less than optimum lighting appear darker. The less than optimum lighting did not impact the study comparisons when the photographs are compared over the 24-month study period.

Figure 16: Control Sample Placed Next to Field Paint

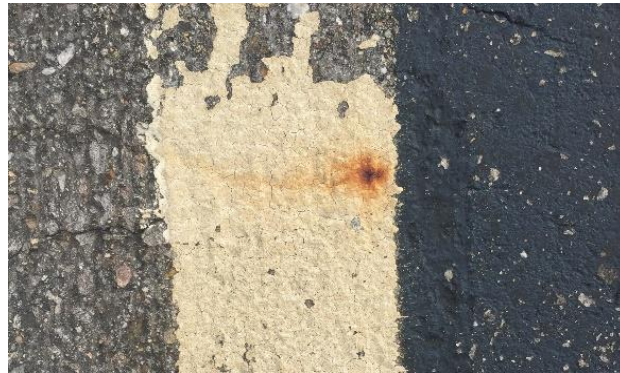
Bottom-up rust spot stains were counted along the first in-board stripe of each area. The count was made by walking the line and if a rust spot stain could be observed at eyelevel, it was counted. The size ranged from the diameter of a pencil eraser to a U.S. nickel. A typical bottom-up rust spot stain can be seen in Figure 17.

Figure 17: Bottom-up Rust Spot Stain

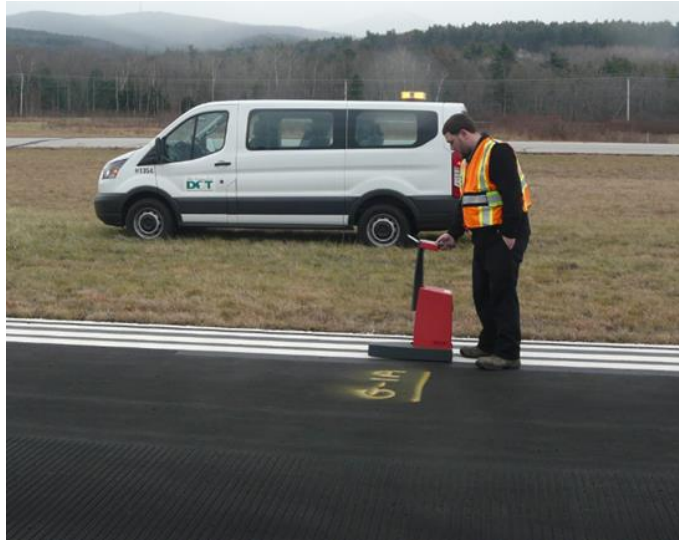
this equipment. In addition, the NHDOT offered the use of the equipment at no additional cost to the study. Trained personnel from the NHDOT Bureau of Materials and Research operated the calibrated retroreflectometer and provided the readings. The retroreflectometer used was LTL-X Mark II manufactured by DELTA. The NHDOT readings are provided in the Appendix D.

Figure 18: Retroreflectometer Reading

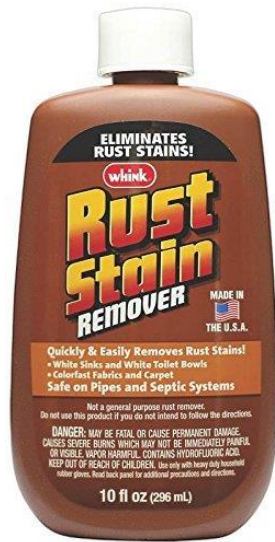
After the first year of field observations, the study's inspectors noticed the discoloration of the paint was becoming darker with time. Various sources of contamination from dirt, algae and rust were considered. To prove the source of contamination, select sites in each area were scrubbed with soap and water or a rust remover was applied. As soap and water made no change to the paint discoloration, the soil and algae contamination possibilities were eliminated. The application of a commercially available rust remover (Figure 20) resulted in a rapid removal of the contamination on the paint, confirming that the paint contamination was rust. Figure 21 shows the white paint next to where the rust remover was applied. It is noted that the rust staining is only on the surface of the paint. The rust is not within and did not damage the paint. Additionally, the bottom-up rust spot stains were removed with the rust remover.

Figure 20: Rust Remover

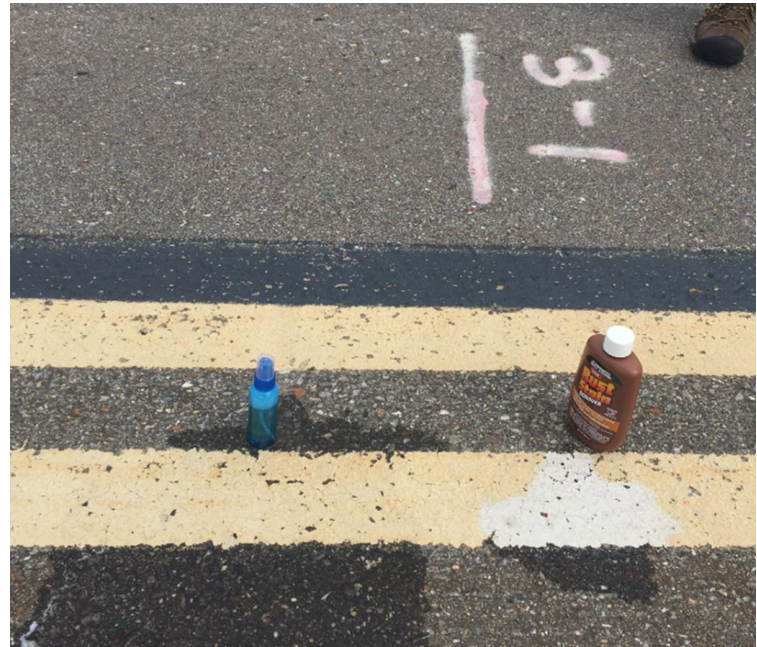
Figure 21: Soap and Water vs. Rust Remover

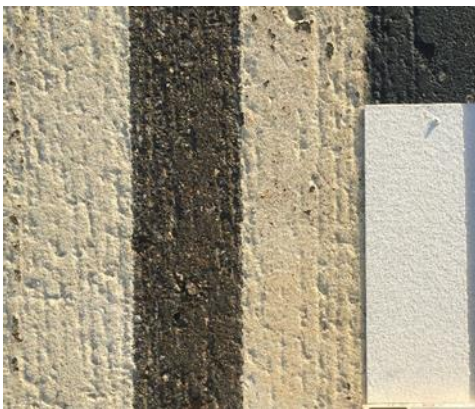
It was observed that over the 24-month period all paint test areas' color deteriorated, changing from white to brown undertones. The paint stripes observed on September 26, 2019, the last observation at the end of the 24-month study period, for each area can be seen below in Figures 22 through 26 along with their associated control panels:

Figure 22: Area 1 II SR/III

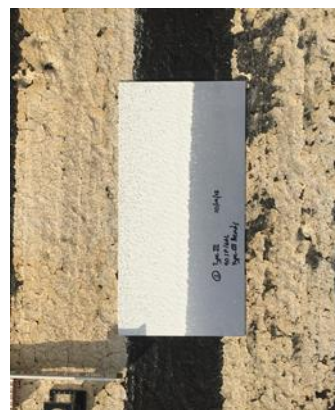
Figure 26: Area G III/III

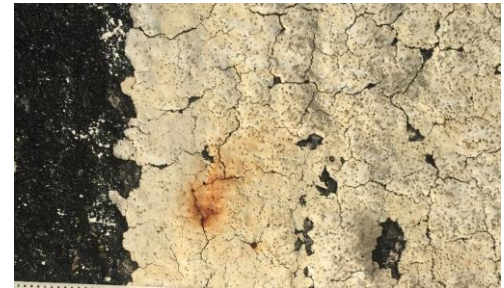
The number of bottom-up rust spot stains were plotted as stains per 100 feet, as each area had a different length. The average number of rust spot stains counted during the 24-month period is shown in Figure 33. These stains are not related to the rust laden stormwater sheet-flowing over the paint. These rust spot stains originate from below the paint.

Figure 32: Rust Spot Stain in Area G

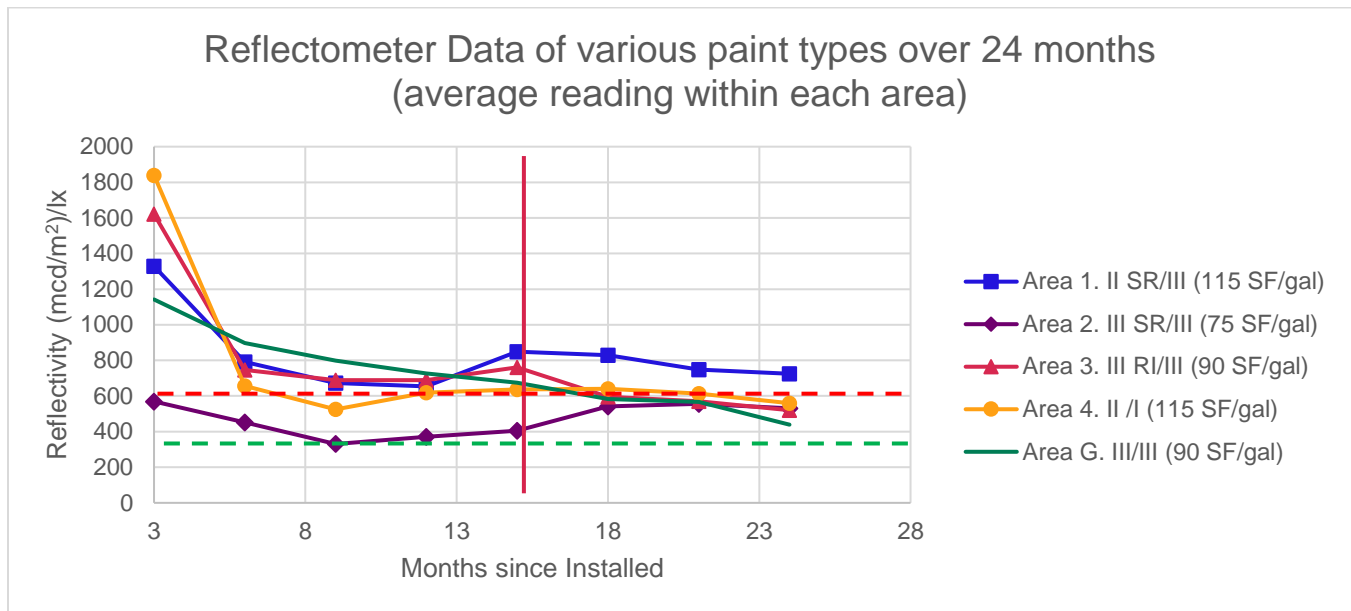
The reflectivity values obtained from the retroreflectometer were averaged for each area by collection date and plotted in Figure 34. The raw reflectivity data is provided in Appendix D.

Figure 34: Average Reflectometer Readings

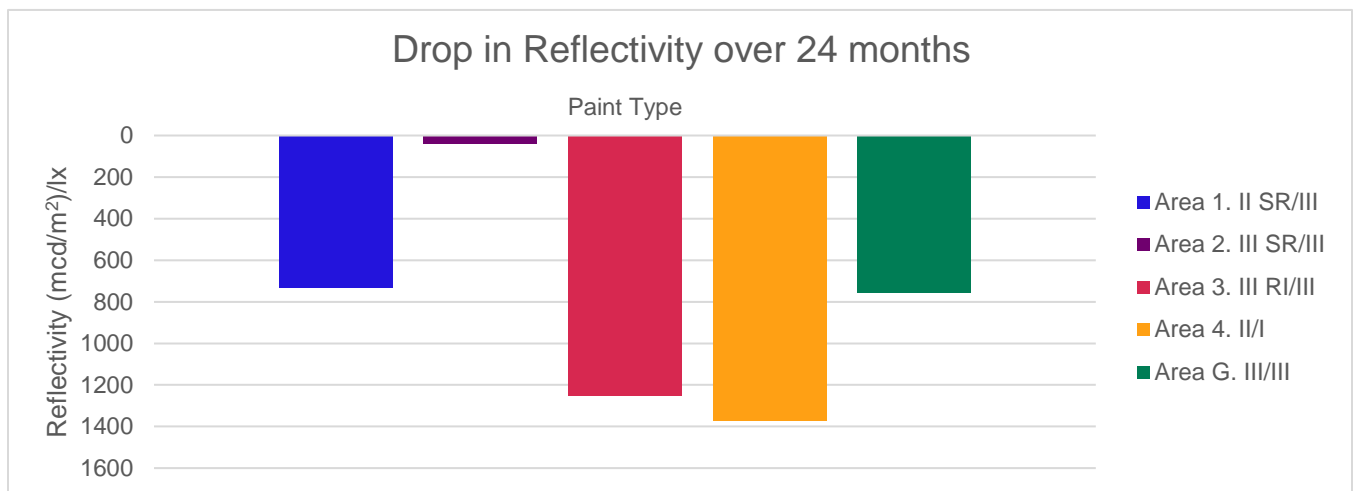
The change in reflectivity was calculated by comparing the paint reflectivity at month three to reflectivity at month 24 (see Figure 35).

Figure 35: Drop in Reflectivity over 24 months

Area 2, the whitest paint at 24 months and the thickest application, had the least drop in reflectivity and had readings that stayed very constant over the 24-month sampling period. All other areas had noteworthy drops in reflectivity with area 4 having the highest drop. The drop in reflectivity between the areas is not very telling as the end reflectivity for all areas cluster closely together, between 750 mcd/m² and 400 mcd/m² and are near or exceed the FAA’s minimum specification requirements at installation even after 24 months of exposure.

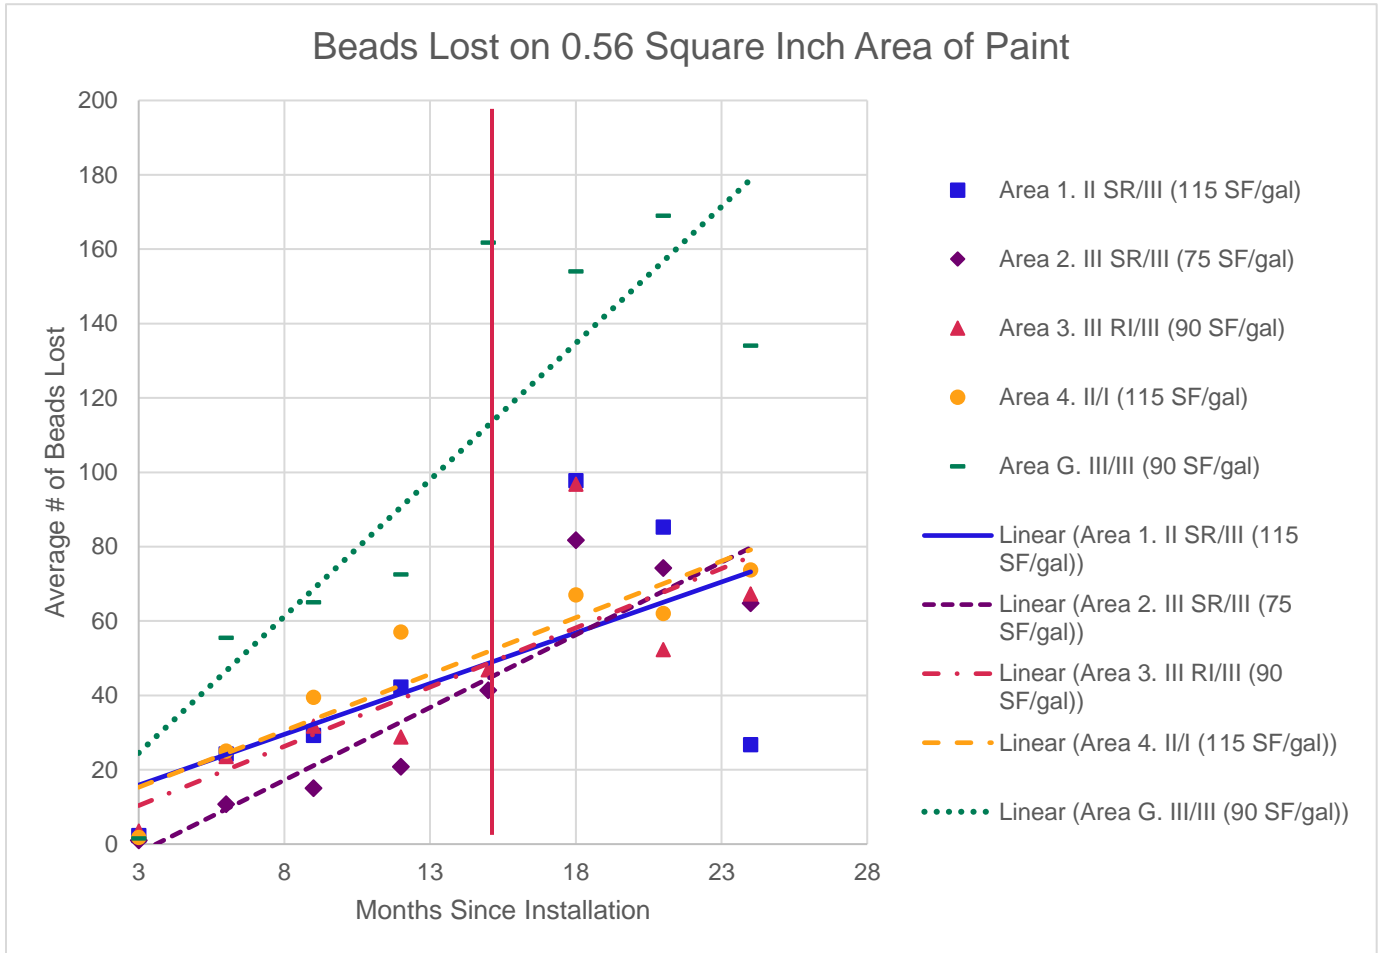
The beads lost per area were averaged for each collection date and plotted to find trends in Figure 36. The raw bead loss data can be found in Appendix E.

Figure 36: Average Bead Loss per Area

Area G experienced the highest bead loss as noted by the steep trend line in comparison to the other areas. The area G paint had a significant amount of cracking and paint chipping which most likely contributed to the loss of beads and resulted in a higher bead loss than the other areas. It is also noted that area G had poor bead embedment at application. The first sampling date in December 2017, a few months after the paint and bead installation, is shown in Figure 37. The figure indicates the poor bead embedment with numerous craters in the paint surface. When reviewing the bead loss data, area G’s paint cracking and poor bead embedment at placement should be considered.

As Figure 36 indicates, areas 1 through 4 tend to have a similar amount of bead loss when looking at the trend lines as the lines cluster together at the end of 24 months and all trend lines are a similar slope. A review of the data indicates that areas 1 through 4 had adequate bead embedment at placement. This can be seen in Figures 40-43.

After month 15 (see vertical red line Figure 36) there is a noticeable scatter in the data. The individual data points for each month are no longer on a constant upward trend. This was attributed to the fact that after month 15 the study started looking at the out-board stripe (see section 2.5.1), which was less deteriorated, and therefore those samples may have had more beads. Additionally, even with careful placement, the magnified images were not always taken at the same location. Therefore, each data collection date image might be at a slightly different location on the paint area explaining why the number of beads lost doesn't always increase. The blurriness of some images also made it difficult to determine where bead loss (craters) were in the sample. These factors made measurement and analysis of bead loss more subjective and prone to human error compared to the reflectivity readings.

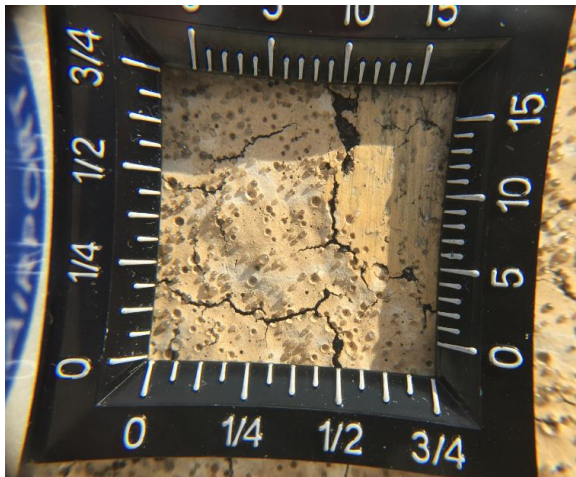
To further illustrate the poor bead embedment in area G, a comparison of areas G and 1 are shown in the Figures 38 and 39 below. Area G has numerous missing bead craters as compared to area 1 with the beads mostly intact.

Figure 38: Area G - Sample 2 – 9/26/19

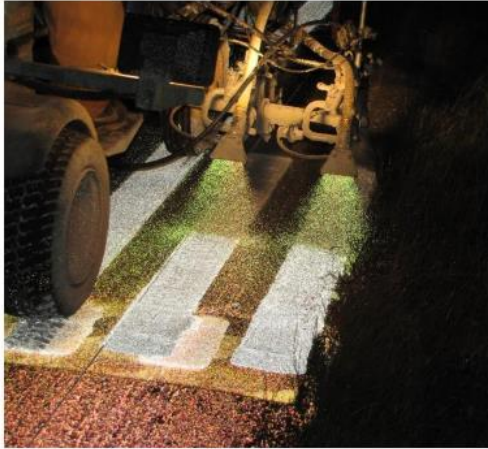
At 7:30 pm, people began to arrive. A crew began removing the areas of runway edge markings that would receive the test lines, equipment was loaded with material, and the paint machine was calibrated for the TT-P-1952E, Type II stain-resistant paint from Safety Coatings, Batch Number BO7728. A 1 quart sample was taken and given to Tim Buzinski to retain for the period of the NHDOT test. Jeremy Cunningham, the striping machine operator, determined his speed to be 1.5 mph when 15 mils wet film thickness was achieved. The glass bead guns were then calibrated to collect 150 ml of TT-B-1325D, Type III glass beads in a 10-second drop for the 5-inch line. Once the bead guns were both calibrated, the equipment was taken out to the runway. The area that had been removed was checked to ensure it was clean enough to paint, and additional blowing and sweeping had to be done to remove the majority of the residue left in the depressions in the pavement. The crews held a string line for the length of the test area ^{east} west of Taxiway F on the ^{north} south side of the runway; and Jeremy painted the first two of four 5-inch lines. During the first run, it was noticed that the bead guns were not adjusted properly to drop the majority of the beads on the painted lines. Jeremy adjusted them to get more of the beads on the lines, seen in Pictures 1 and 2 below.

Picture 1 – glass beads spreading too wide.

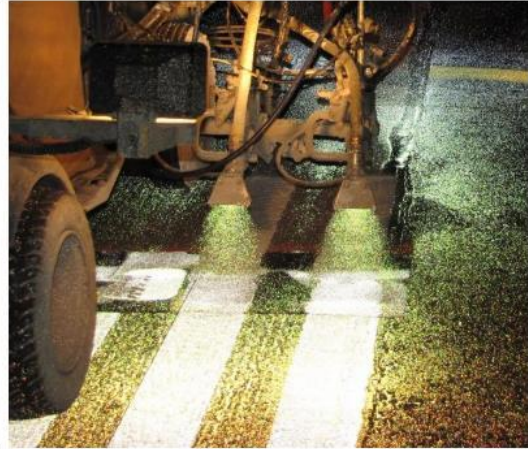
Picture 2 – glass bead guns adjusted.

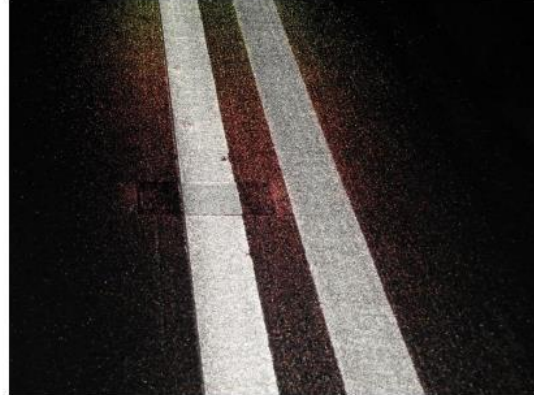
Picture 4 – glass beads applied over line.

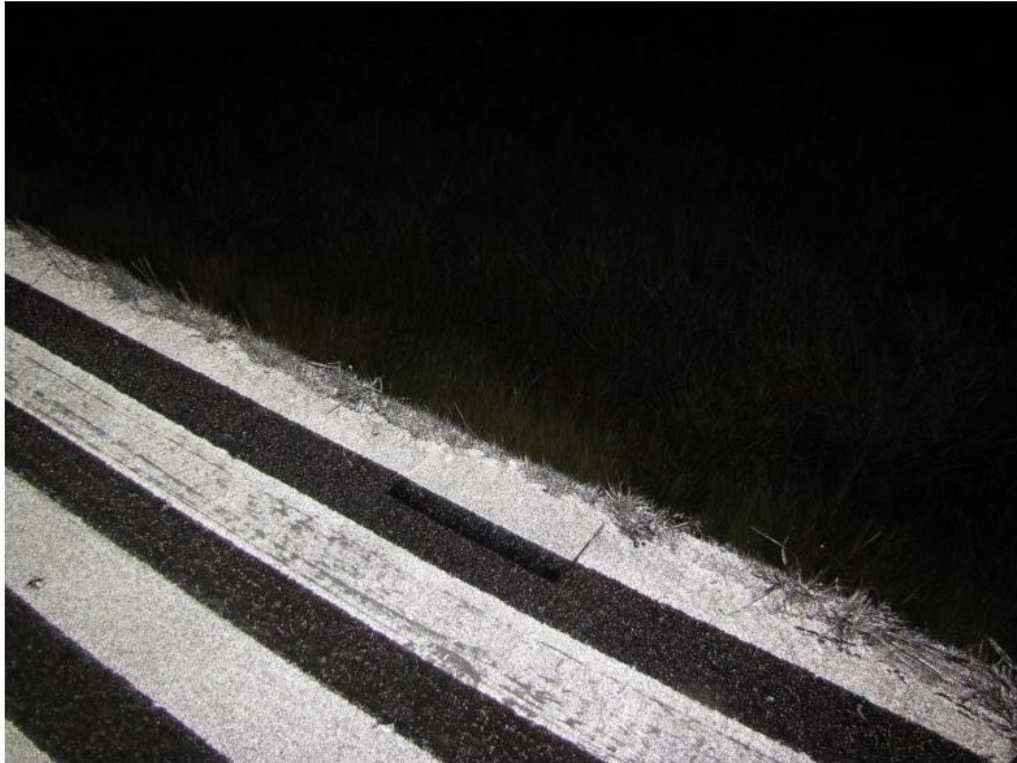
Once the initial test lines were dry, Jeremy proceeded to apply the other two of four 5-inch test lines using the Type II stain resistant paint. Tim Buzinski collected the two panels that were placed along the test lines that would be retained for the duration of the research project. The first test line that was applied had a clogged glass bead gun (Picture 3). Jeremy recognized it, stopped, then went back to the beginning and applied beads over the unbeaded line (Picture 4). The second panel was placed longitudinally along the line closest to the grass, seen in Picture 5. The streaks seen in the line next to the outermost line were from the string line that rolled across the freshly painted line.

Picture 5 – Test panel placed longitudinally along outer line closest to the grass.
