**Engineered Log Jam Monitoring along  
NH Route 16 in Errol, New Hampshire**

**Final Report**

# **Engineered Log Jam along NH Route 16 in Errol, New Hampshire**

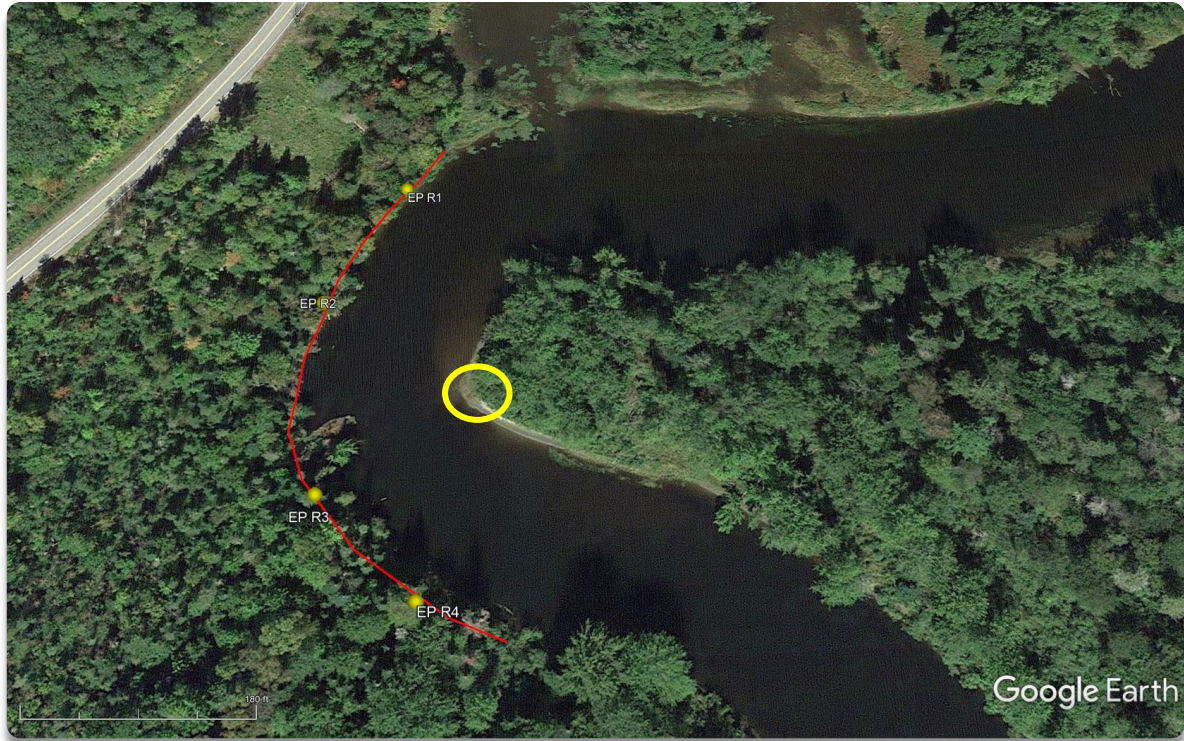
Figure 14. Campground streambank reference site. Yellow circle is location of bar sediment samples

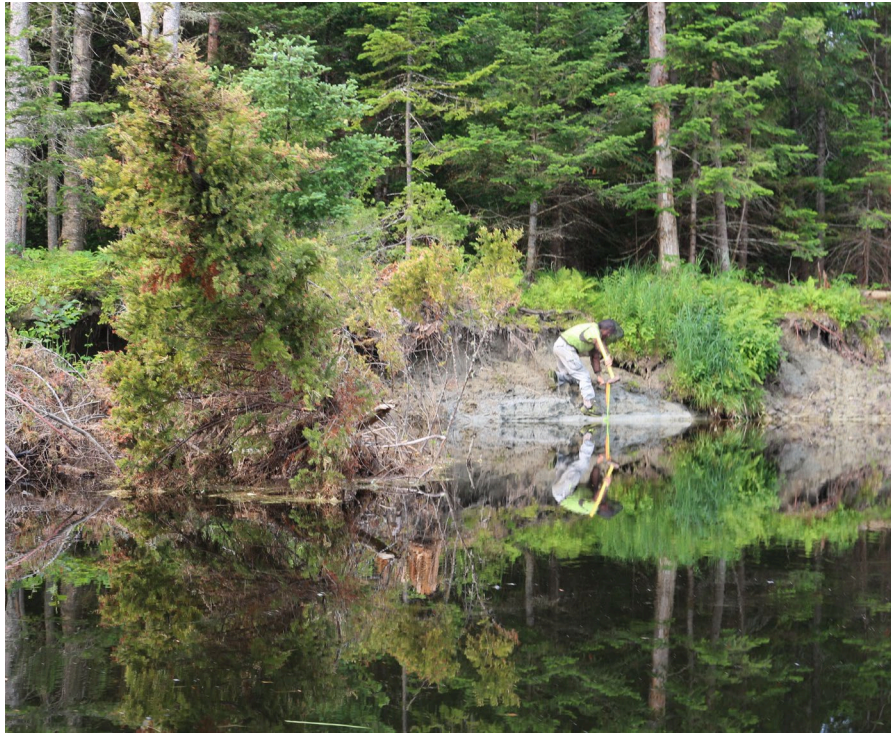
Figure 15. Installation of erosion pin EP R3 at Campground site.

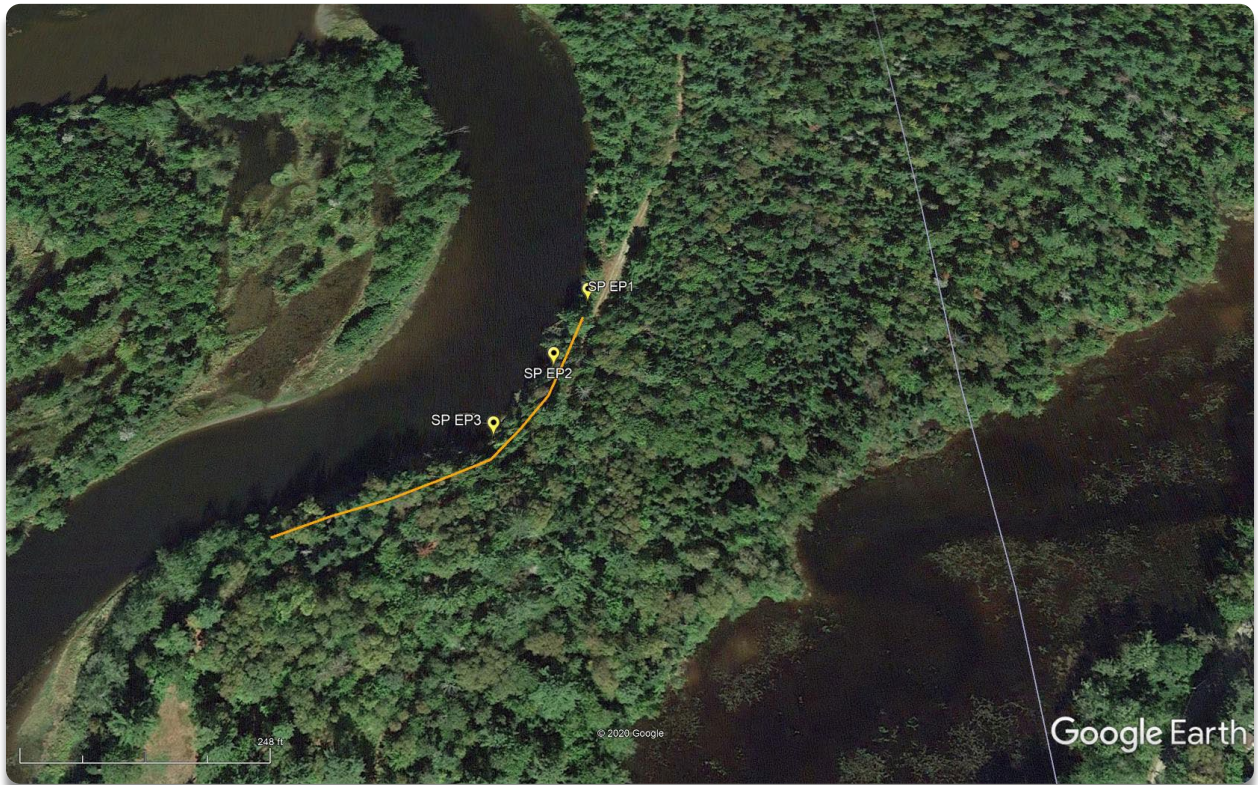
Figure 16. State Line streambank reference site.

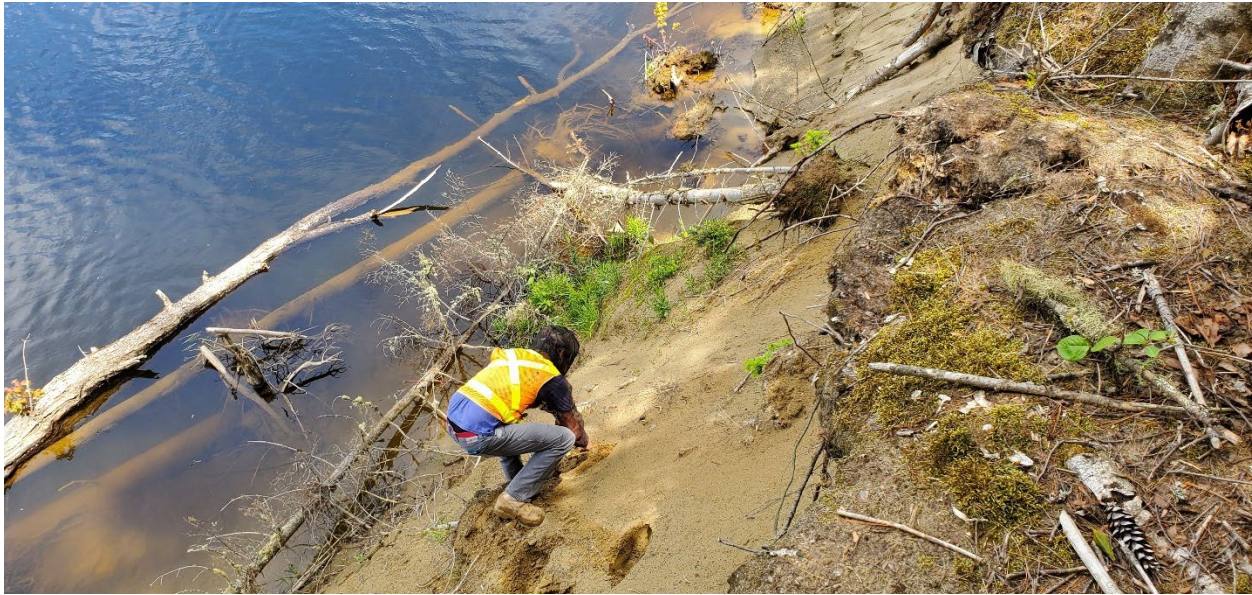
Figure 17. High bank height and steep slope at State Line streambank

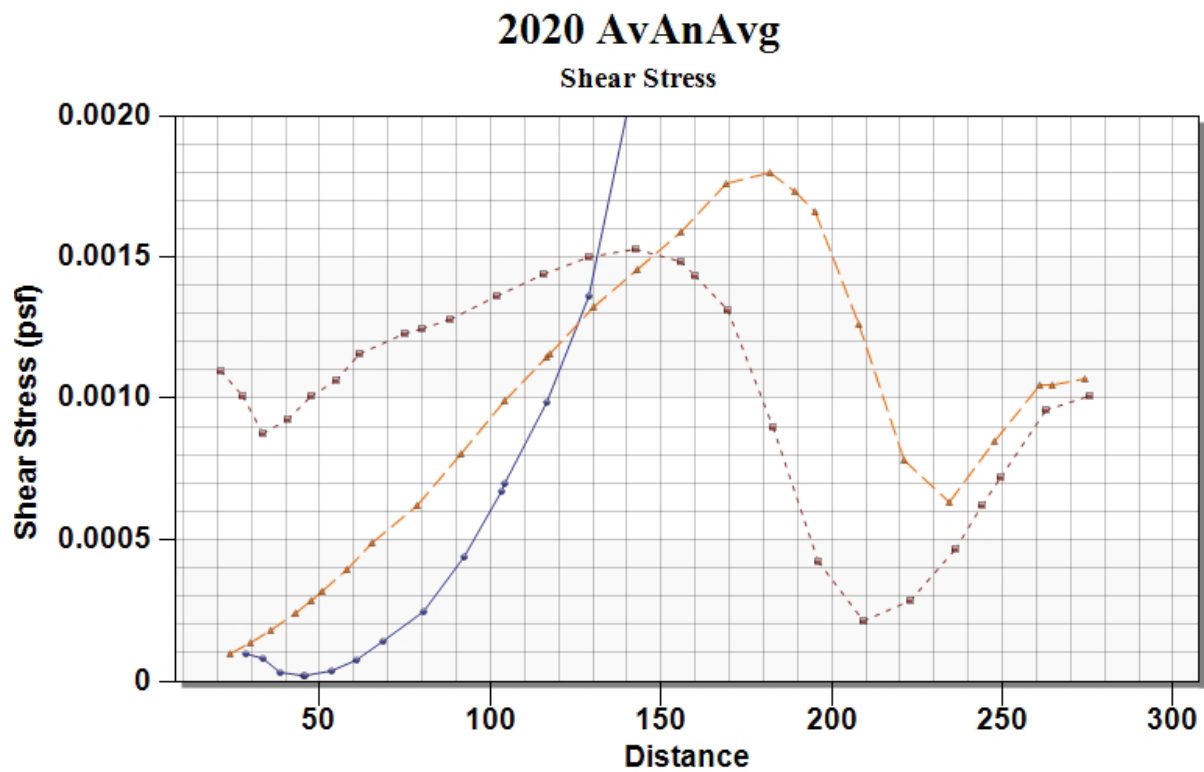
Figure 30. Bed shear stress for transects in Figure 29.

In Figures 29 to 32, low water surface elevation and high flow (Figures 31 and 32) result in smaller cross-sectional area and therefore higher velocities and near bank shear stress compared to higher water surface elevation and lower flow.

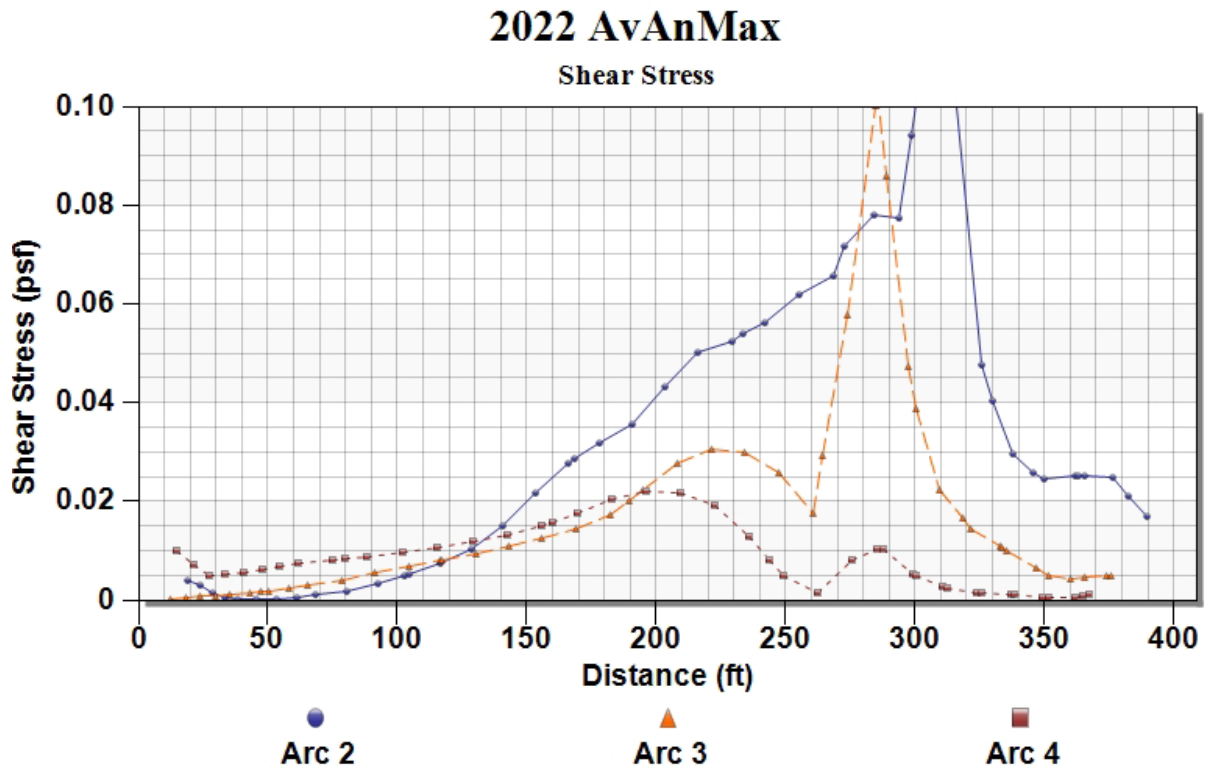
Figure 38. Bed shear stress for transects in Figure 37.

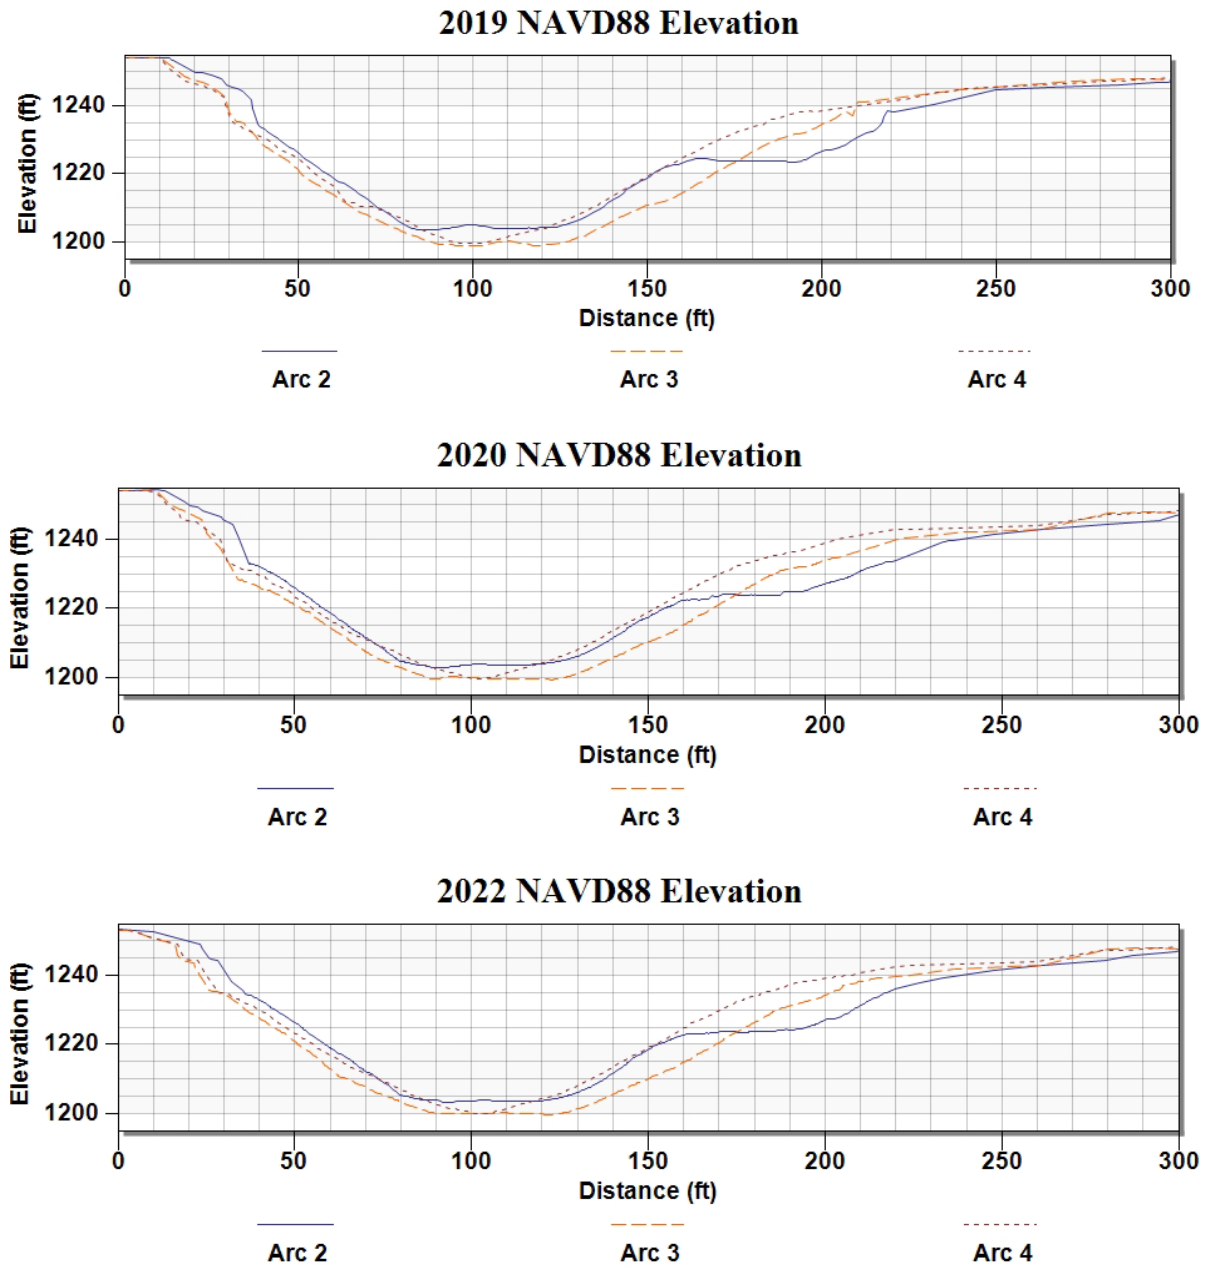
Figure 47. Stream cross sections looking upstream at the three transections delineated in Figures 45 and 46. For each Arc, the ELJ is at Distance: Arc 2, 23.25 ft to 26.25 ft; Arc 3 16.25 ft to 18.25 ft; and Arc 4 16.75 ft to 19.0 ft.

In the two pre-construction surveys, the bank retreat is clearly evident at the waterline from 2019 to 2020. The bank erosion rate is about 2 feet/year, which is double the rate identified in Table 1. Table 1 values are derived from point estimates using erosion pins whereas the figures demonstrate the totality of the erosion along the streambank. It should be noted that the streambank slopes below the waterline in Figures 48 to 50 average 36 degrees which is at the very upper limit of the angle of repose for sands. These lower elevation slopes do not demonstrate significant lateral movement over the monitoring period. Streambanks on the outside of meander bends, such as at the ELJ site, typically demonstrate erosion at the toe of the streambank which then results in bank undercutting and then bank failure.

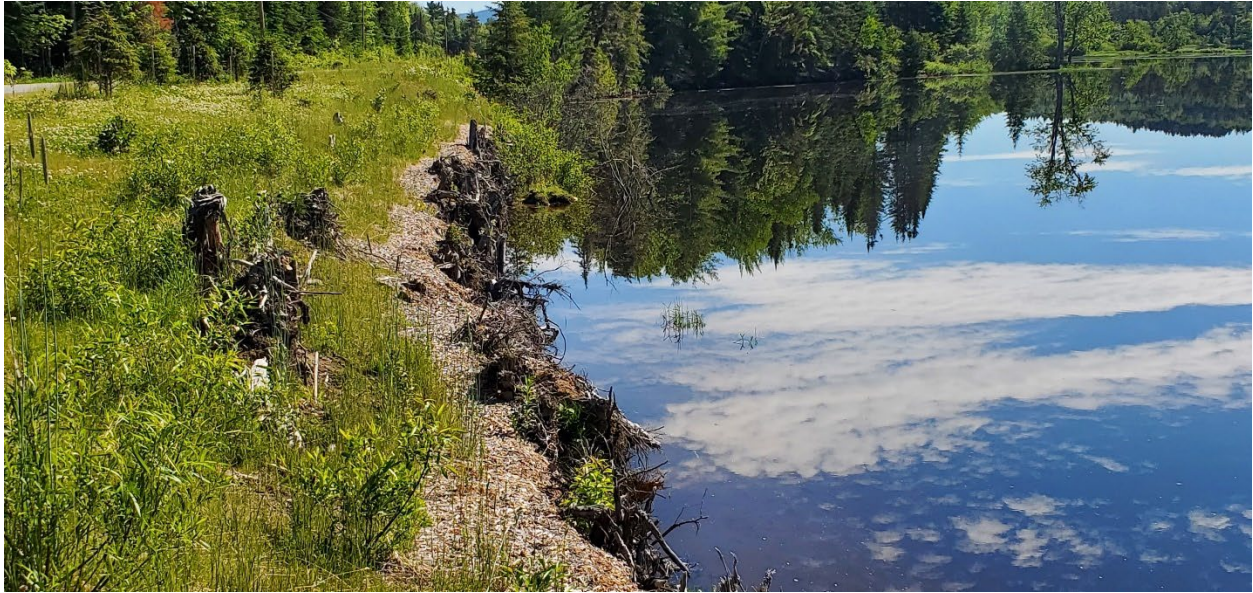
Figure 47. Pre-construction streambank geometry.

Post construction streambank physical attributes included reducing the above-waterline bank angle, moving the road farther away, and planting native vegetation. Some burrowing animals were still present (Figure 35). Although the game cameras did not pick up wildlife along the

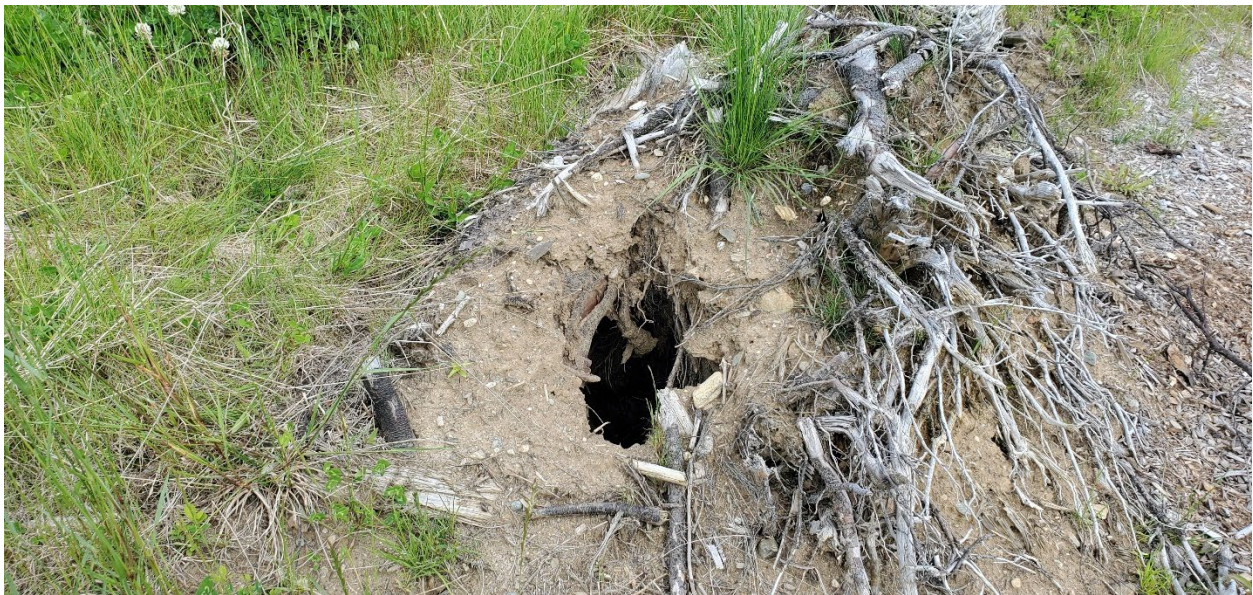
Figure 48. Burrowing animal evidence along the ELJ.
