# **Assessment of Embedded Culvert Low Flow Hydraulics**

## **Final Report**

Prepared by University of New Hampshire Department of Civil and Environmental Engineering, College of Engineering and Physical Sciences, in cooperation with the U.S. Department of Transportation, Federal Highway Administration

**Assessment of Embedded Culvert Low Flow Hydraulics**  
**(SPR Project # 26962Y)**

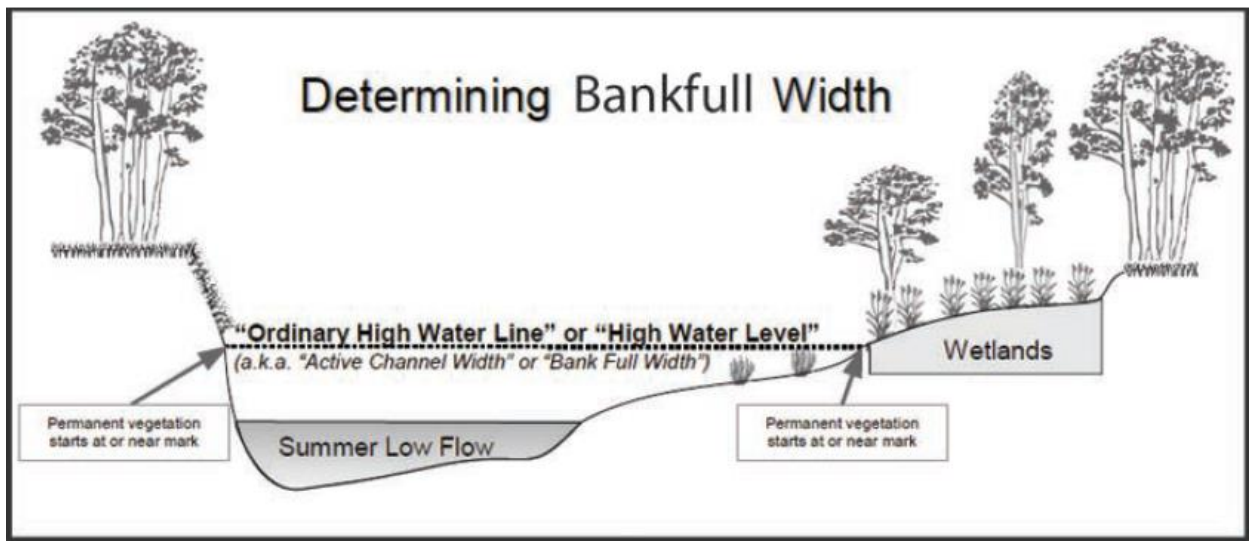
Figure 1. The bankfull condition (MEDOT, Stream Smart Road Crossing Pocket Guide)

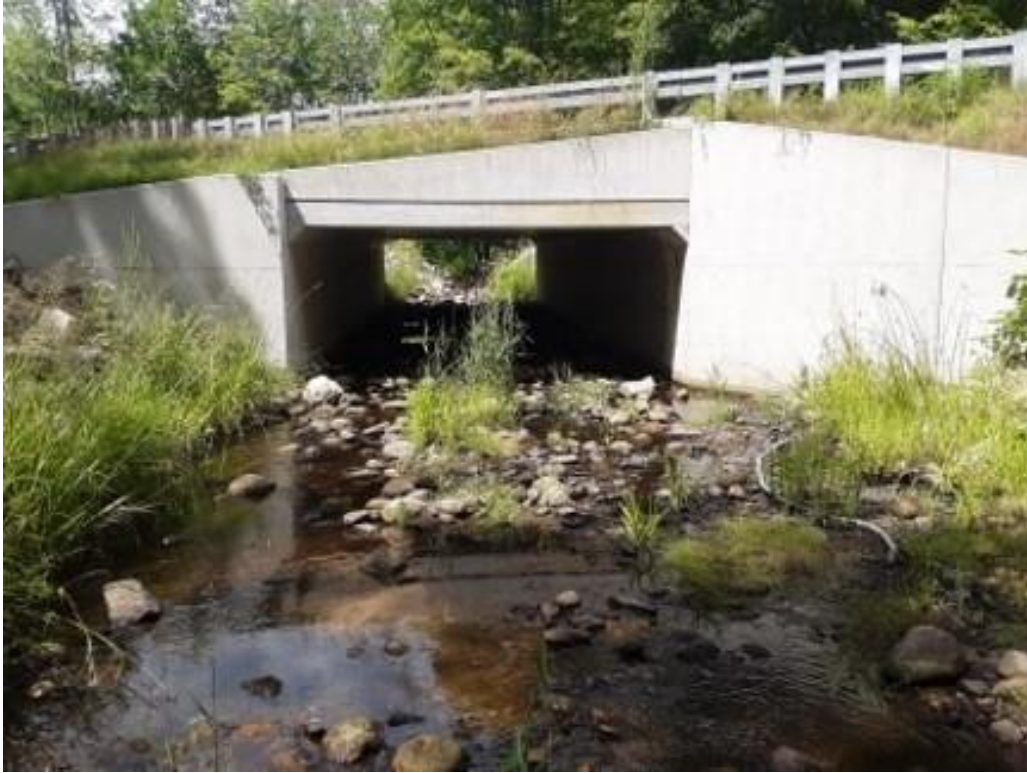
*Figure 5: Outlet of Gilford Culvert, performing adequately at low flow conditions*

It was found that some sites performed adequately during low flows as seen in Figure 5, but other sites either had a loss of bed material or were in hyporheic conditions, as seen in Figures 6 and 7, respectively. A loss of sediment or hyporheic conditions will inhibit aquatic organism passage.

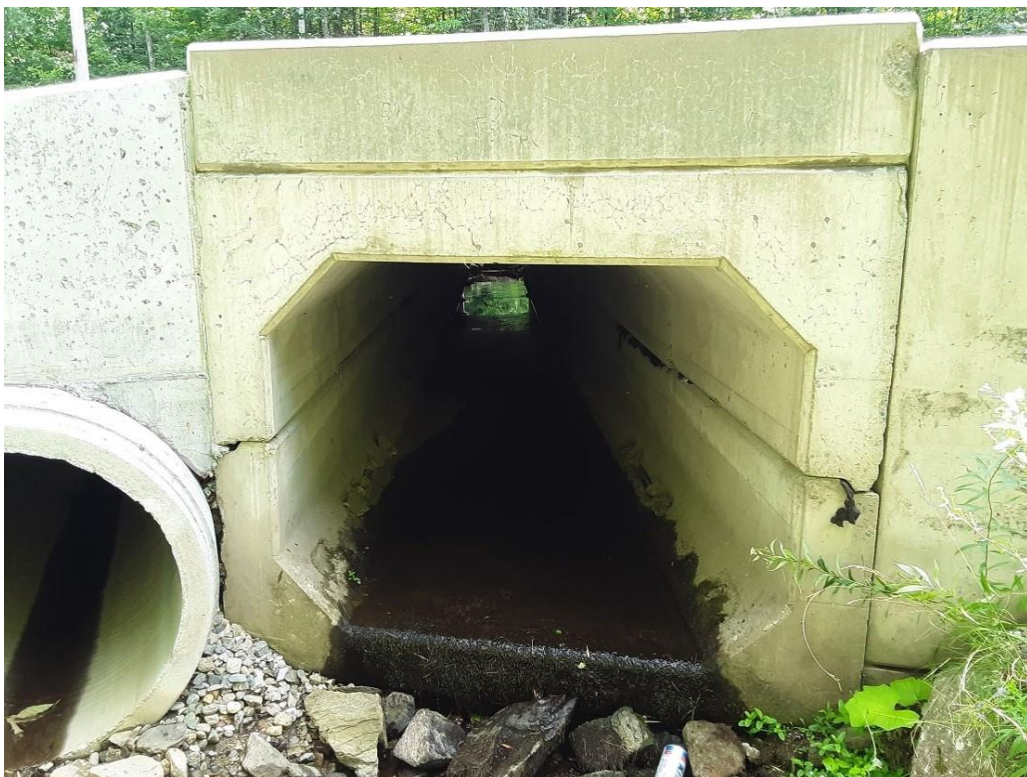
*Figure 6: Outlet of Bethlehem Culvert, loss of bed material*

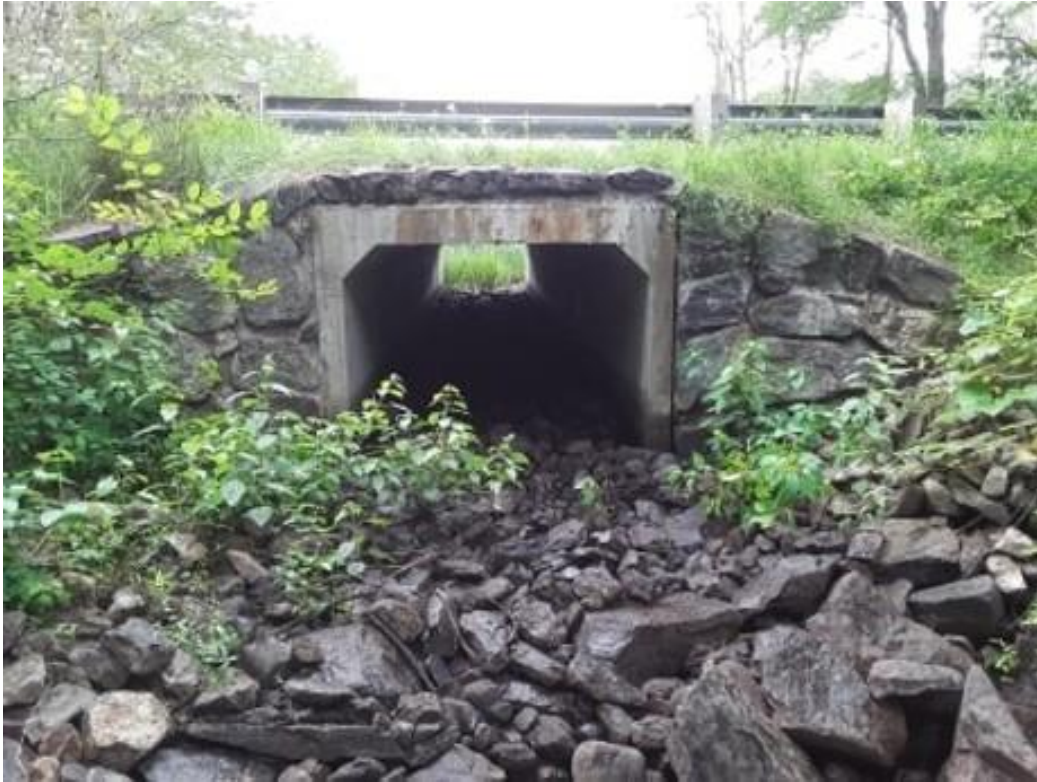
*Figure 7: Outlet of Londonderry, Wiley Hill Road Culvert, in hyporheic conditions*

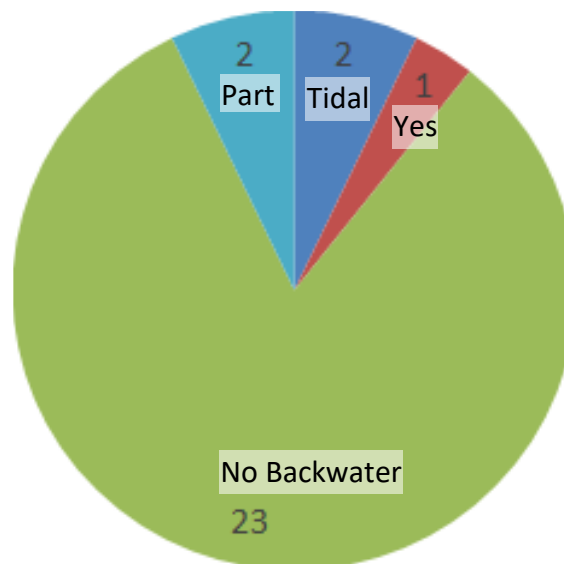
One factor that can improve AOP and retain sediment is if there are backwater conditions on the culvert (water from downstream backing up to the culvert). Figure 10 indicates the culverts with backwater conditions (including tidal). Of the 5 backwatered culverts: all had sediment, one was partly hyporheic, and none were completely impassable.

Figure 10. Culvert Hydraulic Control

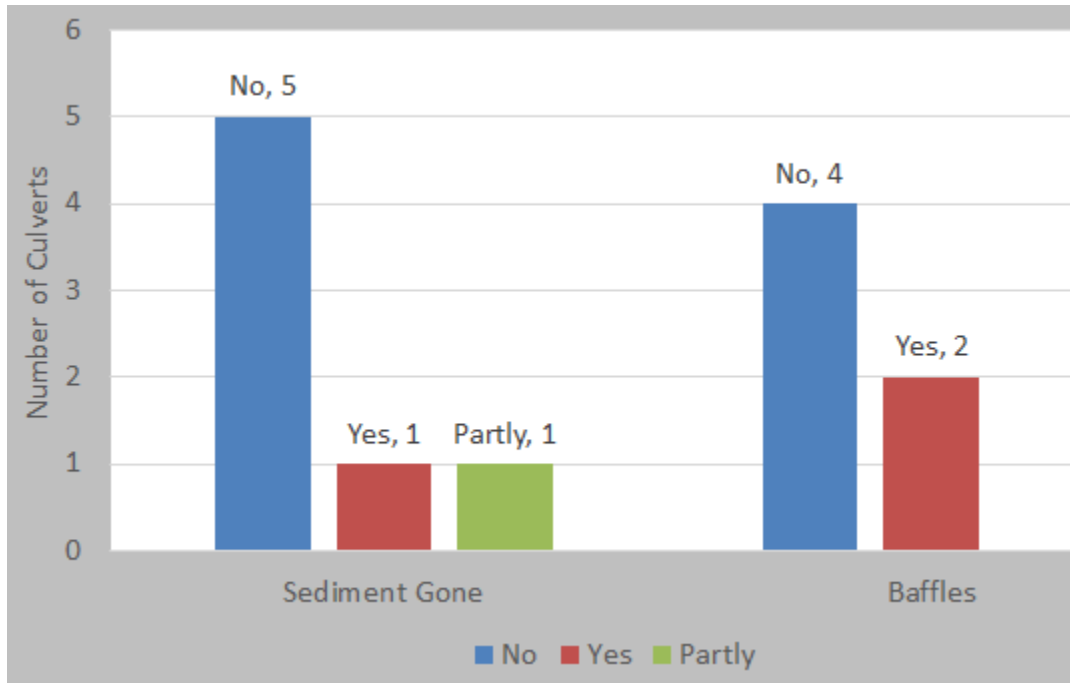
A synthesis of just the seven hyporheic culverts of Figure 8 appears in Figure 11. Baffles did not necessarily prevent the embedded material from going hyporheic.

Figure 11. Statistics for the seven hyporheic culverts

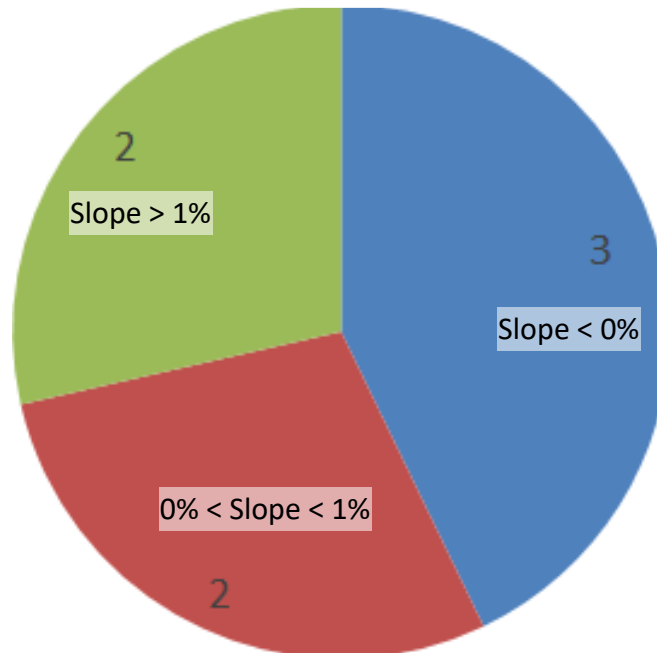
Slope itself did not seem to be a good predictor of losing culvert sediment, as seen in Figure 13. This may indicate that sediment loss is more related to the stream entrenchment ratio and high flow bed shear stress than just slope alone.

Figure 13. Relationship of slope for the seven culverts that lost sediment.

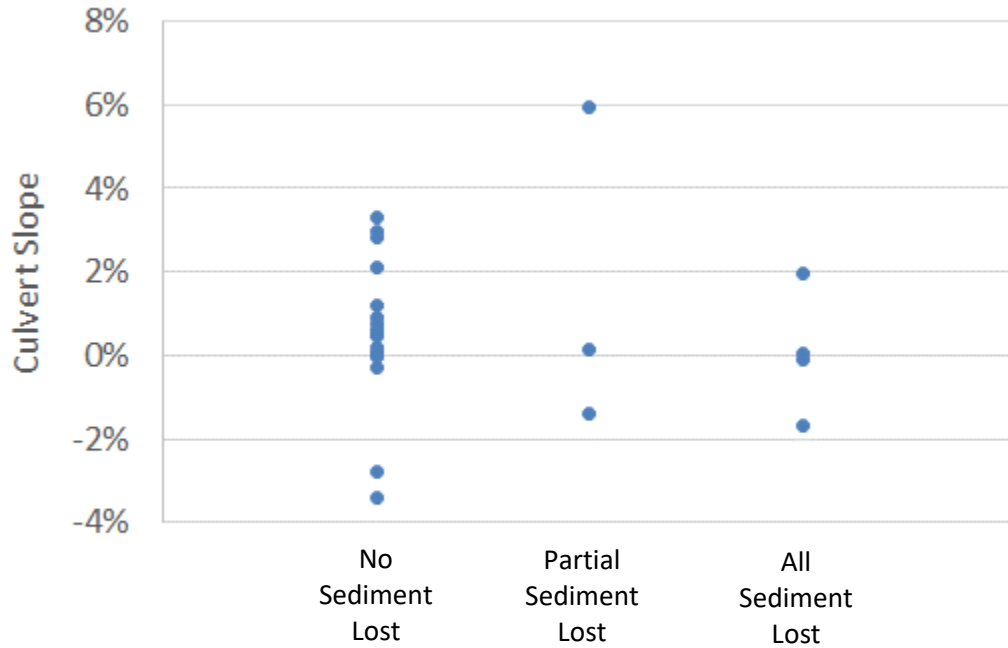
To explore the aspect of culvert slope further, the entire data set is plotted in Figure 14 and stratified by culverts that lost all, partial or no sediment. Here the field-measured culvert slope is plotted for each culvert. It may be seen that there is no strong statistical relationship between slope and whether culverts lost sediment. The steepest culvert in this dataset, is a NH DOT culvert on Carpenter Brook in Littleton, NH. The field-measured culvert slope for this culvert was 5.93% (the design plans indicated 7.42% slope). This culvert lost some sediment at the inlet. It also has baffles and is backwatered.

Figure 14. Relationship between field-measured culvert slope and embedded sediment loss.

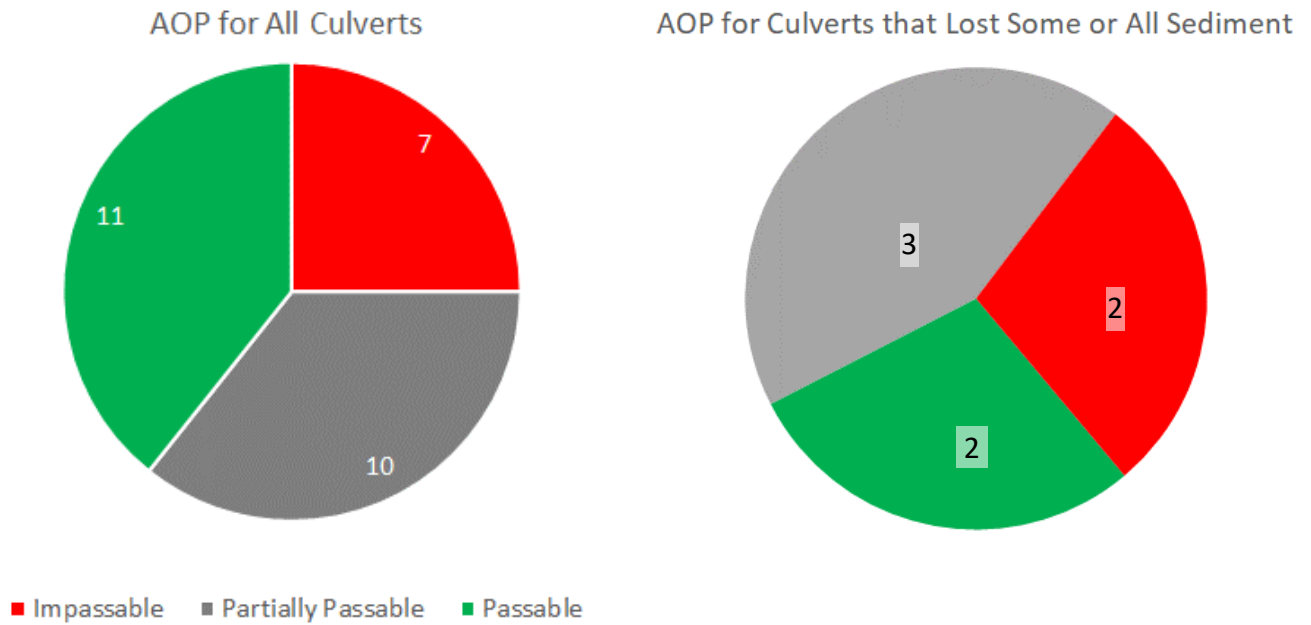
AOP was not guaranteed by embedment alone. Streambed material is but one criterion in the AOP assessment. Figure 15 displays the AOP assessments of all culverts in this study. As demonstrated in the Figure, of the seven culverts that lost sediment (Figures 9 and 12), two had full AOP primarily because of ponded/backwatered conditions in those two culverts.

Figure 15. Aquatic Organism Passage (AOP) for all culverts (left) and those that lost some or all Sediment (right). Green – fully passable, Grey – passable by only best swimming fish, Red – impassable.

When culverts were hyporheic, some were still passable in that the entire culvert width was not hyporheic (Figure 16). However the majority of non-hyporheic embedded culverts afforded some AOP (Figure 15).

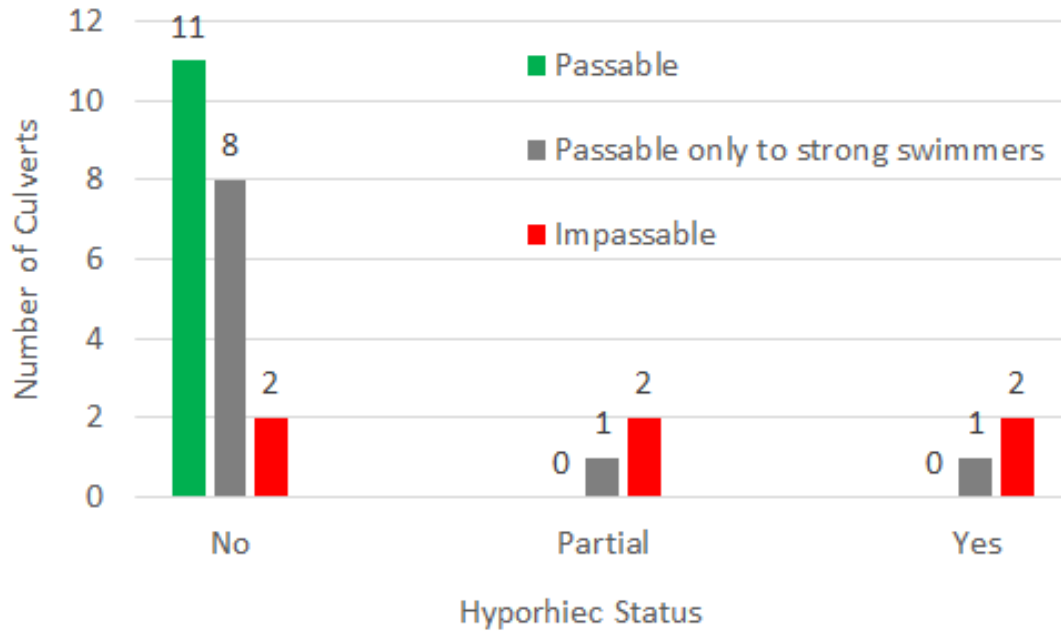
Figure 16. Aquatic Organism Passage for culverts that were Partially or Fully Hyporheic (Green – fully passable, Grey – passable by only best swimming fish, Red – impassable).

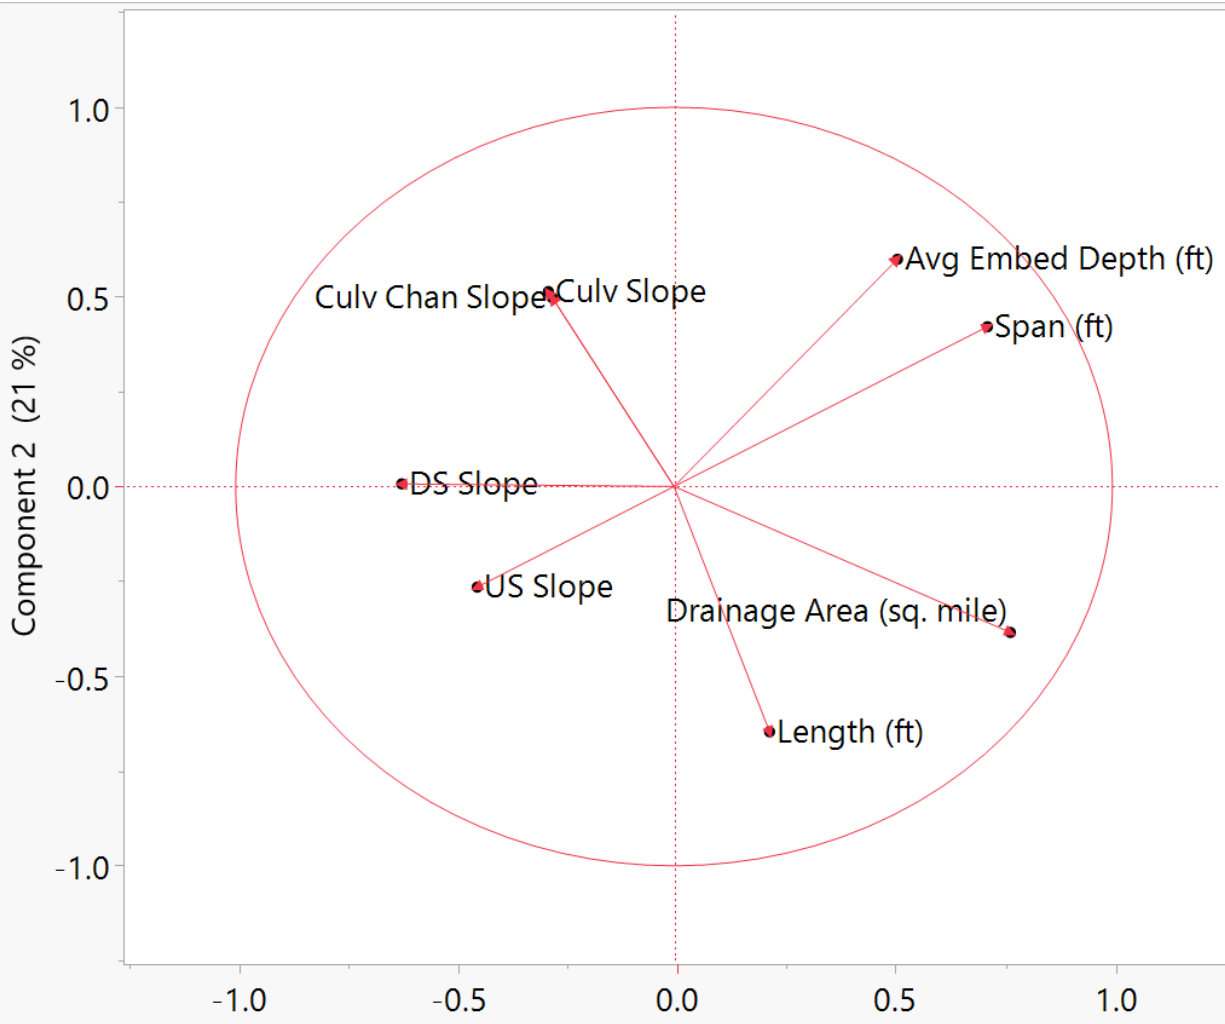
The results of the analysis may suggest that hyporheic sites are caused by culvert, not watershed characteristics and hyporheic sites are caused by culvert dimensions, not culvert slopes. Figure 18 shows a loading plot with the first two principal components as the axes. The farther the variable is from the origin, the stronger its influence on the principal component. Figure 19 shows a score plot which shows how other site variables compare to the first two principal components. Figure 20 displays the eigenvalues of each principal component and the cumulative percent of the variation that each principal component explains. The results of the analysis demonstrate that the principal components are not able to adequately explain the variation in the data. For the culvert data, the first two principal components only explain about 50% of the variation, where above 80% is preferred in order to make a strong conclusion.

Figure 18: Principal Component Loading Plot

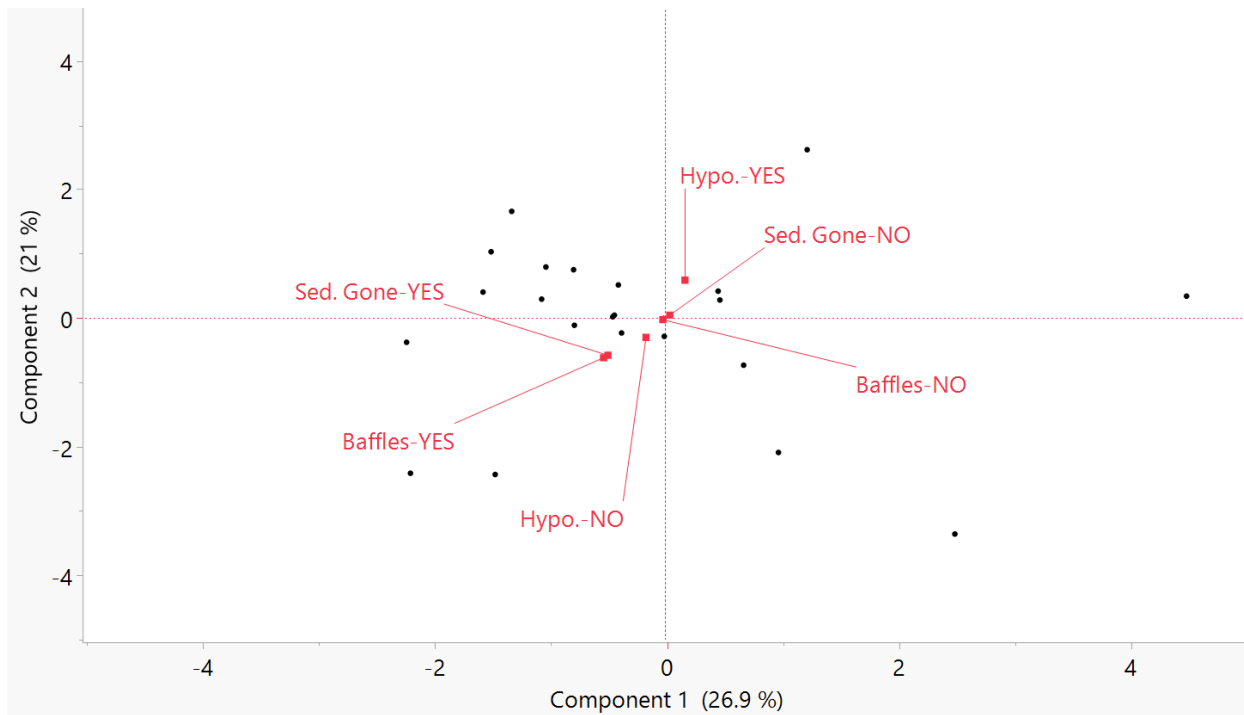
Figure 19: Principal Component Score Plot

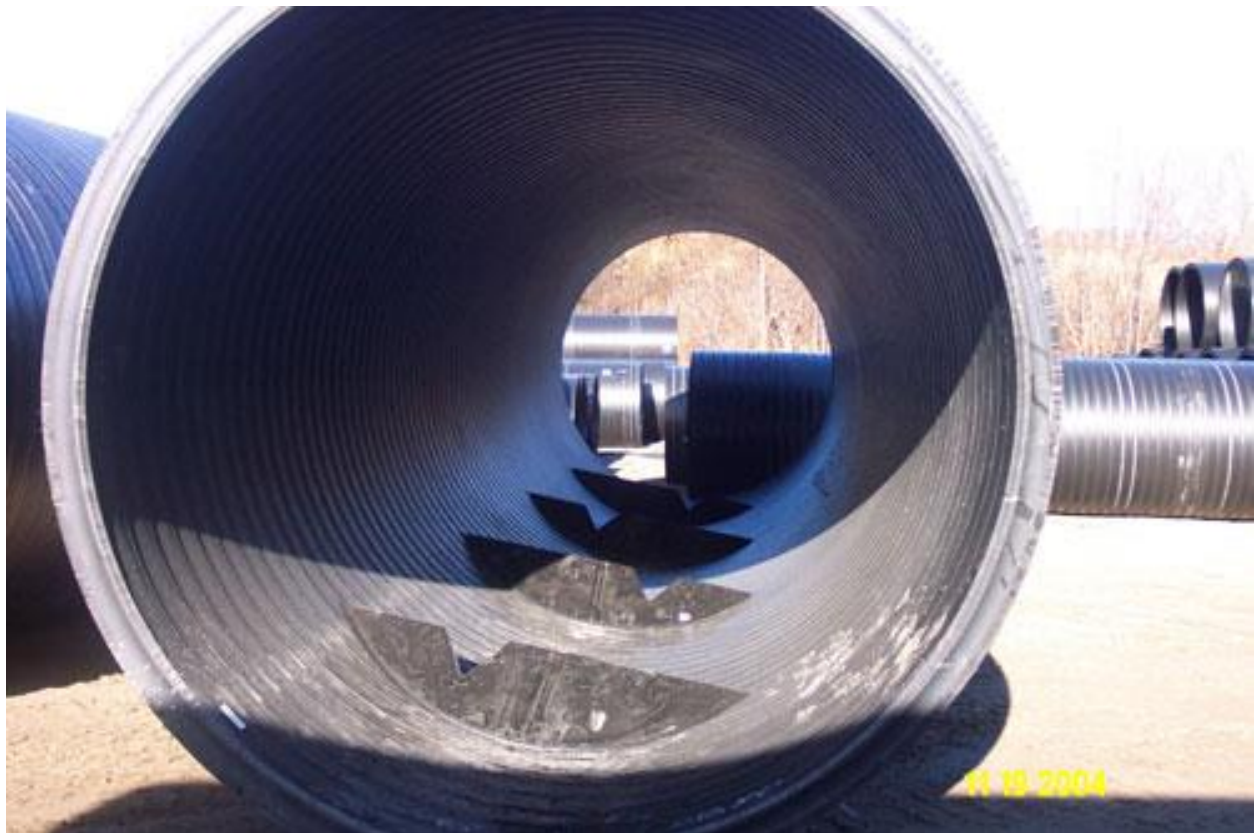
*Figure 21: Corrugated HDPE culvert with pre-installed, notched baffles*

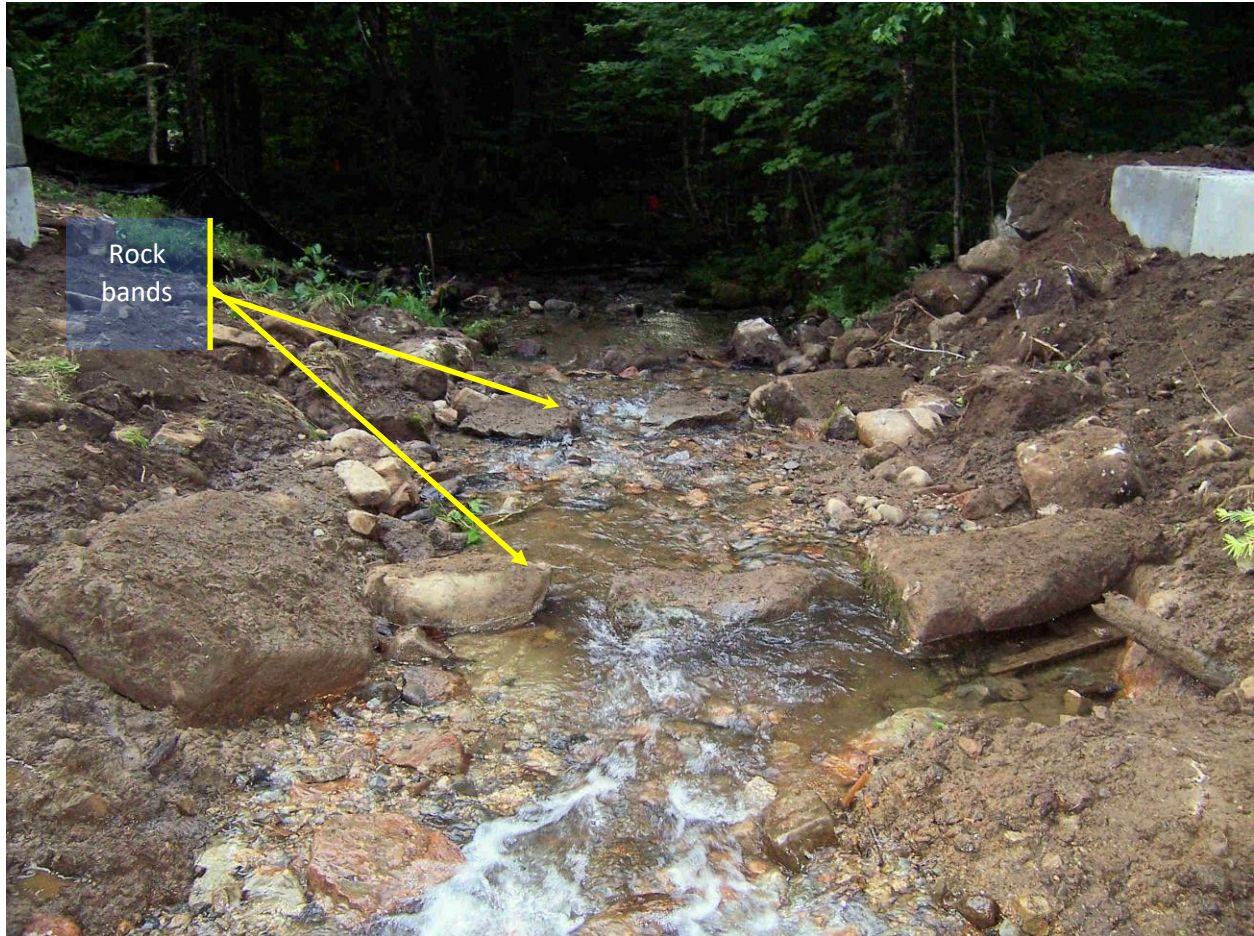
*Figure 22: Streambed with rock bands prior to setting bridge deck*
