STATE OF NEW HAMPSHIRE INTER-DEPARTMENT COMMUNICATION

SUBJECT: Dredge & Fill Application
Plaistow-Kingston, 10044E

NHDES WETLANDS PERMIT APPLICATION

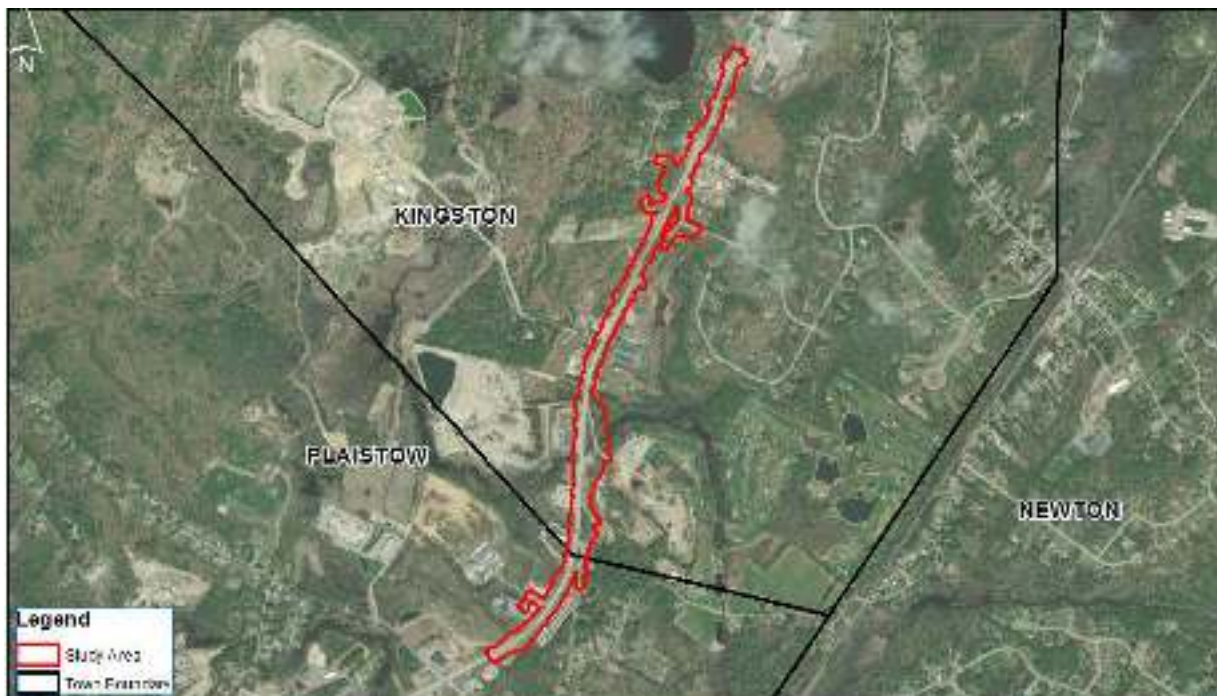
Figure 1. Approximate Project Area

This report describes the results of a wetland delineation completed along NH Route 125 in Kingston and Plaistow, Rockingham County, NH. McFarland Johnson (MJ) completed this work on behalf of the NH Department of Transportation (NHDOT) for the proposed roadway improvement project. Stephen Hoffman was the lead delineator, with assistance from Jordan Tate. Oversight on all matters was provided by Christine Perron, NH Certified Wetland Scientist No. 294. The project is located on NH Route 125 beginning just north of Old Country Road in Plaistow and ending approximately 1.7 miles north at a point just south of Newton Junction Road in Kingston (Figure 1). The field study area encompassed the limits of available survey within the project limits.

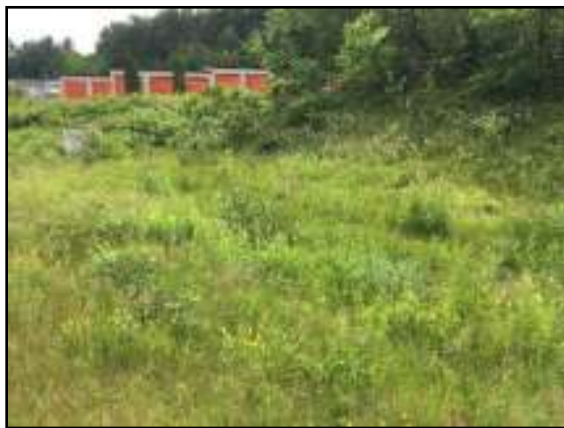
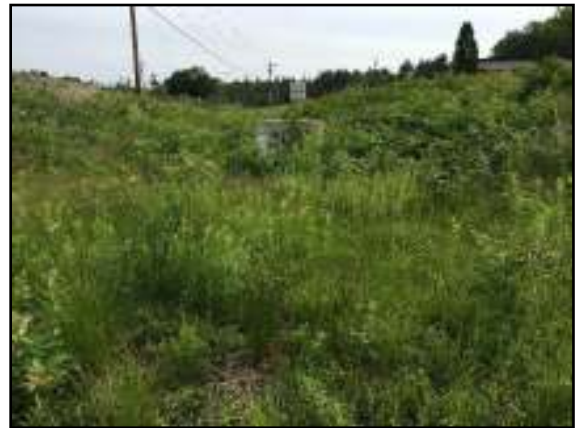
Photo 1. Area DB1: June 28, 2018

Description: Area DB1 was identified during the 2001 wetland delineation effort (done by others) as a palustrine shrub-scrub (PSS) wetland (shown below in Figure 2). Area DB1 is located on the east side of Route 125 approximately 1,000 feet north of Old Country Road. During the 2018 wetland delineation effort, it was determined that DB1 has been modified since 2001, and no longer retained the characteristics necessary to be classified as a wetland. The area appears to have been disturbed for the construction of a stormwater treatment area as evident by the concrete stormwater riser seen in photos 1 and 2. Vegetation in this area was dominated by grass-leaved goldenrod (*Euthamia graminifolia*), broom sedge (*Carex scoparia*), and birdsfoot trefoil (*Lotus corniculatus*). Soils in this area did not exhibit any hydric soil indicators and there were no primary indicators of hydrology.

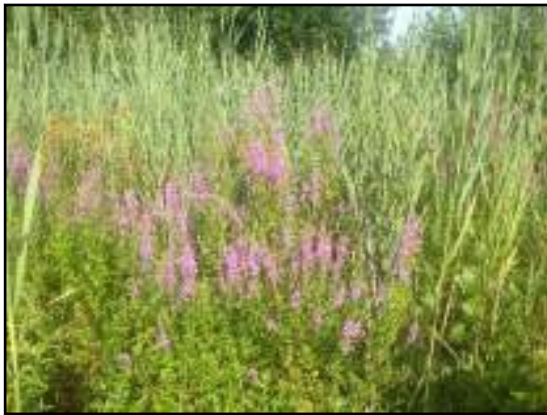
Photo 3. Area BBB: August 8, 2018

Functions & Values: Given the wetland’s proximity to the road and the presence of multiple invasive species, there are limited functions and values. The proximity to the road and its potential sources of sediment and pollutants, along with dense vegetative cover, make this wetland suitable for sediment/toxicant retention and flood flow alteration.

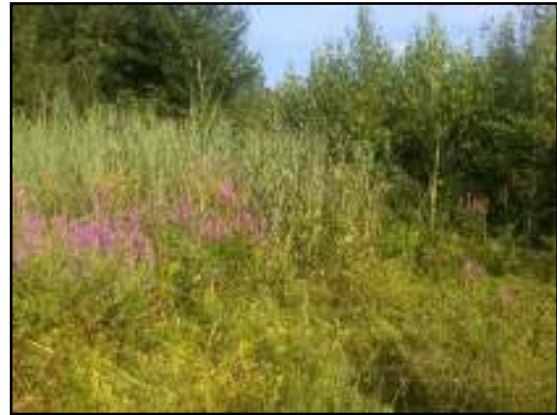
Photo 4. Area BBB: August 8, 2018

Description: Wetland BBB is a depressional palustrine emergent wetland located on the west side of Route 125 located approximately 1,175 feet north of Old Country Road. The vegetation consists primarily of purple loosestrife (*Lythrum salicaria*), swamp dewberry (*Rubus hispidus*), broom sedge, and Phragmites. The portion of the wetland located within the study area is approximately 0.05 acres. The wetland extends beyond the study limits of the area.

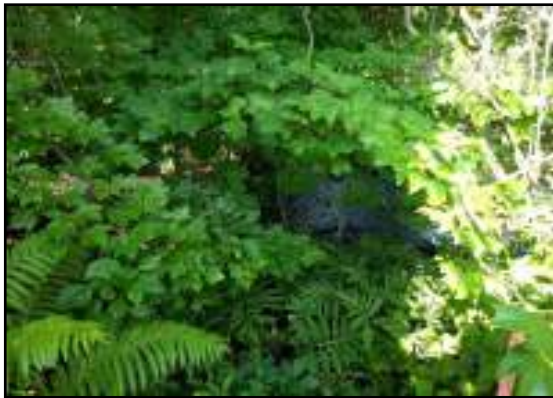
Photo 5. Area DA: August 8, 2018

Functions & Values: Given the proximity to the road, urban surrounding, and relative abundance of impervious surfaces within the watershed, this wetland is suitable for flood flow alteration, sediment/toxicant retention, and nutrient removal.

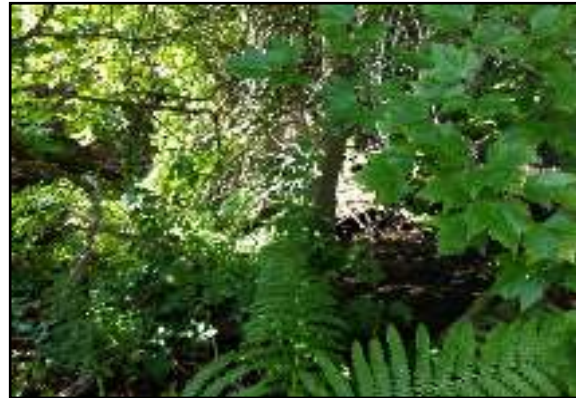
Photo 6. Area DA: August 8, 2018

Description: Area DA is a depressional palustrine forested wetland located behind an auto body shop at 216 Plaistow Road. The vegetation consisted primarily of red maple (*Acer rubrum*), common winterberry (*Ilex verticillate*), sensitive fern (*Onoclea sensibilis*), cinnamon fern (*Osmundastrum cinnamomeum*), and oriental bittersweet (*Celastrus orbiculatus*). Surface water was observed during the delineation. The portion of the wetland located within the study area is approximately 0.06 acres. The wetland extends beyond the study area limits.

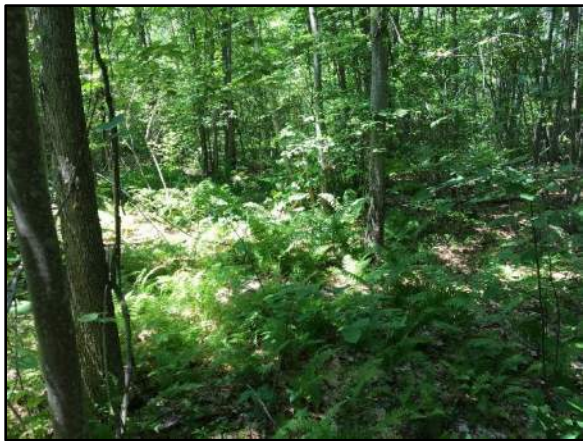
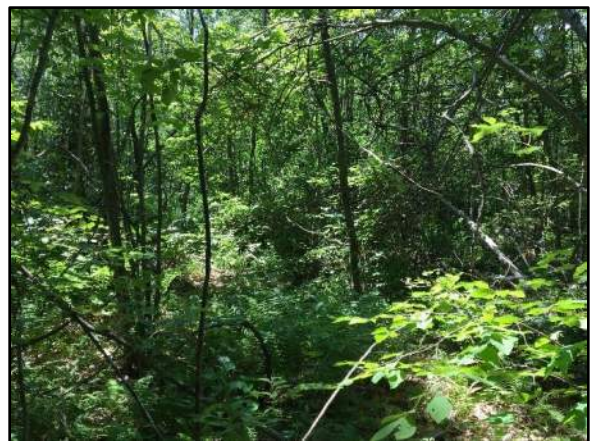
Photo 7. Wetland AAA August 8, 2018

Description: Area AAA is a depressional palustrine forested wetland located on the west side of Route 125, approximately 450 feet south of the intersection of Route 125 and Kingston Road. The wetland portion within the study area consists of red maple, red oak (*Quercus rubra*), white oak (*Quercus alba*), New York fern (*Thelypteris noveboracensis*), and common winterberry.

Functions & Values: Given the proximity to the road, urban surrounding, and relative abundance of impervious surfaces within the watershed, this wetland is suitable for flood flow alteration, sediment/toxicant retention, and nutrient removal.

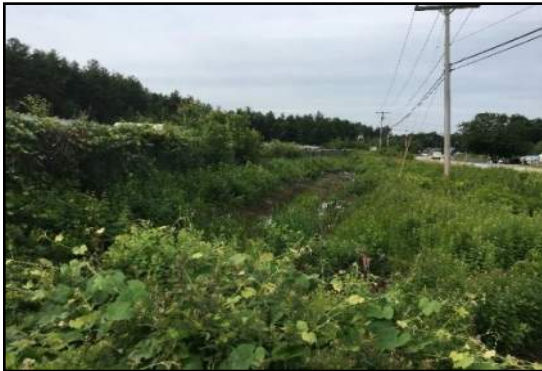
Photo 9. MJ1 June 28, 2018

Functions & Values: Based on the proximity to the road, urban surroundings with relatively abundance of impervious surfaces, and the dense, herbaceous vegetation, the suitable functions and values associated with this swale include flood flow alteration, sediment/toxicant retention, and nutrient removal.

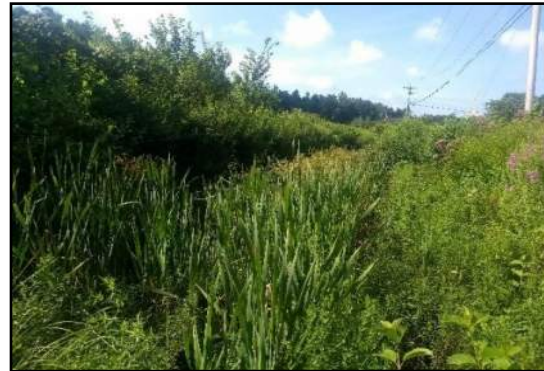
Photo 10. MJ1 August 8, 2018

Description: Area MJ1 is an excavated vegetated stormwater swale (non-jurisdictional) located along the eastern side of Rt. 125, across from wetland AAA, approximately 450 feet south of the intersection of Route 125 and Kingston Road. This non-jurisdictional swale is bordered to the east by a self-storage facility. There is a paved pull-off area that bisects the swale, with a culvert beneath connecting the two portions. The swale consists of emergent vegetation such as swamp candle (*Lysimachia terrestris*), purple loosestrife, silky dogwood (*Cornus amomum*), and broad-leaved cattail (*Typha latifolia*). The swale is located entirely within the study area and is approximately 0.06 acres.

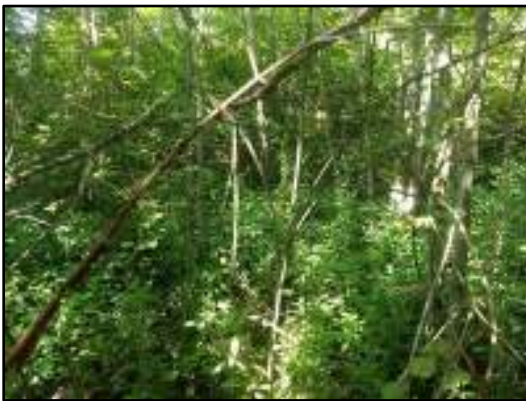
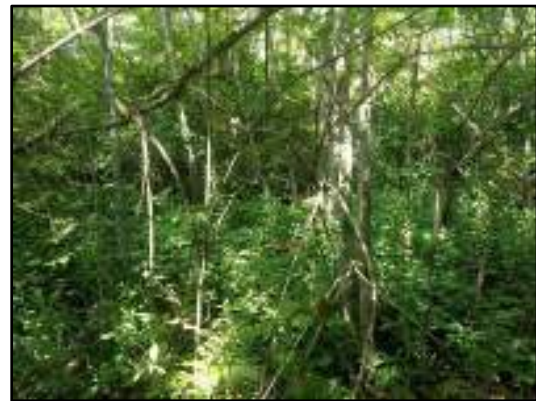
Photo 11. Wetland ZZ August 8, 2018

Description: Area ZZ is a palustrine forested wetland located on the west side of Route 125 approximately 100 feet north of the intersection with Kingston Road. The portion of the wetland within the study area is approximately 0.31 acres and is part of a larger forested wetland complex that extends beyond the study area. The wetland area within the study limit is dominated by red maple, northern arrowwood (*Viburnum dentatum*), Canada mayflower (*Maianthemum canadense*), and poison sumac (*Toxicodendron vernix*).

Functions & Values: Given the proximity to the road, urban surrounding, and relative abundance of impervious surfaces within the watershed, this wetland is suitable for flood flow alteration, sediment/toxicant retention, and nutrient removal. This wetland contains wildlife food sources and is contiguous with undeveloped land, and therefore is also suitable for wildlife habitat.

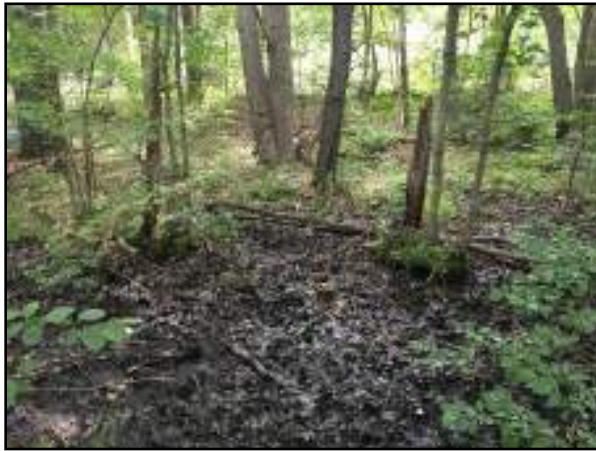
Photo 13. 2018 Wetland L

Description: Area GR is a palustrine emergent wetland located on the eastern side of Granite Road that drains into a culvert that runs under Granite Road and discharges to wetland L. Wetland GR vegetation consists of spotted jewelweed (*Impatiens capensis*), spotted joe-pye weed (*Eutrochium maculatum*), and fringed sedge (*Carex crinita*). Wetland GR extends beyond the study area limits. Wetland L is a depressional palustrine forested wetland located on the western side of Granite Road. Dominant plant species include red maple, northern arrowwood, spotted jewelweed, and field horsetail (*equisetum arvense*). Wetland L is within potential BMP Area B.

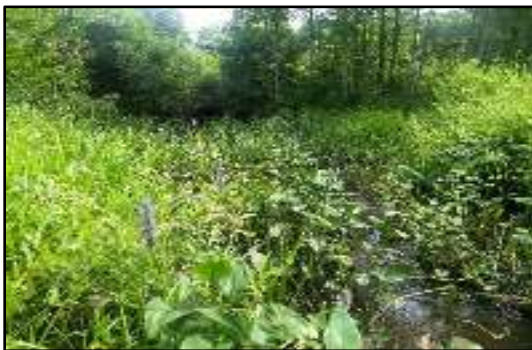
Photo 15. Wetland YY August 8, 2018

Functions & Values: This wetland is suitable for floodflow alteration, sediment/toxicant retention, nutrient removal, sediment/shoreline stabilization, and wildlife habitat.

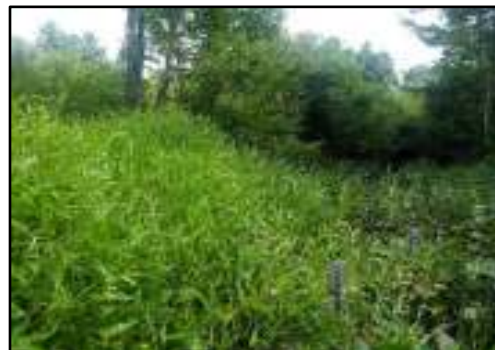
Photo 16. Wetland YY August 8, 2018

Description: Wetland YY is a palustrine emergent wetland located along the bank of the Little River, which flows eastward underneath Route 125 approximately 565 feet north of Granite Road. The vegetation is dominated by arrow-leaved tearthumb (*Persicaria sagittate*) and royal fern (*Osmunda regalis*). The portion of the wetland located within the study area is approximately 0.11 acres, with the wetland extending beyond the study area limits. Due to the flat topography and flooded wetland conditions at the time of the wetland delineation, flagging the full extent of the OHW line was not possible.

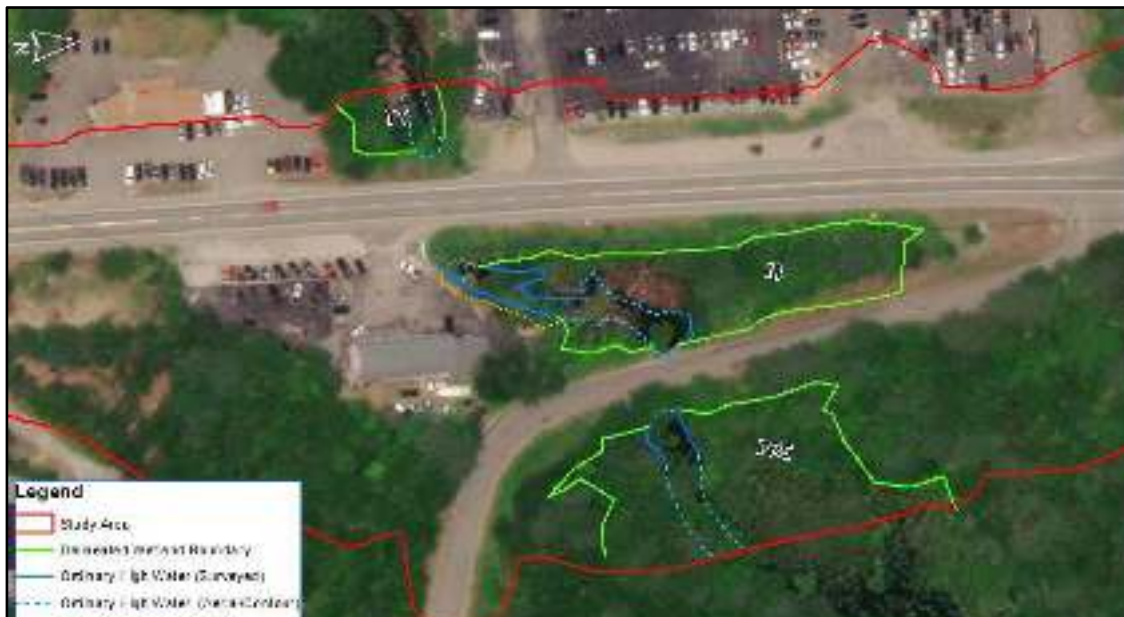
Figure 9. Wetlands YY, M & FR5

Within the Study Area the Little River has a broad floodplain associated with it. This large floodplain area consists of palustrine wetlands (Wetlands YY, M, FR5). Several of these areas were inundated with water during the wetland delineation. The existing crossing structures appear to be undersized, possibly contributing to this ponding/backwatered condition. Additional information on the Little River including stream crossing assessment data forms and photographs are included in Appendix D – Little River Stream Assessment.

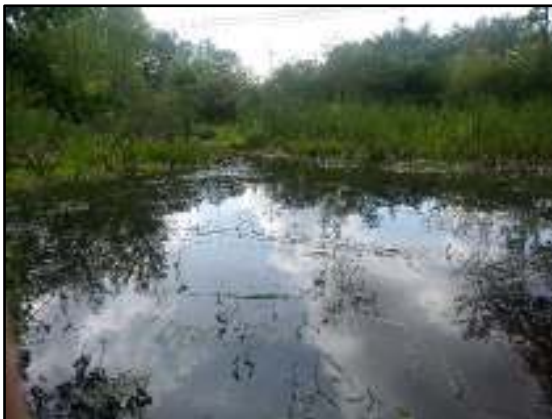
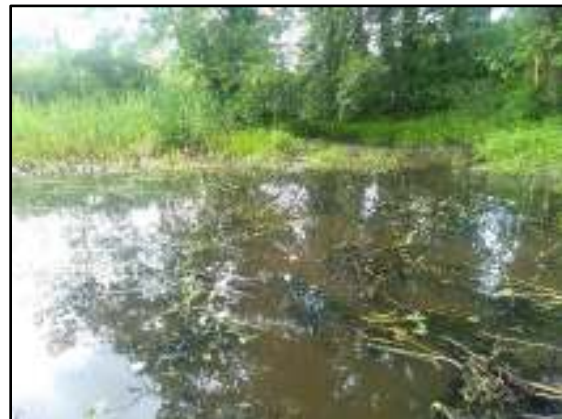
Photo 17. Wetland M August 8, 2018

Description: Area M consists of a fringing palustrine emergent wetland bordering the Little River transitioning into a palustrine forested wetland, located on the eastern side of Route 125. A culvert allows the Little River to flow from wetland YY under Route 125 to wetland M. A second culvert allows the Little River to flow under an entrance road to wetland FR5. The vegetation is dominated by American Elm (*Ulmus Americana*), red maple, red mulberry (*Morus rubra*), black elderberry (*Sambucus nigra*), northern arrowwood, poison ivy (*Toxicodendron radicans*), and rough goldenrod (*Solidago patula*). Due to the flat topography and flooded wetland conditions at the time of the wetland delineation, flagging the full extent of the OHW line was not possible. Wetland M is approximately 0.65 acres and within potential BMP Area C.

Functions & Values: Given the proximity to the road, urban surrounding, and association with the Little River, this wetland is suitable for flood flow alteration, sediment/toxicant retention, and nutrient removal.

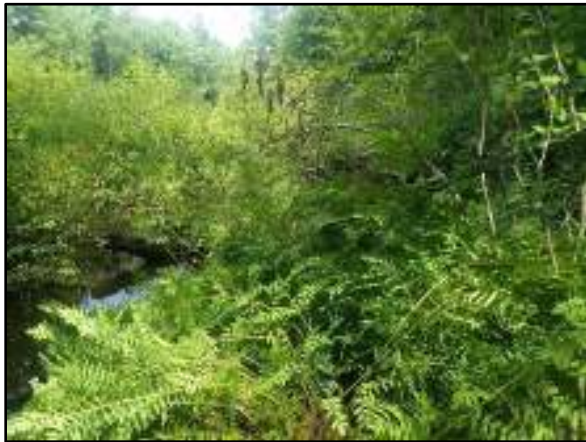
Photo 19. Wetland FR5 August 8, 2018

Functions & Values: This wetland is suitable for floodflow alteration, sediment/toxicant retention, nutrient removal, sediment/shoreline stabilization, and wildlife habitat.

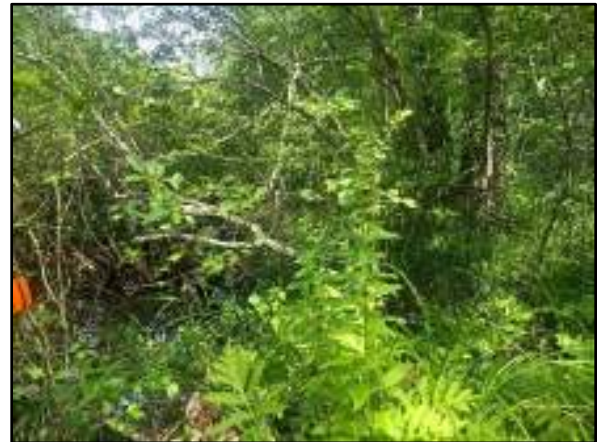
Photo 20. Wetland FR5 August 8, 2018

Description: Wetland FR5 is located on the eastern side of an entrance road for a golf course, downstream of wetland M. Wetland FR5 consists of a palustrine scrub-shrub wetland along a diffuse section of the Little River. Vegetation consisted of red maple, common winterberry, specked alder (*Alnus incana*), sensitive fern, royal fern, and tussock sedge (*Carex stricta*). Due to the flat topography and flooded wetland conditions at the time of the wetland delineation, flagging the full extent of the Ordinary High Water line was not possible. The portion of the wetland located within the study area is approximately 0.76 acres, with the wetland extending beyond the study area limits.

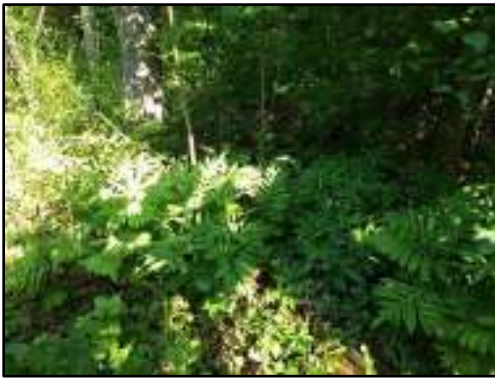
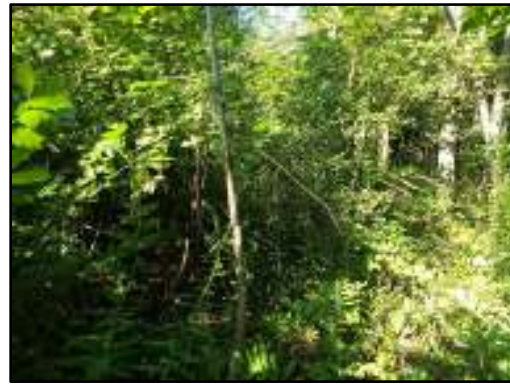
Photo 21. Wetland O August 8, 2018

Description: Area O is a depressional palustrine forested wetland located on the eastern side of Colonial Road. Vegetation consists of red maple, common winterberry, tussock sedge (*Carex stricta*), and oriental bittersweet. The delineated area is smaller than what was delineated in 2001. Wetland O extends beyond the study area limits, and is contiguous with larger areas of undeveloped land, including other wetlands. The portion of the wetland within the study area is approximately 0.13 acres.

Functions & Values: Given the proximity to the road, urban surrounding, and relative abundance of impervious surfaces within the watershed, this wetland is suitable for sediment/toxicant retention and nutrient removal. This wetland contains wildlife food sources and is contiguous with undeveloped land, and therefore is also suitable for wildlife habitat.

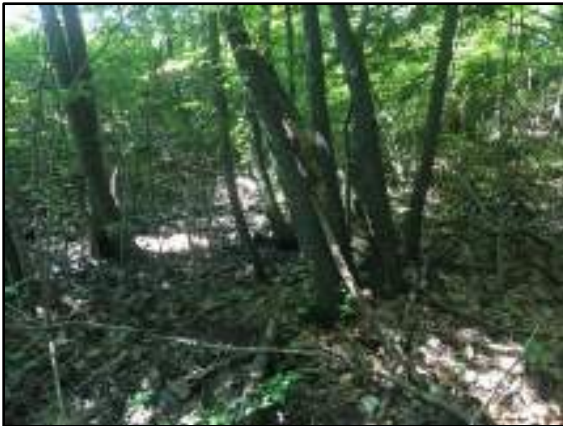
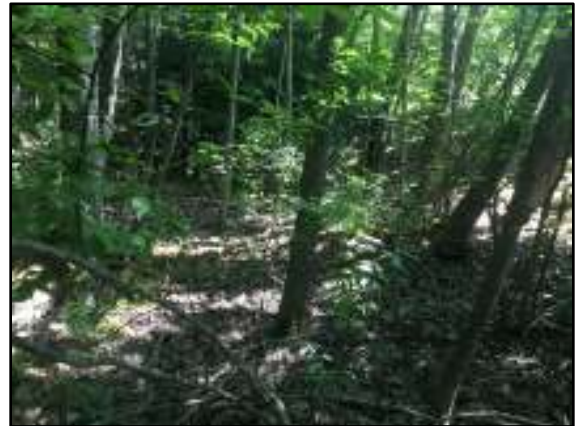
Photo 23. Wetland XX August 8, 2018

Description: Area XX is a depressional palustrine forested wetland located on the western side of Route 125, across from the southern intersection with Colonial Road. The wetland is located entirely within the study area and is approximately 0.06 acres. Dominant vegetation consists of red maple, black birch (*Betula lenta*), and common winterberry.

Functions & Values: Given the proximity to the road and the relatively small size of the wetland, suitable functions and values are limited to flood flow alteration and sediment/toxicant retention.

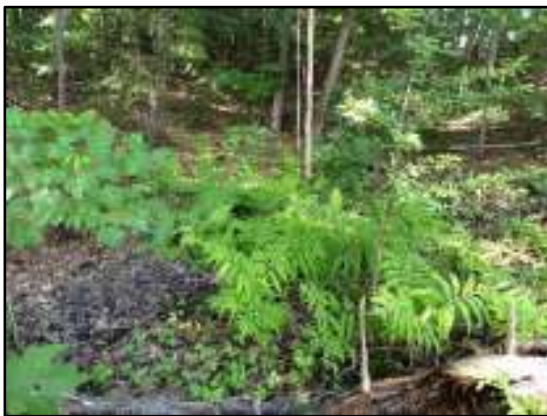
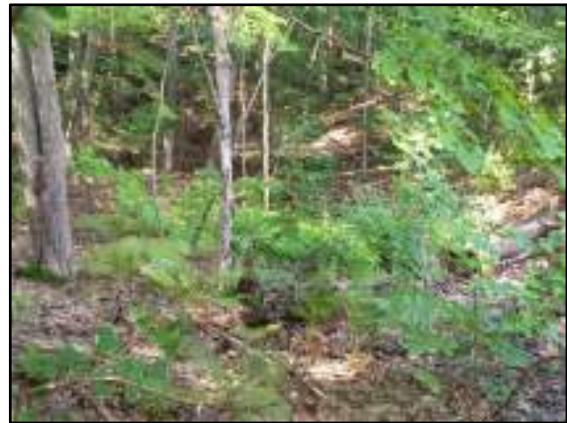
Photo 25: Wetland ISO1 August 8, 2018

Description: Area ISO1 is an isolated depressional palustrine forested wetland located on the western side of Colonial Road. Vegetation consists of red maple, sweet birch (*Betula lenta*), green ash, witch hazel (*Hamamelis virginiana*), and marsh fern (*Thelypteris palustris*). The wetland is located entirely within the study area and is approximately 0.02 acres and is located within potential BMP area E.

Functions & Values: Given the wetland’s proximity to the road, and isolation from other wetlands, there are limited functions and values. This wetland is suitable for flood flow alteration, sediment/toxicant retention, and nutrient removal.

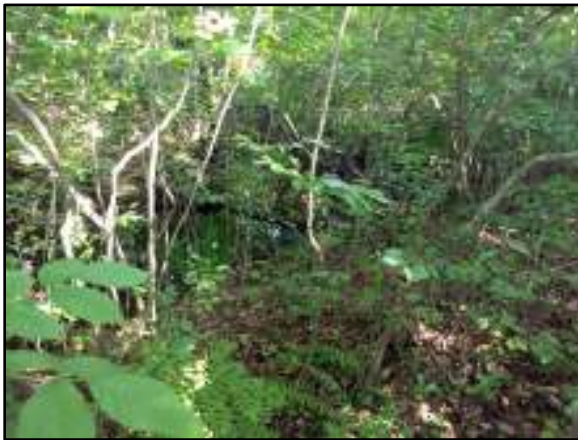
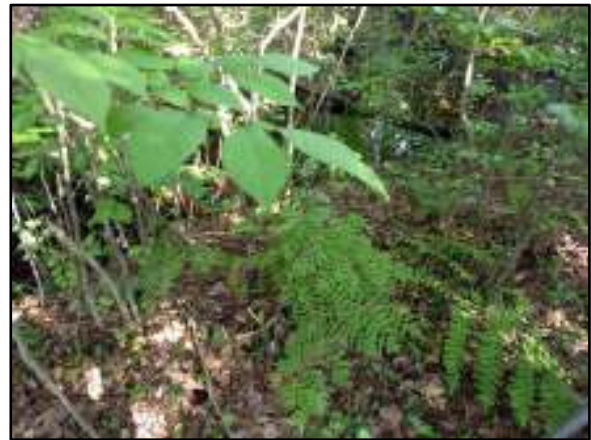
Photo 27: Wetland P August 8, 2018

Description: Area P is a depressional palustrine forested wetland located on the eastern side of Route 125 approximately 350 feet north of the intersection with Debra Road. A culvert in the northern portion of the wetland runs under Route 125, discharging to wetland WW. Dominant vegetation includes red maple, common winterberry, highbush blueberry, and royal fern. The portion of the wetland within the study area is approximately 0.1 acres, with the wetland extending beyond the study area.

Functions & Values: Given the proximity to the road, urban surrounding, and relative abundance of impervious surfaces within the watershed, this wetland is suitable for flood flow alteration, sediment/toxicant retention, and nutrient removal. This wetland contains wildlife food sources and is contiguous with undeveloped land, and therefore is also suitable for wildlife habitat.

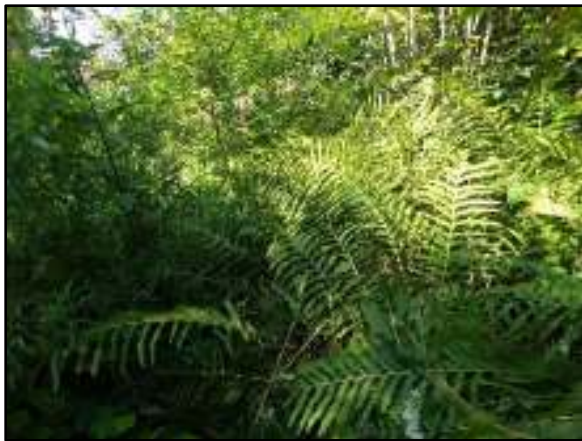
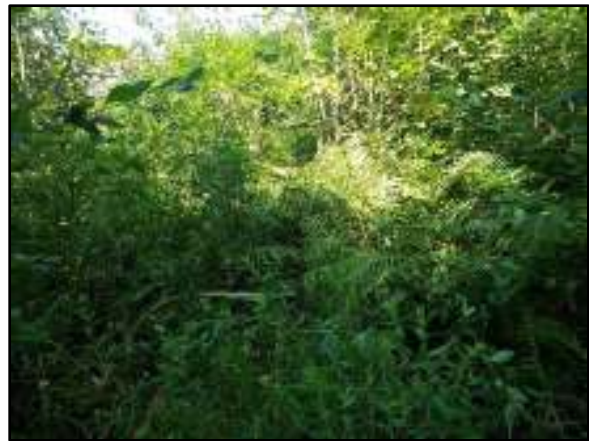
Photo 29: Wetland Q August 8, 2018

Description: Area Q is a depressional palustrine shrub scrub and partially forested wetland located on the eastern side of Route 125, at the northern extent of the study area, approximately 470 feet north of Wetland P. The portion of the wetland within the study area is approximately 0.16 acres, with the wetland extending beyond the study area limits. Dominant vegetation consisted of shrubs including witch hazel, red maple, and black gum, with herbaceous species such as cinnamon fern and jewel weed.

Functions & Values: Given the proximity to the road, urban surrounding, and relative abundance of impervious surfaces within the watershed, this wetland is suitable for flood flow alteration, sediment/toxicant retention, and nutrient removal.

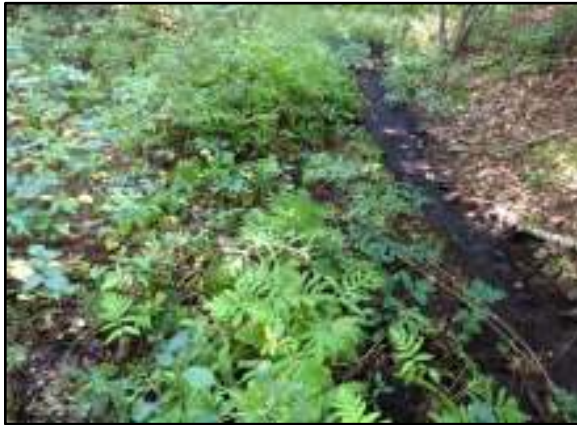
Photo 31: Wetland WW August 8, 2018

Description: Wetland WW is a depressional wetland gently sloping towards the west, located on the western side of Route 125 approximately 560 feet north of Debra Drive. A culvert discharges into wetland WW from wetland P. The portion of the wetland located within the study area is approximately 0.01 acres, with the wetland extending beyond the limits of the study area. Dominant vegetation included black birch, red maple, red mulberry, creeping buttercup, and spotted jewel weed.

Functions & Values: This wetland is suitable for sediment/toxicant retention.

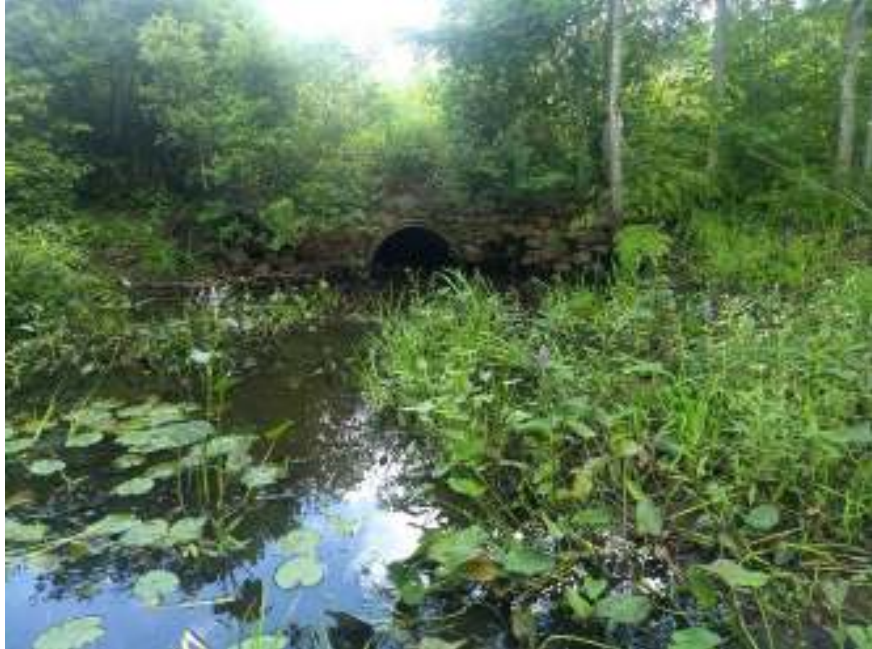
Photo 3: Little River upstream from NH Route 125 Crossing	DATE: 08/08/2018

Comments: Facing downstream, 48" RCP inlet

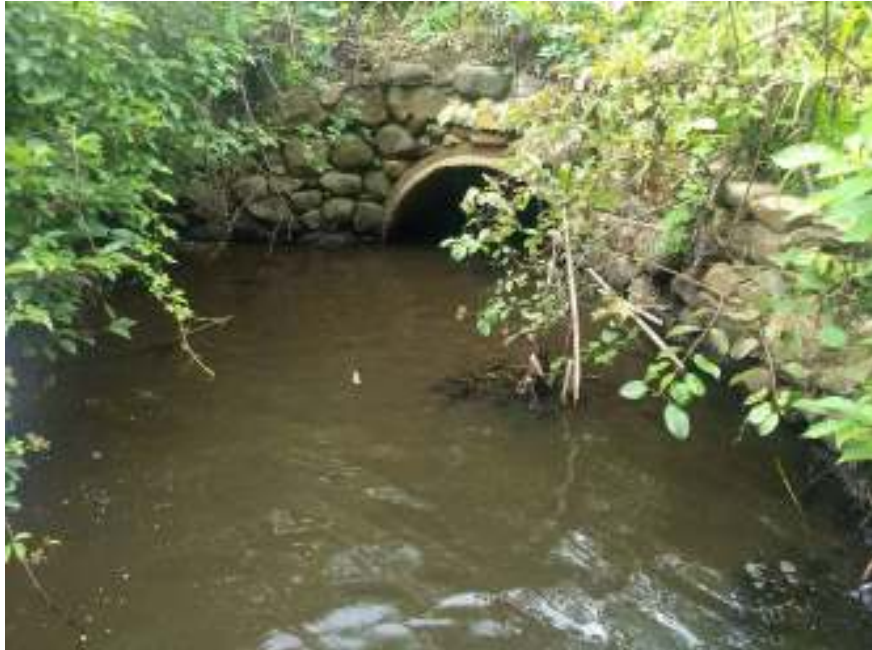
Photo 4: Little River downstream from NH Route 125 Crossing	DATE: 08/08/2018

Comments: 48" RCP outlet

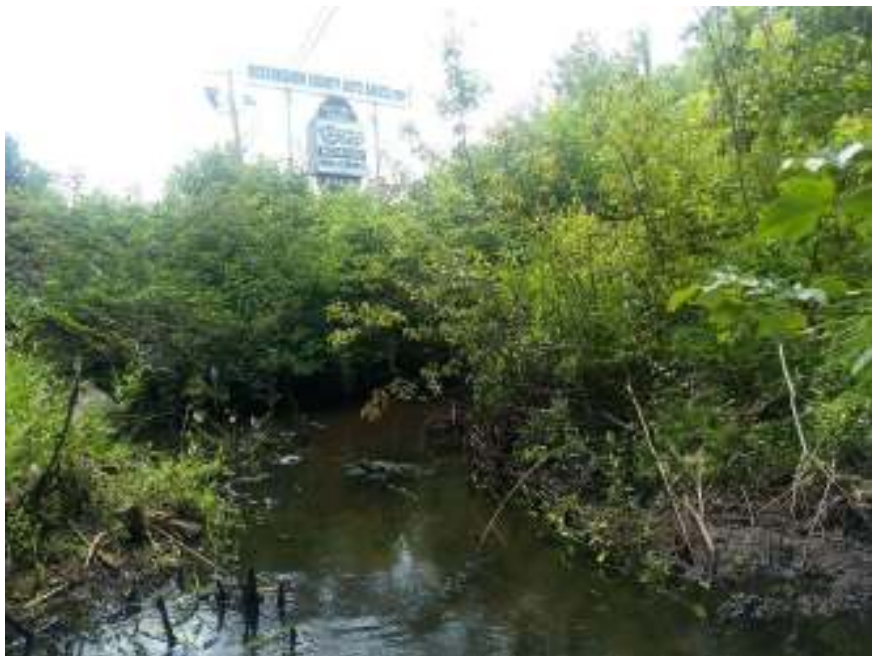
Photo 5: Little River downstream from NH Route 125 Crossing	DATE: 08/08/2018

Comments: Bend in channel downstream from crossing, facing upstream

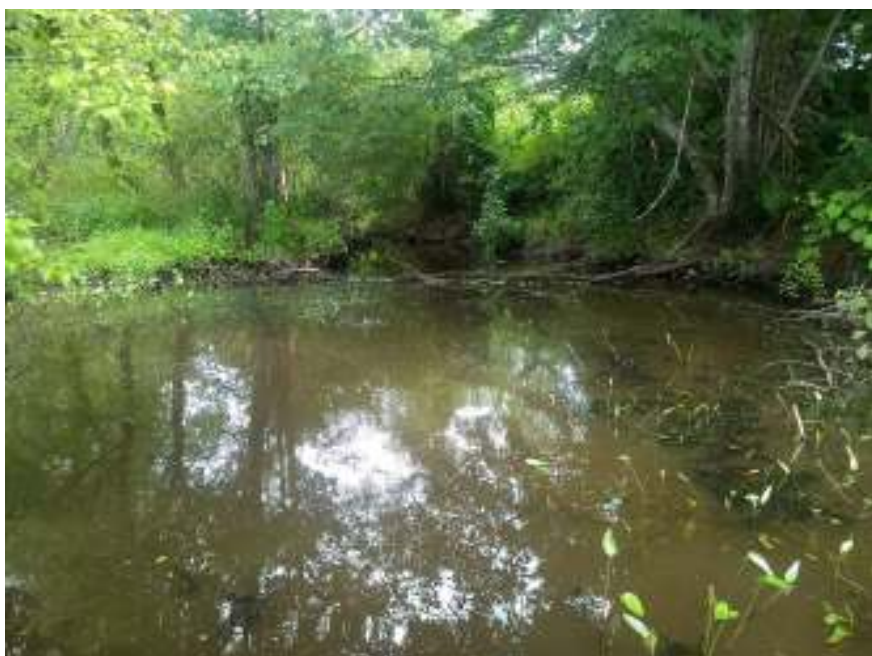
Photo 6: Little River downstream from NH Route 125 Crossing	DATE: 08/08/2018

Comments: River channel downstream from crossing, facing downstream

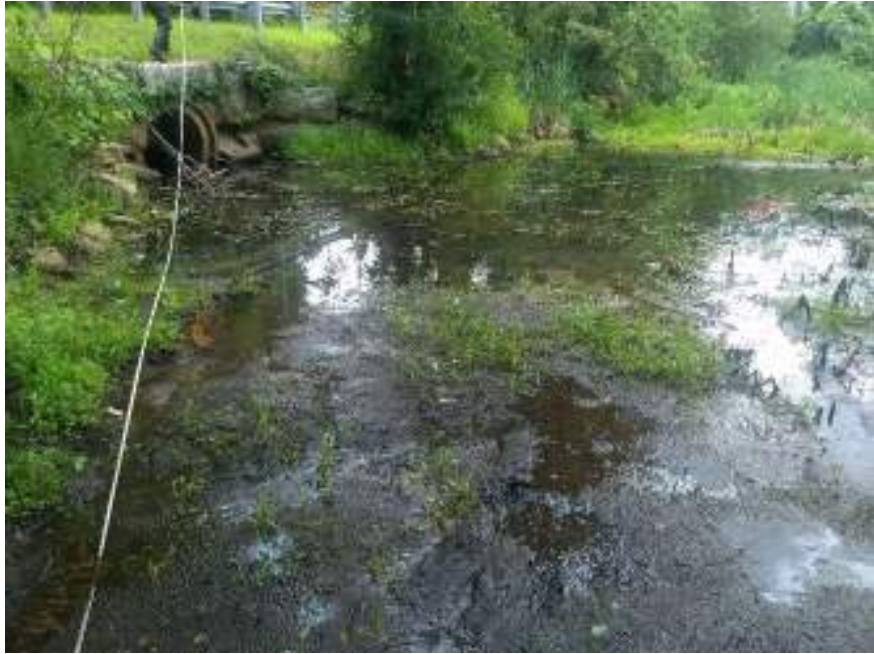
Photo 1: Little River upstream from Diamond Oaks Driveway Crossing	DATE: 08/08/2018

Comments: Culvert inlet

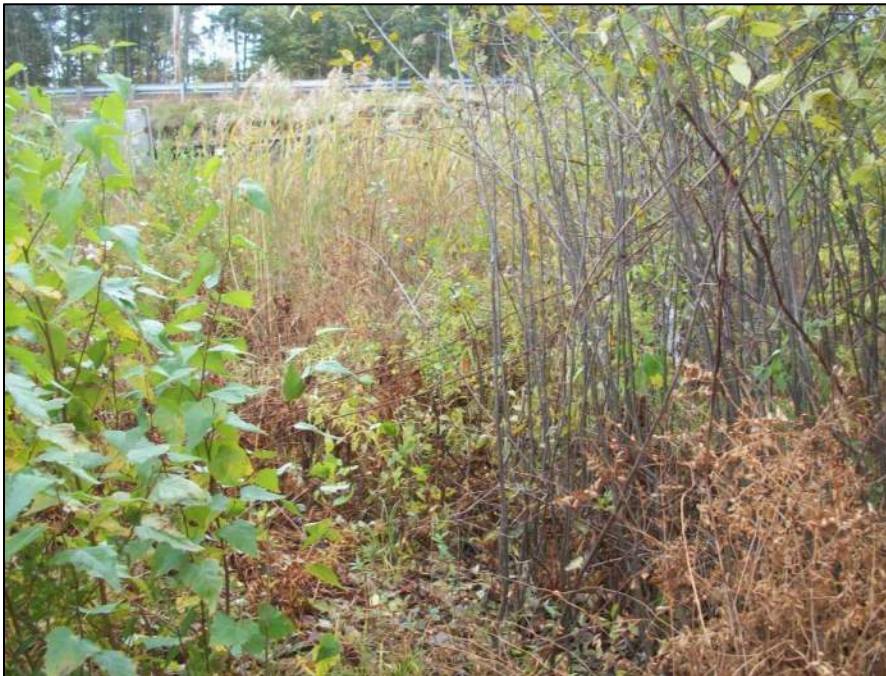
The portion of Wetland BBB near NH Route 125 had been delineated by MJ in 2018. Since very few flags could be found, the wetland was re-flagged in 2019 and extended to cover the potential stormwater BMP area.

Wetland BBB, view toward NH Route 125

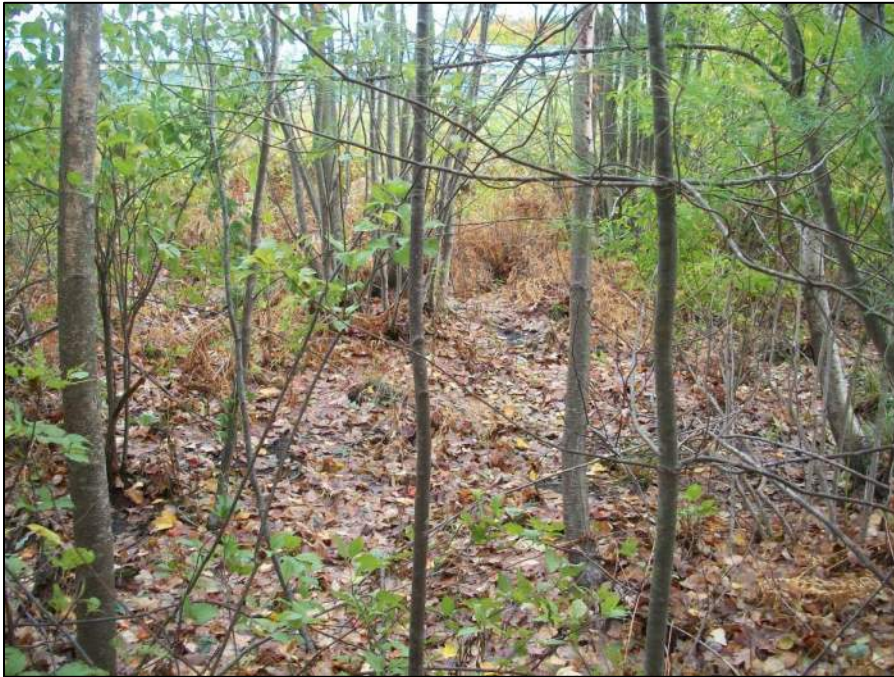
Wetland BBB, scrub-shrub area located further from NH Route 125

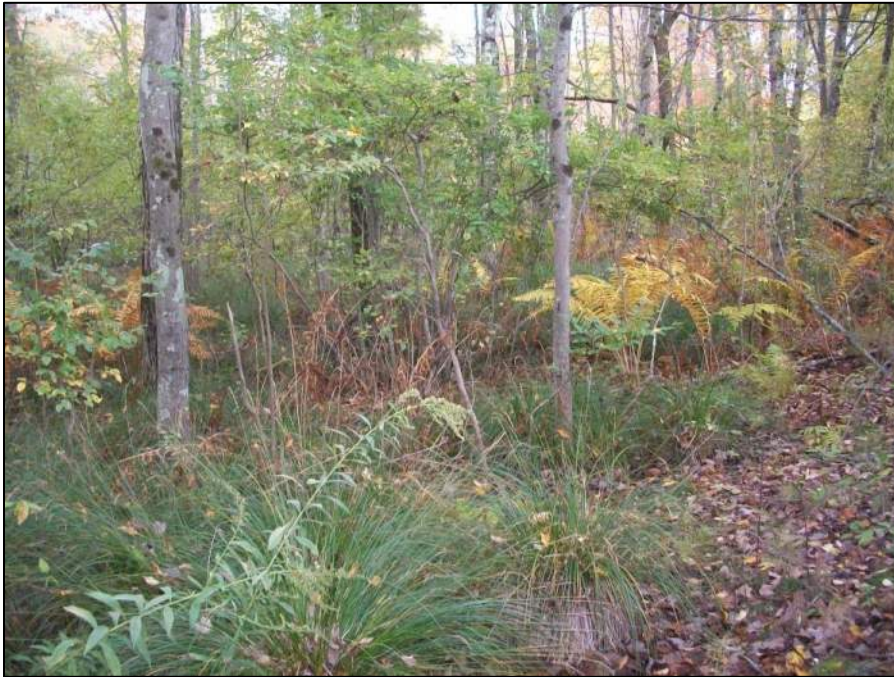
Forested portion of Wetland O, in BMP Area D

A portion of the wetland was previously delineated by MJ in 2018. The wetland boundary was extended by GM2 in 2019, 2020, and 2022 to cover BMP Areas D and D1.

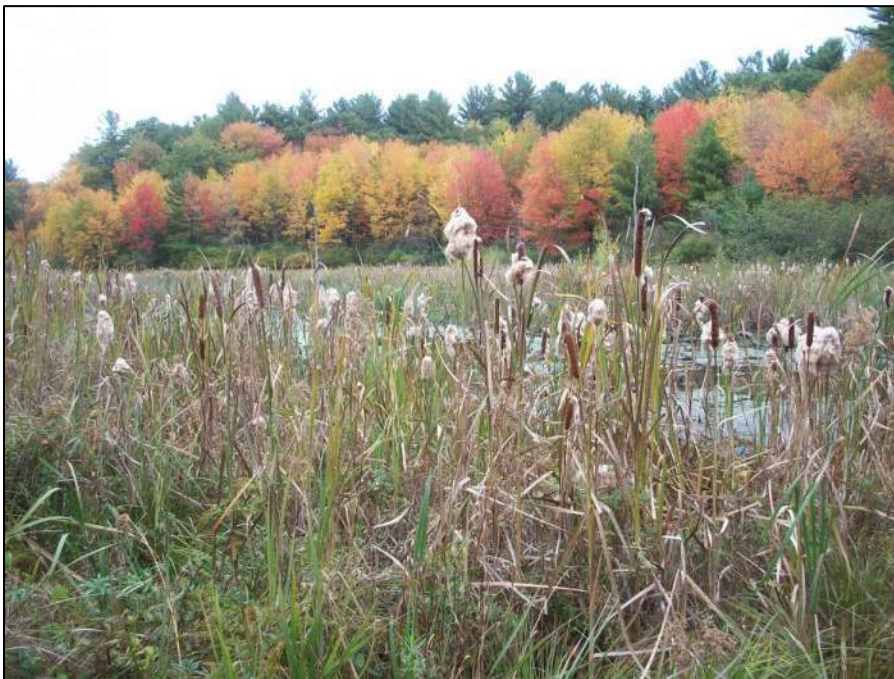
Emergent/ponded portion of
Wetland O, adjacent to BMP Area D

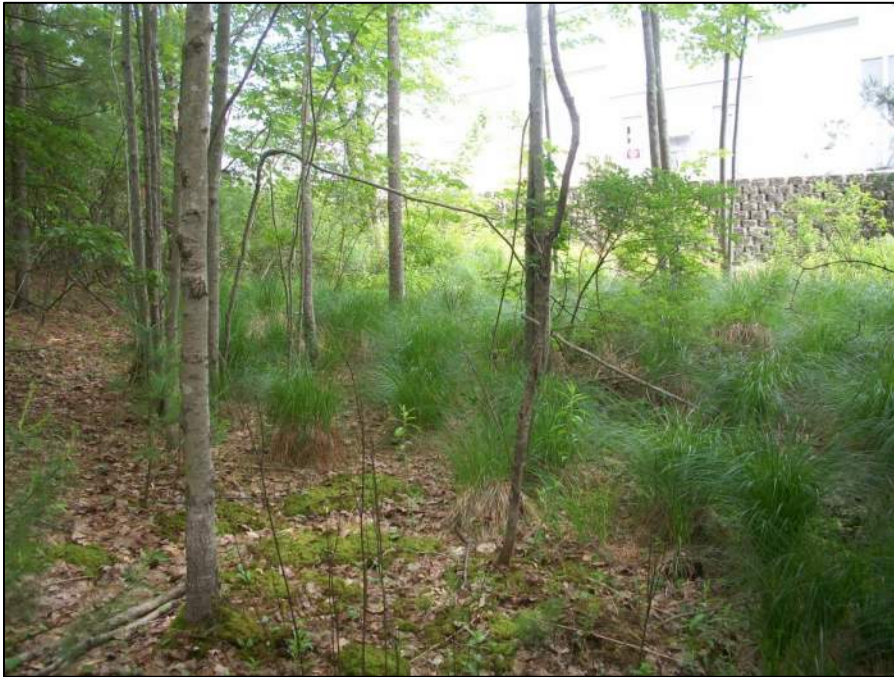
Narrow portion of Wetland O, in
BMP Area D1

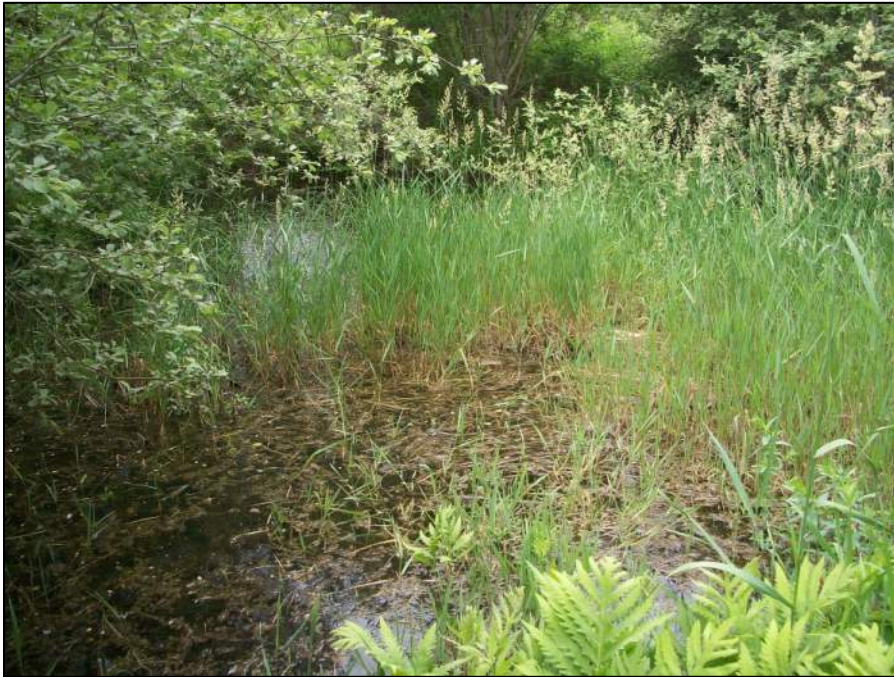
Stormwater Treatment Pond O1

The majority of Area O1 is vegetated with common reed and reed canary grass (*Phalaris arundinacea*), with sensitive fern, speckled alder, willow, and Asian bittersweet (*Celastrus orbiculatus*) located along the edge. Although Area O1 has wetland characteristics, it is not considered a jurisdictional wetland resource since it is a constructed stormwater treatment BMP.

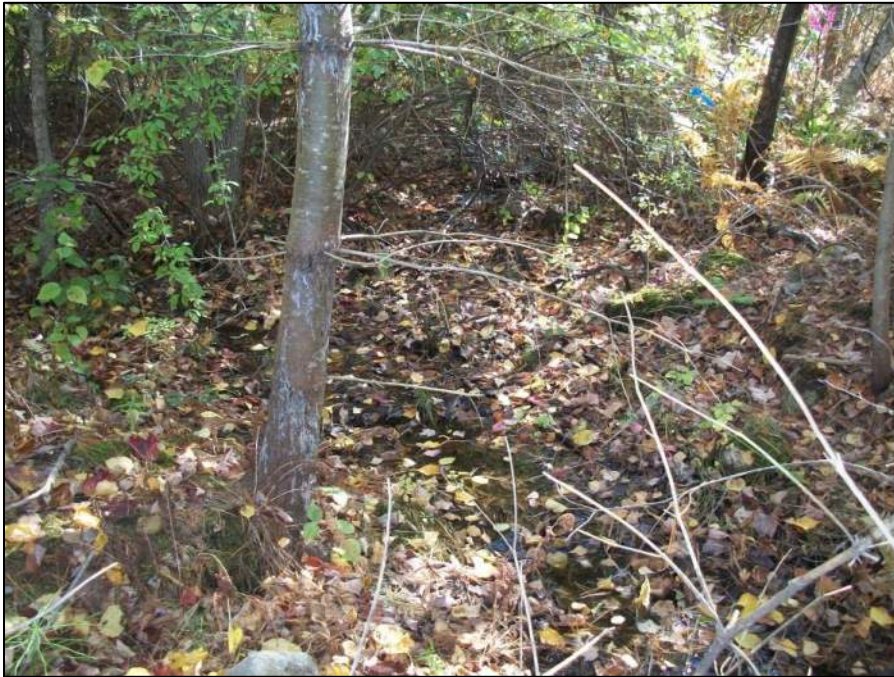
Forested portion of Wetland W2, showing standing water in drainage ditch

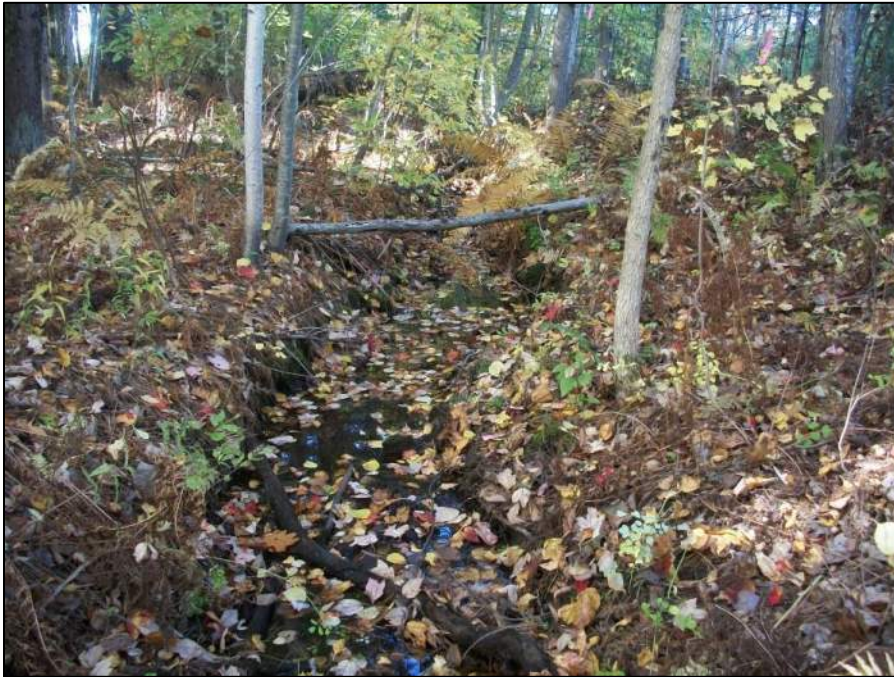
Intermittent stream in Wetland W3

Wetland W3 is classified as palustrine, forested, broad-leaved deciduous, seasonally flooded/saturated (PFO1E). Vegetation includes red maple, white pine, eastern hemlock (*Tsuga canadensis*), common winterberry, cinnamon fern, sensitive fern, and horsetail (*Equisetum sp.*). The intermittent stream that flows through Wetland W3 is classified as riverine, intermittent, streambed (R4SB). The stream channel is approximately 2 to 3 feet wide and has banks that are approximately 1 to 4 feet tall. The substrate is a mix of sand, mud, and some cobbles. During the October 2019 field review, the stream had approximately 1 to 3 inches of water.

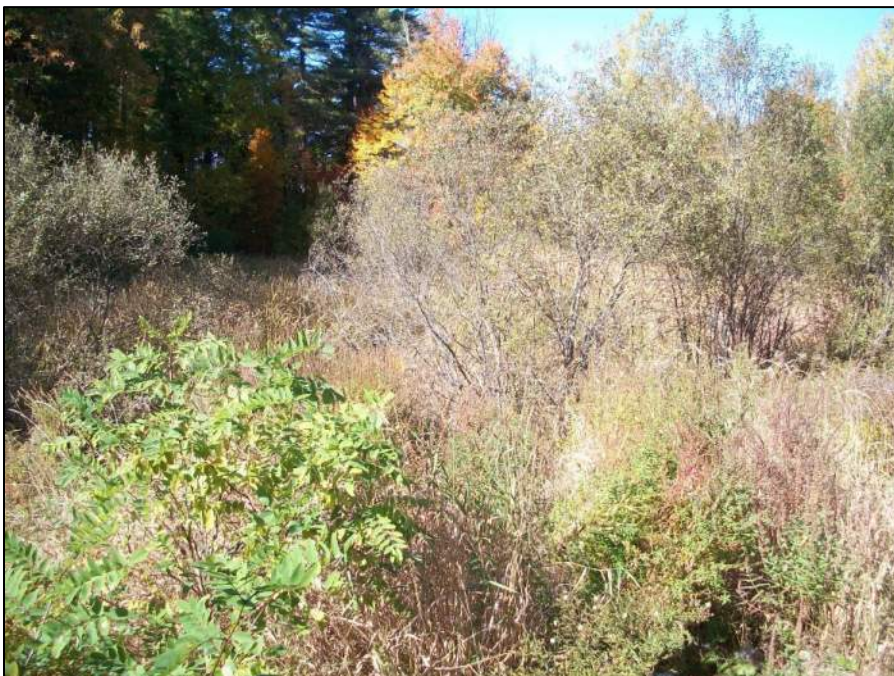
View toward detention pond from embankment next to NH Route 125

The detention pond located on the NHDOT property (BMP Area G) at the northern end of the project was not delineated since it is a constructed stormwater treatment pond. According to plans obtained from NHDOT, the pond was constructed around 2005. The pond is currently overgrown with herbaceous and shrub vegetation.

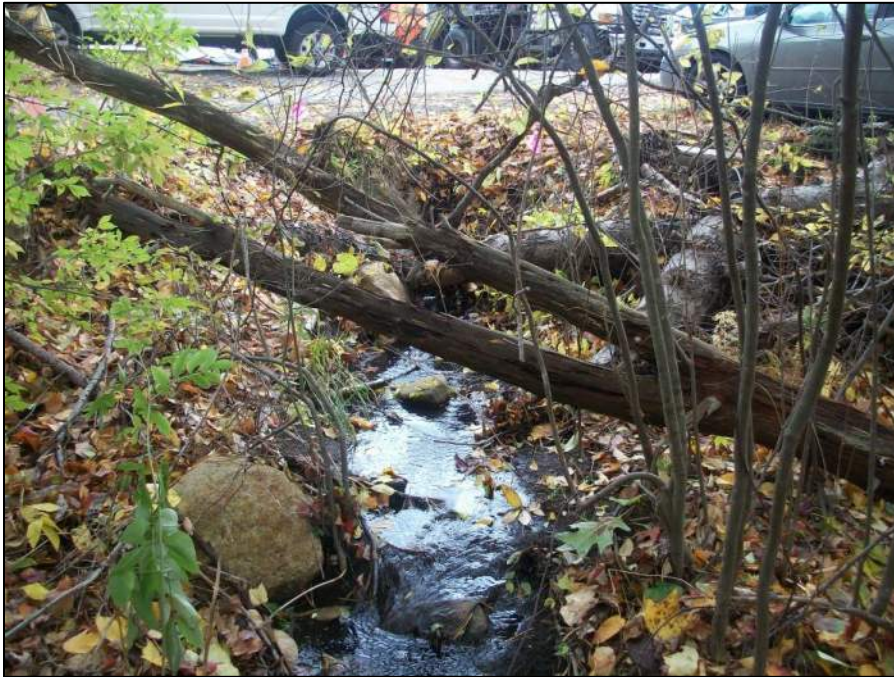
Intermittent stream in Wetland W5
