STATE OF NEW HAMPSHIRE INTER-DEPARTMENT COMMUNICATION

SUBJECT: Dredge & Fill Application
Plaistow-Kingston, 10044E

NHDES WETLANDS PERMIT APPLICATION

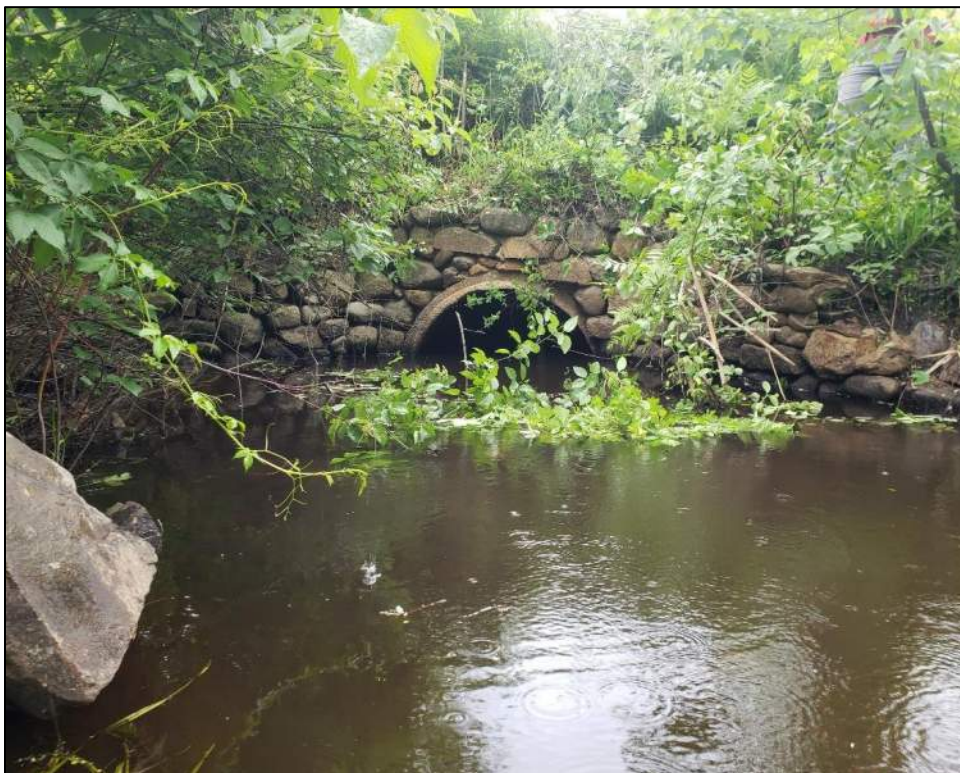
Photo 6
Little River
Wetland 9
(Impact Area L)
R2UBH
View west

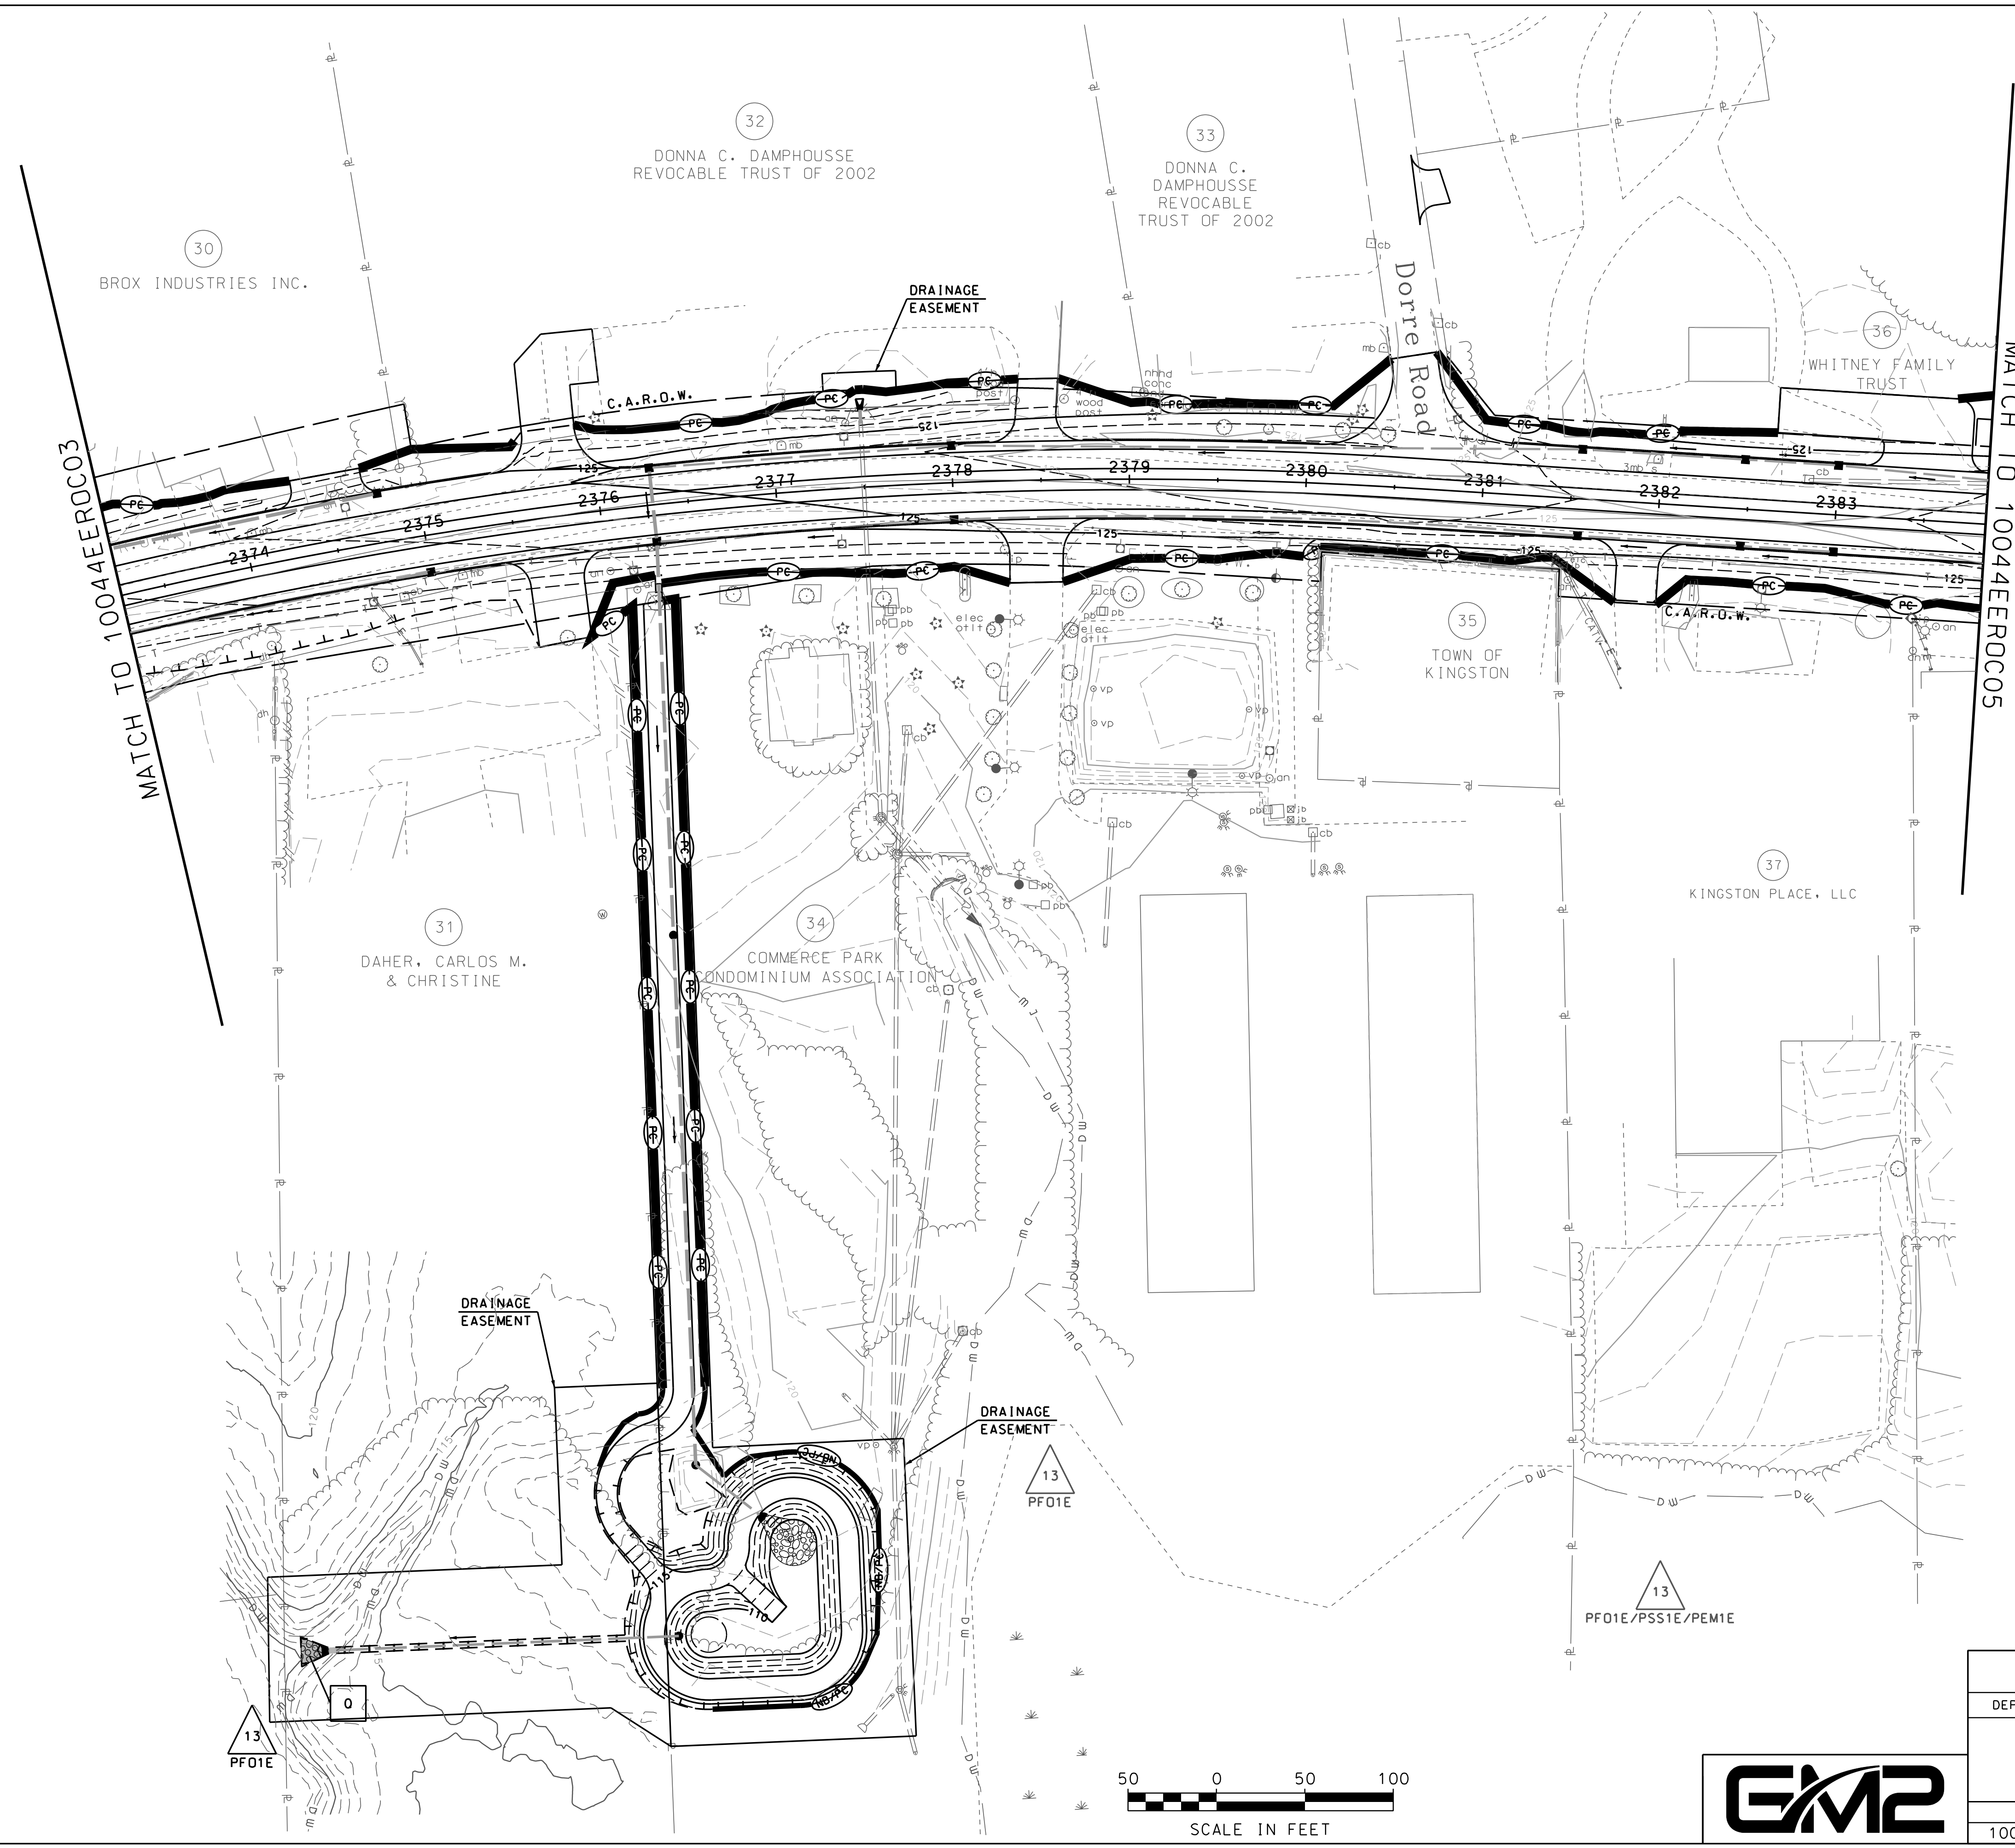
STATE OF NEW HAMPSHIRE			
DEPARTMENT OF TRANSPORTATION • BUREAU OF HIGHWAY DESIGN			
EROSION CONTROL PLANS			
DGN	STATE PROJECT NO.	SHEET NO.	TOTAL SHEETS
10044EEROC04	10044E	17	29

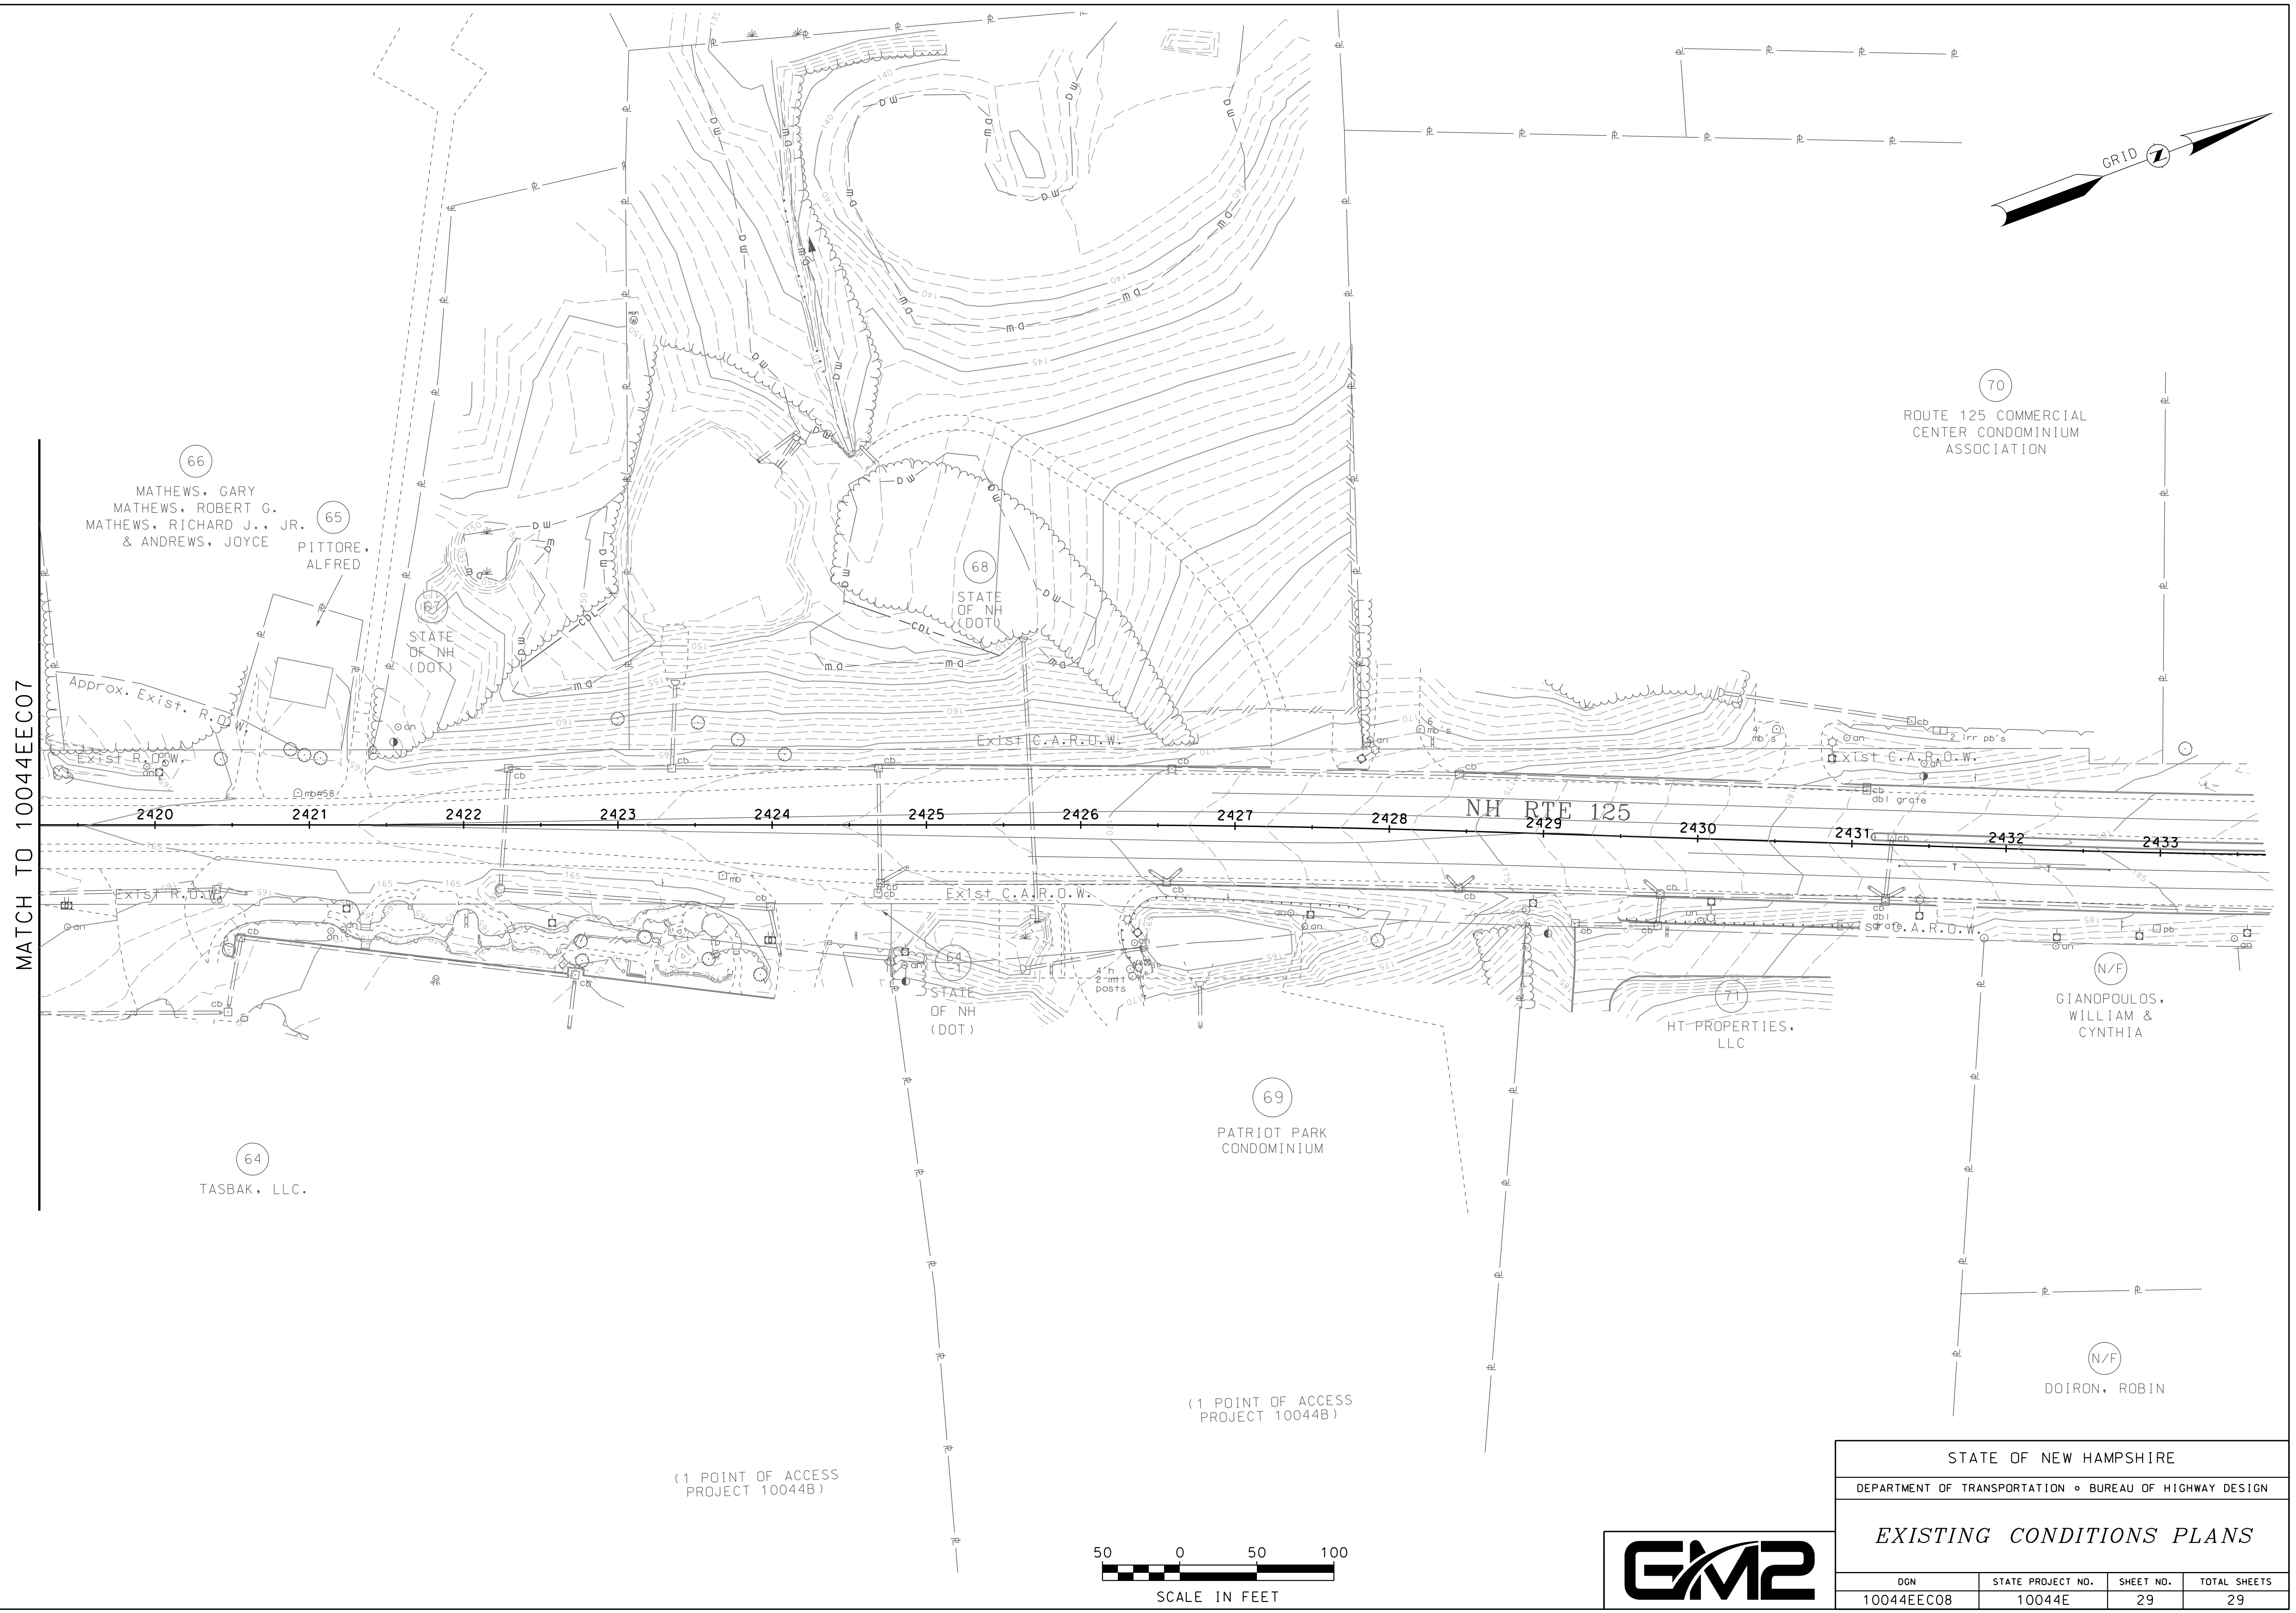
STATE OF NEW HAMPSHIRE			
DEPARTMENT OF TRANSPORTATION • BUREAU OF HIGHWAY DESIGN			
EXISTING CONDITIONS PLAN			
DGN	STATE PROJECT NO.	SHEET NO.	TOTAL SHEETS
10044EEC07	10044E	28	29
