SUBJECT Dredge & Fill Application
Salem, 13933A Bureau of
Environment

NHDES WETLANDS PERMIT APPLICATION
NH DOT PROJECT #13933A; FHWA #A004(435)

I-93, 4th Lane Expansion from Stateline Through Exit 1

Salem, New Hampshire

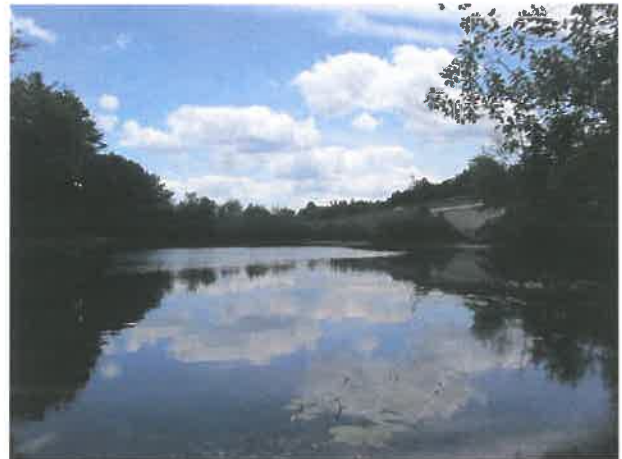
Photo 49. Policy Brook (Stream N-S1) is channelized throughout much of the survey area.

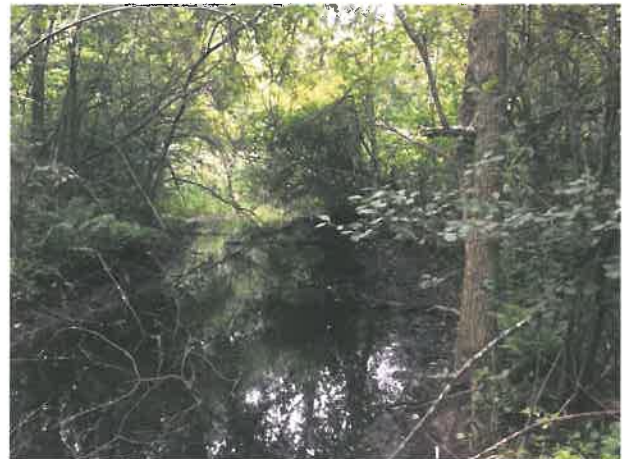
Photo 51. The Spickett River (Stream N-S3) from wetland N1.

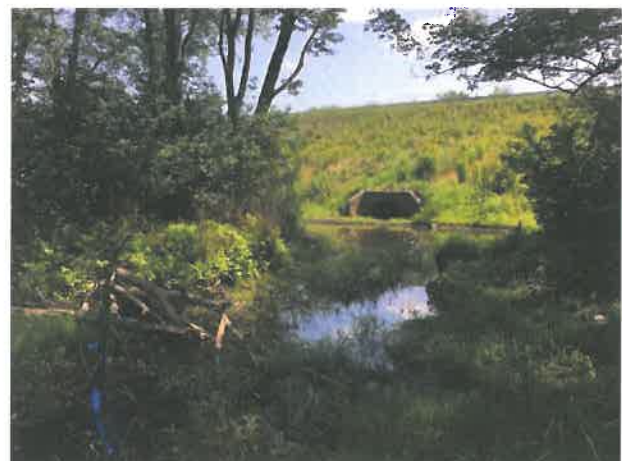
Photo 53. Typical character of streams S-S2 and S-S3.

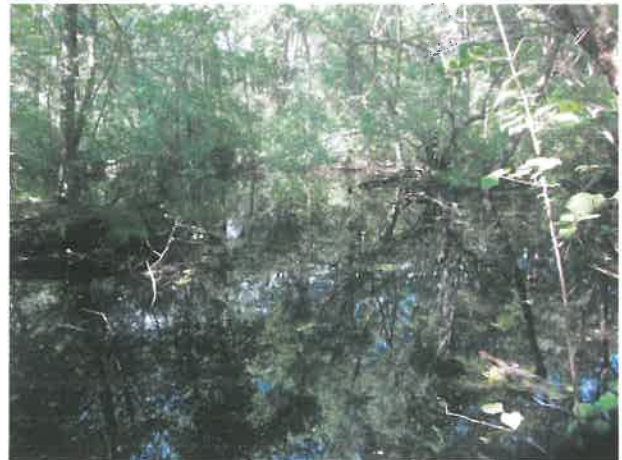
Photo 1. Wetland N-1 is a riparian wetland associated with the Spickett River.

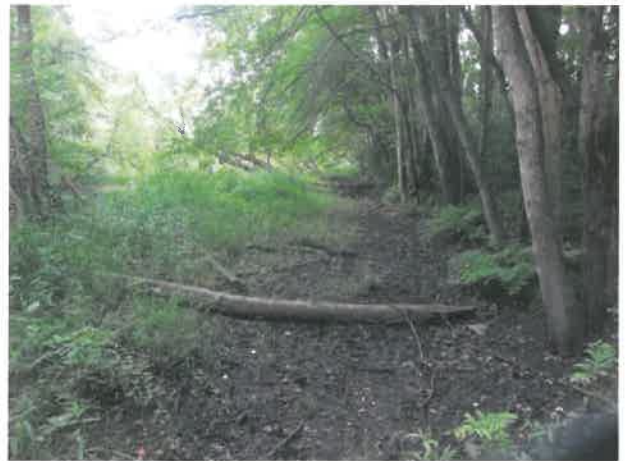
Photo 3. The inlet/outlet of Wetland N-2 to the Spickett River.

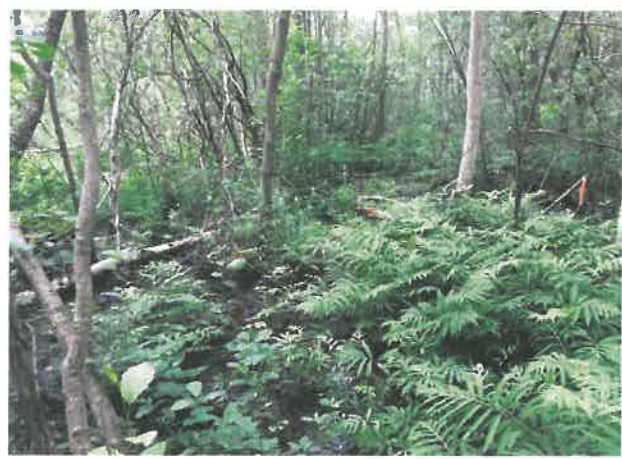
Photo 5. Wetland N-4 is a potential vernal pool.

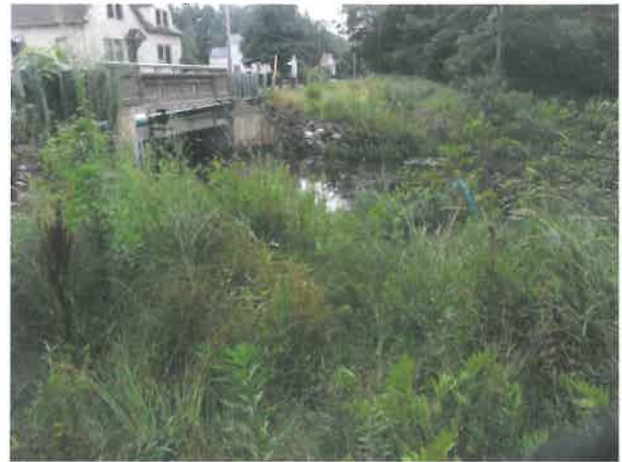
Photo 13. Wetland N-12 is a riparian wetland associated with Porcupine Brook.

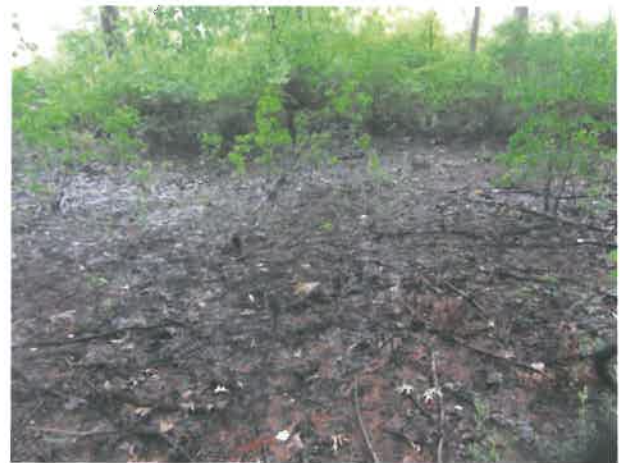
Photo 19. Wetland M-2 is forested wetland in the highway median.

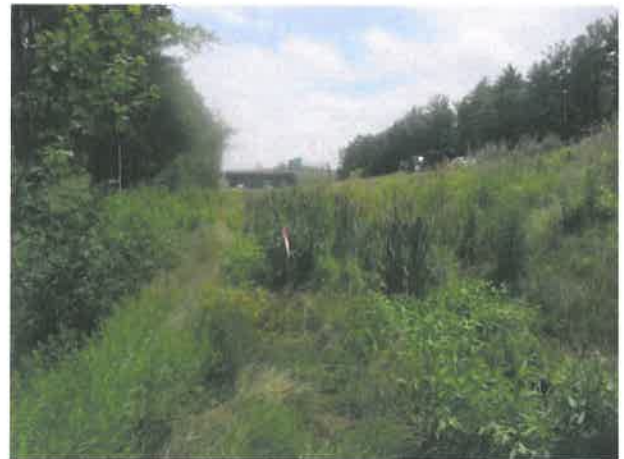
Photo 21. Wetland M-4 is a constructed stormwater treatment wetland on the side of I-93.

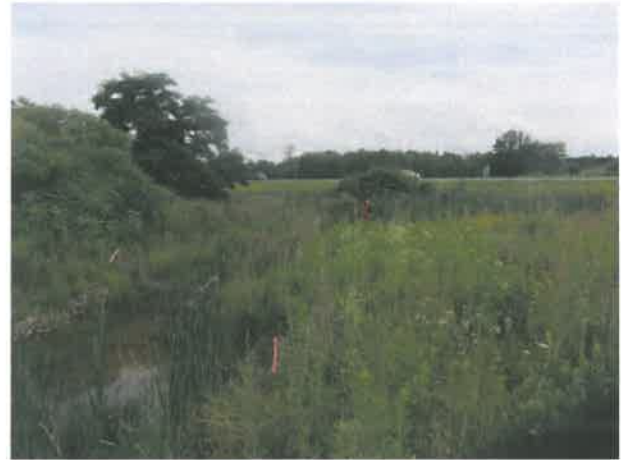
Photo 25. Wetland M-8 is a retention pond.

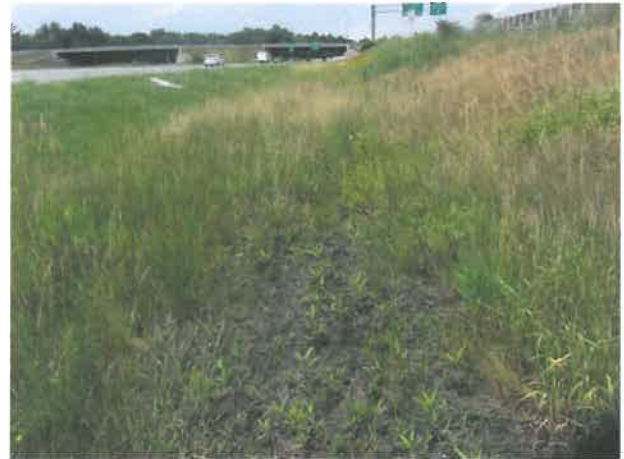
Photo 27. Wetland M-10 is a constructed stormwater treatment wetland.

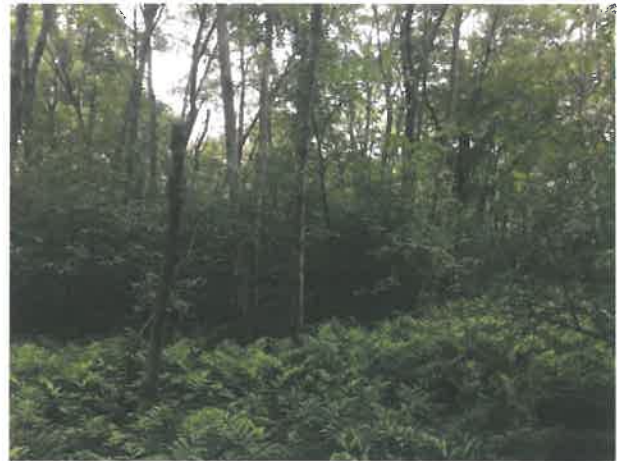
Photo 31. Wetland M-13 is a roadside ditch.

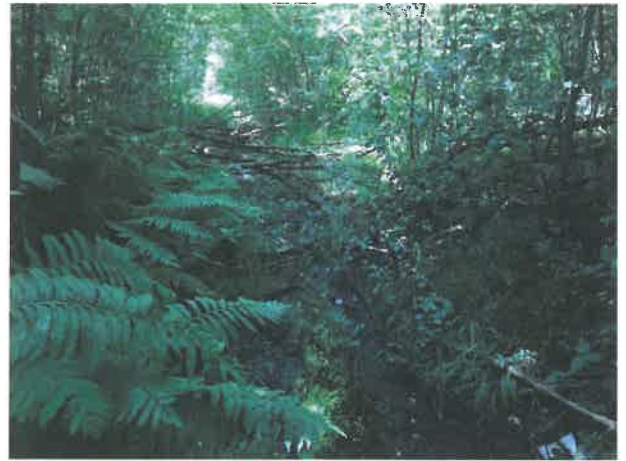
Photo 33. Wetland S-2 is a small forested wetland.

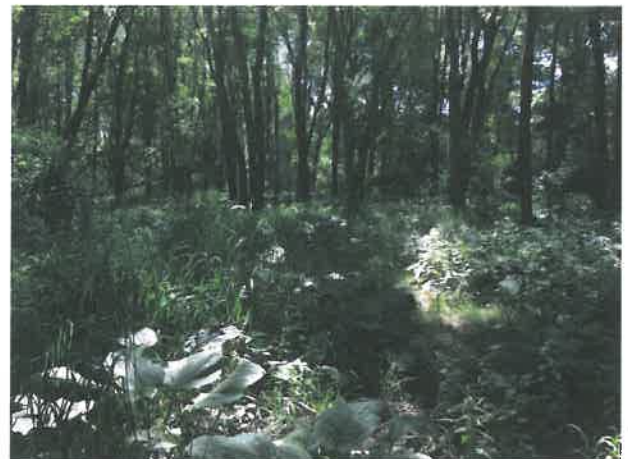
Photo 40. Wetland S-9 is a large forested wetland complex.

Palustrine wetland S-9 is proposed to be impacted by the I-93 roadway widening in Salem. Wetland S-9 is a large palustrine forested (broad leaved deciduous) (PFO1) wetland which continues northwestward after the Harris Brook Tributary terminates. In spots the wetland continues into the yards of residences west of the I-93 corridor. Red maple (*Acer rubrum*) dominates the forest canopy at the USACE plot location. The herb layer consists entirely of slender wood-reed (*Cinna latifolia*). Other plants observed within the wetland include American elm (*Ulmus americana*), glossy false buckthorn (*Frangula alnus*), royal fern (*Osmundastrum spectabilis*), interrupted fern (*Osmunda claytoniana*), jewelweed (*Impatiens capensis*), northeastern manna grass (*Glyceria striata*), and numerous species of sedge (*Carex* spp.).¹

Red maple (*Acer rubrum*) dominates the forest canopy in wetland S-9 at the USACE plot location. The herb layer consists entirely of slender wood-reed (*Cinna latifolia*). Other plants observed within the wetland include American elm (*Ulmus americana*), glossy false buckthorn (*Frangula alnus*), royal fern (*Osmundastrum spectabilis*), interrupted fern (*Osmunda claytoniana*), jewelweed (*Impatiens capensis*), northeastern manna grass (*Glyceria striata*), and numerous species of sedge (*Carex* spp.).

Soils within wetland S-9 meet the criteria for field indicator F-3 – Depleted Matrix as the soil profile contains a 13+ inch layer with a depleted matrix that starts from within ten inches of the mineral soil surface. Water stained leaves (B9) constituted the sole observed indicator of hydrology.

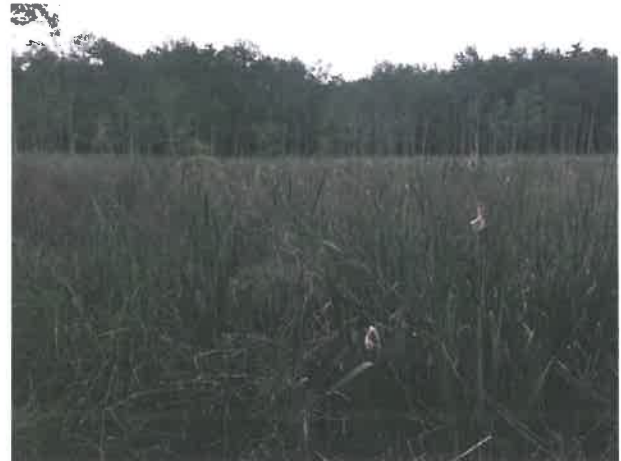
Photo 43. Wetland S-15 is a stormwater treatment wetland.

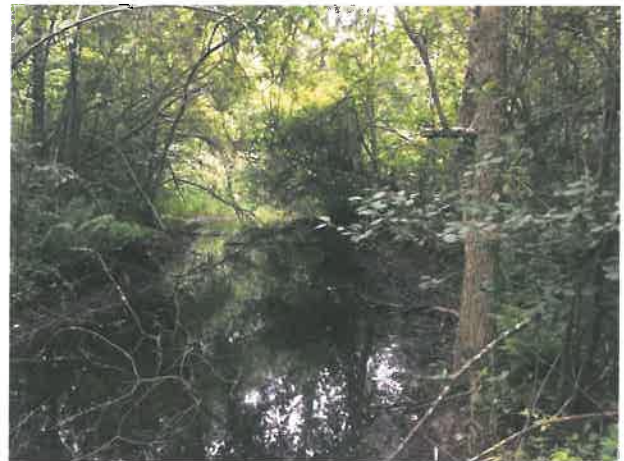
Photo 51. The Spickett River (Stream N-S3) from wetland N1.

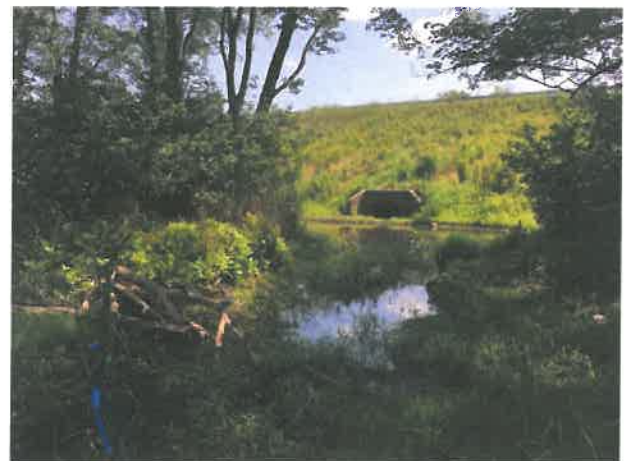
Photo 53. Typical character of streams S-S2 and S-S3.
