Timber, Concrete, and Steel

Bridging Peaslee Road over the Piscataquog River

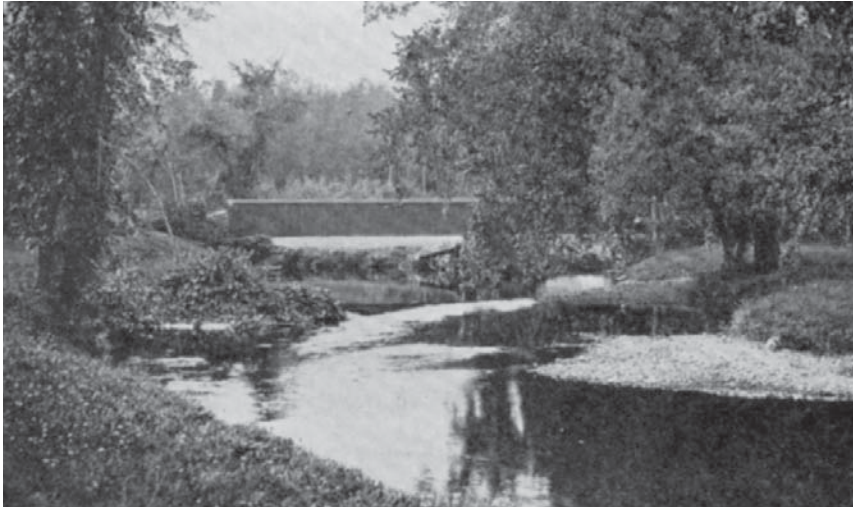
A pre-1907 postcard shows a wooden bridge carrying Peaslee Road over the Piscataquog River. *Courtesy of the Weare Historical Society*

As the nineteenth century progressed, Peaslee Road continued to receive only light traffic related to the Peaslee's mills and farms and the crossing may have retained a wooden bridge. The earliest photographic evidence of a bridge at this location dates from around the turn of the twentieth century and shows a wooden bridge.

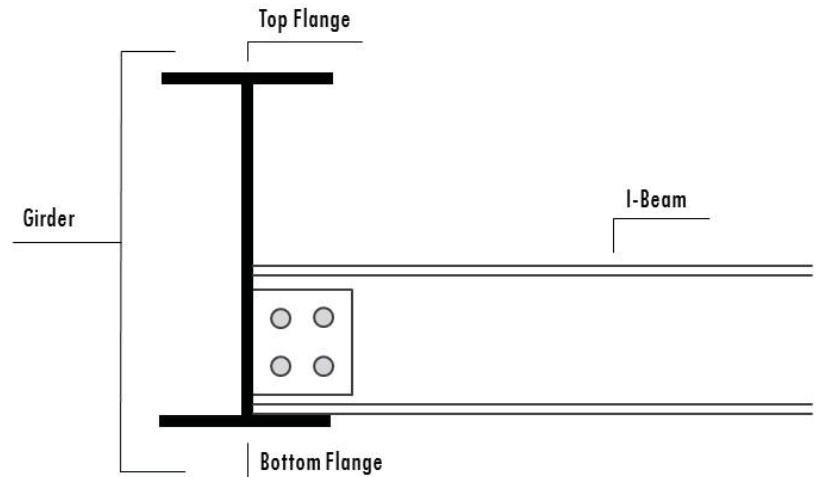
Rolled Girder Diagram

With the advancement of steel production, New Hampshire bridge engineers combined the use of wider flange rolled girders with the 1914 design to increase the total span length. The Peaslee Road Bridge was designed with 33 inch rolled girders with 11 inch wide flanges to span 63 feet. In comparison, the United Construction Company's 1914 Beam Girder design only crossed a 35-foot span.

The Beam Girder bridge type consists of two rolled steel girders supporting I-beam floor beams with a concrete deck. The cover photo illustrates the Peaslee Road Bridge's design: the girders were exterior steel members running parallel with the roadway, while the I-beam floor beams ran under and perpendicular to the roadway. The bridge was further distinguished by the use of rolled girders with wide flanges.

The 1914 Beam Girder design was the result of improved early twentieth-century steel production methods. The wide flange girders found in the design were an advancement in steel production, and specifically, in rolled girder technology. Wider flanges made steel beams stronger. Thus, wide flange girders became popular for constructing longer bridges and taller skyscrapers. Henry Grey of the U.S. Steel Corporation developed this girder around 1900. When Charles M. Schwab quit as president of U.S. Steel in 1904, he bought controlling interest at Bethlehem Steel, a rival competitor. Schwab also bought Grey's patents for wide flange rolled girders and started producing them in 1907. Despite a legal battle with U.S. Steel, Bethlehem Steel retained the patent on the wide flange girders and controlled the technology. In the 1920s Bethlehem Steel finally granted U.S. Steel a license for wide-flange girder production.
