Barron Mountain
Rock Reinforcement Evaluation – Phase I
I-93, Woodstock, New Hampshire

| 4. Title and Subtitle PHASE I: CONDITION ASSESSMENT AND EVALUATION OF ROCK REINFORCEMENT ALONG I-93, BARRON MOUNTAIN ROCK CUT, WOODSTOCK, NEW HAMPSHIRE | | 5. Report Date February 18, 2004 | |
| 7. Author(s) Kenneth L. Fishman, Ph.D., P.E. | | 8. Performing Organization Report No. | |

Project No. 03-024

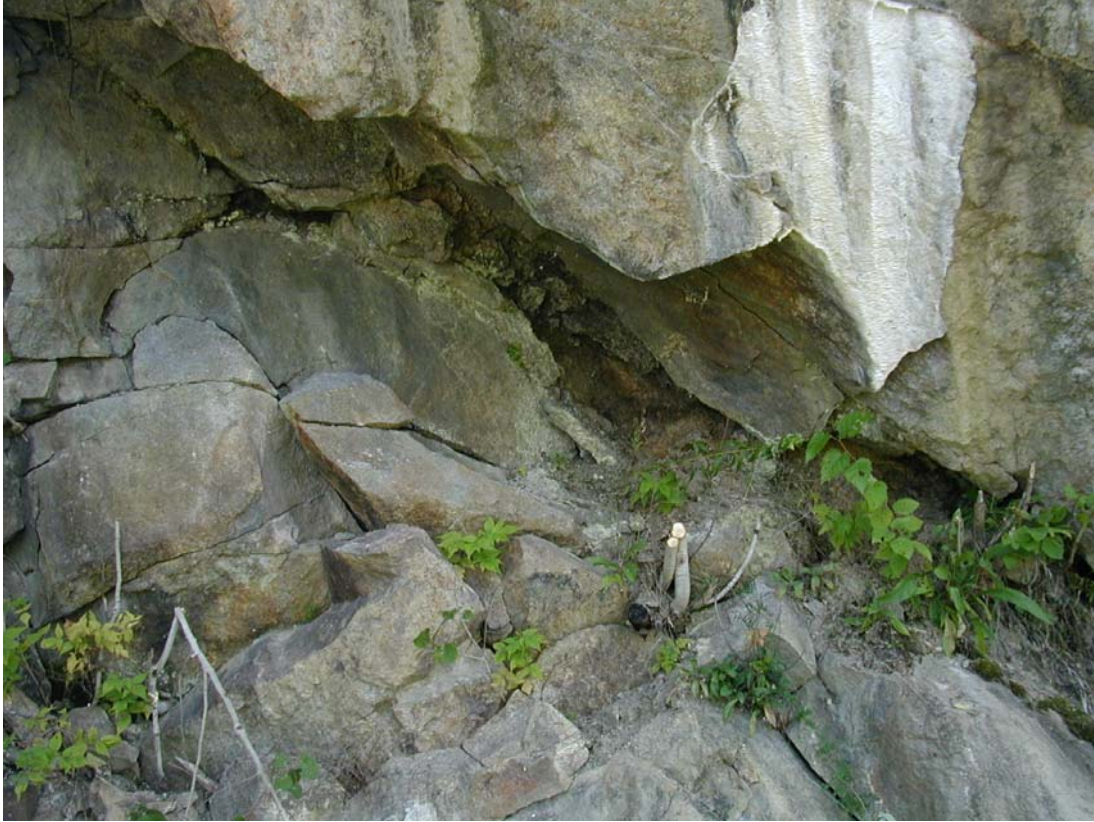
MMCE, together with Marc Fish and Dick Lane from the NHDOT Bureau of Materials and Research, collected samples of weathered rock (see Figure 6) from two locations along the face of the rock cut during MMCE's reconnaissance visit on August 26, 2003, and subsequent fieldwork from September 8, 2003 to September 17, 2003:

Figure 6. Weathered Rock Along Open Rock Joints

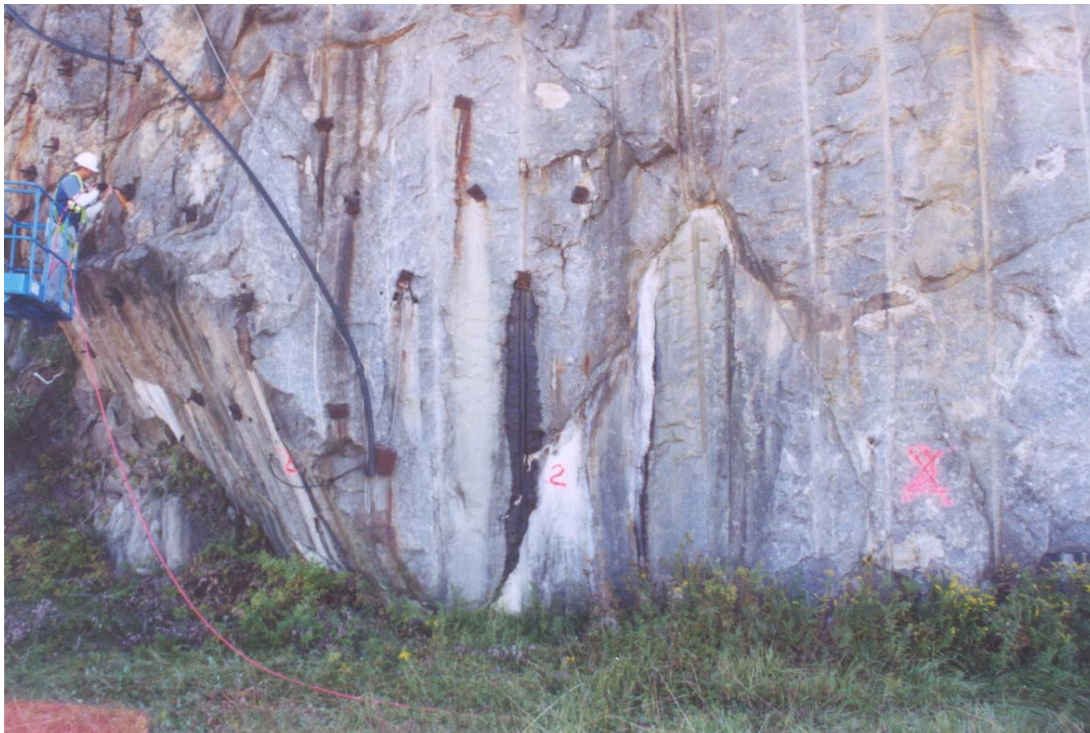
Figure 15. Leaching of Grout Near Tendon Sample 2-2.

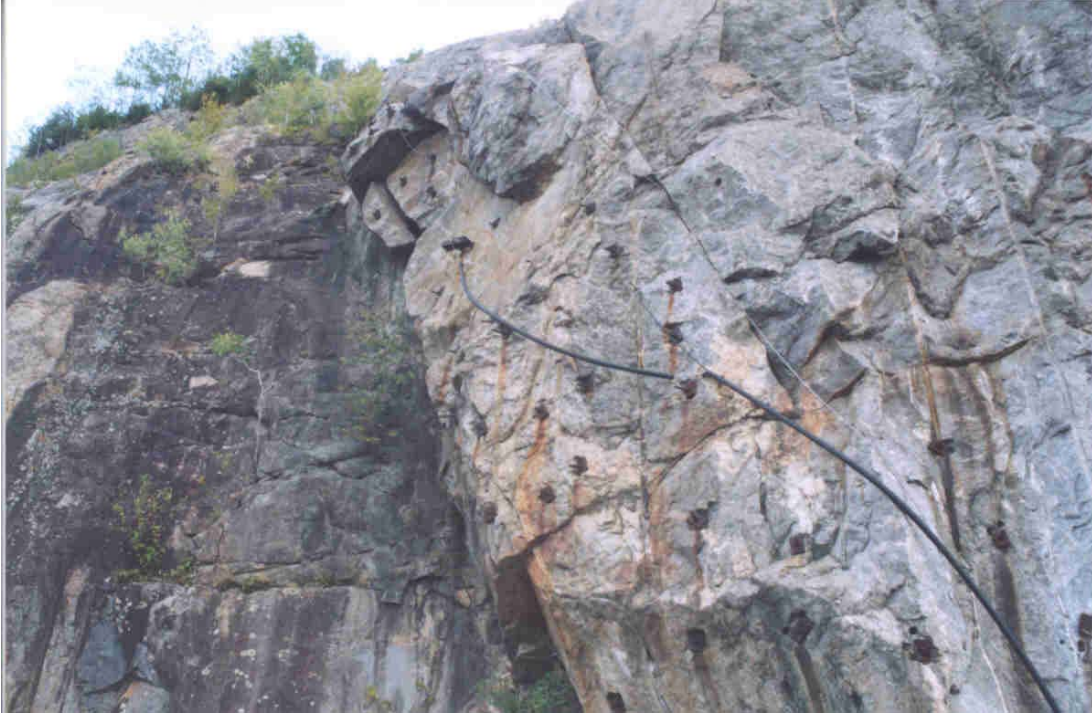
Figure 19. Rockmass Character Near Sta. 1775+25

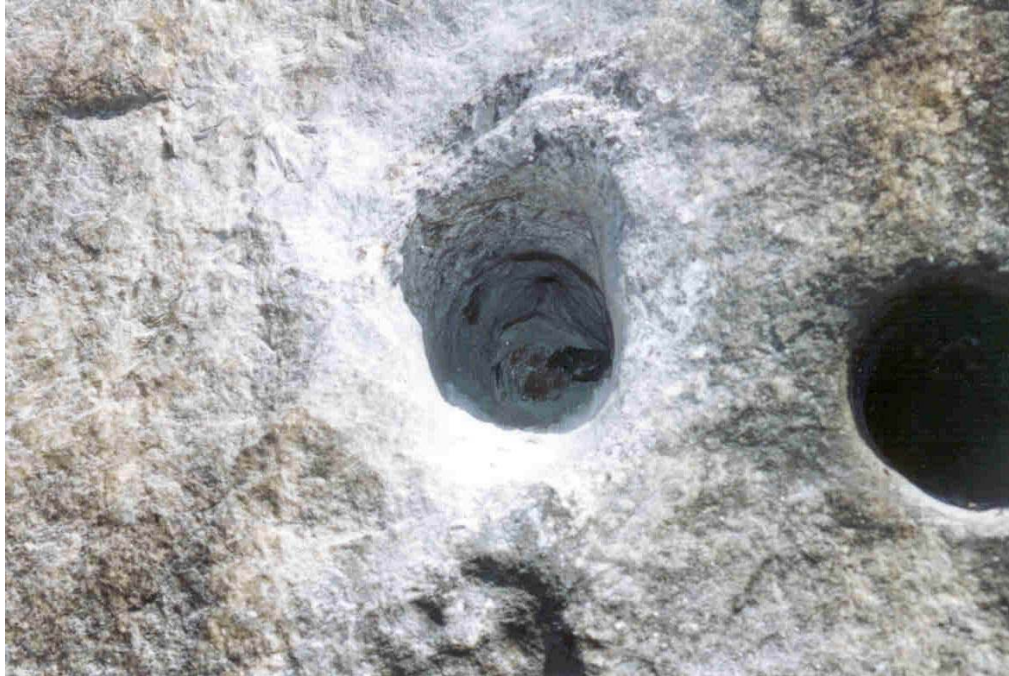
Photograph 1 – Exposed end of Tendon 1-1 after chipping

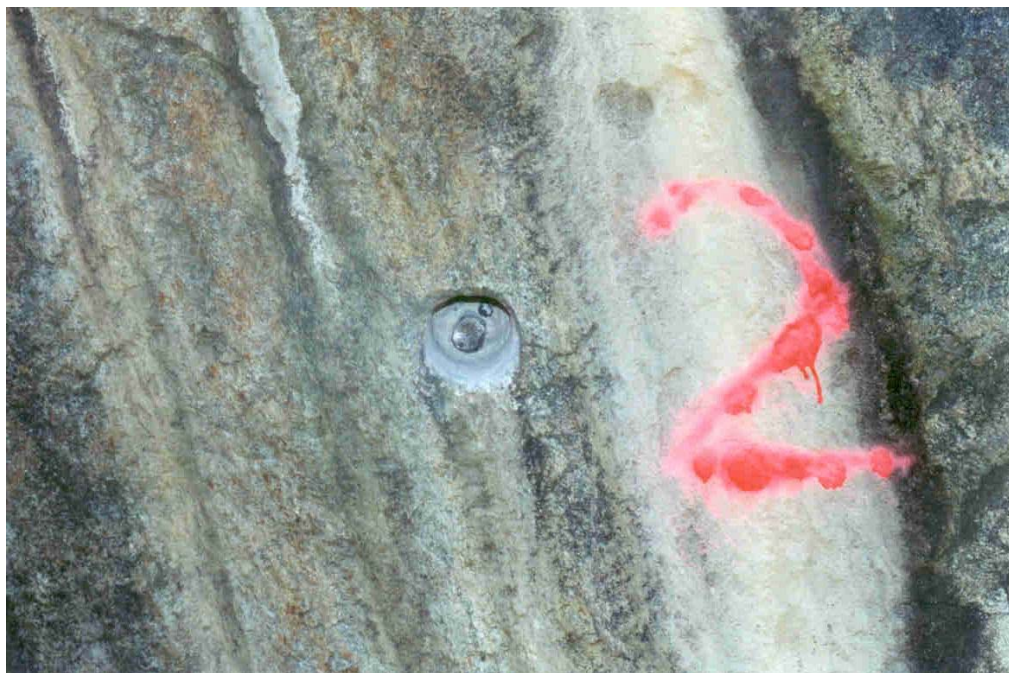
Photograph 2 – Exposed end of Tendon 2-1 after chipping

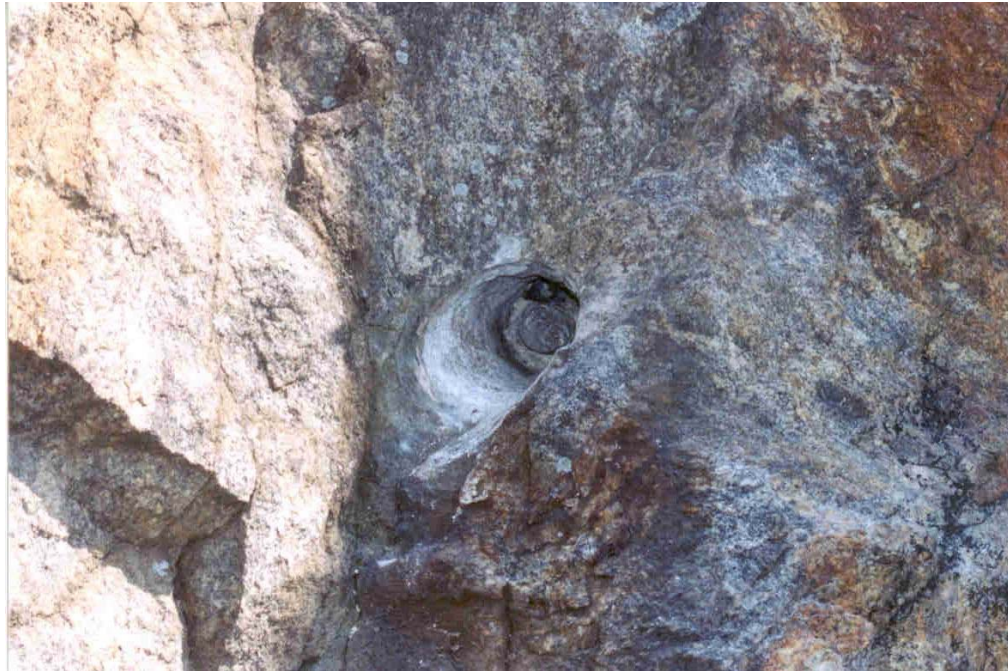
Photograph 5 – Exposed end of Tendon 3-2 after chipping

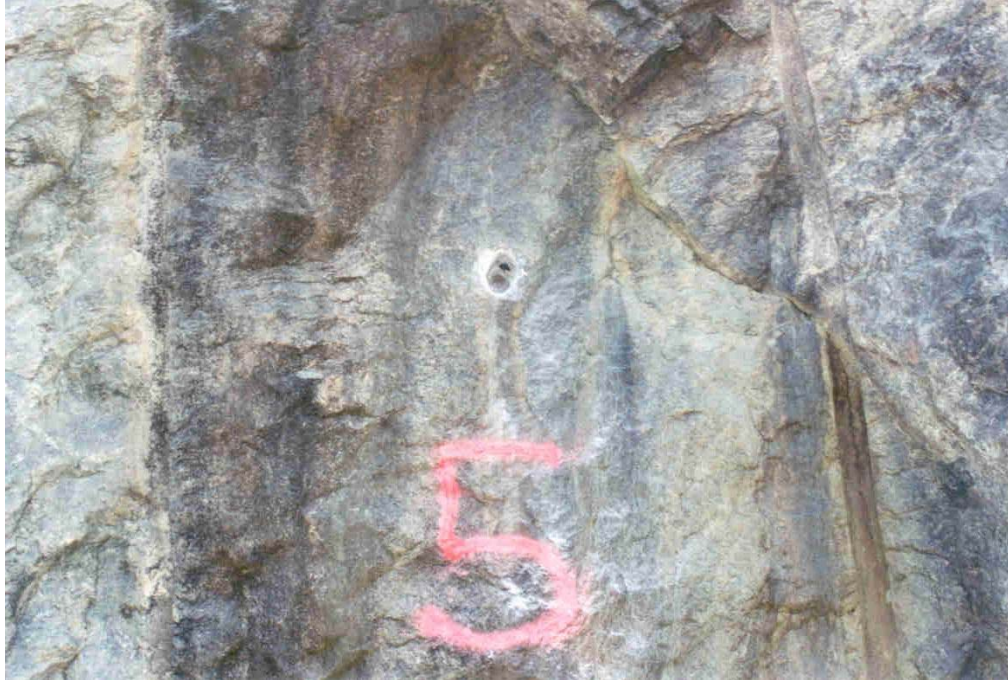
Photograph 9 – Exposed end of Tendon 5-2 after chipping
