Barron Mountain
Rock Reinforcement Evaluation – Phase II
I-93, Woodstock, New Hampshire
Validation of NDT Results for Condition Assessment of
Rock Reinforcements

1. Report No. FHWA-NH-RD-14282C		2. Gov. Acc. No.	3. Recipient's Catalog No.
4. Title and Subtitle PHASE II: CONDITION ASSESSMENT AND EVALUATION OF ROCK REINFORCEMENT ALONG I-93 BARRON MOUNTAIN ROCK CUT, WOODSTOCK, NH Validation of NDT Results for Condition Assessment of Rock Reinforcements		5. Report Date SEPTEMBER, 2005

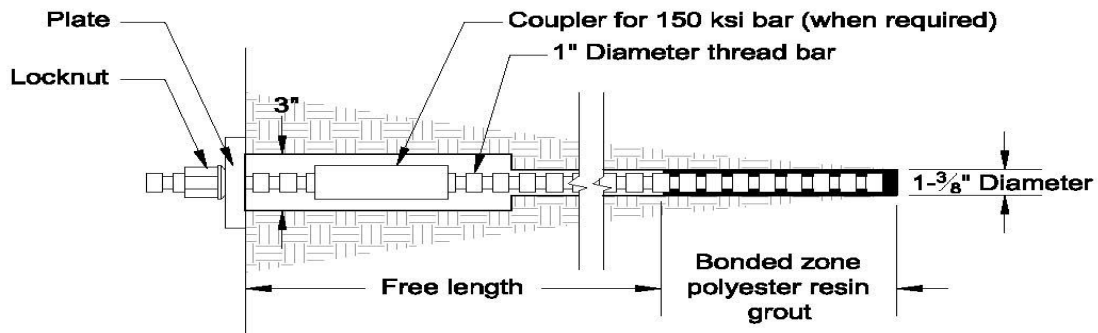
Figure 2. Rock Bolt Details

Figures 2 and 3 portray the rock bolt and tendon installations, respectively. Rock bolts and rock tendons include 1 inch and 1.25 inches diameter steel thread bars, respectively. Most of the reinforcements are Dywidag, Grade 150, high-strength prestressing steel thread bars. Some rock bolts are Grade 80 threaded steel rods supplied by Bethlehem Steel. Prestressed rock bolts are essentially end point anchorages, grouted at the distal end with polyester resin grout, and supported by an anchorage assembly consisting of a nut and a bearing plate at the rock face (proximal end). Rock bolts were initially prestressed to 20 or 40 kips depending on the steel grade. Tendon elements are fully grouted with Portland cement grout, and the proximal ends are recessed into the rock mass. The tendons are passive elements, i.e. they were not prestressed, and there is no anchorage assembly.

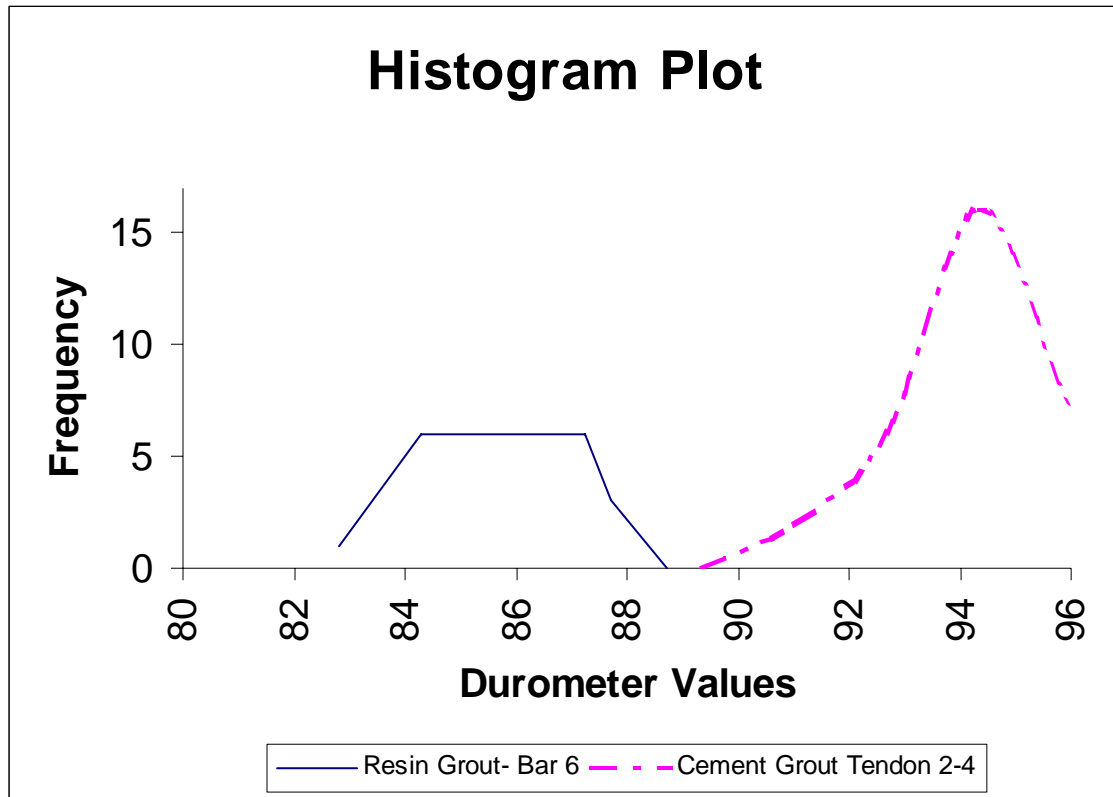
Figure 7. Histogram of Resin Grout and Portland Cement Grout Hardness Measurements.

Figure 7 compares histograms for the Portland cement and resin grout hardness measurements. Hardness measurements for the Portland cement grout ranged between 84 and 96, with an average of 93 and standard deviation 2.1. Hardness measurements for the polyester resin grout ranged between 83 and 90, with an average of 85 and standard deviation 1.8. The comparison shown in Figure 7 indicates that hardness testing may be a useful technique to identify grout type. Grout hardness measurements are very consistent along both samples. Based on this data, differences between Portland cement or resin grout condition appear to be more in terms of the amount of coverage of the reinforcement elements, rather than with respect to the consistency of the different grout mixtures.

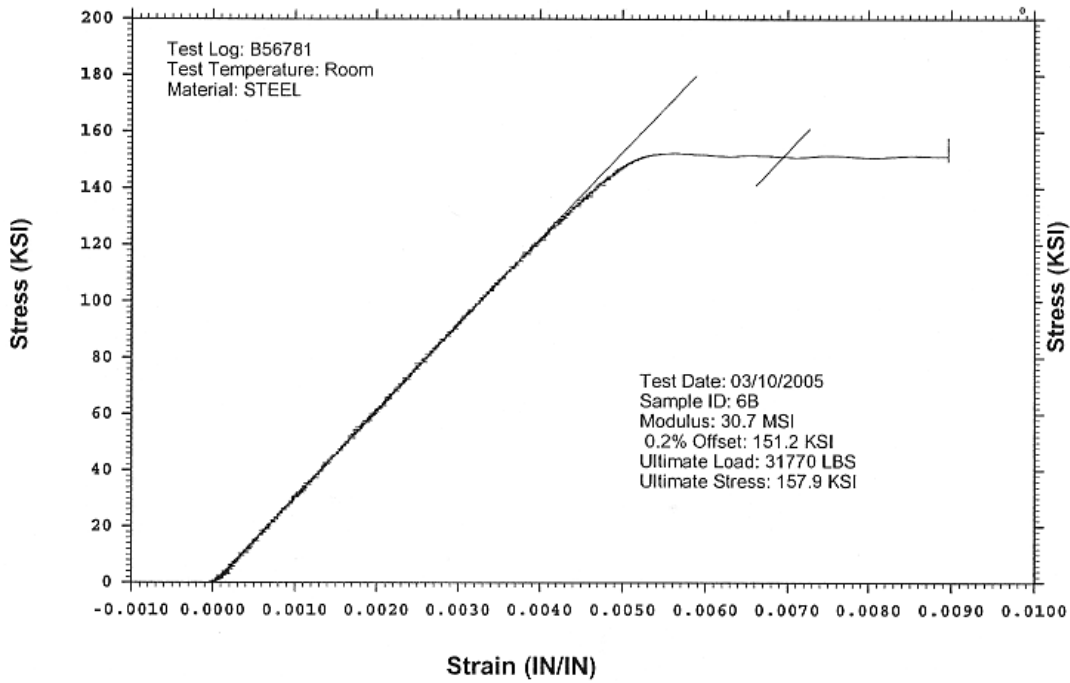
(a) Typical Response

Full specimens had a lower strain at break compared to the machined specimens, and the break occurred near the grips used to secure the ends of the specimen. This may have affected the measurement of strain for the full sections because the break did not occur between the gage points. The machined specimens broke near the middle of the specimens. Otherwise, similar results were obtained from the full and machined sections. With one exception, the strength data are consistent with the specifications for Dywidag Grade 150 thread bar (ASTM A722 steel). Specimen 16A, had a larger strain at break compared to the other specimens and a yield stress below expectations. The ultimate tensile stress for Specimen 16A was consistent with the other samples. A possible explanation for the discrepancy is that specimen 16A was weakened from intergranular corrosion as evidenced from the SEM examination of the fracture surface for this bolt and described in the preceding section. Figures 11 (a) and (b) depicts the stress strain curve for specimen 16A compared to a typical stress-strain curve obtained for the thread bar.

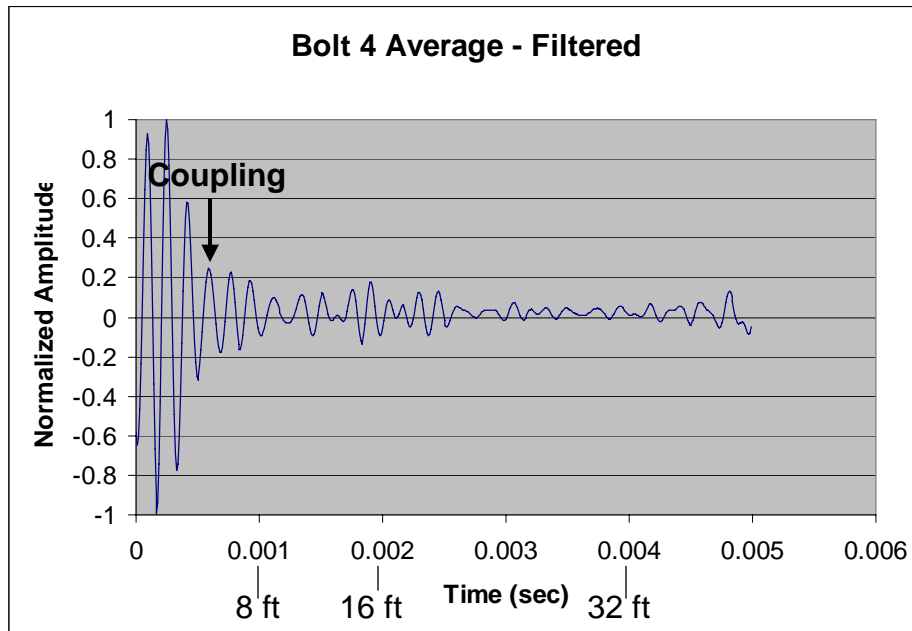
(a) Rock Bolt – G-19 (MMCE #4)

The compression wave velocity of steel is taken as 16,000 ft/sec and 12,000 ft/sec for Portland cement grout. Reflections were observed from relatively proximal locations denoted as L_1 , and from a more distal location, L_2 , often corresponding to the length of the bolts (L_T). Direct observations are described in the comments column including loss of section from corrosion, the presence of couplings and rock conditions observed during drilling of replacement bolts as noted on the drillers logs (Appendix V). In most cases L_1 and L_2 are either correlated with direct physical observations, or with the known lengths of the bolts; within approximately three feet, i.e., corresponding to the wavelength inherent to the impact test. Figures 12 (a), (b) (c) and (d) depict reflections observed along Rock Bolts G-19, G-8 (MMCE #4 and #6) and MMCE #16, and Tendon - MMCE # 2-4.

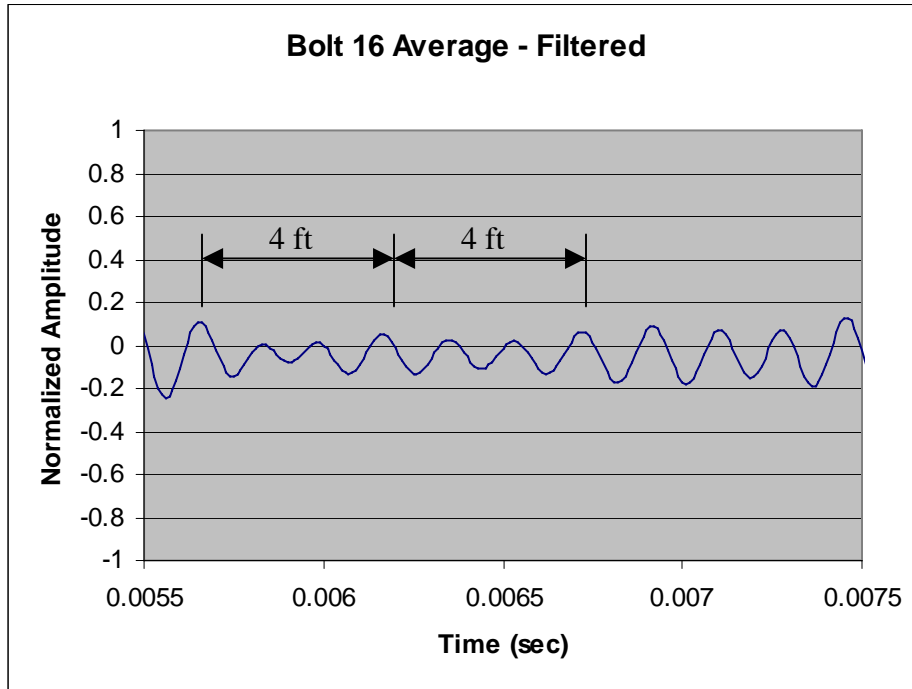
(c) Rock Bolt – MMCE #16

Evaluation of test data from MMCE #16, as shown in Figure 12 (c), indicates that a preexisting fracture surface at four feet from the proximal end of the bolts may be evident in the impact test data. However, these reflections are very subtle and could easily be overlooked without knowledge of the existence of this fracture surface.

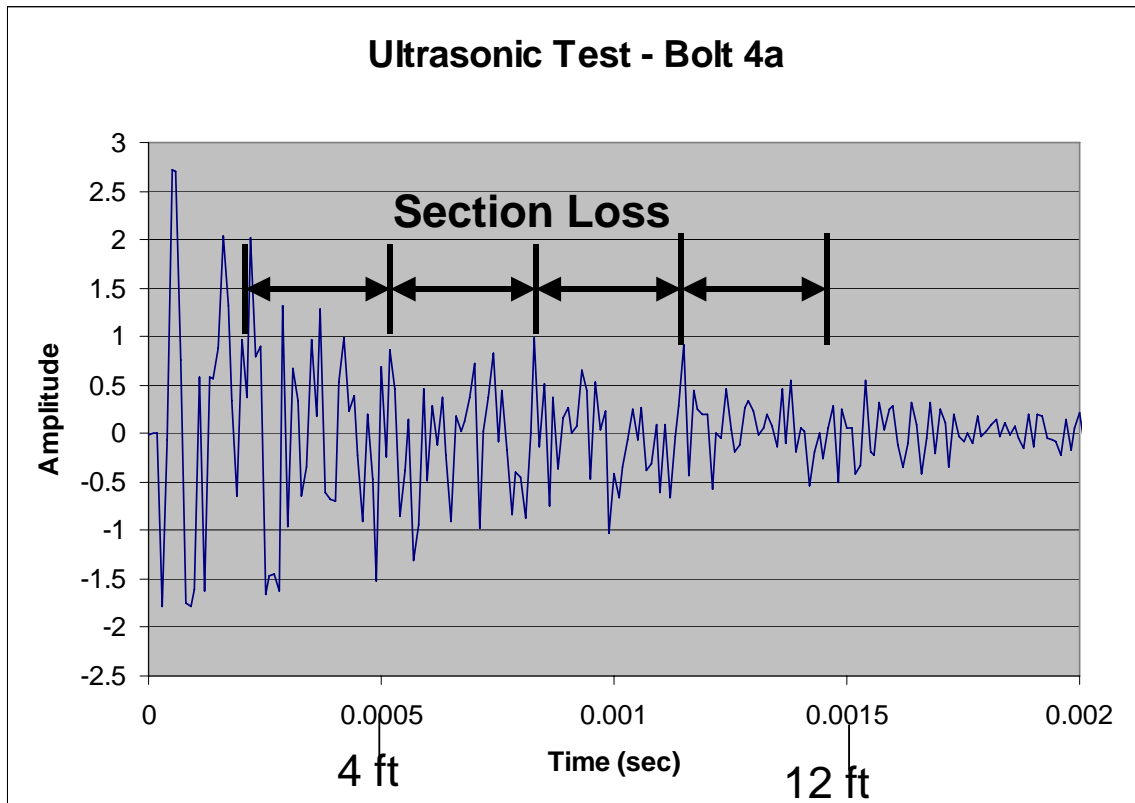
Figure 13. Wave Form From Ultrasonic Test for G-19 (MMCE #4).

Given the details of the anchor head assembly, reflections from a loss of section directly behind the anchor plate are difficult to identify from results of ultrasonic testing. This is because the data are masked by a strong reflection from the anchor head location. Results from the ultrasonic test on Bolt G-19 (MMCE #4) are shown in Figure 13 and a relatively subtle reflection approximately two feet from the end of the element is evident corresponding to the area where significant loss of cross section ($\approx 20\%$) is observed.
